HEADQUARTERS
6497 PARKLAND DR., STE. C
SARASOTA, FLORIDA 34243
PH: 941-727-2600 FX: 941-758-5012
www.delta-engineers.com

Project No. R1610-042

Mr. Bob Kresnik
Vintage Grand Condominium Association, Inc.
4012 Crockers Lake Blvd.
Sarasota, Florida 34238

RE: DRAFT Attic Survey – Vintage Grand

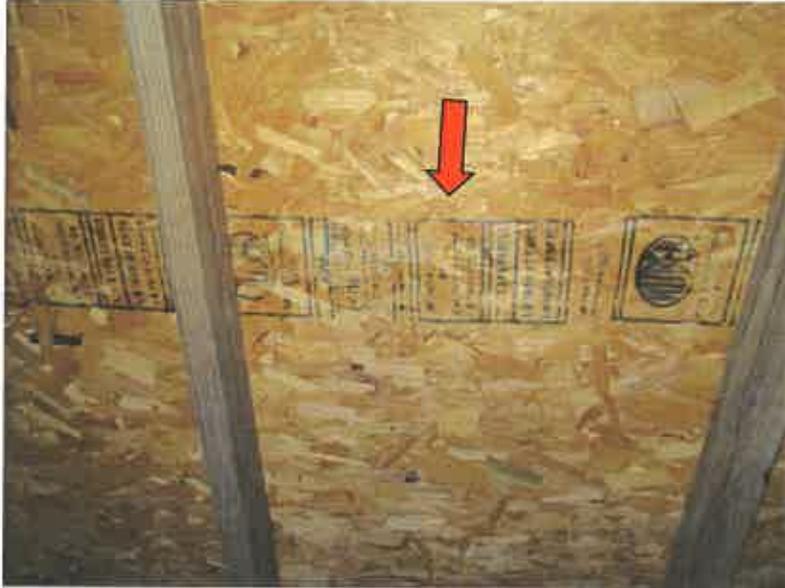
PHOTOGRAPH #1

**VINTAGE GRAND
UNIT #2824
Sheathing Grade Stamp**

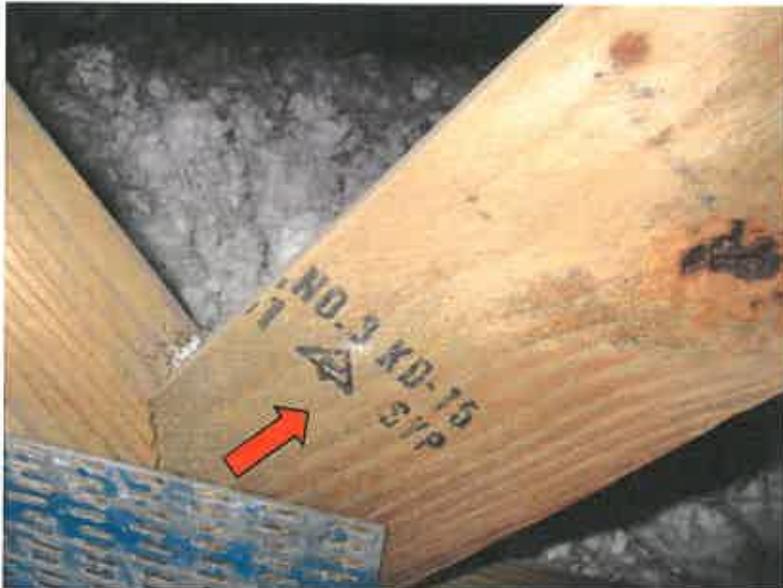
PHOTOGRAPH #2

**VINTAGE GRAND
UNIT #2226
Lumber Grade Stamp**

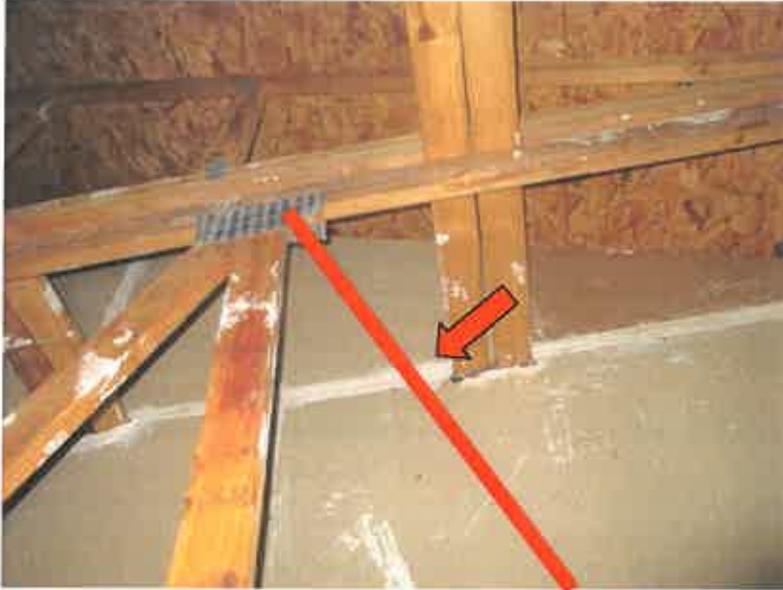
PHOTOGRAPH #3

**VINTAGE GRAND
UNIT #2221
Missing Member**

A structural analysis will be required on each truss profile to determine the appropriate repair details. The missing, broken, damaged, and defective truss members should be reinforced with new framing members in accordance with the 2014 Florida Building Code, BCSI-B5, and construction standards; the joints with missing, offset, damaged, and disengaged truss plates reinforced with new plywood gusset plates in accordance with the 2014 Florida Building Code, BCSI-B5, and construction standards; the piggy back trusses should be strapped to the main trusses in accordance with the 2014 Florida Building Code and construction standards; the permanent lateral restraint installed in accordance with the 2014 Florida Building Code, BCSI-B3, and construction standards; and the holes in and damage to the firewalls repaired to restore the fire rating in accordance with the 2014 Florida Building Code and construction standards. In addition, the damaged and stained roof sheathing should be replaced in accordance with the *NRCA Roofing Manual (Exhibit VII)*; however, this work should be performed by a roofing contractor when performing the repair or replacement of the roof.

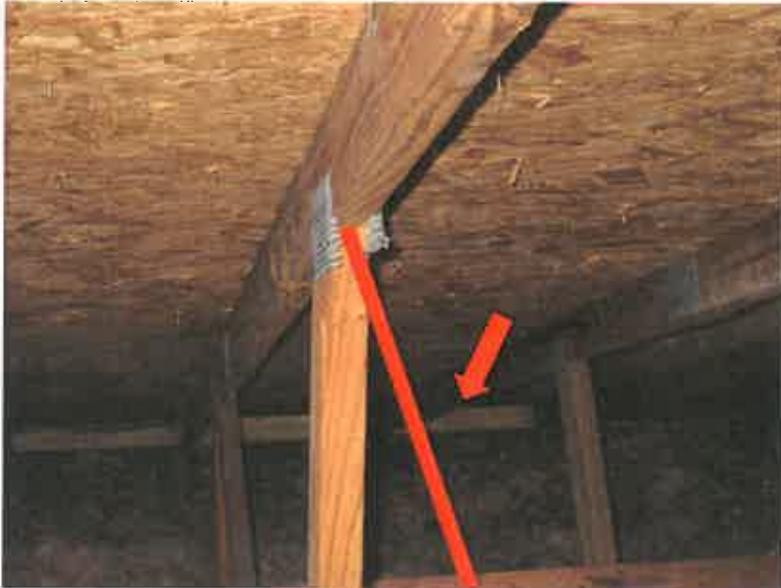
PHOTOGRAPH #4

**VINTAGE GRAND
UNIT #1823
Missing Member**

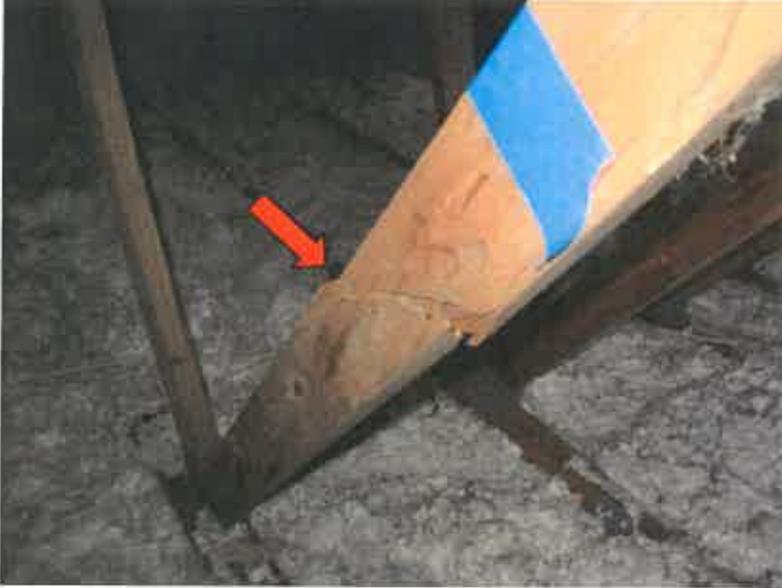
PHOTOGRAPH #5

**VINTAGE GRAND
UNIT #2824
Broken / Damaged Member**

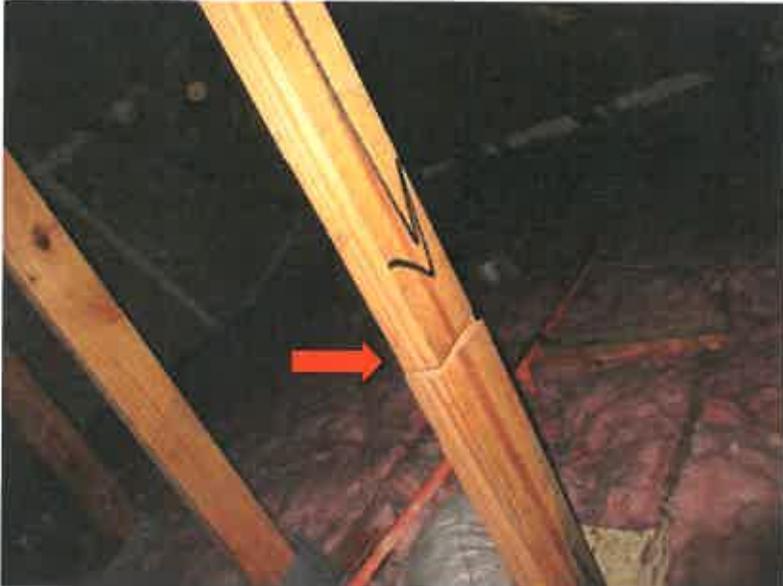
PHOTOGRAPH #6

**VINTAGE GRAND
UNIT #422
Broken / Damaged Member**

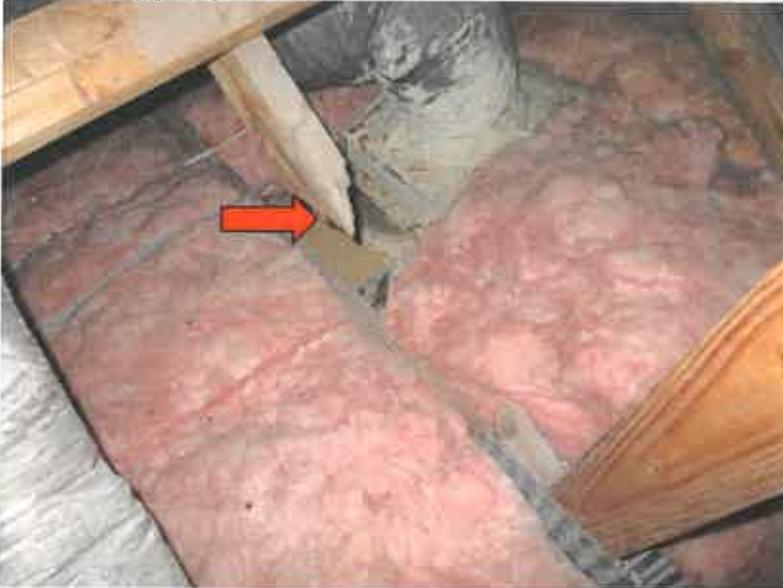
PHOTOGRAPH #7

**VINTAGE GRAND
UNIT #2821
Broken / Damaged Member**

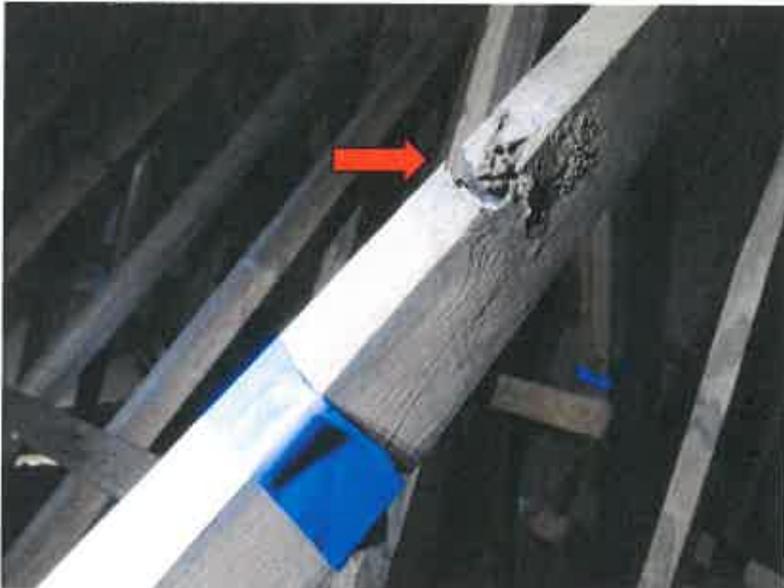
PHOTOGRAPH #8

**VINTAGE GRAND
UNIT #2722
Material Defect in Member**

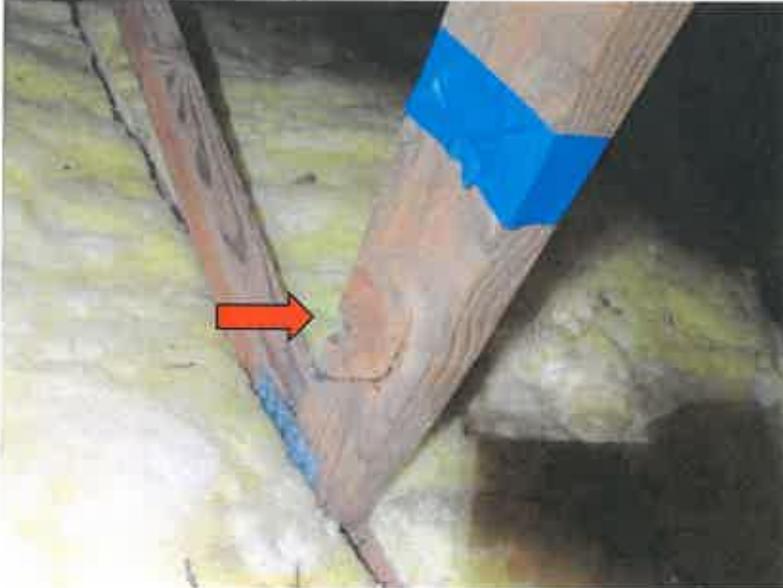
PHOTOGRAPH #9

**VINTAGE GRAND
UNIT #2722
Material Defect in Member**

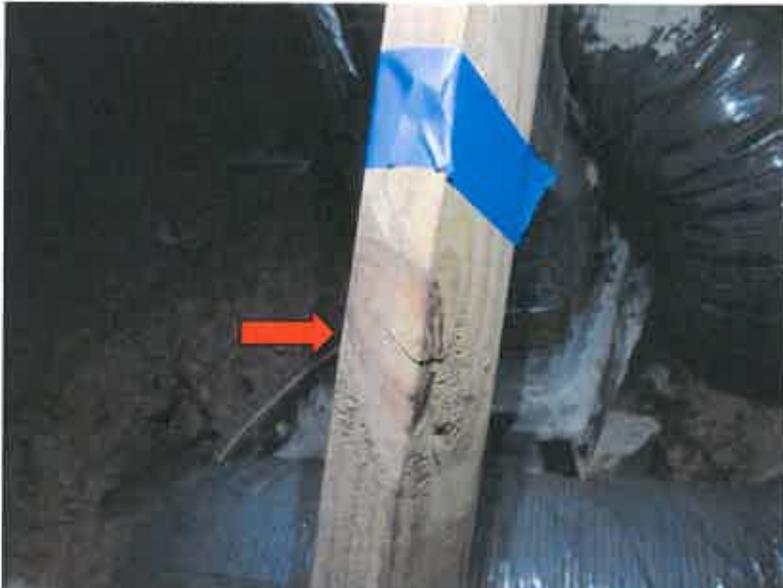
PHOTOGRAPH #10

**VINTAGE GRAND
UNIT #2722
Material Defect in Member**

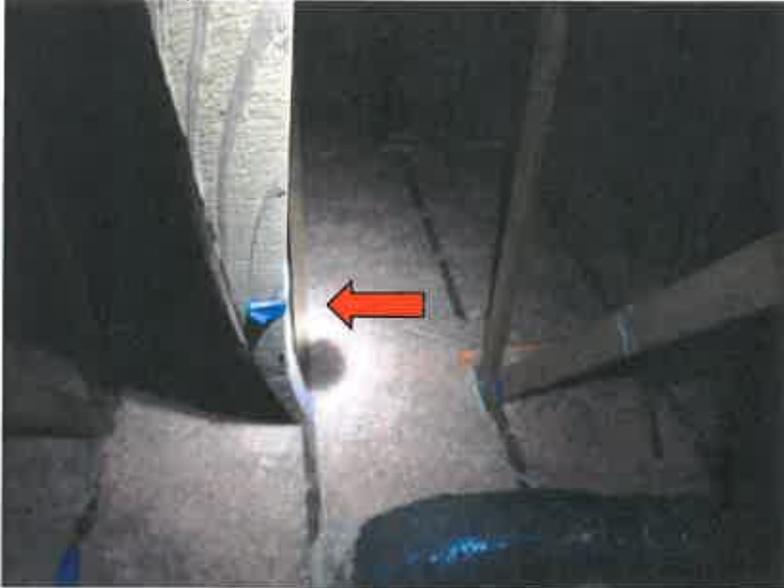
PHOTOGRAPH #11

**VINTAGE GRAND
UNIT #2628
Deflected Member**

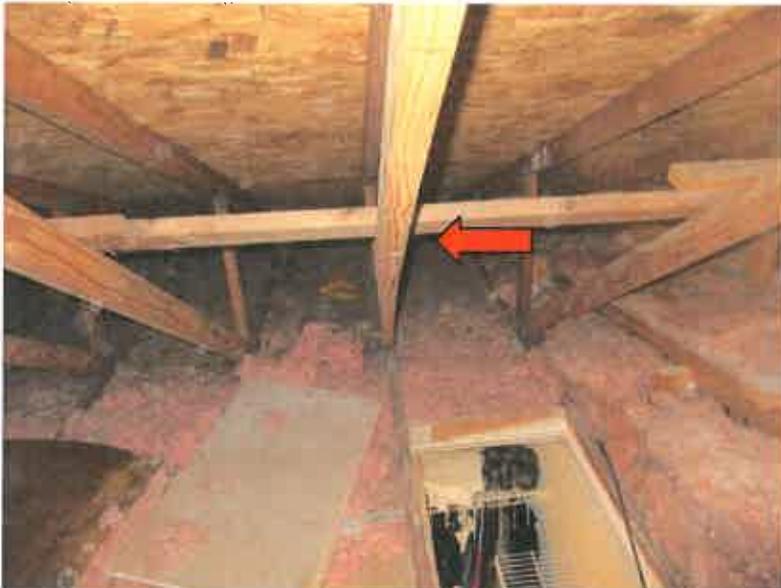
PHOTOGRAPH #12

**VINTAGE GRAND
UNIT #2023
Deflected Member**

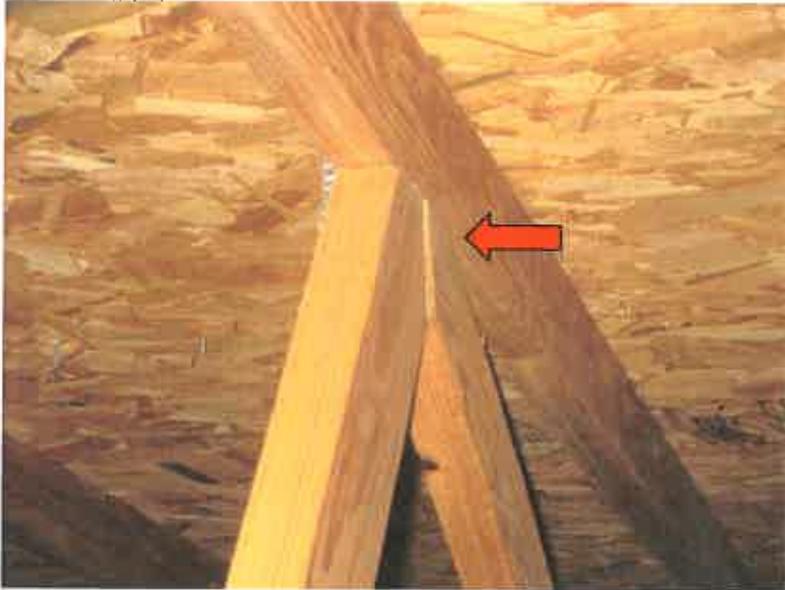
PHOTOGRAPH #13

**VINTAGE GRAND
UNIT #2221
Missing Truss Plate**

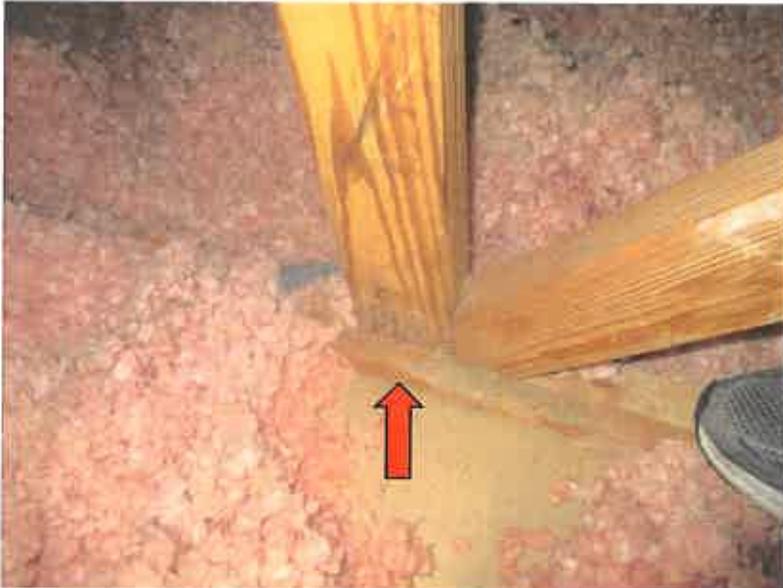
PHOTOGRAPH #14

**VINTAGE GRAND
UNIT #2221
Missing Truss Plate**

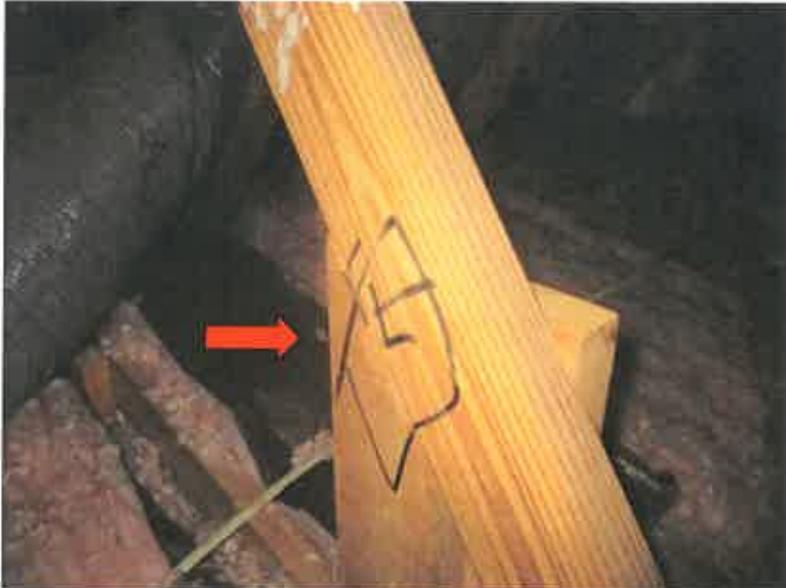
PHOTOGRAPH #15

**VINTAGE GRAND
UNIT #2221
Missing Truss Plate**

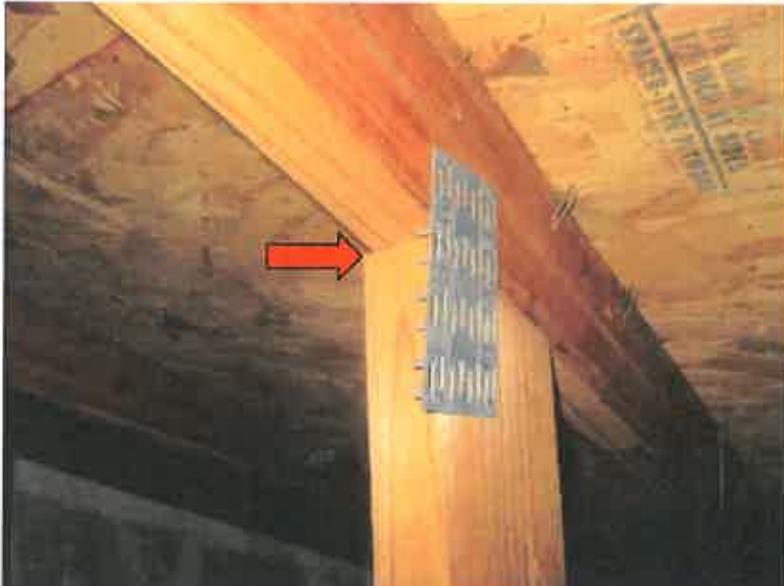
PHOTOGRAPH #16

**VINTAGE GRAND
UNIT #1925
Offset Truss Plate**

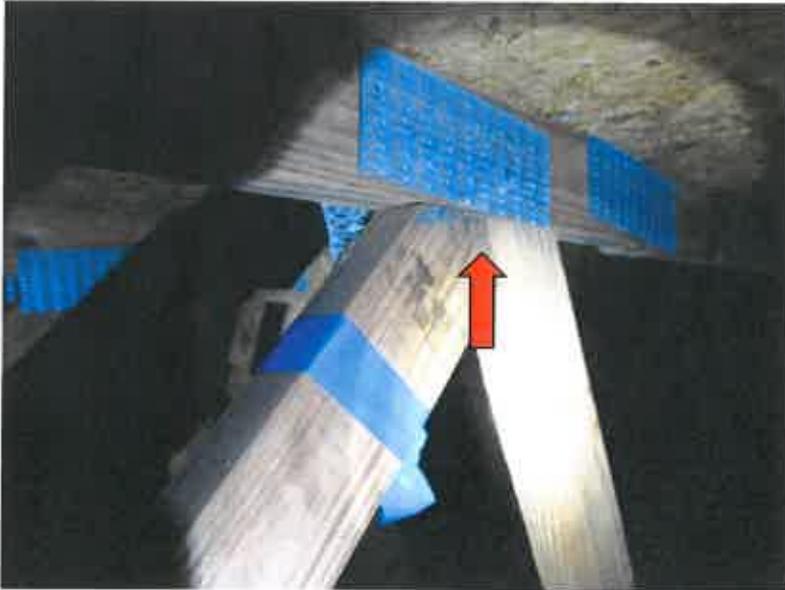
PHOTOGRAPH #17

**VINTAGE GRAND
UNIT #2628
Offset Truss Plate**

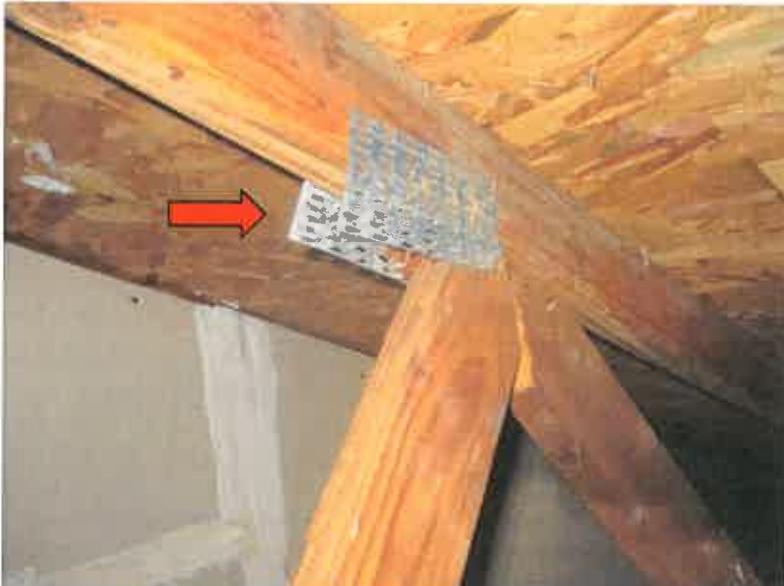
PHOTOGRAPH #18

**VINTAGE GRAND
UNIT #2221
Offset Truss Plate**

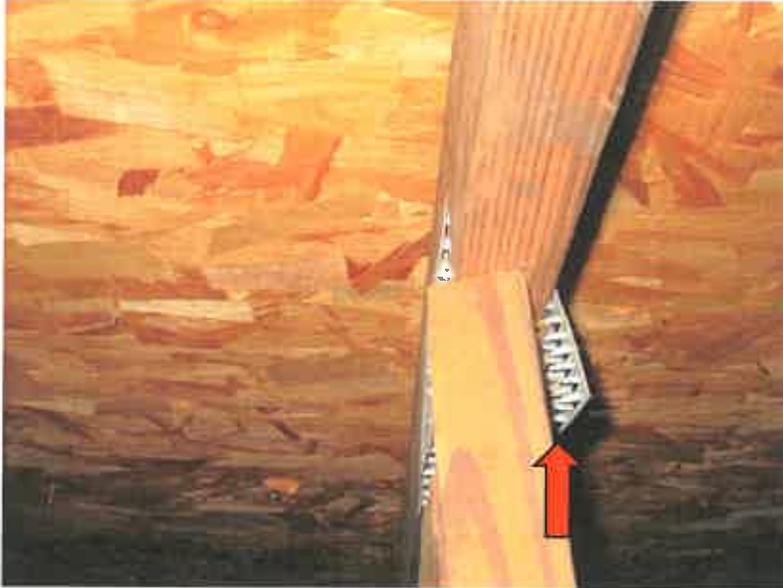
PHOTOGRAPH #19

**VINTAGE GRAND
UNIT #2523
Not Engaged / Damaged Truss Plate**

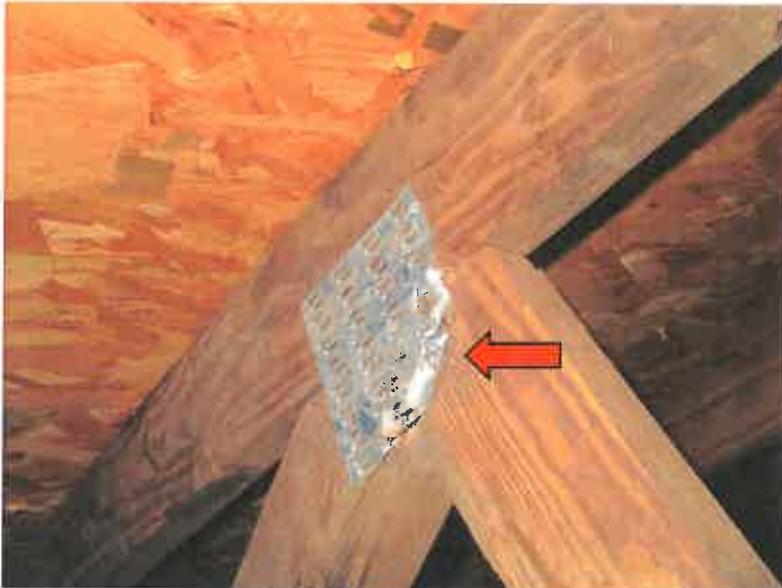
PHOTOGRAPH #20

**VINTAGE GRAND
UNIT #2523
Not Engaged / Damaged Truss Plate**

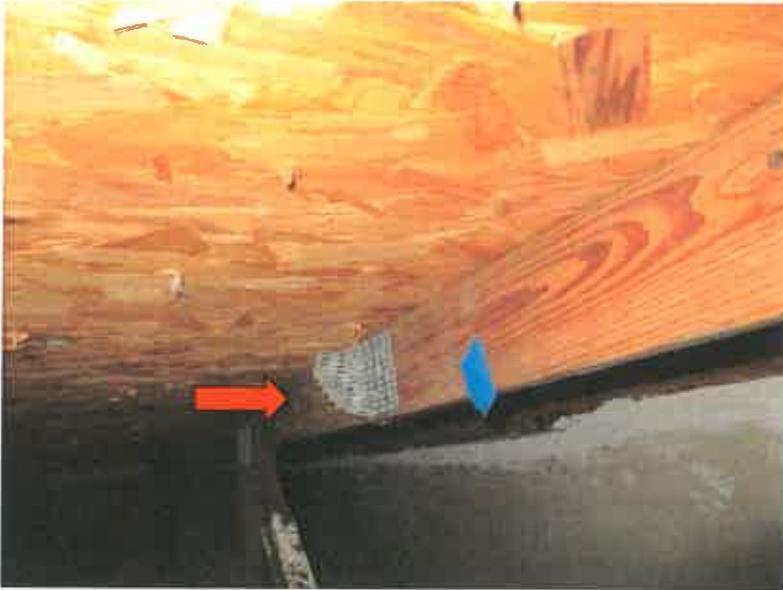
PHOTOGRAPH #21

**VINTAGE GRAND
UNIT #2523
Not Engaged / Damaged Truss Plate**

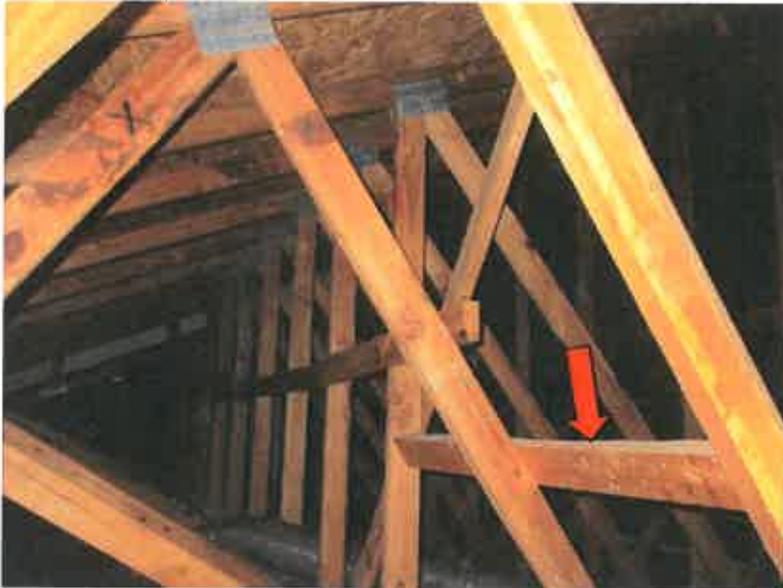
PHOTOGRAPH #22

**VINTAGE GRAND
UNIT #1421
Incorrect Lateral Bracing**

It is further our opinion that repairs must be made to the lateral bracing to restore the structural integrity of the roof system, in accordance with BCSI-B3 *Permanent Restraint/Bracing of Chords and Web Members (Exhibit VI)*:

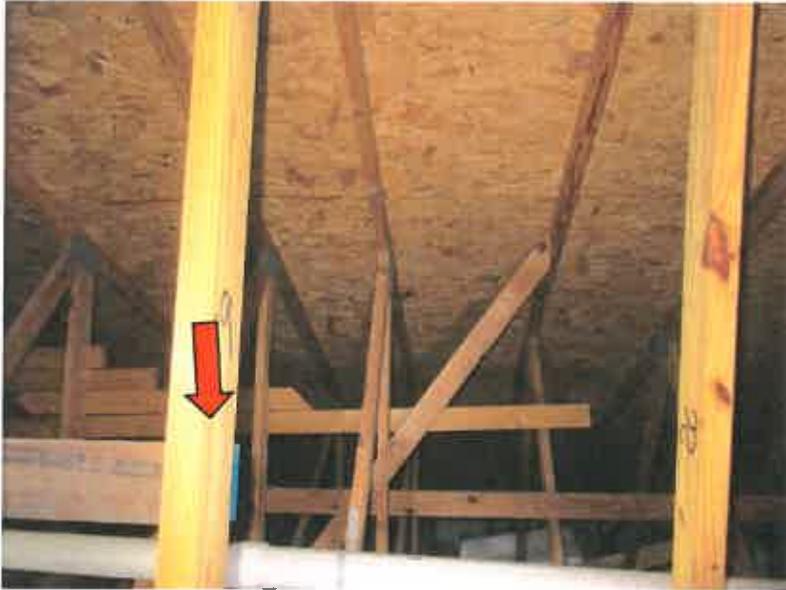
PHOTOGRAPH #23

**VINTAGE GRAND
UNIT #1422
Incorrect Lateral Bracing**

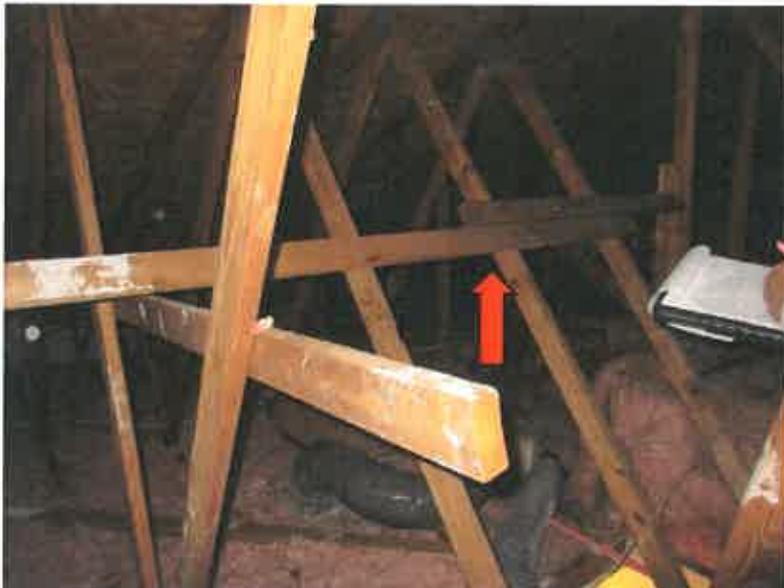
PHOTOGRAPH #24

**VINTAGE GRAND
UNIT #1424
Incorrect Lateral Bracing**

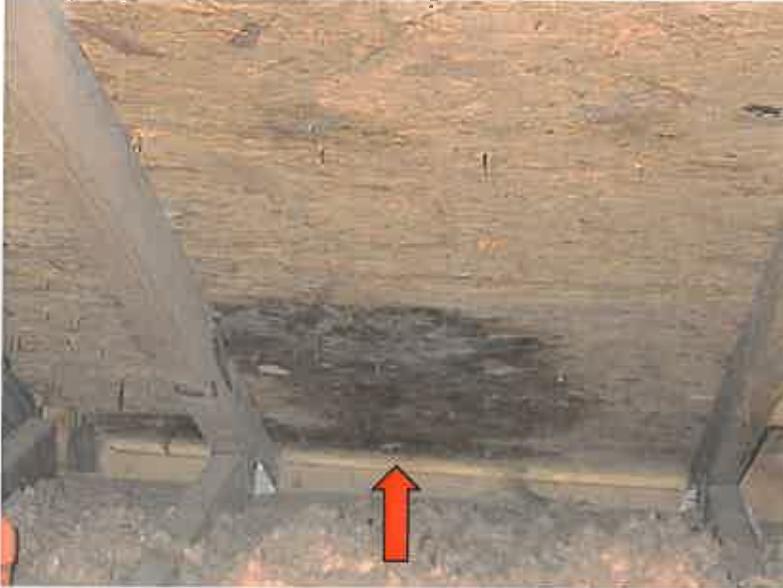
PHOTOGRAPH #25

**VINTAGE GRAND
UNIT #1628
Water Damage in the Sheathing**

It is further our opinion that repairs must be made to the roof sheathing, in accordance with 2014 NRCA Roofing Manual: An Architectural Metal Flashing, Condensation and Air Leakage Control, and Reroofing, *Deck Damage (Exhibit VII)*:

NRCA, §4.7 Deck Damage – Water-damaged or otherwise deteriorated plywood or OSB structural panels should be removed and replaced with new panels of matching type, thickness and size....

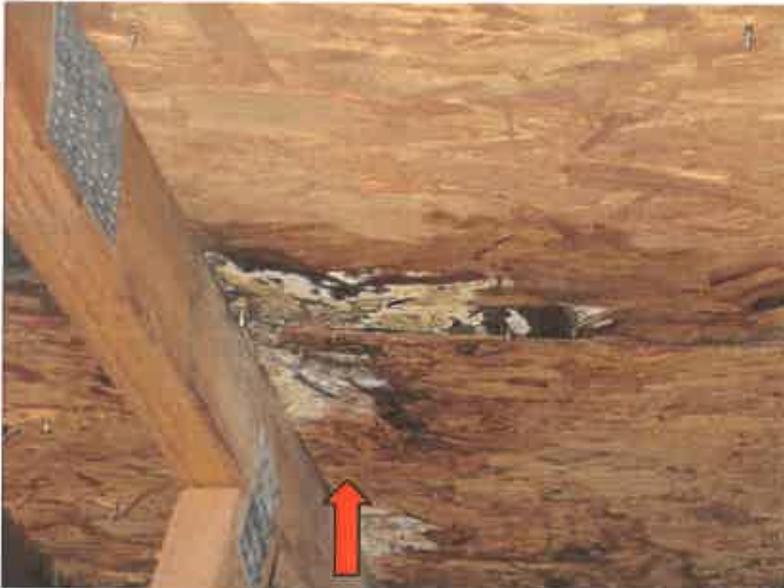
PHOTOGRAPH #26

**VINTAGE GRAND
UNIT #1628
Water Damage in the Sheathing**

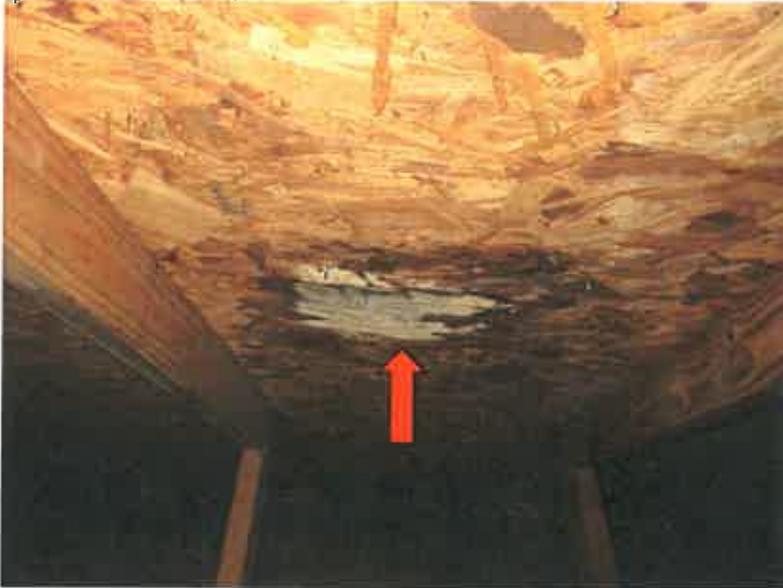
PHOTOGRAPH #27

**VINTAGE GRAND
UNIT #1628
Water Damage in the Sheathing**

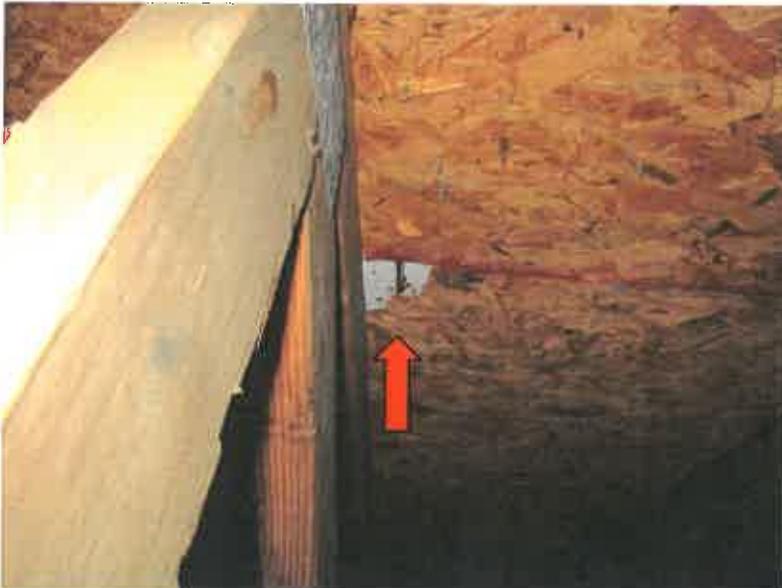
PHOTOGRAPH #28

**VINTAGE GRAND
UNIT #2823
Damage or Holes in the Sheathing**

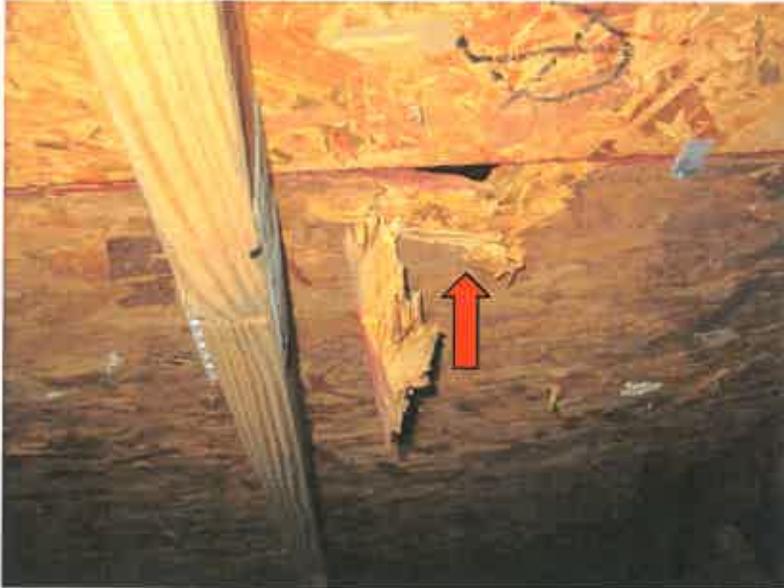
PHOTOGRAPH #29

**VINTAGE GRAND
UNIT #2823**
Damage or Holes in the Sheathing

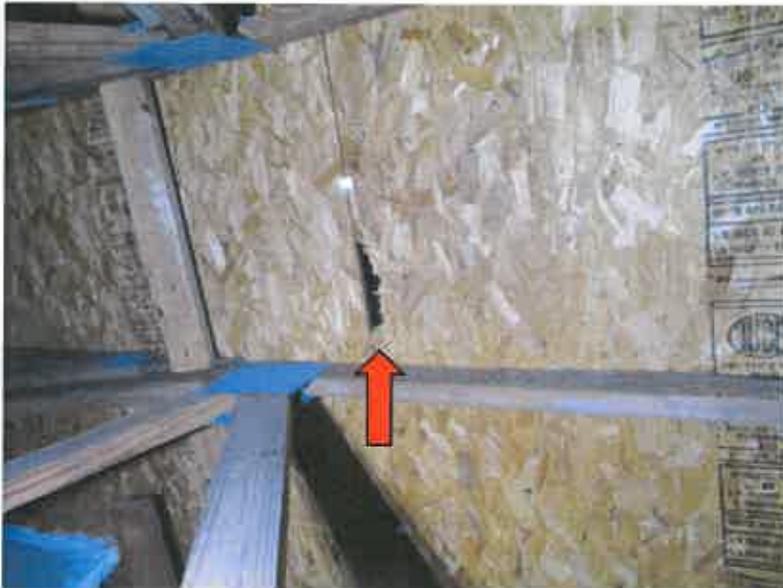
PHOTOGRAPH #30

**VINTAGE GRAND
UNIT #2821**
Damage or Holes in the Sheathing

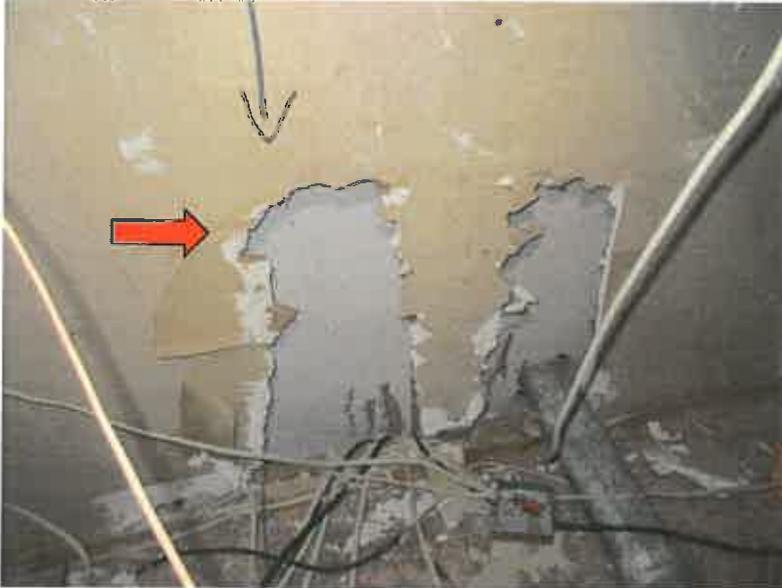
PHOTOGRAPH #31

**VINTAGE GRAND
UNIT #1523
Holes or Gaps in the Firewall**

It is further our opinion that repairs must be made to the fire partitions in the attics between the units, in accordance with 2014 Florida Building Code Chapter 7, **Section 708.4, Continuity (Exhibit V)**:

FBC 2014, Ch. 7 §708.4 – Fire partitions shall extend from the top of the foundation or floor/ceiling assembly below to the underside of the floor or roof sheathing, slab or deck above or to the fire-resistance-rated floor/ceiling or roof/ceiling assembly above, and shall be securely attached thereto.

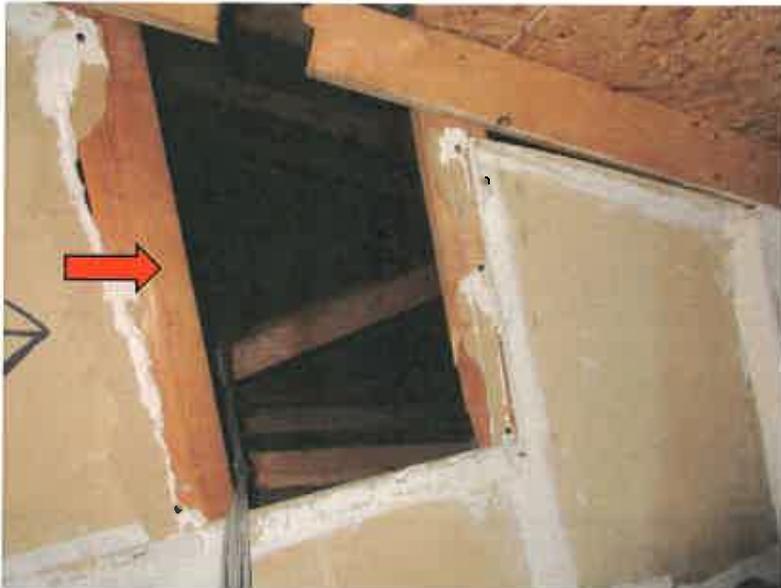
PHOTOGRAPH #32

**VINTAGE GRAND
UNIT #1525
Holes or Gaps in the Firewall**

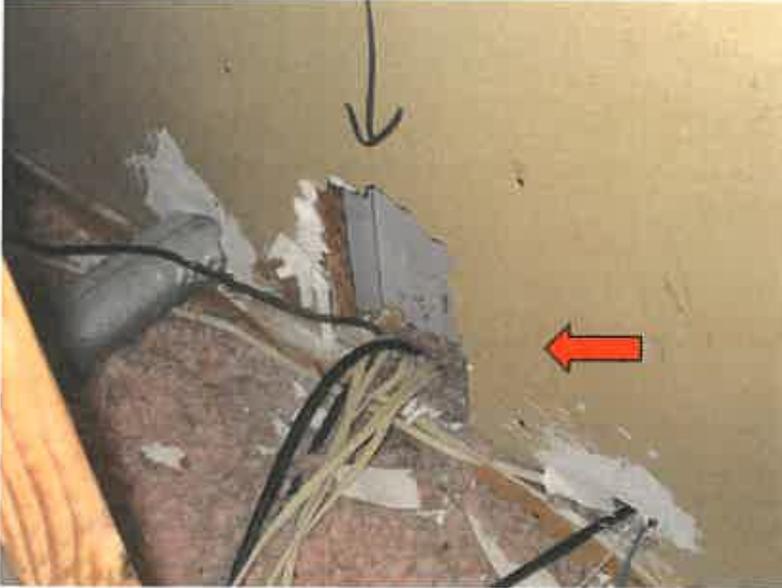
PHOTOGRAPH #33

**VINTAGE GRAND
UNIT #1525
Holes or Gaps in the Firewall**

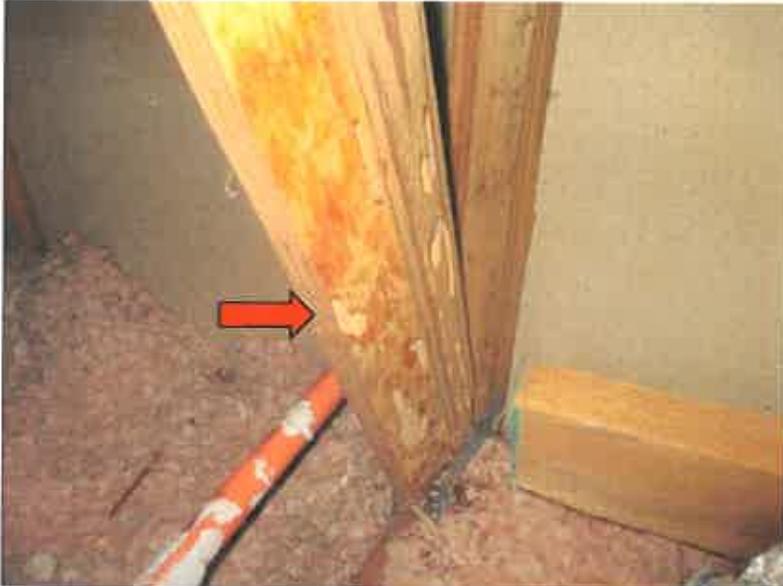
PHOTOGRAPH #34

**VINTAGE GRAND
UNIT #2322
Termite Damage**

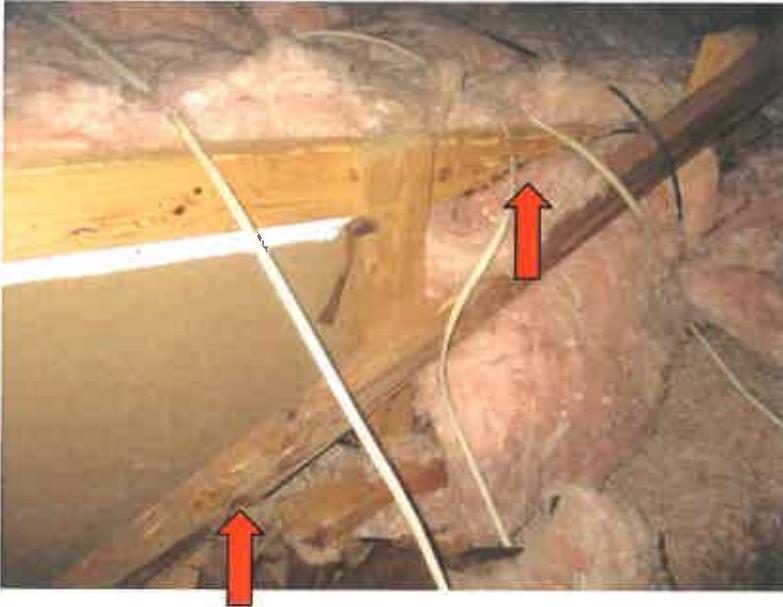
PHOTOGRAPH #35

**VINTAGE GRAND
UNIT #2322
Termite Damage**

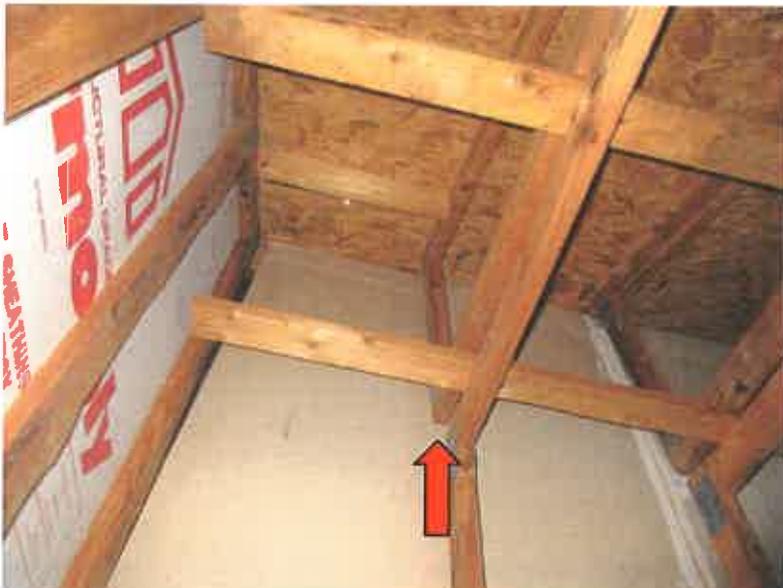
PHOTOGRAPH #36

12	Piggyback Trusses not Strapped to the Main Trusses	Structural	2014 FBC Ch. 23	#36
13	Cut Continuous Lateral Bracing	Structural	2014 FBC Ch. 23 BCSI-B5, & BCSI-B3	#37 and #38

**VINTAGE GRAND
UNIT #2021
Piggyback Not Strapped to Truss**

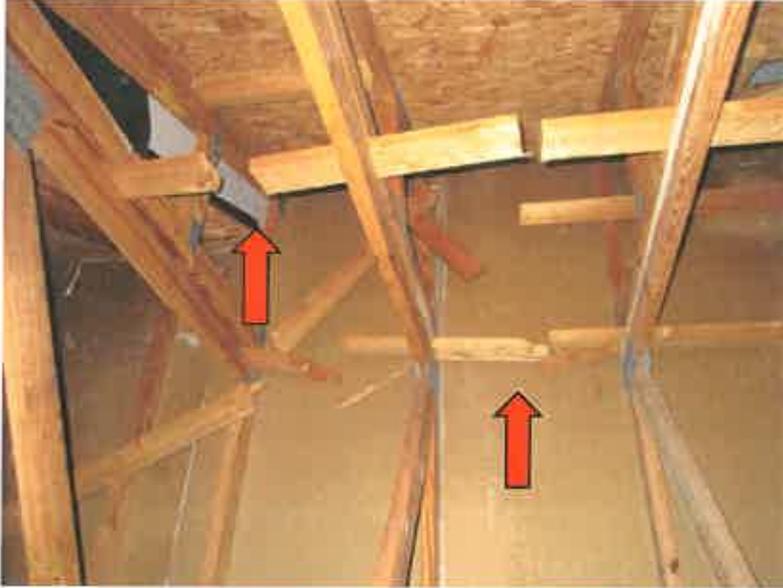
PHOTOGRAPH #37

**VINTAGE GRAND
UNIT #1421
Cut Continuous Lateral Restraint
Bracing**

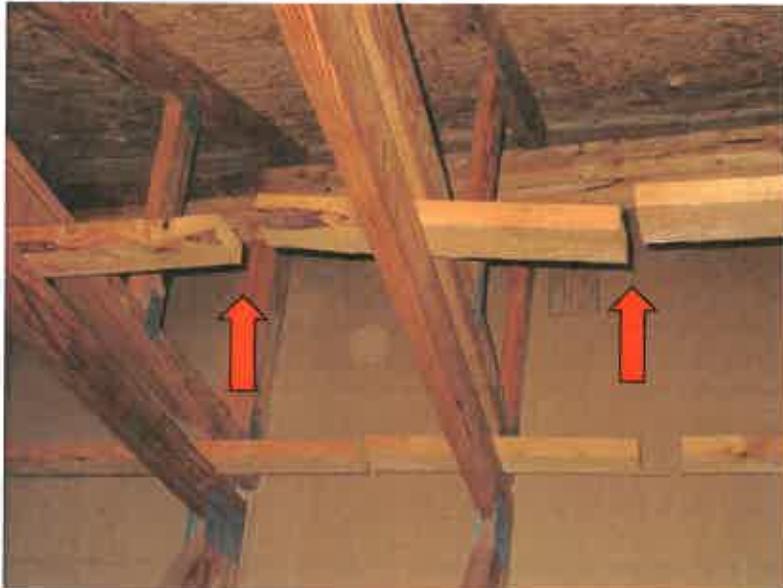
PHOTOGRAPH #38

**VINTAGE GRAND
UNIT #1423
Cut Continuous Lateral Restraint
Bracing**
