FIELD OBSERVATION REPORT - Bldg #14

Permit No. 18-131555-00 BC
 Owner: Vintago Grand Condo Assn, Inc.
 Project Address: 4017 Crockers Lake Blvd., Sarasota, FL
 Contractor: RL James Inc
 Inspector (s): Mark Bose / Steve McNamee / Glenn Warburton
 Type of Assessment: Progress

Project: R1603-302D
 Contact: Glenn Atelli
 Phone/Fax: (941) 923-7380
 Contact: Craig Nicholas / Robert Branscombe
 Phone: (941) 232-8488 / (239) 379-1978

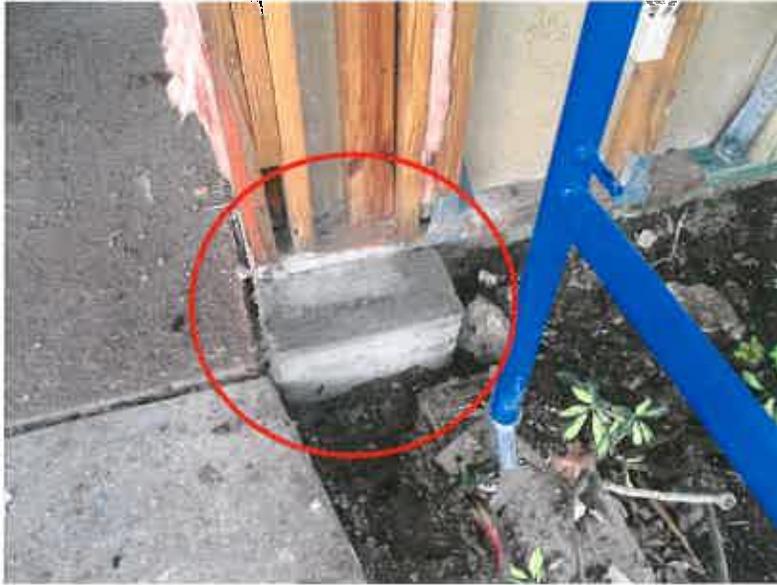
PHOTOGRAPH #1

BUILDING 14 ELEVATION E

Contractor has poured built up pedestal detail as per Delta ESI # 2 at breezeway column using MasterEmaco N425.

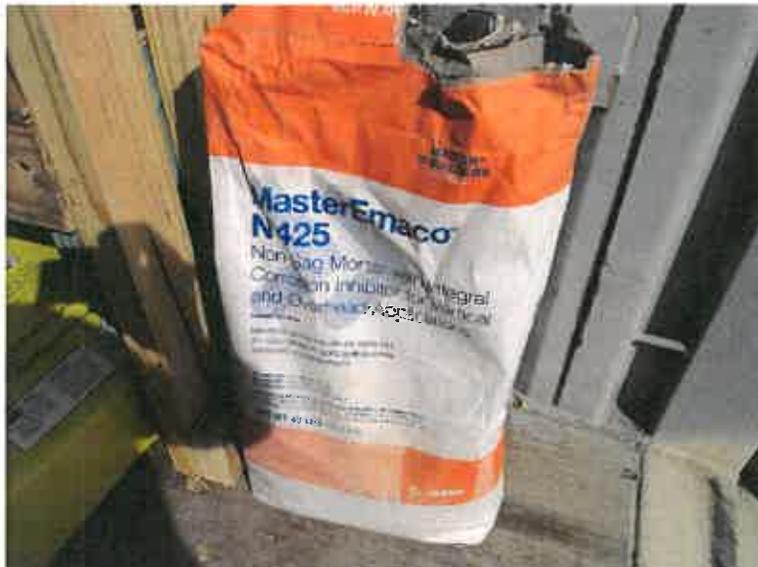
PHOTOGRAPH #2

BUILDING 14 ELEVATION E

Contractor has poured built up pedestal detail as per Delta ESI # 2 at breezeway column using MasterEmaco N425.

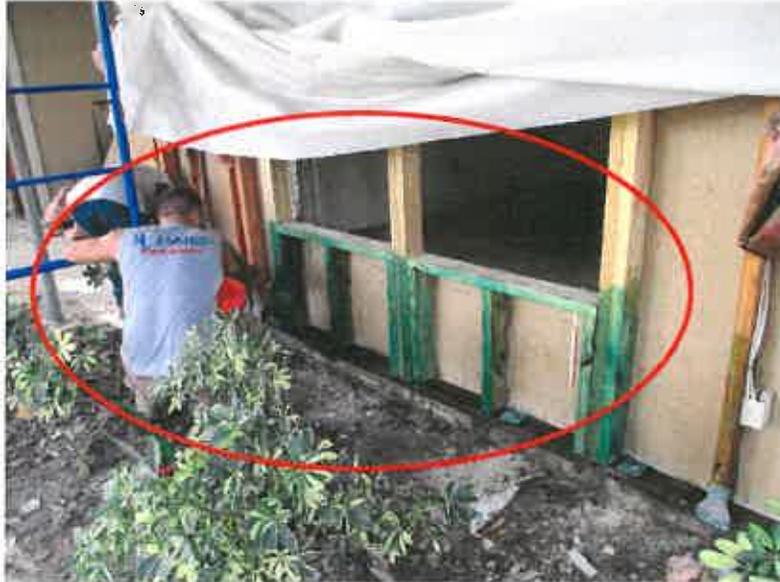
PHOTOGRAPH #3

**BUILDING 14
ELEVATION D**

Contractor applying Copper – green wood preservative at lower two feet up on wood framing as specified.

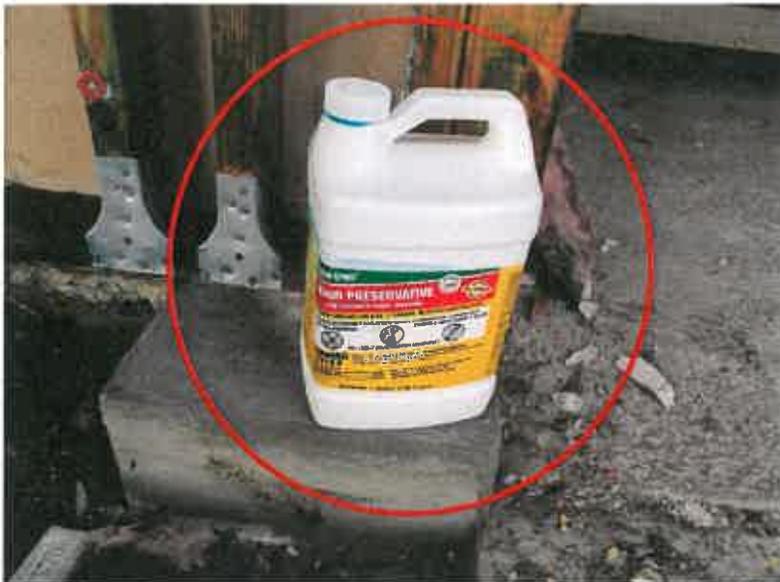
PHOTOGRAPH #4

**BUILDING 14
ELEVATION D**

Contractor applying Copper – green wood preservative at lower two feet up on wood framing as specified.

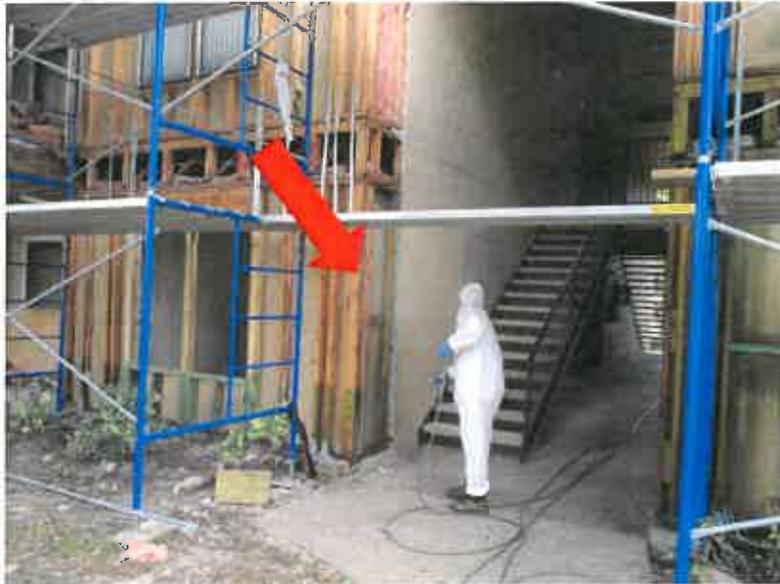
PHOTOGRAPH #5

**BUILDING 14
ELEVATION D BREEZWAY**

Sub-Contractor is spraying inside all wall cavities and between floor cavities for termite control with "BORA-CARE" as per specification and manufacture instructions.

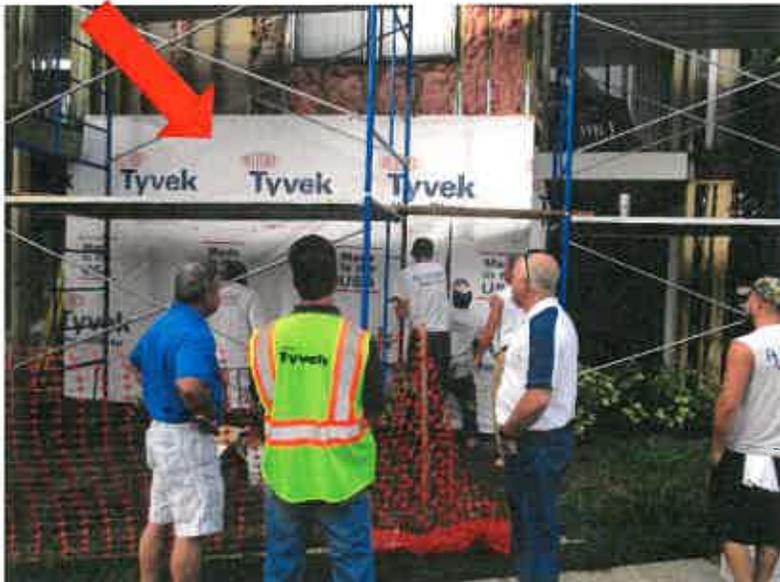
PHOTOGRAPH #6

**BUILDING 14
WINDOW INSTALLATION MOCK-UP
Unit #1412 Ground Level**

Contractor set up mock-up with manufactures representatives as per Project Manual.

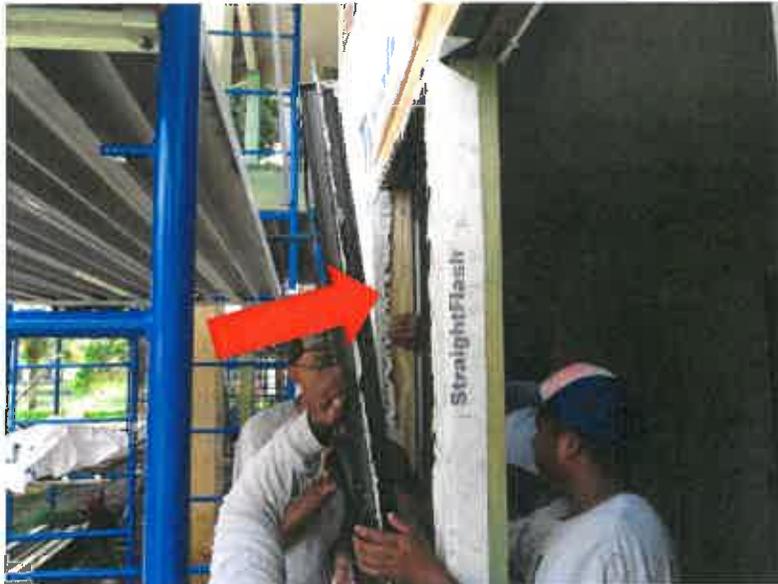
PHOTOGRAPH #7

**BUILDING 14
WINDOW INSTALLATION MOCK-UP
Unit #1412 Ground Level**

Contractor added a wood buck at one side of each window in effort to make window fit opening. This required removal and re-attachment of flashing that did not bond properly when re-attached.

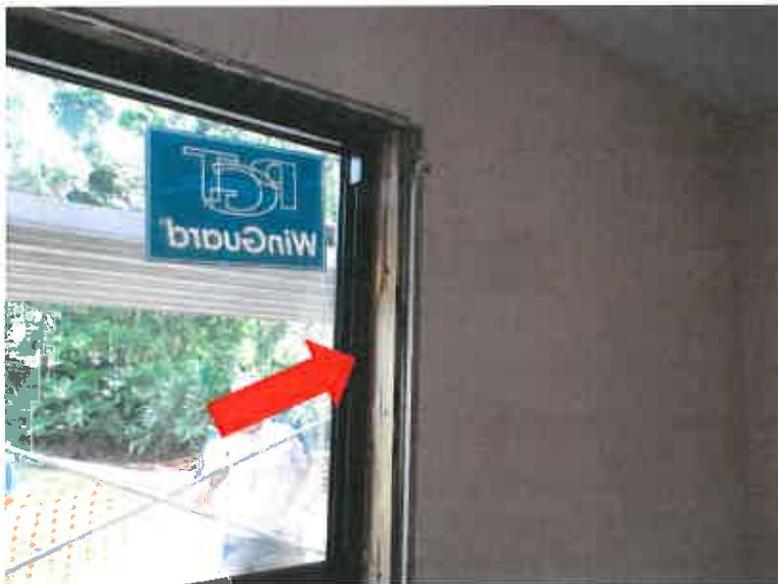
PHOTOGRAPH #8

**BUILDING 14
WINDOW INSTALLATION MOCK-UP
Unit #1412 Ground Level**

Wood buck added to each window jamb did not meet fastening or spacing requirements of NOA or window manufactures installation instructions. Mock-up will be removed and re-done.

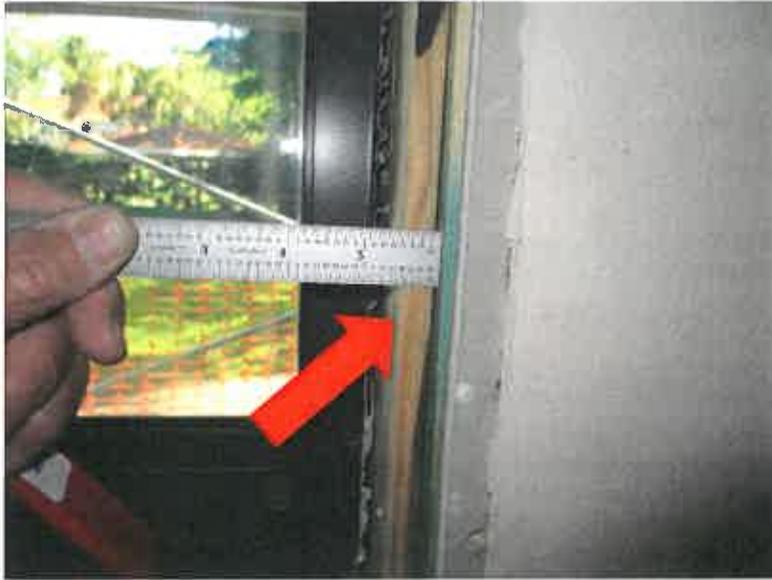
PHOTOGRAPH #9

**BUILDING 14
WINDOW INSTALLATION MOCK UP
Unit #1412 Ground Level**

Wood buck added to each window jamb did not meet fastening or spacing requirements of NOA or window manufactures installation instructions, Mock-up will be removed and re-done.

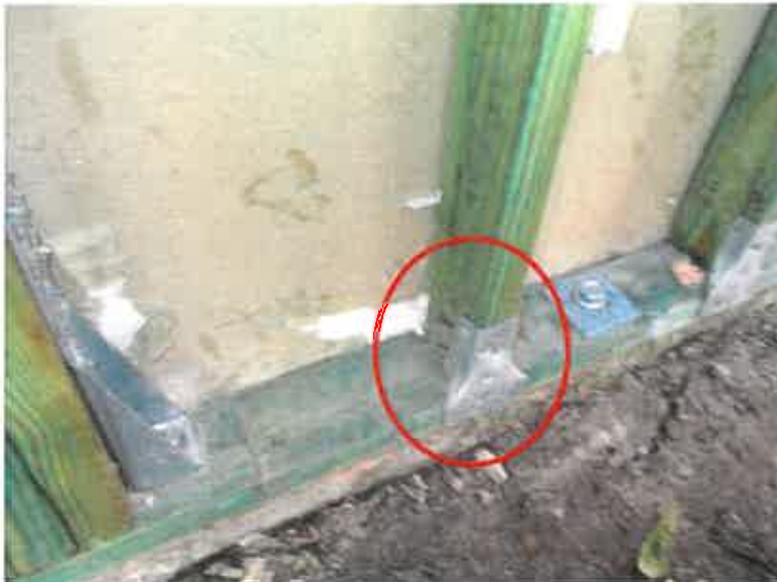
PHOTOGRAPH #10

**BUILDING 14
ELEVATION E**

Simpson Strong-Tie SP1 connector not properly nailed. Delta notified contractor and they were removed and replaced.

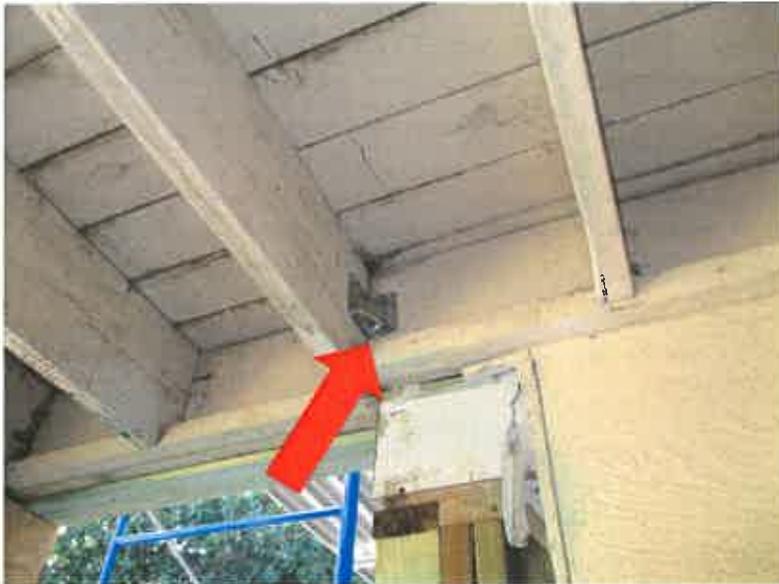
PHOTOGRAPH #11

**BUILDING 14
ELEVATION D BALCONY TYPE C1A**

Simpson Strong -Tie HGA10KTR Shear Clip installed at deck joist as per drawings and specifications.

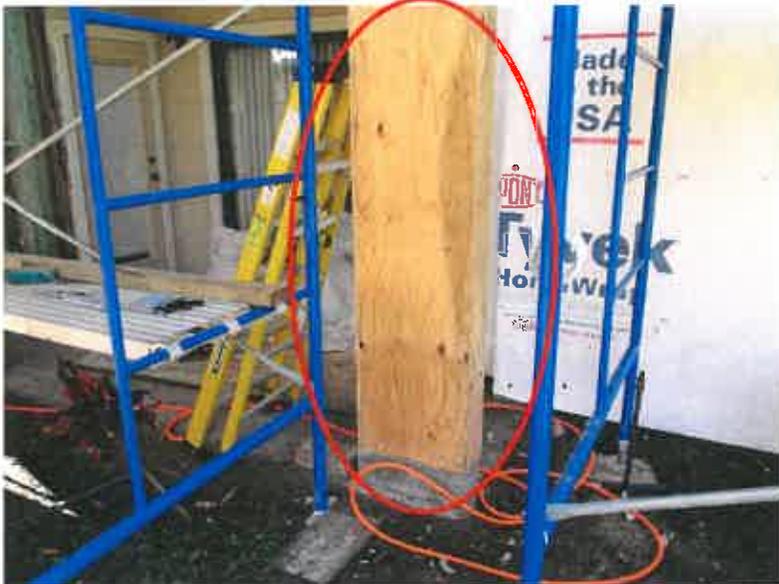
PHOTOGRAPH #12

**BUILDING 14
ELEVATION D BALCONY TYPE C1A**

Sheathing installed at lower section of balcony columns is not pressure treated as required by Delta project manual and specifications. Contractor will be required to remove and replace with pressure treated plywood as per specifications.
