FIELD OBSERVATION REPORT - Bldg #14

Permit No. 18-131555-00 BC
Owner: Vintage Grand Condo Assn, Inc.
Project Address: 4017 Crockers Lake Blvd., Sarasota, FL
Contractor: RL James Inc.
Inspector (s): Mark Boss / Mike Jones / Steve Melinard
Type of Assessment: Progress

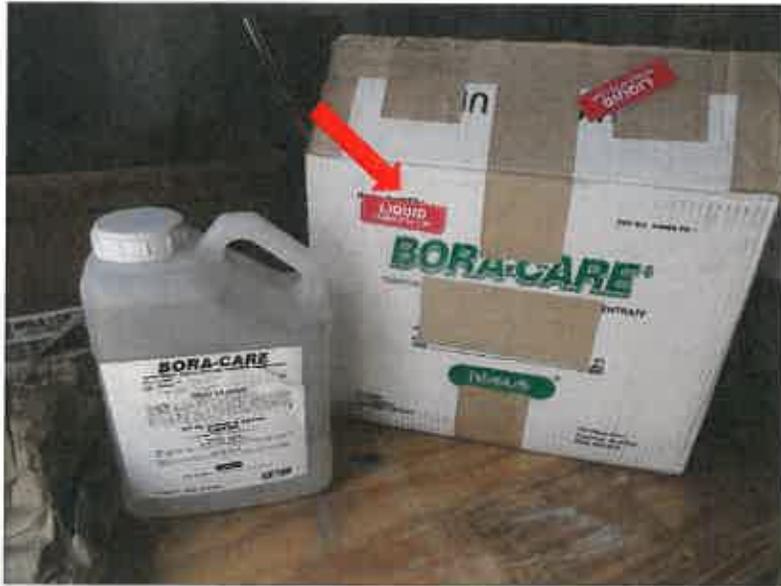
PHOTOGRAPH #1

1. Bora Care Insecticide for termite application in open wall cavities as per specification and approved submittals (Photograph #1).
2. Remaining Simpson Strong-Tie connectors as per drawing schedule (Photograph #1).

Bora Care insecticide for termite application in open wall cavities as per specification and approved submittals.

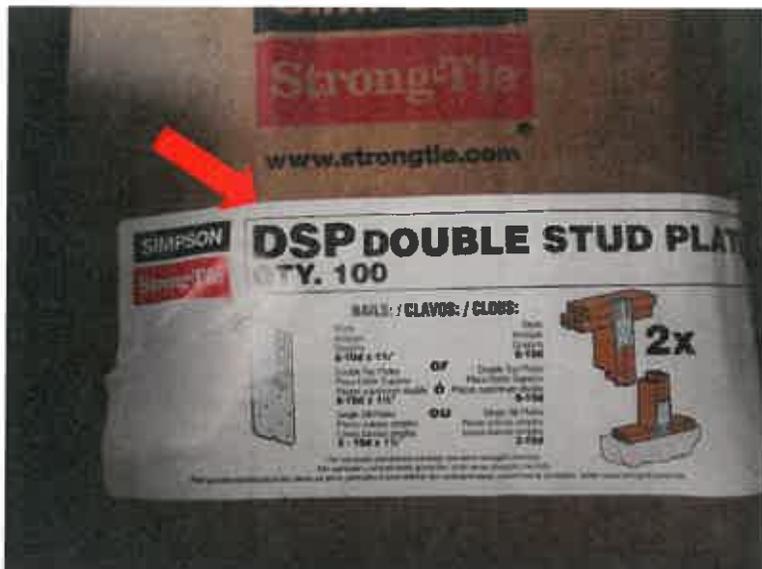
PHOTOGRAPH #2

Remaining Simpson Strong-Tie connectors as per drawing schedule.

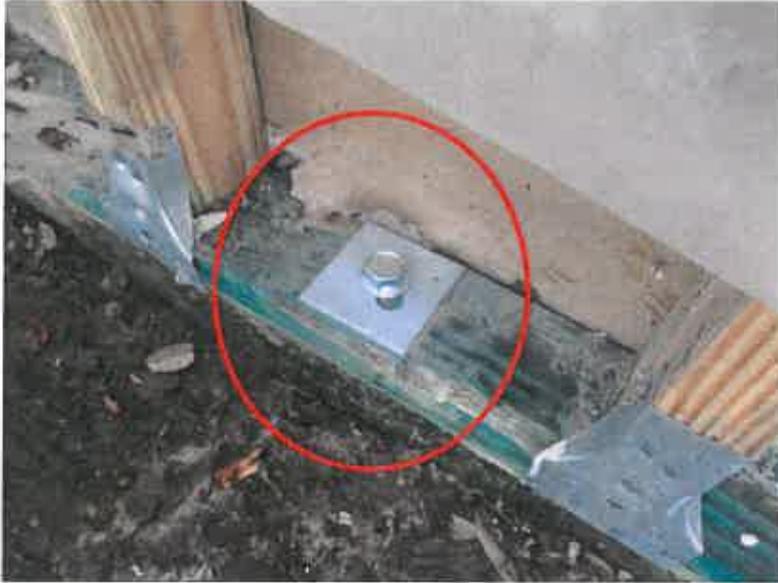
PHOTOGRAPH #3

3. 5/8" Simpson "TITEN HD" with Simpson BP 816-3 installed at bearing wall bottom plate as per drawings and specifications (Photograph #3).
4. Grade at base of walls is too high and not sloped away from building to assist in the drainage of stormwater away from building as required by drawings (not part of contract). Delta has made owners aware this condition if not corrected will cause leaks and deterioration at the base of walls exposed to water.

5/8" Simpson "TITEN HD" with Simpson BP 5/8-3 installed at bearing wall bottom plate as per drawings and specifications.

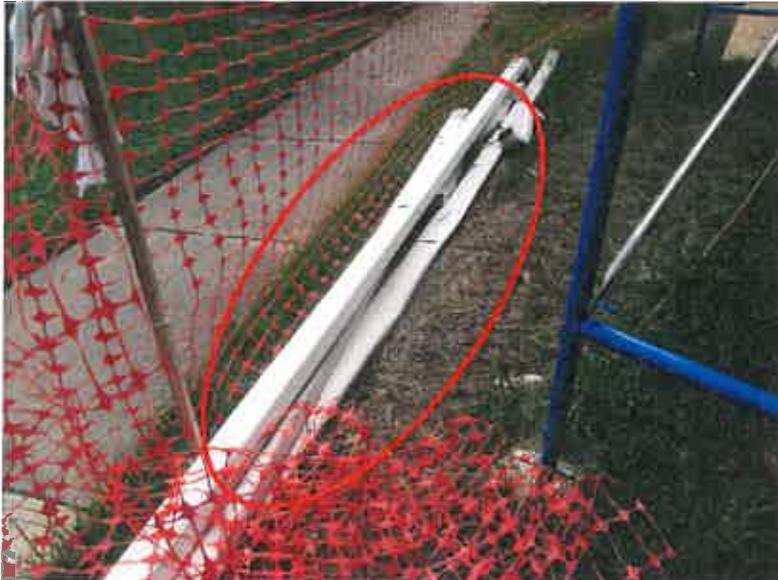
PHOTOGRAPH #4

Contractor has removed downspouts and placed on ground near scaffolding. Damage has occurred from foot traffic in the area. Delta recommends they be moved to a traffic free location.

1. Provide Affidavit stating scaffolding meet OSHA requirements.
2. Determine location each required mock-up (framing & strapping, sheathing, Tyvek, stucco, window & window flashing, sealant joints, and painting).
3. Provide remaining submittals. Sample warranties outstanding.
4. Contractor has removed downspouts and placed on ground near scaffolding. Damage has occurred from foot traffic in the area. Delta recommends they be moved to a traffic free location (Photograph #4).

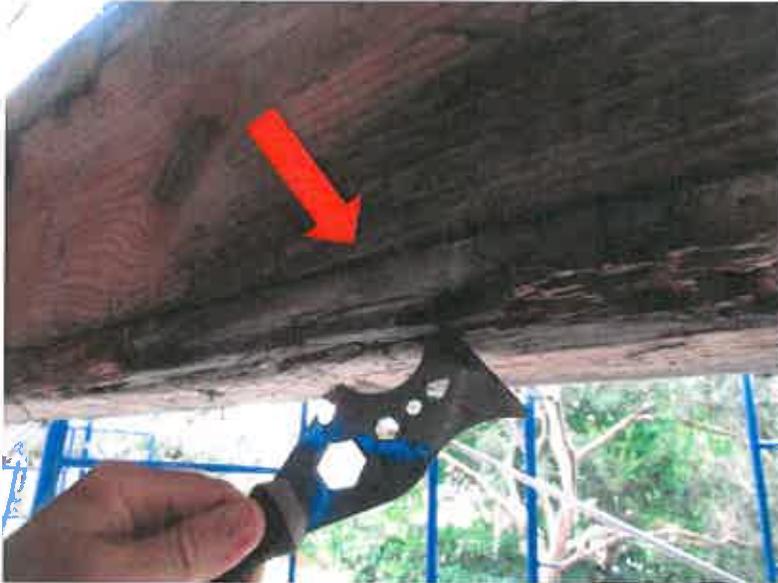
PHOTOGRAPH #5

5. Contractor has removed stucco from beam at breezeway pass through. Delta has reviewed the collapse and marked rotten wood for replacement (Photograph #5 and #6).

Contractor has removed stucco from beam at breezeway pass through. Delta has reviewed the collapse and marked rotten wood for replacement.

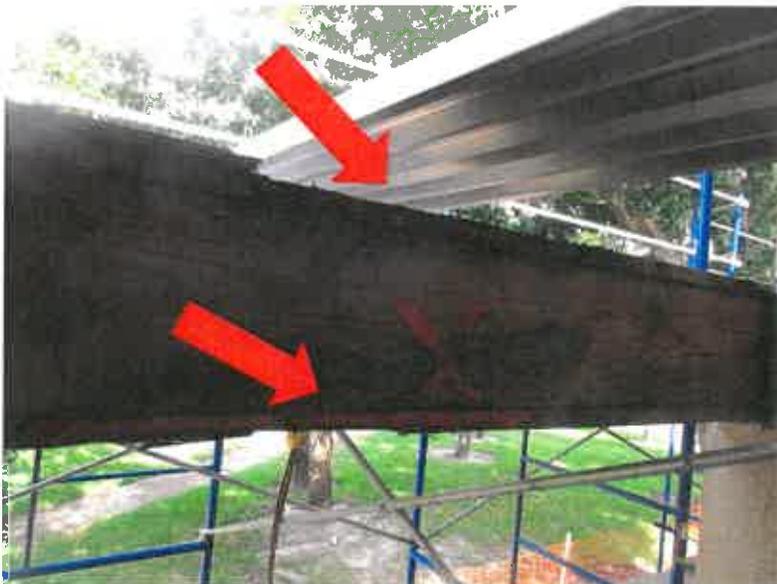
PHOTOGRAPH #6

Contractor has removed stucco from beam at breezeway pass through. Delta has reviewed the collapse and marked rotten wood for replacement.

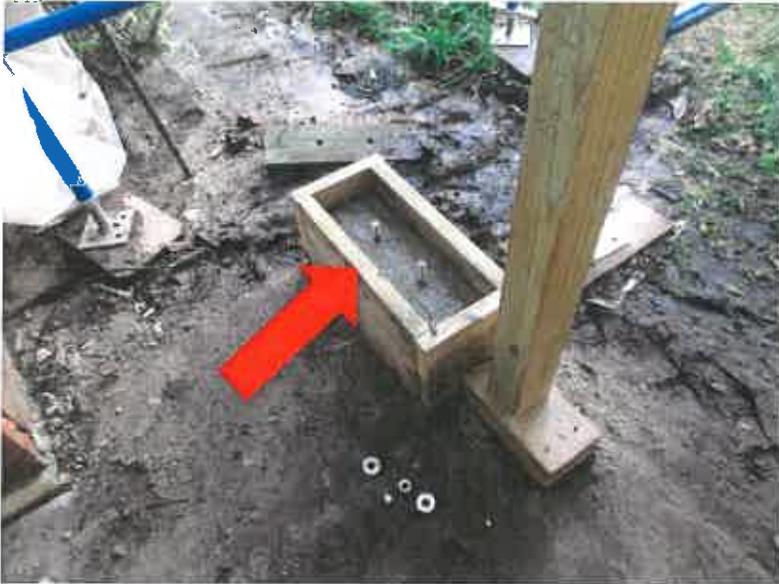
PHOTOGRAPH #7

Contractor has reformed concrete pedestals at balcony columns where previous concrete poured was washed out by rain.

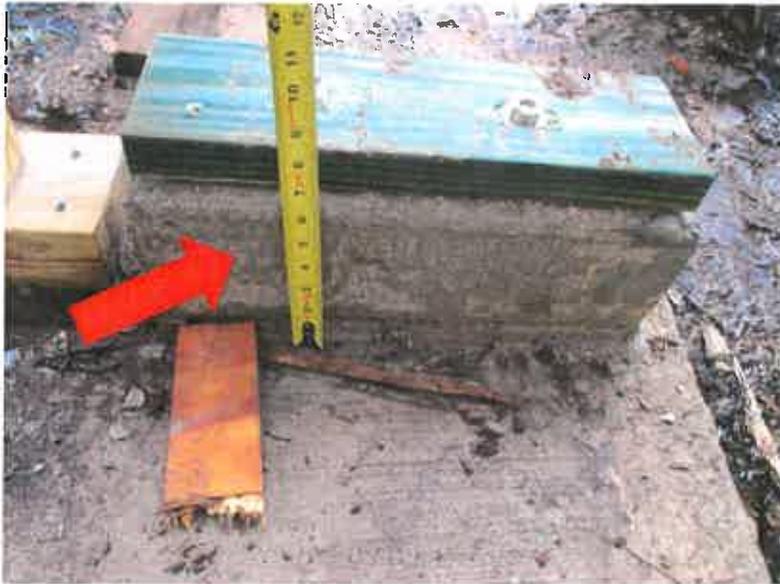
PHOTOGRAPH #8

Contractor has poured new pedestals at balconies for columns as per drawings and specifications and used Simpson Strong -Tie SET EX EPOXY for setting 5/8" threaded rod as per drawings.

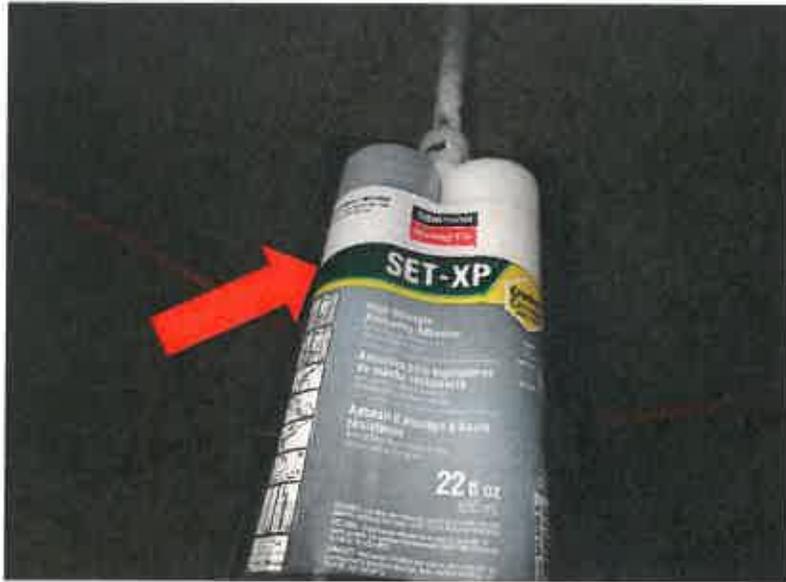
PHOTOGRAPH #9

6. Contractor to contact Delta upon each inspection phase per attachment "Inspection By Affidavit" for the County of Sarasota.
7. Contractor has poured new pedestals at balconies for columns as per drawings and specifications and used Simpson Strong -Tie SET EX EPOXY for setting 5/8" threaded rod as per drawings (Photographs #7, #8 and #9).

Contractor has poured new pedestals at balconies for columns as per drawings and specifications and used Simpson Strong -Tie SET EX EPOXY for setting 5/8" threaded rod as per drawings.

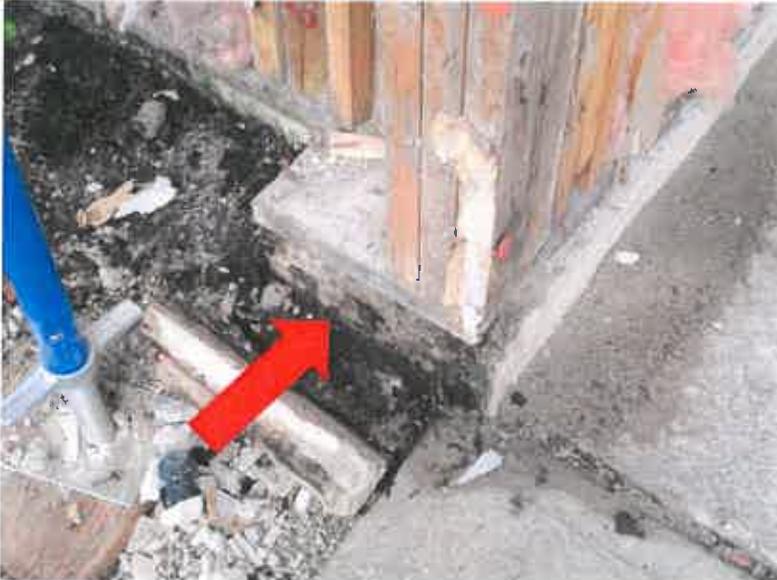
PHOTOGRAPH #10

Existing footing at breezeway columns are not properly supporting column at bottom plate. Additional concrete footing will be required. Delta will provide ESI for build - out repair.

1. Existing footing at breezeway columns are not properly supporting column at bottom plate. Delta will provide ESI for build out repair (Photograph #10)

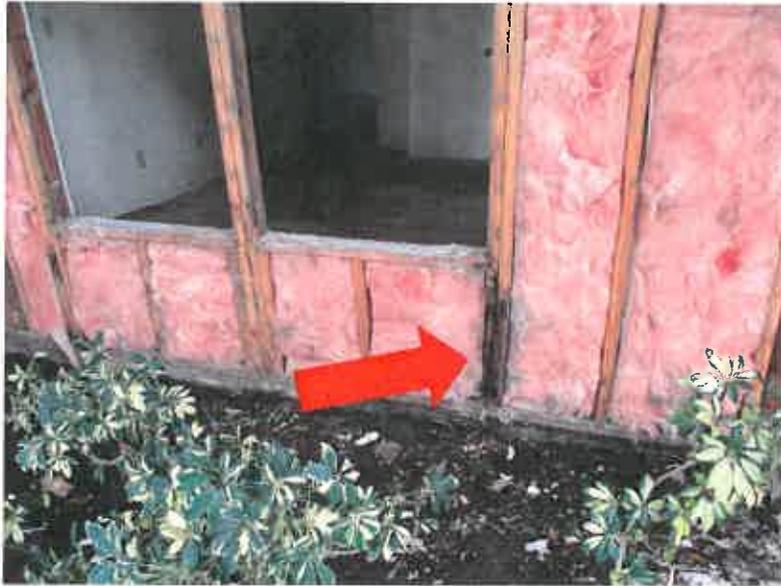
PHOTOGRAPH #11

8. Studs and window framing at ground level are deteriorated and will require replacement. Delta has marked areas for repairs (Photographs #11 and #12).

Studs and window framing at ground level are deteriorated and will require replacement. Delta has marked areas for repairs.

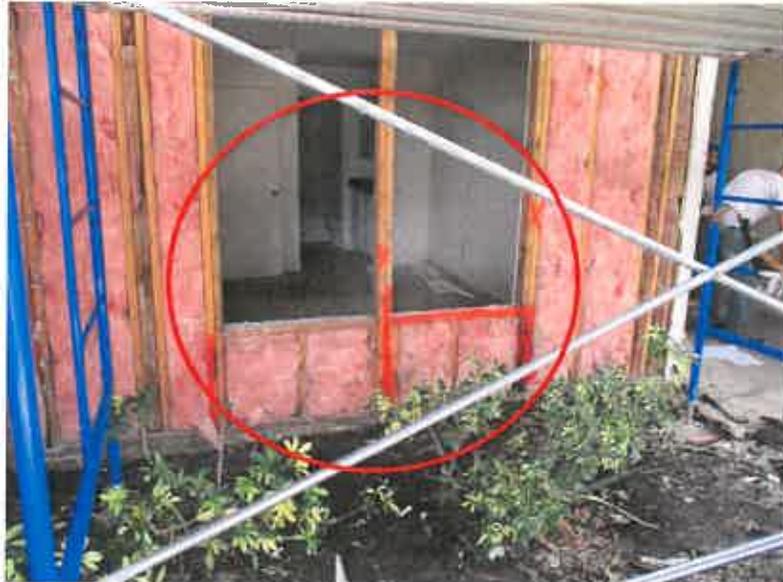
PHOTOGRAPH #12

Studs and window framing at ground level are deteriorated and will require replacement. Delta has marked areas for repairs.

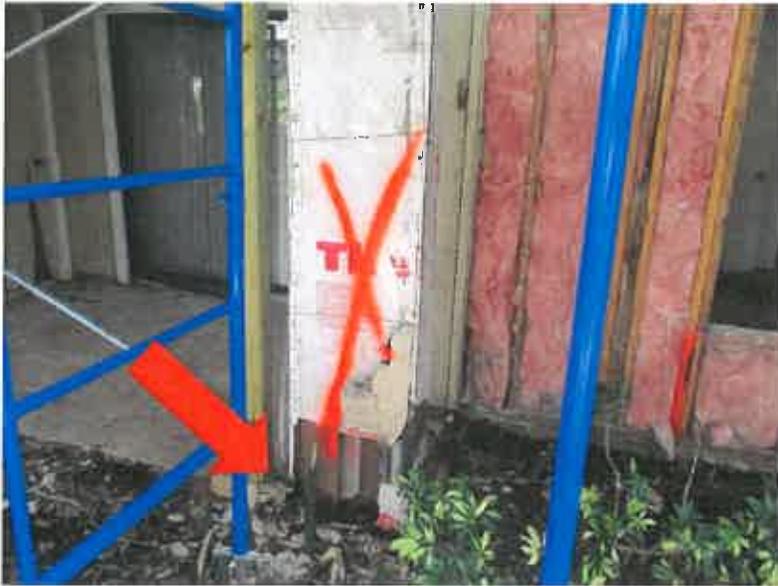
PHOTOGRAPH #13

9. Balcony columns and built up beams are deteriorated. Delta has documented the collapse and marked repairs for repair (Photographs #13 and #14).

Columns and built up beams are deteriorated. Delta has documented the collapse and marked repairs for repair.

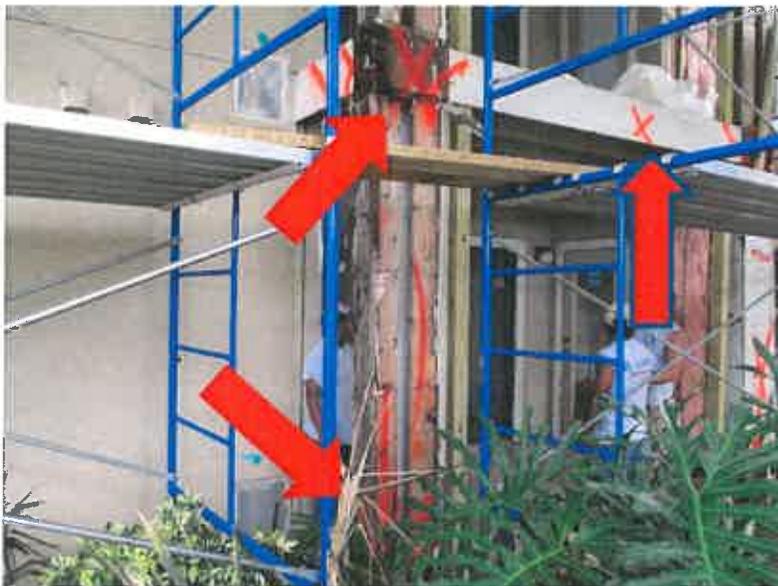
PHOTOGRAPH #14

Columns and built up beams have deteriorated. Delta has documented the collapse and marked repairs for repair.
