FIELD OBSERVATION REPORT - Bldg #14

Permit No. 18-131555-00 BC
 Owner: Vintage Grand Condo Assn, Inc.
 Project Address: 4017 Crochens Lake Blvd., Sarasota, FL
 Contractor: RL James Inc
 Inspector (s): Mark Boss / Steve Mainardi / Glenn Warburton
 Type of Assessment: Progress

Project: R1503-302D
 Contact: Glenn Atelli
 Phone/Fax: (941) 923-7380
 Contact: Craig Nicholas / Robert Branncombe
 Phone: (941) 232-6486 / (239) 378-1978

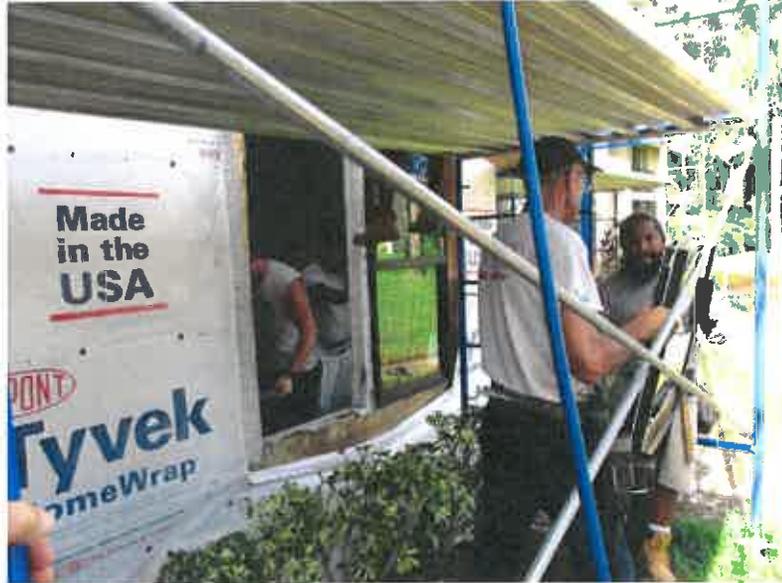
PHOTOGRAPH #1

1. Contractor removing original mock up installation that did not meet NOAs or manufactures fastening requirements (Photograph #1).
2. Contractor re-built framing for installation of new mock up per NOAs, manufacture guidelines and ESI #4 by Delta (Photograph #2).

**BUILDING 14
WINDOW INSTALLATION MOCK-UP
UNIT #1412 GROUND LEVEL**

Contractor removing original mock up installation that did not meet NOAs or manufactures fastening requirements.

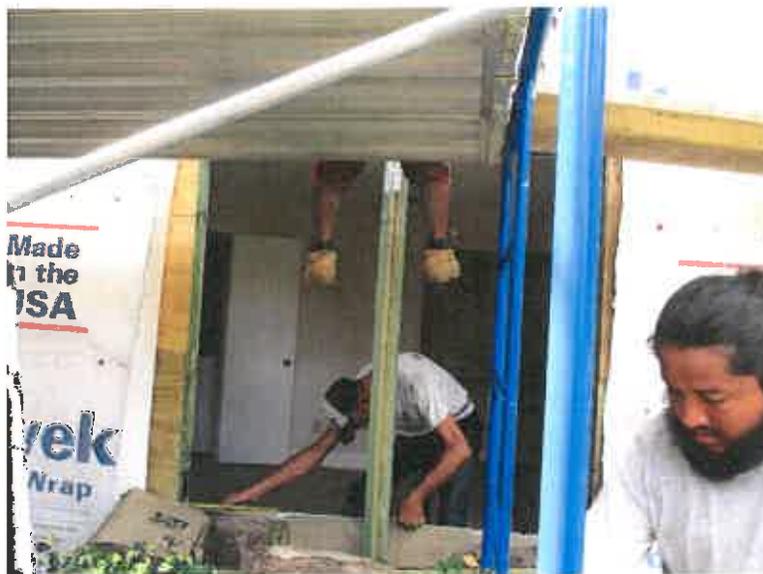
PHOTOGRAPH #2

**BUILDING 14
WINDOW INSTALLATION MOCK-UP
UNIT #1412 GROUND LEVEL**

Contractor re-built framing for installation of new mock up per NOAs, manufacture guidelines and ESI #4 by Delta.

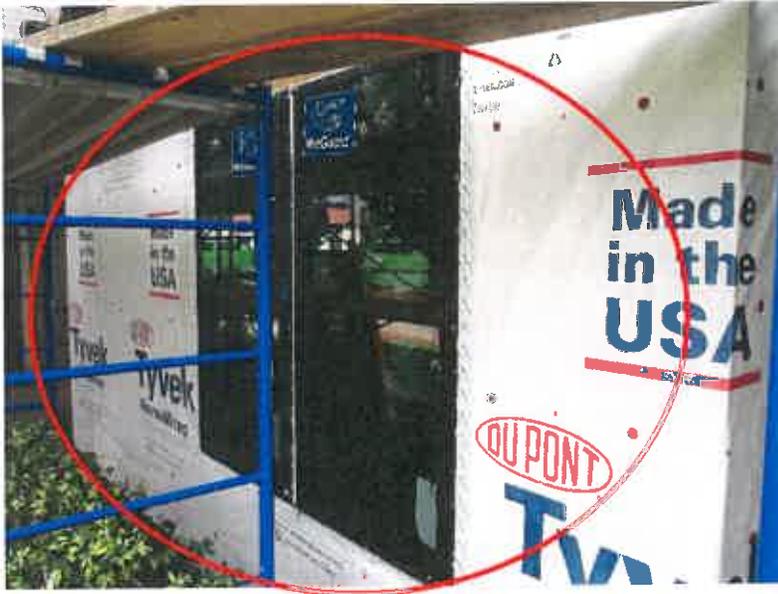
PHOTOGRAPH #3

3. Contractor has re - installed windows following NOAs, manufacture recommendations and ESI #4. Tyvek technical representative will inspect and assist in completion of mock up final flashing (Photograph #3).

**BUILDING 14
WINDOW INSTALLATION MOCK-UP
UNIT #1412 GROUND LEVEL**

Contractor has re - installed windows following NOAs, manufacture recommendations and ESI #4. Tyvek technical representative will inspect and assist in completion of mock up final flashing.

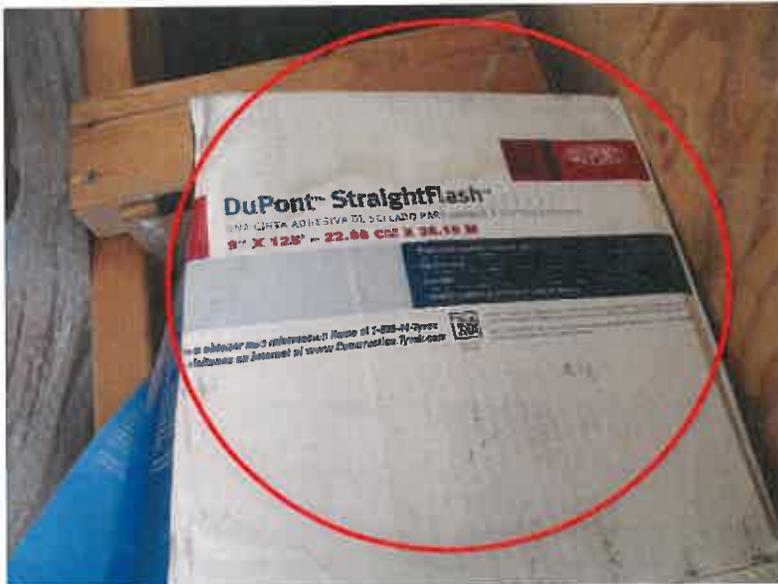
PHOTOGRAPH #4

**BUILDING 14
WINDOW INSTALLATION MOCK-UP
UNIT #1412 GROUND LEVEL**

Specified, submitted and approved products verified on site and used for mock up.

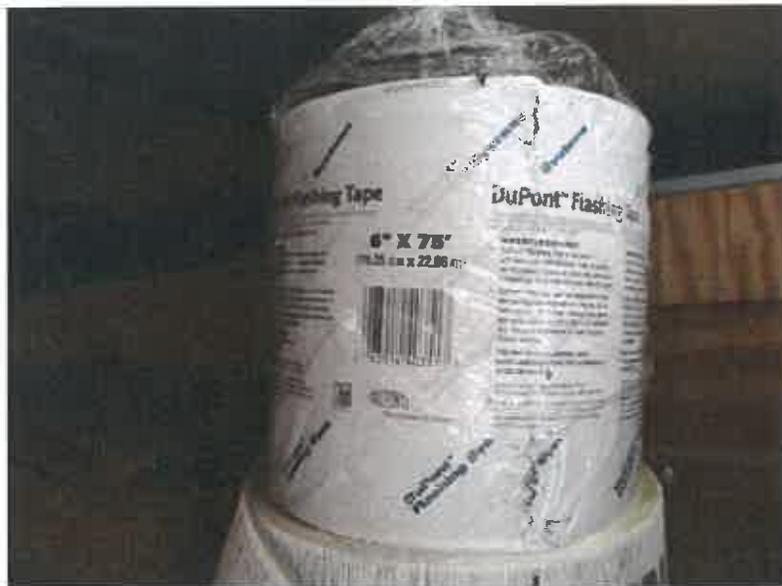
PHOTOGRAPH #5

**BUILDING 14
WINDOW INSTALLATION MOCK-UP
UNIT #1412 GROUND LEVEL**

Specified, submitted and approved products verified on site and used for mock up.

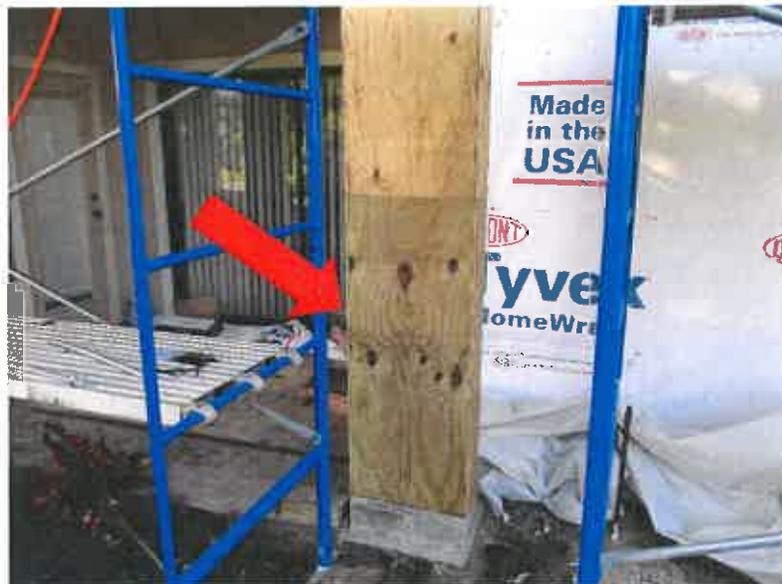
PHOTOGRAPH #6

4. Specified, submitted and approved products verified on site and used for mock up (Photographs #4 and #5).
5. Contractor has corrected areas where PT plywood was not used at lower sections of balcony columns (Photograph #6).

**BUILDING 14
ELEVATION E Balcony Type C1A**

Contractor has corrected areas where PT plywood was not used at lower sections of balcony columns.

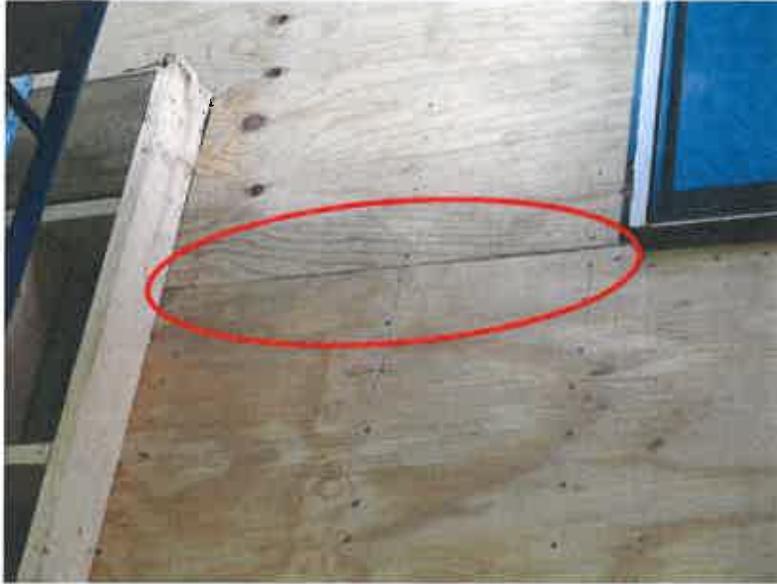
PHOTOGRAPH #7

Elevation	Demo	Gable Bracing	Gable Vents	Framing & Strapping	Sheathing	Softit	Window flashing	Window Install	Stucco Lath Acc	Stucco	Sealant	Painting	Punch	Comments
A		NA	NA											
B		NA	NA											
C														
D	/	NA	NA	/			/	/						
E	X	NA	NA	X	/		/	/						Contractor has not meet requirements for fastening plywood sheathing at all perimeters 4" O.C. as per drawings and will make corrections prior to installation of Tyvek Building Wrap (Photograph #7).
F

**BUILDING 14
ELEVATION E**

Contractor has not meet requirements for fastening plywood sheathing at all perimeters 4" O.C. as per drawings and will make corrections prior to installation of Tyvek Building Wrap.

1. Provide Affidavit staging scaffolding meet OSHA requirements.
2. Determine location each required mock-up (framing & strapping, sheathing, Tyvek, stucco, window & window flashing, sealant joints, and painting).
3. Provide remaining submittals. Stucco Sample warranty is outstanding.
4. Contractor has not meet requirements for fastening plywood sheathing at all perimeters 4" O.C. as per drawings and will make corrections prior to installation of Tyvek Building Wrap (Photograph #7).

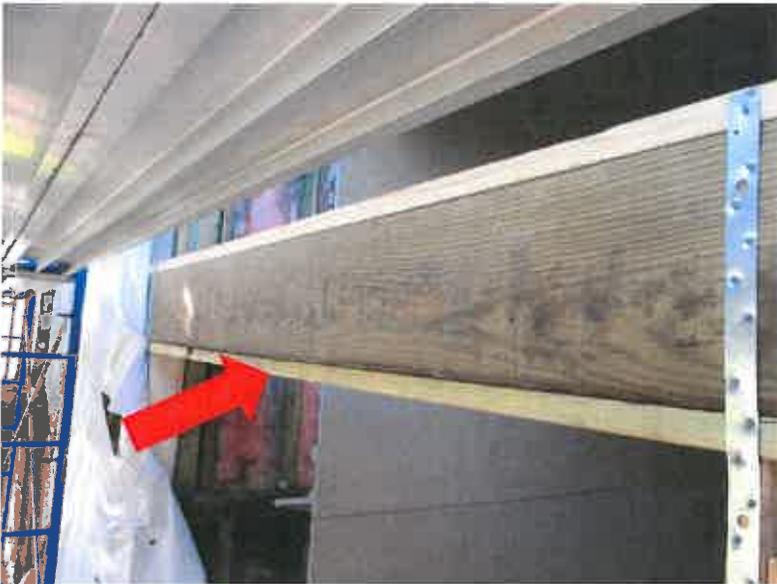
PHOTOGRAPH #8

**BUILDING 14
ELEVATION E BREEZWAY**

Contractor has replaced header and added strapping as per drawings and specifications.

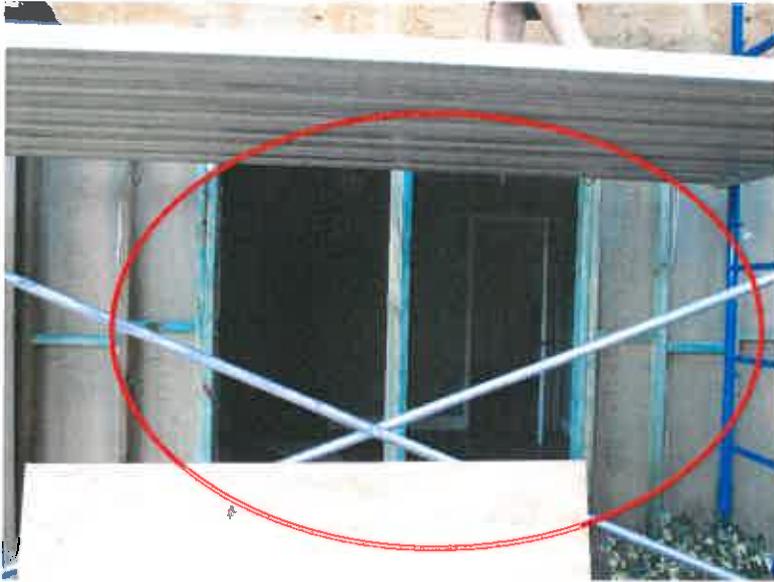
PHOTOGRAPH #9

**BUILDING 14
ELEVATION D**

Contractor has replaced framing where marked by Delta for replacement at lower sections.

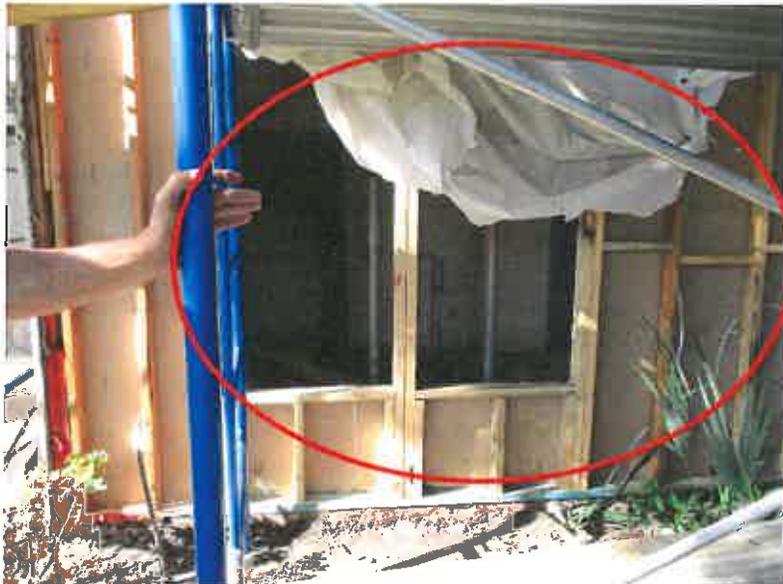
PHOTOGRAPH #10

**BUILDING 14
ELEVATION D**

Contractor has replaced framing where marked by Delta for replacement at lower sections.

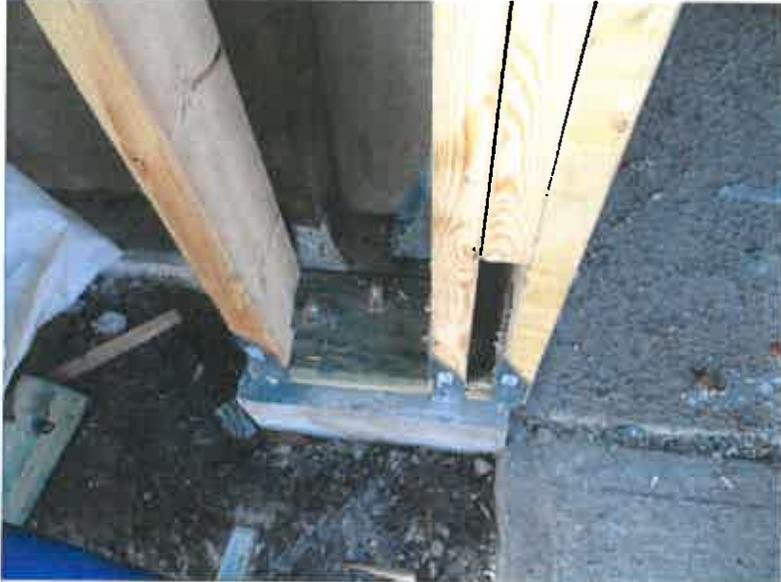
PHOTOGRAPH #11

8. Contractor has replaced column and installed anchors and connectors as per drawings and specifications (Photograph #11).
9. Contractor has installed upper window and Tyvek building wrap (Photograph #12).

**BUILDING 14
ELEVATION D BREEZWAY**

Contractor has replaced column and installed anchors and connectors as per drawings and specifications.

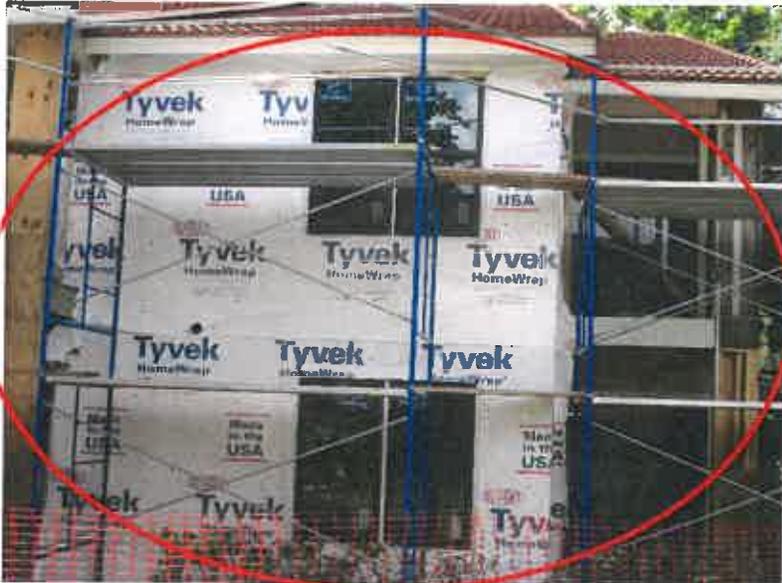
PHOTOGRAPH #12

**BUILDING 14
ELEVATION E**

Contractor has installed upper window and Tyvek building wrap.

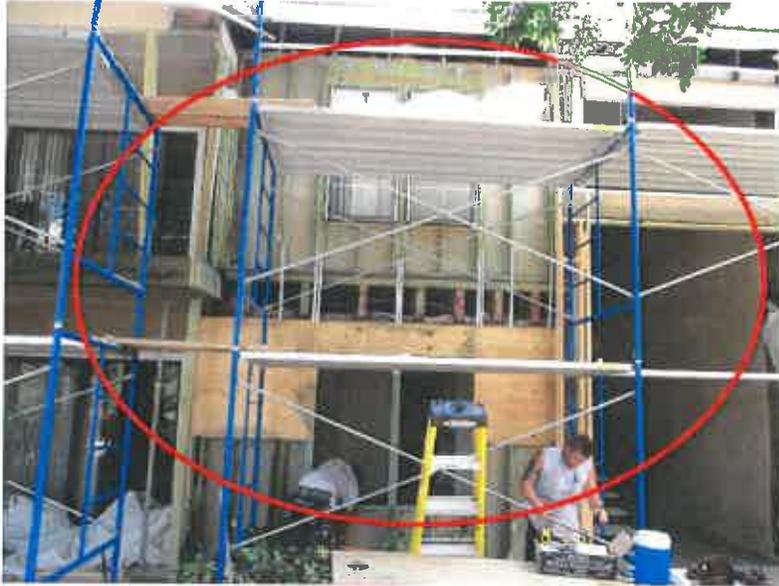
PHOTOGRAPH #13

**BUILDING 14
ELEVATION D**

Contractor has installed strapping and connectors and is starting sheathing installation.

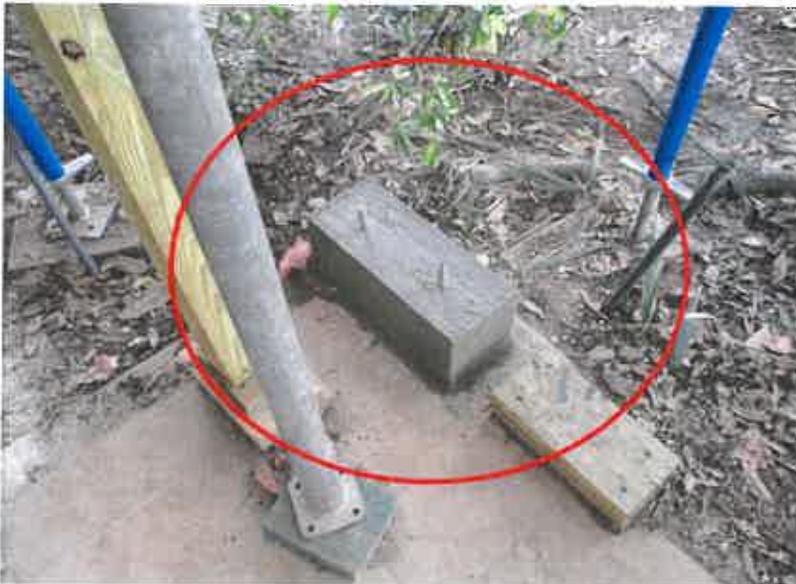
PHOTOGRAPH #14

**BUILDING 14
ELEVATION E Balcony Type C1A**

Contractor has poured pedestals for columns as per drawings and set anchors with Simpson-Tie Strong XP Epoxy.
