SUPPLEMENTAL DESTRUCTIVE INVESTIGATION

**Vintage Grand Condominium
4012 Crockers Lake Blvd.
Sarasota, FL 34238**

Project No. R1606-231

October 28, 2016

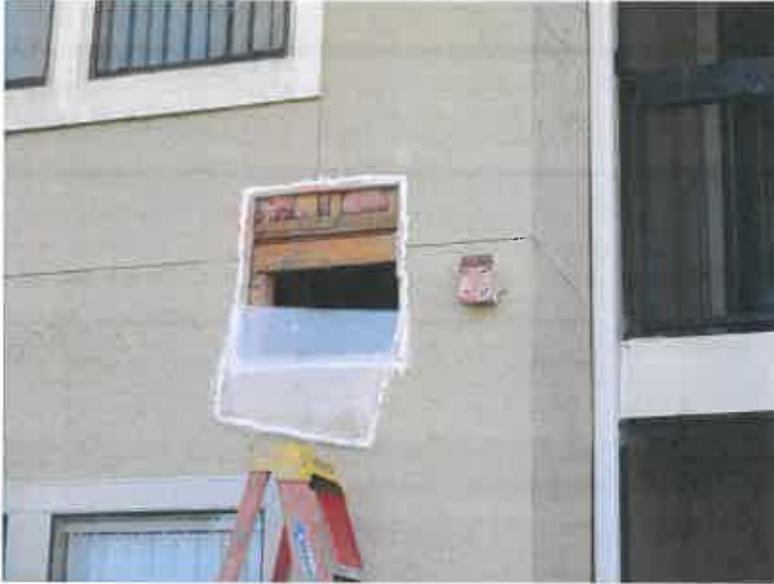
PHOTOGRAPH #1

**DESTRUCTIVE INVESTIGATION
OPENINGS – MARK 1
2nd Floor Below Window**

No damage

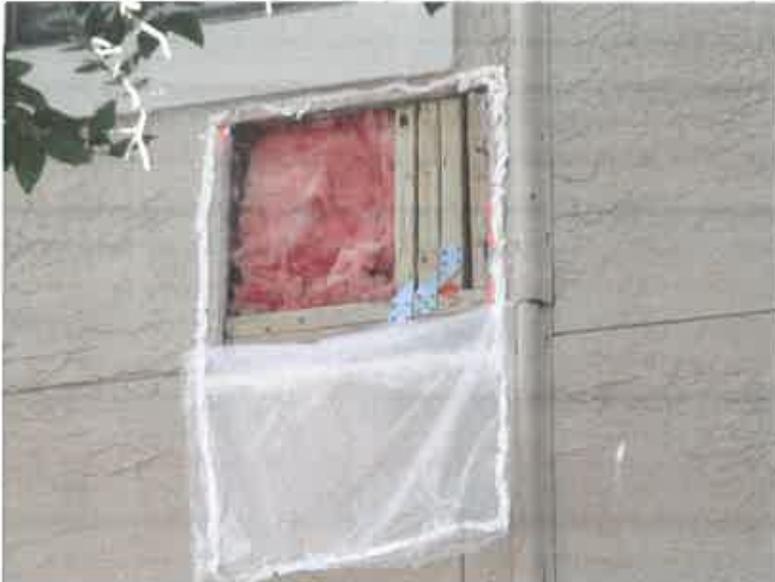
PHOTOGRAPH #3

**DESTRUCTIVE INVESTIGATION
OPENINGS – MARK 3
2nd Floor Below Window**

No damage

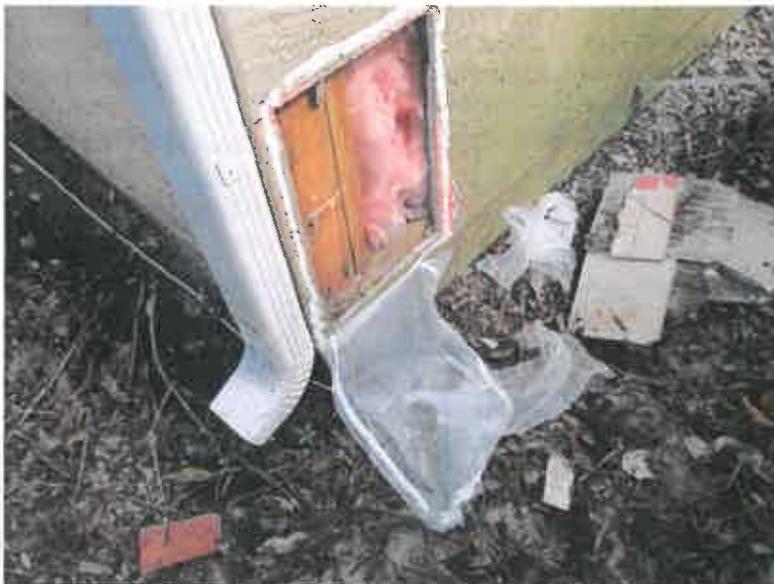
PHOTOGRAPH #4

**DESTRUCTIVE INVESTIGATION
OPENINGS – MARK 4
1st Floor Outside Corner**

No damage

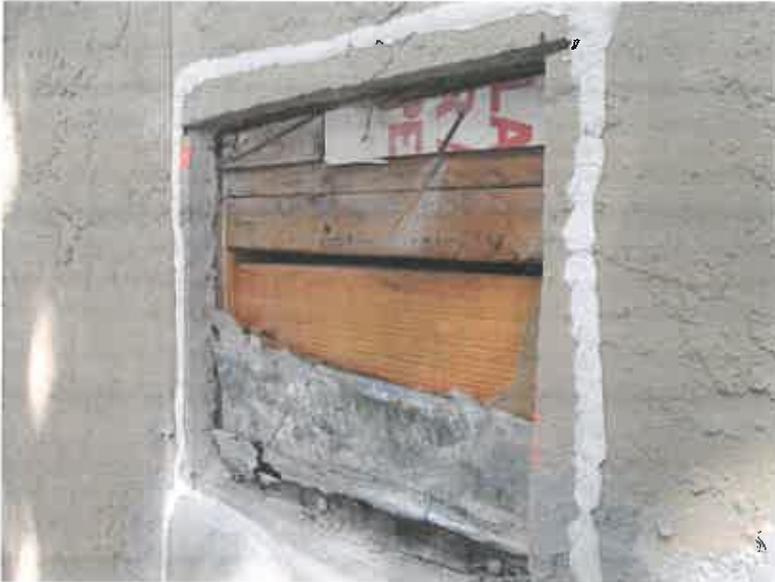
PHOTOGRAPH #5

**DESTRUCTIVE INVESTIGATION
OPENINGS – MARK 5
1st Floor Above Window**

No damage

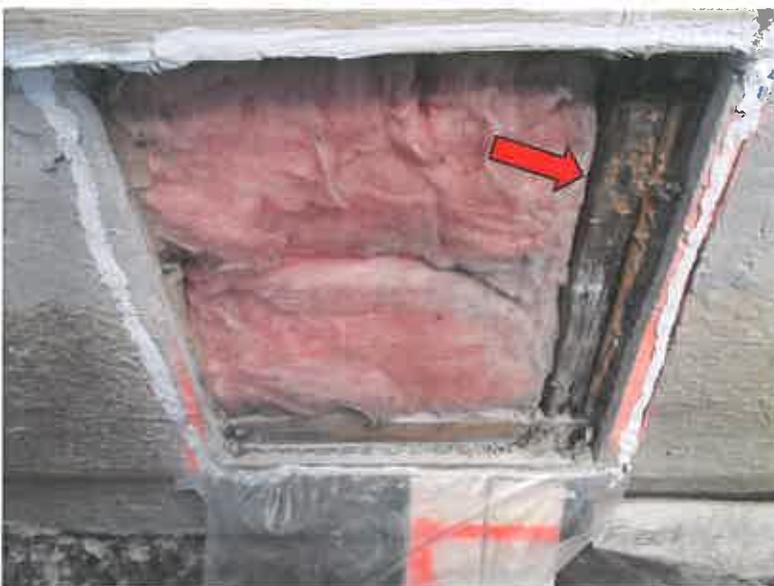
PHOTOGRAPH #6

**DESTRUCTIVE INVESTIGATION
OPENINGS – MARK 6
1st Floor Below Window**

Wood frame damage

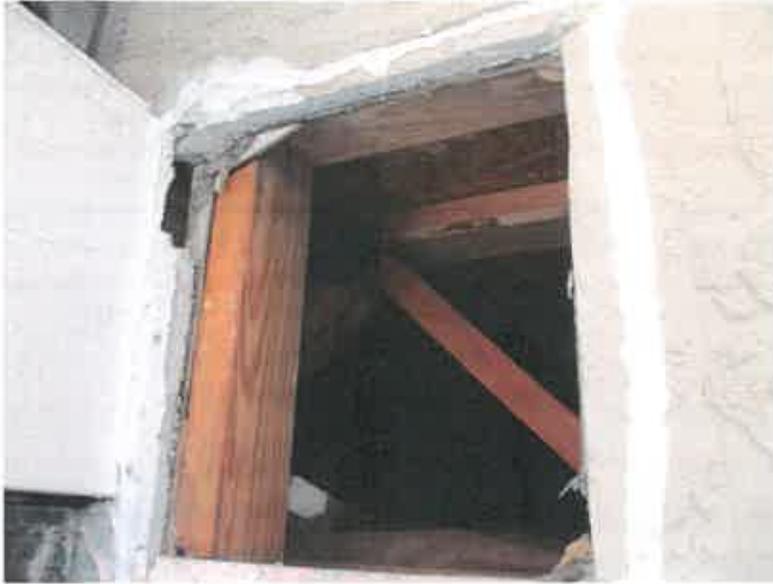
PHOTOGRAPH #7

**DESTRUCTIVE INVESTIGATION
OPENINGS – MARK 7
2nd Floor Adjacent to Balcony**

No damage

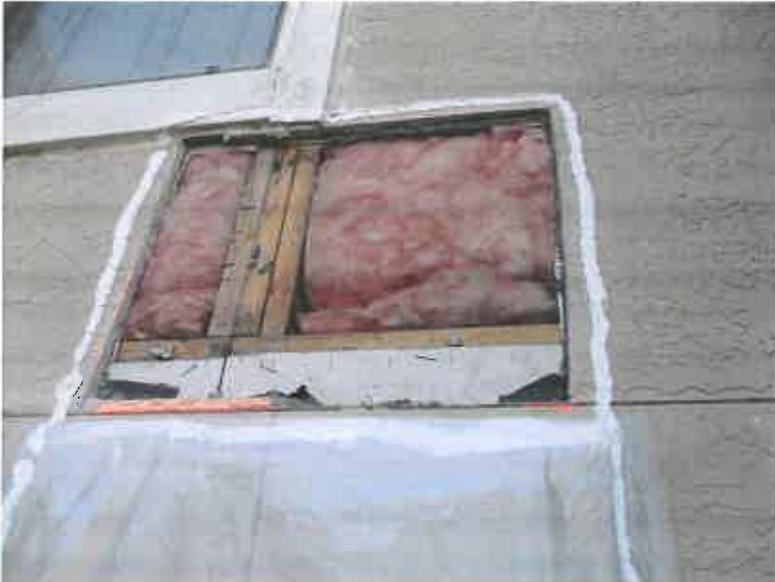
PHOTOGRAPH #11

**DESTRUCTIVE INVESTIGATION
OPENINGS – MARK 11
2nd Floor Below Window**

No damage

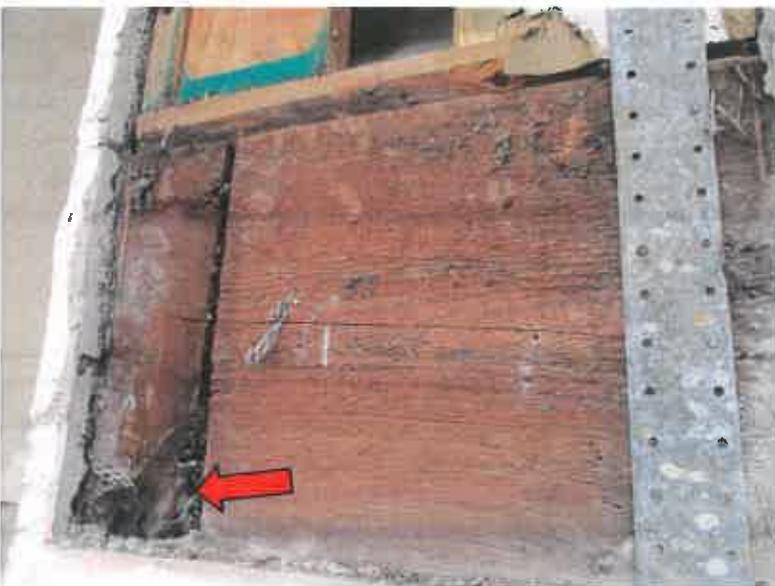
PHOTOGRAPH #12

**DESTRUCTIVE INVESTIGATION
OPENINGS – MARK 12
2nd Floor Adjacent to Balcony**

Wood frame damage

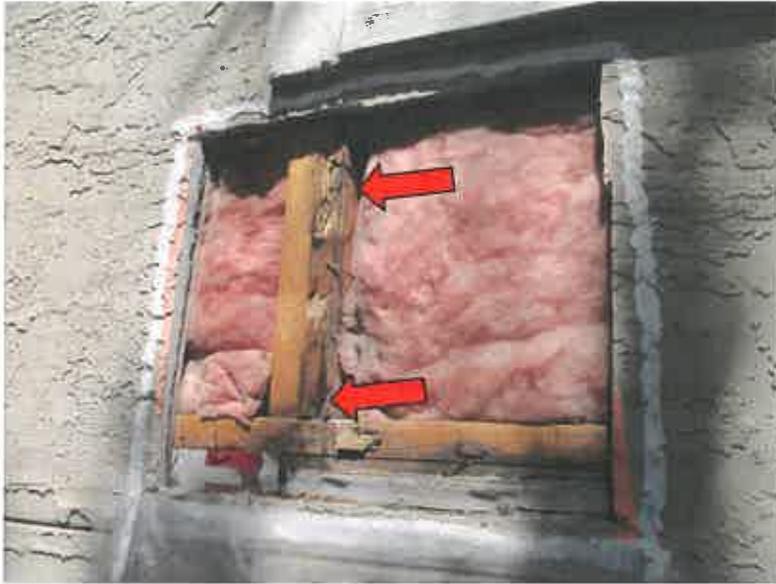
PHOTOGRAPH #13

**DESTRUCTIVE INVESTIGATION
OPENINGS – MARK 13
2nd Floor Below Window**

Wood frame damage

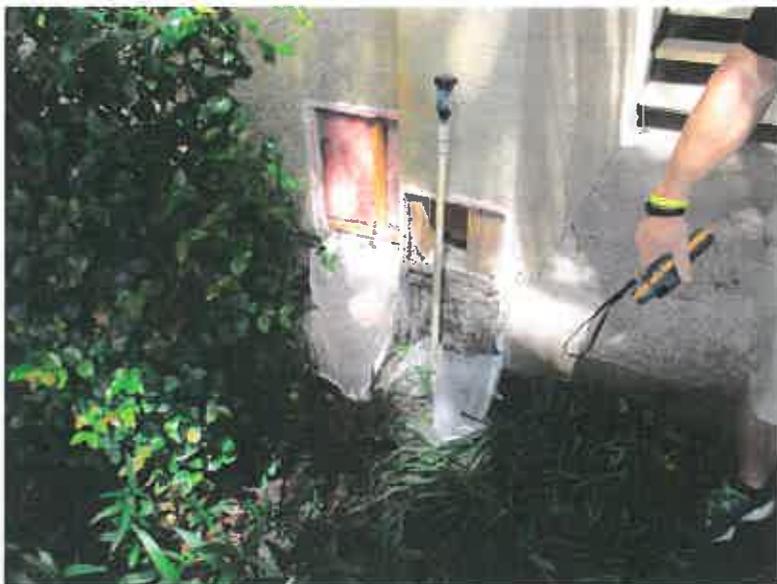
PHOTOGRAPH #14

**DESTRUCTIVE INVESTIGATION
OPENINGS – MARK 14
1st Floor Near Stair at Base**

No damage

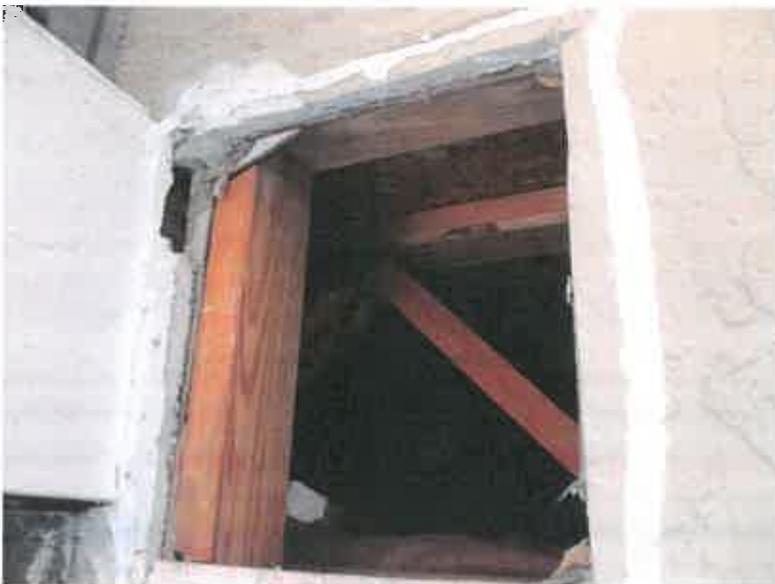
PHOTOGRAPH #16

**DESTRUCTIVE INVESTIGATION
OPENINGS – MARK 16
2nd Floor Adjacent to Balcony**

No damage

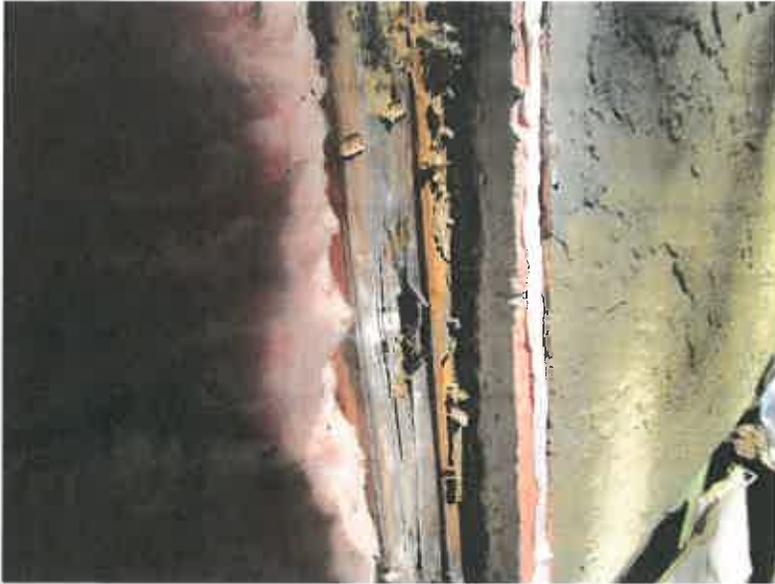
PHOTOGRAPH #17

**DESTRUCTIVE INVESTIGATION
OPENINGS – MARK 17
1st Floor Below Window**

Wood frame damage

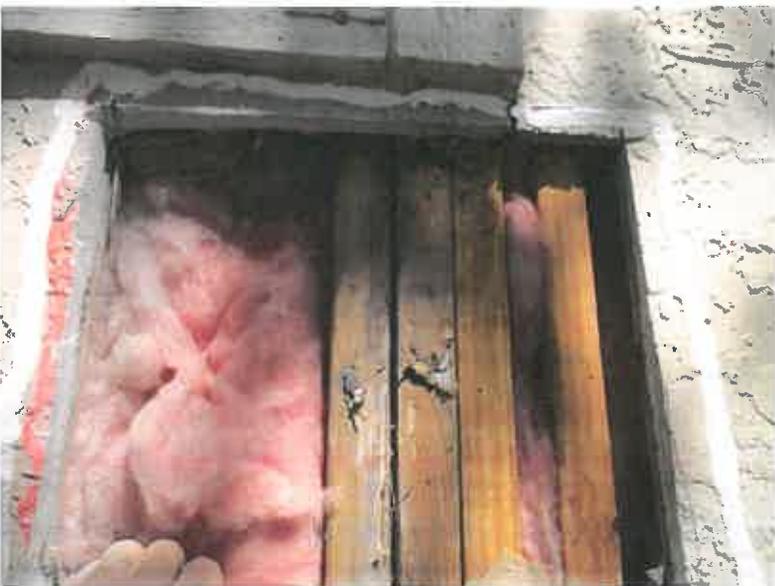
PHOTOGRAPH #18

**DESTRUCTIVE INVESTIGATION
OPENINGS – MARK 18
2nd Floor Below Window**

No damage

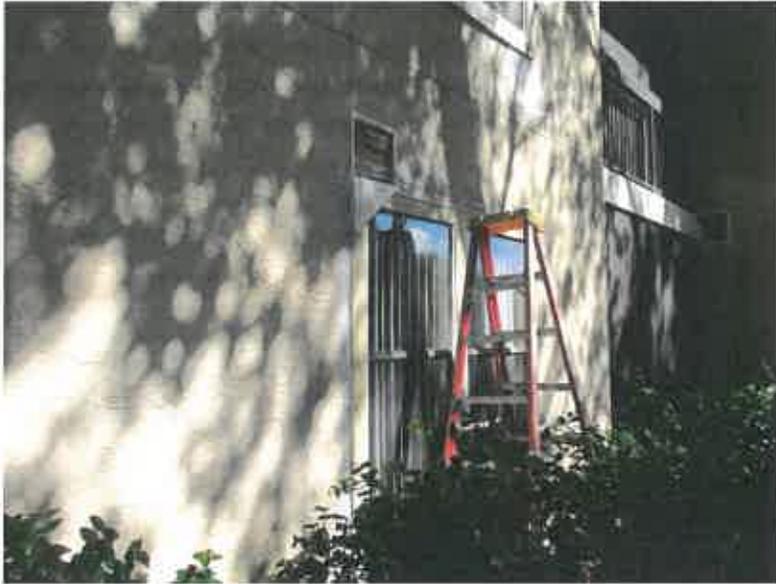
PHOTOGRAPH #19

**DESTRUCTIVE INVESTIGATION
OPENINGS – MARK 19
1st Floor Above Window**

No damage

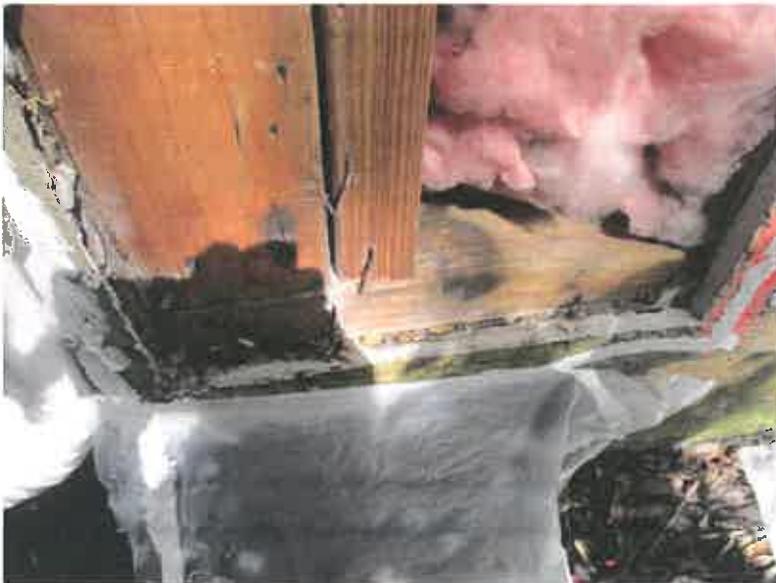
PHOTOGRAPH #20

**DESTRUCTIVE INVESTIGATION
OPENINGS – MARK 20
1st Floor Outside Corner**

No damage

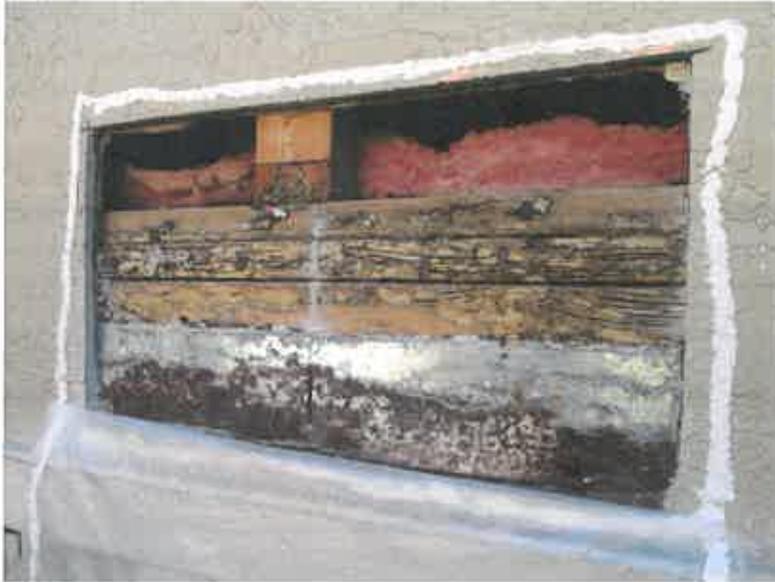
PHOTOGRAPH #23

**DESTRUCTIVE INVESTIGATION
OPENINGS – MARK 23
1st Floor Above Window**

Wood frame damage

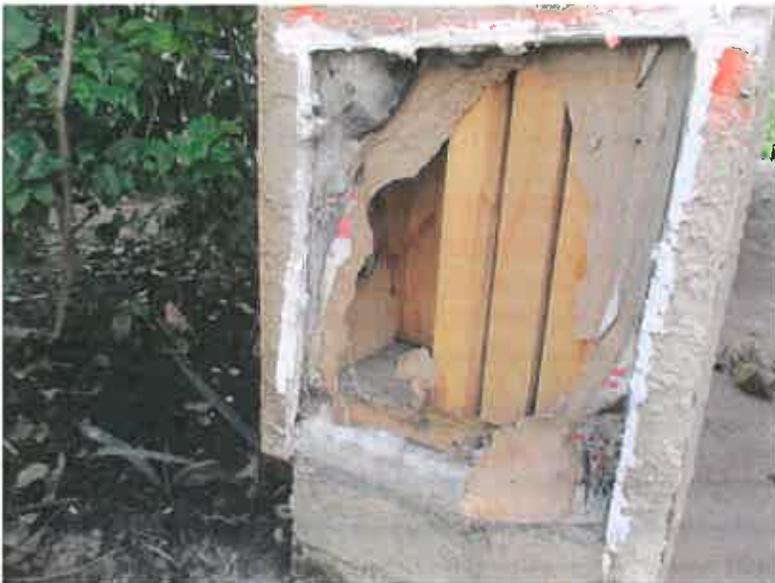
PHOTOGRAPH #24

**DESTRUCTIVE INVESTIGATION
OPENINGS – MARK 24
1st Floor Near Stair at Base**

No damage

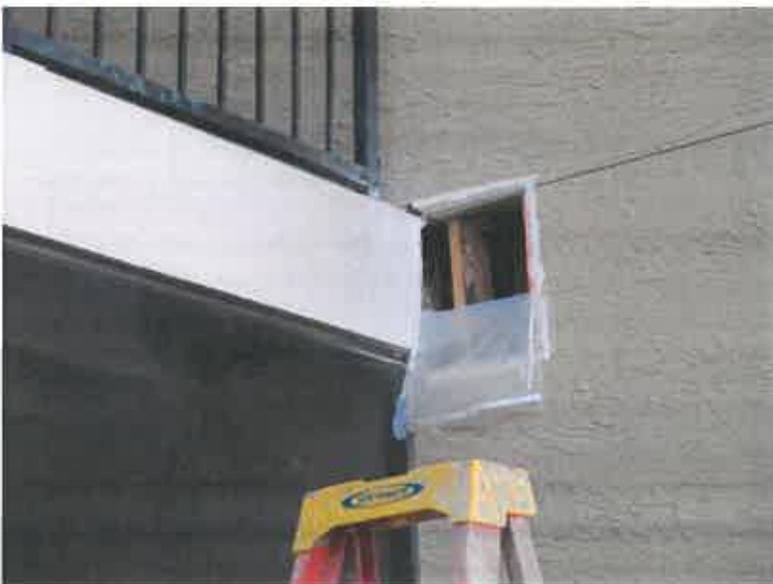
PHOTOGRAPH #26

**DESTRUCTIVE INVESTIGATION
OPENINGS – MARK 26
2nd Floor Adjacent to Balcony**

No damage

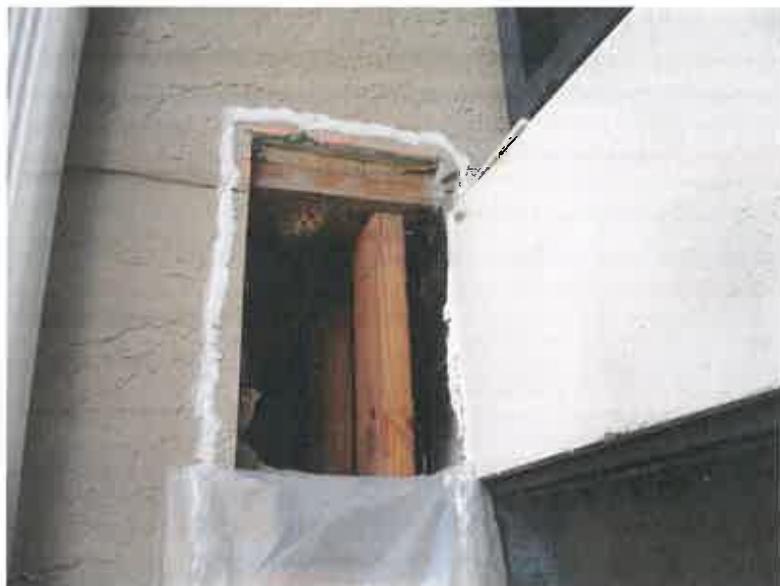
PHOTOGRAPH #27

**DESTRUCTIVE INVESTIGATION
OPENINGS – MARK 27
2nd Floor Adjacent to Balcony**

No damage

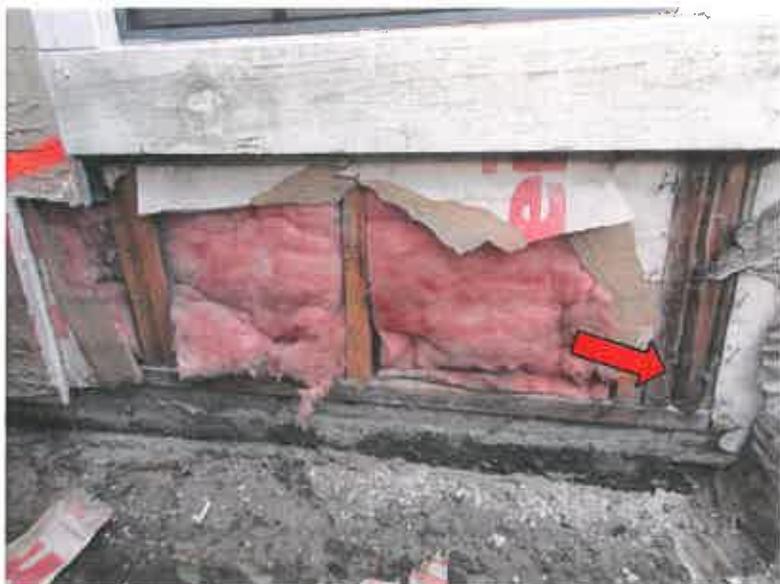
PHOTOGRAPH #28

**DESTRUCTIVE INVESTIGATION
OPENINGS – MARK 28
1st Floor Below Window**

Wood frame damage

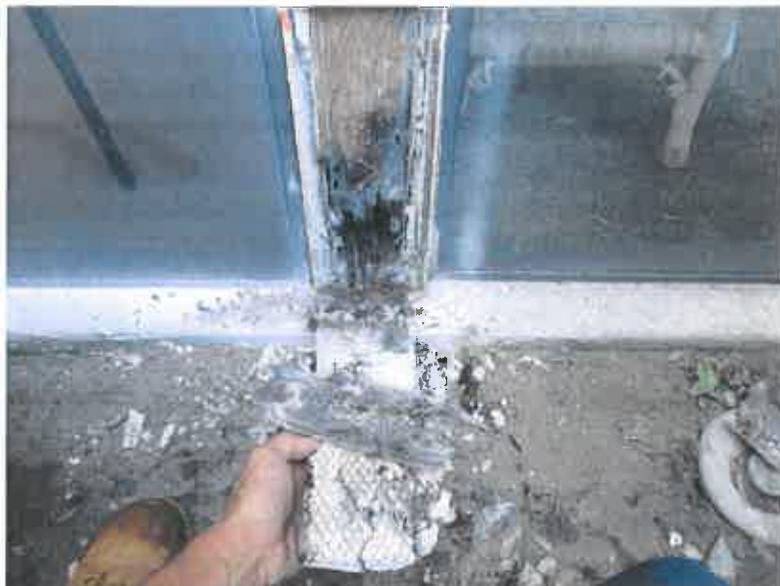
PHOTOGRAPH #29

**DESTRUCTIVE INVESTIGATION
OPENINGS – MARK 29
1st Floor Between Lanais**

Wood frame damage

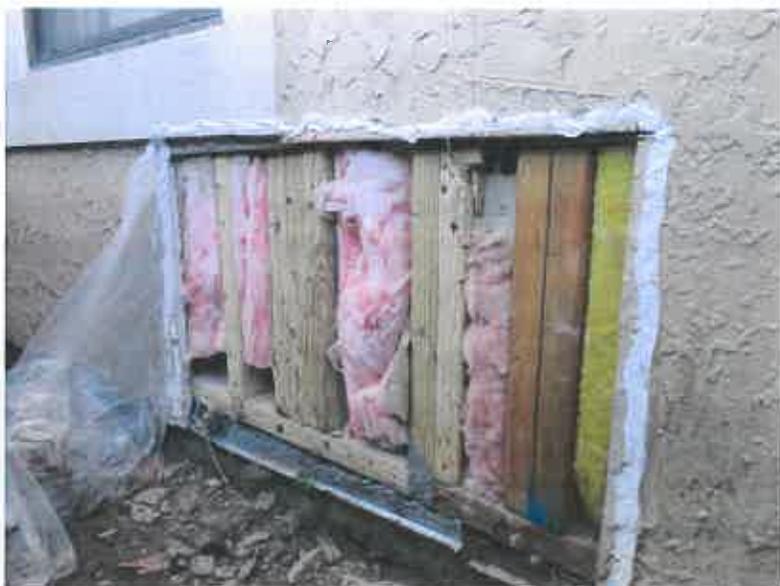
PHOTOGRAPH #30

**DESTRUCTIVE INVESTIGATION
OPENINGS – MARK 30
1st Floor Below Window**

No damage, previous repair

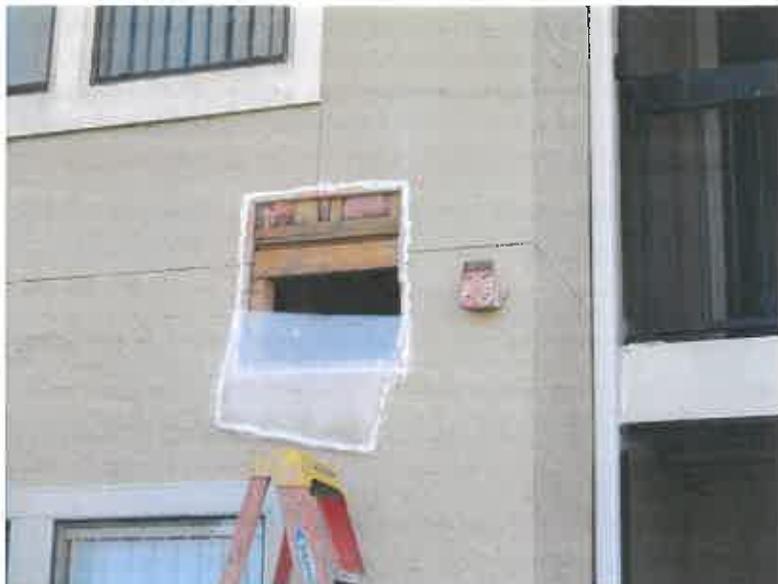
PHOTOGRAPH #31

**DESTRUCTIVE INVESTIGATION
OPENINGS – MARK 31
1st & 2nd Floor at Control Joint**

No damage

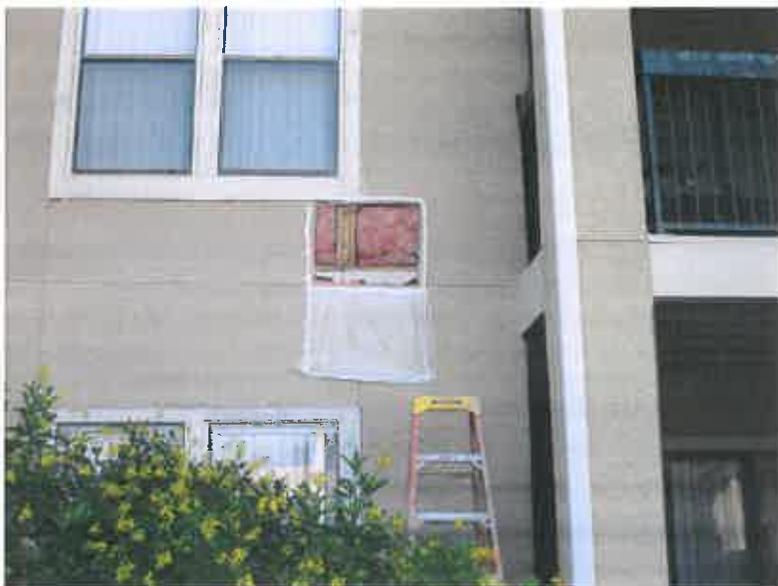
PHOTOGRAPH #32

**DESTRUCTIVE INVESTIGATION
OPENINGS – MARK 32
2nd Floor Below Window**

No damage

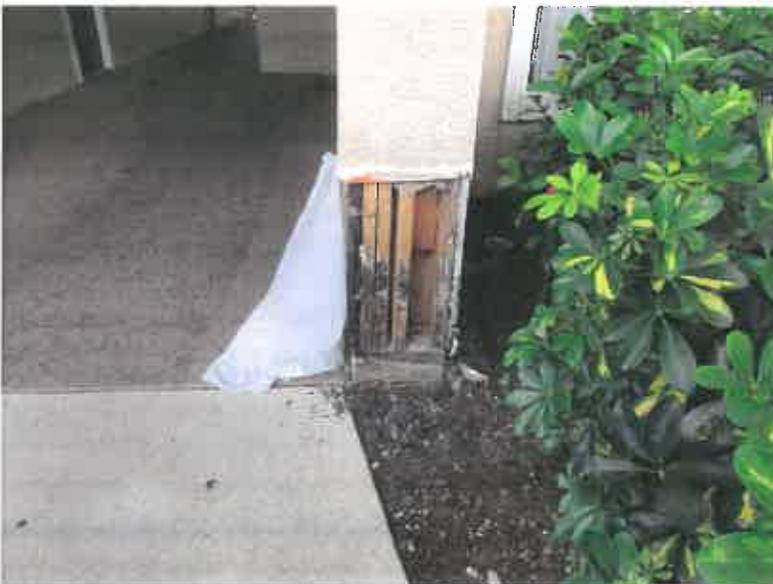
PHOTOGRAPH #34

**DESTRUCTIVE INVESTIGATION
OPENINGS – MARK 34
1st Floor Near Stair at Base**

Wood frame damage

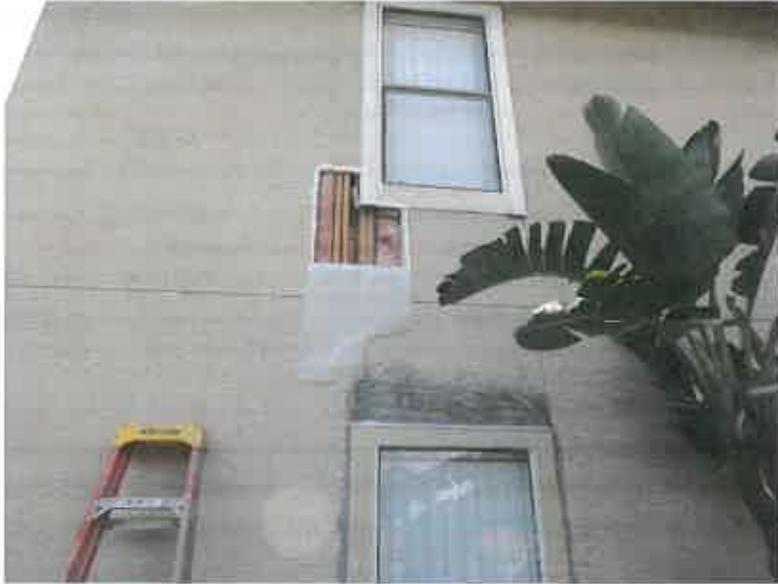
PHOTOGRAPH #35

**DESTRUCTIVE INVESTIGATION
OPENINGS – MARK 1
2nd Floor Below Window**

No damage

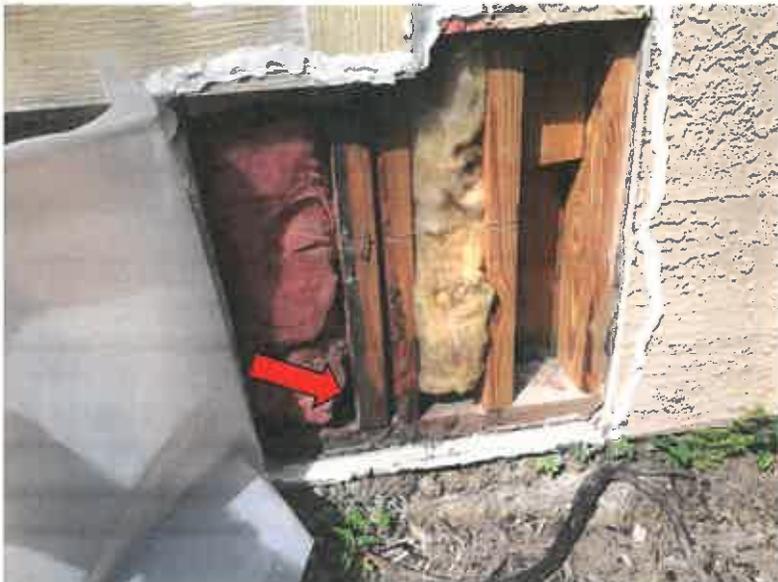
PHOTOGRAPH #36

**DESTRUCTIVE INVESTIGATION
OPENINGS – MARK 2
1st Floor Below Window**

No damage, water stains on studs

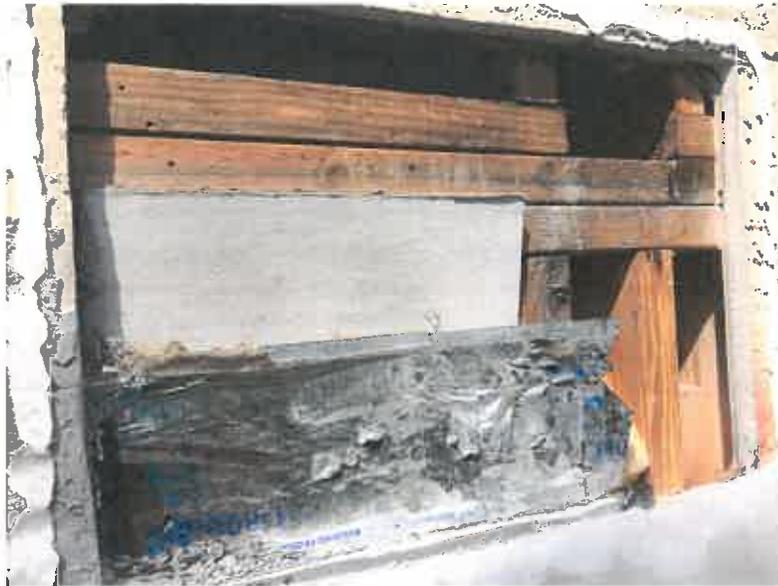
PHOTOGRAPH #37

**DESTRUCTIVE INVESTIGATION
OPENINGS – MARK 3
1st Floor Above Window**

No damage

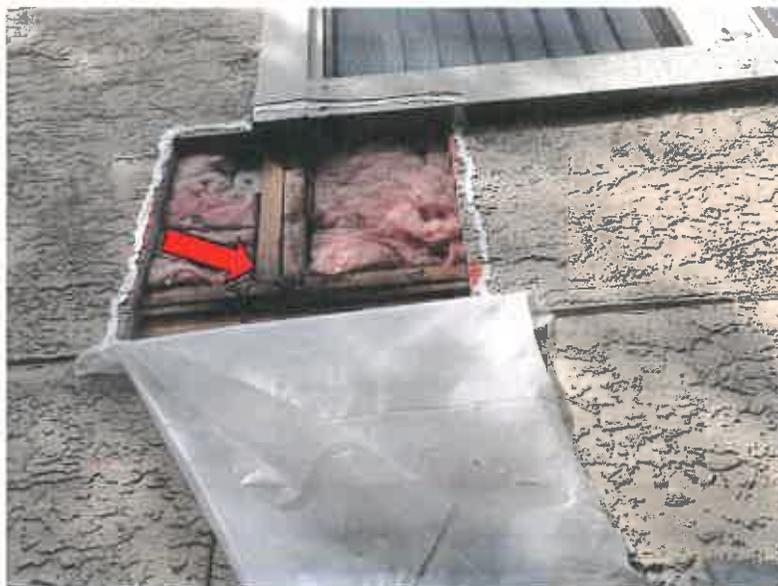
PHOTOGRAPH #38

**DESTRUCTIVE INVESTIGATION
OPENINGS – MARK 4
2nd Floor Below Window**

Wood frame damage

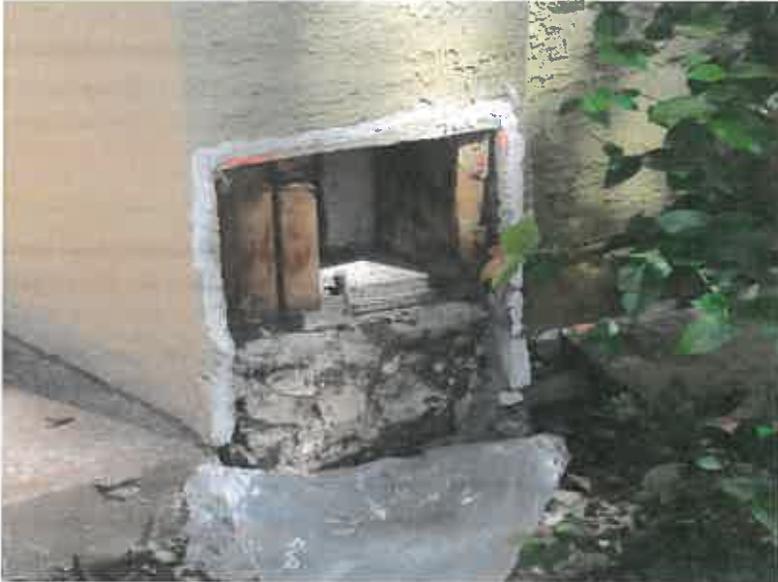
PHOTOGRAPH #39

**DESTRUCTIVE INVESTIGATION
OPENINGS – MARK 5
1st Floor Near Stairs at Base**

No damage

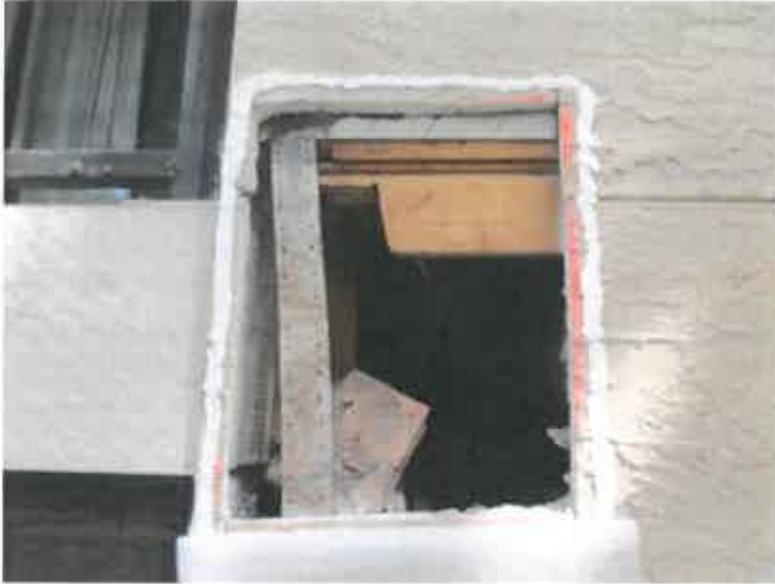
PHOTOGRAPH #41

**DESTRUCTIVE INVESTIGATION
OPENINGS – MARK 7
2nd Floor Adjacent to Balcony**

No damage

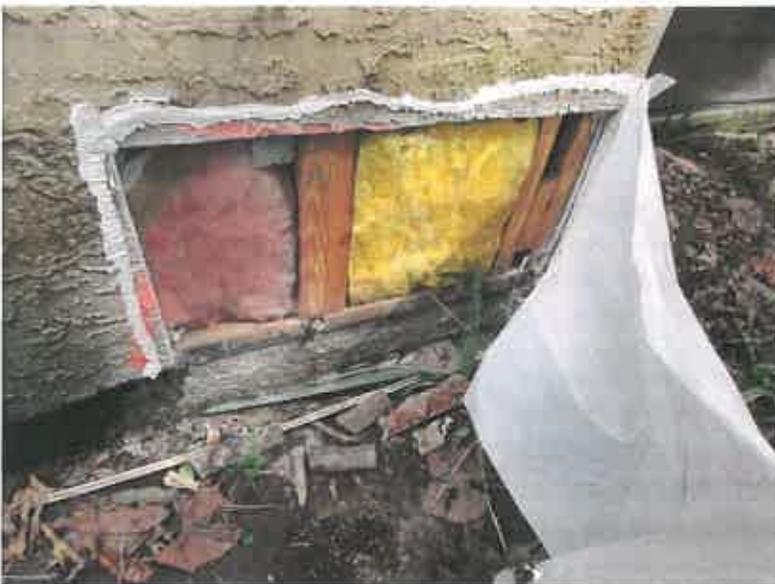
PHOTOGRAPH #42

**DESTRUCTIVE INVESTIGATION
OPENINGS – MARK 8
1st Floor Outside Corner**

No damage

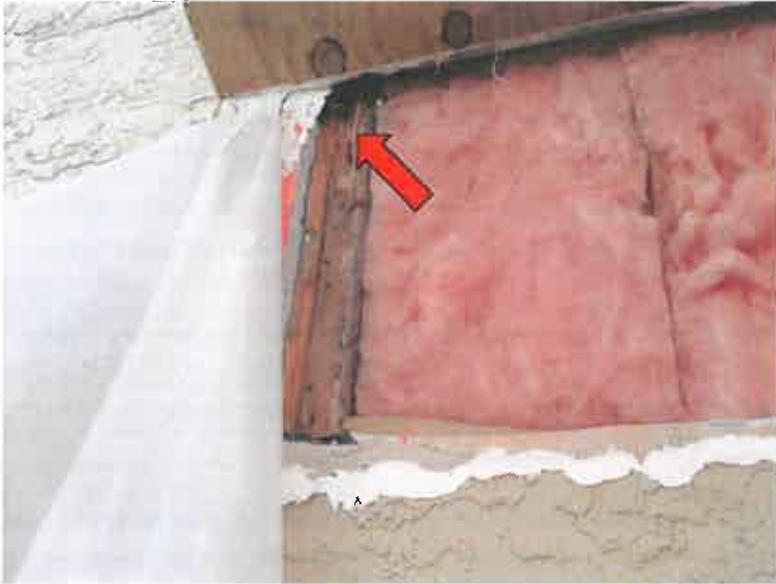
PHOTOGRAPH #43

**DESTRUCTIVE INVESTIGATION
OPENINGS – MARK 9
2nd Floor Below Window**

Wood frame damage

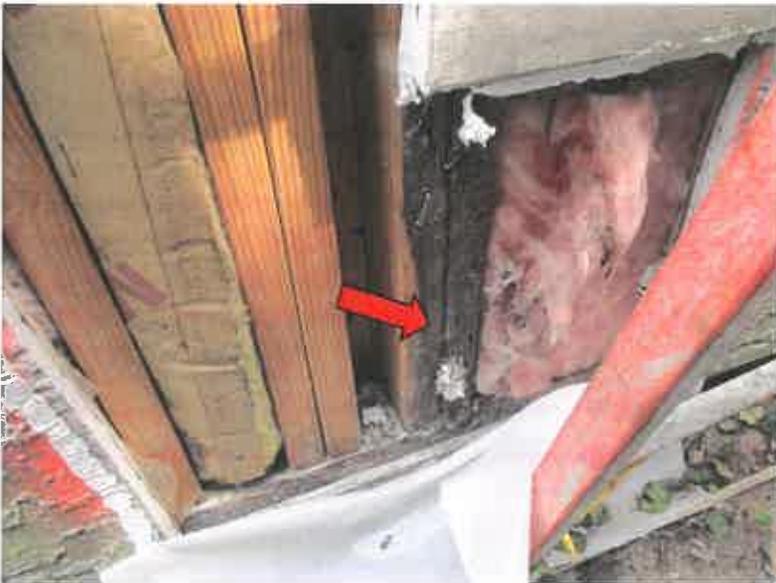
PHOTOGRAPH #44

**DESTRUCTIVE INVESTIGATION
OPENINGS – MARK 10
1st Floor Below Window**

Wood frame damage

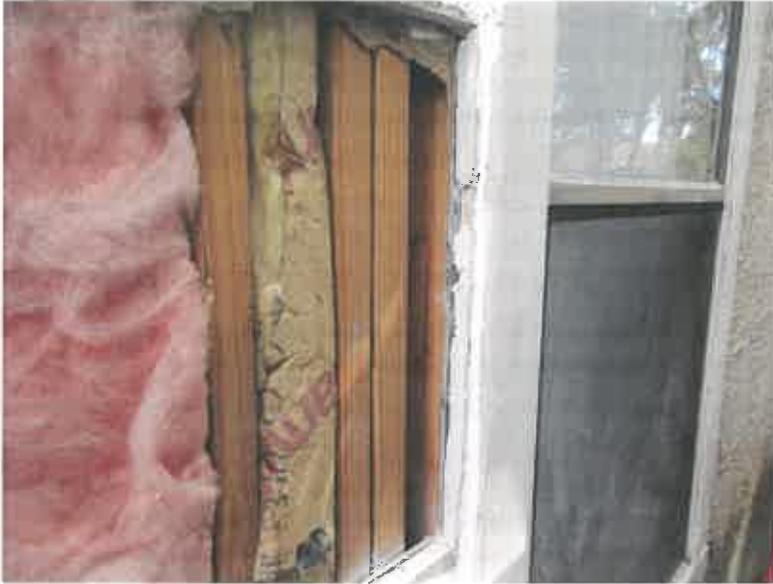
PHOTOGRAPH #45

**DESTRUCTIVE INVESTIGATION
OPENINGS – MARK 11
1st Floor Adjacent to Window**

No damage

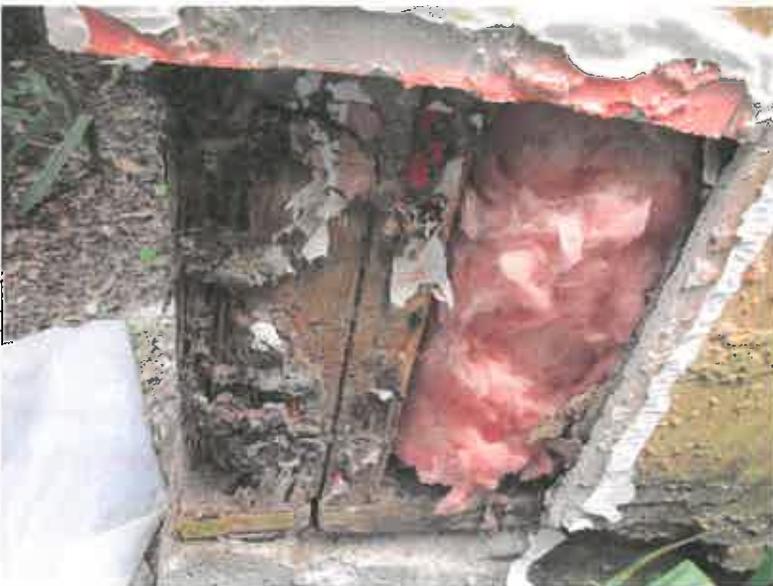
PHOTOGRAPH #46

**DESTRUCTIVE INVESTIGATION
OPENINGS – MARK 12
1st Floor Outside Corner**

Wood frame damage

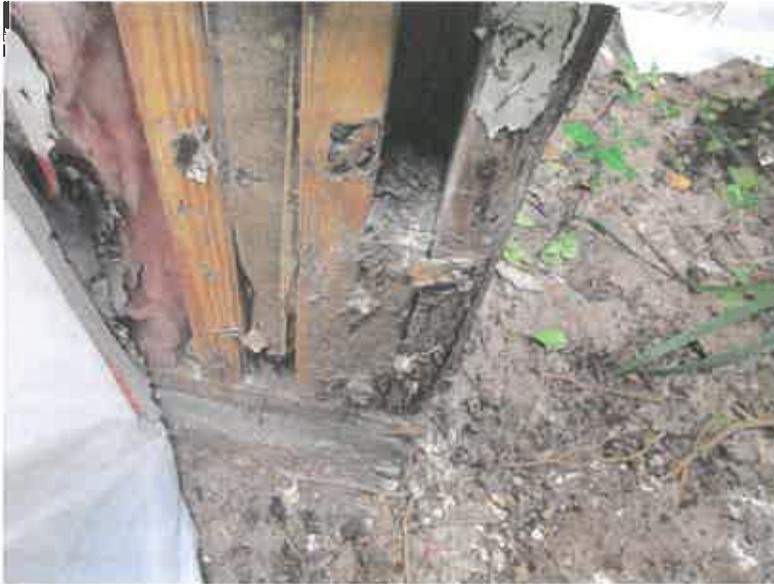
PHOTOGRAPH #47

**DESTRUCTIVE INVESTIGATION
OPENINGS – MARK 13
1st Floor Outside Corner**

Wood frame damage

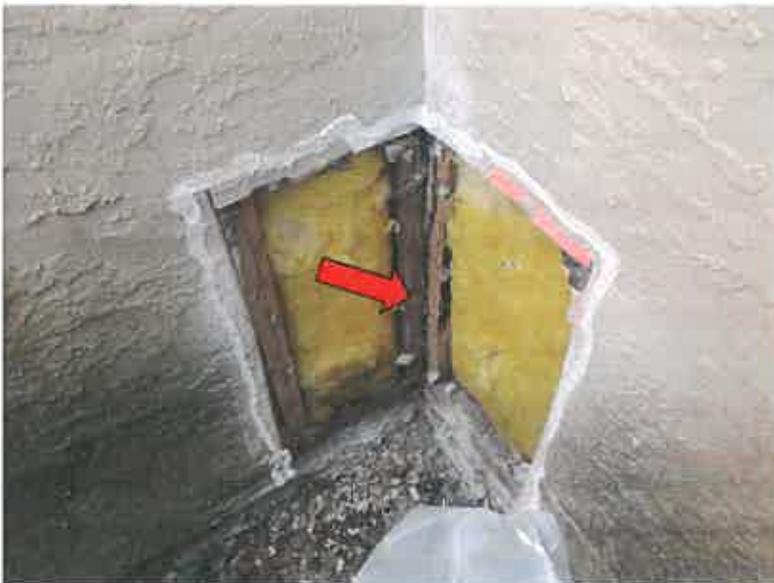
PHOTOGRAPH #48

**DESTRUCTIVE INVESTIGATION
OPENINGS – MARK 14
1st Floor Inside Corner**

Wood frame damage

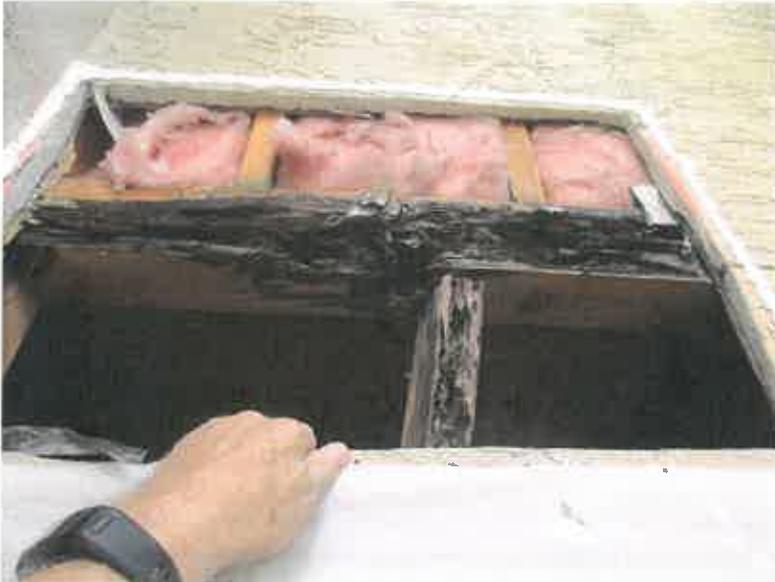
PHOTOGRAPH #49

**DESTRUCTIVE INVESTIGATION
OPENINGS – MARK 15
1st & 2nd Floor at Control Joint**

Wood frame damage

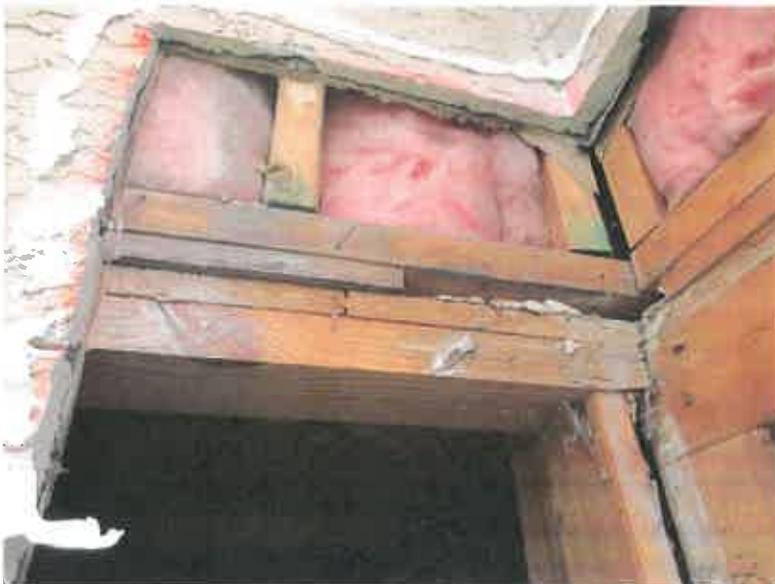
PHOTOGRAPH #50

**DESTRUCTIVE INVESTIGATION
OPENINGS – MARK 16
1st & 2nd Floor Inside Corner**

No damage

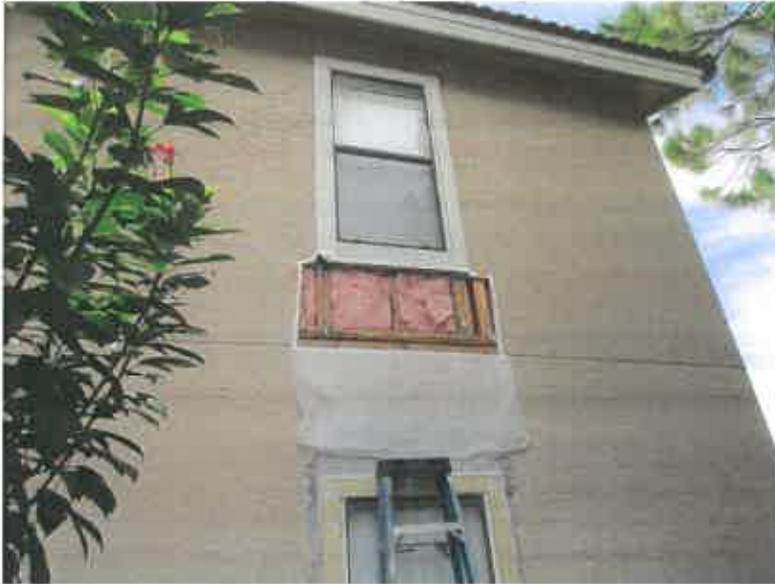
PHOTOGRAPH #51

**DESTRUCTIVE INVESTIGATION
OPENINGS – MARK 17
2nd Floor Below Window**

No damage

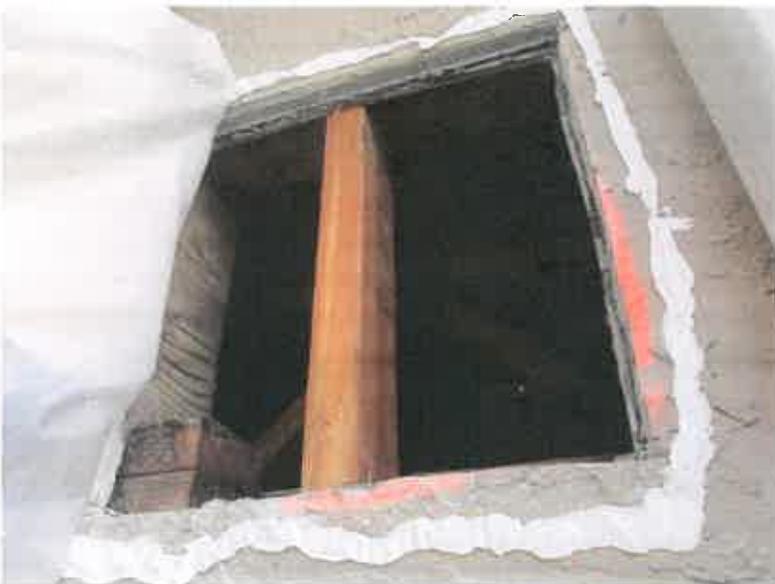
PHOTOGRAPH #52

**DESTRUCTIVE INVESTIGATION
OPENINGS – MARK 18
2nd Floor Adjacent to Balcony**

No damage

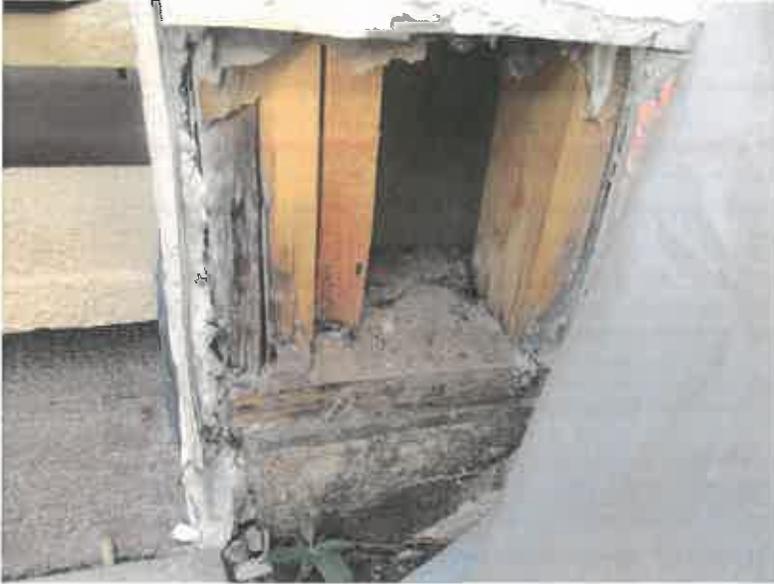
PHOTOGRAPH #53

**DESTRUCTIVE INVESTIGATION
OPENINGS – MARK 19
1st Floor Near Stair at Base**

Wood frame damage

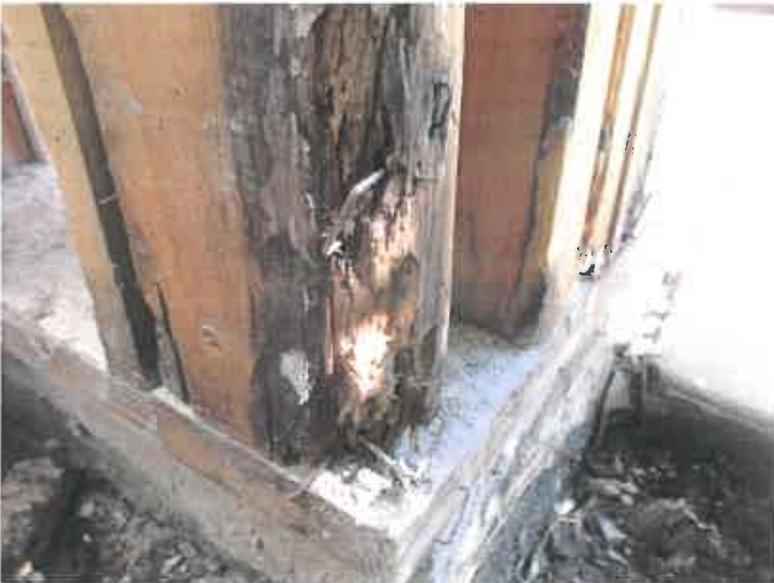
PHOTOGRAPH #54

**DESTRUCTIVE INVESTIGATION
OPENINGS – MARK 20
1st Floor Near Stair at Base**

Wood frame damage

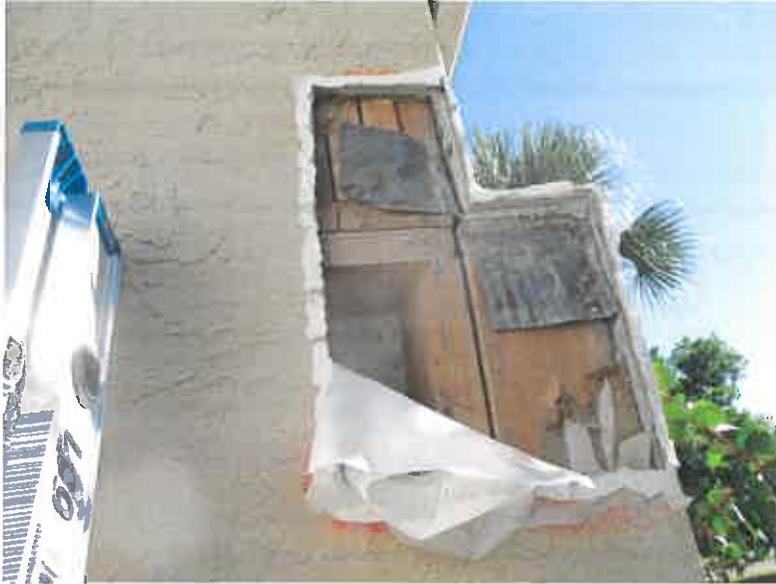
PHOTOGRAPH #55

**DESTRUCTIVE INVESTIGATION
OPENINGS – MARK 21
2nd Floor Above Stairwell**

No damage

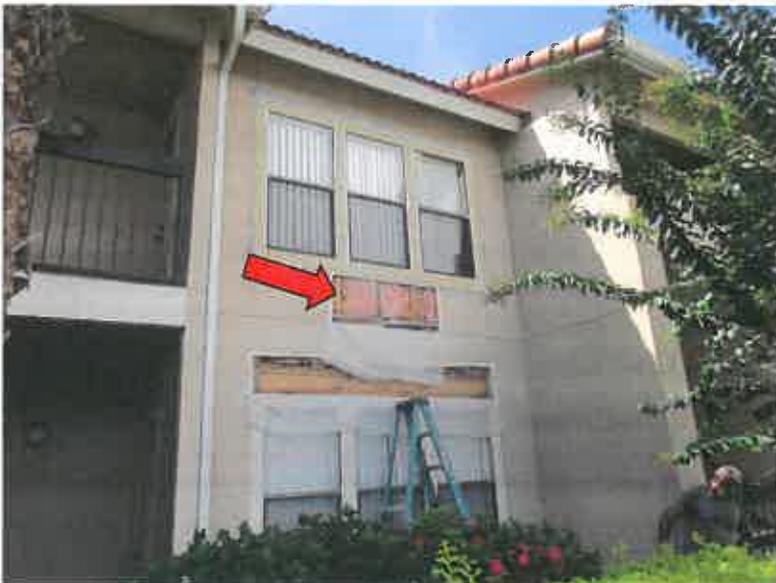
PHOTOGRAPH #56

**DESTRUCTIVE INVESTIGATION
OPENINGS – MARK 22
2nd Floor Below Window**

No damage

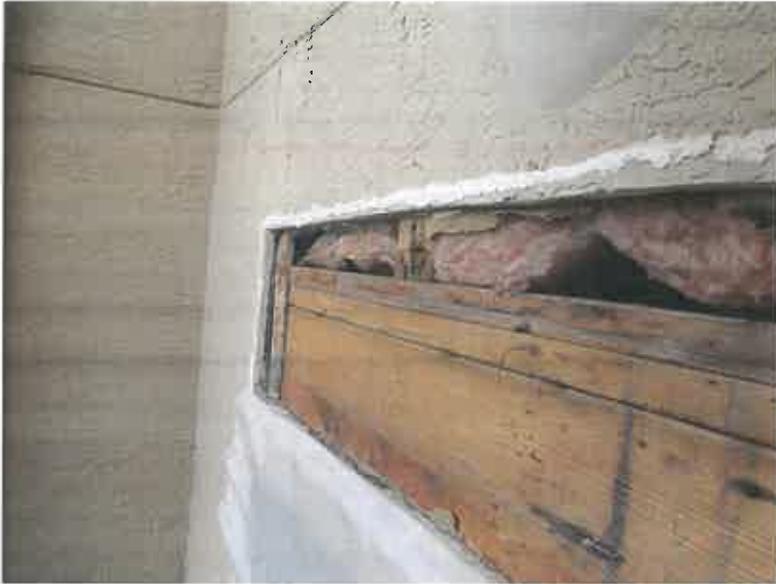
PHOTOGRAPH #57

**DESTRUCTIVE INVESTIGATION
OPENINGS – MARK 23
1st Floor Above Window**

No damage

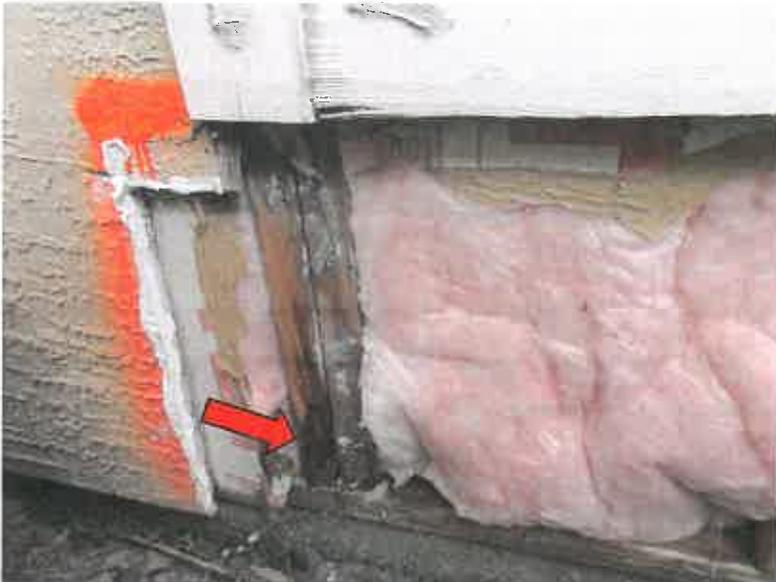
PHOTOGRAPH #59

**DESTRUCTIVE INVESTIGATION
OPENINGS – MARK 25
1st Floor Below Window**

Wet framing, water stains on studs
