SUPPLEMENTAL DESTRUCTIVE INVESTIGATION

**Vintage Grand Condominium
4012 Crockers Lake Blvd.
Sarasota, FL 34238**

Project No. R1606-231

October 28, 2016

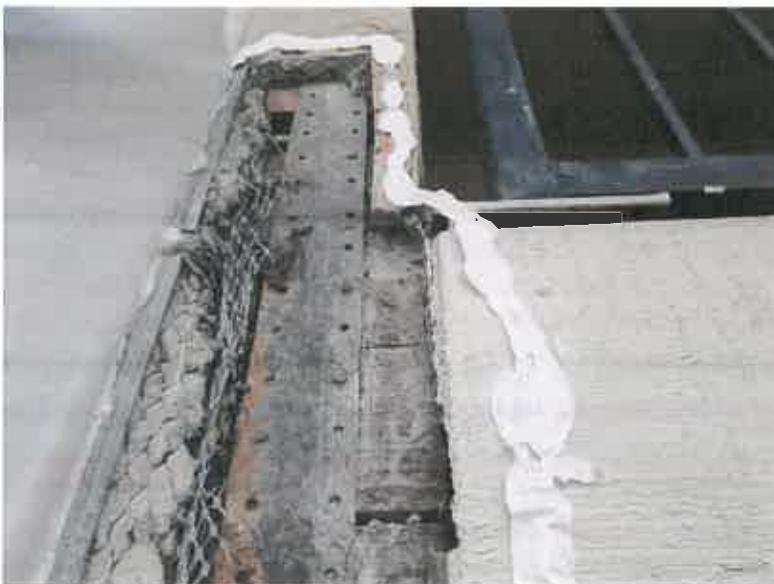
PHOTOGRAPH #60

**DESTRUCTIVE INVESTIGATION
OPENINGS – MARK 26
2nd Floor Adjacent to Balcony**

No damage

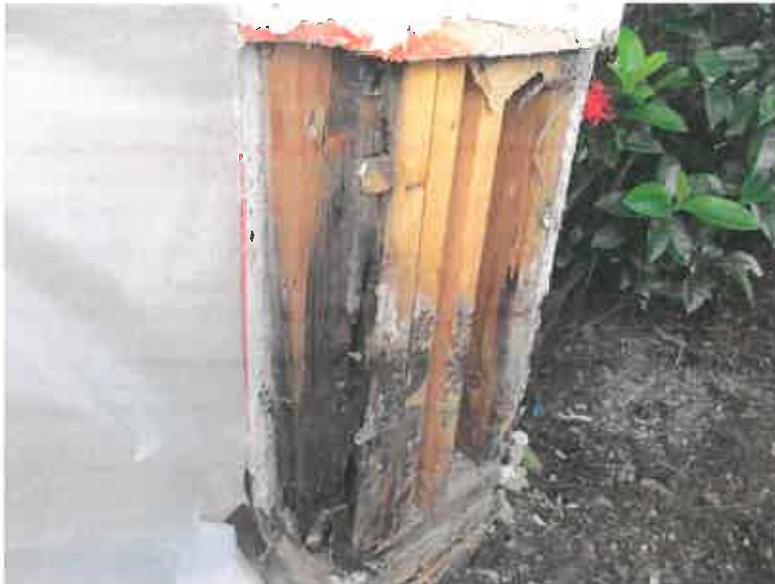
PHOTOGRAPH #61

**DESTRUCTIVE INVESTIGATION
OPENINGS – MARK 27
1st Floor Near Stair at Base**

Wood frame damage

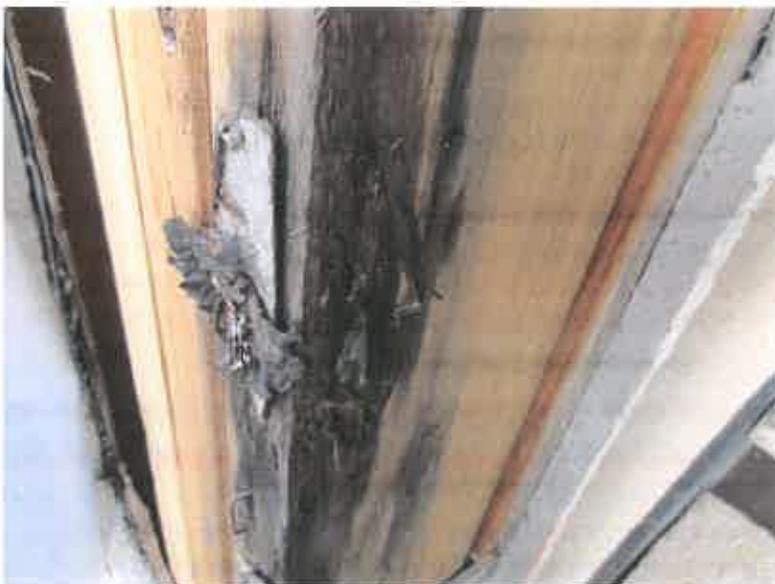
PHOTOGRAPH #62

**DESTRUCTIVE INVESTIGATION
OPENINGS – MARK 28
1st Floor Near Stair at Base**

Wood frame damage

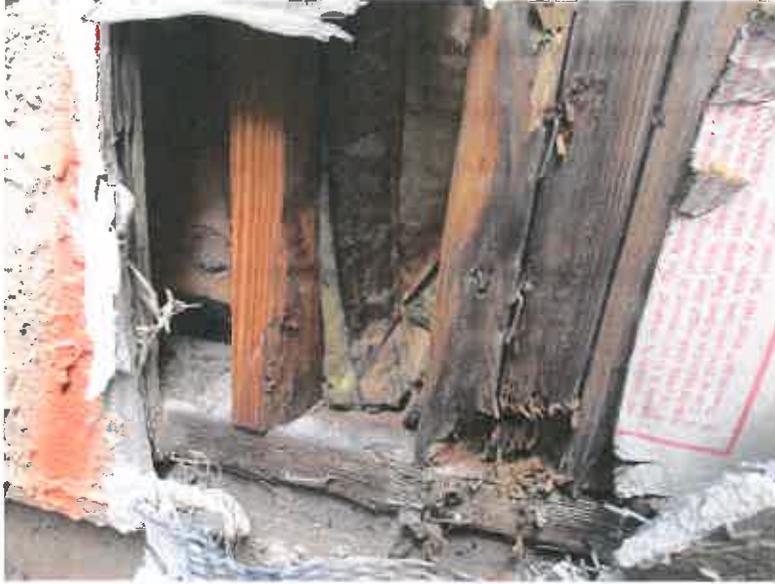
PHOTOGRAPH #63

**DESTRUCTIVE INVESTIGATION
OPENINGS – MARK 1
1st Floor Below Window**

Wood frame damage

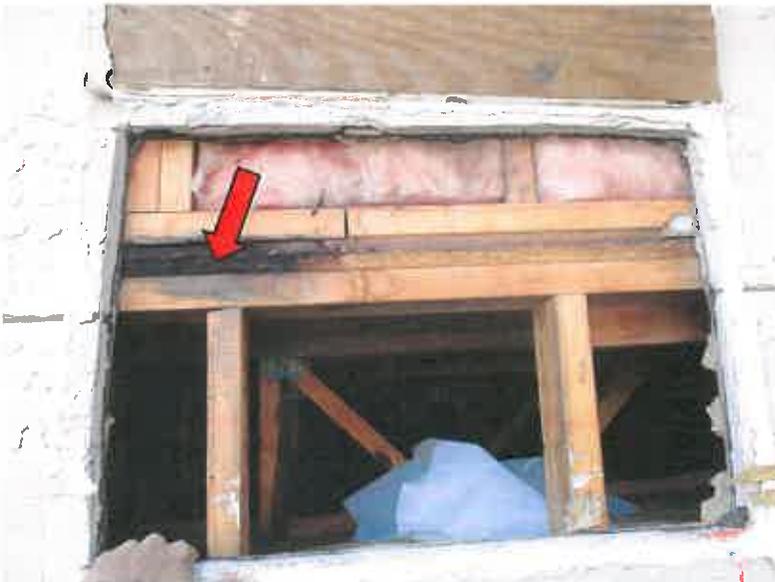
PHOTOGRAPH #64

**DESTRUCTIVE INVESTIGATION
OPENINGS – MARK 2
2nd Floor Sheathing**

Wood frame damage

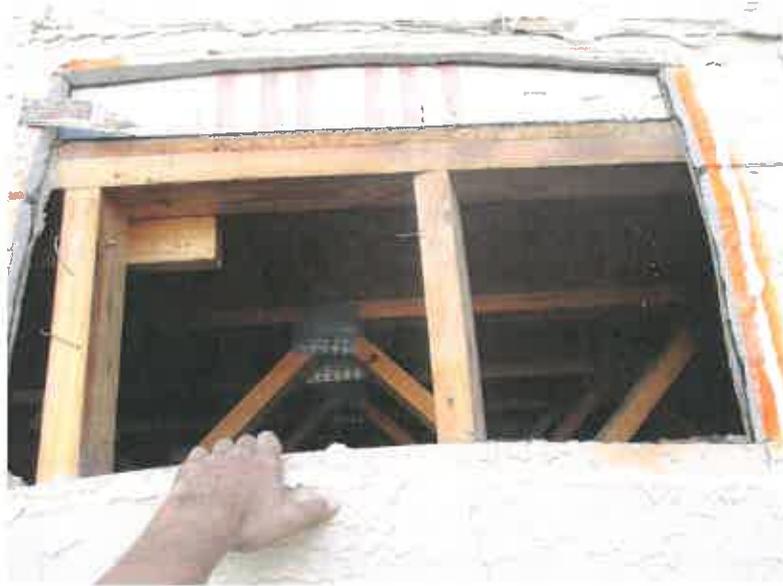
PHOTOGRAPH #65

**DESTRUCTIVE INVESTIGATION
OPENINGS – MARK 3
1st & 2nd Floor at Control Joint**

No damage

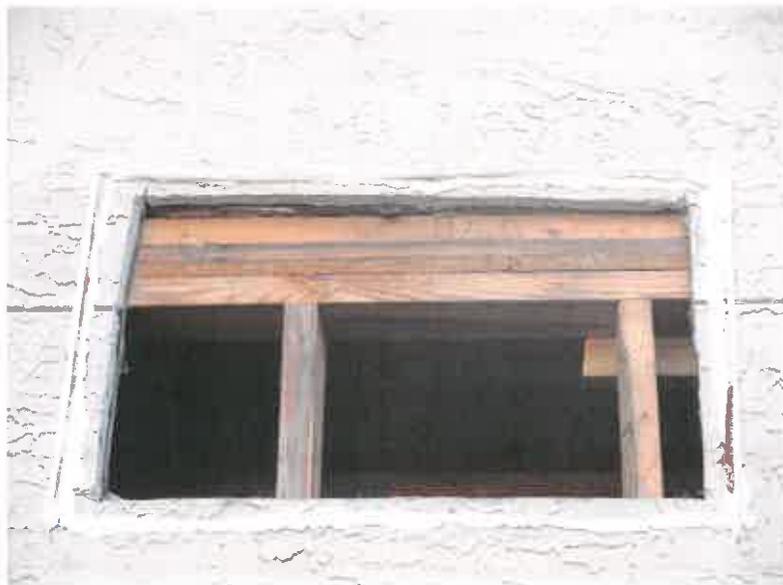
PHOTOGRAPH #66

**DESTRUCTIVE INVESTIGATION
OPENINGS – MARK 4
1st & 2nd Floor at Control Joint**

No damage

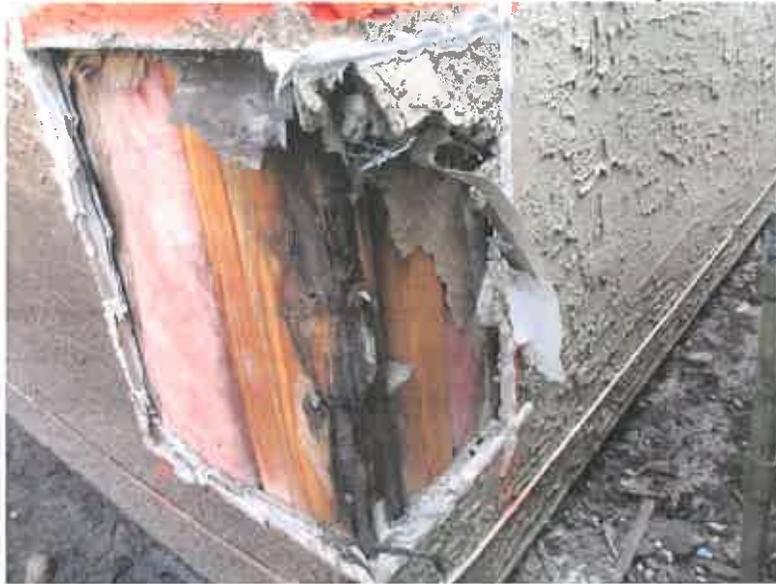
PHOTOGRAPH #67

**DESTRUCTIVE INVESTIGATION
OPENINGS – MARK 5
1st Floor Outside Corner**

Wood frame damage

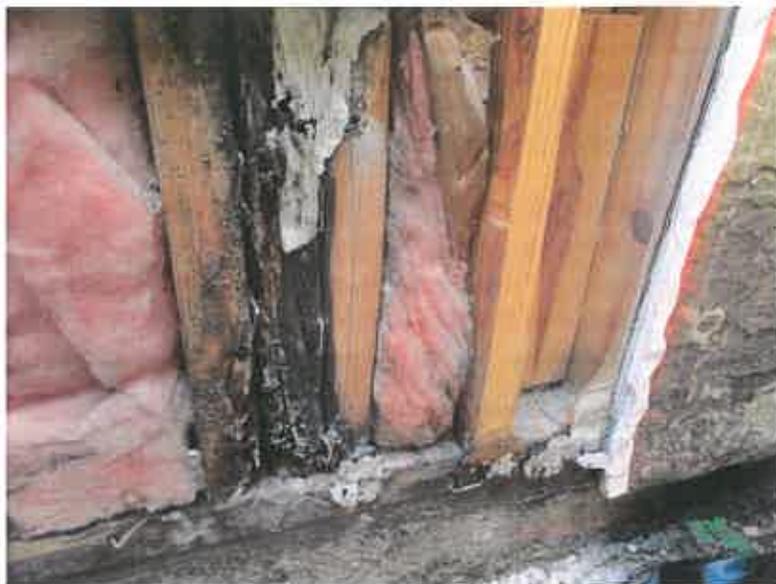
PHOTOGRAPH #68

**DESTRUCTIVE INVESTIGATION
OPENINGS – MARK 6
1st Floor Below Window**

Wood frame damage

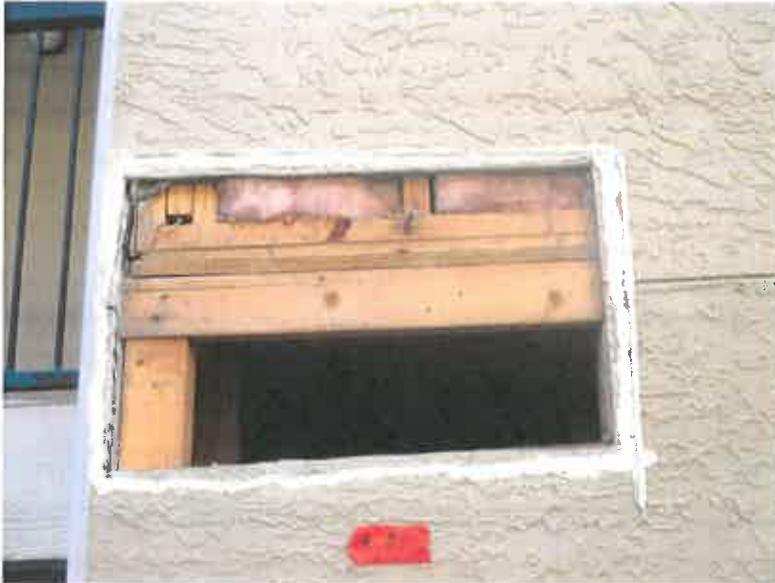
PHOTOGRAPH #69

**DESTRUCTIVE INVESTIGATION
OPENINGS – MARK 7
2nd Floor Adjacent to Balcony**

No damage

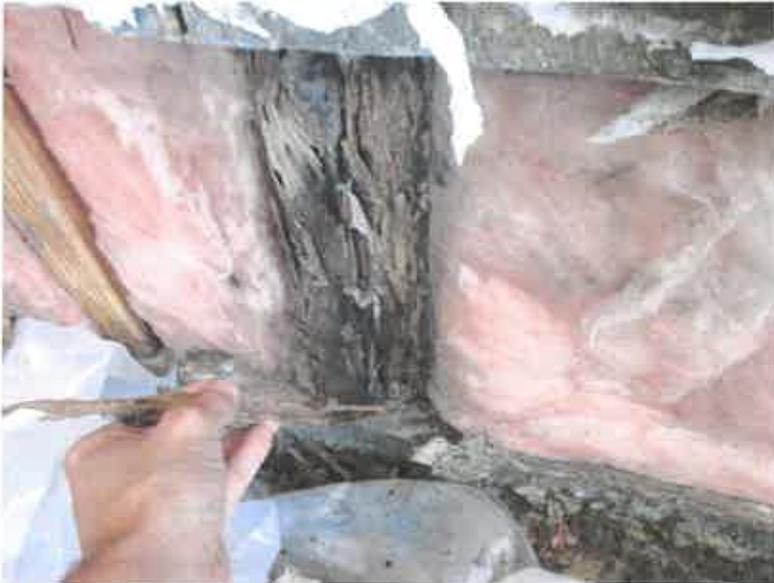
PHOTOGRAPH #71

**DESTRUCTIVE INVESTIGATION
OPENINGS – MARK 9
1st Floor Below Window**

Wood frame damage

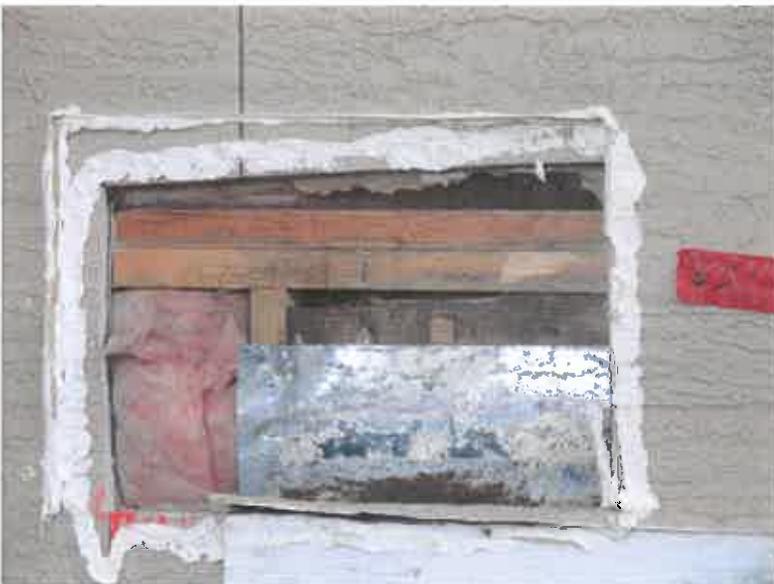
PHOTOGRAPH #72

**DESTRUCTIVE INVESTIGATION
OPENINGS – MARK 10
1st Floor Above Window**

No damage

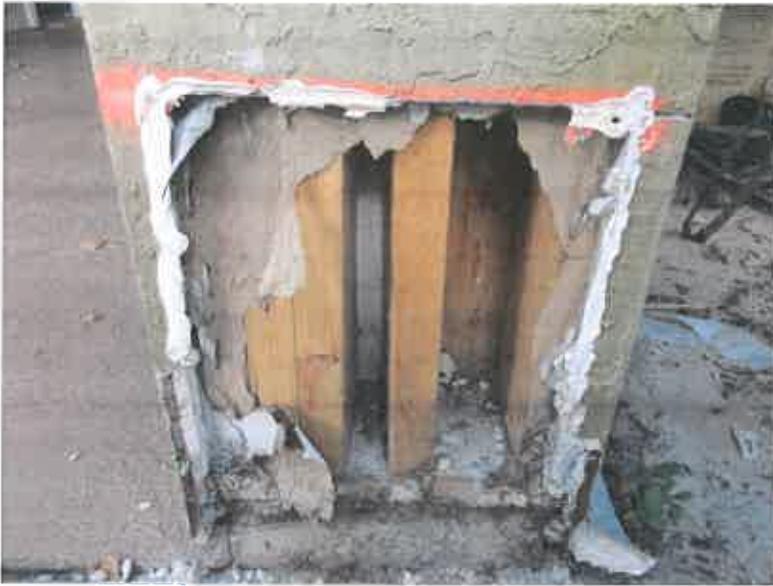
PHOTOGRAPH #73

**DESTRUCTIVE INVESTIGATION
OPENINGS – MARK 11
1st Floor Near Stair at Base**

No damage

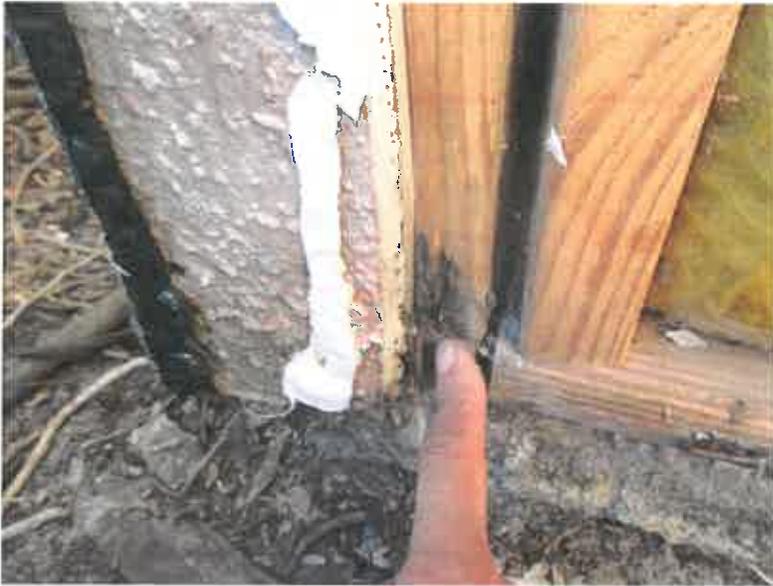
PHOTOGRAPH #75

**DESTRUCTIVE INVESTIGATION
OPENINGS – MARK 13
1st Floor Outside Corner**

Wood frame damage

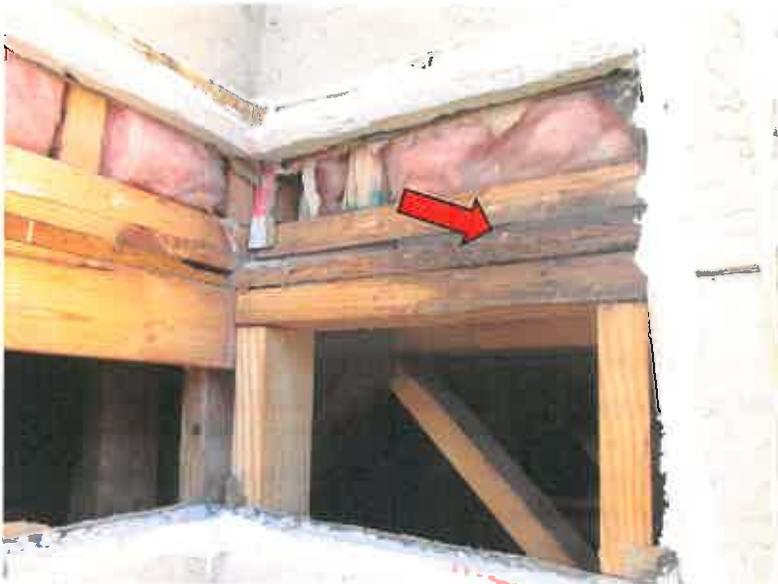
PHOTOGRAPH #76

**DESTRUCTIVE INVESTIGATION
OPENINGS – MARK 14
1st Floor Inside Corner**

Wood frame damage

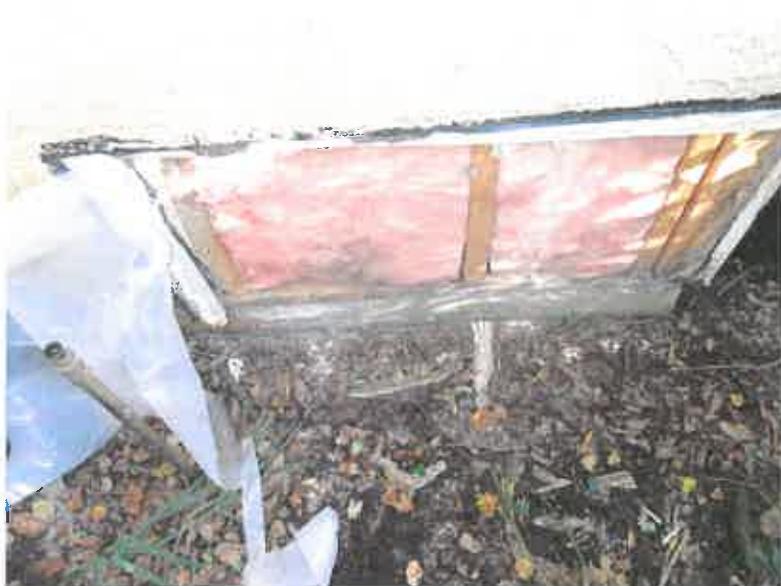
PHOTOGRAPH #77

**DESTRUCTIVE INVESTIGATION
OPENINGS – MARK 15
1st Floor Outside Corner**

No damage

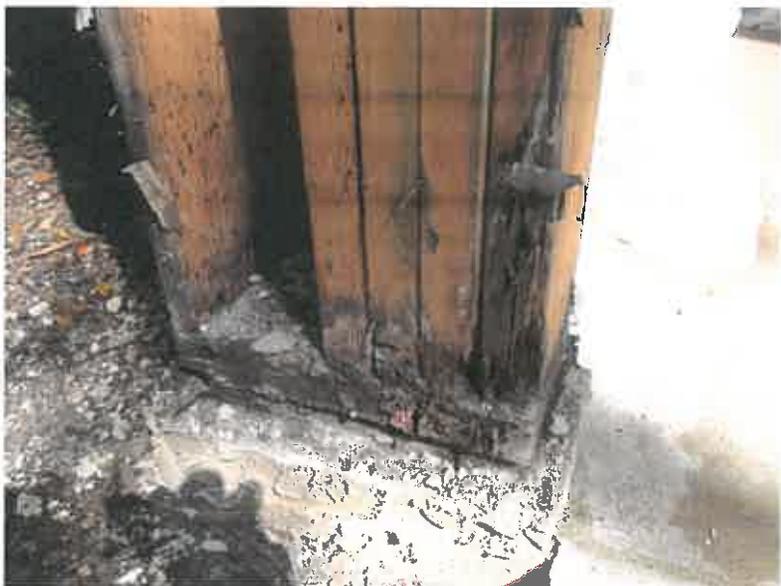
PHOTOGRAPH #78

**DESTRUCTIVE INVESTIGATION
OPENINGS – MARK 16
1st Floor Near Stair at Base**

Wood frame damage

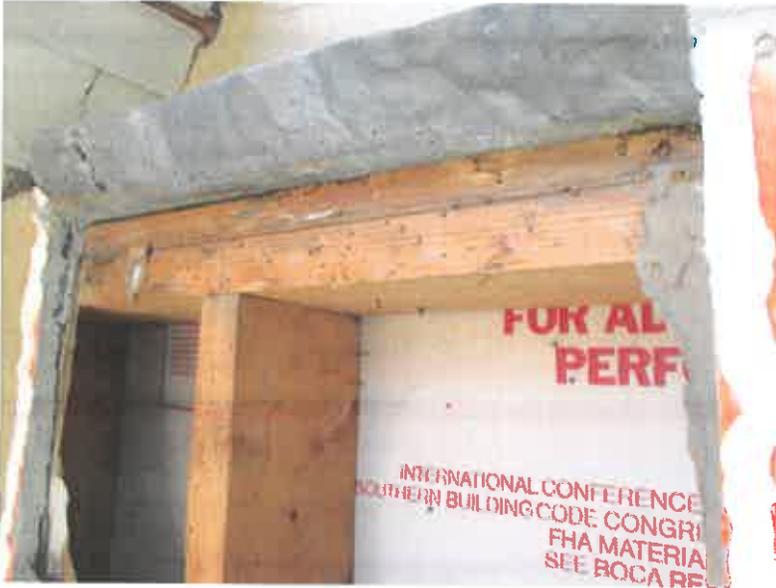
PHOTOGRAPH #79

**DESTRUCTIVE INVESTIGATION
OPENINGS – MARK 17
Roof to Wall Intersection**

No damage
