FIELD OBSERVATION REPORT - Bldg #14

Permit No: 18-131555-00 BC
 Owner: Vintage Grand Condo Assn., Inc.
 Project Address: 4017 Crockers Lake Blvd., Sarasota, FL
 Contractor: RL James Inc
 Inspector (s): Mark Boss / Mike Jones
 Type of Assessment: Progress

Project: R1803-302D
 Contact: Glenn Atall
 Phone/Fax: (941) 923-7380
 Contact: Craig Nicholas / Robert Branscombe
 Phone: (941) 232-6486 / (239) 379-1978

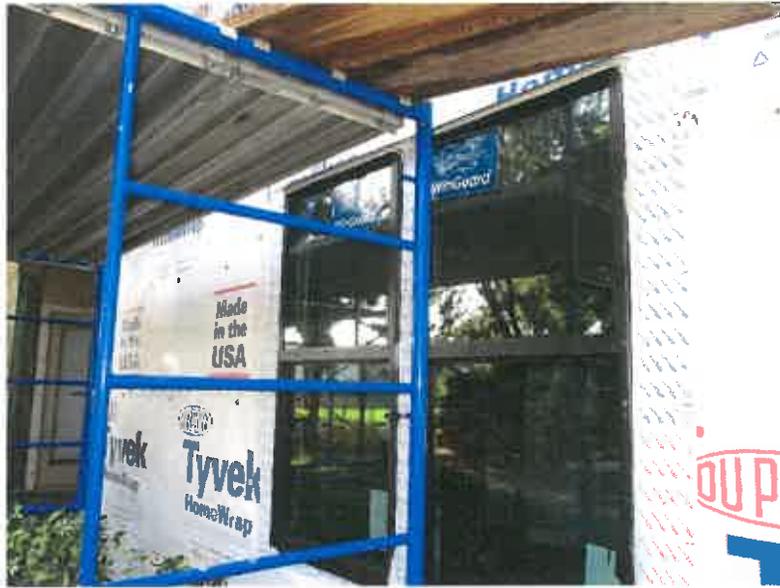
PHOTOGRAPH #1

1. Tyvek representative worked with contractor to complete flashing details at mock up (Photograph #1).
2. Unit #1412 - Certified 3rd party contractor set up test chamber for water testing and performed AAMA 502/ASTM E 1105 at the windows unit (Photograph #3 and #4).

**BUILDING 14
WINDOW INSTALLATION MOCK-UP
UNIT #1412 GROUND LEVEL**

Tyvek representative worked with contractor to complete flashing details at mock up.

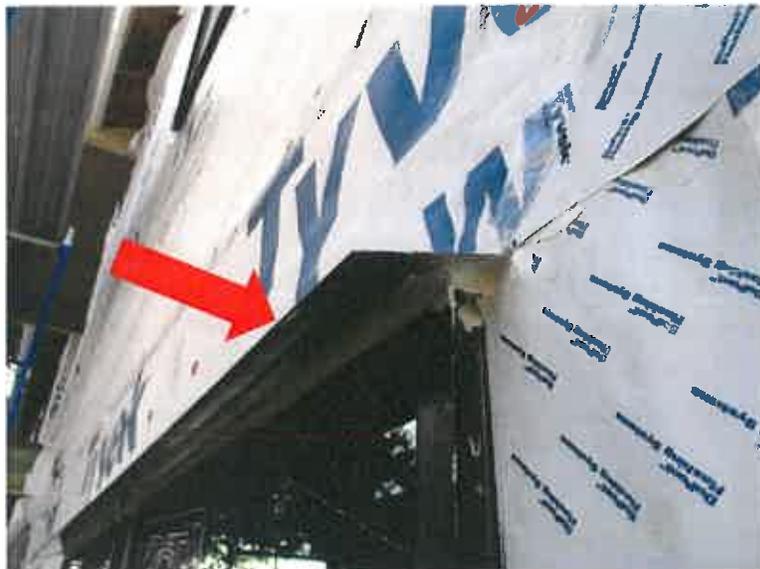
PHOTOGRAPH #2

Elevation	Demo	Gable Bracing	Gable Vents	Framing & strapping	Sheathing	Soffit	Window flashing	Window Install	Stucco Lath Acc	Stucco	Sealant	Painting	Punch	Comments
A		NA	NA											
B		NA	NA											
C														
D	/	NA	NA	X	/	/	/	/						
E	X	NA	NA	X	/	/	/	/						Flashing at head of window is not correct dimensions and will be replaced with proper dimensions / configuration per drawings and specifications (Photograph #2).
F	/

**BUILDING 14
WINDOW INSTALLATION MOCK-UP
UNIT #1412 GROUND LEVEL**

Flashing at head of window is not correct dimensions and will be replaced with proper dimensions / configuration per drawings and specifications.

1. Provide Affidavit stalling scaffolding meet OSHA requirements.
2. Determine location each required mock-up (framing & strapping, sheathing, Tyvek, stucco, window & window flashing, sealant joints, and painting).
3. Provide remaining submittals. Stucco Sample warranty is outstanding.
4. Replace flashing at header of Unit #1412 with correct dimensions and configuration as per drawings and specification as noted.

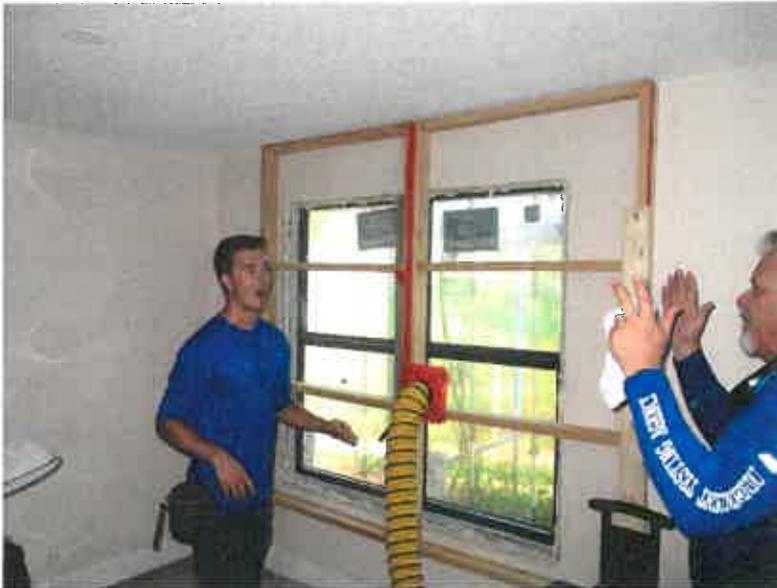
PHOTOGRAPH #3

**BUILDING 14
WATER TESTING
UNIT #1412 GROUND LEVEL**

Certified 3rd party contractor set up test chamber for water testing and performed AAMA 502/ASTM E 1105 at the two windows.

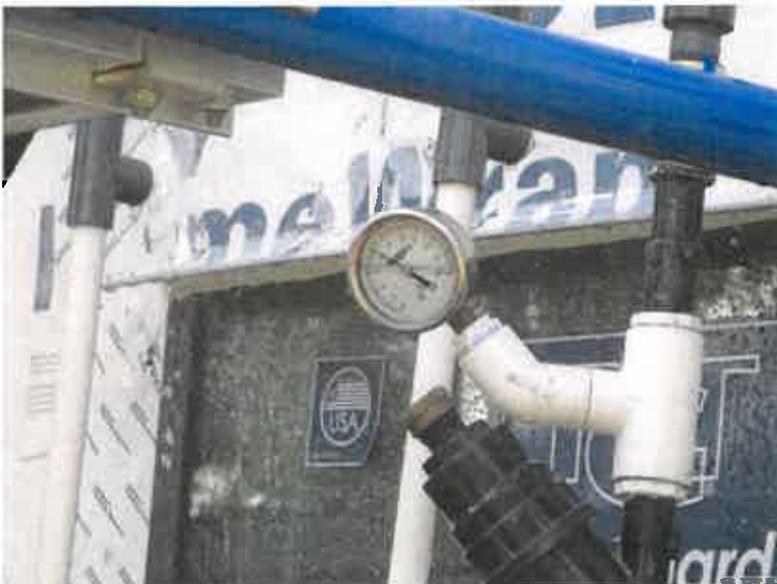
PHOTOGRAPH #4

**BUILDING 14
WATER TESTING
UNIT #1412 GROUND LEVEL**

Certified 3rd party contractor set up test chamber for water testing and performed AAMA 502/ASTM E 1105 at the two windows.

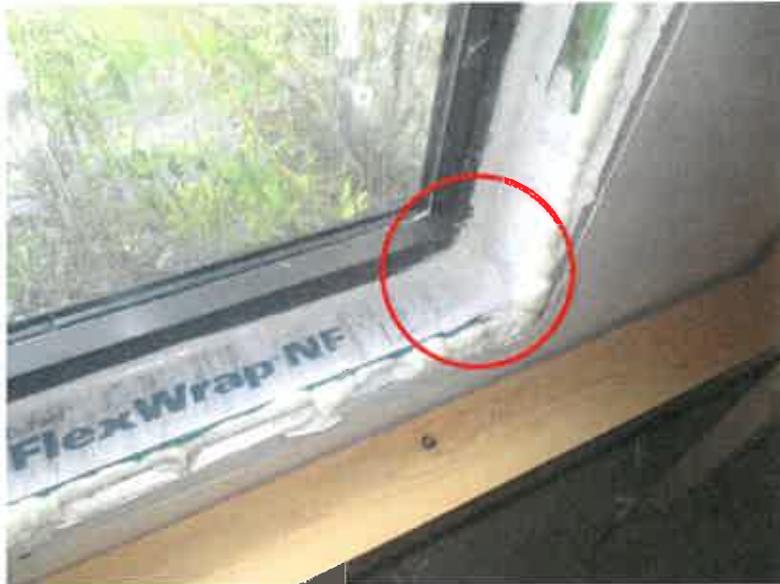
PHOTOGRAPH #5

3. Unit #1412 - At lower right corner of right side of window, a very small amount of moisture was detected after testing was complete and chamber removed. Remediation by contractor took place and windows passed re-testing with no leaks or failures (Photograph #5).

**BUILDING 14
WATER TESTING
UNIT #1412 GROUND LEVEL**

At lower right corner of right window, a very small amount of moisture was detected after testing was complete and chamber removed. Remediation by contractor took place and windows passed re-testing with no leaks or failures.

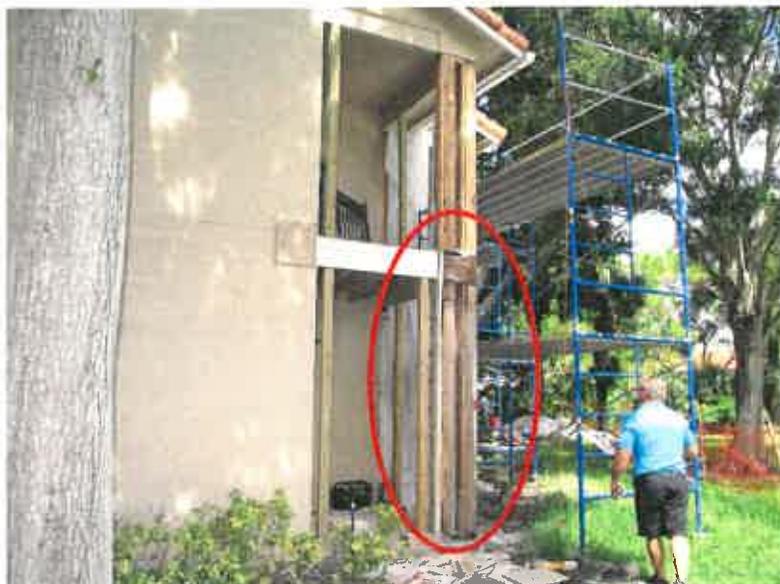
PHOTOGRAPH #6

4. Elevation D - balcony type C1B - contractor has removed stucco for inspection by Delta. Built up beam and lower column is deteriorated. Collapse documented and marked for repairs (Photographs #6, #7, #8 and #9).

**BUILDING 14
ELEVATION D Balcony Type C1B**

Contractor has removed stucco for inspection by Delta. Built up beam and lower column is deteriorated. Collapse documented and marked for repairs.

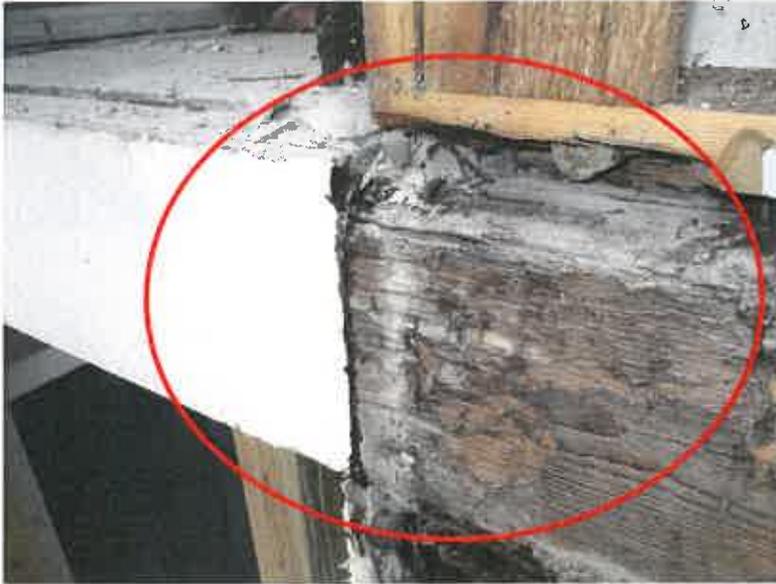
PHOTOGRAPH #7

**BUILDING 14
ELEVATION D BALCONY TYPE C1B**

Contractor has removed stucco for inspection by Delta. Built up beam and lower column is deteriorated. Collapse documented and marked for repairs.

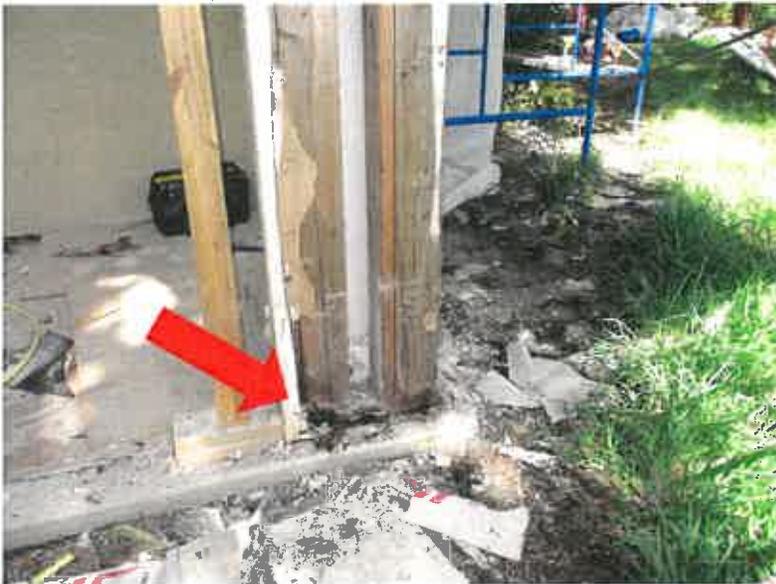
PHOTOGRAPH #8

**BUILDING 14
ELEVATION D BALCONY TYPE C1B**

Contractor has removed stucco for inspection by Delta. Built up beam and lower column is deteriorated. Collapse documented and marked for repairs.

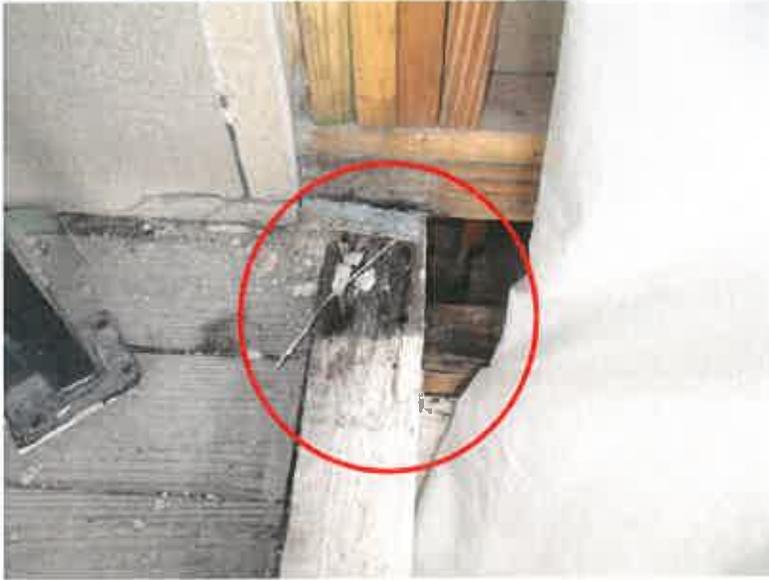
PHOTOGRAPH #9

**BUILDING 14
ELEVATION D BALCONY TYPE C1B**

Contractor has removed stucco for inspection by Delta. Built up beam and lower column is deteriorated. Collapse documented and marked for repairs.

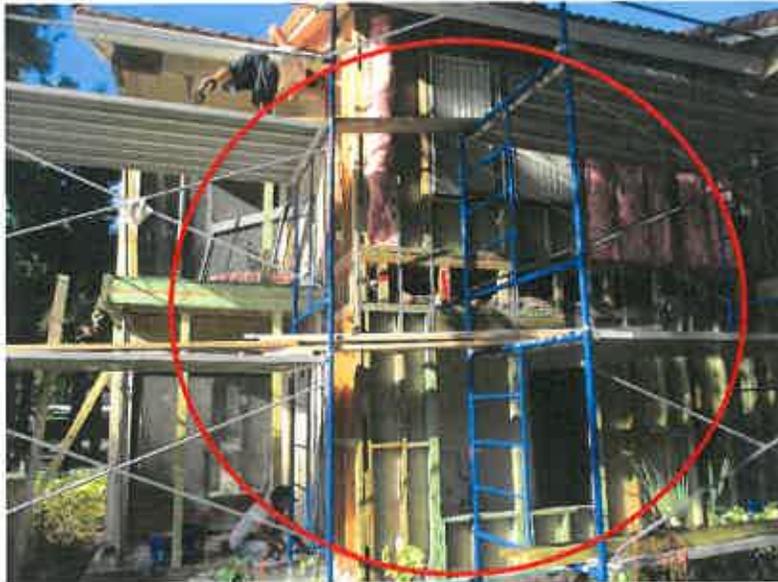
PHOTOGRAPH #10

**BUILDING 14
ELEVATION D**

Contractor has completed straps, connectors and new framing at bearing wall sections and begun repairs at end balcony.

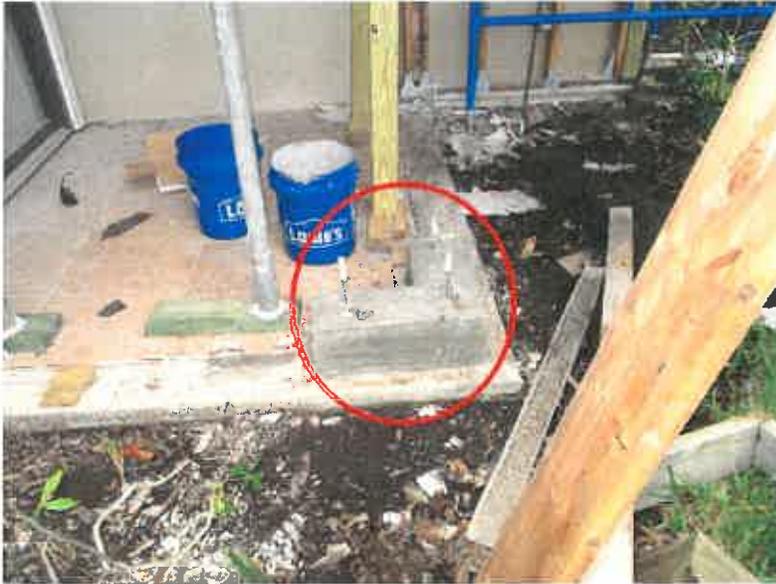
PHOTOGRAPH #11

**BUILDING 14
ELEVATION D BALCONY TYPE C1B**

Contractor has poured new pedestal as per drawing and specification for building new columns.

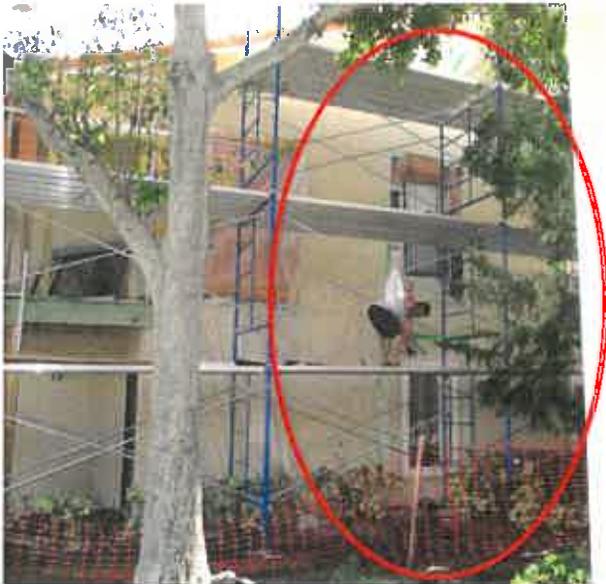
PHOTOGRAPH #12

**BUILDING 14
ELEVATION F**

Contractor has begun removal of stucco at designated areas for observation and documentation by Delta.

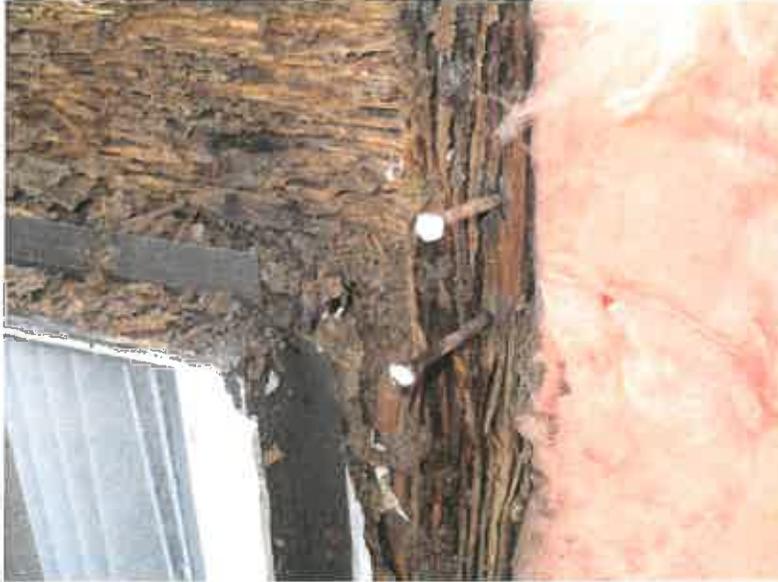
PHOTOGRAPH #13

7. Section F - Contractor has begun removal of stucco at designated areas for observation and documentation by Delta (Photograph #12).
8. Section F - Lower window Unit #1412 header deterioration and collapse observed and documented (Photograph #13).

**BUILDING 14
ELEVATION F**

Lower window Unit #1412 header deterioration and collapse observed and documented.

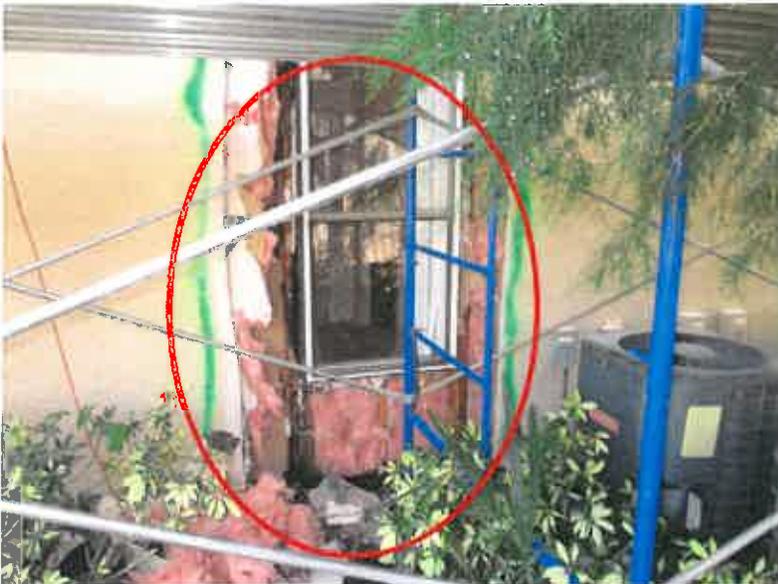
PHOTOGRAPH #14

9. Section F - Lower window Unit #1412 framing deterioration and collapse observed and documented (Photographs #14 and #15).

**BUILDING 14
ELEVATION F**

Lower window Unit #1412 framing deterioration and collapse observed and documented.

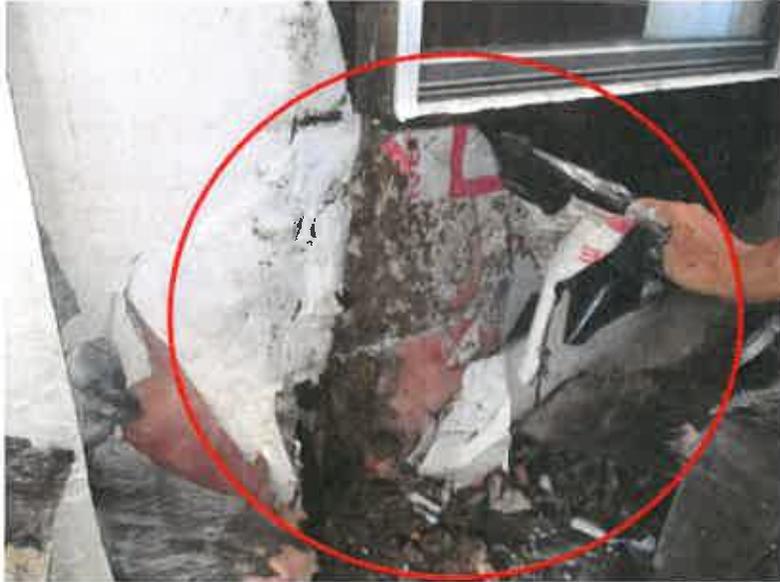
PHOTOGRAPH #15

**BUILDING 14
ELEVATION F**

Lower window Unit #1412 framing deterioration and collapse observed and documented.
