FIELD OBSERVATION REPORT - Bldg #14

Permit No. 18-131555-00 DC
 Owner: Vinager Grand Centro Assn, Inc.
 Project Address: 4017 Crookers Lake Blvd., Sarasota, FL
 Contractor: RL James Inc.
 Inspector (s): Mark Boss / Mike James
 Type of Assessment: Progress

Project: R1603-302D
 Contact: Glenn Asbill
 Phone/Fax: (941) 923-7390
 Contact: Craig Nicholas / Robert Barncombe
 Phone: (941) 232-6486 / (239) 379-1978

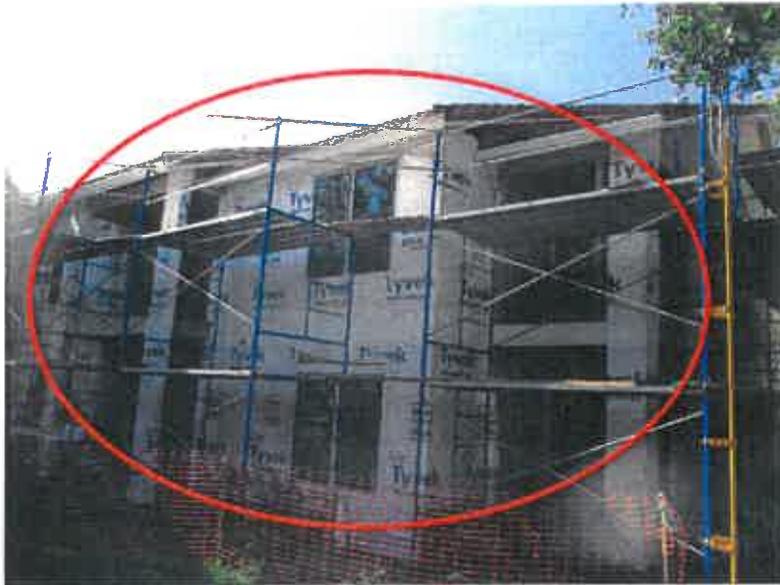
PHOTOGRAPH #1

BUILDING 14 ELEVATION E

Framing, insulation and sheathing inspections have been performed by Delta for Inspection by affidavit at bearing walls and balconies with lower sections and breezeways remaining incomplete.

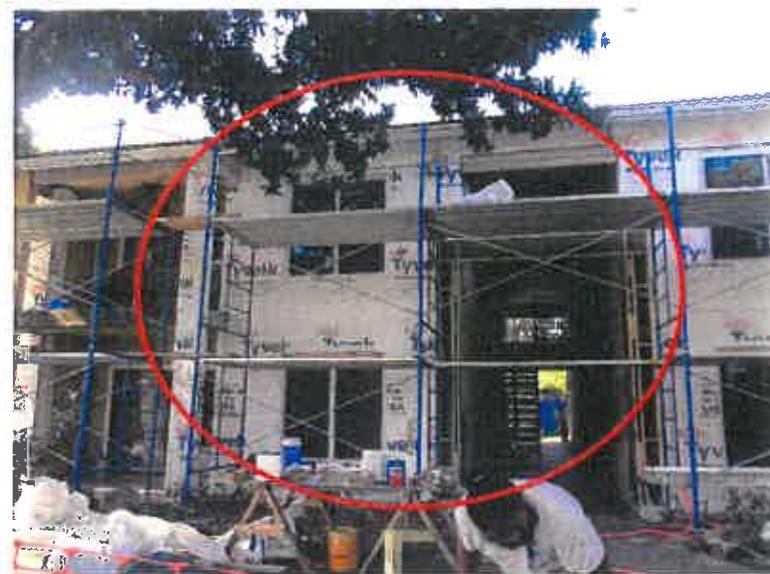
PHOTOGRAPH #2

BUILDING 14 ELEVATION D

Framing, insulation and sheathing inspections have been performed by Delta for Inspection by affidavit at bearing walls and balconies with lower sections and breezeways remaining incomplete.

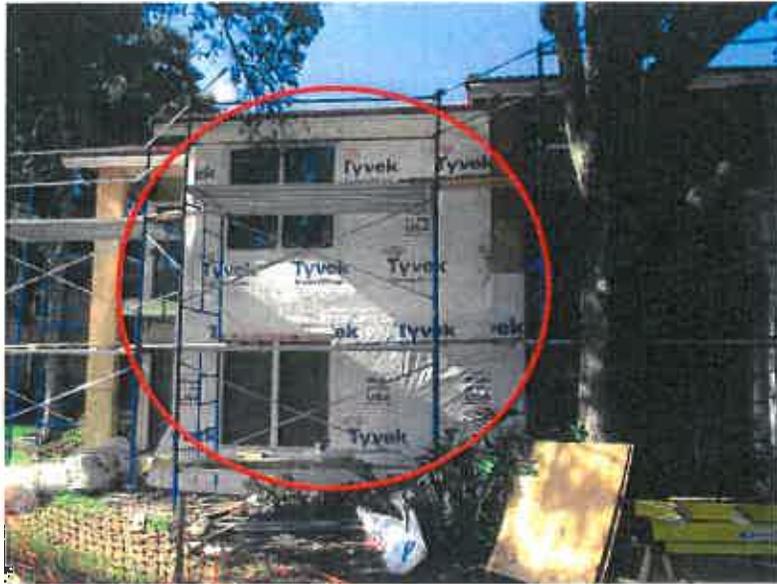
PHOTOGRAPH #3

**BUILDING 14
ELEVATION D**

Framing, insulation and sheathing inspections have been performed by Delta for Inspection by affidavit at bearing walls and balconies with lower sections and breezeways remaining incomplete.

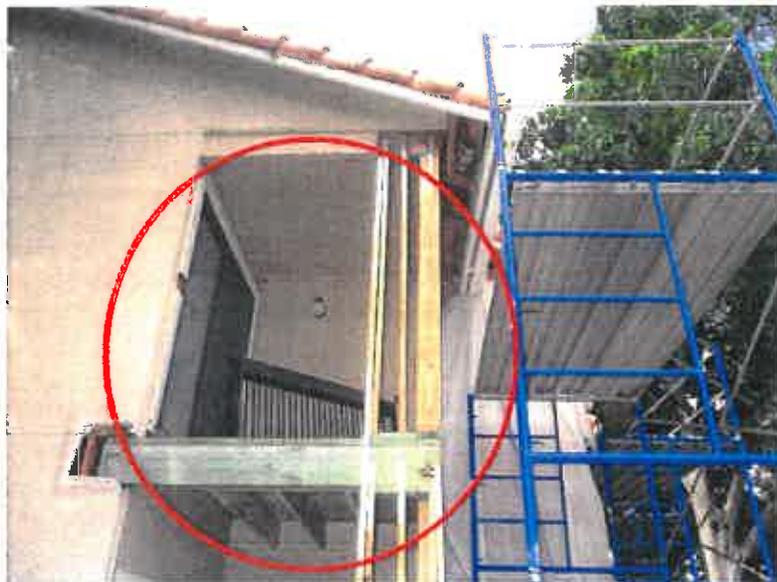
PHOTOGRAPH #4

**BUILDING 14
ELEVATION D**

Type C1B balcony re framing and strapping as per drawings and specifications.

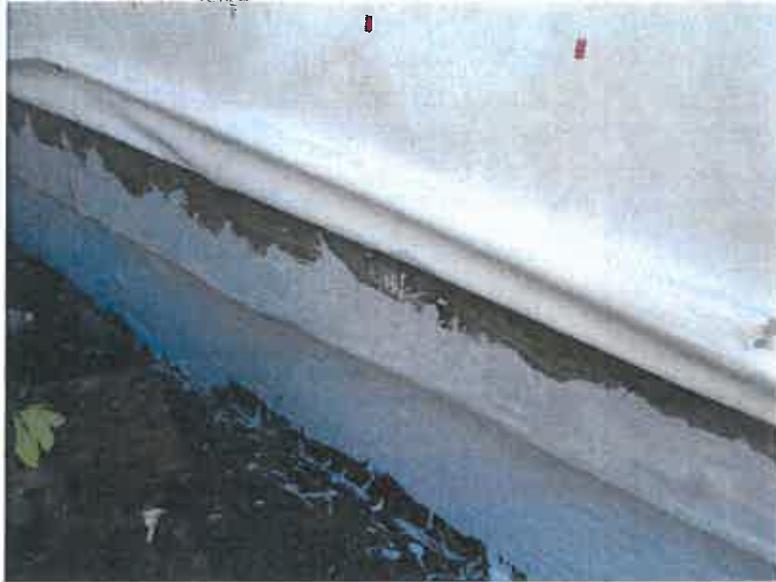
PHOTOGRAPH #5

**BUILDING 14
ELEVATIONS D AND E**

SIKALASTIC ROOF PRO waterproofing system applied at base of sheathing transition to foundation as per ESI # 1.

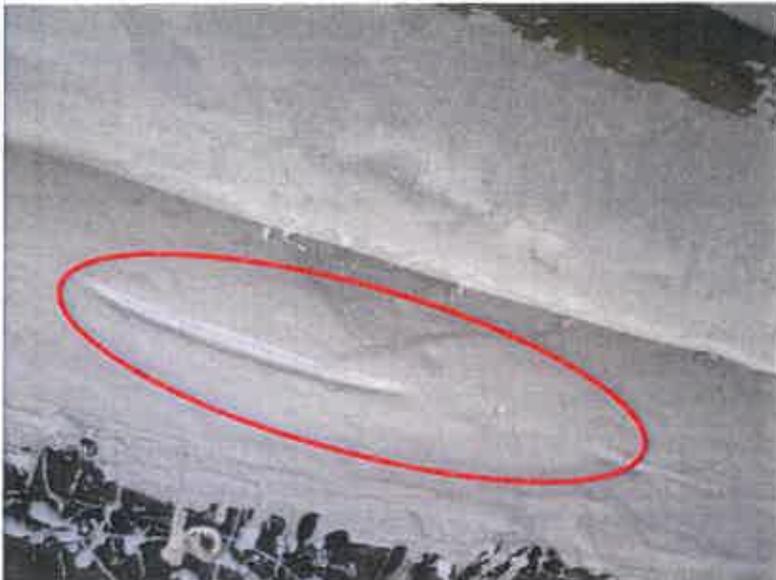
PHOTOGRAPH #6

**BUILDING 14
ELEVATIONS D AND E**

SIKALASTIC ROOF PRO waterproofing system applied at base of sheathing transition to foundation as per ESI # 1. Voids in REEMAT mesh will require correction.

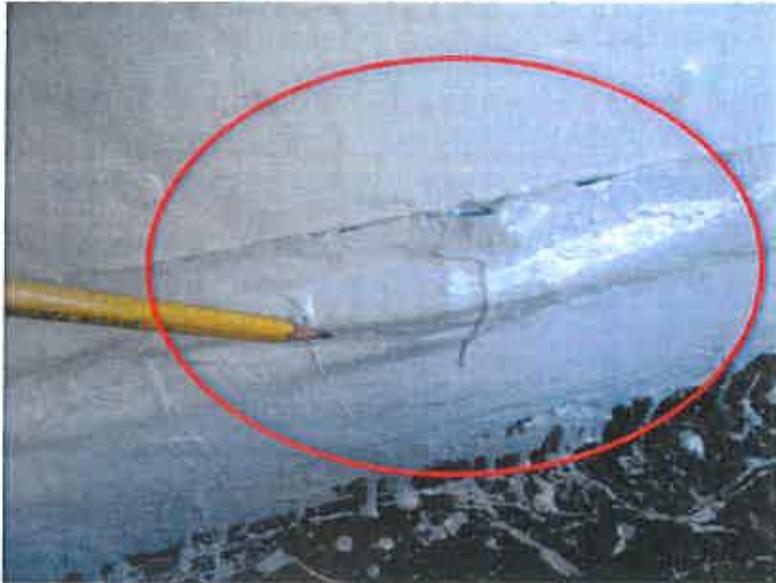
PHOTOGRAPH #7

**BUILDING 14
ELEVATIONS D AND E**

SIKALASTIC ROOF PRO waterproofing system applied at base of sheathing transition to foundation as per ESI # 1. Voids in REEMAT mesh will require correction.

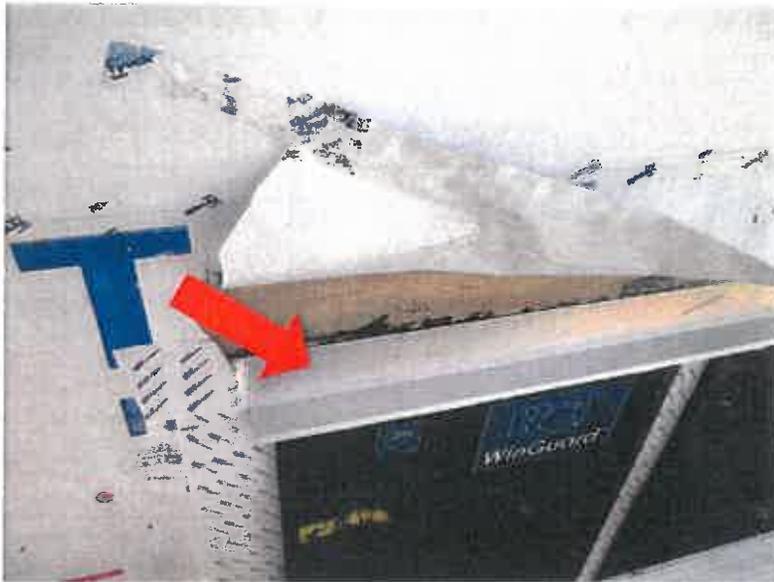
PHOTOGRAPH #8

**BUILDING 14
ELEVATION E**

Head flashing replaced with correct dimension flashing at Unit #1412-bedroom window.

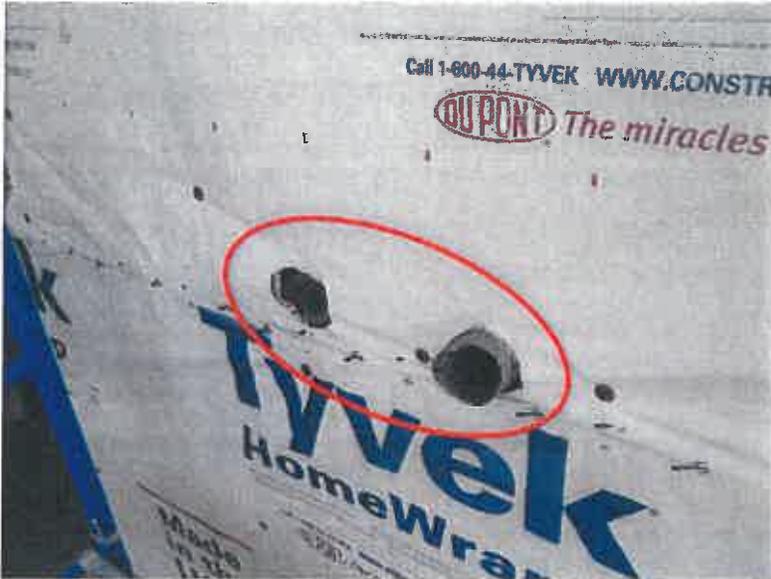
PHOTOGRAPH #9

**BUILDING 14
ELEVATION E**

Dryer vents in wall will require extension and flashing details per specifications prior to stucco system application.

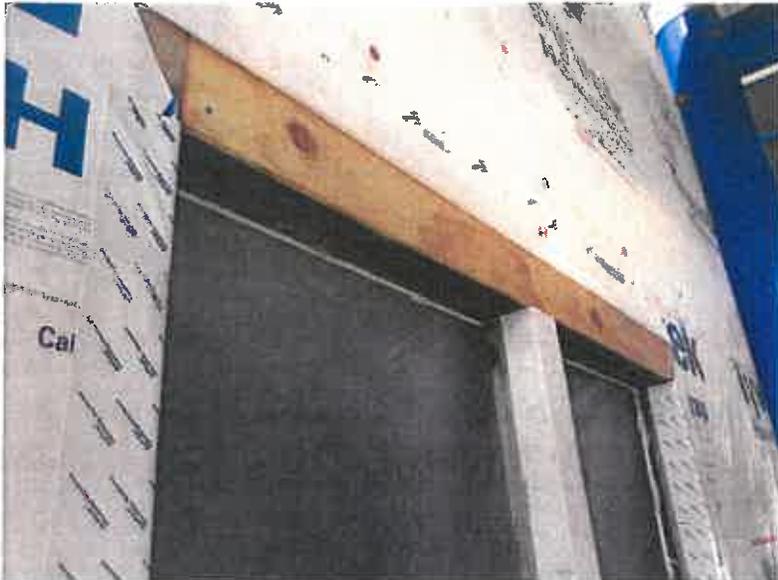
PHOTOGRAPH #10

**BUILDING 14
ELEVATION D**

Contractor has flashed window openings in preparation for window installation per drawings and Tyvek installation instructions.

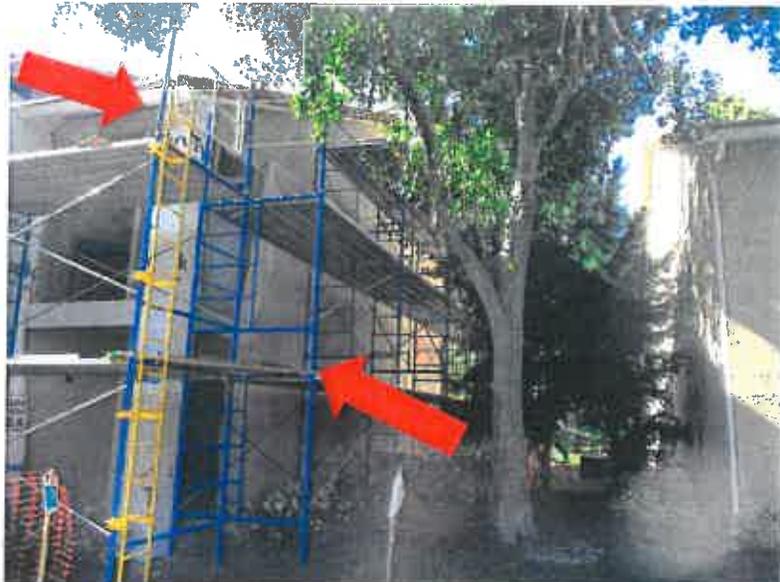
PHOTOGRAPH #11

**BUILDING 14
ELEVATION E**

As defined by OSHA, scaffolding must be designed by qualified person. Erection, dismantling, moving or altering must be supervised by competent person. The access ladder is not correct or the rail in place at wallboards between platforms. Contractor will make corrections as per OSHA regulations.

1. Provide Affidavit stating scaffolding meet OSHA requirements.
2. Determine location each required mock-up (framing & strapping, sheathing, Tyvek, stucco, window & window flashing, sealant, joints, and painting).
3. Provide remaining submittals. Special weather barrier manufacturer warranty still outstanding.
4. SIKALASTIC ROOF PRO waterproofing system applied at base of sheathing transition to foundation as per ESI # 1. Voids in REEMAT mesh will require correction.
5. As defined by OSHA, scaffolding must be designed by qualified person. Erection, dismantling, moving or altering must be supervised by competent person. The access ladder is not correct or the rail in place at wallboards between platforms. Contractor will make corrections as per OSHA regulations.
