FIELD OBSERVATION REPORT - Bldg #14

Permit No. 18-131555-00 BC
 Owner: Vintage Grand Condo Assn, Inc.
 Project Address: 4017 Crackers Lake Blvd., Sarasota, FL
 Contractor: RL James Inc
 Inspector (s): Mark Boss / Mike Jones
 Type of Assessment: Progress

FIELD OBSERVATION REPORT - Bldg #25

PROJECT NAME:
WOOD FRAME REPAIRS & RELATED WORK (PHASE II)
VINTAGE GRANDE CONDOMINIUM ASSOCIATION, INC.
4012 CROCKERS LAKE BLVD., SARASOTA, FL 34238

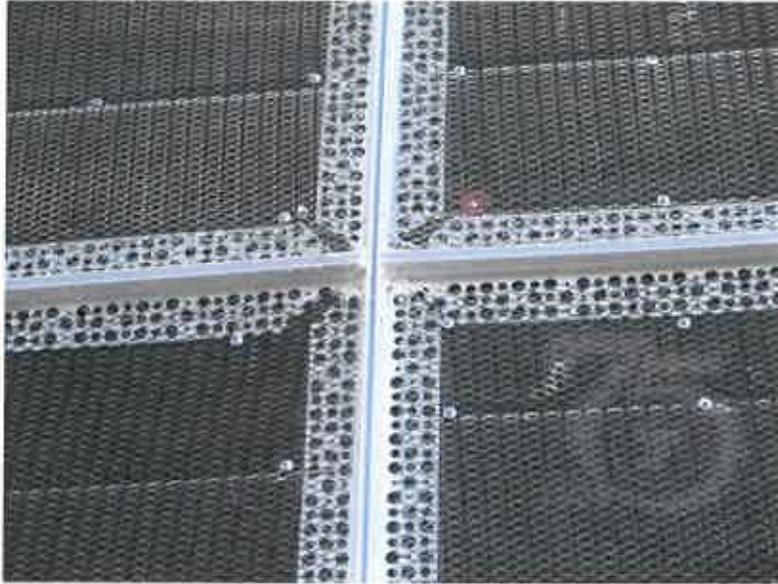
PHOTOGRAPH #1

**BUILDING 14
ELEVATION E**

Stucco accessories and lath mock ups in review. Lath and accessories attachments are approved as per specifications.

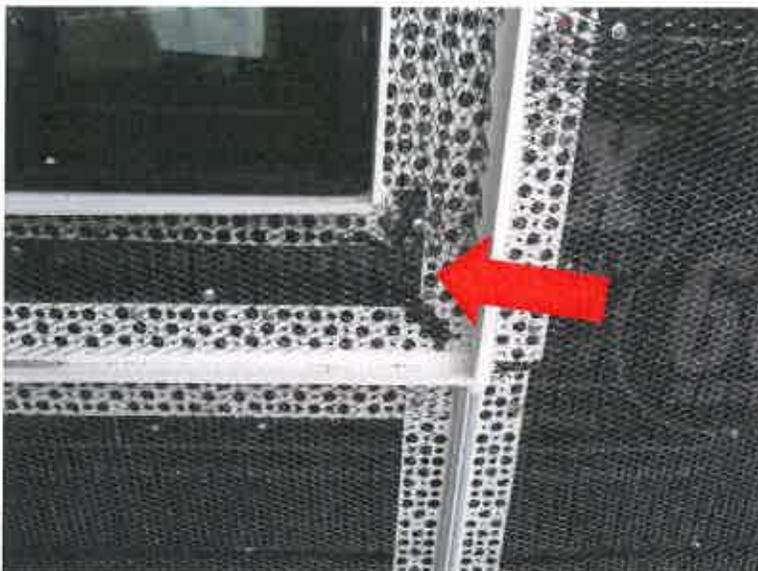
PHOTOGRAPH #2

**BUILDING 14
ELEVATION E**

Stucco accessories and lath mock ups in review. 2" X 4" metal lath butterfly tied lath at each corner, will be required as per specification and drawings.

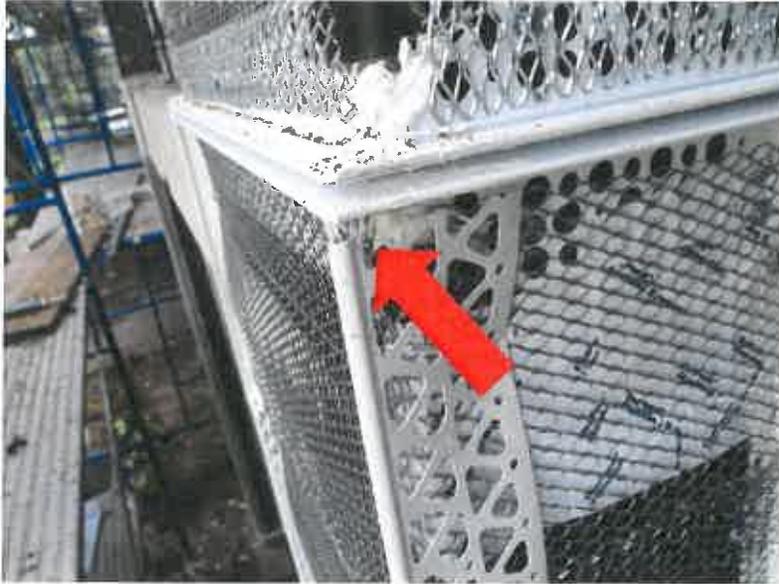
PHOTOGRAPH #3

**BUILDING 14
ELEVATION E**

Stucco accessories and lath mock ups in review. All transitions at corners and butt joints will be sealed with approved urethane sealants as per specifications.

- Provide alternate pricing requested for wall termination Change Order.
- At stucco accessories seal all transitions at corners and butt joints with approved urethane sealants as per specifications (Photograph #3). Provide weep holes at window head and balcony column stucco accessories as per drawings and specifications (Photographs #4 and #5).

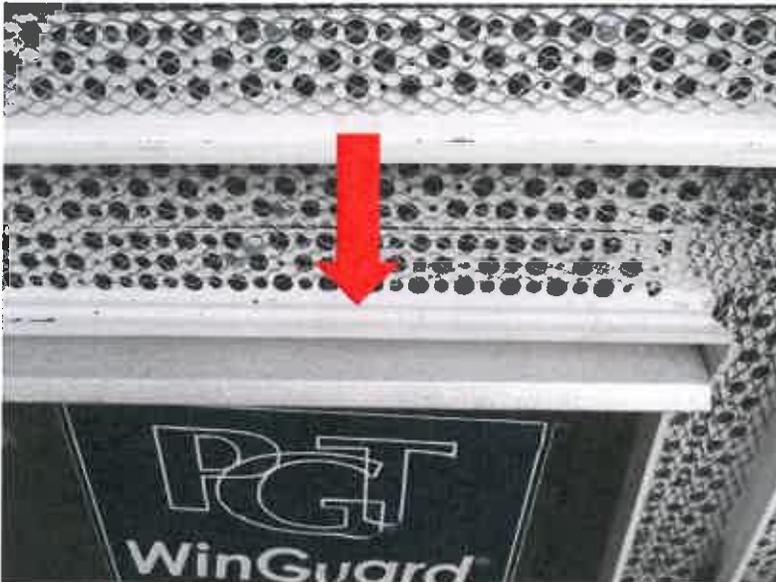
PHOTOGRAPH #4

**BUILDING 14
ELEVATION E**

Stucco accessories and lath mock ups in review. Weep holes will be provided at head accessory detail as per specifications and drawings.

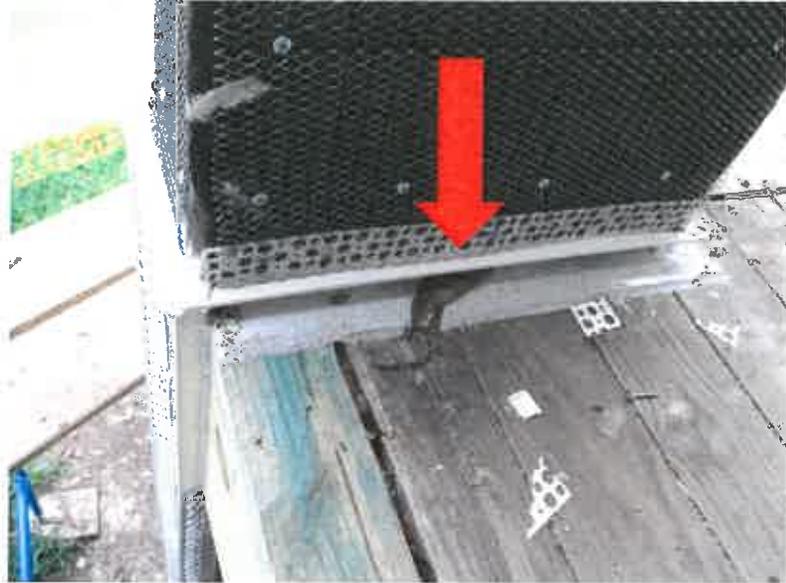
PHOTOGRAPH #5

**BUILDING 14
ELEVATION E**

Stucco accessories and lath mock ups in review. Weep holes will be provided at balcony columns accessory detail as per specifications and drawings.

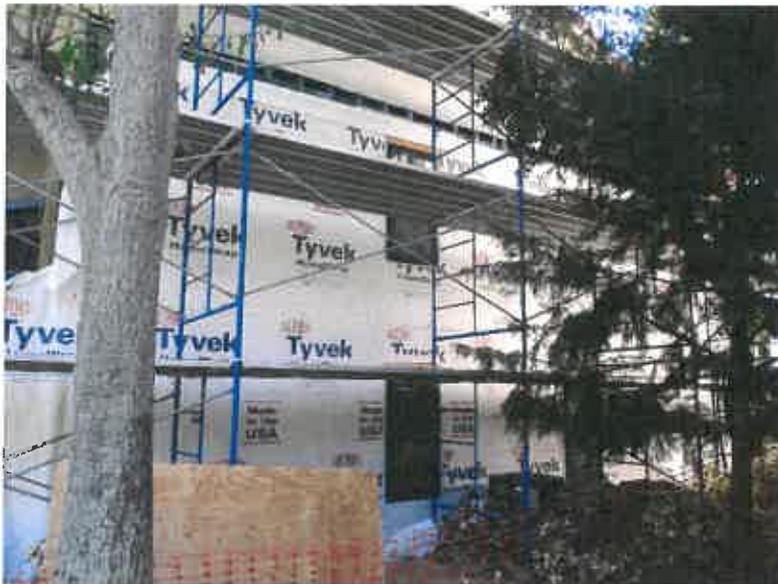
PHOTOGRAPH #6

F	/			/	/		X	X						Below gable Tyvek building wrap and windows have been installed as per specifications and drawings (Photograph #6).

**BUILDING 14
ELEVATION F**

Below gable Tyvek building wrap and windows have been installed as per specifications and drawings.

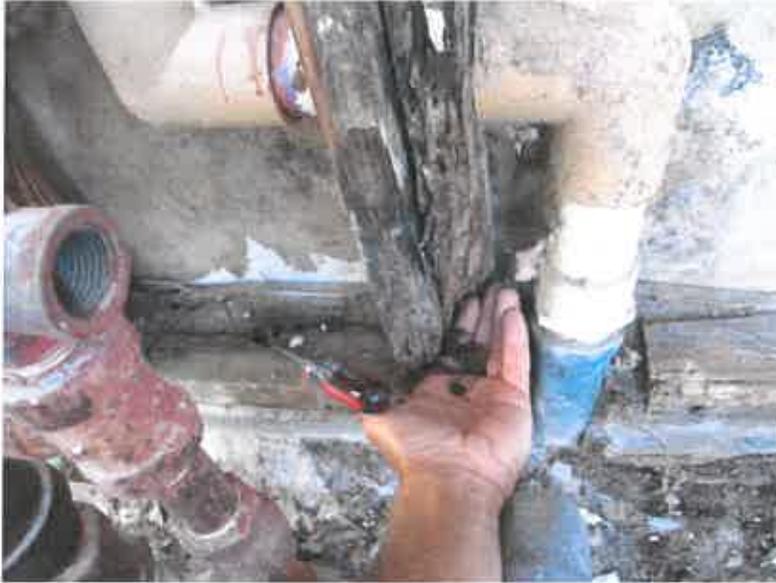
PHOTOGRAPH #7

**BUILDING 14
ELEVATION A**

Damage and collapse conditions observed, documented and marked for repairs.

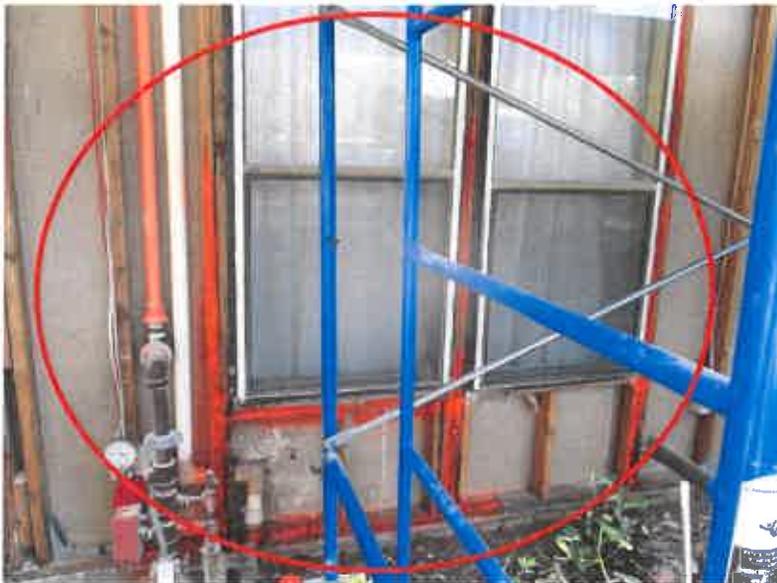
PHOTOGRAPH #8

**BUILDING 14
ELEVATION A**

Damage and collapse conditions observed, documented and marked for repairs.

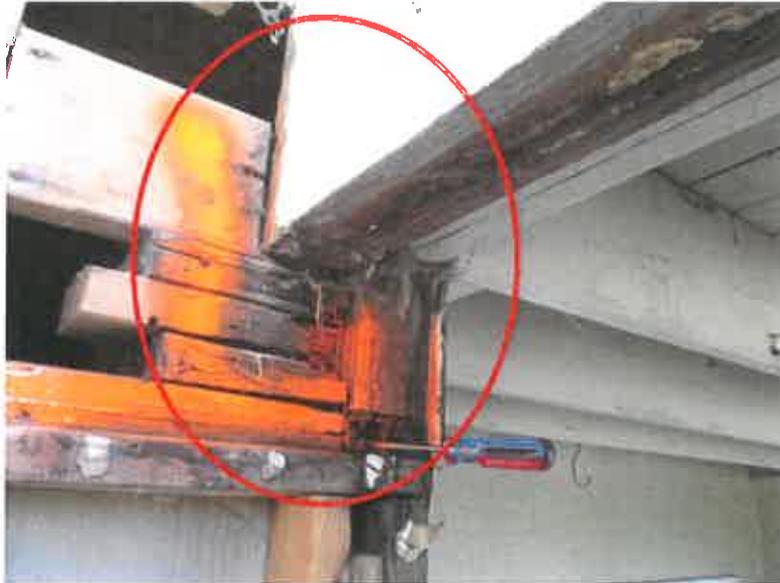
PHOTOGRAPH #9

**BUILDING 14
ELEVATION A**

Damage and collapse conditions observed, documented and marked for repairs.

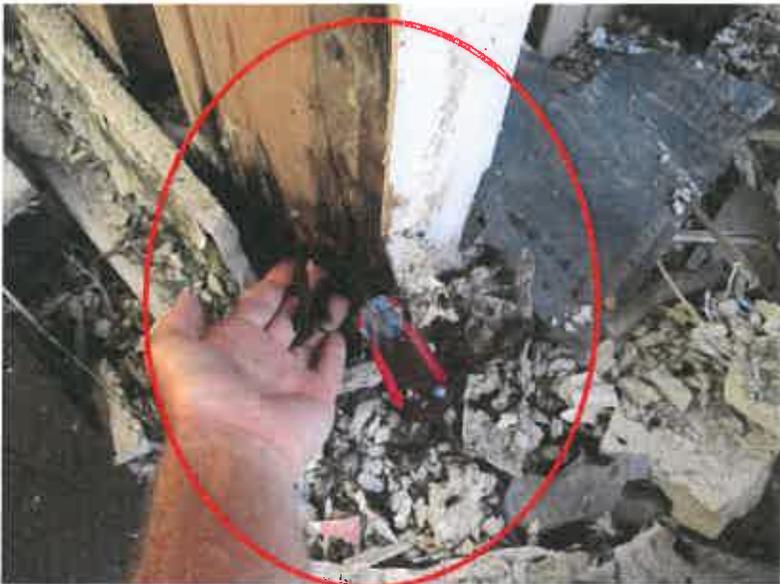
PHOTOGRAPH #10

**BUILDING 14
ELEVATION A**

Damage and collapse conditions observed, documented and marked for repairs.

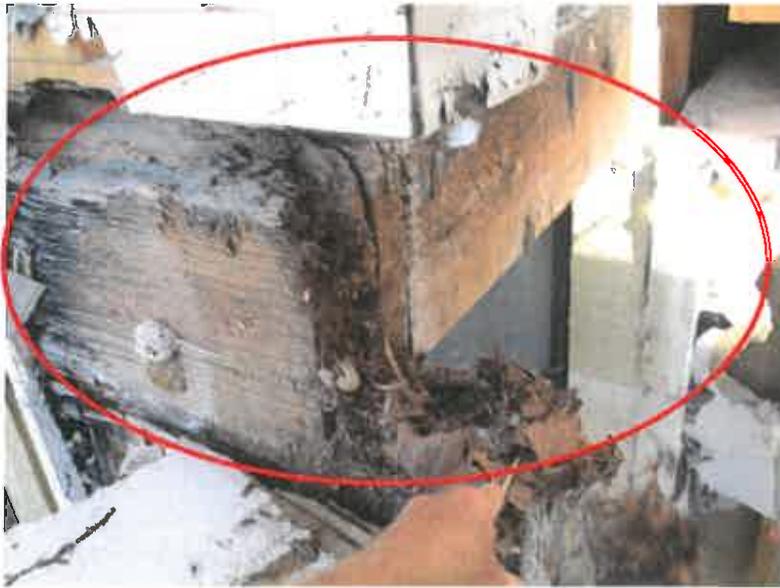
PHOTOGRAPH #11

**BUILDING 14
ELEVATION A**

Damage and collapse conditions observed, documented and marked for repairs.

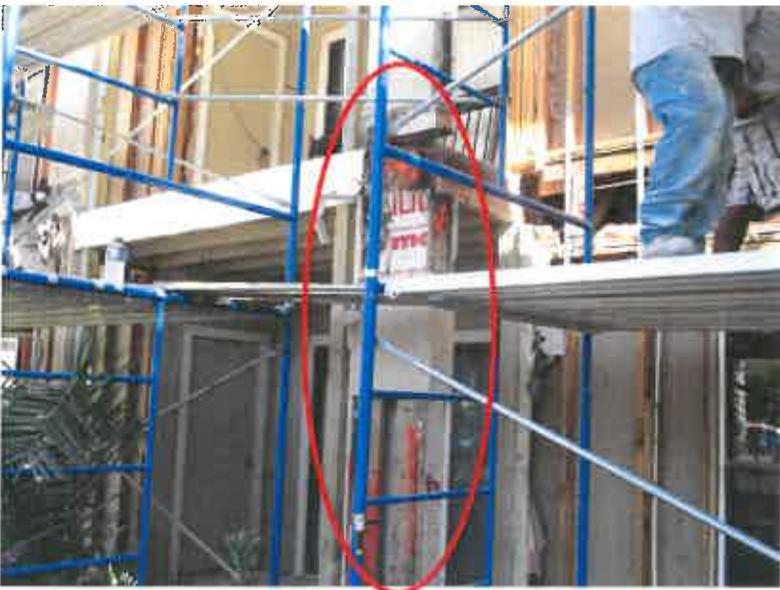
PHOTOGRAPH #12

**BUILDING 14
ELEVATION A**

Damage and collapse conditions observed, documented and marked for repairs.

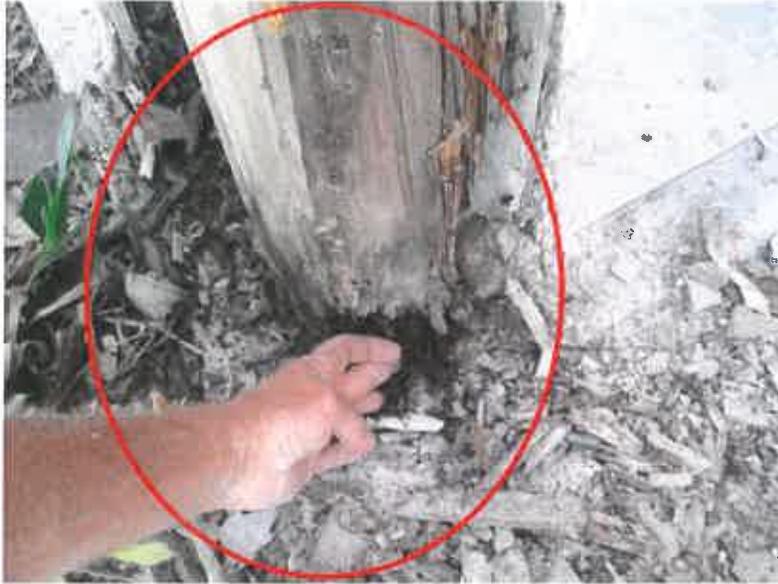
PHOTOGRAPH #13

**BUILDING 14
ELEVATION B**

Damage and collapse conditions observed, documented and marked for repairs.

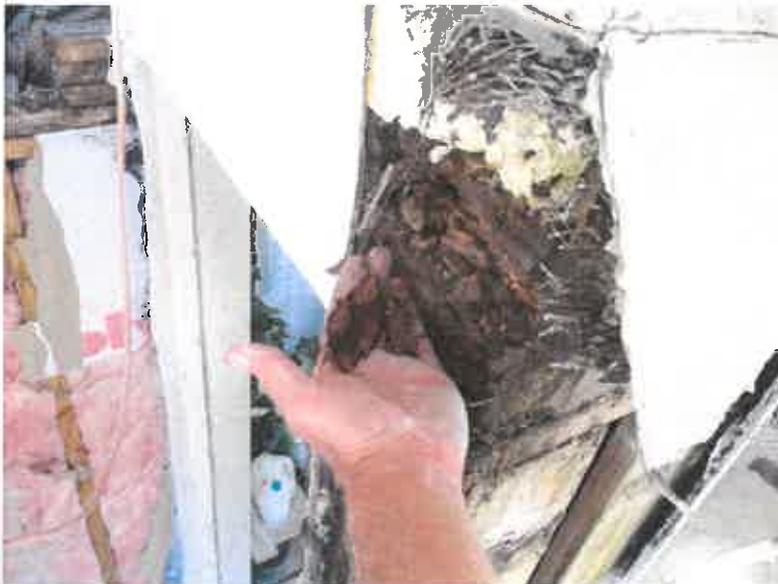
PHOTOGRAPH #14

**BUILDING 14
ELEVATION B**

Damage and collapse conditions observed, documented and marked for repairs.

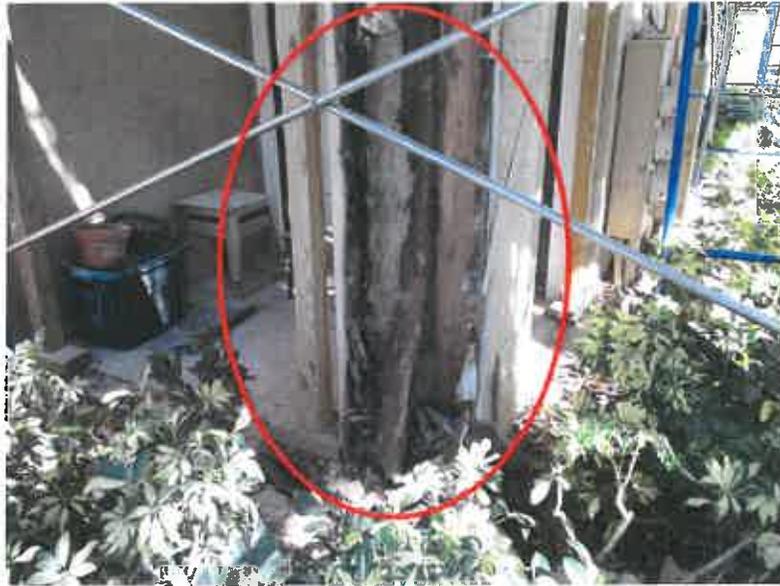
PHOTOGRAPH #15

**BUILDING 14
ELEVATION B**

Damage and collapse conditions observed, documented and marked for repairs.

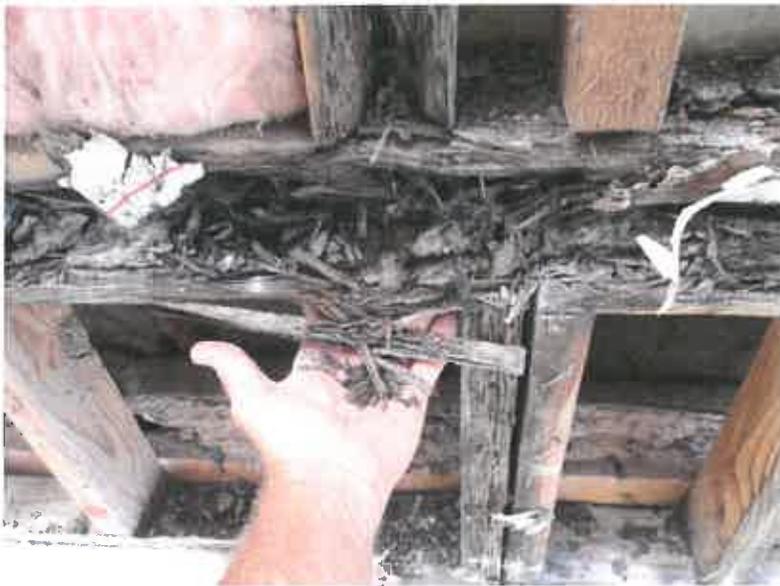
PHOTOGRAPH #16

**BUILDING 14
ELEVATION C**

Damage and collapse conditions identified and marked for repairs with contractor.

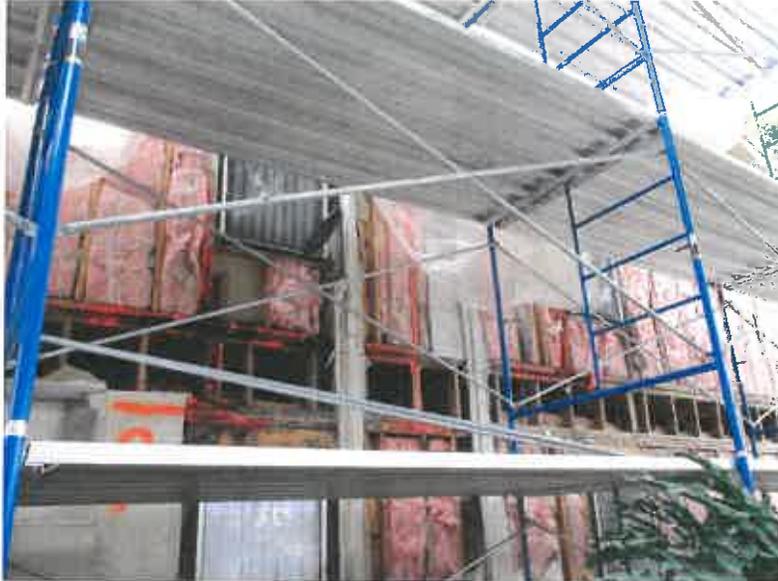
PHOTOGRAPH #17

**BUILDING 14
ELEVATION C**

Damage and collapse conditions identified and marked for repairs with contractor.

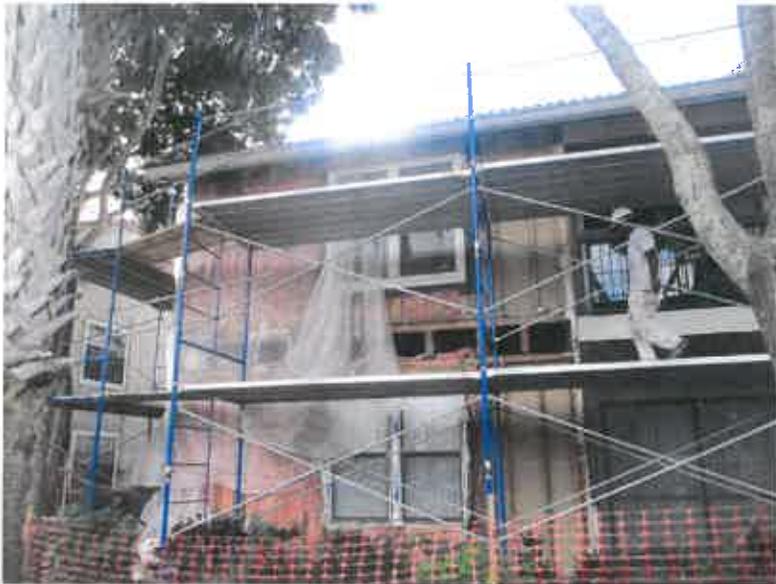
PHOTOGRAPH #18

- Demolition removal work has begun with observations and documentations by Delta (Photograph #18).

**BUILDING 25
ELEVATION A**

Demolition removal work has begun with observations and documentations by Delta.

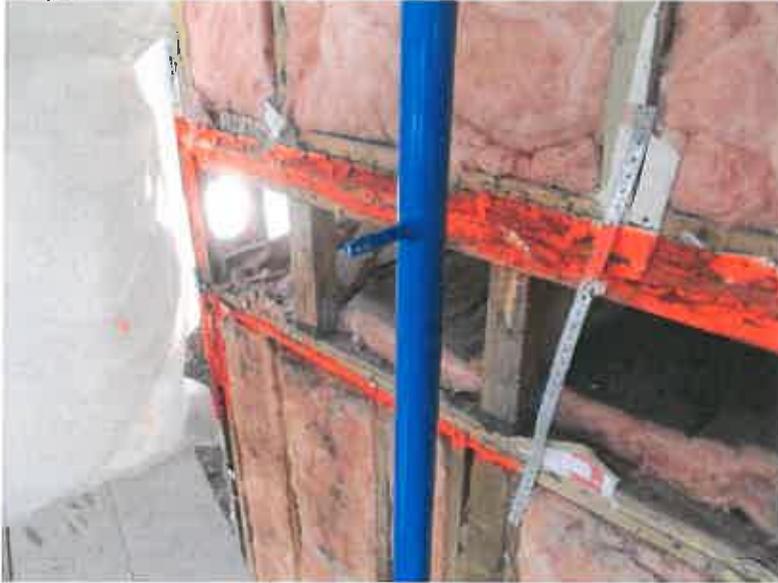
PHOTOGRAPH #19

**BUILDING 25
ELEVATION A**

Damage and collapse conditions identified and marked for repairs with contractor.

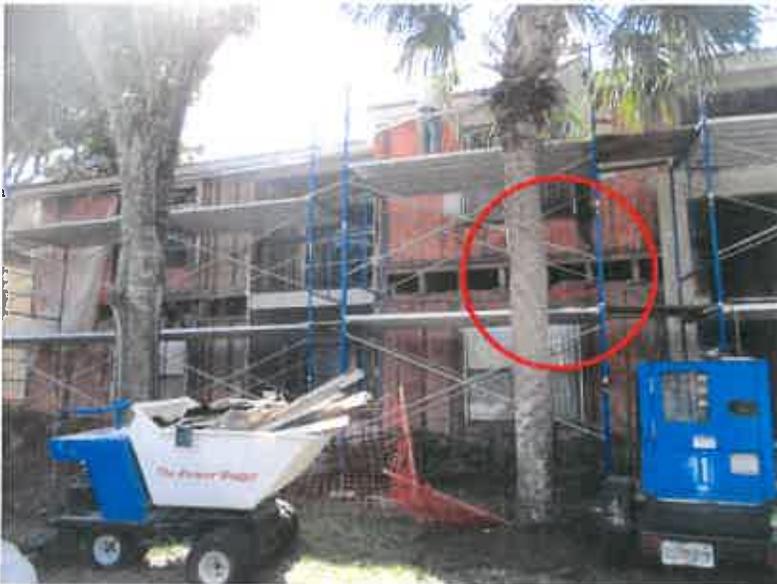
PHOTOGRAPH #20

**BUILDING 25
ELEVATION A**

Damage and collapse conditions identified and marked for repairs with contractor.
