**FIELD OBSERVATION REPORT - Bids #14**

Permit No. 18-131555-00 BC  
 Owner: Vintage Grand Condo Assn, Inc.  
 Project Address: 4017 Crookers Lake Blvd., Sarasota, FL  
 Contractor: RL James Inc  
 Inspector (s): Mark Boss / Steve Mainardi  
 Type of Assessment: Progress

**PROJECT NAME:**  
 WOOD FRAME REPAIRS & RELATED WORK (PHASE II)  
 VINTAGE GRANDE CONDOMINIUM ASSOCIATION, INC.  
 4012 CROCKERS LAKE BLVD., SARASOTA, FL 34238

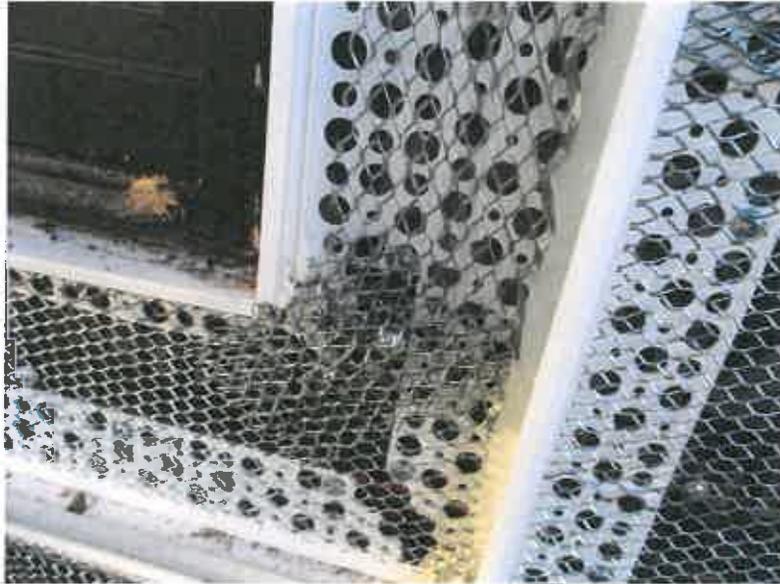
PHOTOGRAPH #1

Stucco accessories and lath mock ups in review. 2" X 4" metal lath butterfly tied at each corner has been installed and approved as per specification and drawings.

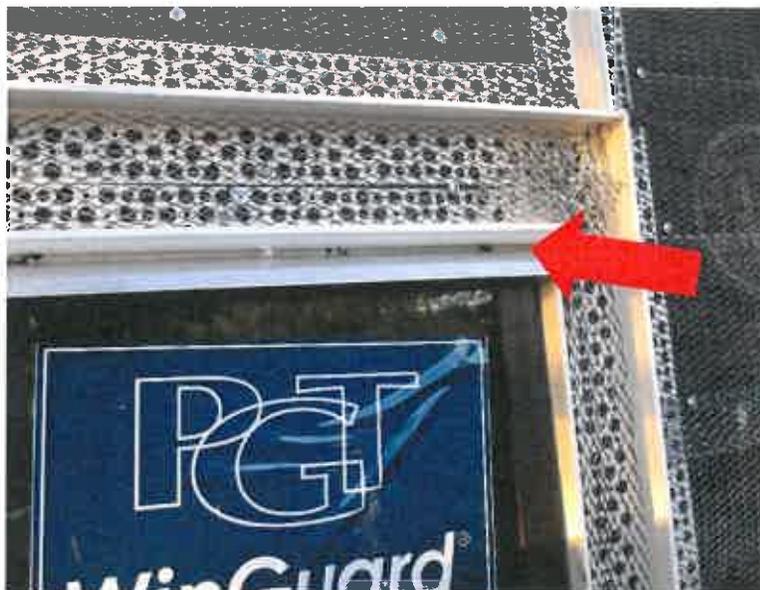
PHOTOGRAPH #2

Stucco accessories and lath mock ups in review. Window at unit #1412 space between window head flashing and stucco band accessory is too wide and is required to be 1/4" as per drawings.

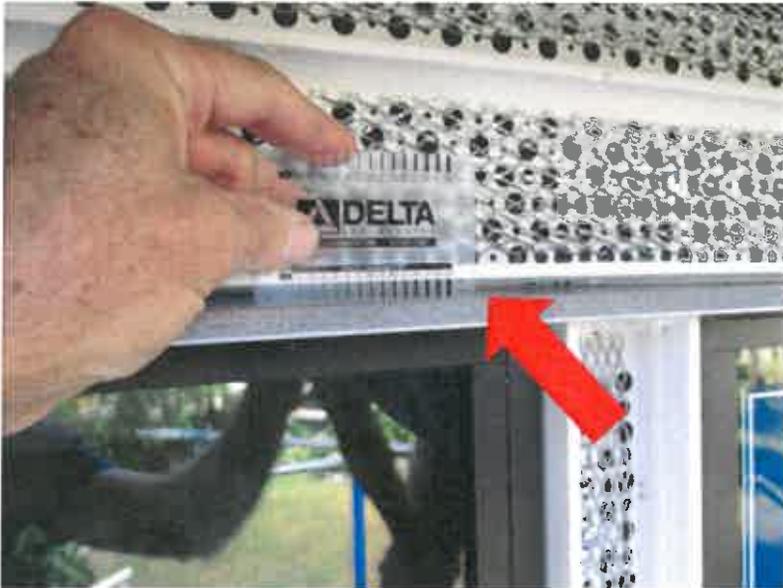
**PHOTOGRAPH #3**

Stucco accessories and lath mock ups in review. Window at unit #1422 space between window head flashing and stucco band accessory is correct and approved as required to be 1/4" as per drawings.

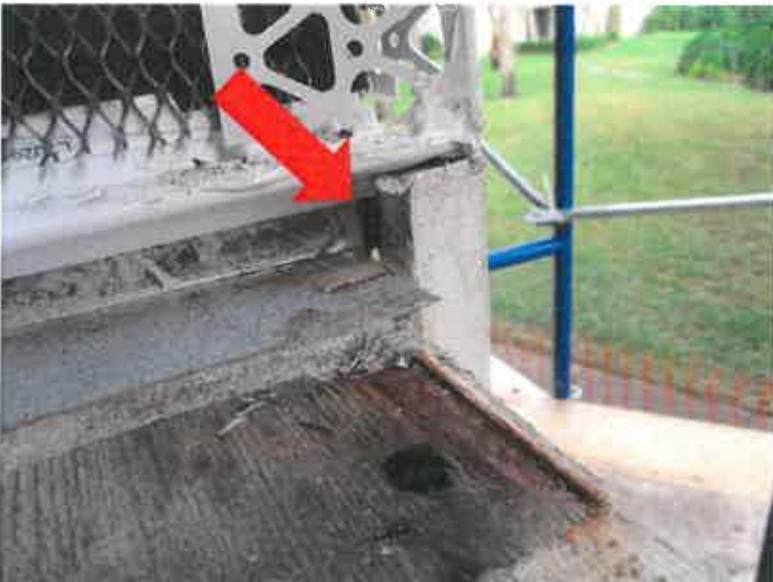
**PHOTOGRAPH #4**

Stucco accessories and lath mock ups in review. At balcony column flashing transition with stucco accessories, a mockup will be provided and approved to accomplish proper diversion of water and waterproofing seal at this transition.

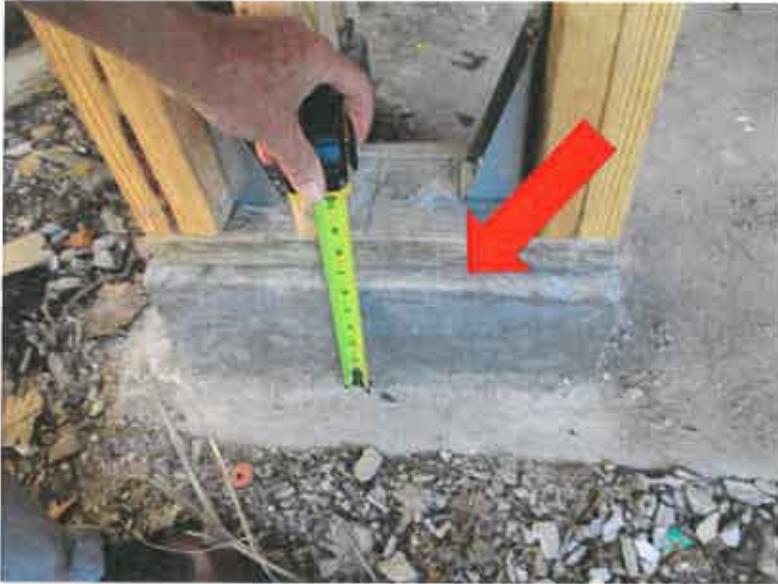
**PHOTOGRAPH #5**

Contractor has installed pedestals at balcony columns as per drawings and specifications.

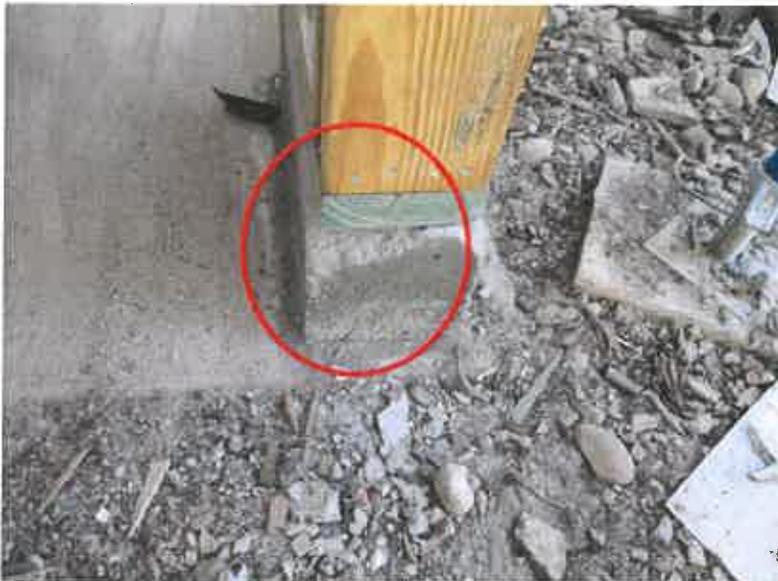
**PHOTOGRAPH #6**

This pedestal will require patching where damaged at edge during frame repairs.

- Determine location each required mock-up (framing & strapping, sheathing, Tyvek, stucco, window & window flashing, sealant, joints, and painting).
- SIKALASTIC ROOF PRO applied at base of sheathing transition to foundation as per ESI #1 has not been installed or corrected according to manufactures requirements.
- Windows installed with new head flashing as per drawings and specification will require sealants at flashing to window prior to stucco details.
- Dryer vents in wall will require extension and flashing details per specifications prior to stucco system application.
- Repair damaged pedestal at elevation A where clipped (Photograph #6).

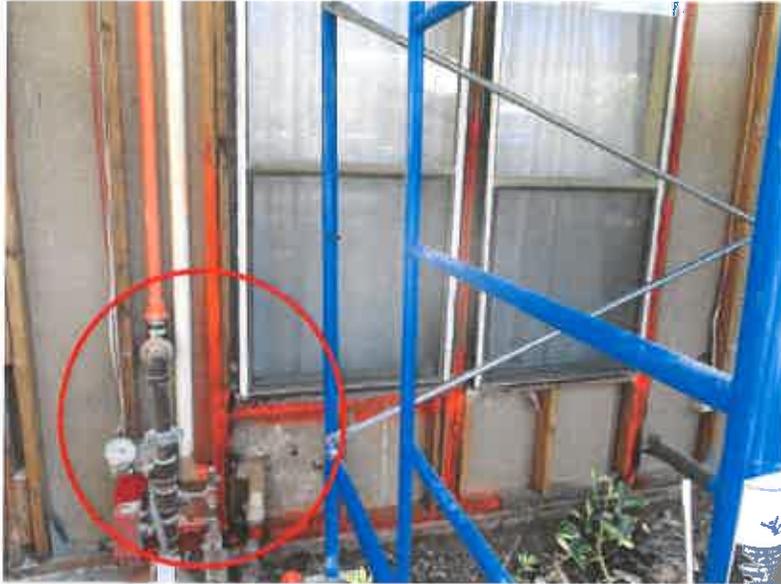
**PHOTOGRAPH #7**

Contractor will be required to disconnect and reconnect plumbing in this condition in order to perform repairs at framing as required. Contractor will coordinate with property manager.

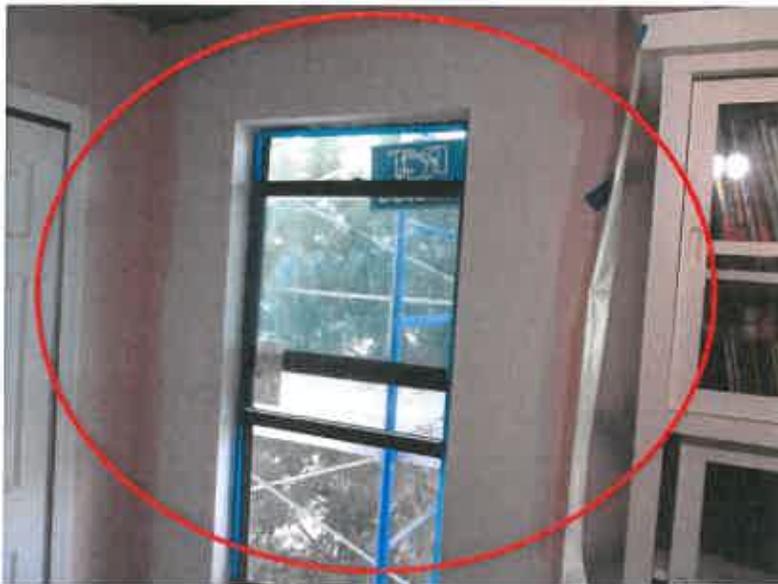
**PHOTOGRAPH #8**

Contractor has begun repairs to interior drywall and will be required to retexture to match existing as closed as possible.

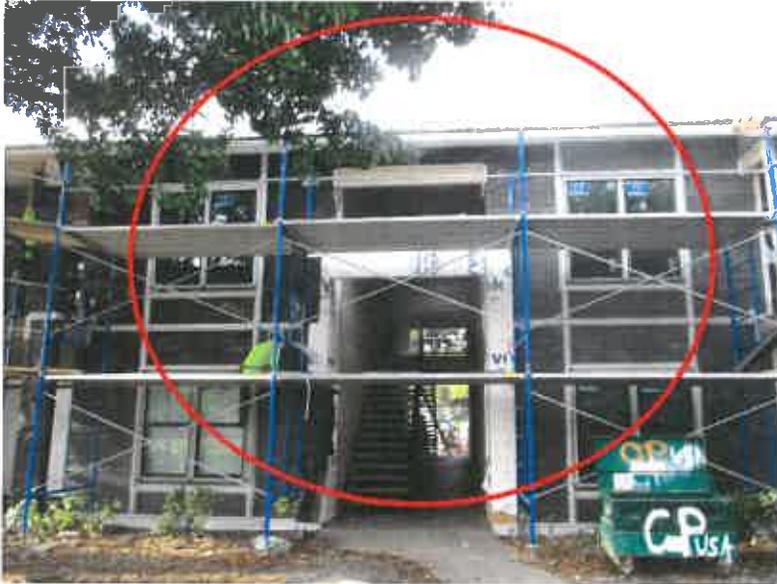
**PHOTOGRAPH #9**

Stucco sub-contractor has begun accessories and lath installation as per approved mock ups.

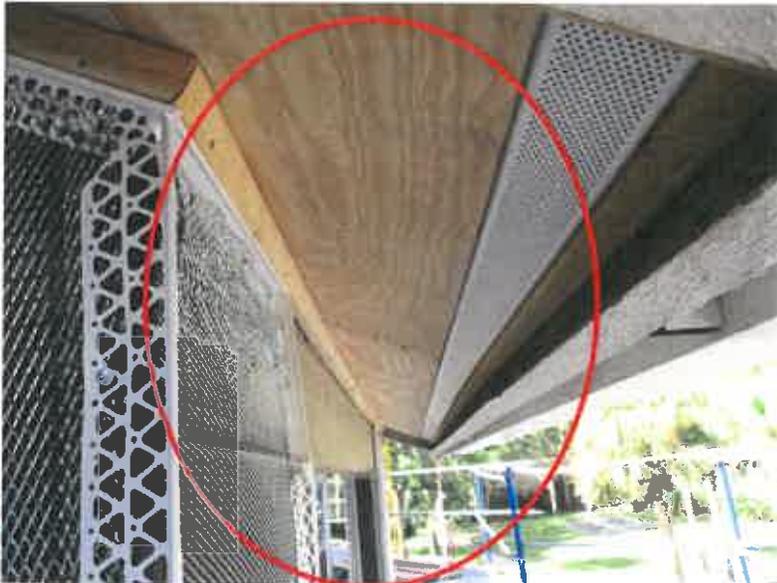
**PHOTOGRAPH #10**

Contractor has begun replacing soffit and soffit screen as per specifications.
