FIELD OBSERVATION REPORT - Biga #14

Permit No. 19-131555-00 BC
 Owner: Village Grand Condo Assn, Inc.
 Project Address: 4017 Crookers Lake Blvd., Sarasota, FL
 Contractor: RL James Inc
 Inspector (e): Mark Boss PM / Mike Jones
 Type of Assessment: Progress

FIELD OBSERVATION REPORT - Bldg #25

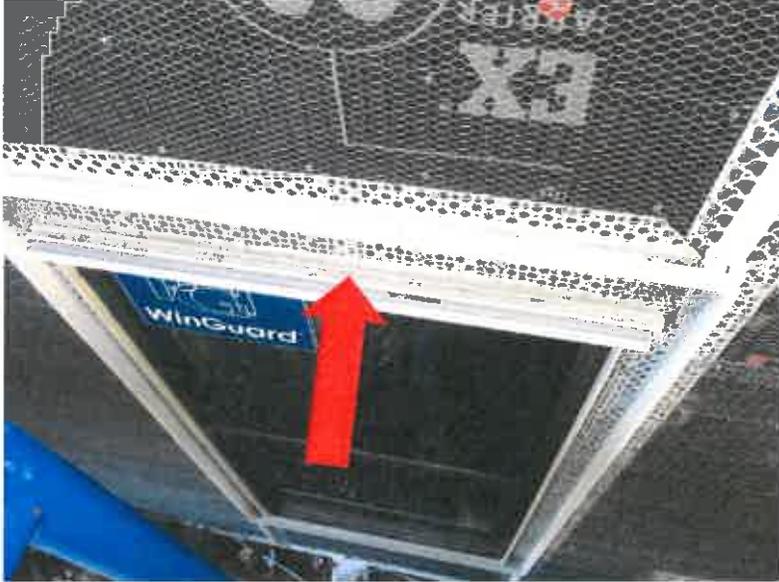
PHOTOGRAPH #1

**BUILDING 14
ELEVATION F**

Several new accessories at window heads do not have weep holes as required by project manual and drawings. Contractor will add weep holes as required.

D	X	NA	NA	X	X	X	X	X	X	X				Several new accessories at window heads do not have weep holes as required by project manual and drawings. Contractor will add weep holes as required (Photograph #1).
E	X	NA	NA	X	X	X	X	X	X	X				Several new accessories at window heads do not have weep holes as required by project manual and drawings. Contractor will add weep holes as required (Photograph #1).
F	X	X	X	X	X	X	X	X	X	X				Several new accessories at window heads do not have weep holes as required by project manual and drawings. Contractor will add weep holes as required (Photograph #1).

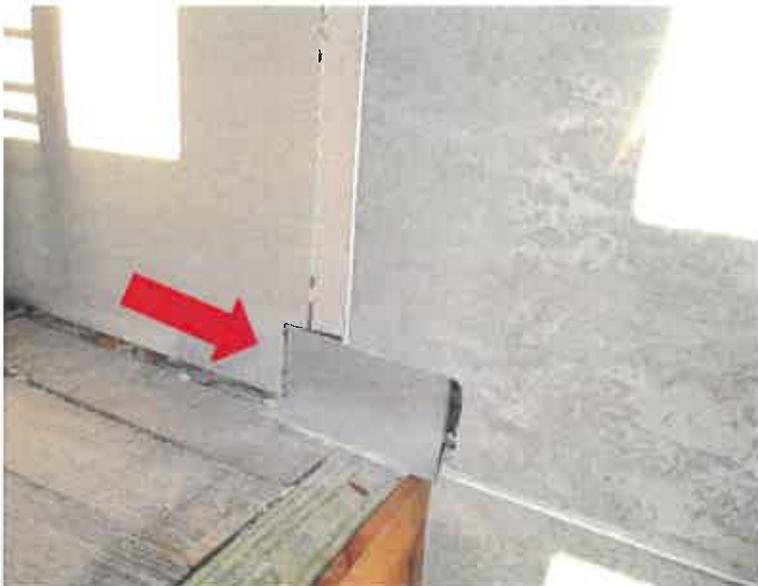
PHOTOGRAPH #2

**BUILDING 14
ELEVATION D**

Flashing at balcony has been repositioned and will require stucco accessories, lath and new stucco as per specifications.

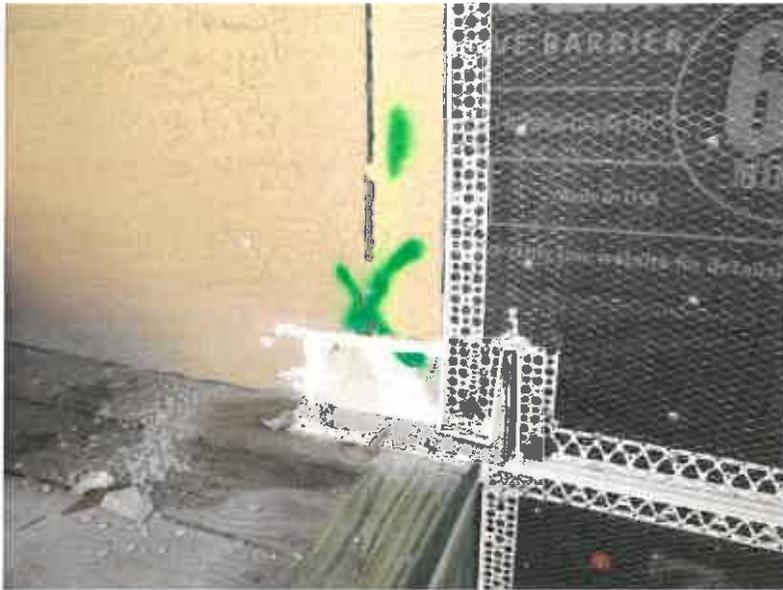
PHOTOGRAPH #3

**BUILDING 14
ELEVATION A**

Flashing at balcony has been re-positioned and will require re-placing stucco accessories, lath and new stucco as per specifications.

Elevation	Demo	Gable Bracing	Gable Vents	Framing & strapping	Sheathing	Soffit	Window flashing	Window Install	Stucco Lath Acc	Stucco	Sealant	Painting	Punch	Comments
A	X	NA	NA	X	X	X	X	X	X					Flashing at balcony has been re-positioned and will require re-placing stucco accessories, lath and new stucco as per specifications (Photograph #3). Contractor is not cleaning the site daily as required by Project Manual (Photograph #6).
B	X	NA	NA	X	X	X	X	X	X					Flashing at balcony has been re-positioned and will require re-placing stucco accessories, lath and new stucco as per specifications (Photograph #3). Contractor is not cleaning the site daily as required by Project Manual (Photograph #6).
C	X	X	X	X	X	X	X	X	X	X				Contractor has applied Tyvek flashing and installed new vents as per drawings and specifications (Photograph #4). Contractor has not completed flashing requirements at hose bib penetration as required (Photograph #5). Contractor is not cleaning the site daily as required by Project Manual (Photograph #7). Flashing at balcony has been re-positioned and will require re-placing stucco accessories, lath and new stucco as per specifications (Photograph #3).

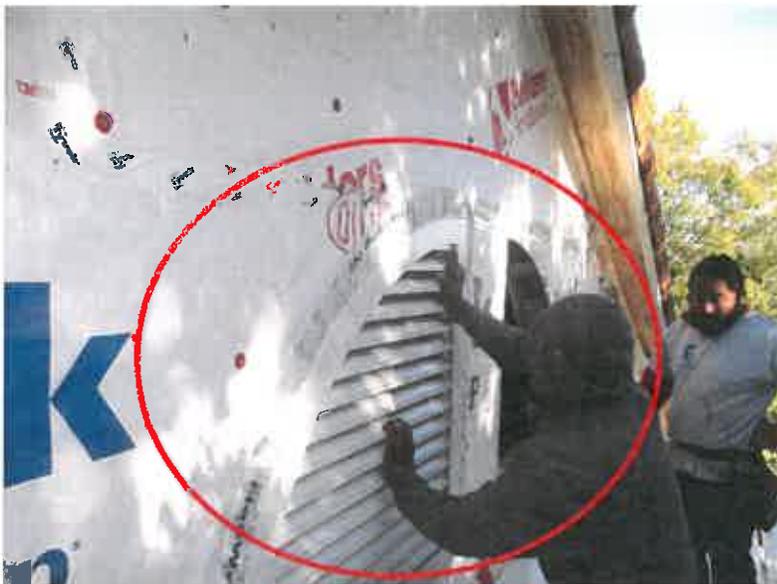
PHOTOGRAPH #4

**BUILDING 14
ELEVATION C**

Contractor has applied Tyvek flashing and installed new vents as per drawings and specifications.

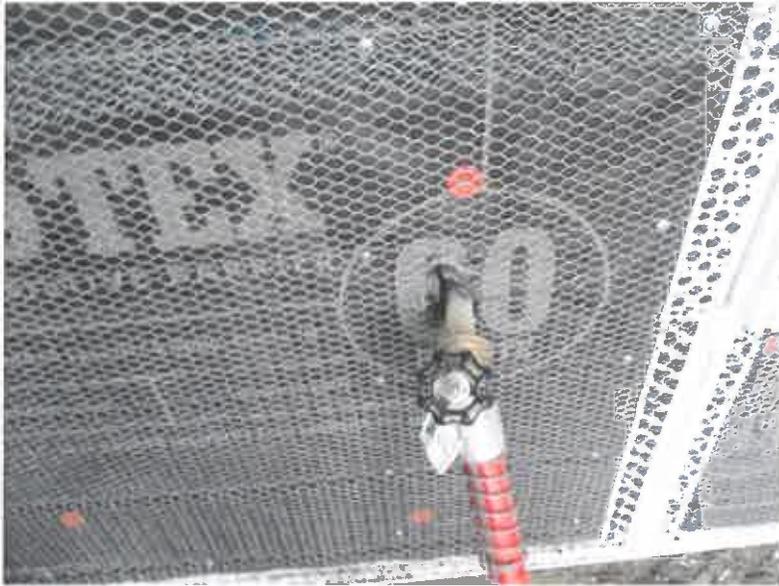
PHOTOGRAPH #5

**BUILDING 14
ELEVATION C**

Contractor has not completed flashing requirements at hose bib penetration as required.

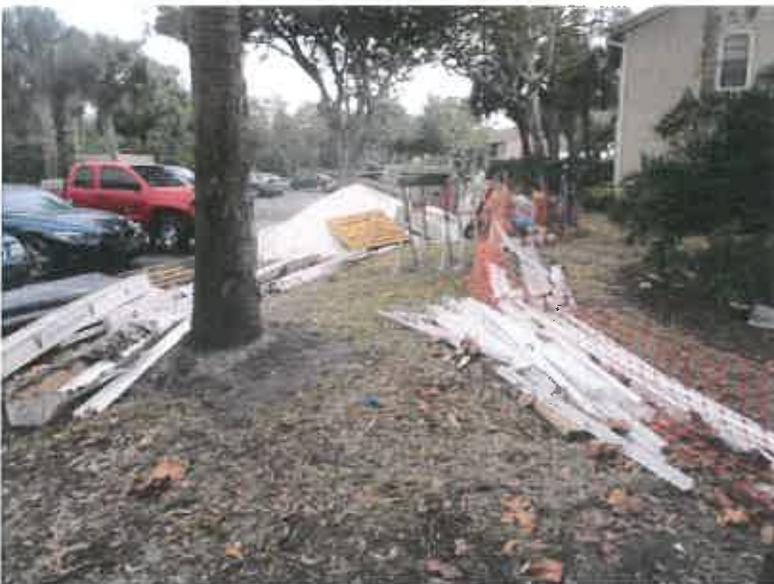
PHOTOGRAPH #6

**BUILDING 14
ELEVATION A**

Contractor is not cleaning the site daily as required by Project Manual.

- Determine location each required mock-up (framing & strapping, sheathing, Tyvek, stucco, window & window flashing, sealant joints, and painting).
- Several new accessories at window heads do not have weep holes as required by project manual and drawings. Contractor will add weep holes as required (Photograph #1).
- Flashing at balcony has been re-positioned and will require re-placing stucco accessories, lath and new stucco as per specifications (Photograph #2).
- Flashing at balcony has been re-positioned and will require re-placing stucco accessories, lath and new stucco as per specifications (Photograph #3).
- Contractor has not completed flashing requirements at hose bib penetration as required (Photograph #5).
- Contractor is required by Project Manual to clean site daily (Photographs #6 and #7).

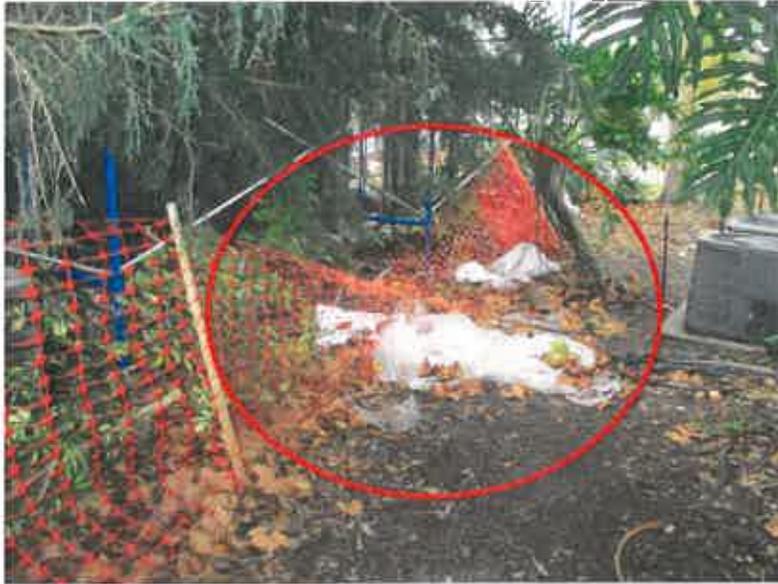
PHOTOGRAPH #7

**BUILDING 14
ELEVATION C**

Contractor is not cleaning the site daily as required by Project Manual.

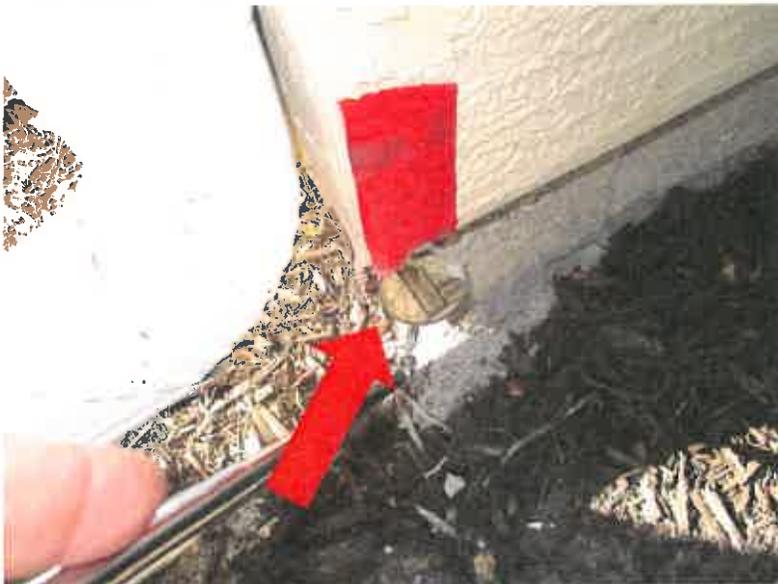
PHOTOGRAPH #8

BUILDING 4

Contractor has performed sealant work as per Change Order # 6 at the bottom edge of weep screed to the foundation. Delta began inspection and discontinued after marking several missed locations.

- Contractor has not sealed bottom edge of wall termination as per C.O. #7. Stucco weep screed accessories and stucco has already been applied and will require removal for proper application.

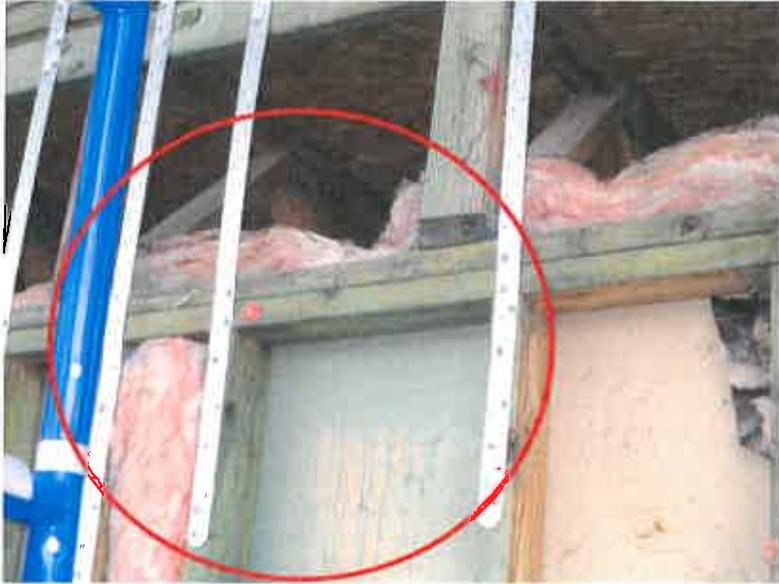
PHOTOGRAPH #9

**BUILDING 25
ELEVATION C**

Several straps have been installed without nailing all nail holes as required. Contractor will make corrections prior to re – inspection by Delta.

- Determine location each required mock-up (framing & strapping, sheathing, Tyvek, stucco, window & window flashing, sealant, joints, and painting).
- Strapping is required to extend from studs past top plate and onto trusses. Contractor will add blocking as required for proper nailing to truss as per drawings (Photograph #1).
- Several straps have been installed without nailing all nail holes as required. Contractor will make corrections prior to re - inspection by Delta (Photograph #9).

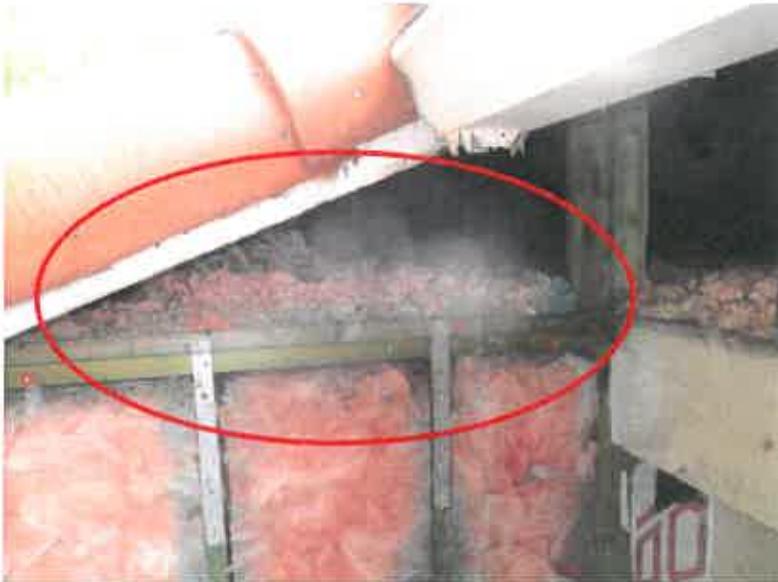
PHOTOGRAPH #10

**BUILDING 25
ELEVATION B**

Strapping is required to extend from studs past top plate and onto trusses. Contractor will add blocking as required for proper nailing to truss as per drawings.

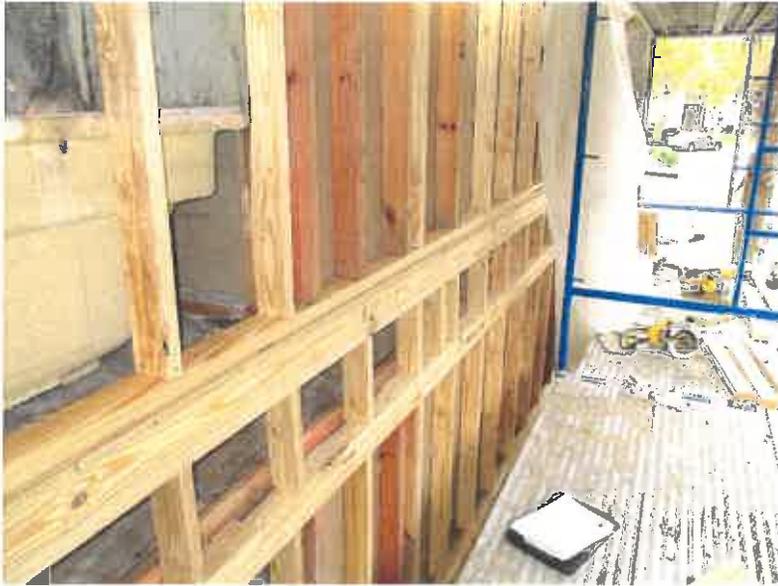
PHOTOGRAPH #11

**BUILDING 25
ELEVATION H**

Extensive repairs of subfloors, and wall studs are in progress as per drawings and specifications.
