FIELD OBSERVATION REPORT - Bldg #14

Permit No. 16-131655-00 BC
Owner: Vintage Grand Condo Assn, Inc.
Project Address: 4017 Crocodiers Lake Blvd, Sarasota, FL
Contractor: RL James Inc
Inspector (s): Mark Boss PM
Type of Assessment: Progress

FIELD OBSERVATION REPORT - Bldg #25

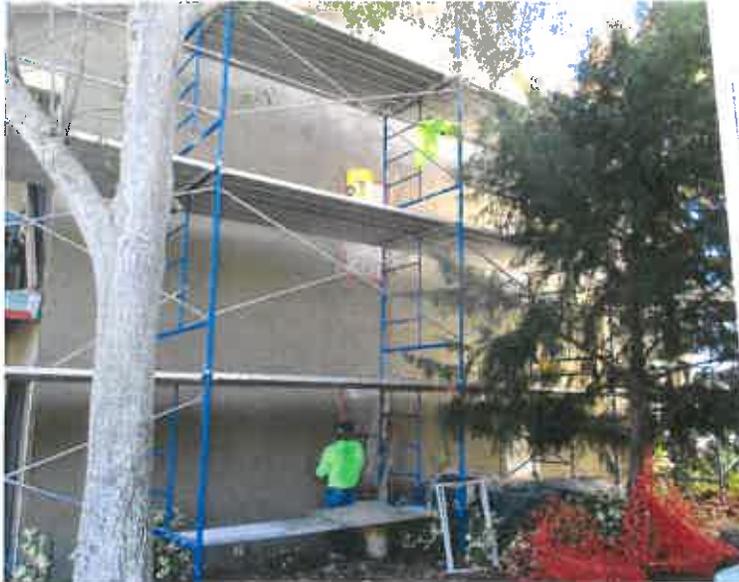
PHOTOGRAPH #1

D	X	NA	NA	X	X	X	X	X	X				Contractor has applied scratch coat and was applying brown coat of stucco. (Photograph #1). Contractor has applied finish texture coat of stucco. (Photograph #2).
E	X	NA	NA	X	X	X	X	X	X				
F	X	X	X	X	X	X	X	X	X

Contractor has applied scratch coat and was applying brown coat of stucco.

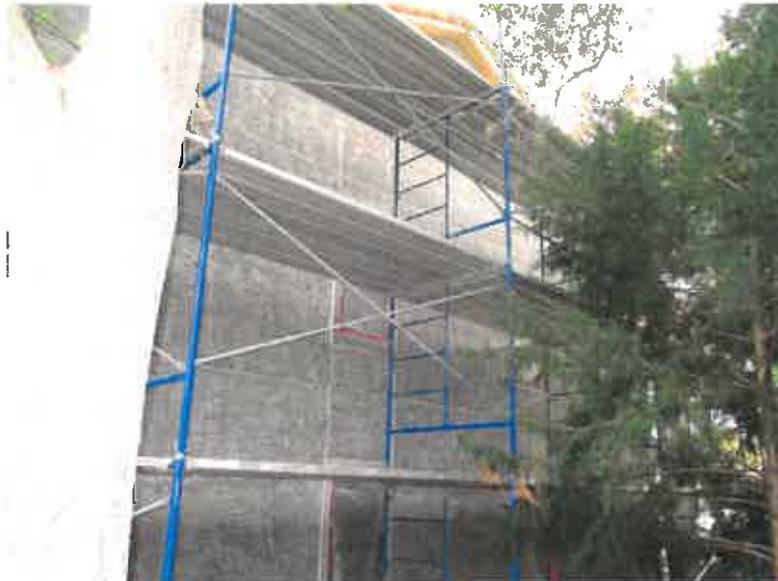
PHOTOGRAPH #2

Contractor has applied finish texture coat of stucco.

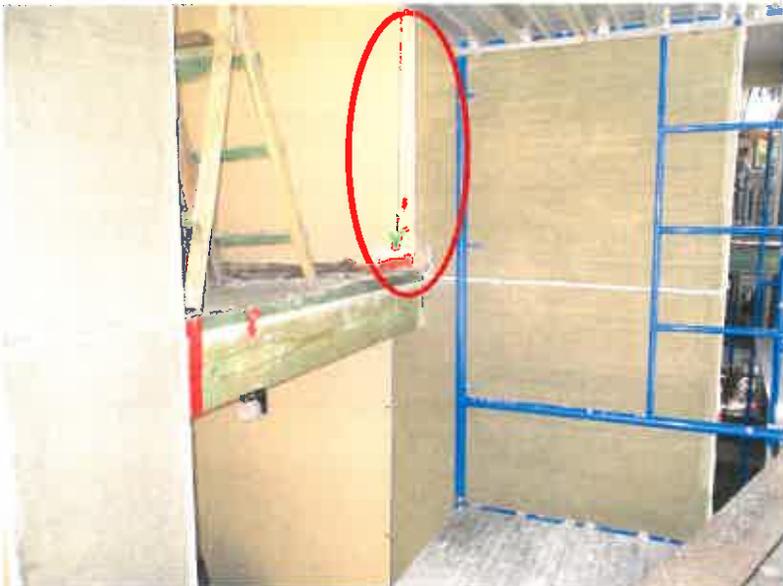
PHOTOGRAPH #4

New Stucco to existing stucco termination is too far outbound on this corner balcony. Termination is to occur within the balcony area that will not be seen from the exterior when screen framing is installed.

- Determine location each required mock-up (framing & sheathing, Tyvek, stucco, window & window flashing sealant joints, and painting).
- New Stucco to existing stucco termination is too far outboard on this corner balcony. Termination is to occur within the balcony area that will not be seen from the exterior when screen framing is installed. (Photograph #4).

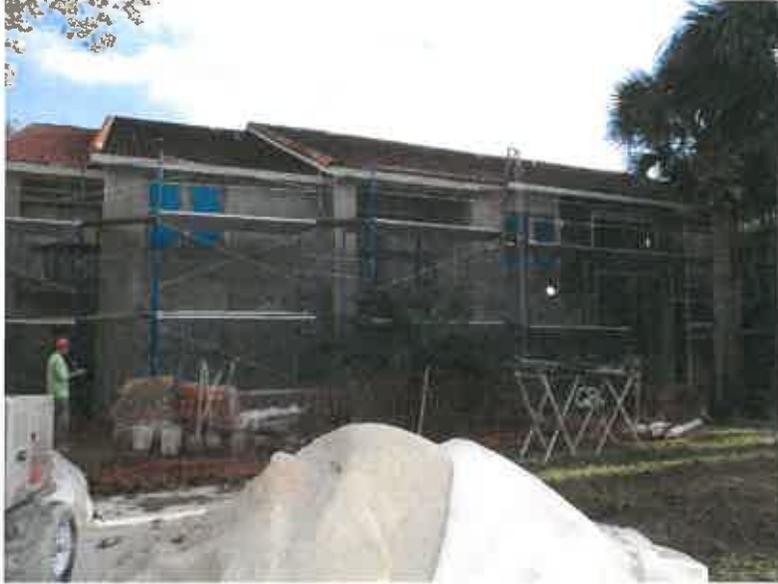
PHOTOGRAPH #5

Contractor has begun scratch coat of stucco as per specifications. Job site has been cleaned up in preparation for holiday break.

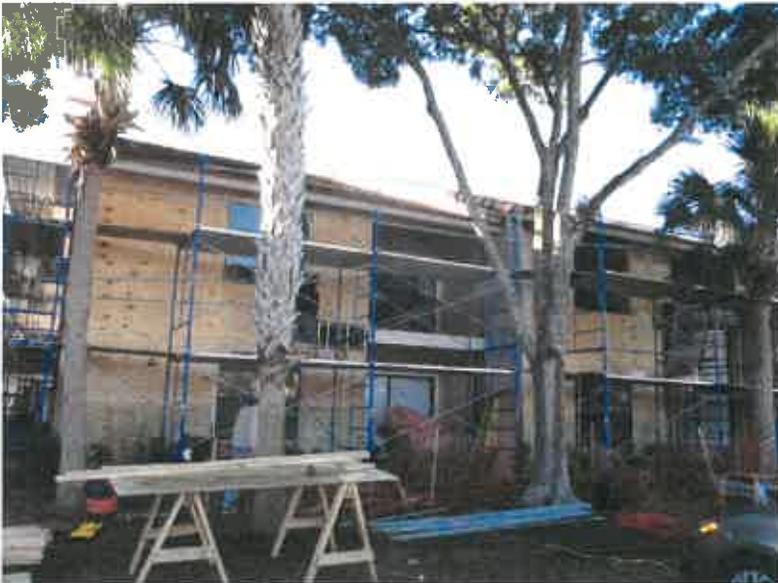
PHOTOGRAPH #6

Contractor has completed repairs, applied termite and lumber treatments to framing, installed new insulation and begun sheathing installation.

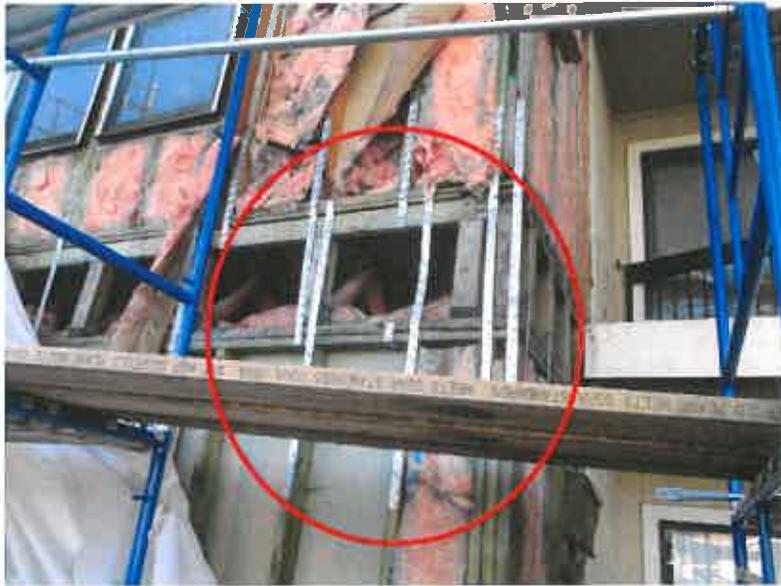
PHOTOGRAPH #7

C	X	NA	NA	/	/									Contractor has not installed all nails as per specifications in the strapping and will be required to complete nailing prior to Delta inspection and sheathing installation (Photograph #7). Contractor has over-driven nails into the sheathing and is required to re-fasten where fastener has been over-driven (Photograph #9). Open walls were exposed to wet conditions. Contractor is required to protect and cover as per project manual and specifications. Conditions will require evaluation and repair as required prior to sheathing installation (Photograph #14).
D														
E		NA	NA											
F		NA	NA											
G		NA	NA											
H	X			/										Extensive repairs of subfloors, and wall studs are in progress as per drawings and specifications.

Contractor has not installed all nails in the strapping as per specifications and will be required to complete nailing prior to Delta inspection and sheathing installation.

- Determine location each required mock-up (framing & strapping, sheathing, Tyvek, stucco, window & window flashing, sealant joints, and painting).
- Contractor has not installed all nails as per specifications in the strapping and will be required to complete nailing prior to Delta inspection and sheathing installation (Photograph #7).

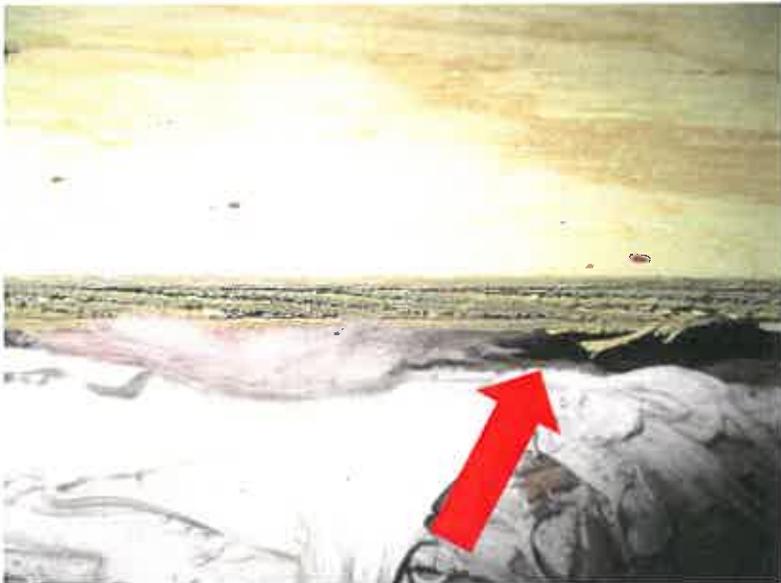
PHOTOGRAPH #8

Contractor has not completed sealing the bottom edge of sheathing to the base plate as per C.O. # 7 and detail provided by Delta. Corrections will be required prior to application of weep screed.

- Contractor has not completed sealing the bottom edge of sheathing to the base plate as per C.O. # 7 and detail provided by Delta. Corrections will be required prior to application of weep screen (Photograph #9).

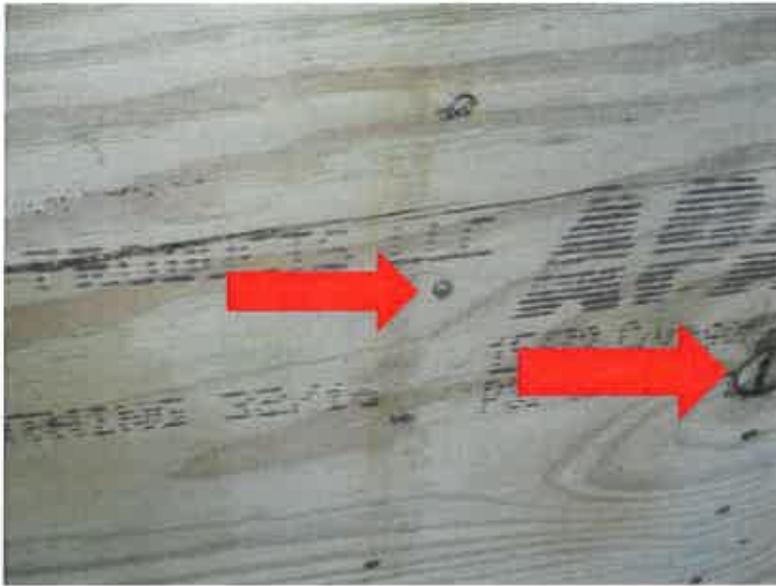
PHOTOGRAPH #9

Contractor has over-driven nails into the sheathing and is required to re-fasten where fastener has been over-driven.

- Contractor has over-driven nails into the sheathing and is required to re-fasten where fastener has been over-driven (Photograph #9).
- New sheathing was left unprotected from the elements and walls above breezeway left open. Contractor is required to protect and cover as per project manual and specifications. (Photographs #10 and #11).

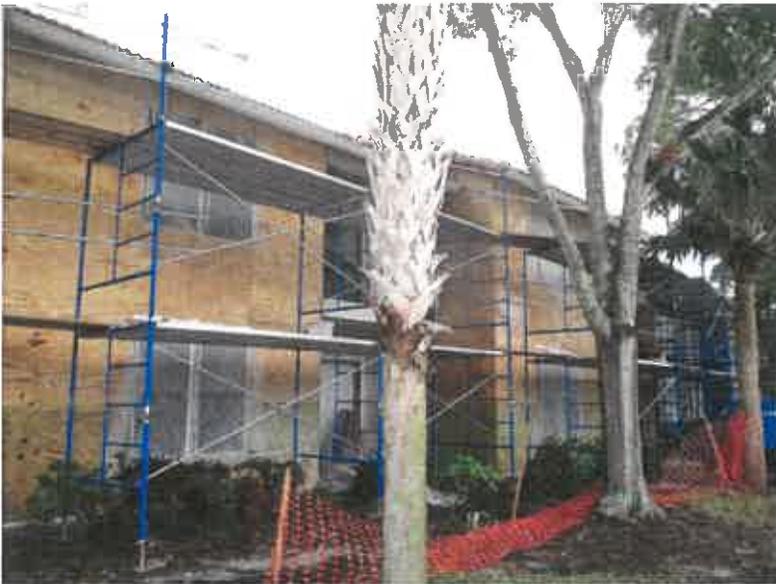
PHOTOGRAPH #10

New sheathing was left unprotected from the elements. Contractor is required to protect and cover as per project manual and specifications.

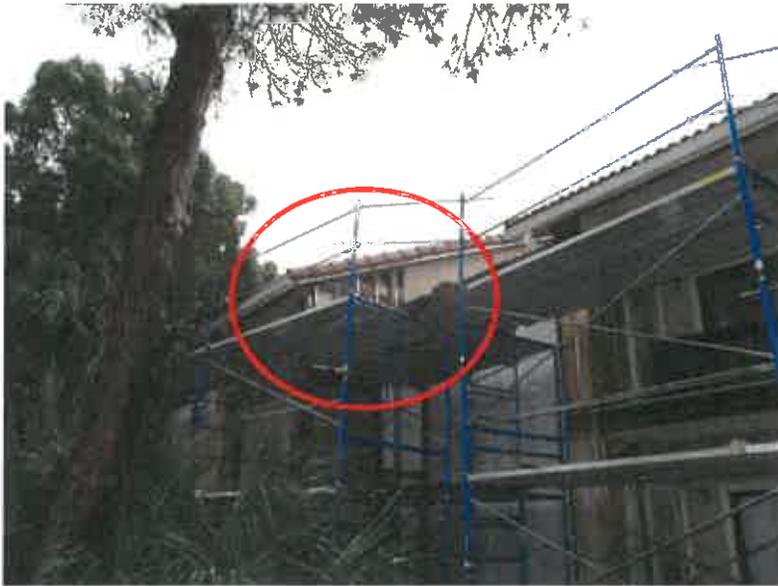
PHOTOGRAPH #11

Walls above breezeway left open without protection from the elements. Contractor is required to protect and cover as per project manual and specifications.

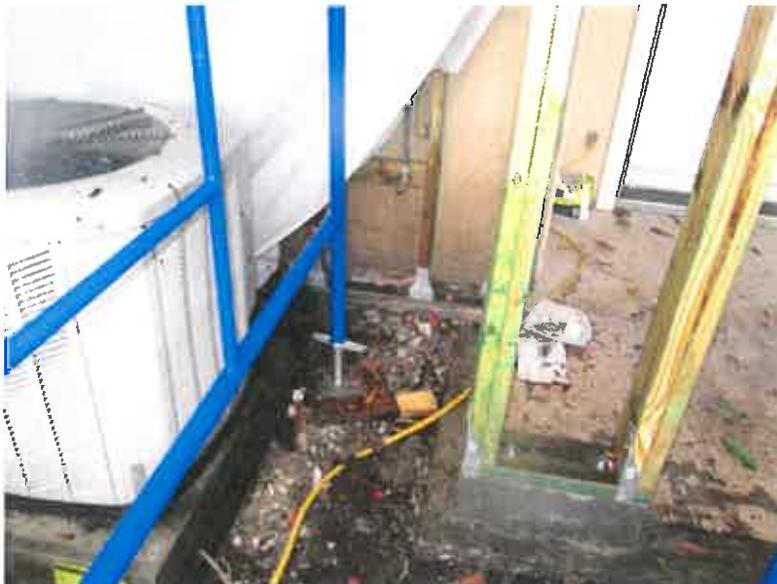
PHOTOGRAPH #12

Open walls were exposed to wet conditions. Contractor is required to protect and cover as per project manual and specifications. Conditions will require evaluation and repair as required prior to sheathing installation.

- Open walls were exposed to wet conditions. Contractor is required to protect and cover as per project manual and specifications. Conditions will require evaluation and repair as required prior to sheathing installation (Photographs #12 and #13).

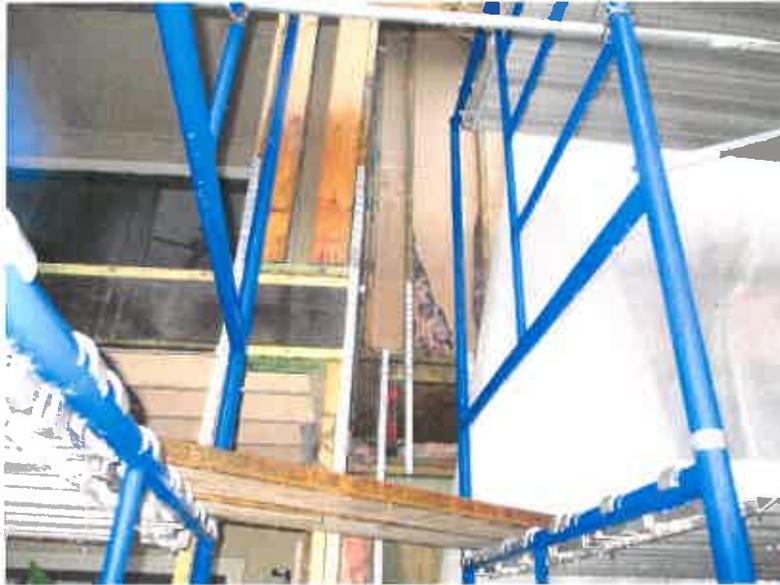
PHOTOGRAPH #13

Open walls were exposed to wet conditions. Contractor is required to protect and cover as per project manual and specifications. Conditions will require evaluation and repair as required prior to sheathing installation.

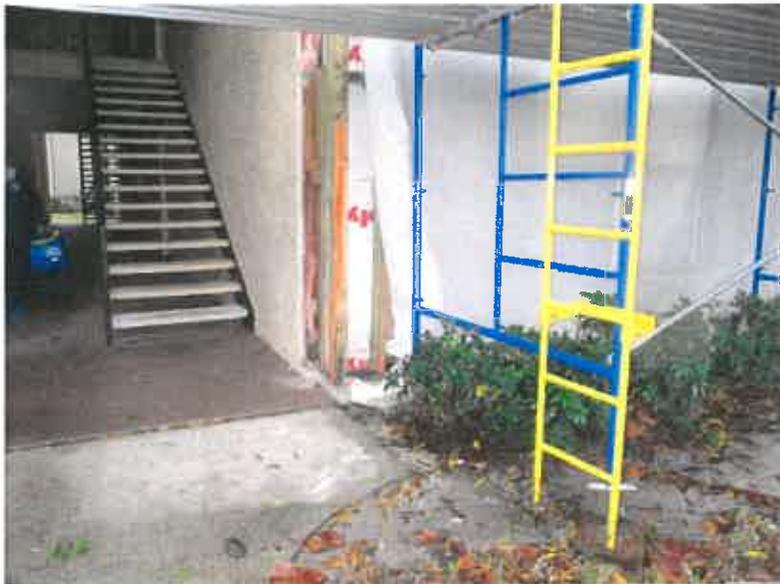
PHOTOGRAPH #14

Open walls were exposed to wet conditions. Contractor is required to protect and cover as per project manual and specifications. Conditions will require evaluation and repair as required prior to sheathing installation.
