**FIELD OBSERVATION REPORT - Bldg #25**

Permit No: 18-14807-2-00 BC  
Owner: Vintage Grand Condo Assn, Inc.  
Project Address: 4017 Crickets Lake Blvd, Sarasota, FL  
Contractor: RL James Inc  
Inspector (s): Mark Boss  
Type of Assessment: Progress

**FIELD OBSERVATION REPORT - Bldg #14**

**PROJECT NAME:**  
 WOOD FRAME REPAIRS & RELATED WORK (PHASE II)  
 VINTAGE GRANDE CONDOMINIUM ASSOCIATION, INC.  
 4012 CROCKER'S LAKE BLVD., SARASOTA, FL 34238

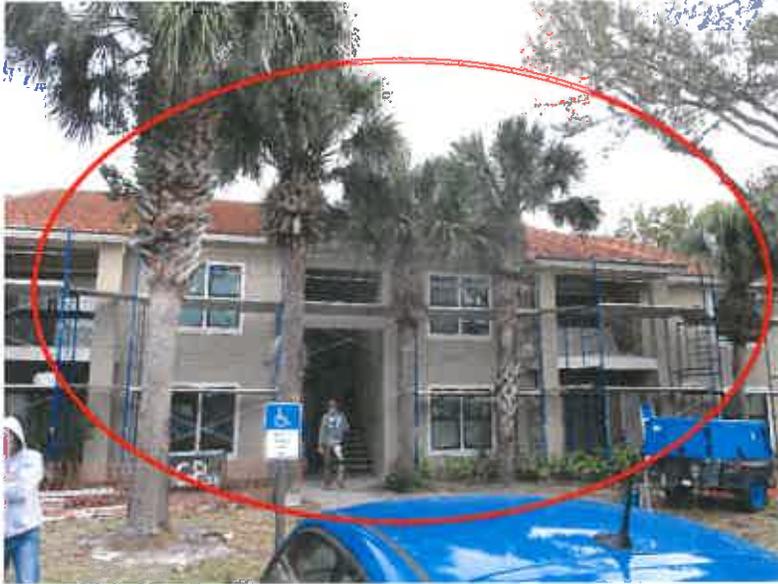
**PHOTOGRAPH #1**

#### **BUILDING 14 ELEVATION A & B**

Contractor has applied specified primer to stucco and wood surfaces as per specifications and manufacturers recommendations.

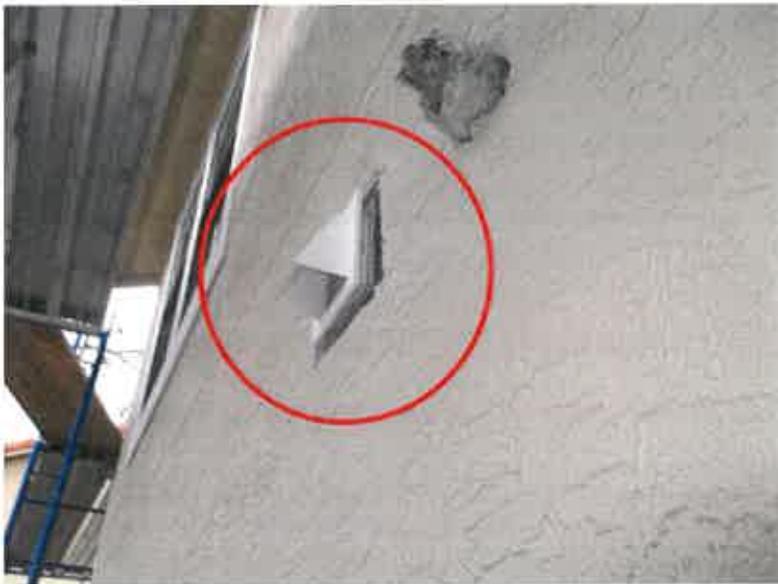
**PHOTOGRAPH #2**

#### **BUILDING 14 ELEVATION A**

Dryer vents have not been installed as specified. Stucco repairs will be required at this location.

- Dryer vents in wall will require extension and flashing details per specifications prior to stucco system application. Stucco repairs will be required at some locations (Photograph #2).

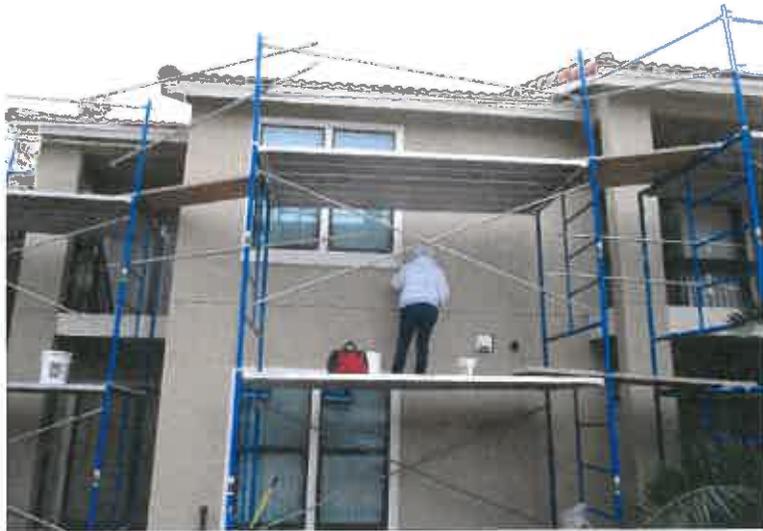
**PHOTOGRAPH #3**

**BUILDING 25  
ELEVATION A**

Contractor applying finish paint to window trim as per specifications and manufacturers recommendations.

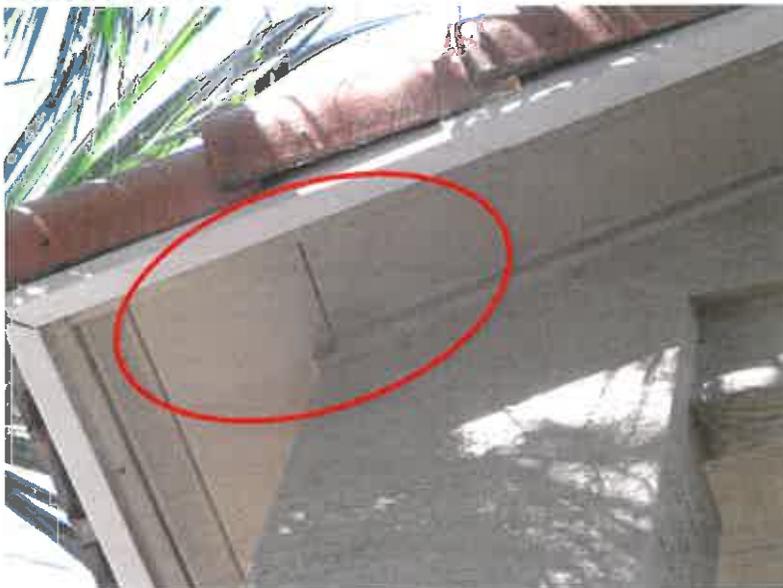
**PHOTOGRAPH #4**

**BUILDING 14  
ELEVATION C**

Contractor has applied primer and finish paint to soffit but has not sealed seams or filled nail holes as required.

- Contractor has applied primer and finish paint to soffits but has not sealed seams or filled nail holes as required (Photograph #4).

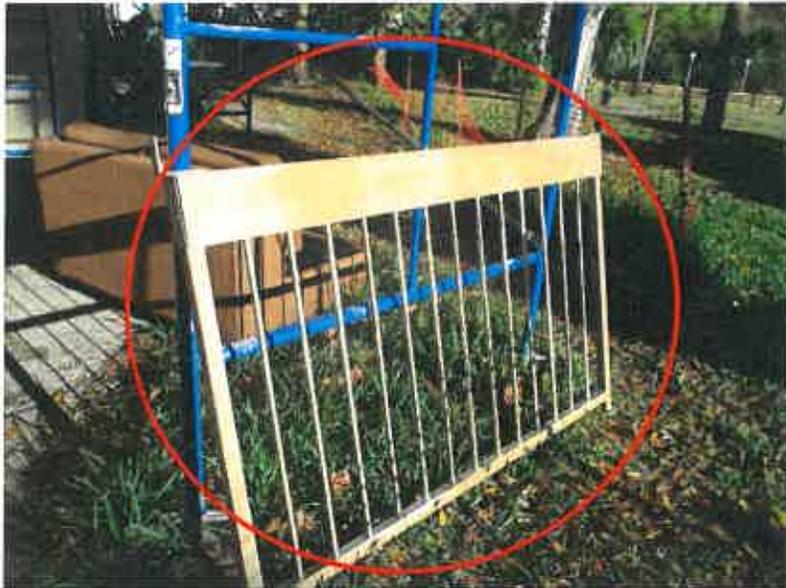
**PHOTOGRAPH #5**

**BUILDING 14  
BALCONY RAILING PAINT MOCK- UP**

Contractor has sand blasted railing in order to prepare surface for prime and finish coats of paint. Paint manufacturer representative will inspect mock ups for approval.

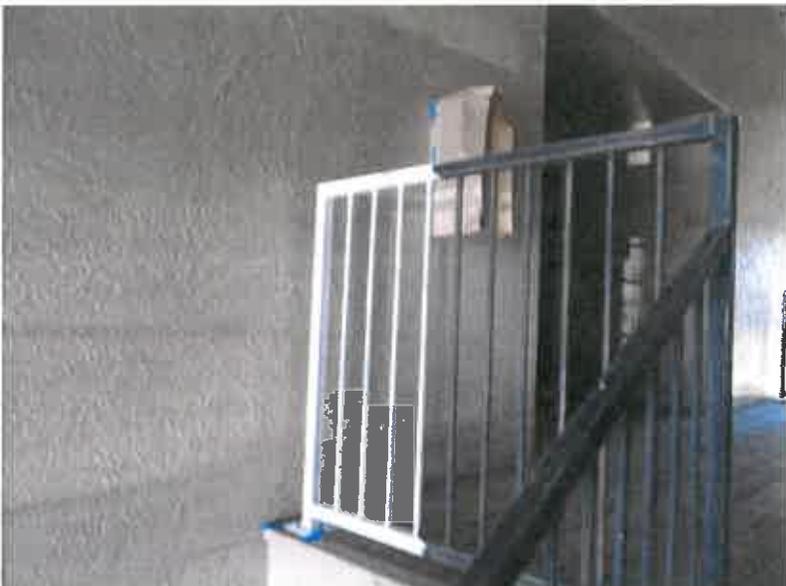
**PHOTOGRAPH #6**

**BUILDING 14  
STAIRWAY RAILING PAINT MOCK- UP**

Contractor has applied specified epoxy mastic primer for inspection and approval by manufacturers representative.

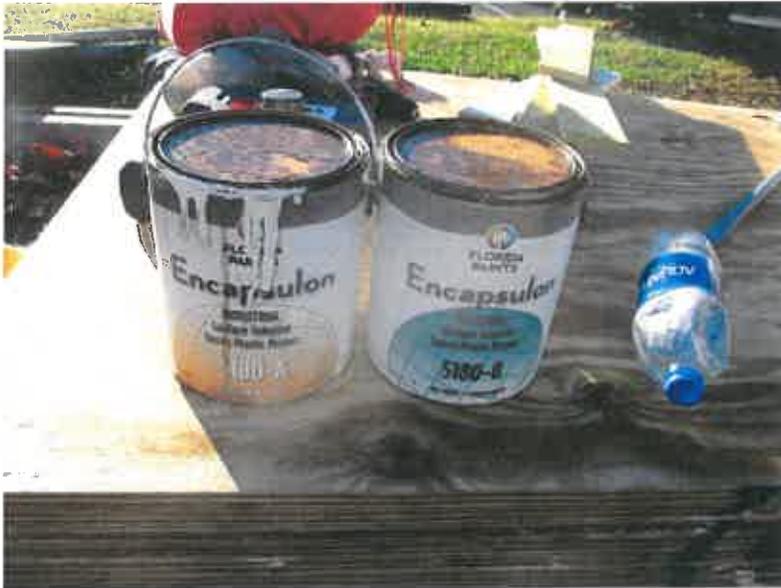
**PHOTOGRAPH #7**

**BUILDING 14  
STAIRWAY RAILING PAINT MOCK- UP**

Contractor has applied specified epoxy mastic primer for inspection and approval by manufacturers representative.

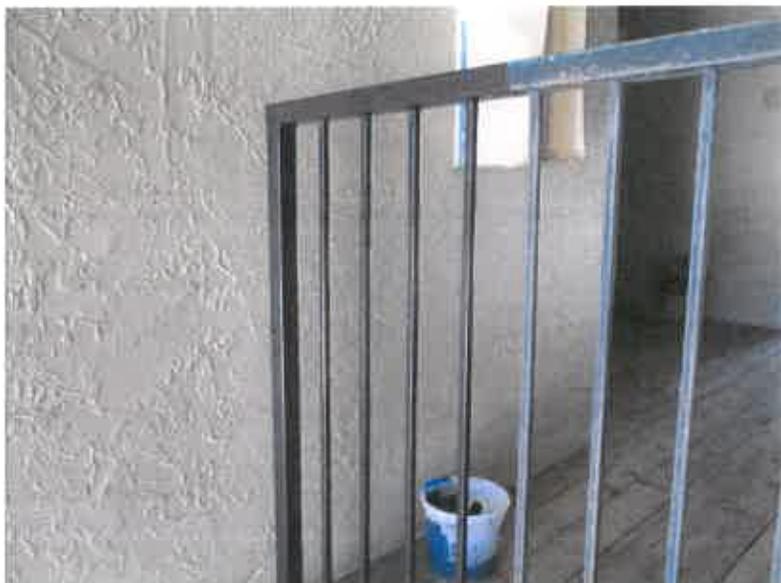
**PHOTOGRAPH #8**

**BUILDING 14  
STAIRWAY RAILING PAINT MOCK- UP**

Contractor has applied specified urethane acrylic finish coating for inspection and approval by manufacturers representative.

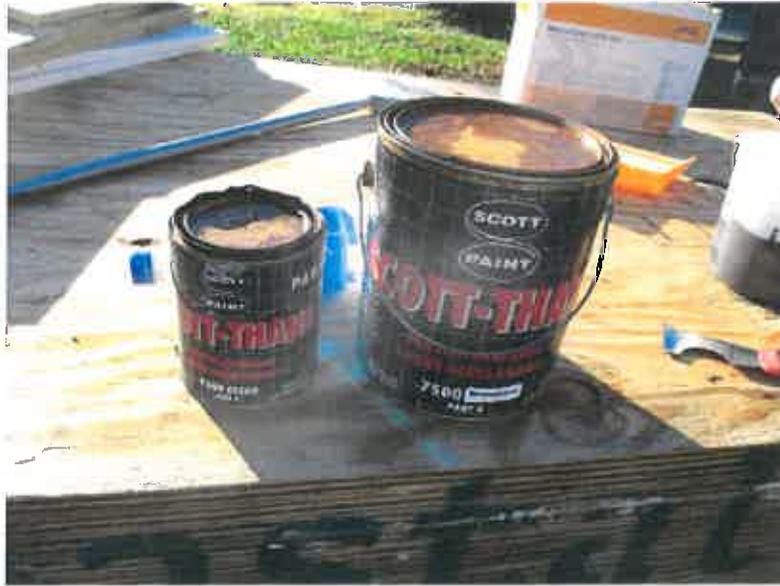
**PHOTOGRAPH #9**

**BUILDING 14  
STAIRWAY RAILING PAINT MOCK- UP**

Contractor has applied specified urethane acrylic finish coating for inspection and approval by manufacturers representative.

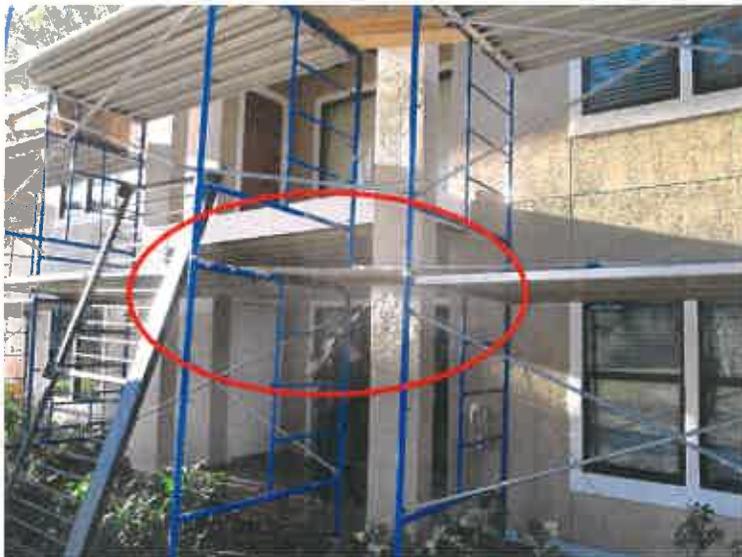
**PHOTOGRAPH #10**

**BUILDING 14  
ELEVATION D**

Contractor is cleaning mildew from wood surface prior to application of primer and finish coating.

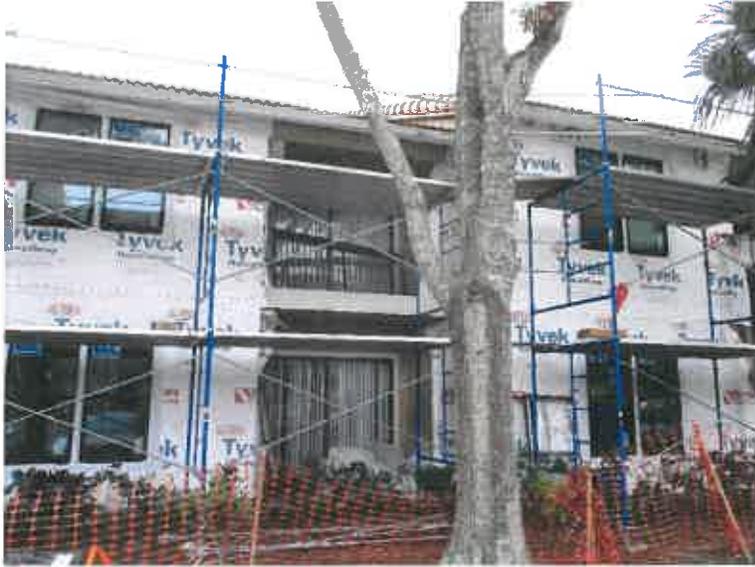
**PHOTOGRAPH #11**

**BUILDING 25  
ELEVATION A**

Weather barrier and windows have been installed as per drawings manufacturer NOAs and specifications.

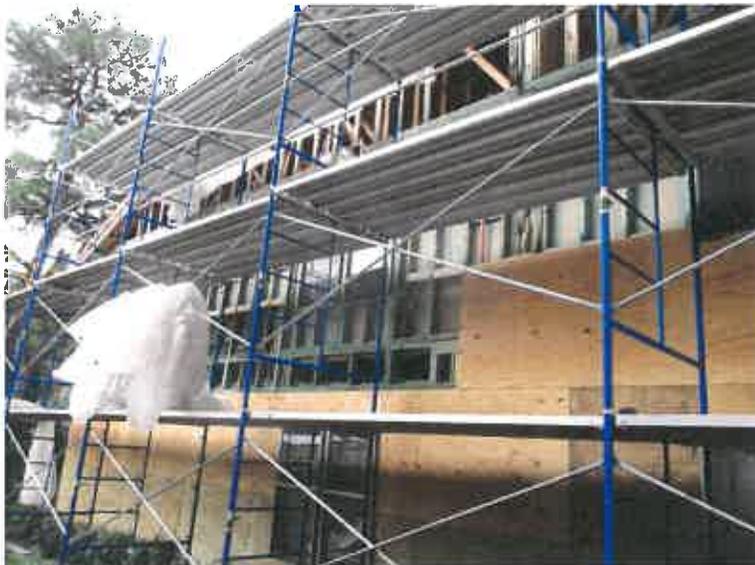
**PHOTOGRAPH #12**

**BUILDING 25  
ELEVATION H**

Contractor has completed repairs at gable end wall and begun sheathing.

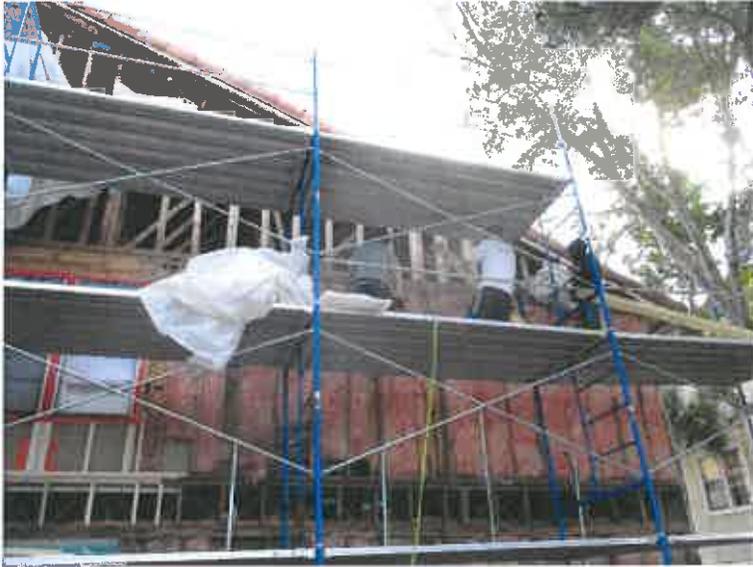
**PHOTOGRAPH #13**

**BUILDING 25  
ELEVATION D**

Contractor has completed framing repairs at gable end wall and begun gable bracing.

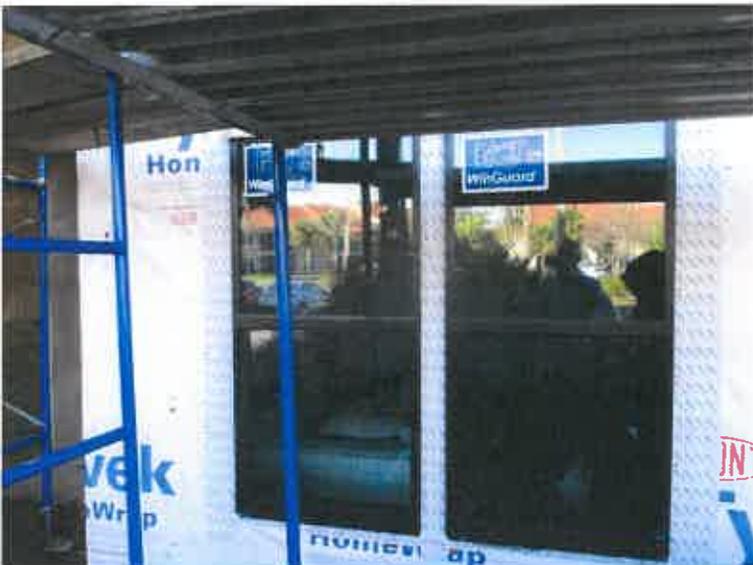
**PHOTOGRAPH #14**

**BUILDING 25  
ELEVATION B**

Weather barrier and windows have been installed as per drawings manufacturer NOAs and specifications.

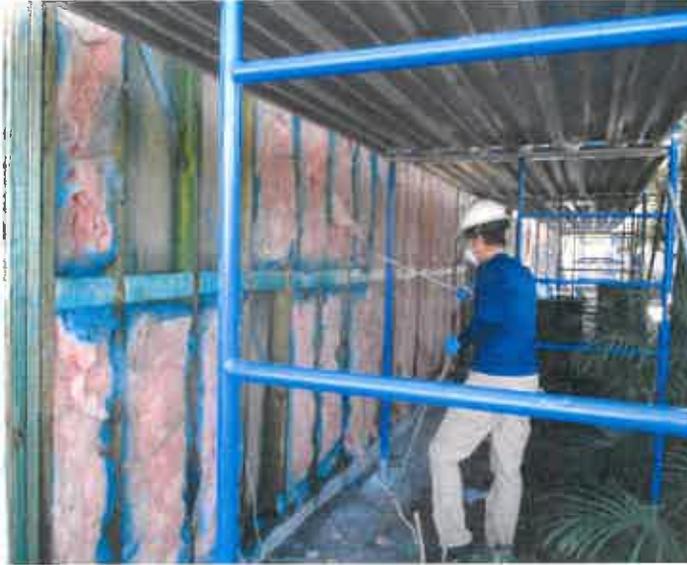
**PHOTOGRAPH #15**

**BUILDING 25  
ELEVATION D**

Contractors, Sub-Contractor applying Bora-Care Termite treatment as per specifications.

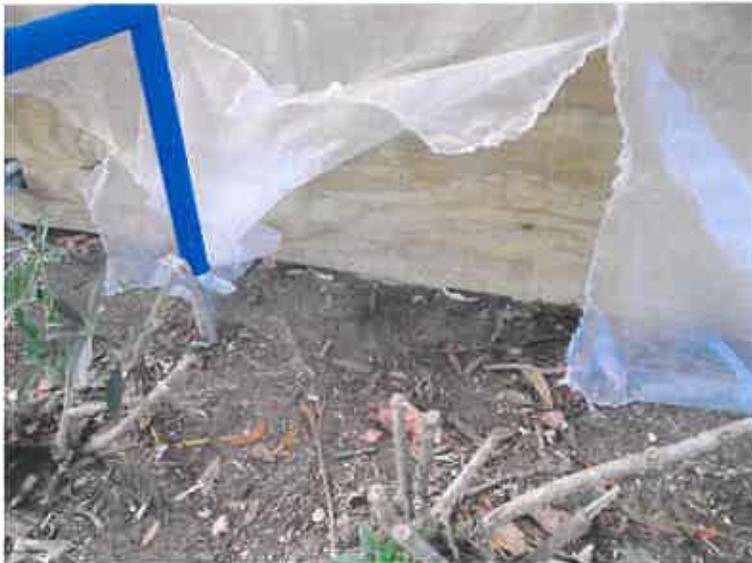
**PHOTOGRAPH #16**

**BUILDING 25  
ELEVATION H**

Soil grade is all the way up to the new sheathing. Owners are required to regrade soils around building to provide a minimum of 6 inches from top of grade to bottom of stucco and slope grade 2% to provided positive drainage.

- Regrade soils around building to provide a minimum of 6 inches from top of grade to bottom of stucco and slope grade 2% to provided positive drainage (Photograph # 16).

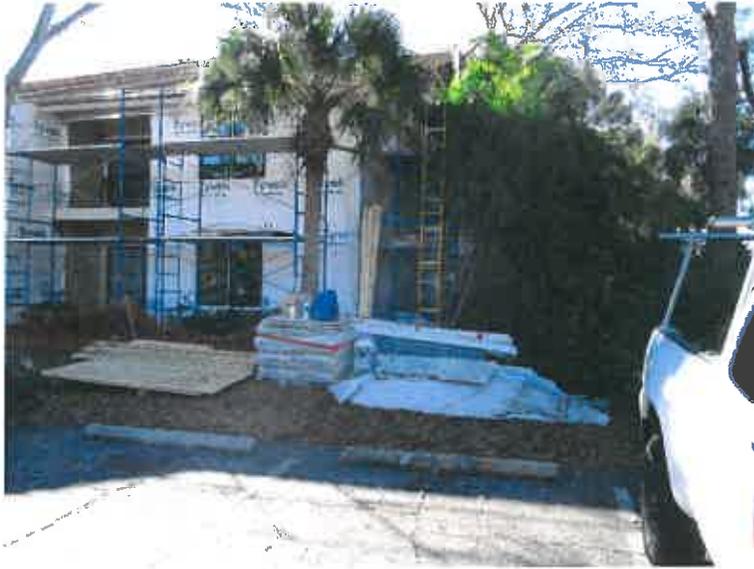
**PHOTOGRAPH #17**

**BUILDING 25  
ELEVATION C**

Contractor has staged materials outside of construction fencing. Construction materials are to be organized within fenced construction area and site cleaned daily.

- Contractor has staged materials outside of construction fencing. Construction materials are to be organized within fenced construction area and site cleaned daily (Photographs #17 and #18).

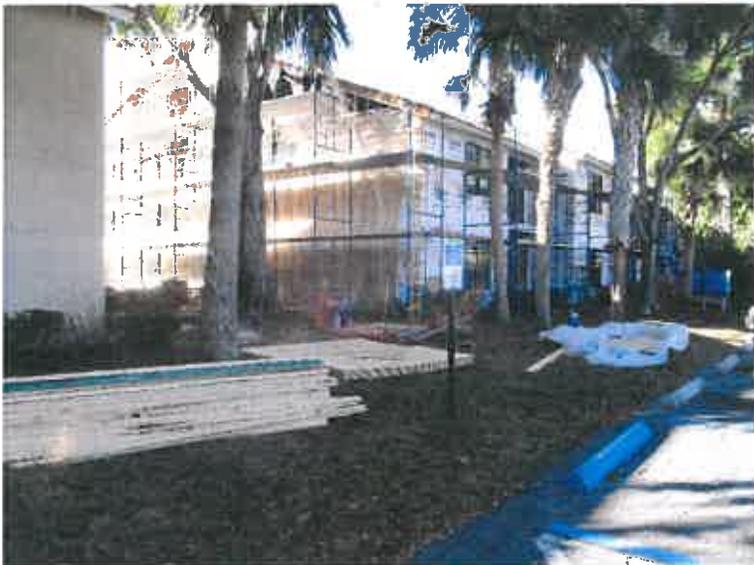
**PHOTOGRAPH #18**

**BUILDING 25  
ELEVATION H**

Contractor has staged materials outside of construction fencing. Construction materials are to be organized within fenced construction area and site cleaned daily.
