**FIELD OBSERVATION REPORT - Bldg #14**

Permit No. 18-131565-00 BC  
 Owner: Village Grand Condo Assn, Inc.  
 Project Address: 4017 Crockers Lake Blvd., Sarasota, FL  
 Contractor: RL James Inc.  
 Inspector (s): Mark Boss PM  
 Type of Assessment: Progress

**FIELD OBSERVATION REPORT - Bldg #25**

WOOD FRAME REPAIRS & RELATED WORK (PHASE II)  
 VINTAGE GRANDE CONDOMINIUM ASSOCIATION, INC.  
 4012 CROCKERS LAKE BLVD., SARASOTA, FL 34238

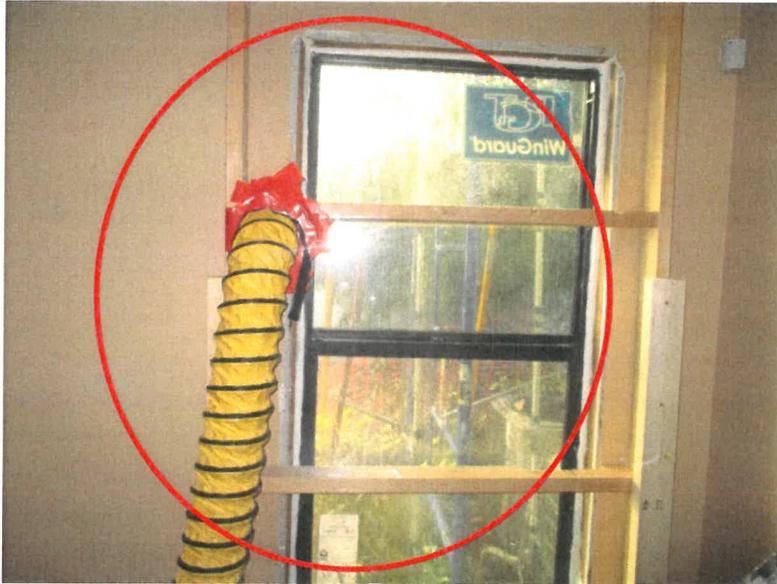
PHOTOGRAPH #1

### BUILDING 14 UNIT # 1411

Water testing by certified AAMA certified testing contractor was performed as per project manual protocol.

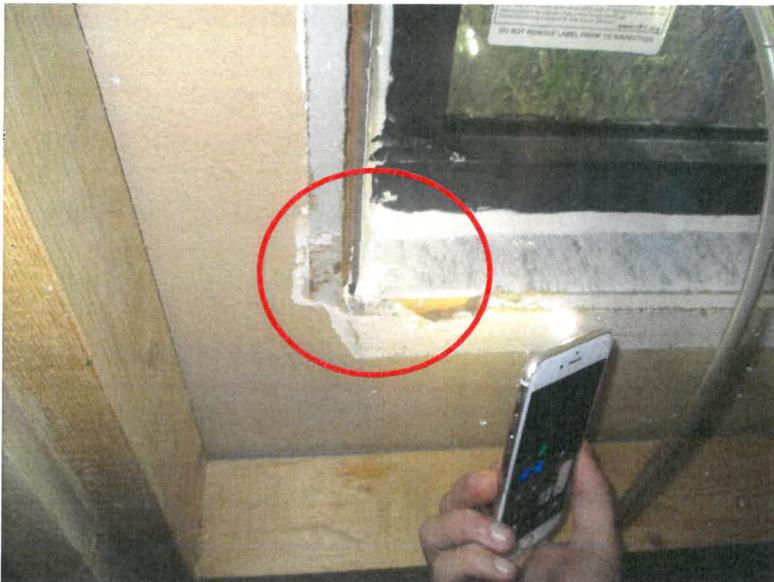
PHOTOGRAPH #2

- Unit #1411- 2nd water test water penetrated the interior plane of window at the bottom left sill location, failing the test. Contractor will perform corrective measures and re schedule water testing.

### BUILDING 14 UNIT # 1411

Water testing by certified AAMA certified testing contractor was performed as per project manual protocol. Test failed as small amount of water entered and passed the interior plan of window at bottom left side.

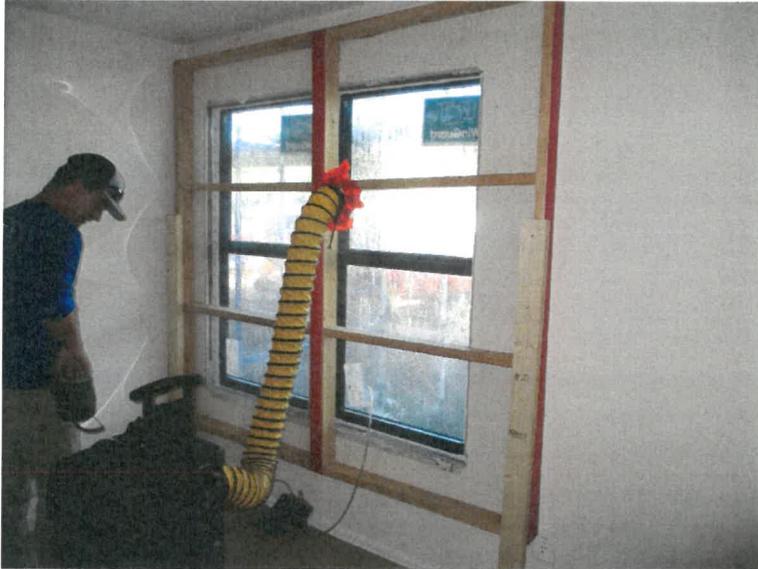
**PHOTOGRAPH #3**

**BUILDING 25  
UNIT # 2511**

Water testing by certified AAMA certified testing contractor was performed as per project manual protocol. Water test passed with no leaks.

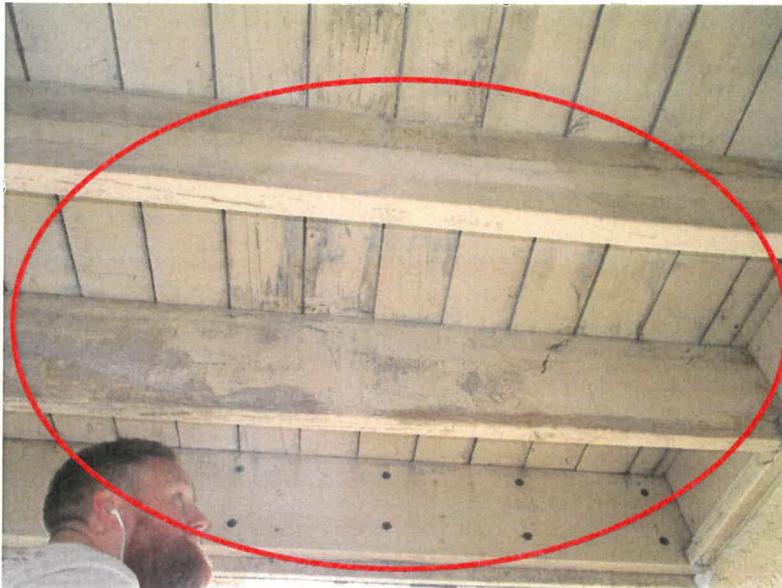
**PHOTOGRAPH #4**

**BUILDING 14  
ELEVATION E**

Contractor began to prime balcony ceiling surface before cleaning mildew from the surface as required by specifications and paint manufacturers application instructions.

- Contractor began to prime balcony ceiling surface before cleaning mildew from the surface as required by specifications and paint manufacturers application instructions (Photograph #4).
- Contractor has applied wood primer as specified to the new wood soffit. Nail holes will be filled and sealants applied at transitions and seams prior to application of finish paint (Photograph #9).

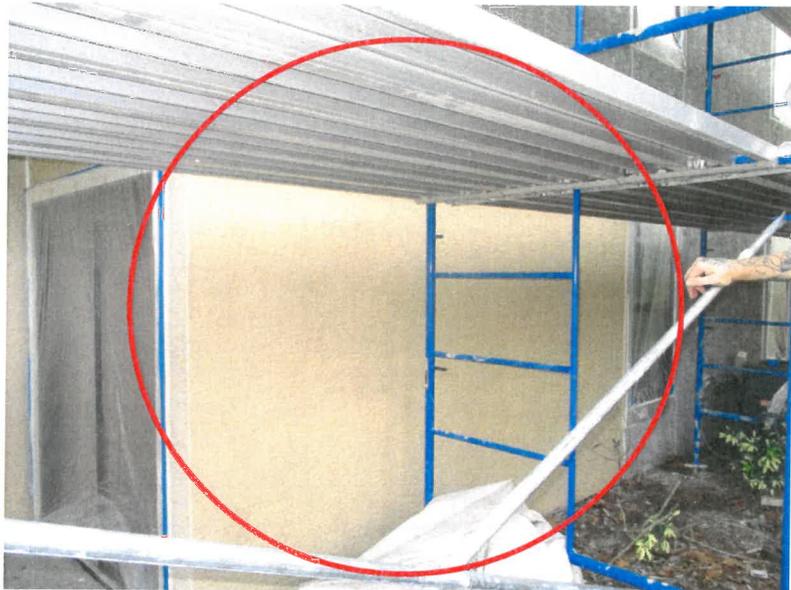
**PHOTOGRAPH #5**

**BUILDING 14  
ELEVATION F**

Contractor has applied specified primer and finish paint on new stucco mock up area.

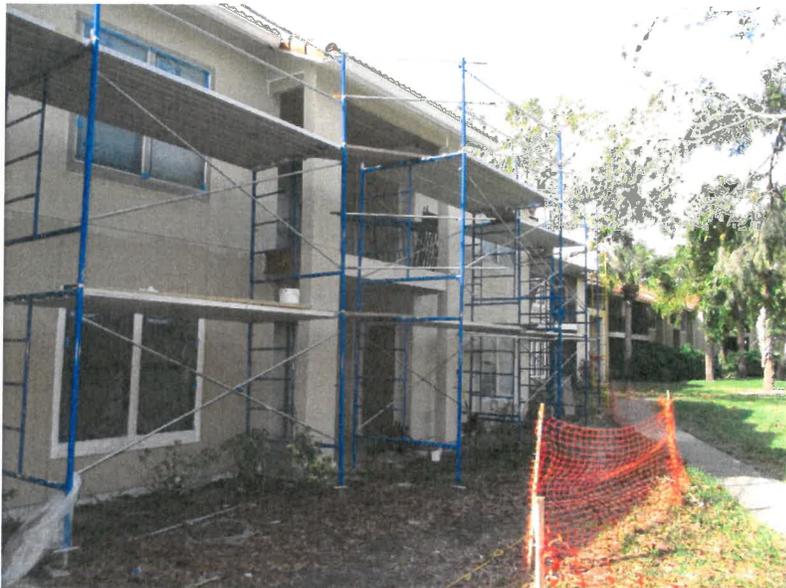
**PHOTOGRAPH #6**

**BUILDING 14  
ELEVATION D**

Contractor has applied specified primer to new stucco.

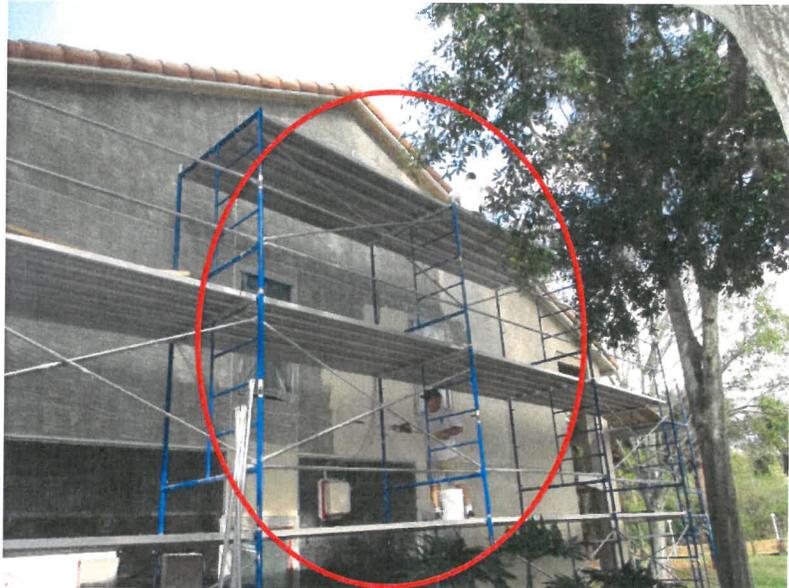
**PHOTOGRAPH #7**

**BUILDING 14  
ELEVATION C**

Contractor has begun to apply specified primer to new stucco.

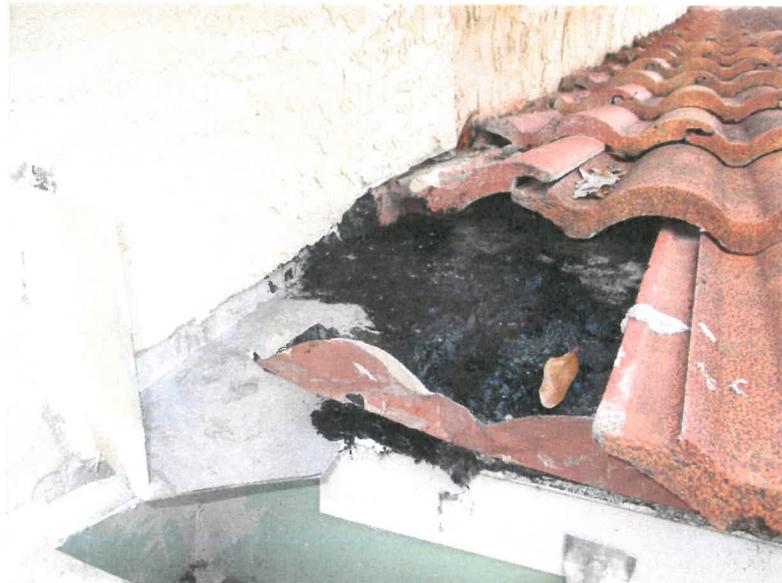
**PHOTOGRAPH #8**

**BUILDING 14  
ELEVATION E**

Contractor has completed mock up at gutter diversion kick out flashing detail.

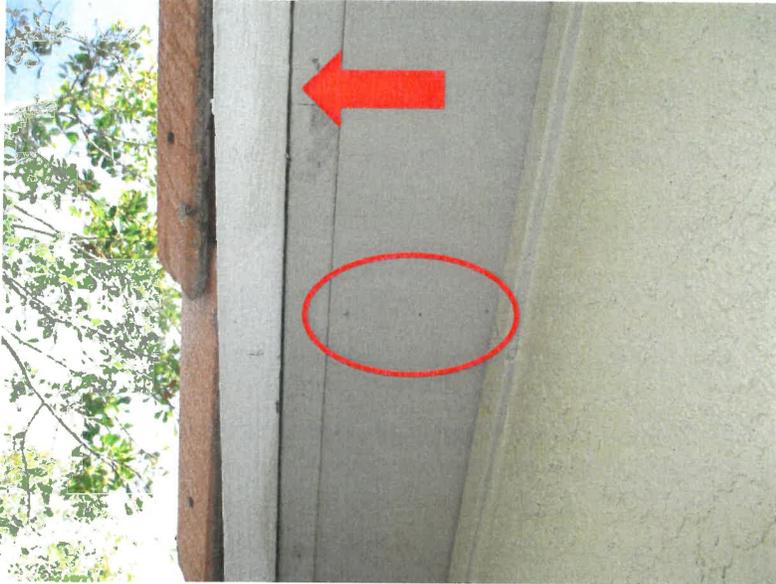
**PHOTOGRAPH #9**

**BUILDING 14  
ELEVATION F**

Contractor has applied wood primer as specified to the new wood soffit. Nail holes will be filled and sealants applied at transitions and seams prior to application of finish paint.

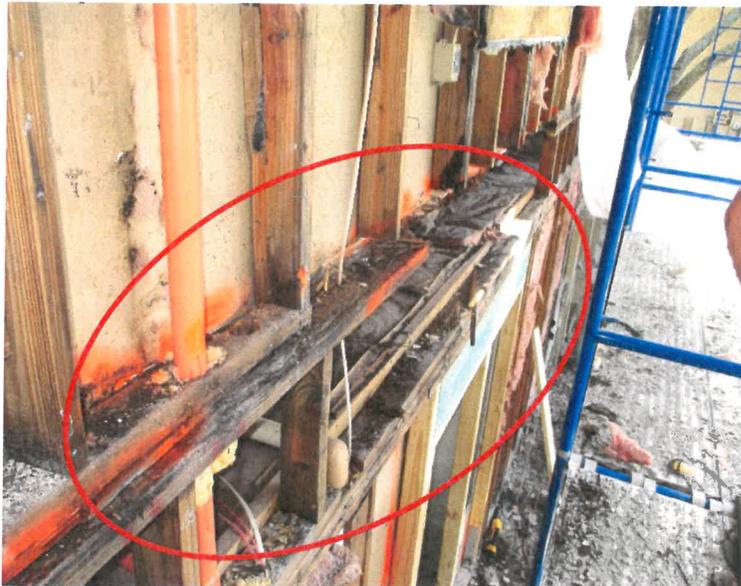
**PHOTOGRAPH #10**

**BUILDING 25  
ELEVATION D**

Damage, deterioration and collapse conditions observed and marked for repairs.

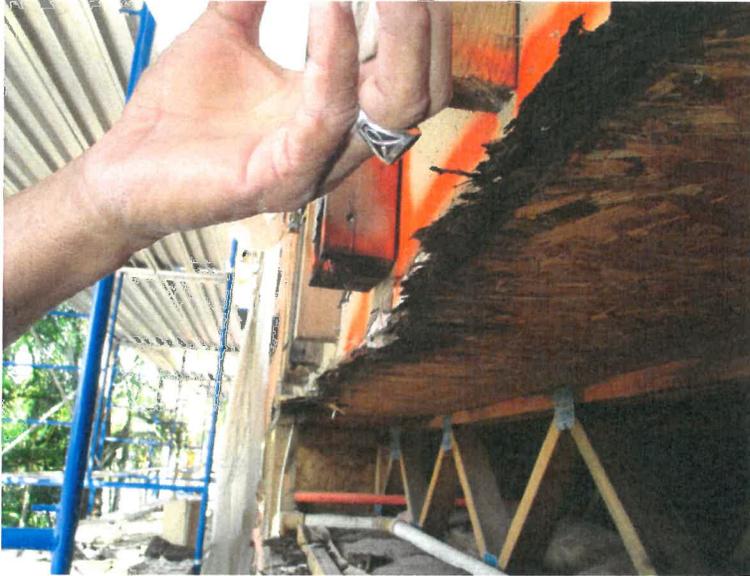
**PHOTOGRAPH #11**

**BUILDING 25  
ELEVATION D**

Damage, deterioration and collapse conditions observed and marked for repairs.

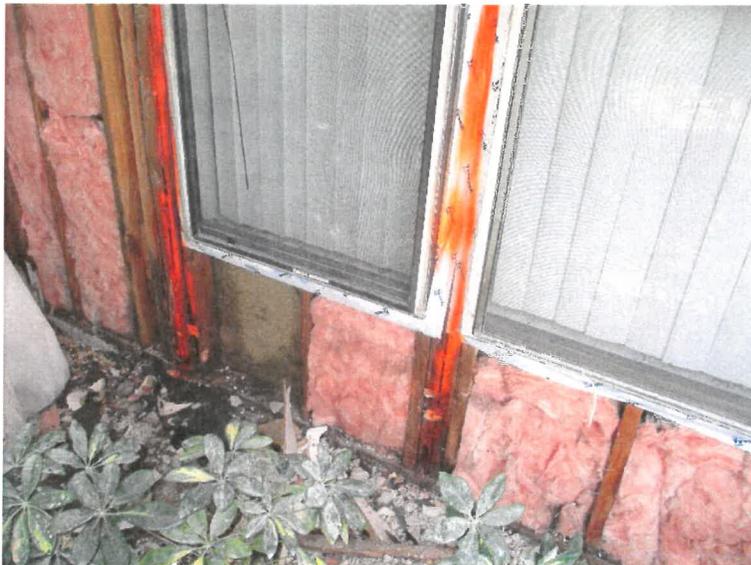
**PHOTOGRAPH #12**

**BUILDING 25  
ELEVATION D**

Damage, deterioration and collapse conditions observed and marked for repairs.

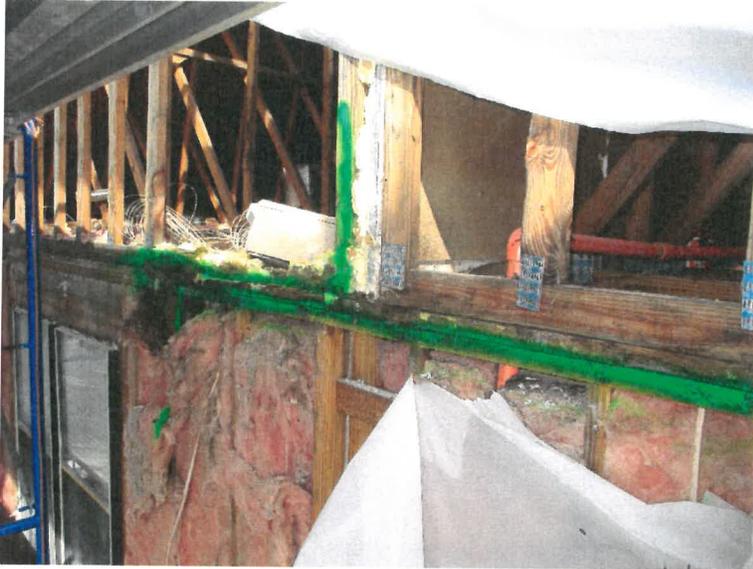
**PHOTOGRAPH #13**

**BUILDING 25  
ELEVATION D**

Damage, deterioration and collapse conditions observed and marked for repairs.

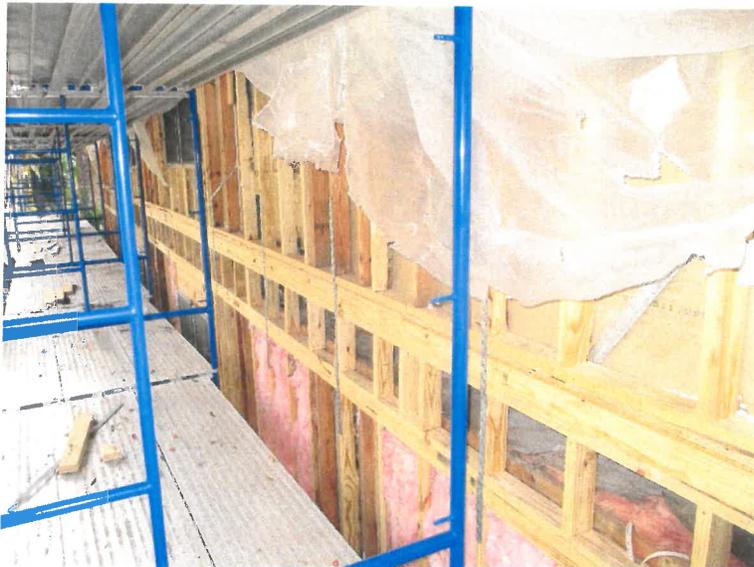
**PHOTOGRAPH #14**

Elevation	Demo	Gable Bracing	Gable Vents	Framing & strapping	Sheathing	Softi	Window flashing	Window Install	Stucco Lath Acc	Stucco	Sealant	Painting	Punch	Comments
A	X	NA	NA	X	X	/	/	/						Unit #2511-Water testing by certified AAMA certified testing contractor was performed as per project manual protocol. Water test passed with no leaks (Photograph #5).
B	X	NA	NA	X	/	/								
C	X	NA	NA	X	/	/								
D	X			/										Damage, deterioration and collapse conditions observed and marked for repairs (Photographs #10, #11, #12 and #13).
E		NA	NA											
F		NA	NA											
G		NA	NA											
H	X	/		/										Framing repairs at gable end wall has been completed and quantified with contractor (Photograph #14).

**BUILDING 25  
ELEVATION H**

Framing repairs at gable end wall has been completed and quantified with contractor.
