FIELD OBSERVATION REPORT - Bldg #14

Permit No. 18-131555-00 BC
 Project Vintage Grand Condo Assn, Inc.
 Owner 4017 Crockers Lake Blvd., Sarasota, FL
 Contractor RL James Inc
 Inspector (s): Mark Boss PM
 Type of Assessment: Progress

FIELD OBSERVATION REPORT - Bldg #25

PROJECT NAME
**WOOD FRAME REPAIRS & RELATED WORK (PHASE II)
 VINTAGE GRANDE CONDOMINIUM**

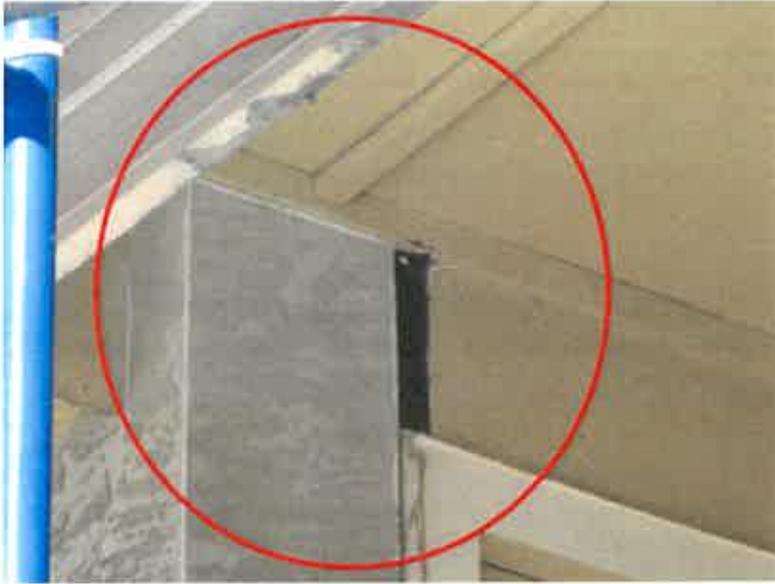
PHOTOGRAPH #1

D	X	NA	NA	X	X	X	X	X	X	/			Contractor has not completed stucco at several balconies above service door where old stucco was removed (Photograph #1). Flashing at balcony has been re-positioned and will require stucco accessories, lath and new stucco as per specifications.
E	X	NA	NA	X	X	X	X	X	X	/			Contractor has applied specified primer on new stucco mock up area (Photographs #2 and #3). Contractor has applied specified finish paint on new stucco mock up area (Photographs #4 and #5).
F	X	X	X	X	X	X	X	X	X

**BUILDING 14
ELEVATION D**

Contractor has not completed stucco at several balconies above service door where old stucco was removed.

ACTION REQUIRED BY CONTRACTOR:
 Contractor has not completed stucco at several balconies above service door where old stucco was removed (Photograph #1).

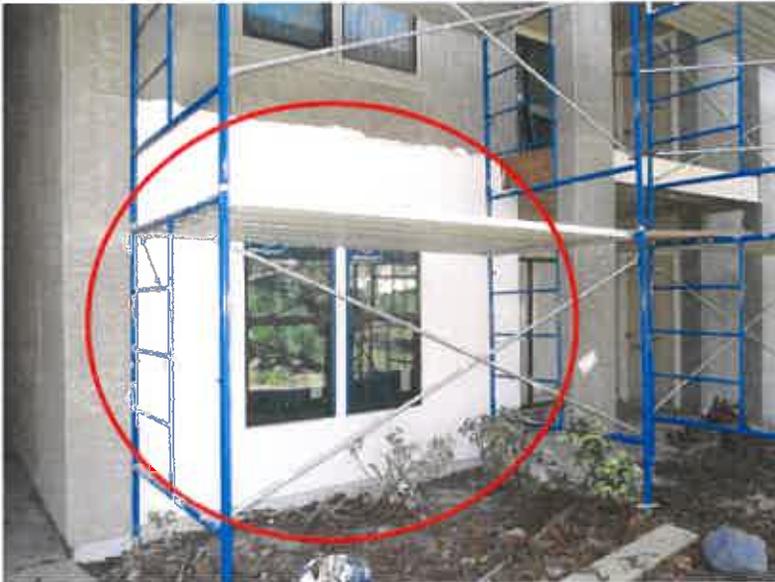
PHOTOGRAPH #2

**BUILDING 14
ELEVATION E**

Contractor has applied specified primer on new stucco mock up area.

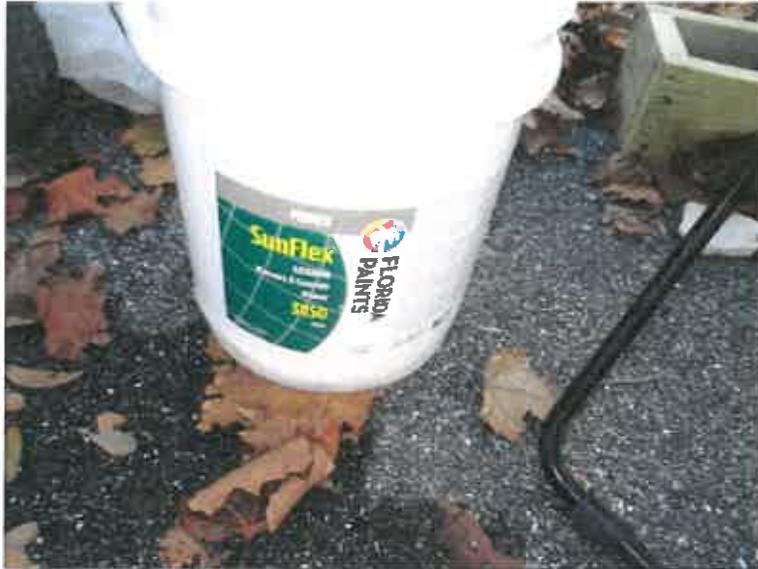
PHOTOGRAPH #3

**BUILDING 14
ELEVATION E**

Contractor has applied specified primer on new stucco mock up area.

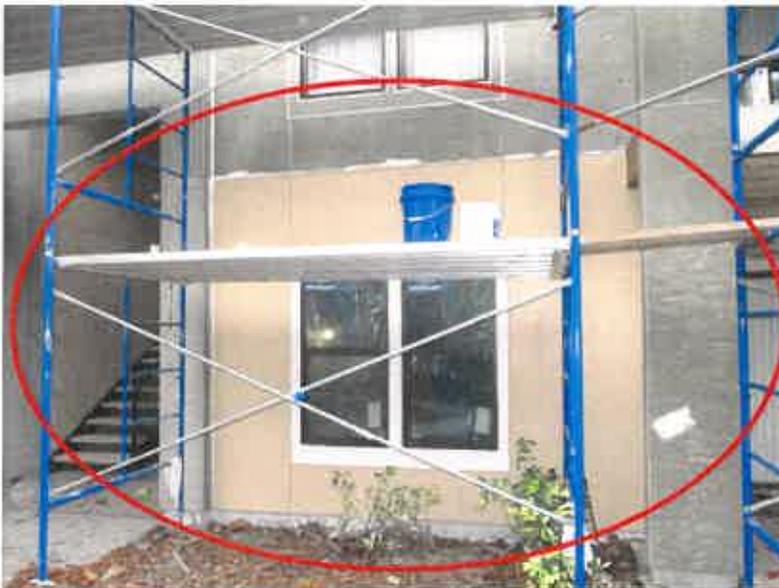
PHOTOGRAPH #4

**BUILDING 14
ELEVATION E**

Contractor has applied specified finish paint on new stucco mock up area.

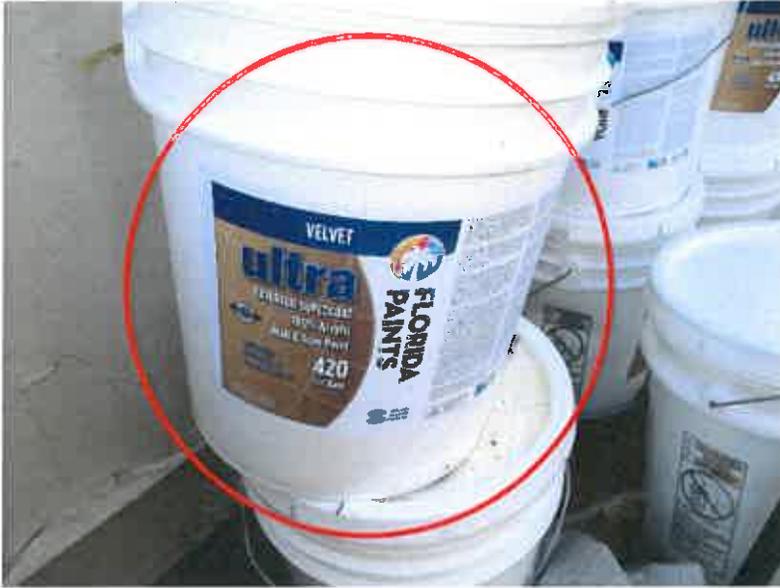
PHOTOGRAPH #5

**BUILDING 14
ELEVATION E**

Contractor has applied specified finish paint on new stucco mock up area.

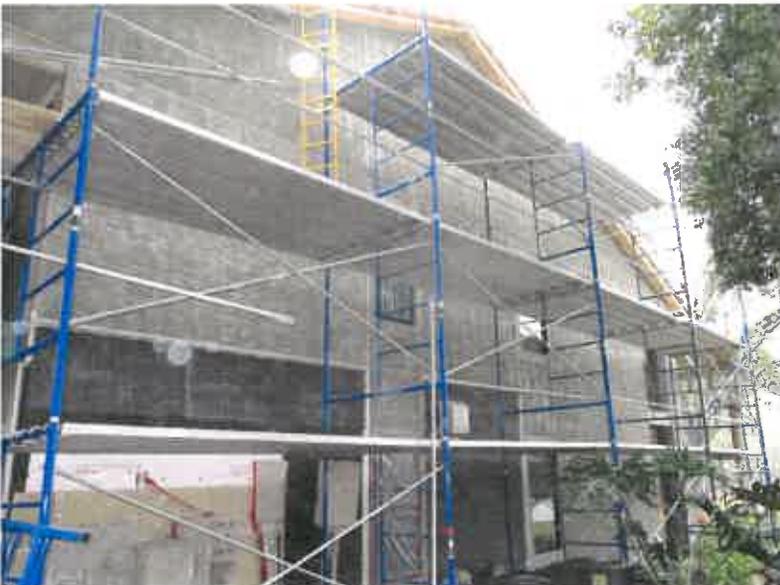
PHOTOGRAPH #6

Elevation	Demo	Gable Bracing	Gable Vents	Framing & Sheathing	Soffit	Window flashing	Window install	Stucco Lath Acc	Stucco	Sealant	Painting	Punch	Comments
A	X	NA	NA	X	X	X	X	X	X				New Stucco to existing stucco termination is too far outboard on the corner balcony. Termination is to occur within the balcony area that will not be seen from the exterior when screen framing is installed.
B	X	NA	NA	X	X	X	X	X	X				Stucco weep screed accessory at foundation is not properly sealed to the sheathing as change order # 6 requires. This location will require re-sealing. Light fixture has been improperly attached directly to the plywood sheathing and stucco has been stopped with a stucco stop accessory. Stucco is required to be continuous behind light fixtures. Contractor will remove and re-do stucco as required.
C	X	X	X	X	X	X	X	X	/				Contractor has applied finish texture stucco to majority of wall. Two sections remain for stucco application (Photograph #6).

**BUILDING 14
ELEVATION C**

Contractor has applied finish texture stucco to majority of wall. Two sections remain for stucco application.

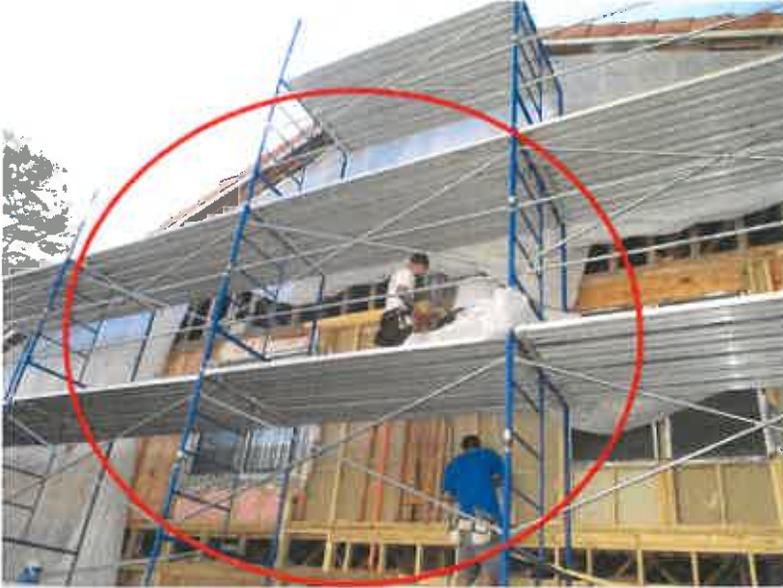
PHOTOGRAPH #7

**BUILDING 25
ELEVATION H**

Contractor is continuing repairs at gable end wall as per specifications and drawings.

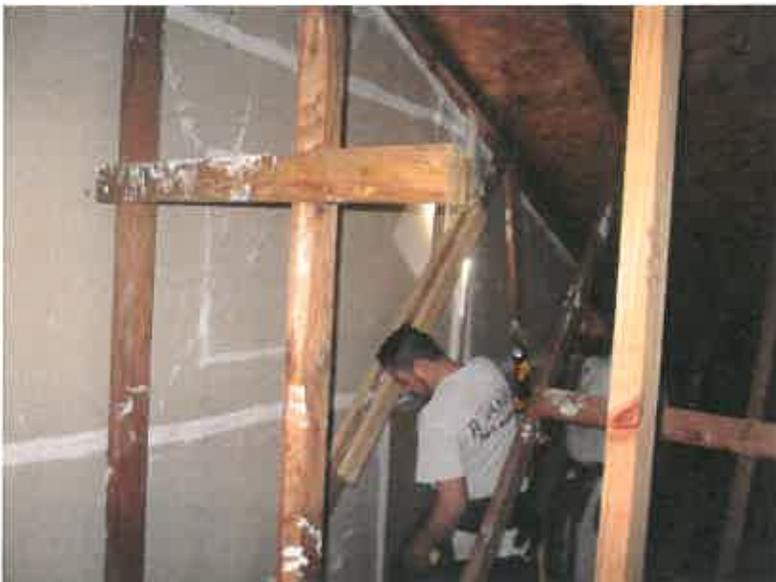
PHOTOGRAPH #8

**BUILDING 25
ELEVATION H**

Contractor performing truss repairs in attic areas as per drawings and specifications.

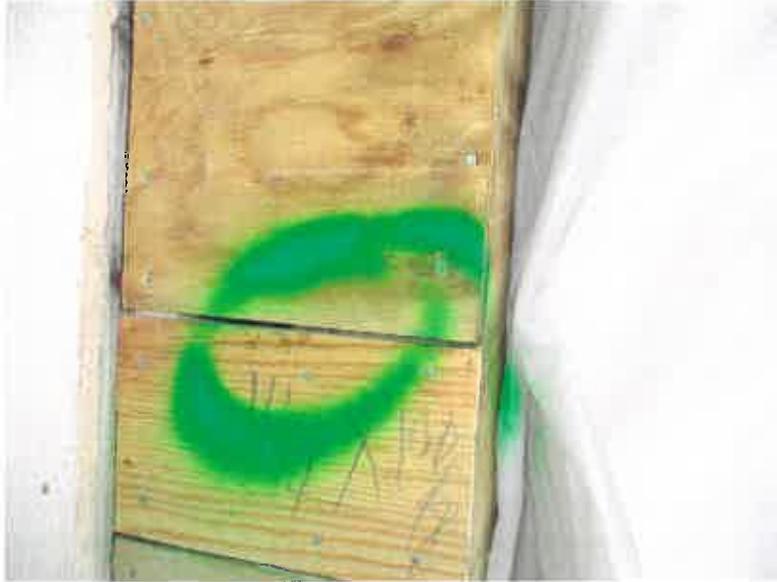
PHOTOGRAPH #9

**BUILDING 25
ELEVATION B**

Gaps between plywood sheathing are too wide at several locations. Contractor will be required to replace with new sheathing or fill seam with sealant prior to application of Tyvek Homewrap.

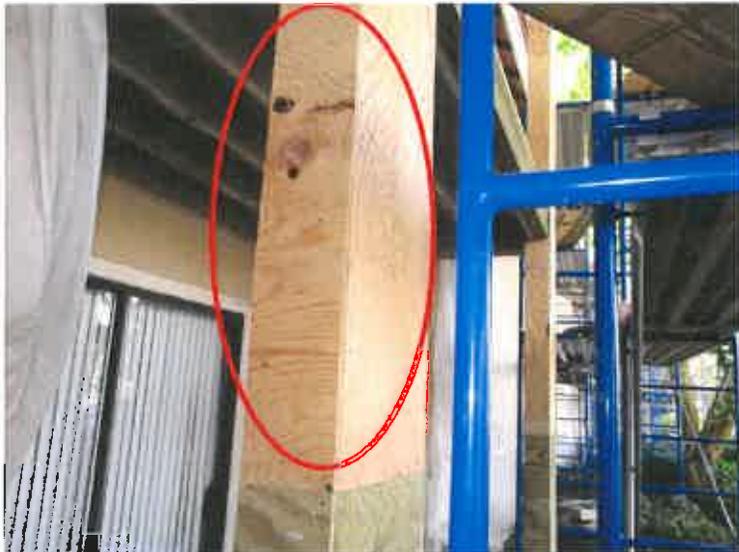
PHOTOGRAPH #10

**BUILDING 25
ELEVATION B**

Plywood sheathing not properly nailed at balcony column will be corrected, re-inspected and approved by Delta prior to application of Tyvek HomeWrap.

- Gaps between plywood sheathing are too wide at several locations. Contractor will be required to replace with new sheathing or fill seam with sealant prior to application of Tyvek HomeWrap (Photograph #8).
- Plywood sheathing not properly nailed at balcony column will be corrected, re-inspected and approved by Delta prior to application of Tyvek HomeWrap (Photograph #10).

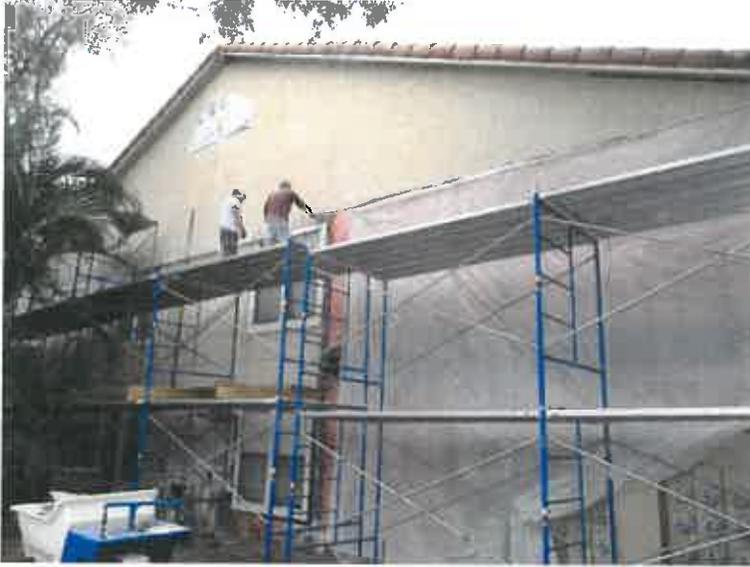
PHOTOGRAPH #11

**BUILDING 25
ELEVATION D**

Contractor has begun demolition at gable end wall.
