FIELD OBSERVATION REPORT - Bldg #14

Permit No. 18-131555-00 BC
 Owner: Vintage Grand Condo Assn, Inc.
 Project Address: 4017 Crookers Lake Blvd., Sarasota, FL
 Contractor: RL James Inc
 Inspector (s): Mark Boss PM / Mike Jones
 Type of Assessment: Progress

Project: R1503-302D
 Contact: Glenn Atelli
 Phone/Fax: (941) 923-7380
 Contact: Craig Nicholas / Robert Branscombe
 Phone: (941) 232-6486 / (239) 379-1978

PHOTOGRAPHS

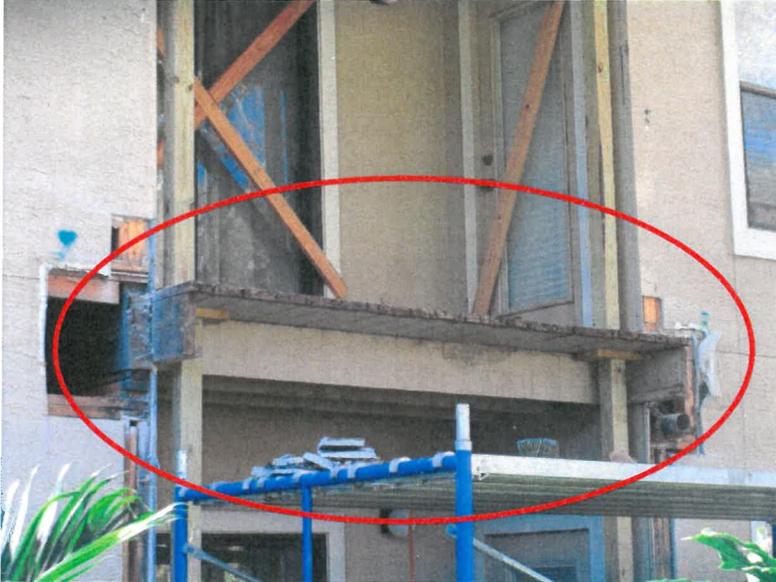
PHOTOGRAPH #1

BUILDING 13 UNIT # 1324

Contractor has removed rails and deteriorated build up beam, exposing areas of repair required as per drawings and specifications.

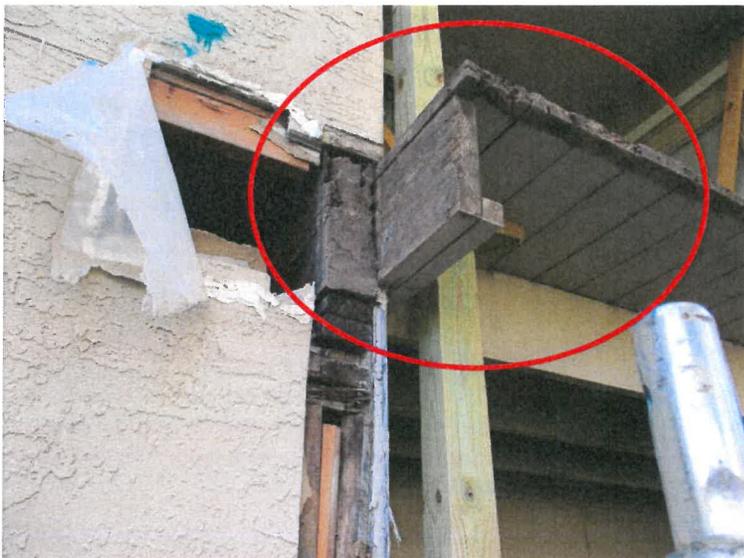
PHOTOGRAPH #2

BUILDING 13 UNIT # 1324

Contractor has removed rails and deteriorated build up beam, exposing areas of repair required as per drawings and specifications.

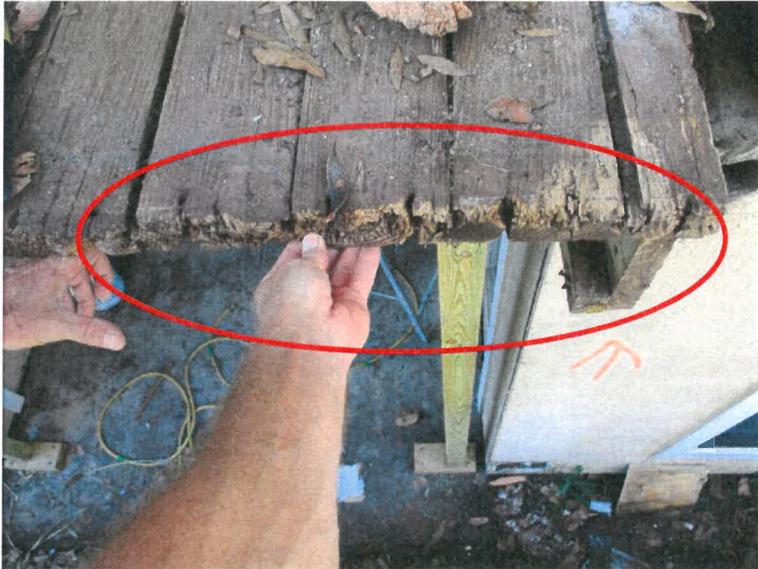
PHOTOGRAPH #3

**BUILDING 13
UNIT # 1324**

Balcony tong and groove deck boards will be replaced due to deteriorated condition.

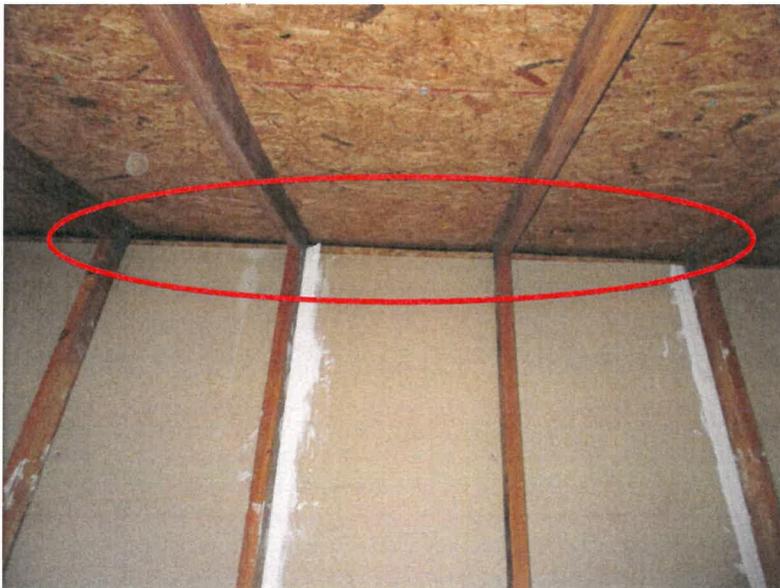
PHOTOGRAPH #4

**BUILDING 4
ATTIC REPAIRS UNIT #423**

Fire wall does not meet roof sheathing at top of wall. Contractor will be required to make fire wall repairs at this location.

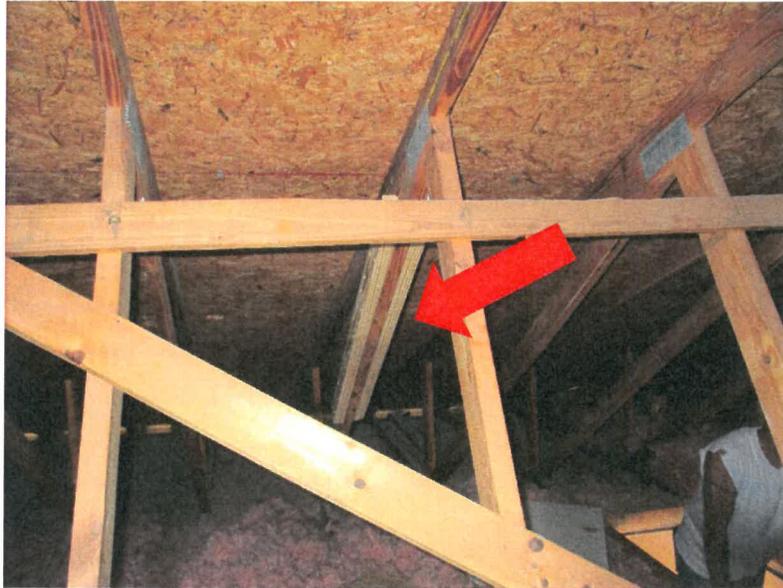
PHOTOGRAPH #5

**BUILDING 4
ATTIC REPAIRS UNIT #423**

Contractor has made repairs to broken truss members as per repair details and drawings. Delta is verifying repairs and quantities.

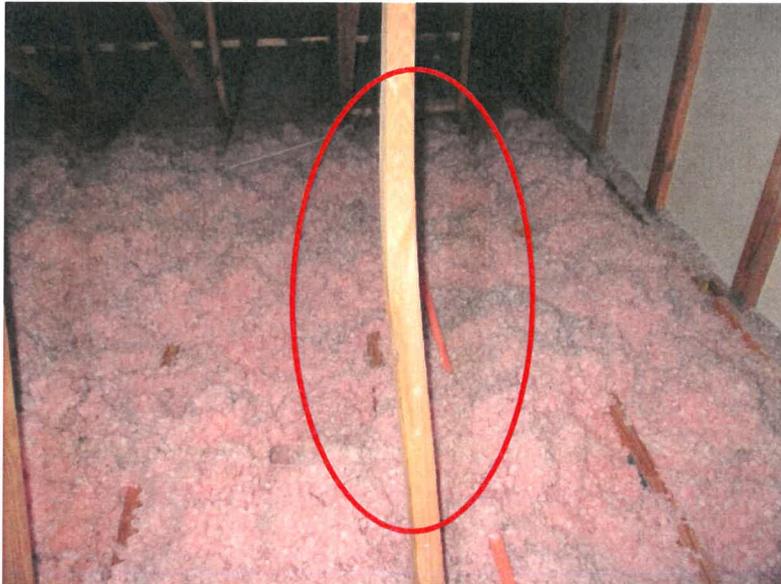
PHOTOGRAPH #6

**BUILDING 4
ATTIC REPAIRS UNIT #424**

Contractor will make repairs to deflected truss member as per BCSI-B3 standards.

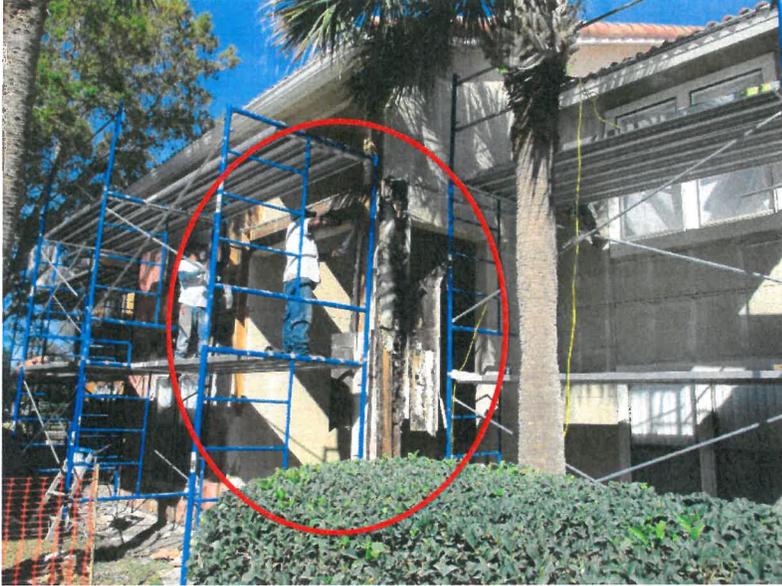
PHOTOGRAPH #7

**BUILDING 25
BREEZWAY ELEVATION E**

Contractor has removed old stucco and thermo-ply, exposing deterioration and collapse of framing. Delta has inspected and marked for repairs.

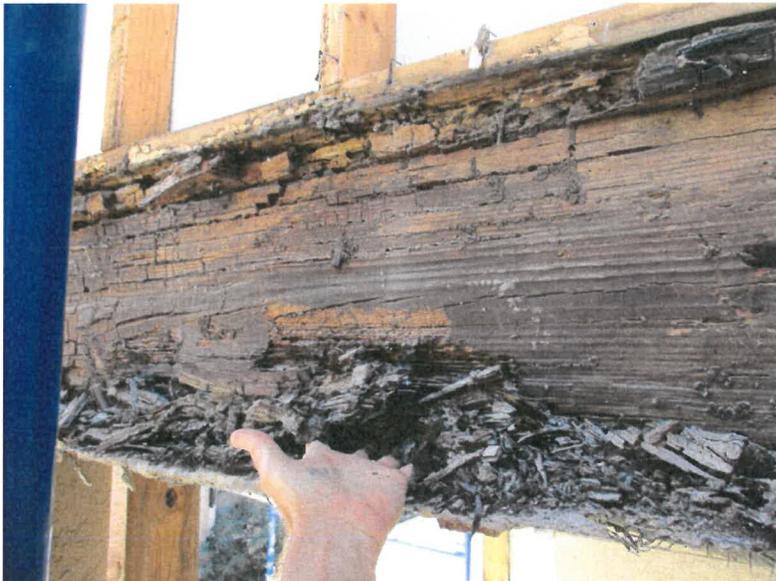
PHOTOGRAPH #8

**BUILDING 25
BREEZWAY ELEVATION E**

Contractor has removed old stucco and thermo-ply, exposing deterioration and collapse of framing. Delta has inspected and marked for repairs.

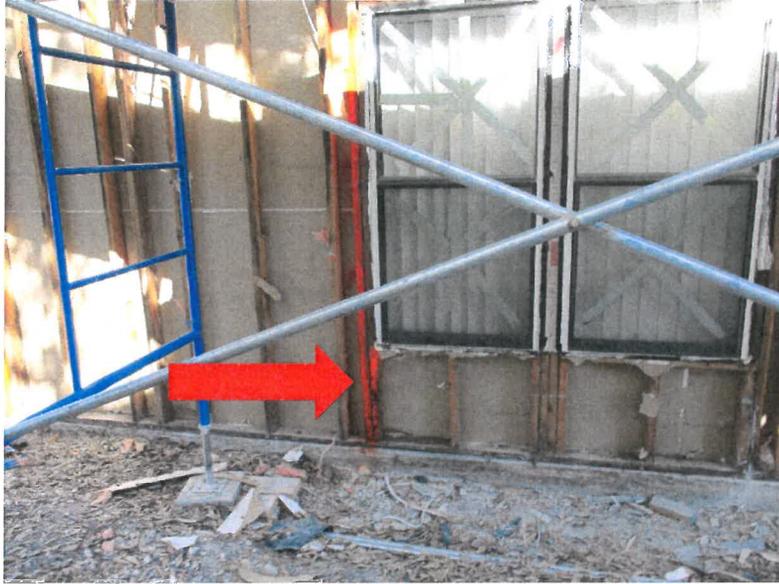
PHOTOGRAPH #9

**BUILDING 25
ELEVATION E**

Contractor has removed old stucco and thermo-ply, exposing deteriorated framing Delta has inspected and marked for repairs.

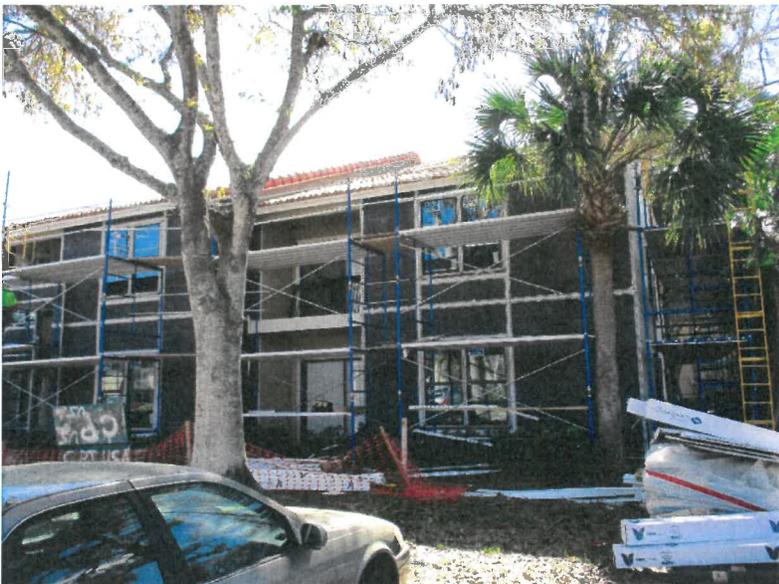
PHOTOGRAPH #10

**BUILDING 25
ELEVATION C**

Sub-contractor has installed new PVC accessories and lath per specifications and drawings.

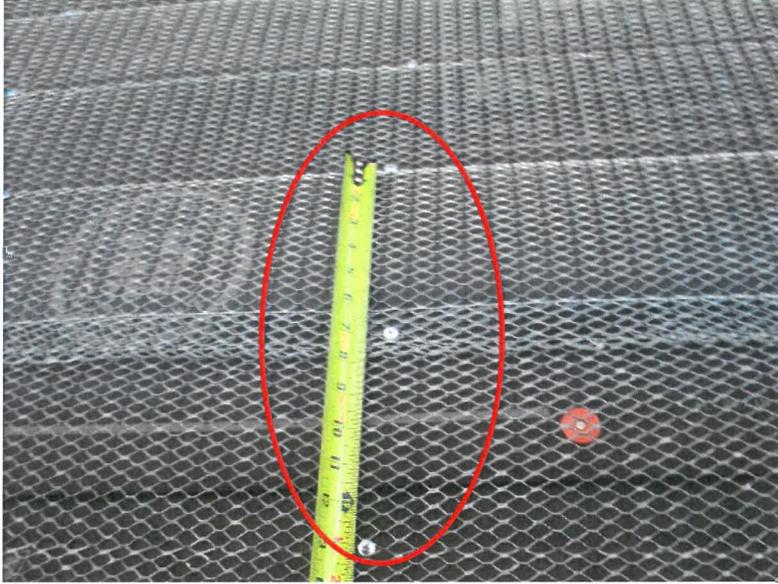
PHOTOGRAPH #11

**BUILDING 25
ELEVATION C**

Sub-contractor has installed new PVC accessories and lath per specifications and drawings. New fasteners meet distance minimums and lath over lapping is as per specifications.

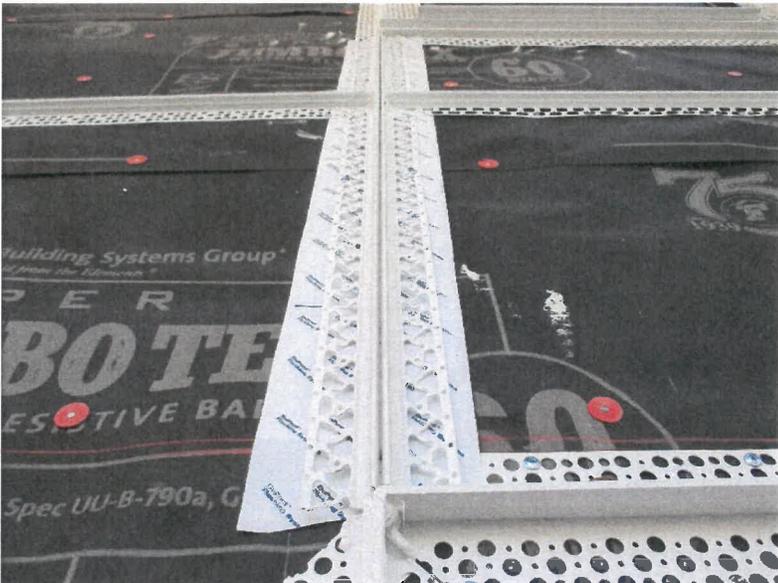
PHOTOGRAPH #12

**BUILDING 25
ELEVATION A**

Sub-contractor has installed vertical 6" self-adhering straight – flash at vertical control joints as per drawings.
