**FIELD OBSERVATION REPORT - Bldg #4**

Permit No. 1815874700BR  
 Owner: Village Grand Condo Assn, Inc.  
 Project Address: 4017 Crookers Lake Blvd., Sarasota, FL  
 Contractor: RL James Inc  
 Inspector (s): Mark Boss PM  
 Type of Assessment: Progress

Project: R1503-302D  
 Contact: Glenn Ateili  
 Phone/Fax: (941) 923-7380  
 Contact: Craig Nicholas / Robert Branscombe  
 Phone: (941)232-6466 / (239) 379-1978

PROJECT NAME  
 WOOD FRAME REPAIRS & RELATED WORK  
 (PHASE II)  
 VINTAGE GRANDE CONDOMINIUM  
 ASSOCIATION, INC.  
 4012 CROCKERS LAKE BLVD.,  
 SARASOTA, FL 34238

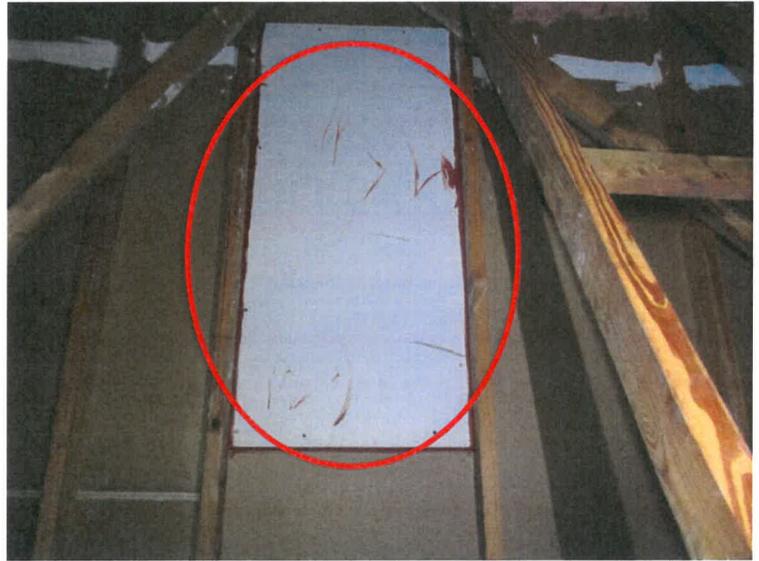
PHOTOGRAPH #1

Unit	Demo	Truss Repairs	Fire Wall Repairs	Punch	Comments
421	X	X	X	X	Contractor used 3m fire protectant foam in place of fire caulk as required. Corrections have been made by contractor.
422	X	X	X	X	Contractor has provided 5/8" Type X fire rated gypsum board at access hole through fire walls. (Photograph #1)
423	/	/	/	/	Contractors made truss repairs. This defective truss was added for repairs.
424	X	X	X	X	
425	/	/	/	/	
426	/	/	/	/	
427	/	/	/	/	
428	/	/	/	/

**BUILDING 4**  
**UNIT #422 ATTIC**  
Contractor has provided 5/8" Type X fire rated gypsum board as at access hole through fire walls.

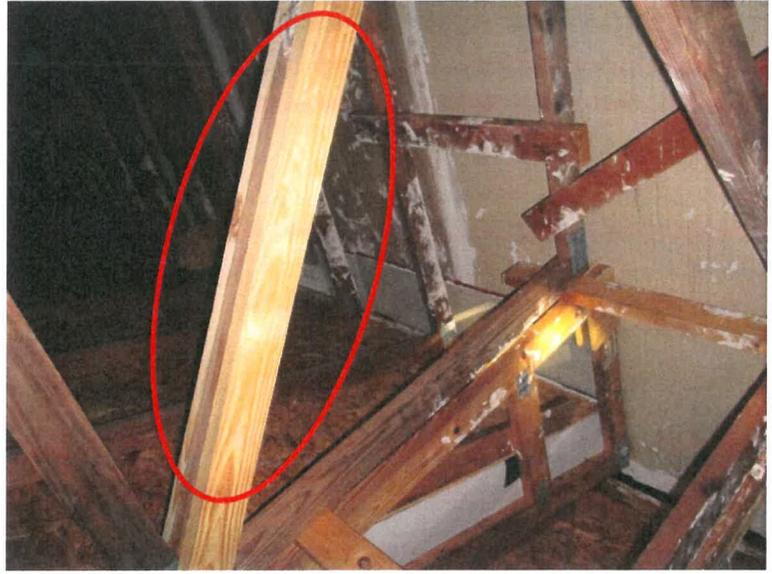
PHOTOGRAPH #2

Unit	Demo	Truss Repairs	Fire Wall Repairs	Punch	Comments
1721	X	X	X	X	Contractors made truss repairs. This gusset repair was added.
1722	/	/	/		
1723	X	X	X	X	Contractor has provided truss scab repairs at damaged truss (Photograph #2).
1724	X	X	X	X	Contractor has provided truss scab repairs at damaged truss (Photograph #4).
1725	/	/	/		
1726	X	X	X	X	Contractors made truss repairs. This broken truss was added for repairs.
1727	X	X	X	X	Contractor has provided truss scab repairs at damaged truss (Photograph #3).
1728	/	/	/

**BUILDING 17**  
**UNIT #1723 ATTIC**  
Contractor has provided truss scab repairs at damaged truss.

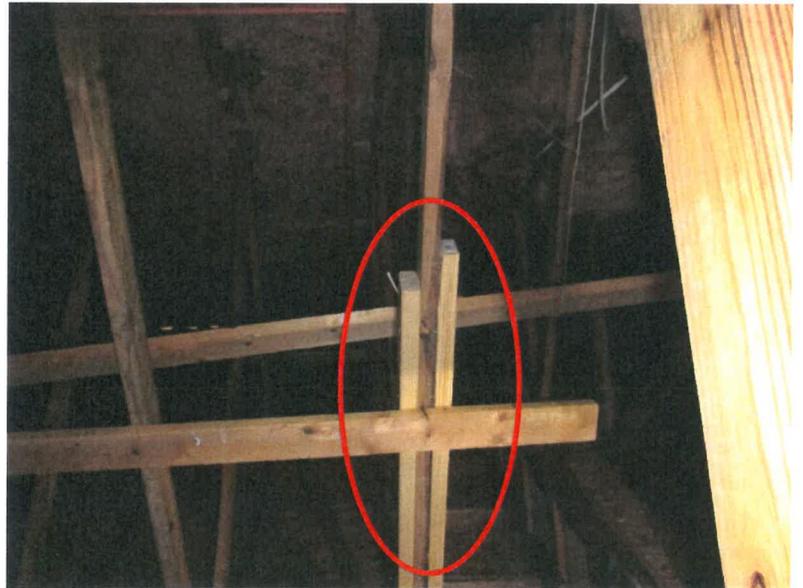
PHOTOGRAPH #3

Contractor has provided truss scab repairs at damaged truss.

**BUILDING 17  
UNIT #1727 ATTIC**

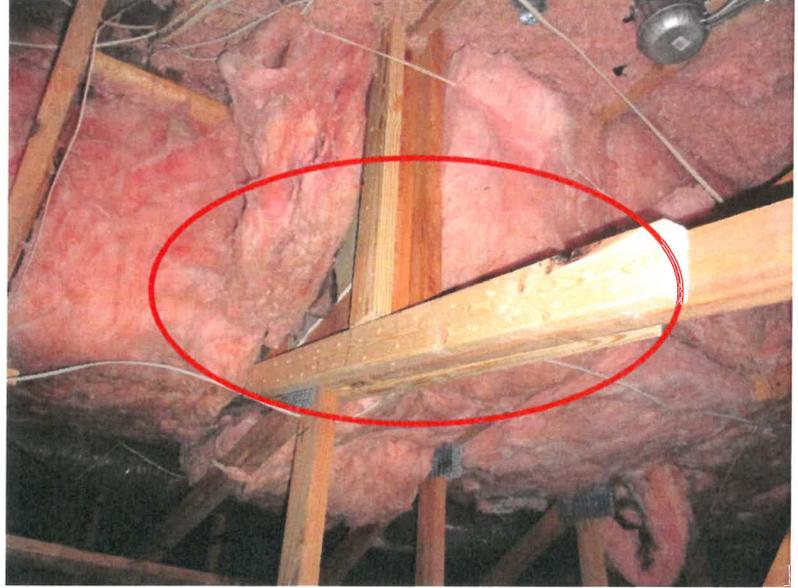
PHOTOGRAPH #4

Contractor has provided truss scab repairs at damaged truss.

**BUILDING 17  
UNIT #1724 ATTIC**

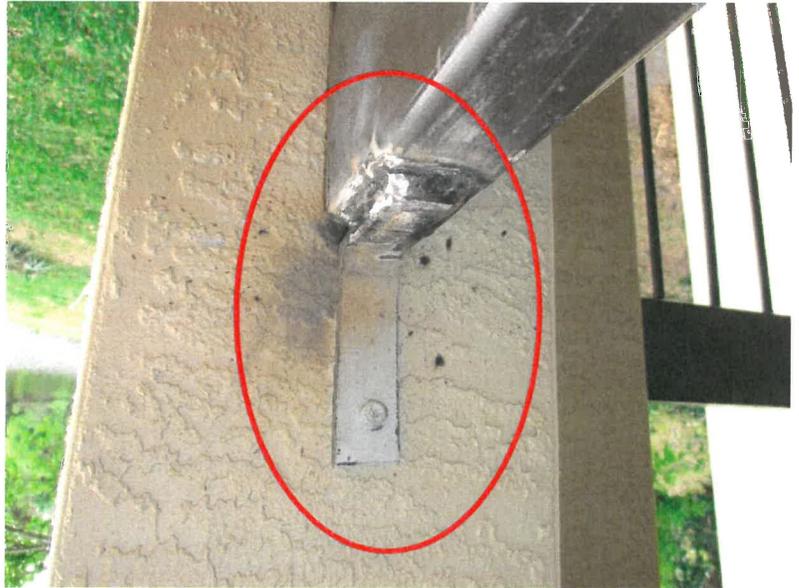
PHOTOGRAPH #5

Balcony top railing attachments have been adjusted to fit, welded to top rails as previously attached and bolted to walls with new fasteners.

**BUILDING 14  
SECTION B**

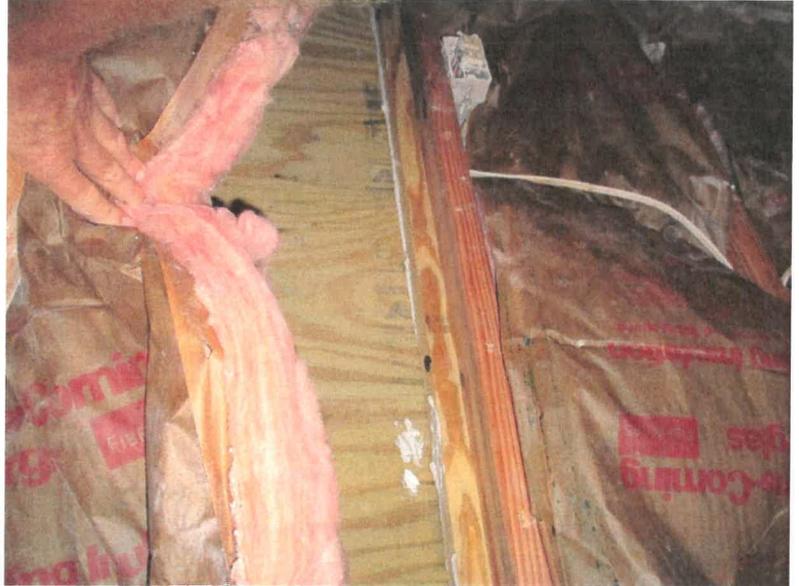
PHOTOGRAPH #6

Contractor has performed repairs at internal wall, attaching new exterior sheathing to wall studs. Reference ESI #6, detail drawing.

**BUILDING 14  
UNIT #1413**

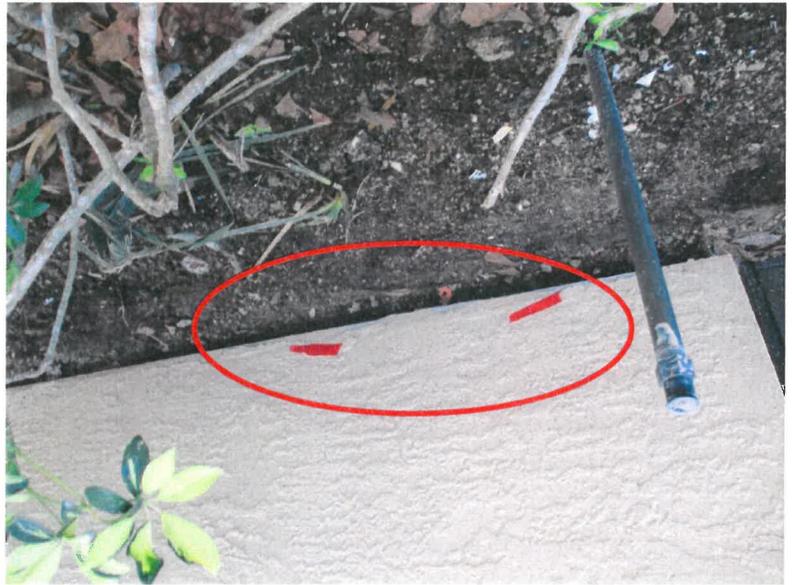
PHOTOGRAPH #7

Delta performed final punch walk through with contractor and on-site manager. Punch items were marked to be addressed. Delta will provide punch list and verify completion of punch items.

**BUILDING 14  
SECTION F**

1. Delta performed final punch walk through with Contractor and on-site manager. Punch items were marked to be addressed. Delta will provide punch list and verify completion of punch items (Photograph #7).

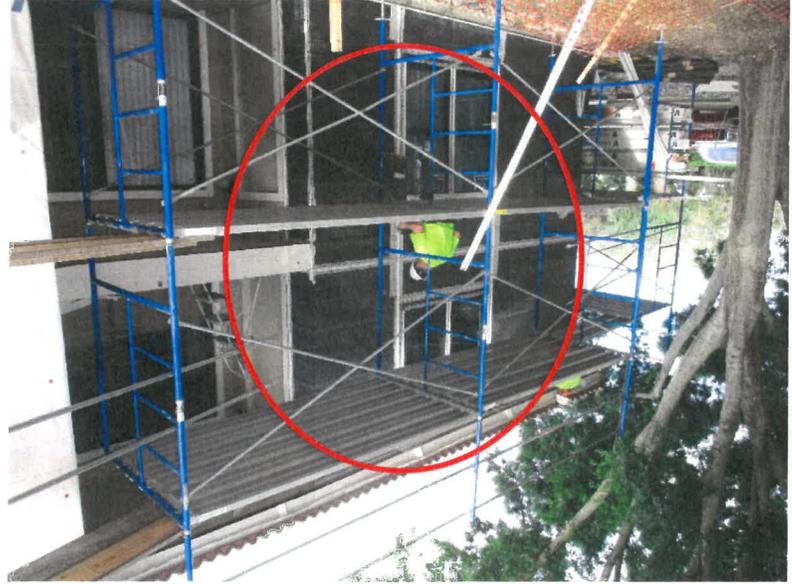
PHOTOGRAPH #8

Stucco sub-contractor has started stucco accessories application.

**BUILDING 25  
SECTION E**

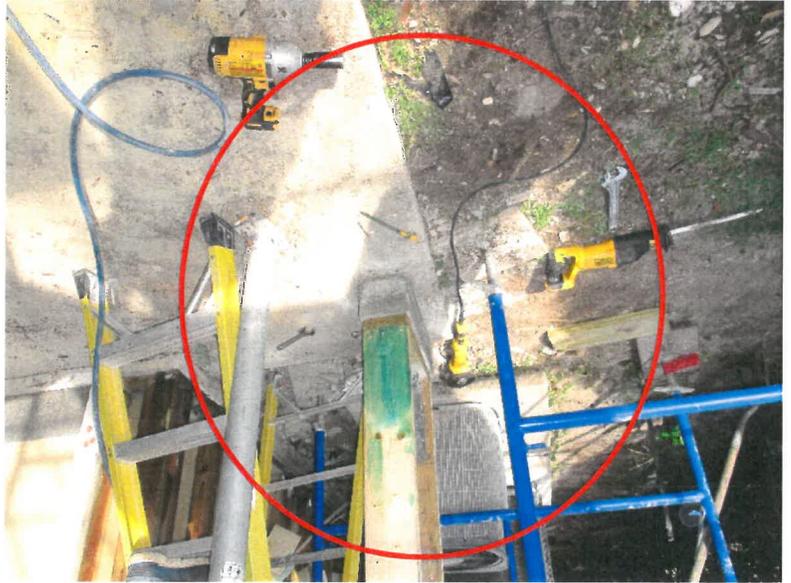
PHOTOGRAPH #9

Contractor has provided new concrete pedestals, column framing and wood preservative at balcony Type C1A.

**BUILDING 25  
SECTION F**

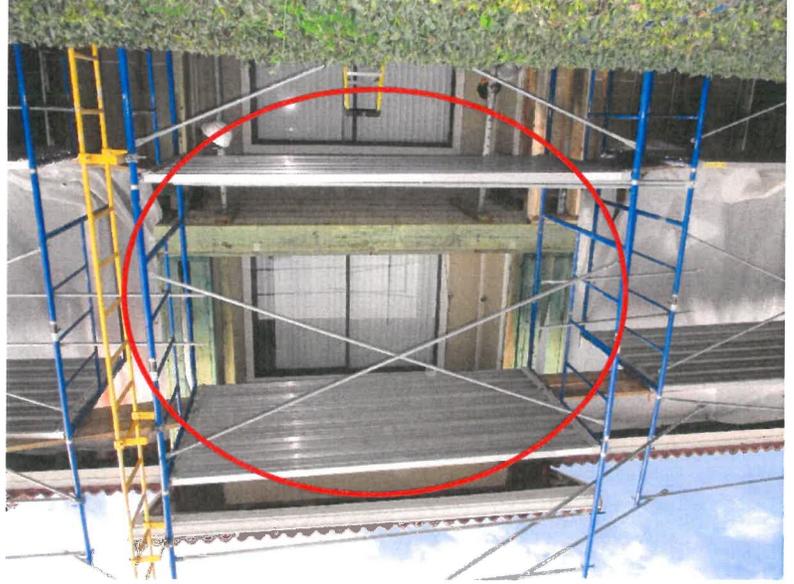
PHOTOGRAPH #10

Contractor has re-framed and installed strapping connectors at balcony C1A.

**BUILDING 25  
SECTION F**

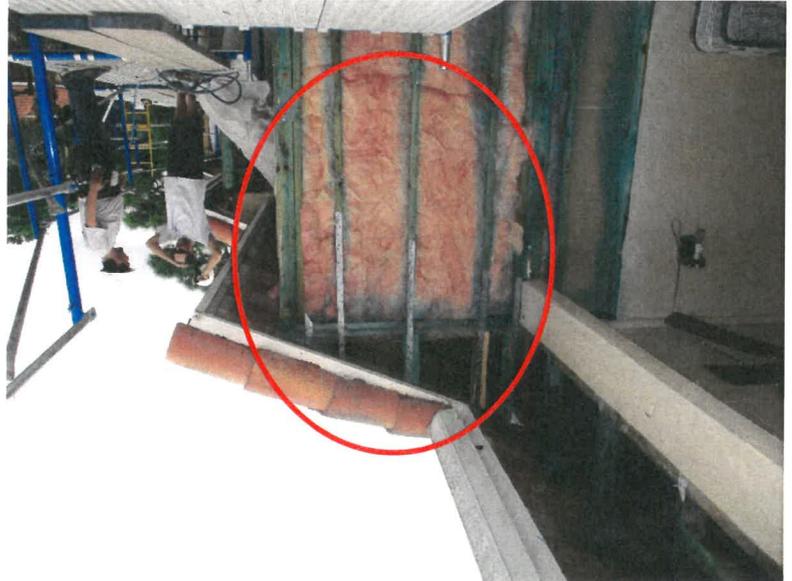
PHOTOGRAPH #11

Contractors has provided strapping  
connectors and termite treatment.

**BUILDING 25  
SECTION F**

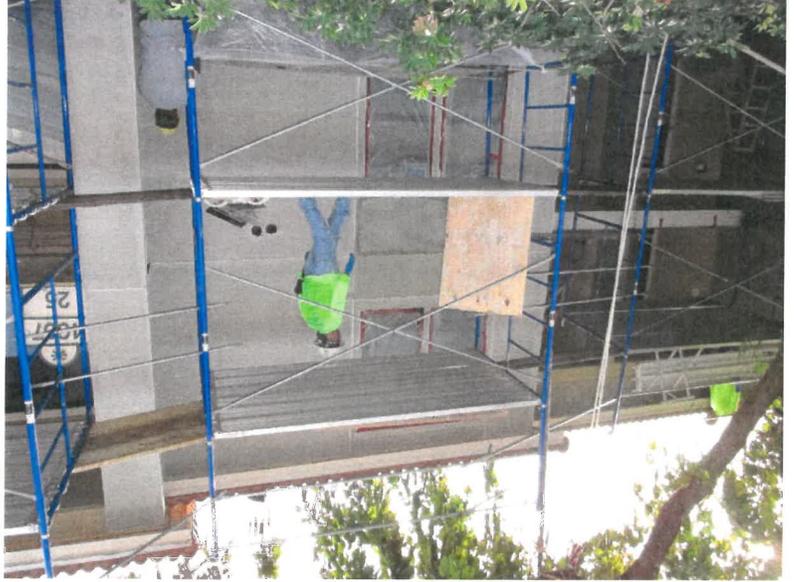
PHOTOGRAPH #12

Stucco contractor has applied scratch and  
brown coats of stucco.

**BUILDING 25  
SECTION B**

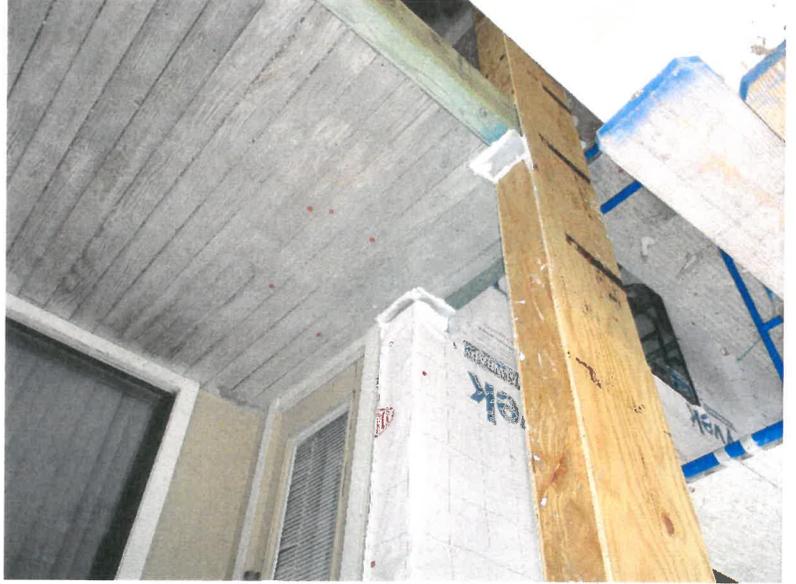
PHOTOGRAPH #13

Contractor has installed new flashing at balconies.

**BUILDING 25  
SECTION F**

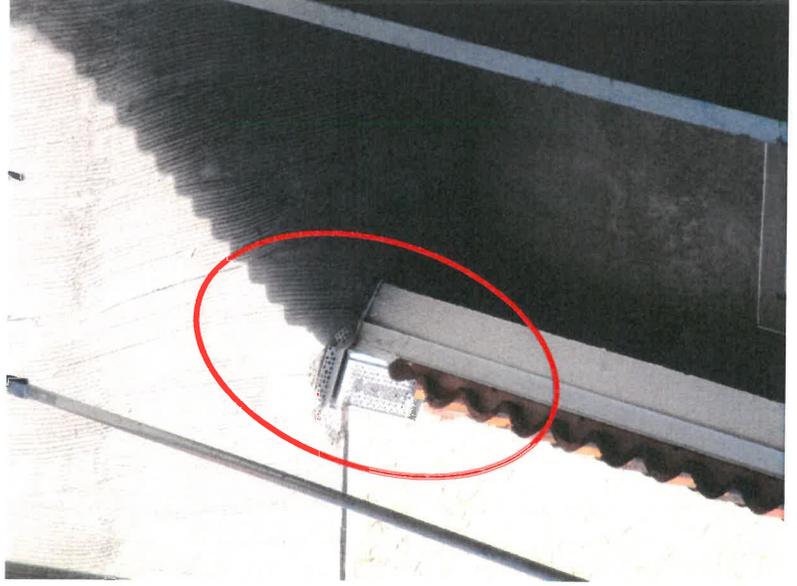
PHOTOGRAPH #14

Contractor has corrected new kick-out flashing at roof to wall intersections in preparation for new stucco.

**BUILDING 25  
SECTION B**

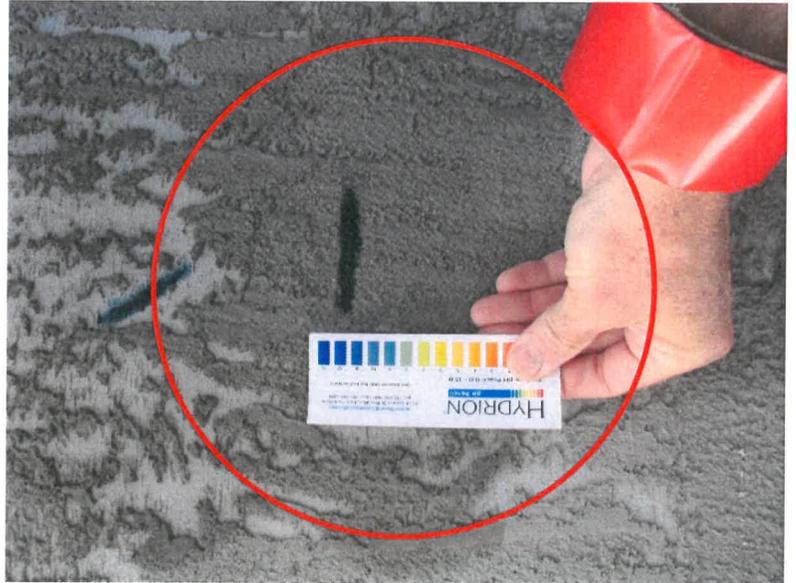
PHOTOGRAPH #15

Delta has performed PH testing of new stucco in preparation for primer application.

**BUILDING 25  
SECTION H**

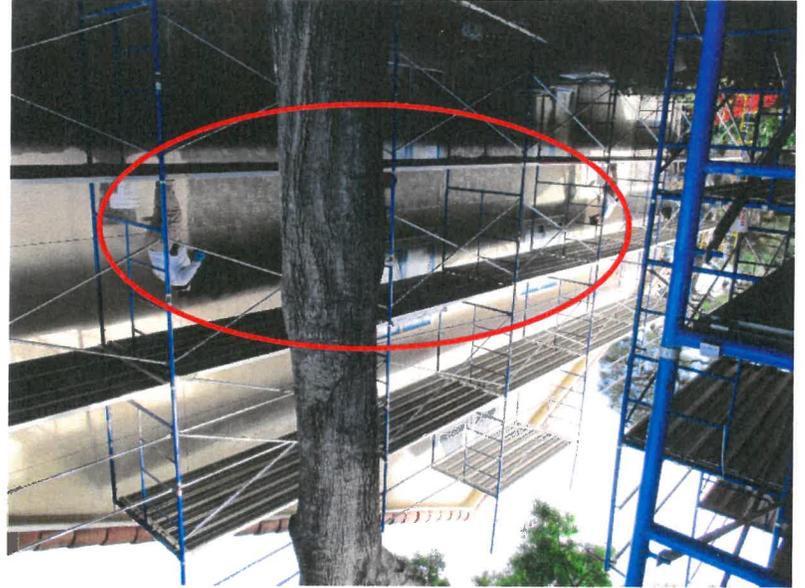
PHOTOGRAPH #16

Contractor has begun application of primer with specified Florida Paints primer.

**BUILDING 25  
SECTION H**

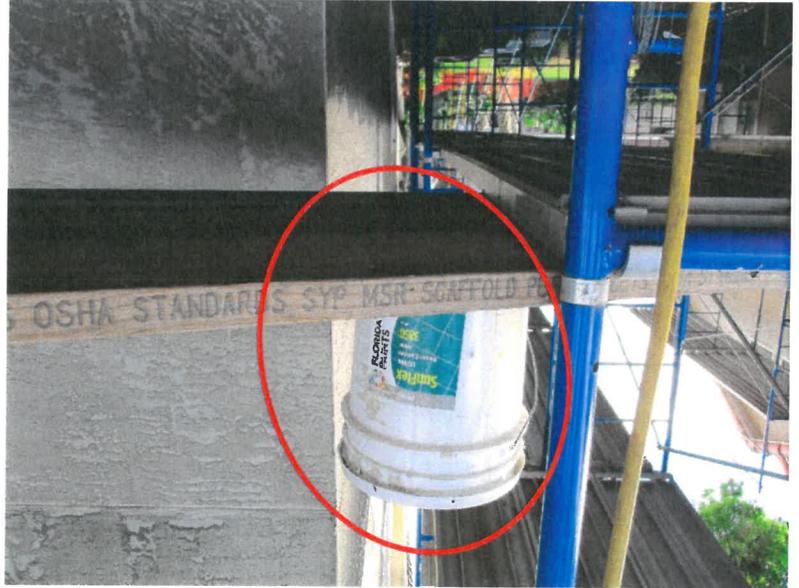
PHOTOGRAPH #17

Contractor has begun application of primer with specified Florida Paints

**SECTION H  
BUILDING 25**

primer.

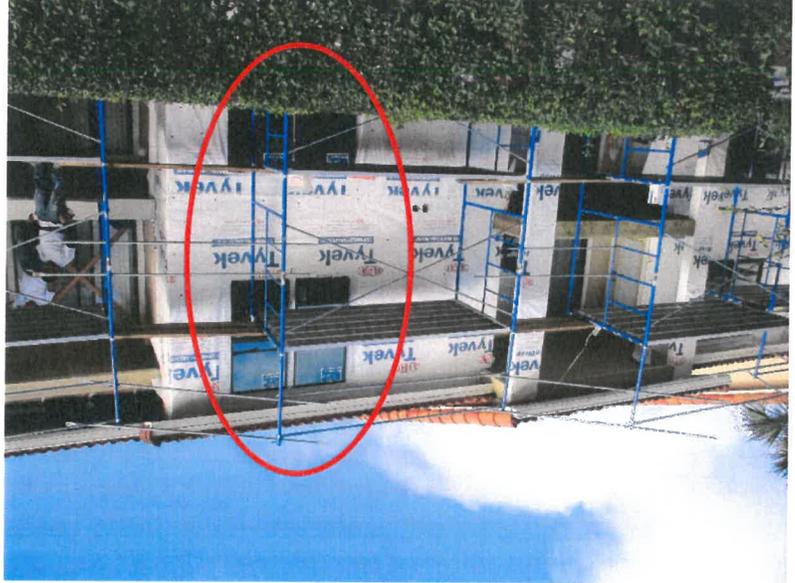
PHOTOGRAPH #18

Contractor has begun installation of new windows.

**SECTION F  
BUILDING 25**
