**FIELD OBSERVATION REPORT - Bldg. #25**

Permit No. 18-146012-00 BC  
Owner: Vintage Grand Condo Assn, Inc.  
Project Address: 4017 Crockers Lake Blvd., Sarasota, FL  
Contractor: RL James Inc  
Inspector (s): Mark Boss  
Type of Assessment: Progress

Project: R1503-302D  
Contact: Glenn Atell  
(941) 923-7380  
Contact: Craig Nicholas / Robert Branscombe  
Phone: (941)232-6486 / (239) 379-1978

PROJECT NAME:  
WOOD FRAME REPAIRS & RELATED WORK  
(PHASE II)  
VINTAGE GRANDE CONDOMINIUM  
ASSOCIATION, INC.  
4012 CROCKERS LAKE BLVD.,  
SARASOTA, FL 34238

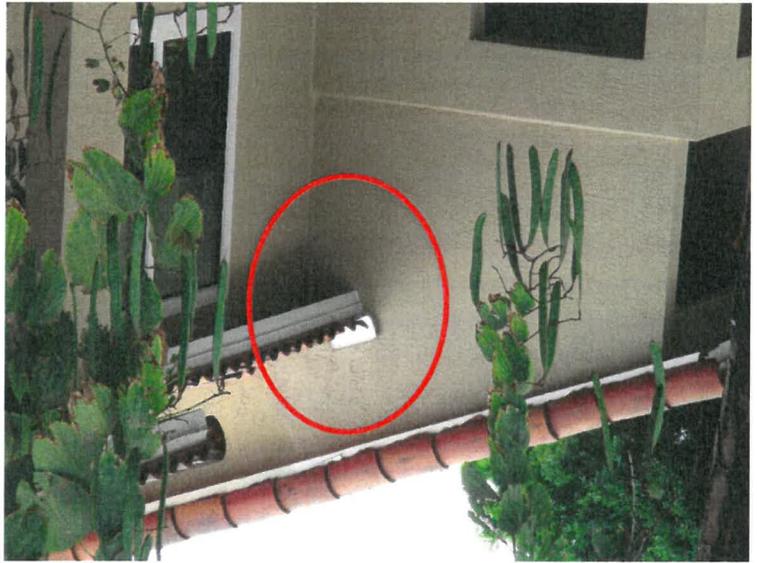
PHOTOGRAPH #1

Kick out flashing at roof has not been completed with lath and stucco details.

**BUILDING 25  
SECTION B**

- Contractor will complete kick out flashing detail as per drawings with lath and stucco applied (Photograph #1).
- Unit #2512 - Contractor will provide sealant at interior of window perimeter as per manufacturer instructions (Photographs #2).

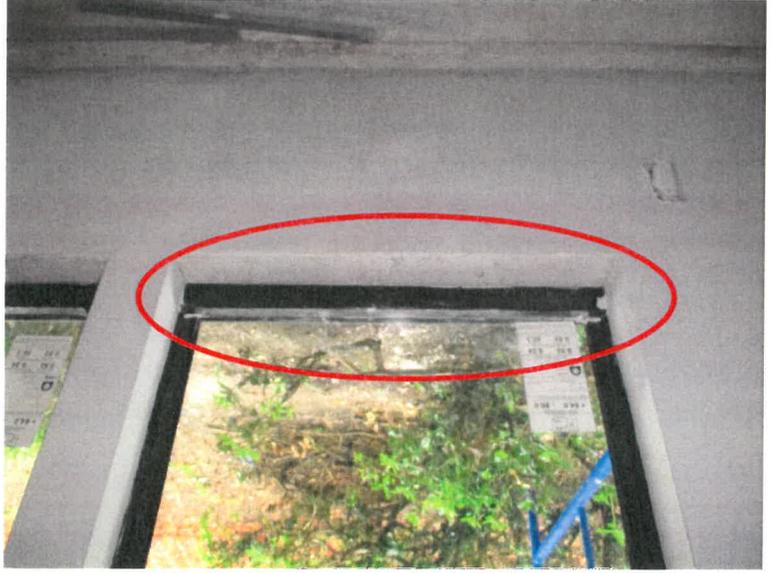
PHOTOGRAPH #2

G	X	NA	NA	X	X	/	X	X	/					
H	X	X	X	X	X	X	X	X	X	X	X	/		Soil at grade has not been removed to provide 6 inches from top of grade to bottom of stucco and slope grade 2% to provide positive drainage. Unit #2512 - Contractor has not provided interior sealant at new window perimeter (Photograph #2).

Contractor has not provided interior sealant at new window perimeter.

**BUILDING 14  
UNIT # 2512**

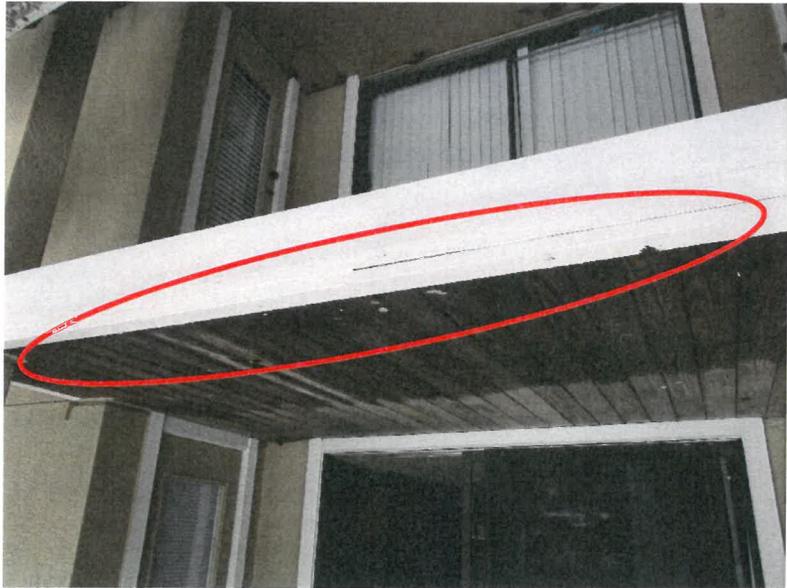
PHOTOGRAPH #3

Contractor has replaced top 2"X 4" with continuous PT board at built up beam as per drawings.

**BUILDING 25  
UNIT #2525**

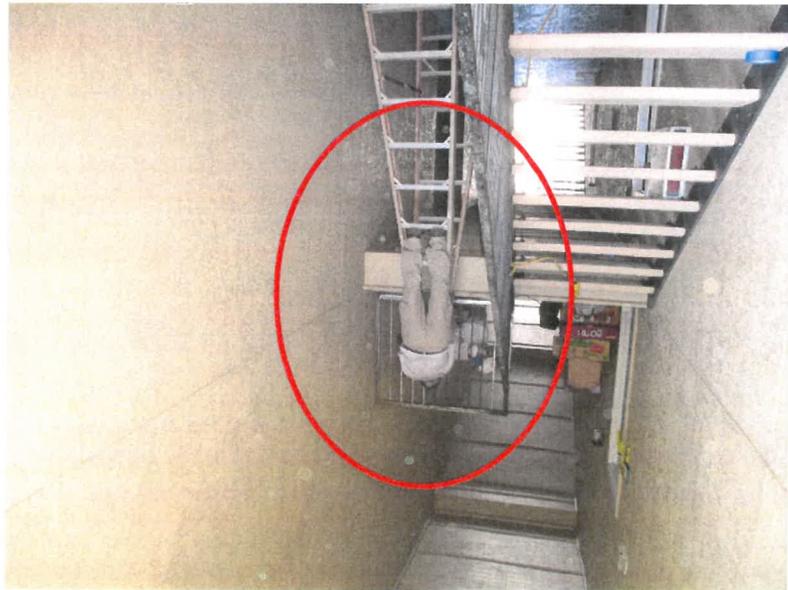
PHOTOGRAPH #4

Contractor has begun surface preparation at steel handrails by removing loose paint and rusty surface.

**BUILDING 25  
SECTION E -BREEZWAY**

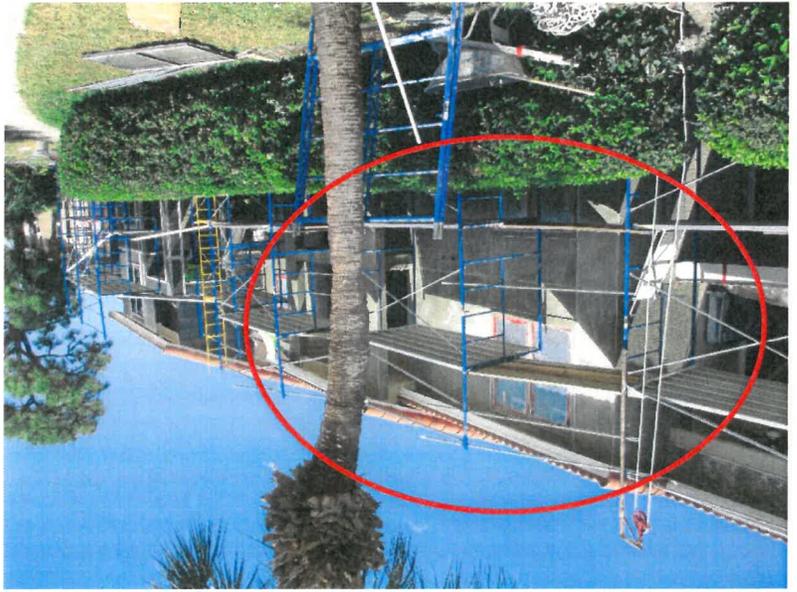
PHOTOGRAPH #5

Stucco sub – contractor is in process of applying brown coats and texture coats of stucco.

**BUILDING 25  
SECTION F**

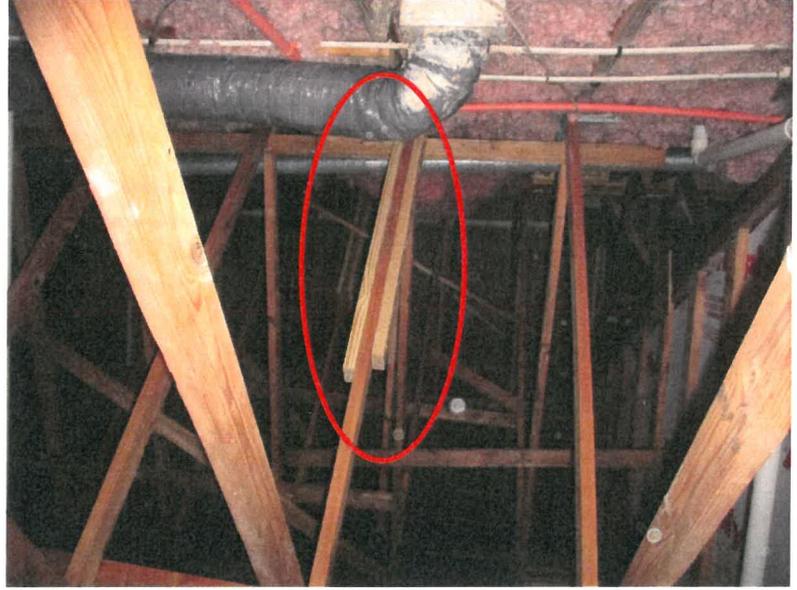
PHOTOGRAPH #6

Contractor has provided scab repairs at damaged truss.

**BUILDING 19  
UNIT #1928 ATTIC**

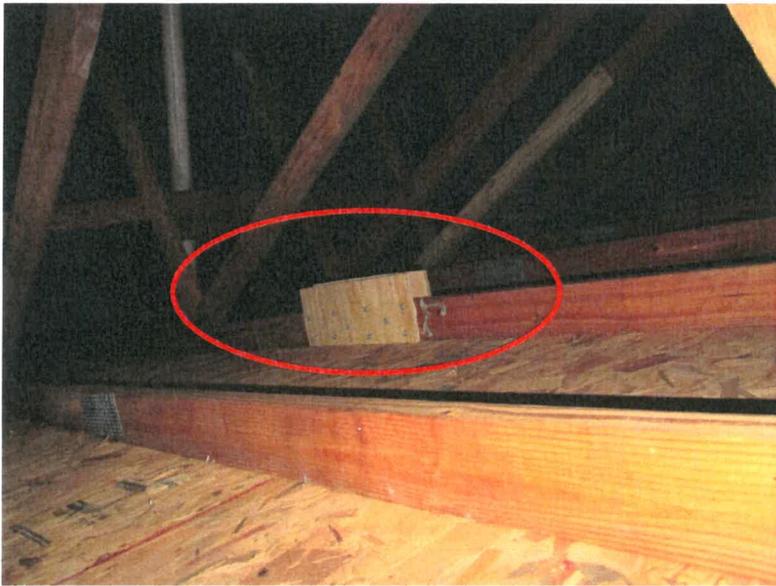
PHOTOGRAPH #7

Contractor has provided gusset repairs at truss connections where connectors are damaged or not engaged.

**BUILDING 19**  
**UNIT #1927 ATTIC**

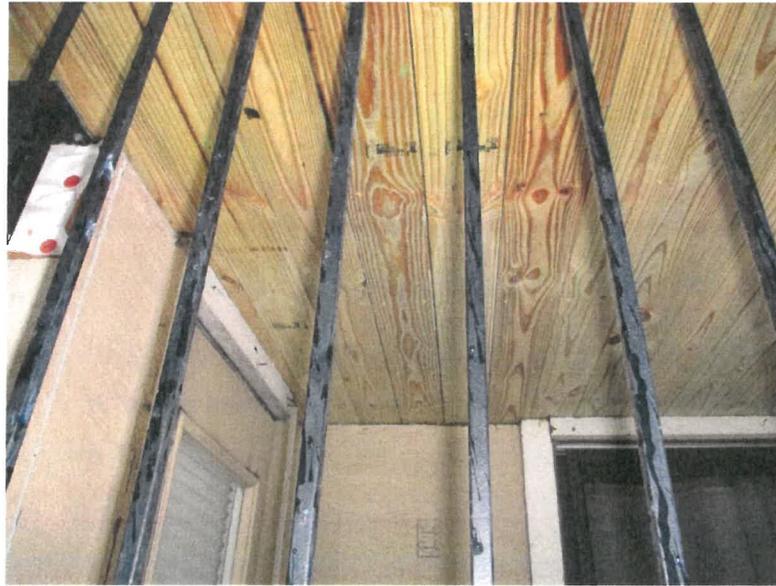
PHOTOGRAPH #8

Contractor has provided new 2"x6" pressure treated boards at deck.

**BUILDING 13**  
**UNIT #1324 BALCONY**

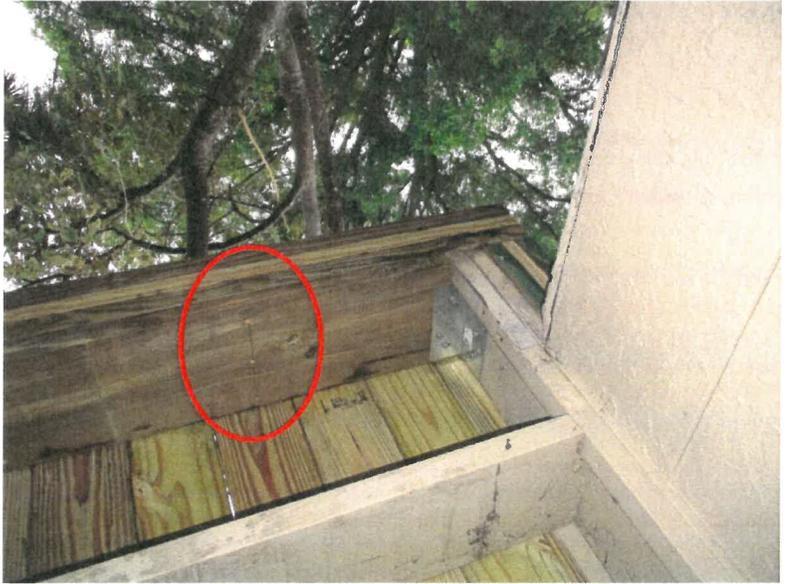
PHOTOGRAPH #9

Unit	Demo	Framing & Shapping	Sheathing	Stucco	Sealant	Painting	Punch	Comments
1324	X	/						Contractor has not provided proper screws at built up beam (Photograph #9). Contractor has provided new 2"x6" pressure treated boards at deck (Photograph #8).

**BUILDING 13**  
**UNIT #1324 BALCONY**  
Contractor has not provided proper screws at built up beam.

- Contractor is required to provide (2) rows Simpson #SDW22488 screws @ 12" C/C as per drawings (Photograph #9).

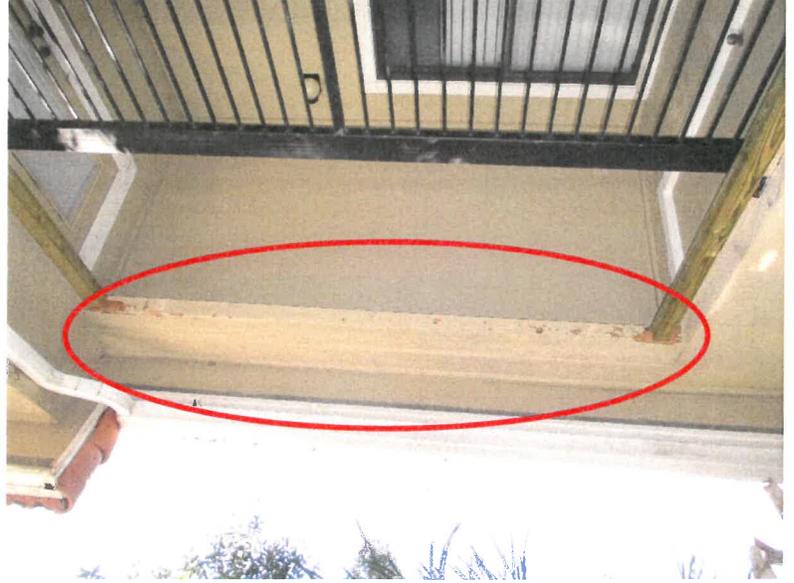
PHOTOGRAPH #10

Unit	Demo	Framing & strapping	Sheathing	Stucco	Sealant	Painting	Punch	Comments
727	X	/						Cedar header beam is damaged and will be required to be replaced (Photograph #10).

**BUILDING 7**  
**UNIT #727**  
Cedar header beam is damaged and will be required to be replaced.
