FIELD OBSERVATION REPORT - Bldg. #14

Permit No: 18-131555-00 BC
Owner: Vintage Grand Condo Assn, Inc.
Project Address: 4017 Crookers Lake Blvd., Sarasota, FL
Contractor: RL James Inc
Inspector (s): Mark Boss PM
Type of Assessment: Progress

Project: R1503-302D
Contact: Glenn Atwill
Phone/Fax: (941) 923-7380
Contact: Craig Nicholas / Robert Branscombe
Phone: (941)232-6486 / (239) 379-1978

PROJECT NAME:
 WOOD FRAME REPAIRS & RELATED WORK (PHASE II)
 VINTAGE GRANDE CONDOMINIUM ASSOCIATION, INC.
 4012 CROCKERS LAKE BLVD., SARASOTA, FL 34238

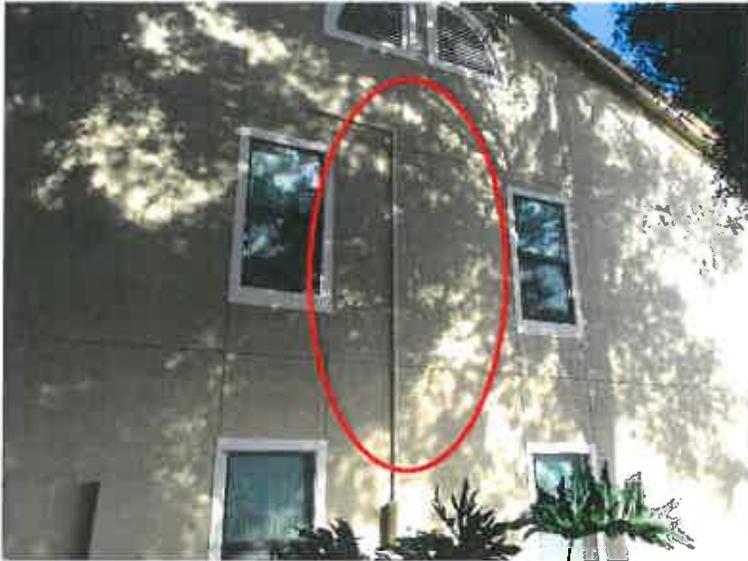
PHOTOGRAPH #1

**BUILDING 14
SECTION C**

Contractor has provided cover for electric wires and painted.

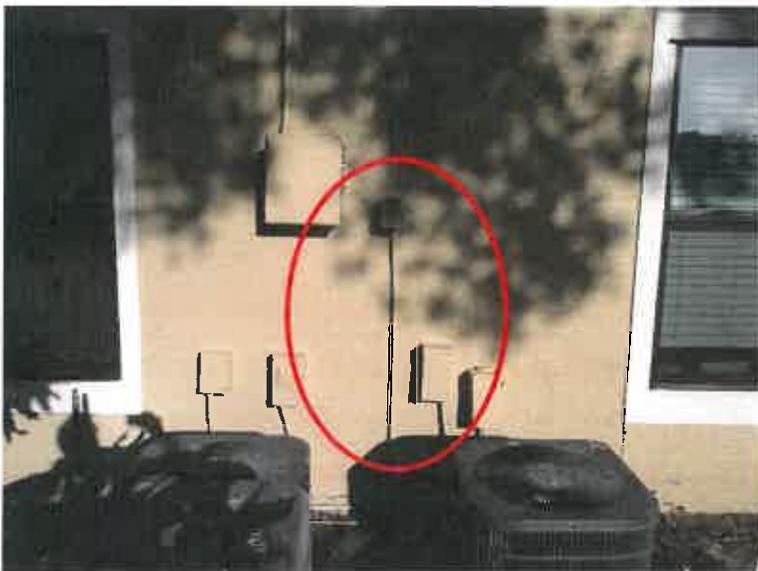
PHOTOGRAPH #2

**BUILDING 14
SECTION C**

Contractor has reinstalled electric box at wall area as agreed with property manager.

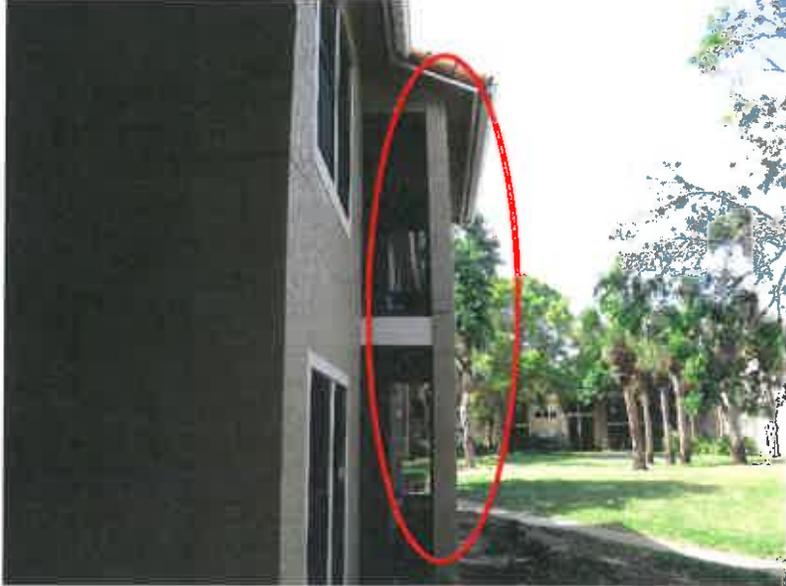
PHOTOGRAPH #3

**BUILDING 14
UNITS #1422 AND #1412**

Balcony Columns are not plum or square top to bottom, and will not be acceptable finished repairs. This item will be added to the punch list for building completion.

- Delta performed final punch walk through with Contractor and on-site manager. Punch items were marked to be addressed. Delta provided punch list and will verify completion of punch items.
- Units - 1422 and 1412- balcony columns are not plum or square top to bottom, and will not be acceptable finished repairs. This item will be added to the punch list for building completion (Photographs #3 and #4).

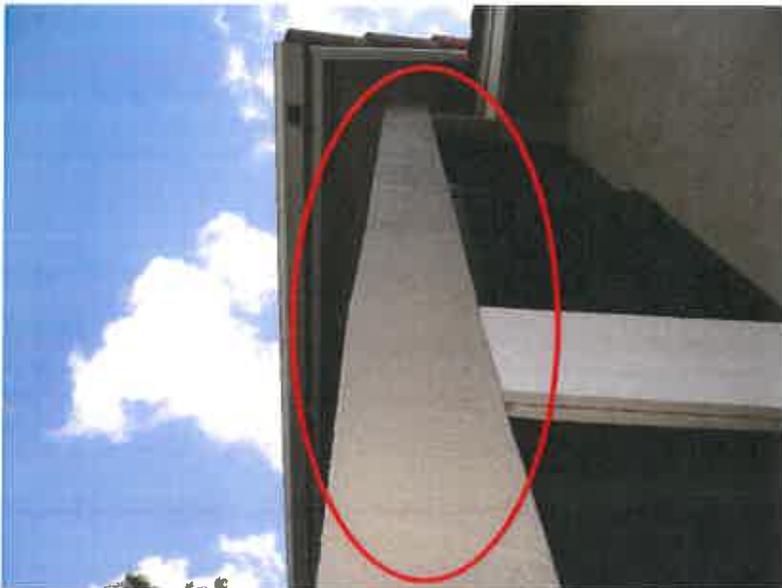
PHOTOGRAPH #4

**BUILDING 14
UNITS #1422 AND #1412**

Balcony Columns are not plum or square top to bottom, and will not be acceptable finished repairs. This item will be added to the punch list for building completion.

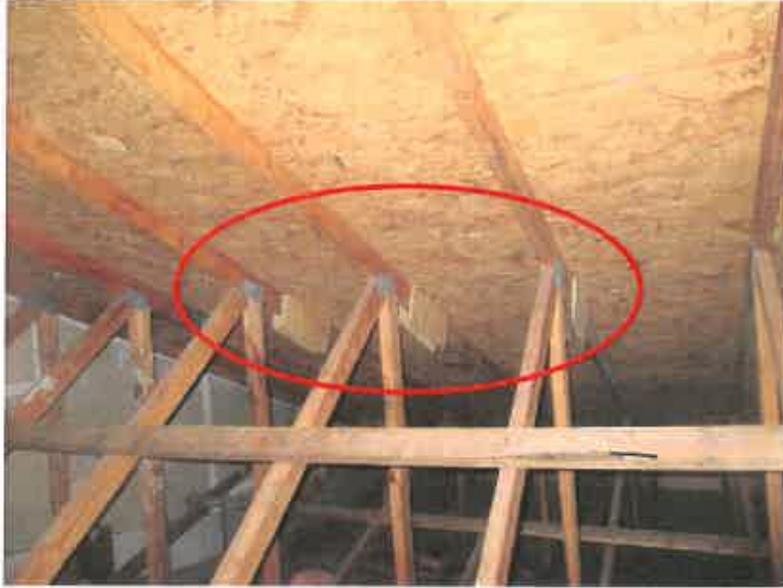
PHOTOGRAPH #5

**BUILDING 19
UNIT #1921 ATTIC**

Contractor has provided gusset repairs at damaged truss.

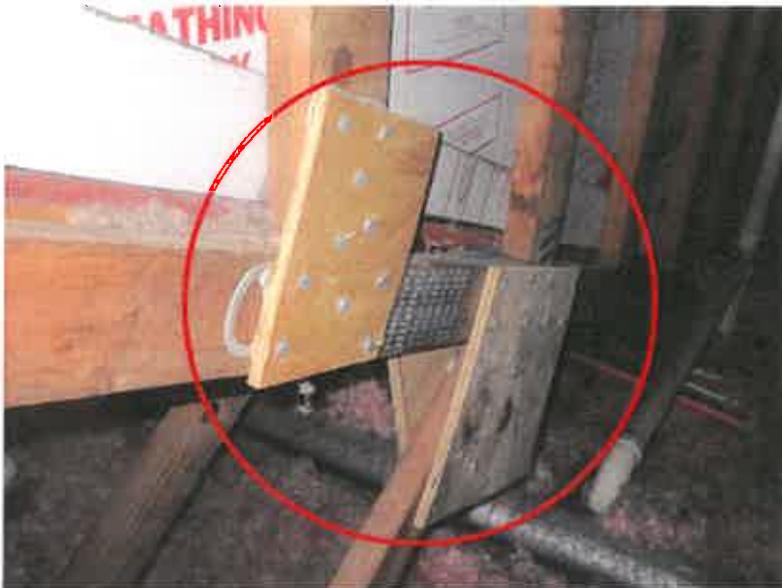
PHOTOGRAPH #6

**BUILDING 19
UNIT #1922 ATTIC**

Contractor has provided gusset repairs at damaged truss.

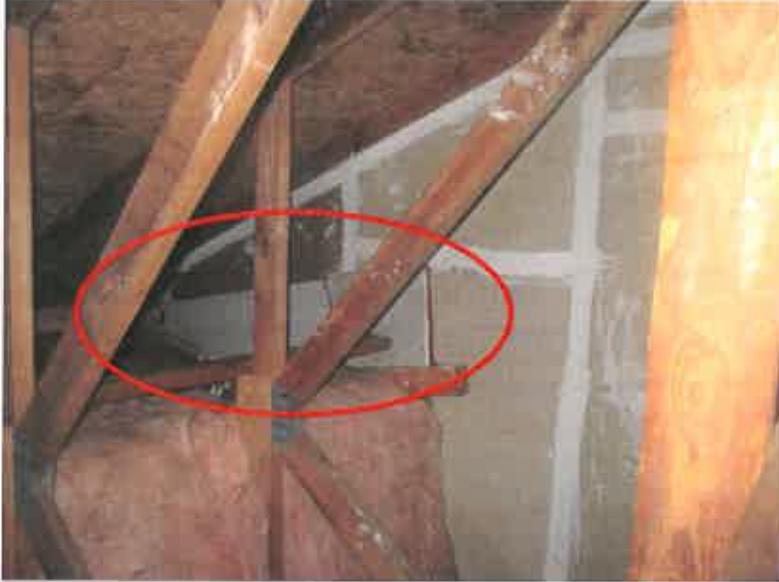
PHOTOGRAPH #7

**BUILDING 19
UNIT #1923 ATTIC**

Contractor has provided fire wall repairs with Type X fire rated board and fire caulk.

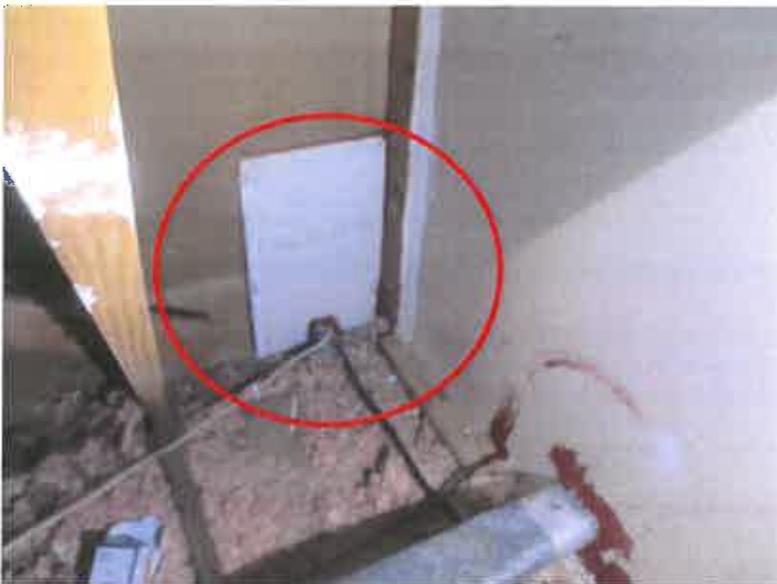
PHOTOGRAPH #8

**BUILDING 19
UNIT #1924 ATTIC**

Contractor has provided fire wall repairs with Type X fire rated board and fire caulk.

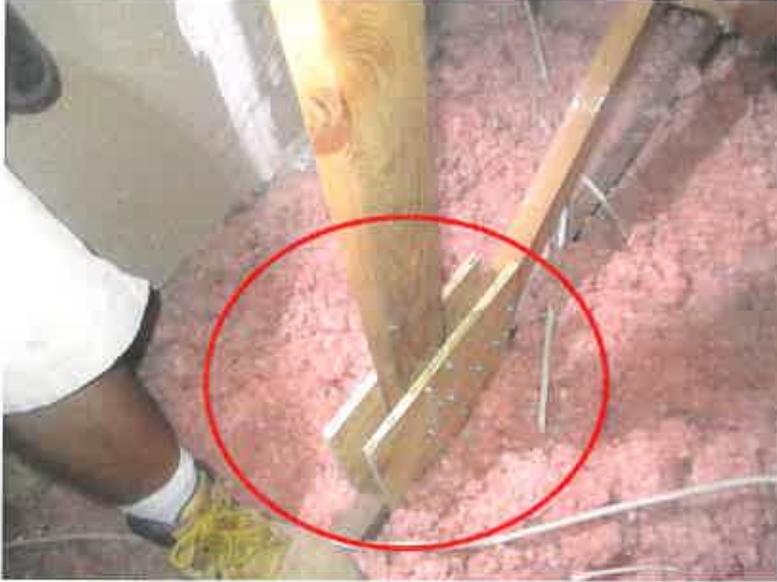
PHOTOGRAPH #9

**BUILDING 19
UNIT #1925**

Contractor has provided gusset repairs at damaged truss.

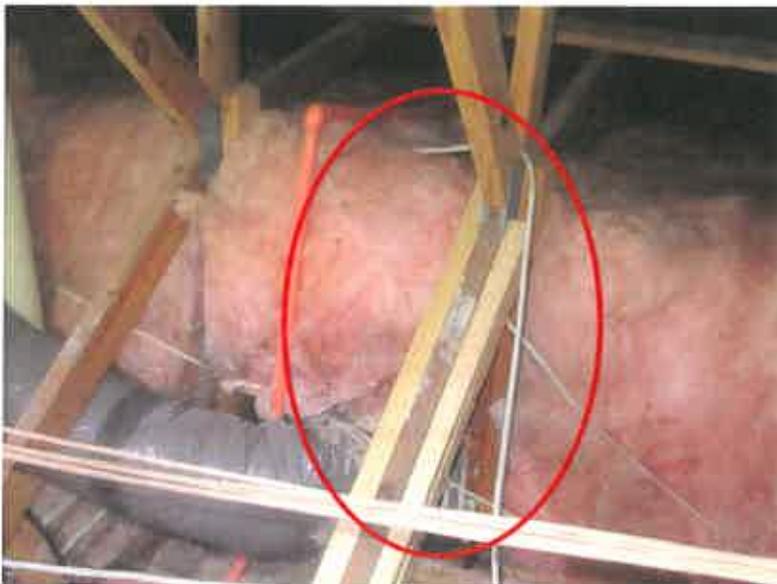
PHOTOGRAPH #10

**BUILDING 19
UNIT #1926**

Contractor has provided scab repairs at damaged truss members.

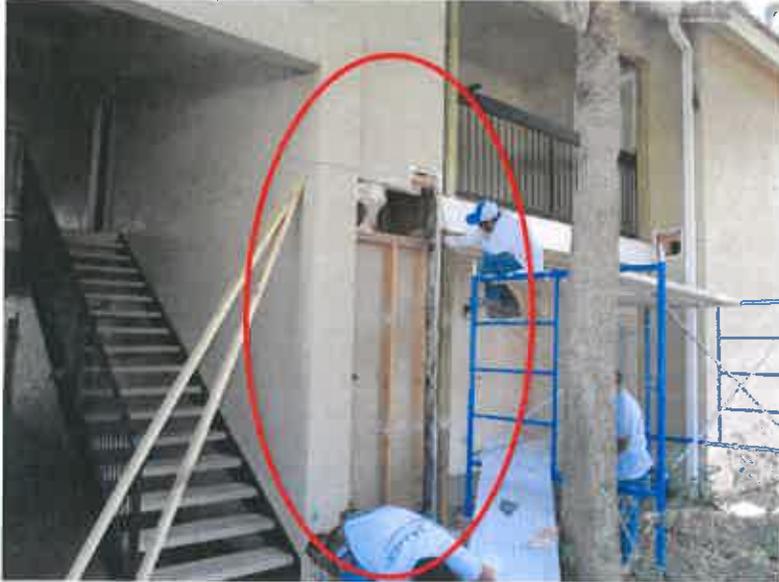
PHOTOGRAPH #11

Unit	Demo	Framing & sheathing	Sheathing	Stucco	Sealant	Painting	Punch	Comments
727	X							Contractor has opened damaged balcony areas for repairs. Support members have collapsed and temporary bracing is in place (Photographs #11 and #12).

**BUILDING 7
UNIT # 727**

Contractor has opened damaged balcony areas for repairs. Support members have collapsed and temporary bracing is in place.

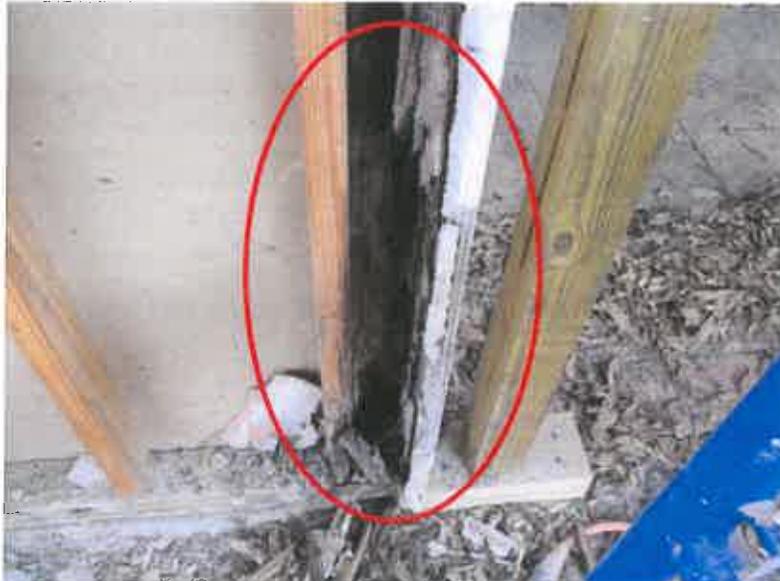
PHOTOGRAPH #12

**BUILDING 7
UNIT # 727**

Contractor has opened damaged balcony areas for repairs. Support members have collapsed and temporary bracing is in place.

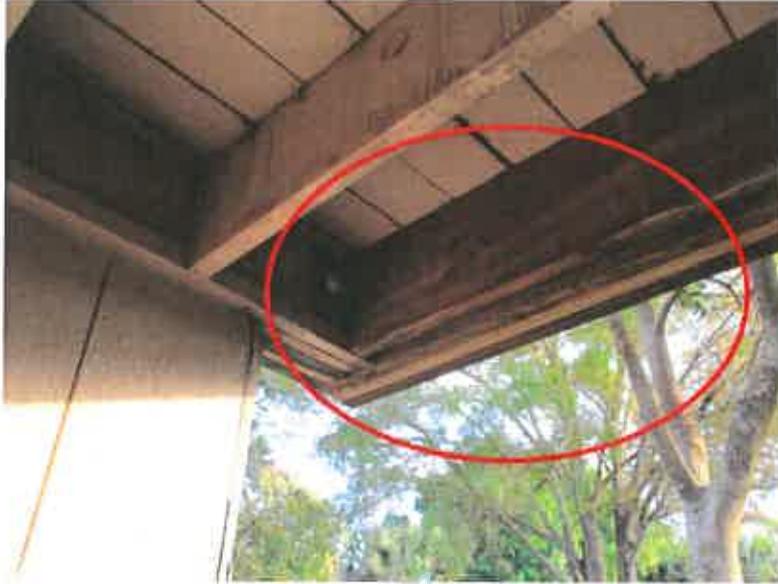
PHOTOGRAPH #13

Unit	Demo	Framing & shepping	Sheathing	Stucco	Sealant	Painting	Punch	Comments
1324	X	/						Contractor has not repaired the built-up beam as per drawings or specifications and will be required to remove a replace repair (Photograph #13).

**BUILDING 13
UNIT #1324**

Contractor has not repaired the built-up beam as per drawings or specifications and will be required to remove a replace repair.

- 1. Contractor has not repaired the built-up beam as per drawings or specifications and will be required to remove a replace repair (Photograph #13).

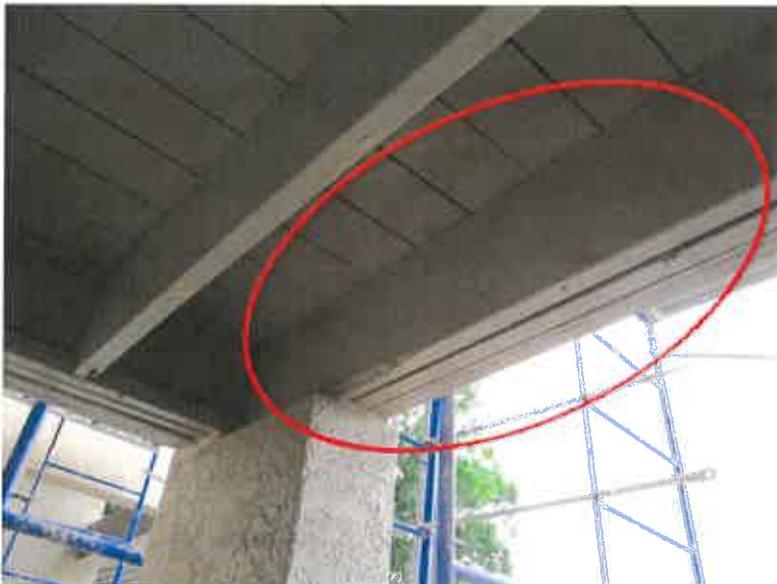
PHOTOGRAPH #14

**BUILDING 25
SECTION B**

At built up beam contractor has not provided Simpson Strong #SDW22458 screws 12" O.C. as per balcony repair drawings.

- Section B - at balconies, contractor will provide Simpson Strong #SDW22458 screws 12" O.C. as per drawings (Photograph #14).
- Section F - A/C boxes have been left attached to the sheathing and will be removed and attached after stucco is applied (Photographs #15).
- Construction equipment and materials left outside fenced construction area must be kept within fenced construction area (Photograph #19).
- Section H - peel and stick flashing will be required at vertical overlapping JUMBO TEX water resistant barrier (Photograph #20).

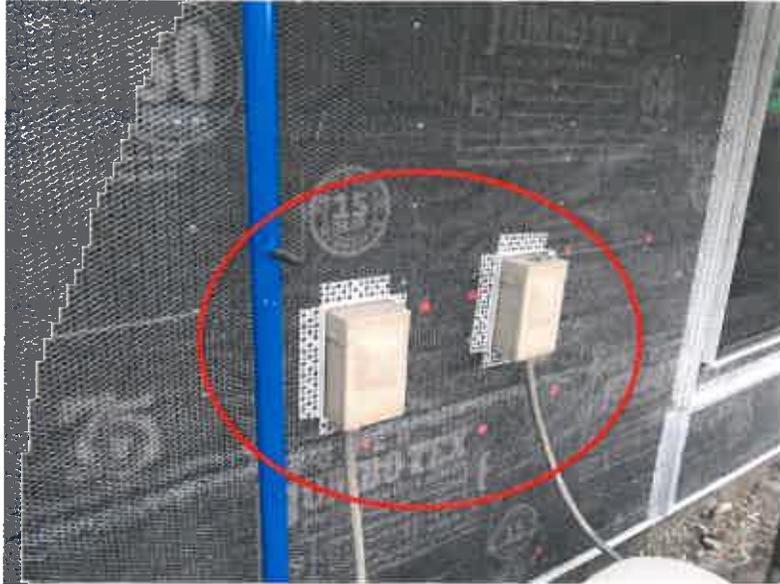
PHOTOGRAPH #15

F	X	NA	NA	X	/	X	X	/	/				A/C boxes have been left attached to the sheathing and stucco accessories have been installed improperly (Photographs #15).
G	X	NA	NA	X									Soil at grade has not been removed to provide 6 inches from top of grade to bottom of stucco and slope grade 2% to provide positive drainage. JUMBO TEX water resistant barrier is wrapped around corner and overlapping itself. Peel and stick flashing will be required at vertical overlapping (Photograph #20).
H	X	X	X	X	X	X	X	X	/

**BUILDING 25
SECTION F**

A/C boxes have been left attached to the sheathing and stucco accessories have been installed improperly.

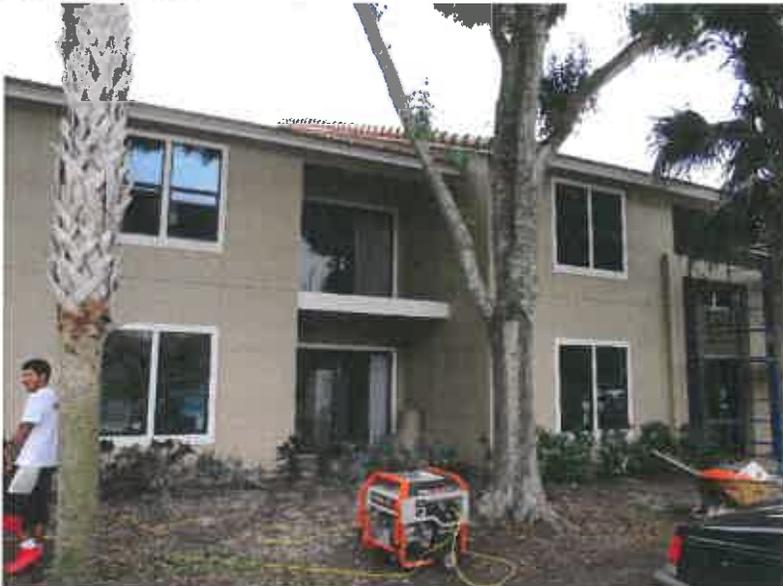
PHOTOGRAPH #16

**BUILDING 25
SECTION A**

Contractor has applied finish coatings and removed scaffolding.

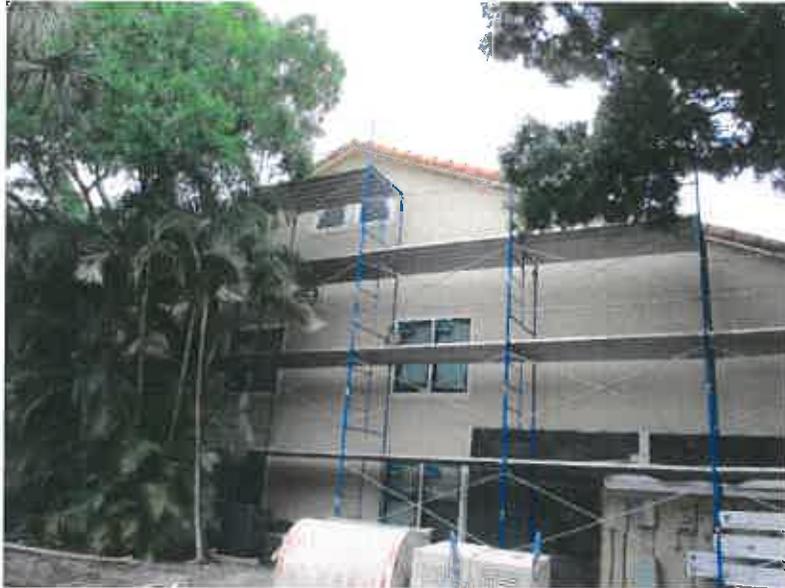
PHOTOGRAPH #17

**BUILDING 25
SECTION D**

Contractor has primed new stucco in preparation for finish painting.

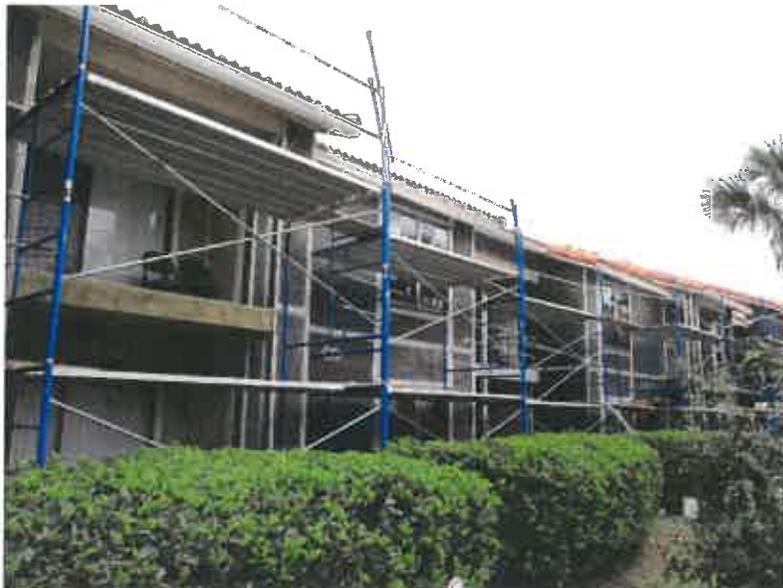
PHOTOGRAPH #18

**BUILDING 25
SECTION E**

Stucco Sub – contractor has completed stucco accessories and lath in preparation for stucco application.

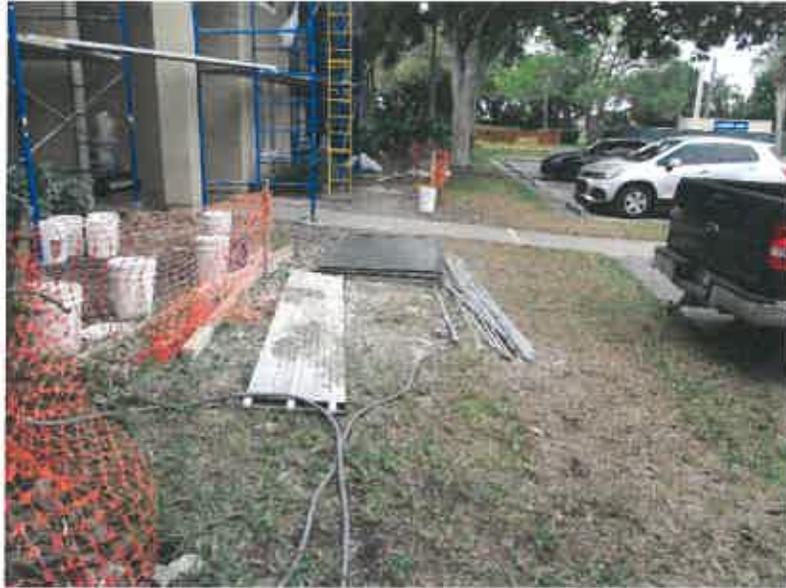
PHOTOGRAPH #19

**BUILDING 25
SECTION B**

Construction equipment and materials
outside fenced construction area.

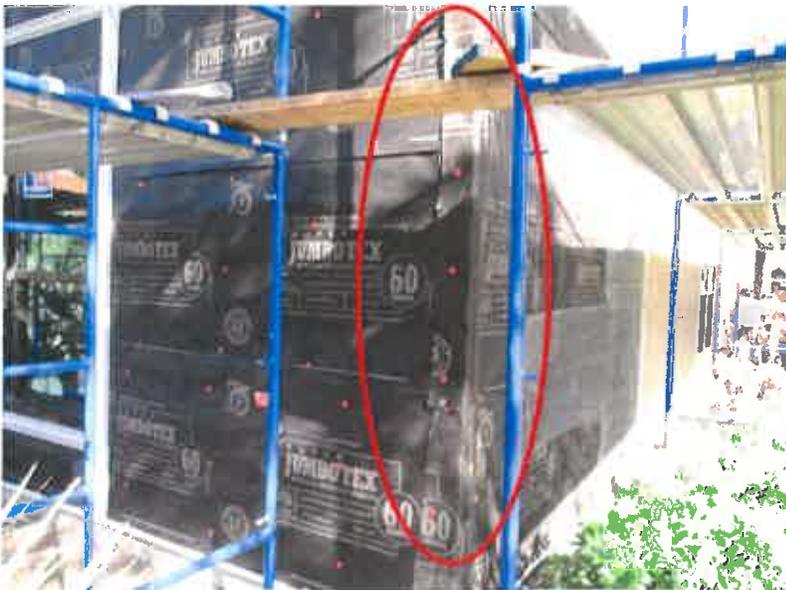
PHOTOGRAPH #20

**BUILDING 25
SECTION H**

JUMBO TEX water resistant barrier is
wrapped around corner and overlapping
itself. Peel and stick flashing will be
required at vertical overlapping.
