**FIELD OBSERVATION REPORT - Bldg #14**

Permit No. 18-131555-00 BC  
Owner: Village Grand Condo Assn, Inc.  
Project Address: 4017 Crookers Lake Blvd., Sarasota, FL  
Contractor: RL James Inc  
Inspector (s): Mark Boss PM / Mike Jones  
Type of Assessment: Progress

Project: R1503-302D  
Contact: Glenn Atelli  
Phone/Fax: (941) 923-7380  
Contact: Craig Nicholas / Robert Branscombe  
Phone: (941)232-6486 / (239) 379-1978

**FIELD OBSERVATION REPORT - Bldg #25**

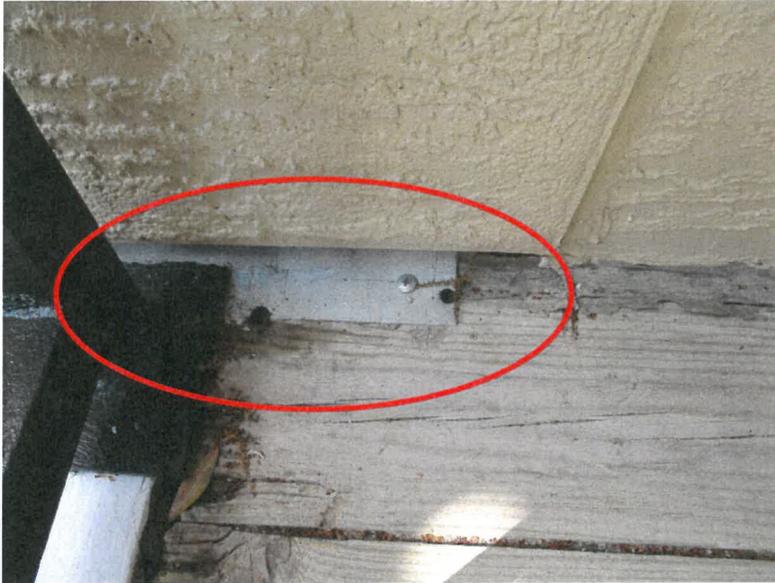
PHOTOGRAPH #1

**BUILDING 14  
UNIT # 1423**

Contractor has installed screws through flashing at deck. Flashing is to be set in bead of sealant as per drawings. Contractor will make corrections and notify Delta for inspection.

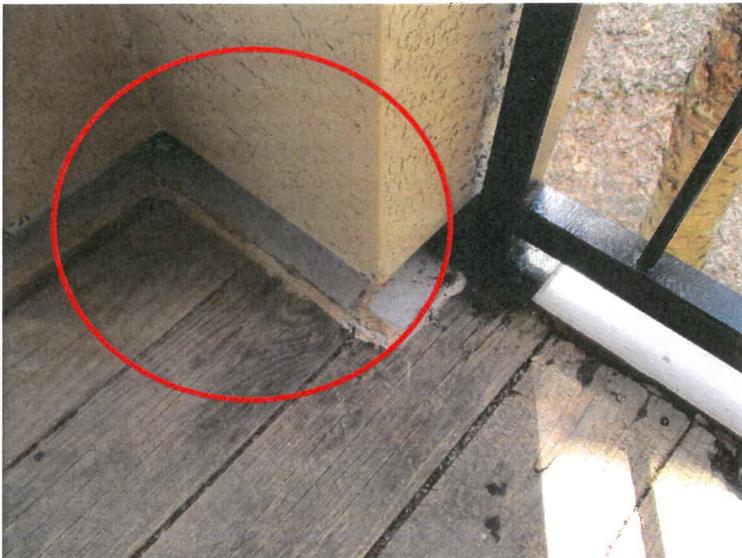
PHOTOGRAPH #2

**BUILDING 14  
UNIT # 1423**

Unfinished flashing at deck where exposed will require paint to match and protect sealant.

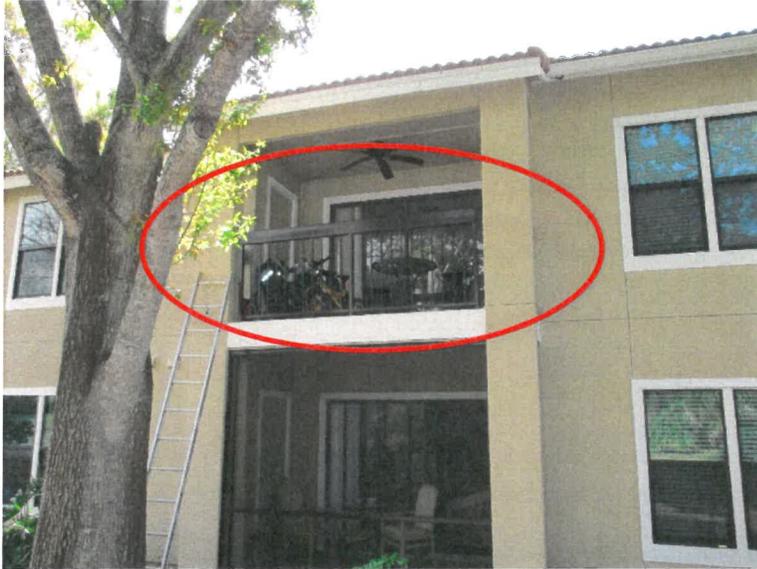
**PHOTOGRAPH #3**

**BUILDING 14  
UNIT # 1424**

Balcony rails have not been attached at top rail as required and owners has accessed the balcony. Owners should not be allowed on balcony until properly secured.

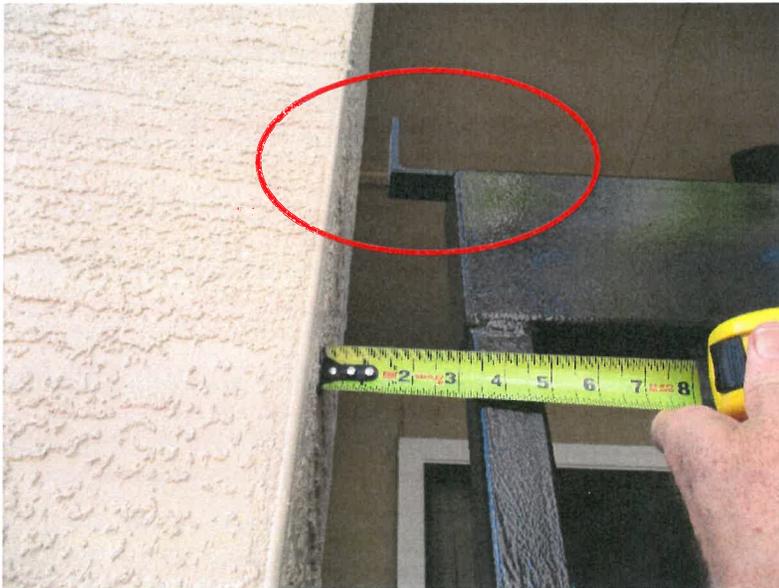
**PHOTOGRAPH #4**

**BUILDING 14  
UNIT # 1424**

Balcony rails have not been attached at top rail as required and occupants have accessed the balcony. Contractor will secure doors to prevent occupants on balcony until properly secured.

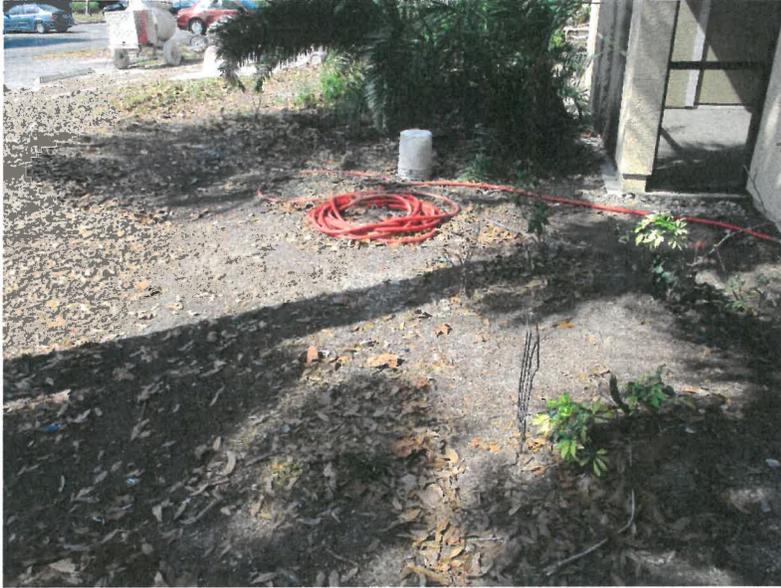
**PHOTOGRAPH #5**

**BUILDING 14  
SITE CONDITION**

Contractors material remains and equipment is scattered around building and is required to be removed with final clean up as per project manual.

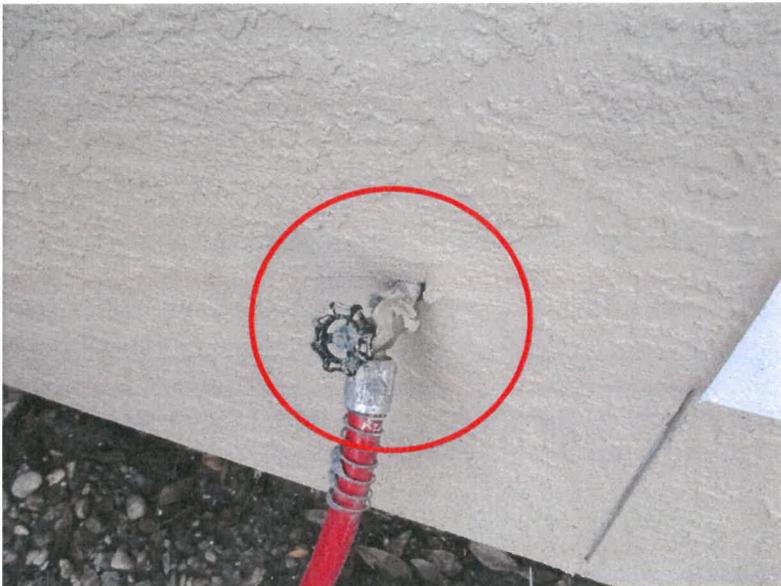
**PHOTOGRAPH #6**

**BUILDING 14  
SECTION A**

Penetration at hose bib will require sealant at stucco to metal transition.

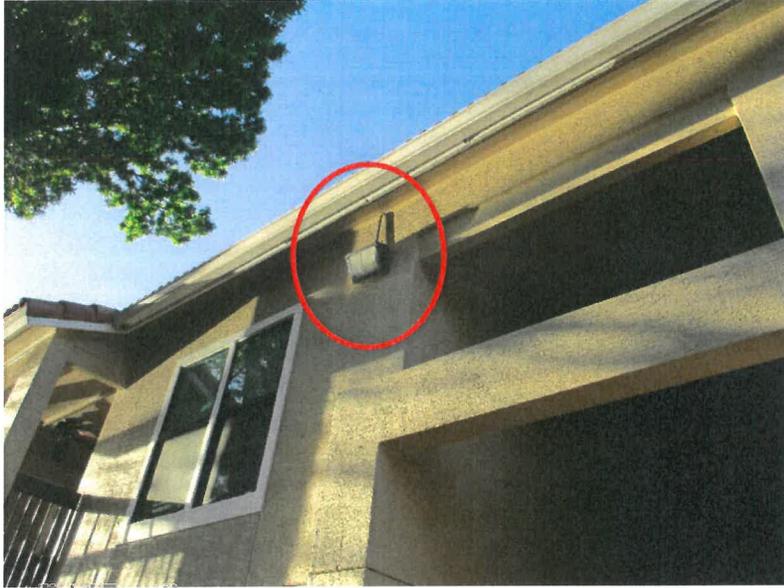
**PHOTOGRAPH #7**

**BUILDING 14  
SECTION B**

Light fixtures will require sealant at stucco to metal transition.

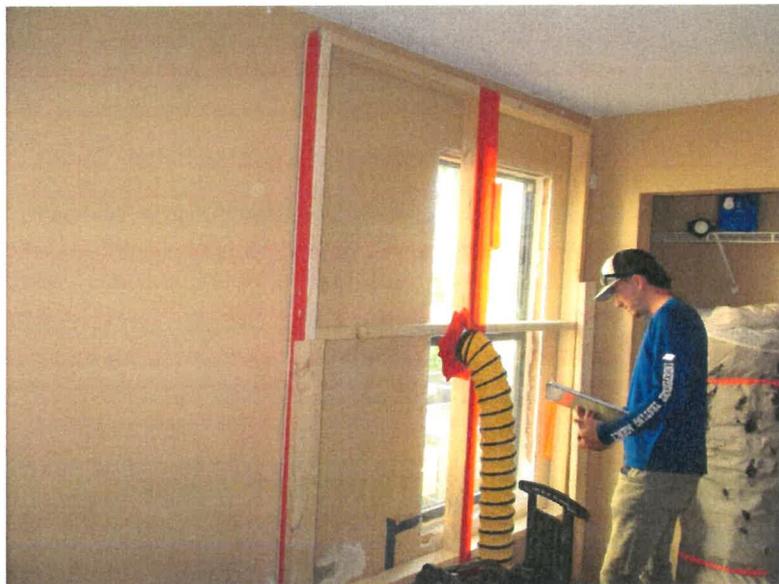
**PHOTOGRAPH #8**

**BUILDING 14  
UNIT #1411**

Bedroom window that had previously failed water testing has been re-tested by certified AAMA contractor and has passed in compliance with ASTM testing per project manual.

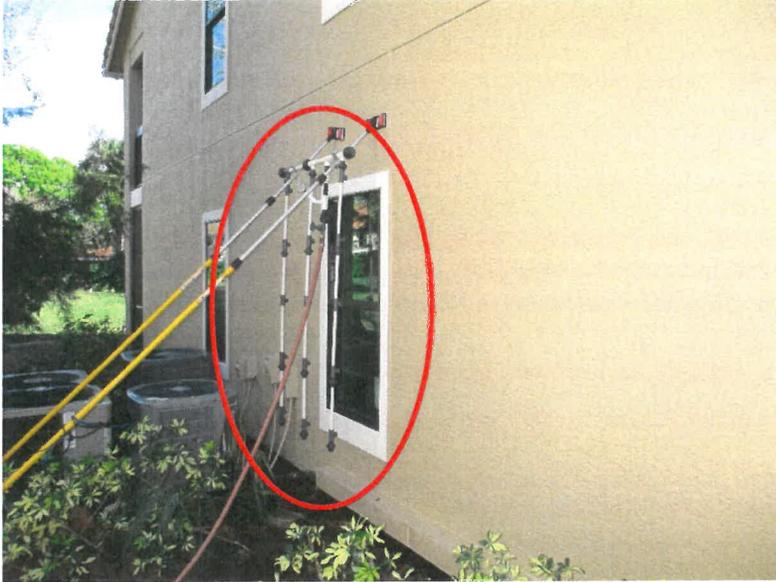
**PHOTOGRAPH #9**

**BUILDING 14  
UNIT #1411**

Bedroom single window that had previously failed water testing has been re-tested by certified AAMA contractor and has passed in compliance with ASTM testing per project manual.

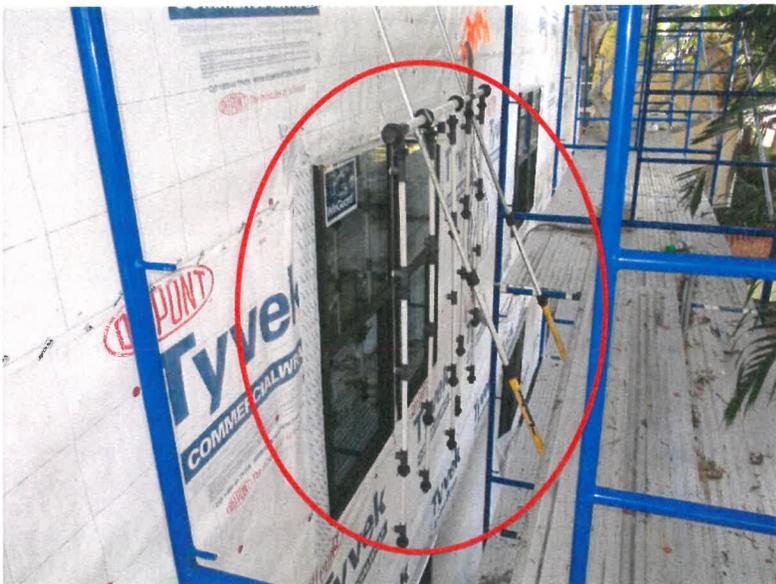
**PHOTOGRAPH #10**

**BUILDING 25  
UNIT #2527**

Bedroom double window has been tested by certified AAMA contractor and has passed in compliance with ASTM testing per project manual.

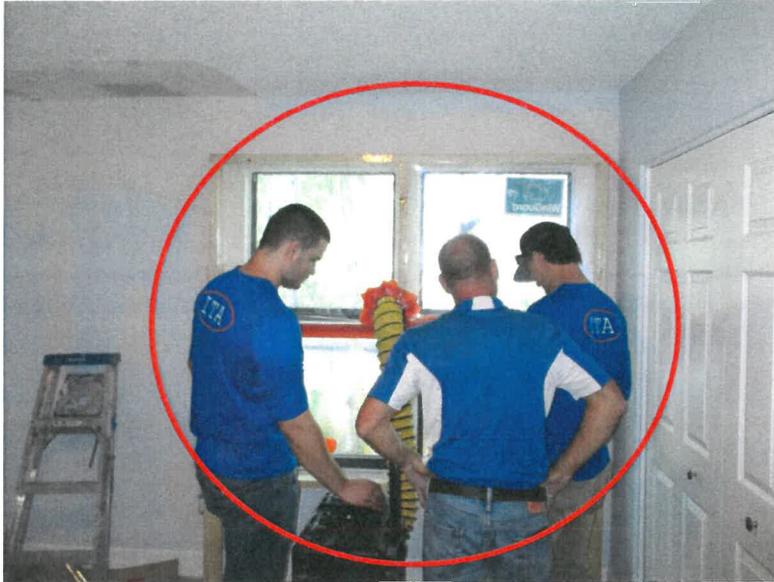
**PHOTOGRAPH #11**

**BUILDING 25  
UNIT #2527**

Bedroom double window has been tested by certified AAMA contractor and has passed in compliance with ASTM testing per project manual.

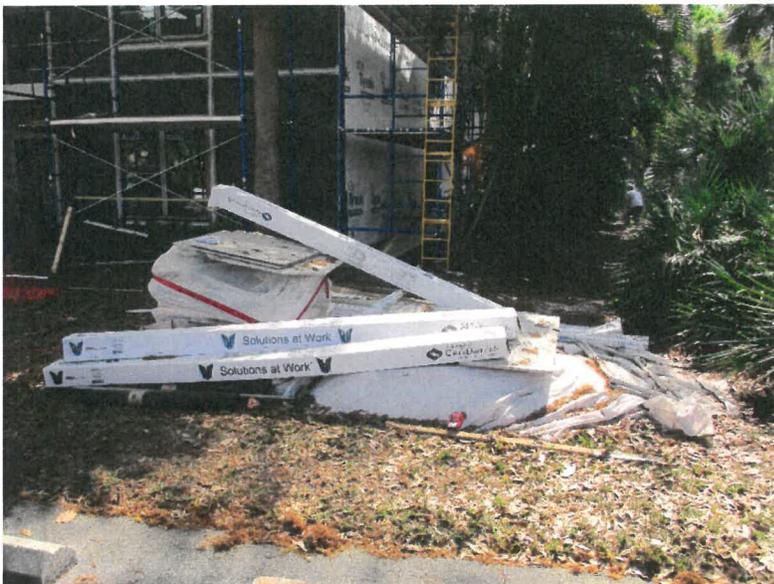
**PHOTOGRAPH #12**

- Contractors have piled materials on lawn outside fenced construction area. Construction materials on site must be contained within fenced areas. (Photograph #12).

**BUILDING 25  
ELEVATION C**

Contractors have piled materials on lawn outside fenced construction area. Construction materials on site must be contained within fenced areas.

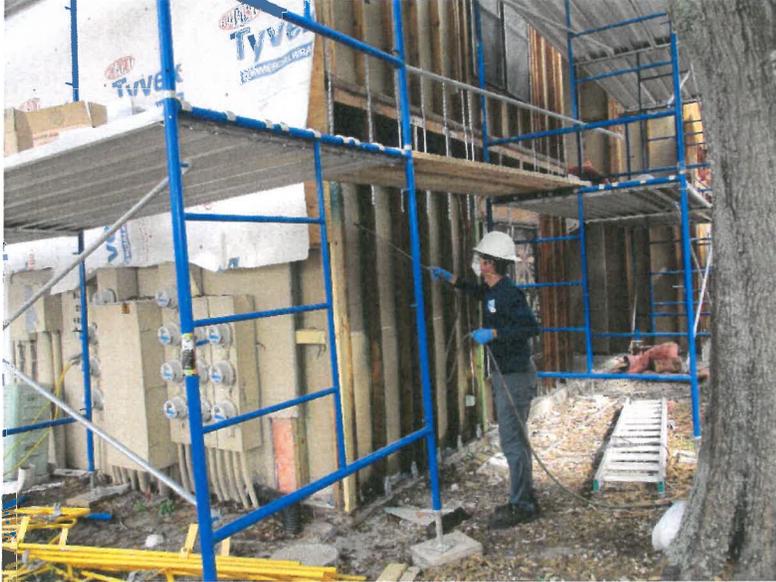
**PHOTOGRAPH #13**

**BUILDING 25  
ELEVATION E**

Bora Care termite treatment has been applied as per scope and specifications.

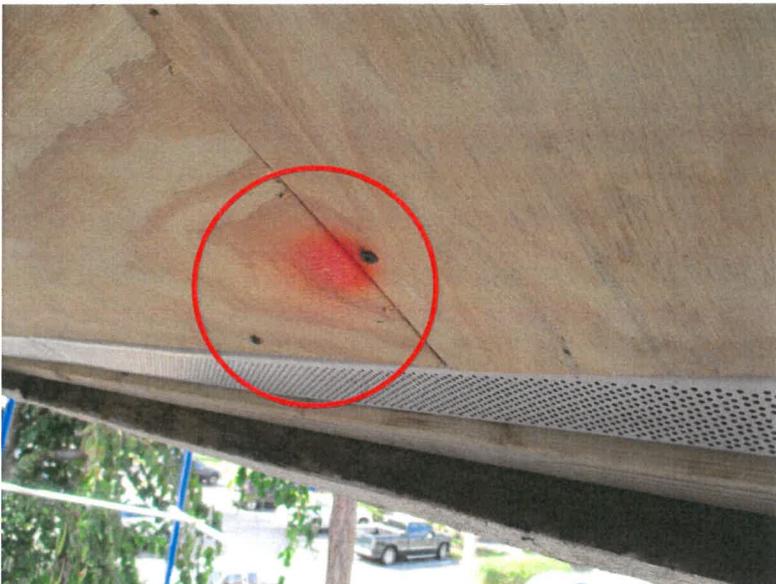
**PHOTOGRAPH #14**

- New soffit wood has been attached at some locations with screws. These fasteners must be counter sunk and patched over prior to primer and finish coat painting. (Photograph #14).

**BUILDING 25  
ELEVATION B**

New soffit wood has been attached at some locations with screws. These fasteners must be counter sunk and patched over prior to primer and finish coat painting.

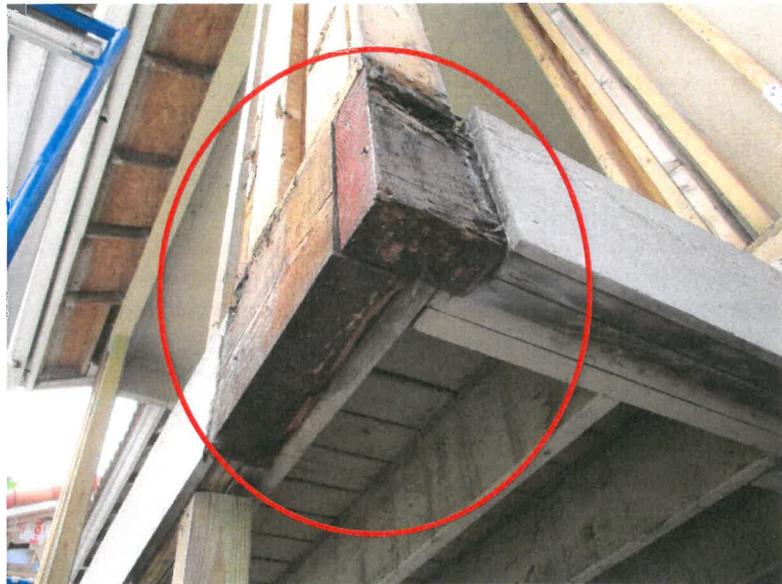
**PHOTOGRAPH #15**

**BUILDING 25  
ELEVATION F**

Previous deficient balcony built up beam repairs have rotted and will be replaced as per scope and specifications.

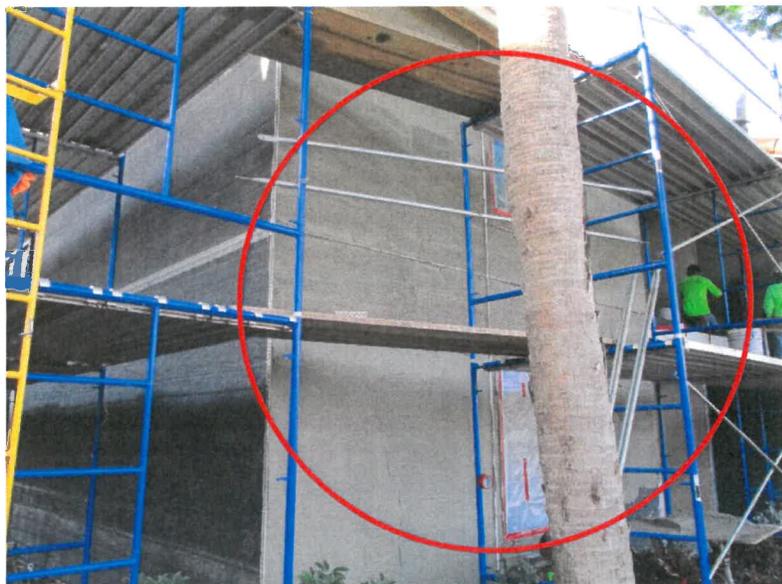
**PHOTOGRAPH #16**

**BUILDING 25  
ELEVATION A**

Stucco contractor has begun scratch coat stucco application.

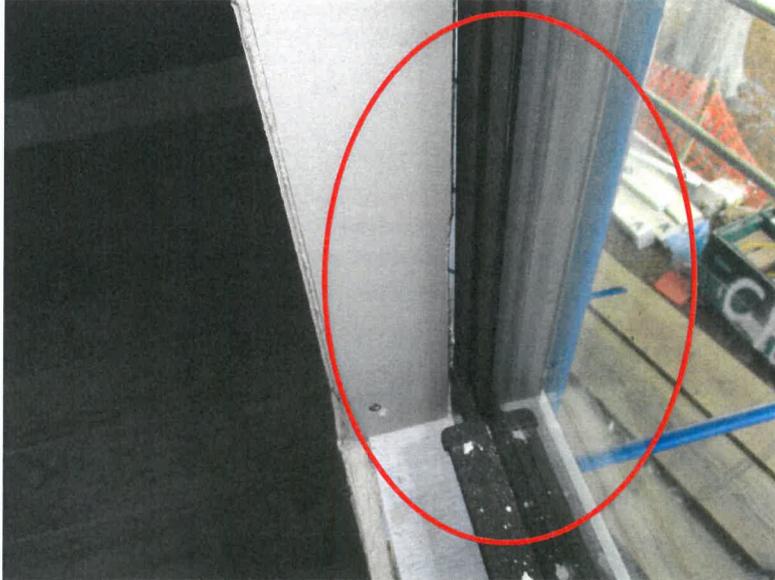
**PHOTOGRAPH #17**

- Unit #2527-Drywall has been installed prior to finish bead of sealant being installed at window perimeter. Contractor will remove drywall and complete window installation as per drawing and specifications. (Photograph #17).

**BUILDING 25  
UNIT #2527**

Drywall has been installed prior to finish bead of sealant being installed at window perimeter. Contractor will remove drywall and complete window installation as per drawing and specifications.
