FIELD OBSERVATION REPORT - Bidg #24

Permit No. 18-177559-00 BC
 Owner: Vintage Grand Condo Assn, Inc.
 Project Address: 4017 Crockers Lake Blvd., Sarasota, FL
 Contractor: RL James Inc
 Inspector (s): Mark Boss
 Type of Assessment: Progress

Project: R1503-302E
 Contact: Glenn Atelli
 Phone/Fax: (941) 923-7360
 Contact: Craig Nicholas / Robert Branscombe
 Phone: (941) 232-6186 / (239) 379-1978

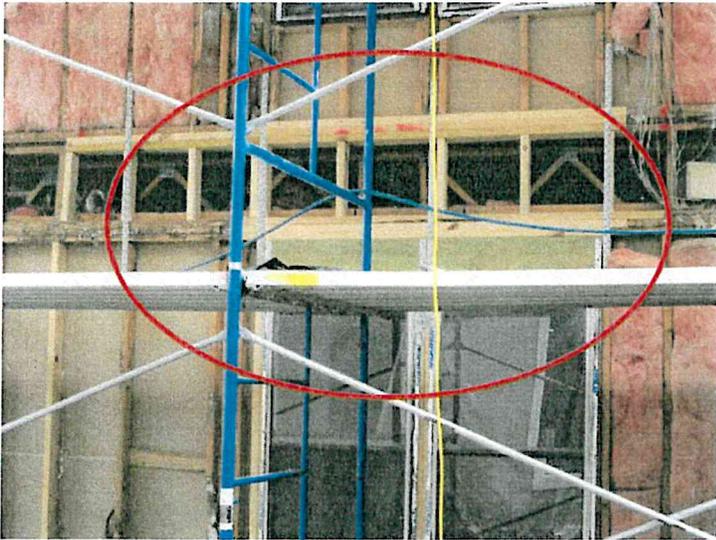
PHOTOGRAPH #1

**BUILDING 24
SECTION D**

Contractor has provided repairs at window headers, top plate and subflooring.

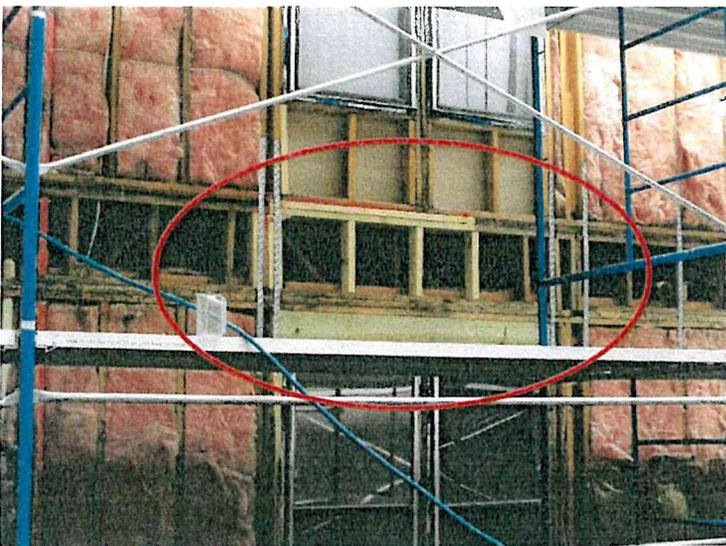
PHOTOGRAPH #2

**BUILDING 24
SECTION D**

Contractor has provided repairs at window headers, top plate and subflooring.

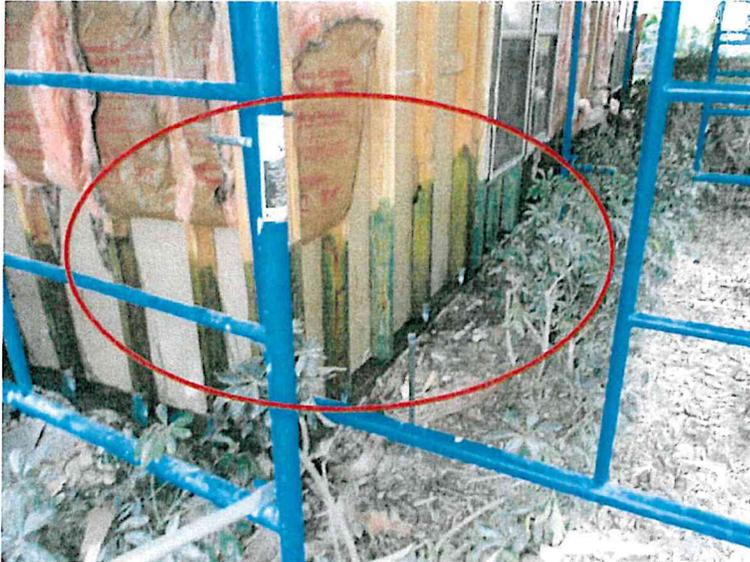
PHOTOGRAPH #3

**BUILDING 24
SECTION D**

Contractor has provided Copper-Green Wood preservative at lower two feet of framing.

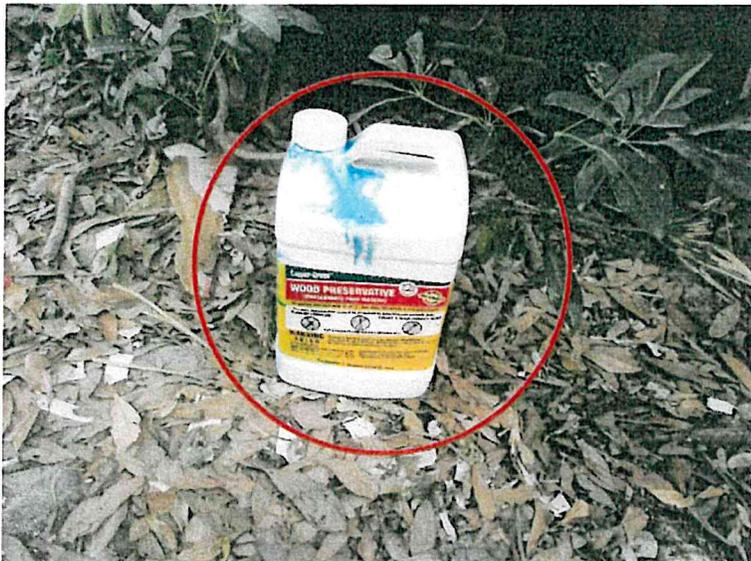
PHOTOGRAPH #4

**BUILDING 24
SECTION D**

Contractor has provided Copper-Green Wood preservative at lower two feet of framing.

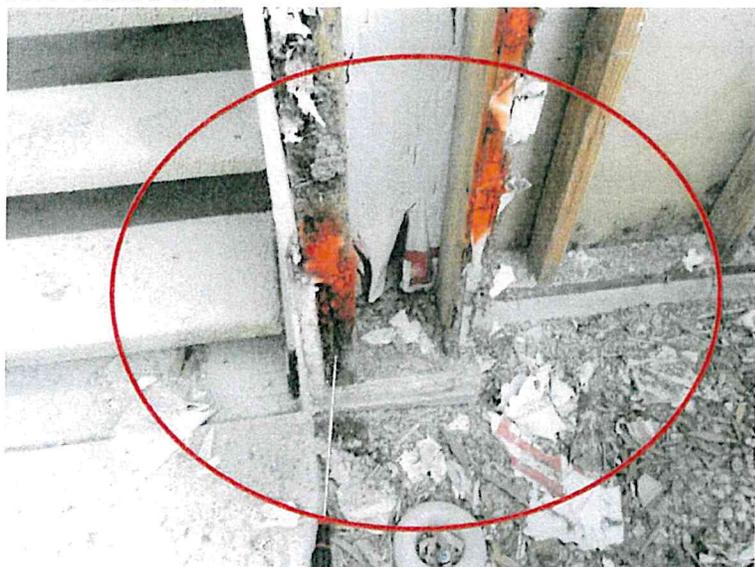
PHOTOGRAPH #5

**BUILDING 24
SECTION C**

Framing damages are being identified and marked for repairs by Delta.

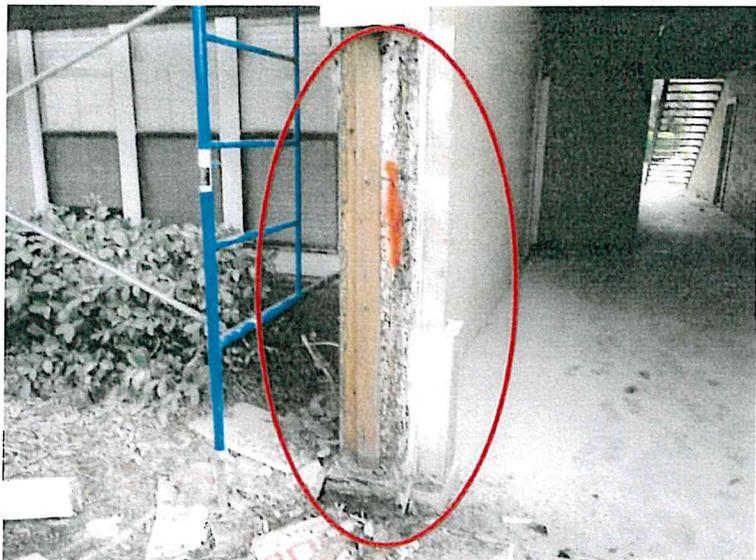
PHOTOGRAPH #6

**BUILDING 24
SECTION C**

Framing damages are being identified and marked for repairs by Delta.

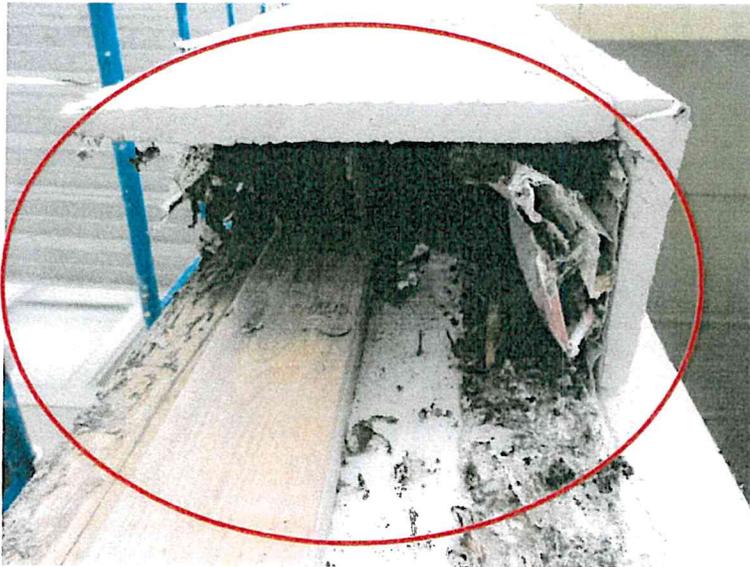
PHOTOGRAPH #7

**BUILDING 24
SECTION C**

Framing damages are being identified and marked for repairs by Delta.

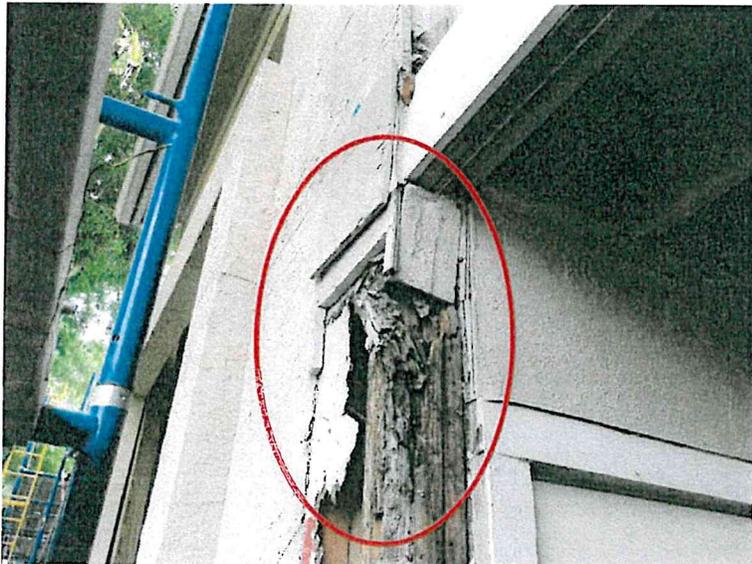
PHOTOGRAPH #8

**BUILDING 24
SECTION B**

Framing damages are being identified and marked for repairs by Delta.

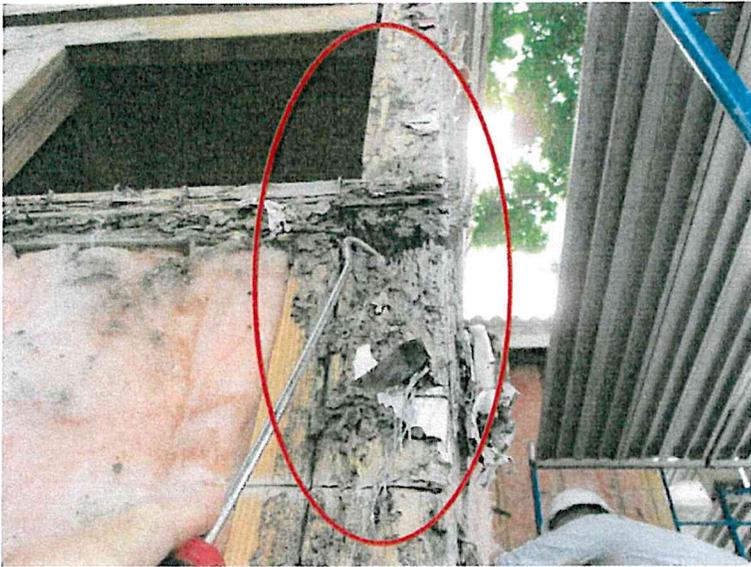
PHOTOGRAPH #9

**BUILDING 24
SECTION**

Framing damages are being identified and marked for repairs by Delta.
