FIELD OBSERVATION REPORT - Bldg #22 Attic Repairs

Permit No. 18158746 00 BR
 Owner: Vintage Grand Condo Assn, Inc.
 Project Address: 4017 Crockers Lake Blvd., Sarasota, FL
 Contractor: RL James Inc
 Inspector (s): Mark Boss PM / Mike Jones
 Type of Assessment: Progress

Project: R1503-302D
 Contact: Glenn Ateili
 Phone/Fax: (941) 923-7380
 Contact: Craig Nicholas / Robert Branscombe
 Phone: (941)232-6486 / (239) 379-1978

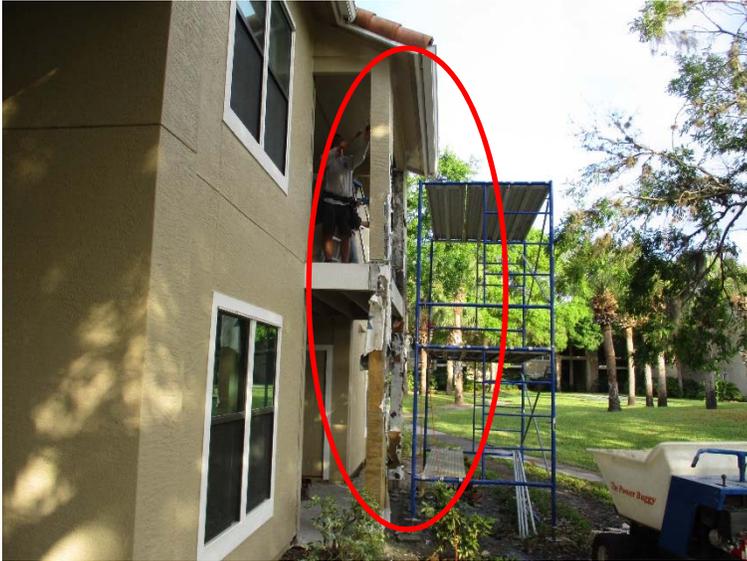
PHOTOGRAPH #1

**BUILDING 14
UNIT #1422 & #1412**

Contractor has begun removal of stucco in preparation for repairing columns.

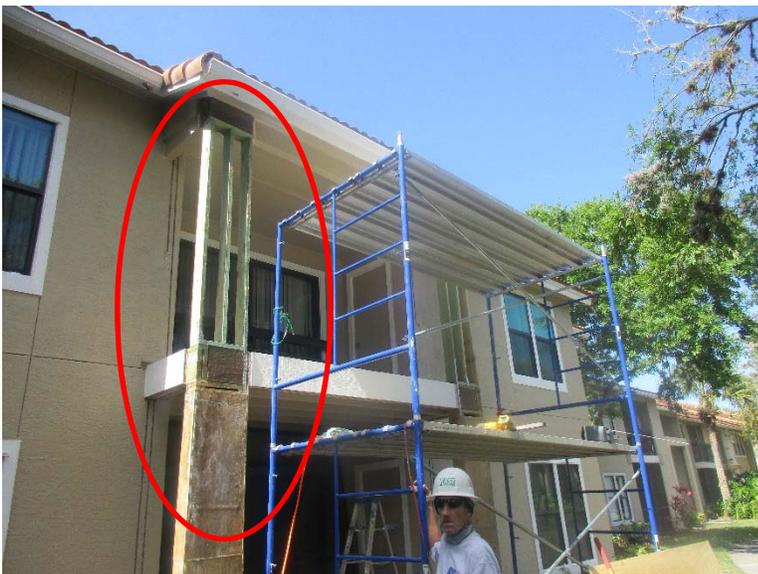
PHOTOGRAPH #2

**BUILDING 14
UNIT #1422 & #1412**

Contractor has moved upper columns and re-attached at head beam.

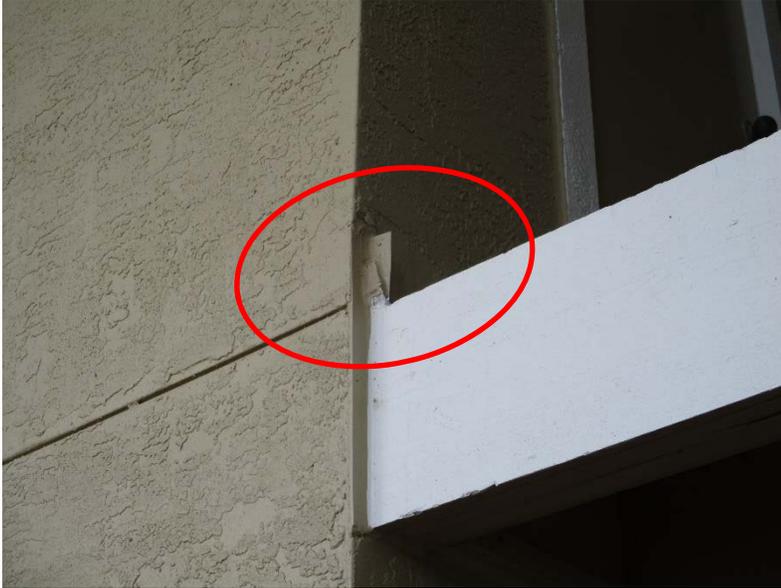
PHOTOGRAPH #3

**BUILDING 25
SECTION A**

Kick out flashing is installed incorrectly at balcony deck built up beam.

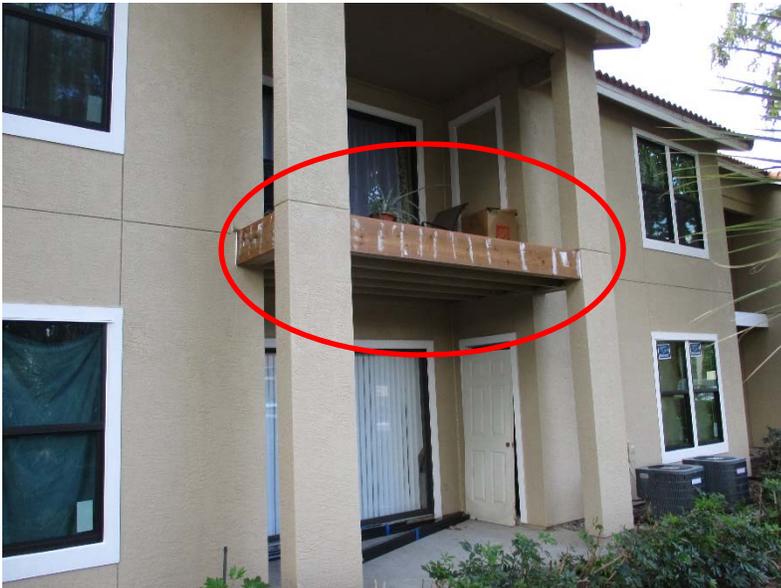
PHOTOGRAPH #4

**BUILDING 25
SECTION B**

Contractor has provided cedar cover boards at balcony built up beam.

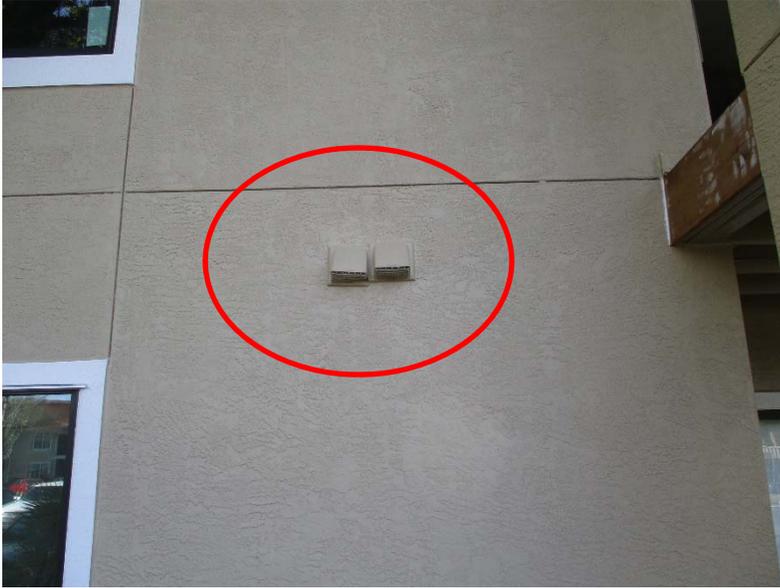
PHOTOGRAPH #5

**BUILDING 25
SECTION B**

Newly installed dryer vents are not level or square.

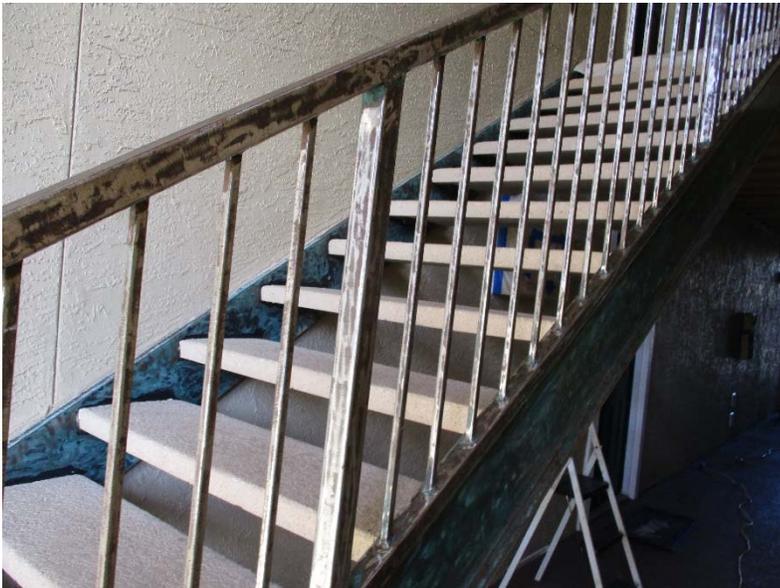
PHOTOGRAPH #6

**BUILDING 25
BREEZWAY STAIR RAIL**

Contractor has prepared steel railings by removing rust and loose materials in preparation for priming and painting.

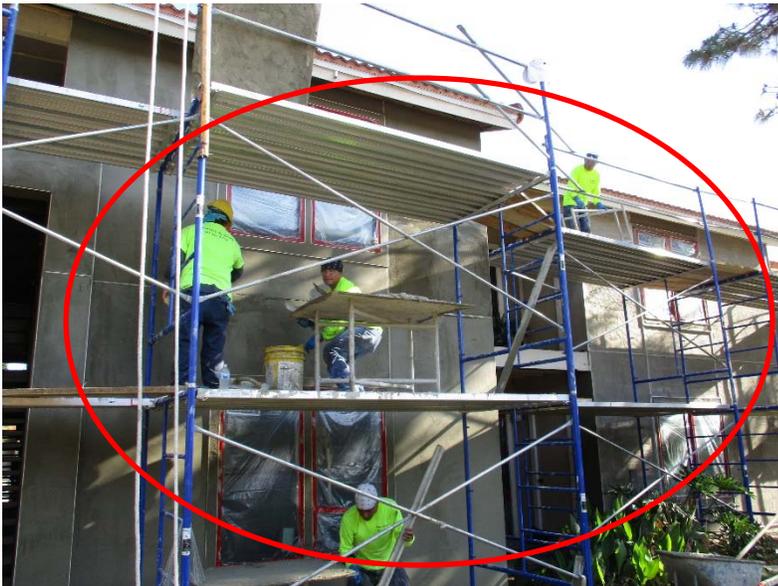
PHOTOGRAPH #7

**BUILDING 25
SECTION G**

Stucco sub-contractor applying brown coats and scratch coats.

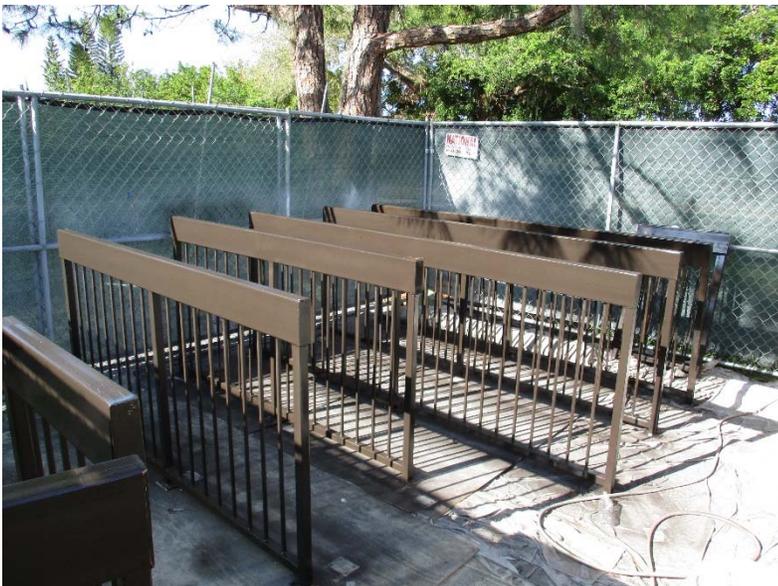
PHOTOGRAPH #8

**BUILDING 25
BALCONY RAILINGS**

Contractor has prepared, primed and finish coated railing. Ready for re-installation.

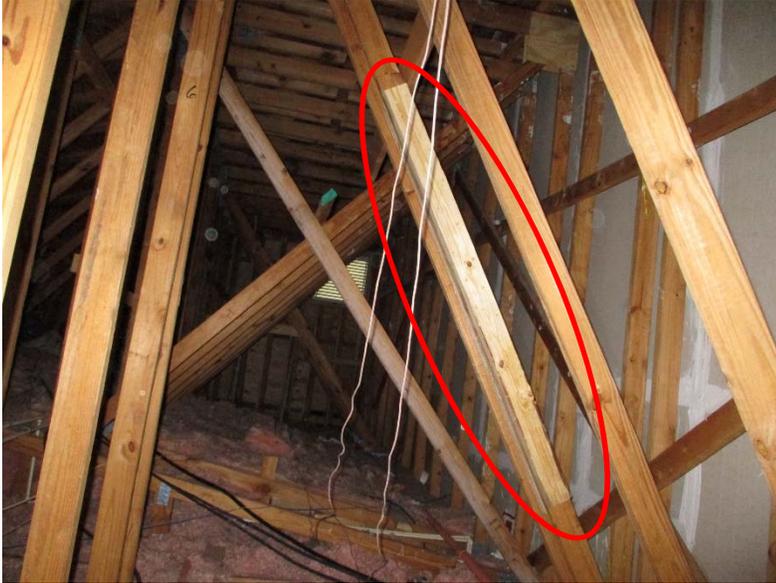
PHOTOGRAPH #9

**BUILDING 22
UNIT # 2221 ATTIC REPAIRS**

Contractor has provided truss scab repairs at damaged truss.

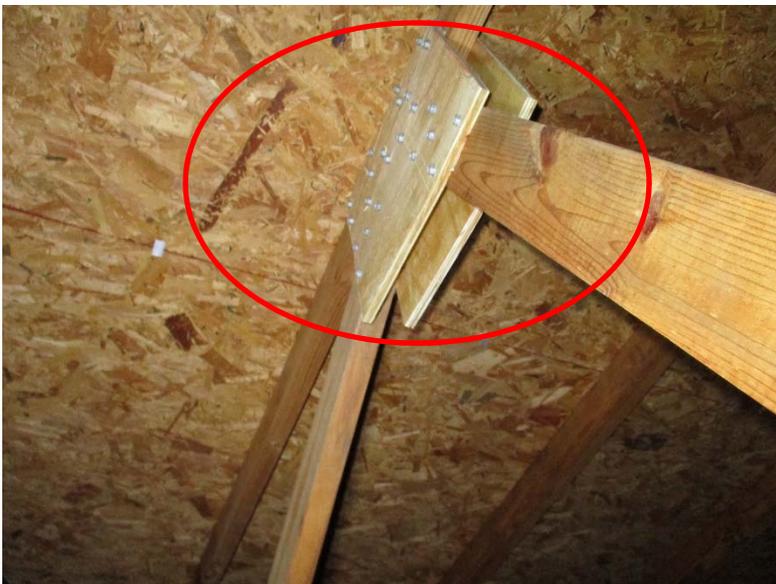
PHOTOGRAPH #10

**BUILDING 22
UNIT # 2223 ATTIC REPAIRS**

Contractor has provided gusset repairs at damage truss connections.

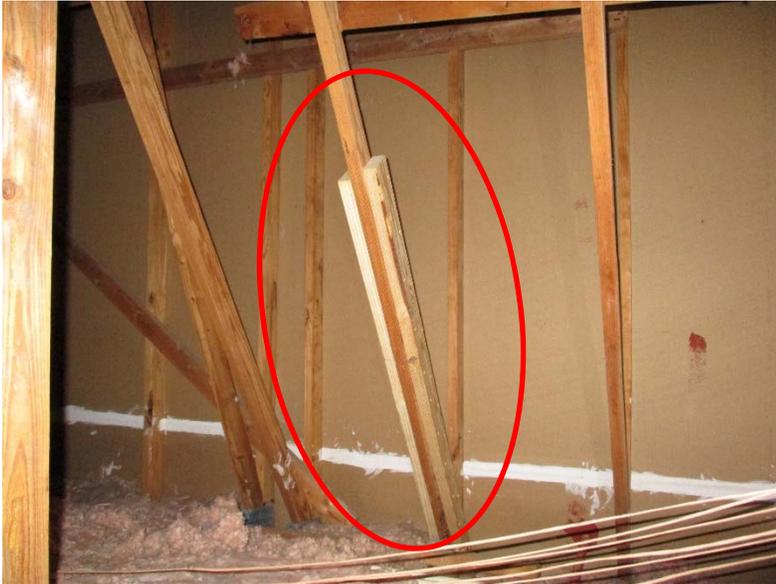
PHOTOGRAPH #11

**BUILDING 22
UNIT # 2224 ATTIC REPAIRS**

Contractor has provided truss scab repairs at damaged truss.

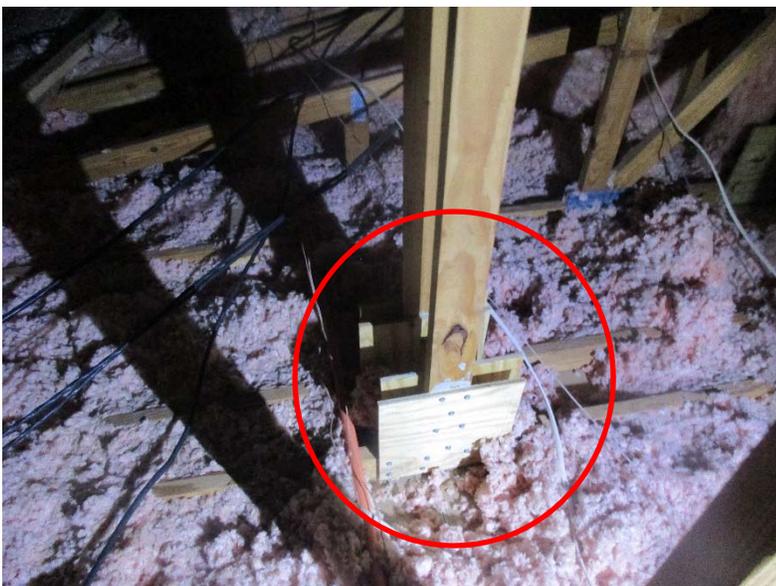
PHOTOGRAPH #12

**BUILDING 22
UNIT # 2222 ATTIC REPAIRS**

Contractor has provided gusset repairs at damage truss connections.
