FIELD OBSERVATION REPORT - Bldg. #25

Permit No. 18-146012-00 BC
 Owner: Vintage Grand Condo Assn, Inc.
 Project Address: 4017 Crockers Lake Blvd., Sarasota, FL
 Contractor: RL James Inc
 Inspector (s): Mark Boss
 Type of Assessment: Progress

FIELD OBSERVATION REPORT - Bldg #28 Attic Repair

PROJECT NAME:
**WOOD FRAME REPAIRS & RELATED WORK (PHASE II)
 VINTAGE GRANDE CONDOMINIUM ASSOCIATION, INC.
 4012 CROCKERS LAKE BLVD., SARASOTA, FL 34238**

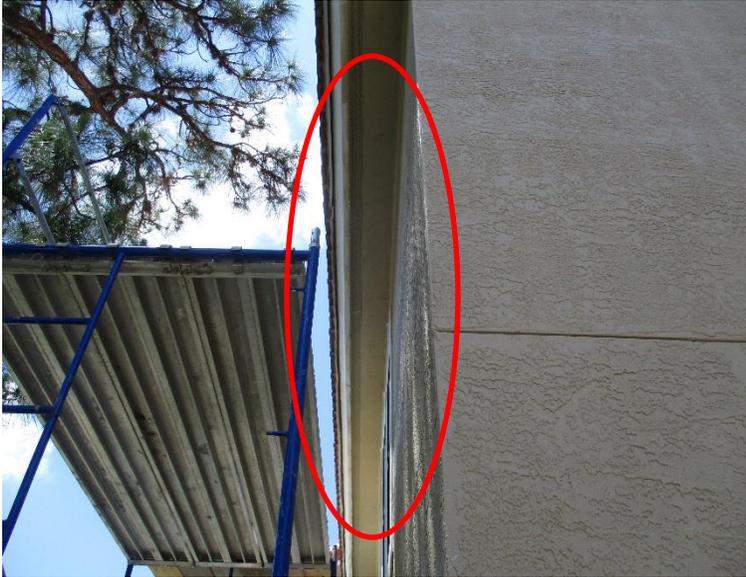
PHOTOGRAPH #1

Contractor has installed new soffit screen with vinyl perforated soffit screen to match previous soffit screen.

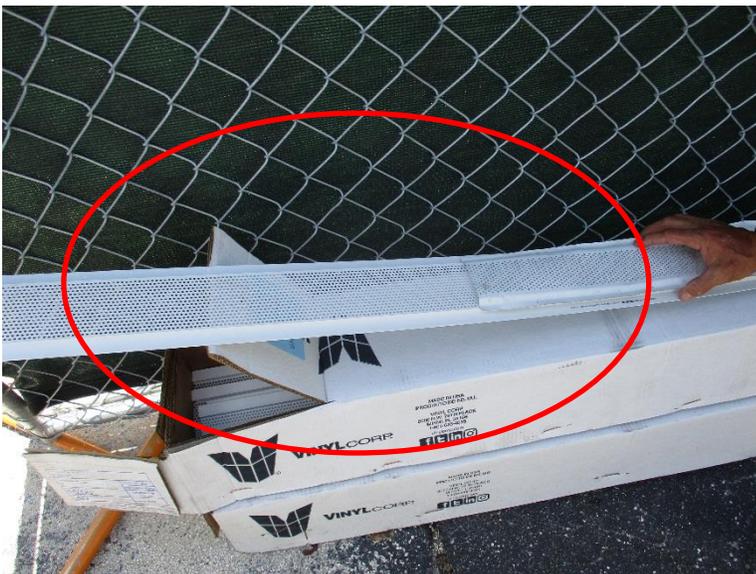
PHOTOGRAPH #2

Contractor has installed new soffit screen with vinyl perforated soffit screen to match previous soffit screen.

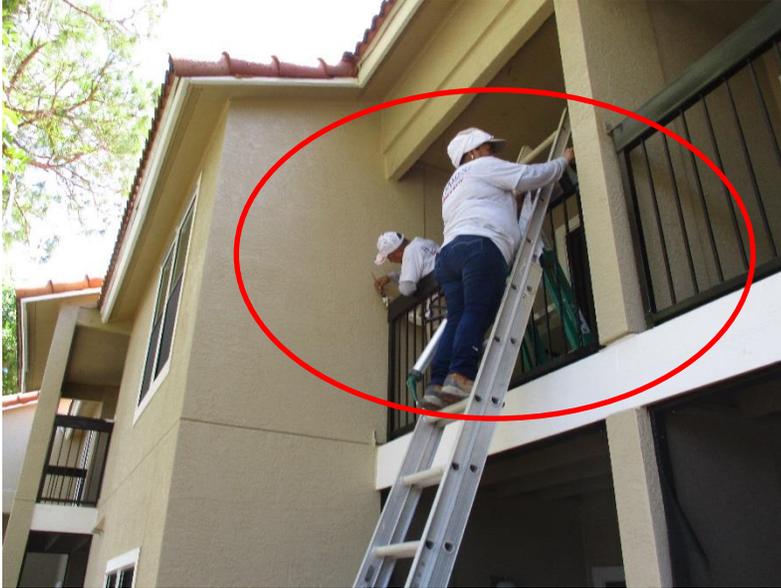
PHOTOGRAPH #3

Contractor has re-installed newly painted railings and is touching up welded angle attachments and fasteners.

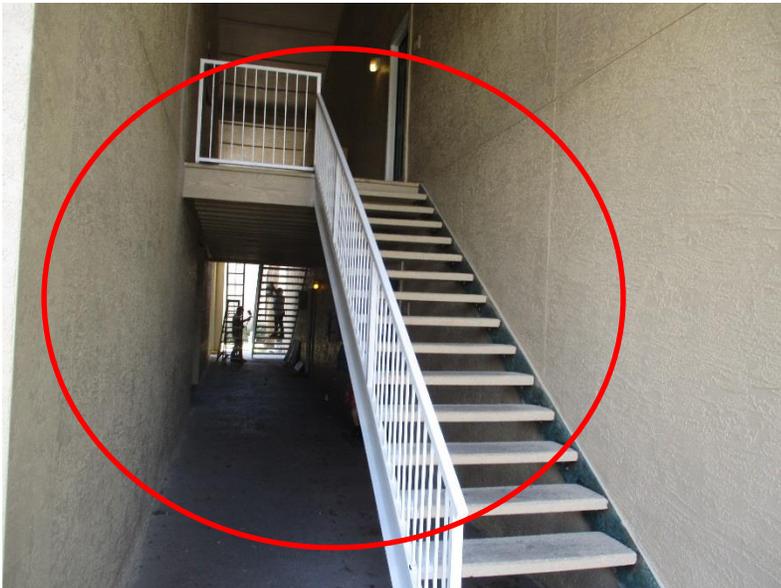
PHOTOGRAPH #4

Contractor has painted walls and primed stairway railings at breezeway area.

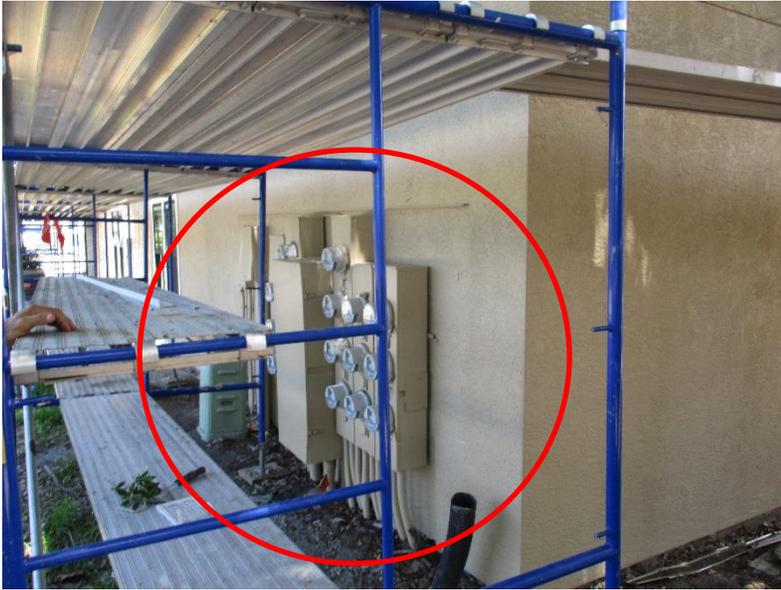
PHOTOGRAPH #5

Contractor has completed flashing, stucco and painting at FPL boxes.

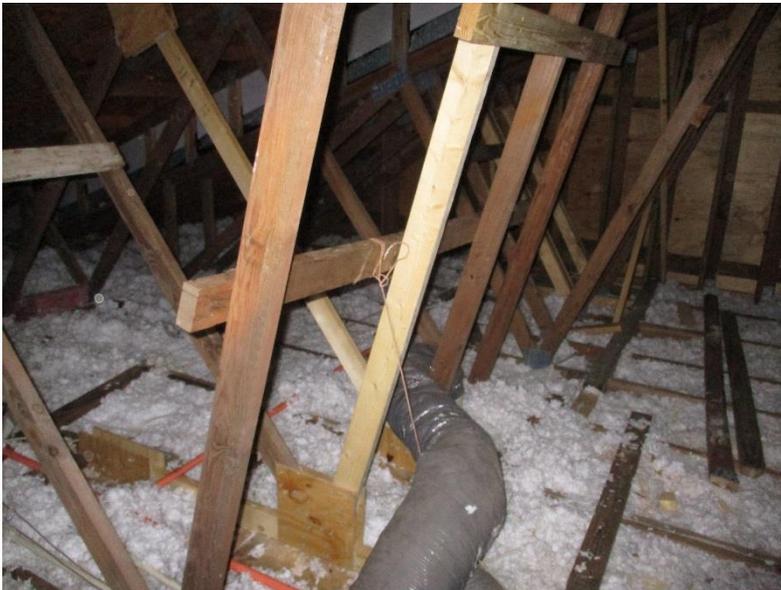
PHOTOGRAPH #6

Contractor has replaced full truss members where extensive termite damage was previously identified for repairs.

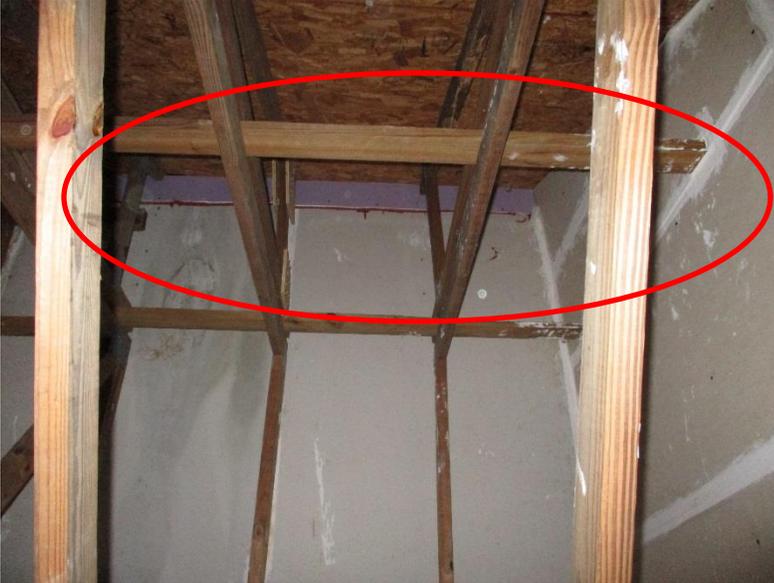
PHOTOGRAPH #7

Fire wall repairs made with Type X fire rated drywall.

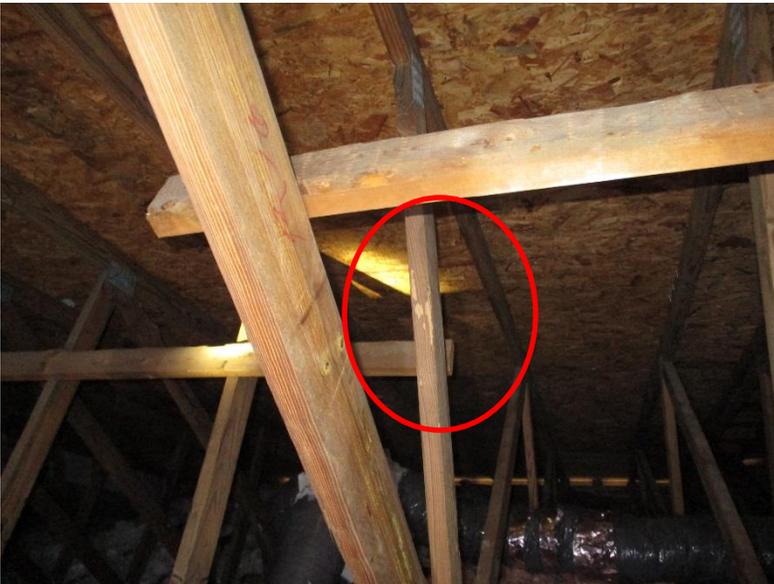
PHOTOGRAPH #8

Contractor identified termite damage at truss locations that were not previously identified from reports. Damage observed not acceding 20% of member integrity will not be repaired as part of current scope of work.
