**FIELD OBSERVATION REPORT - Bldg. #25**

Permit No. 18-146012-00 BC  
 Owner: Vintage Grand Condo Assn., Inc.  
 Project Address: 4017 Crockers Lake Blvd., Sarasota, FL  
 Contractor: RL James Inc  
 Inspector (s): Mark Boss  
 Type of Assessment: Progress

Project: R1503-302D  
 Contact: Glenn Ateili  
 Phone/Fax: (941) 923-7380  
 Contact: Craig Nicholas / Robert Branscombe  
 Phone: (941)232-6486 / (239) 379-1978

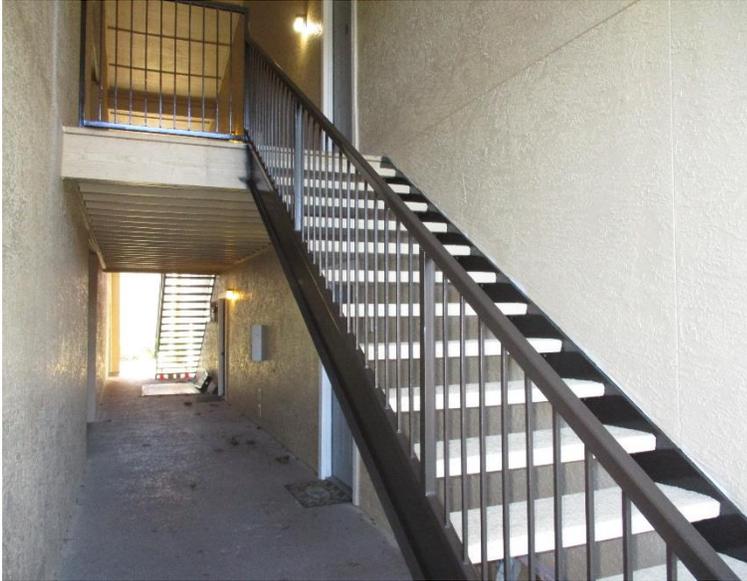
PHOTOGRAPH #1

Elevation	Demo	Gable Bracing	Gable Vents	Framing & strapping	Sheathing	Soffit	Window flashing	Window Install	Stucco Lath Acc	Stucco	Sealant	Painting	Punch	Comments
A	X	NA	NA	X	X	X	X	X	X	X	X	X		
B	X	NA	NA	X	X	X	X	X	X	X	X	X		
C	X	NA	NA	X	X	X	X	X	X	X	X	X		Contractor has finish painted stairway railings and steps ( <b>Photograph #1</b> ) Unit #2517 - Contractor has prepped and primed front entrance metal doors ( <b>Photograph #2</b> ). Contractor is repairing drywall returns and damaged areas of interior drywall at new window locations ( <b>Photograph #3</b> ). Contractor has transitioned new stucco to existing stucco with stucco stop and sealant control joint ( <b>Photograph #4</b> ).
D	X	X	X	X	X	X	X	X	X	X	X	X		
E	X	NA	NA	X	X	X	X	X	X	X	X	X		
F	X	NA	NA	X	X	X	X	X	X	X	X	X		
G	X	NA	NA	X	X	X	X	X	X	X	X	/		
H	X	X	X	X	X	X	X	X	X	X	X	X

### **BUILDING 25 SECTION C**

Contractor has finish painted stairway railings and steps.

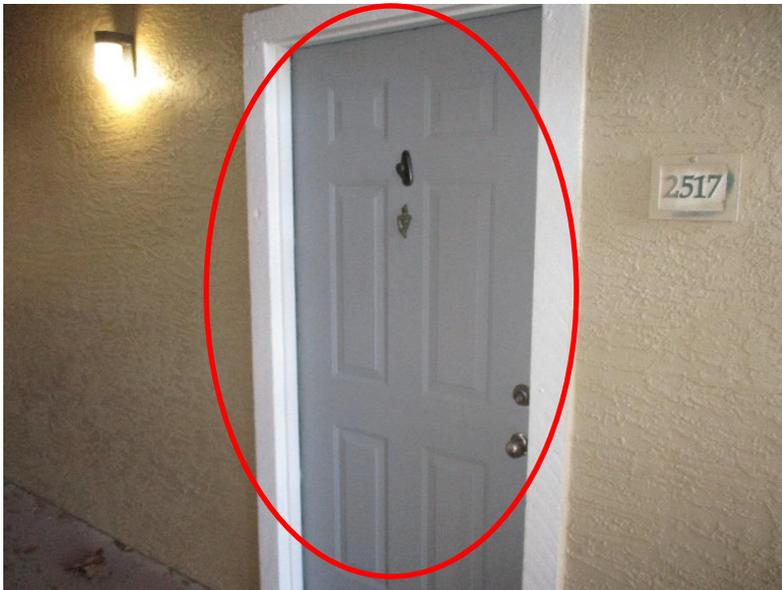
PHOTOGRAPH #2

### **BUILDING 25 UNIT #2517**

Contractor has prepped and primed front entrance metal doors.

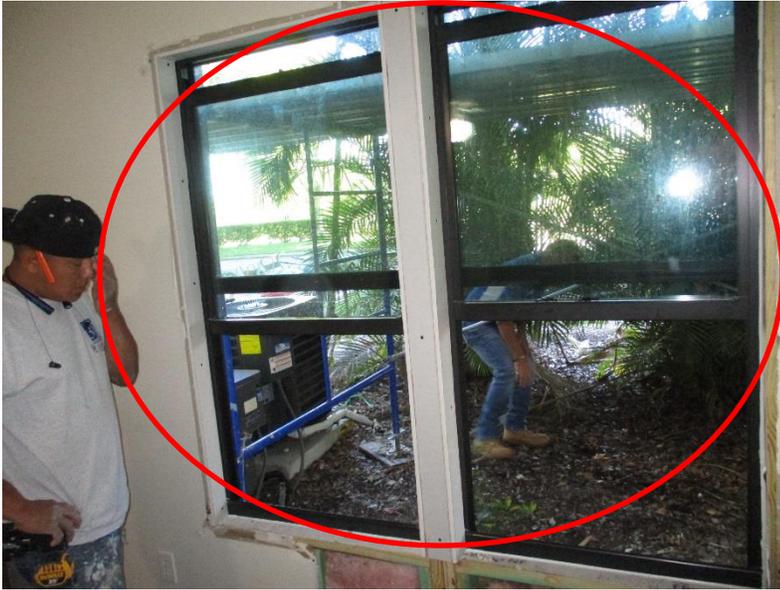
**PHOTOGRAPH #3**

**BUILDING 25  
UNIT #2517**

Contractor is repairing drywall returns and damaged areas of interior drywall at new window locations.

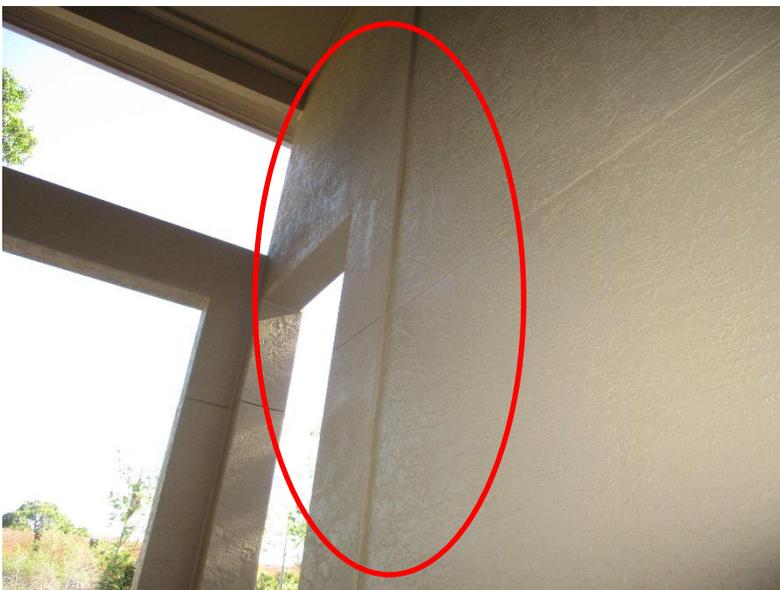
**PHOTOGRAPH #4**

**BUILDING 25  
SECTION C BREEZWAY**

Contractor has transitioned new stucco to existing stucco with stucco stop and sealant control joint.

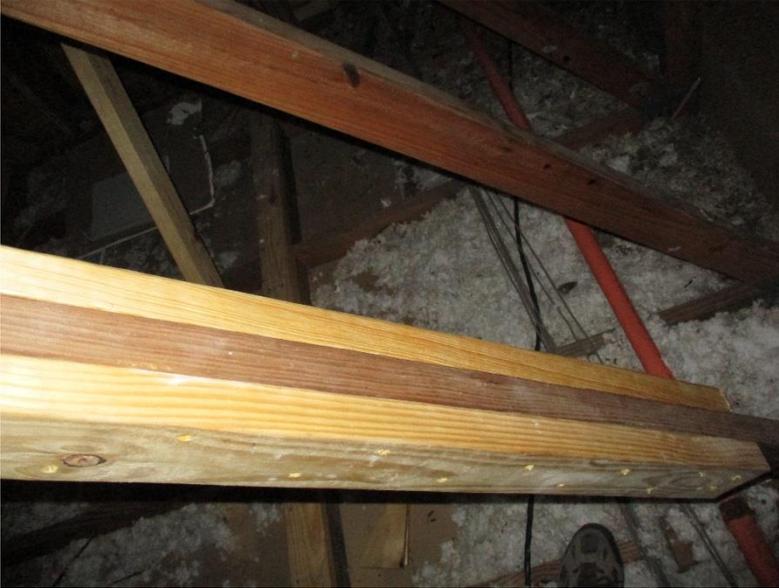
**PHOTOGRAPH #5**

Unit	Demo	Truss Repairs	Fire Wall Repairs	Punch	Comments
2821	X	X	X	X	Contractor has repaired damaged truss with new scab detail (Photograph #5). Fire wall repairs made with Type X fire rated drywall (Photograph #6).
2822	X	X	X	X	Contractor has repaired damaged truss members with scab repair detail (Photograph #7). Contractor has repaired damaged truss members with scab repair detail (Photograph #8).
2823	X	X	X	X	Contractor identified termite damage at truss locations that were not previously identified from reports. Damage observed not acceding 20% of member integrity will not be repaired as part of current scope of work.
2824	X	X	X	X	Contractor has replaced full truss members where extensive termite damage was previously identified for repairs. Fire wall repairs made with Type X fire rated drywall.

**BUILDING 28  
UNIT #2821 ATTIC**

Contractor has repaired damaged truss with new scab detail.

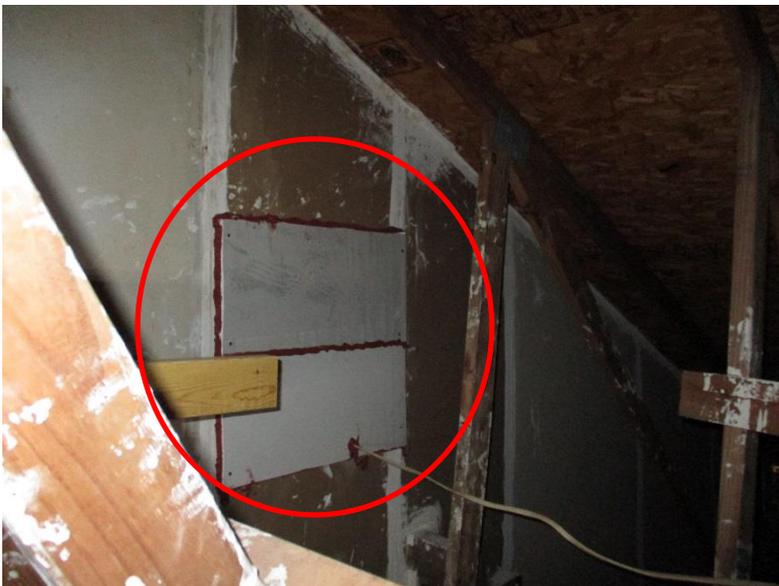
**PHOTOGRAPH #6**

**BUILDING 28  
UNIT #2821 ATTIC**

Fire wall repairs made with Type X fire rated drywall.

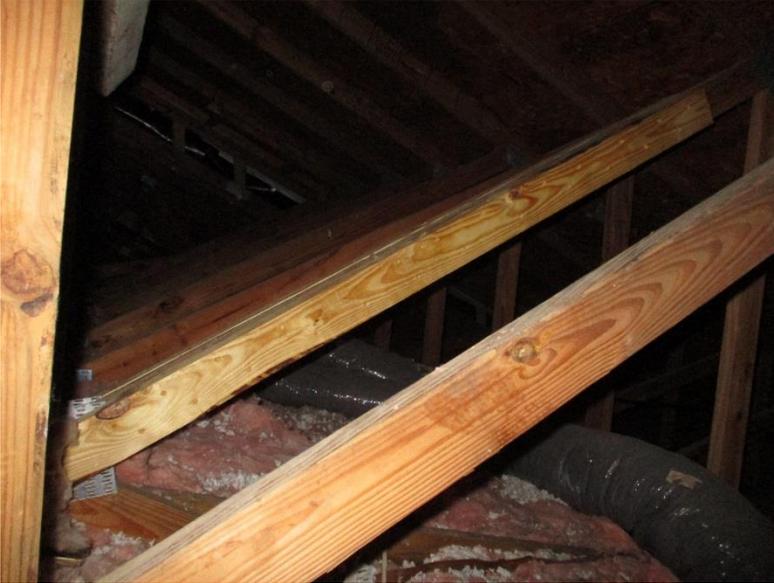
**PHOTOGRAPH #7**

**BUILDING 28  
UNIT #2822 ATTIC**

Contractor has repaired damaged truss members with scab repair detail.

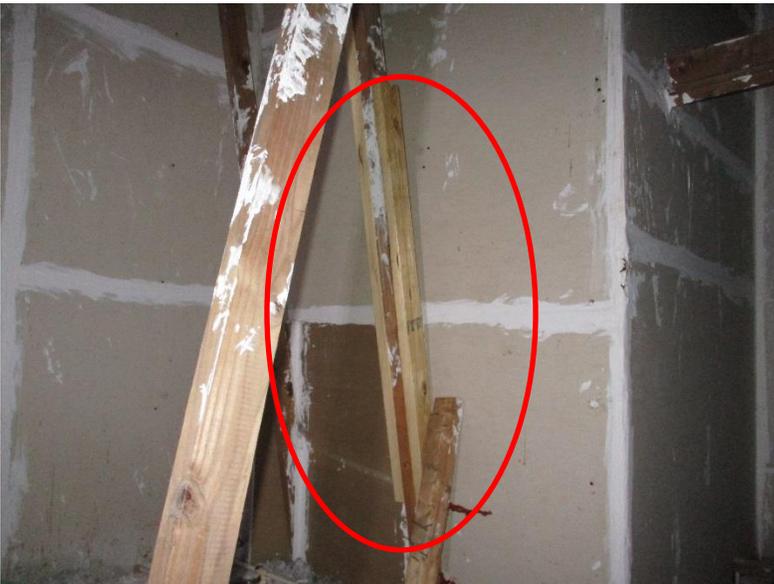
**PHOTOGRAPH #8**

**BUILDING 28  
UNIT #2822 ATTIC**

Contractor has repaired damaged truss members with scab repair detail.

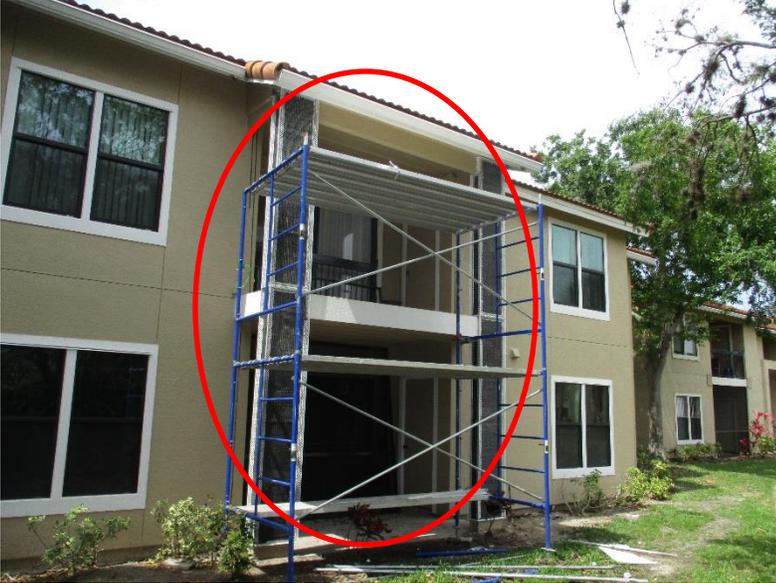
**PHOTOGRAPH #9**

Elevation	Demo	Gable Bracing	Gable Vents	Framing & strapping	Sheathing	Soffit	Window flashing	Window Install	Stucco Lath Acc	Stucco	Sealant	Painting	Punch	Comments
A	X	NA	NA	X	X	X	X	X	X	X	X	X	X	
B	X	NA	NA	X	X	X	X	X	X	X	X	X	X	
C	X	X	X	X	X	X	X	X	X	X	X	X	X	
D	X	NA	NA	X	X	X	X	X	X	X	X	X	/	Units - 1422 and 1412- Contractor has provided WRB, stucco accessories and lathing in preparation for new stucco at repaired columns (Photograph #9).
E	X	NA	NA	X	X	X	X	X	X	X	X	X	X	
F	X	X	X	X	X	X	X	X	X	X	X	X	X

1. Units- 1422 and 1412- balcony columns are not plum or square top to bottom, and will not be acceptable finished repairs. This item will be added to the punch list for building completion.  
 2. Punch List- Final grounds clean up and damage to be discussed with and resolved with management.

**BUILDING 14  
UNIT #1422 BALCONY**

Contractor has provided WRB, stucco accessories and lathing in preparation for new stucco at repaired columns.

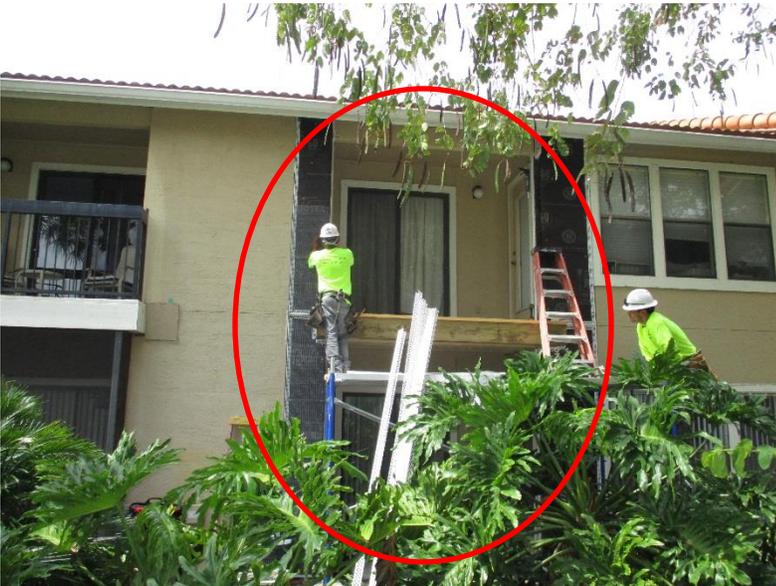
**PHOTOGRAPH #10**

Unit	Demo	Framing & strapping	Sheathing	Stucco	Sealant	Painting	Punch	Comments
1324	X	X	X					Contractor is proving WRB, stucco accessories and lathing in preparation for new stucco at balcony repairs (Photograph #10).

**BUILDING 13  
UNIT #1324 BALCONY**

Contractor is proving WRB, stucco accessories and lathing in preparation for new stucco at balcony repairs.

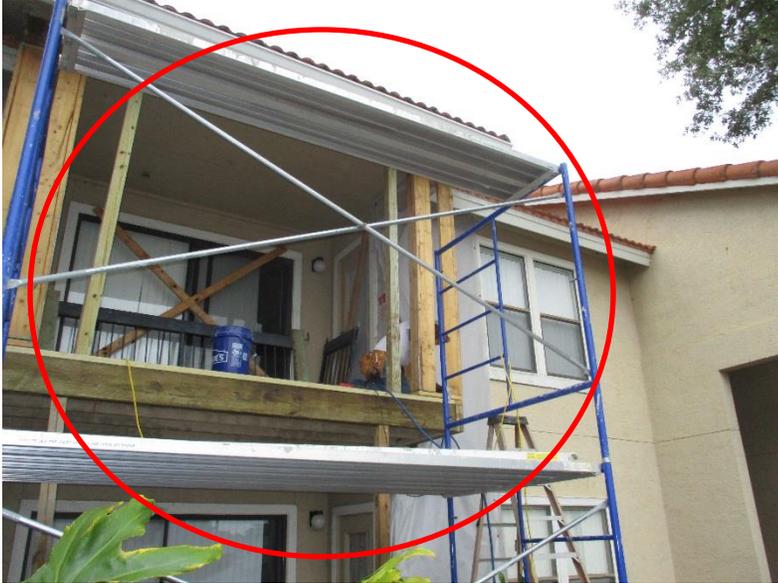
**PHOTOGRAPH #11**

Unit	Demo	Framing & strapping	Sheathing	Stucco	Sealant	Painting	Punch	Comments
1824A	X	/						Contractor rebuilding upper columns and built up beam (Photograph #11). Contractor has poured new column pedestals (Photograph #12).

**BUILDING 18  
UNIT #1824 BALCONY**

Contractor rebuilding upper columns and built up beam.

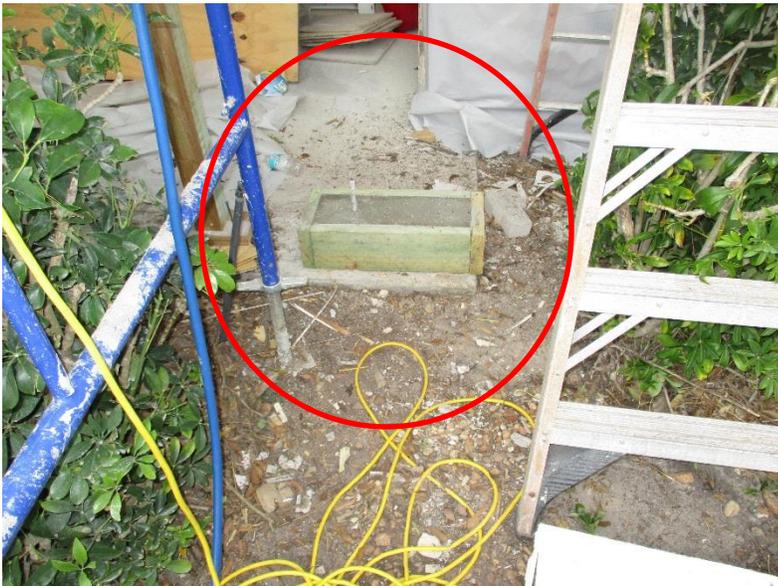
**PHOTOGRAPH #12**

**BUILDING 18  
UNIT #1824 BALCONY**

Contractor has poured new column pedestals.
