FIELD OBSERVATION REPORT - Bldg. #25

Permit No. 18-146012-00 BC
 Owner: Vintage Grand Condo Assn, Inc.
 Project Address: 4017 Crockers Lake Blvd., Sarasota, FL
 Contractor: RL James Inc
 Inspector (s): Mark Boss
 Type of Assessment: Progress

Project: R1503-302D
 Contact: Glenn Ateili
 Phone/Fax: (941) 923-7380
 Contact: Craig Nicholas / Robert Branscombe
 Phone: (941)232-6486 / (239) 379-1978

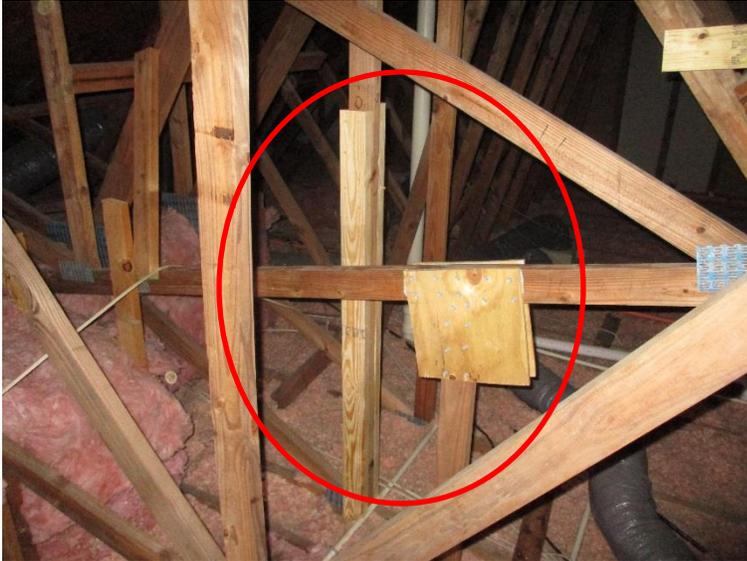
PHOTOGRAPH #1

**BUILDING 25
ATTIC 2523**

Contractor has made repairs at gussets and damaged truss members.

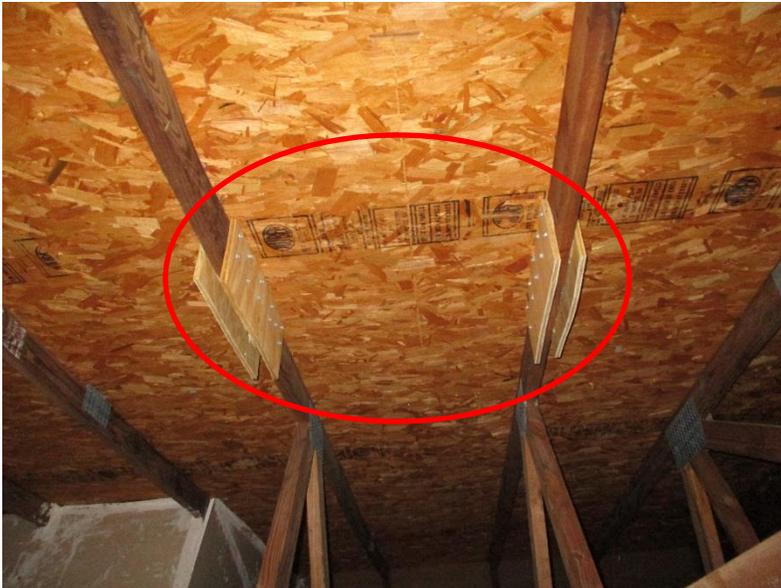
PHOTOGRAPH #2

**BUILDING 25
ATTIC 2524**

Contractor has made repairs at gussets and damaged truss members.

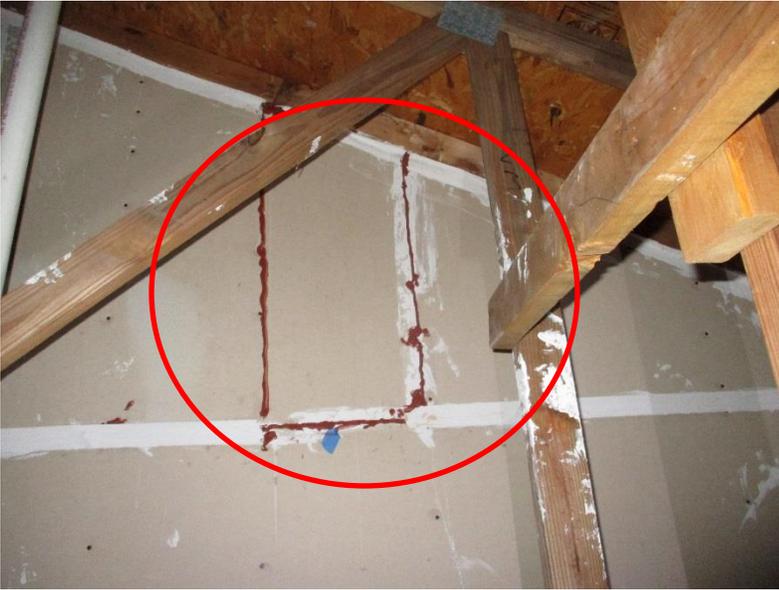
PHOTOGRAPH #3

**BUILDING 25
ATTIC 2525**

Contractor has made repairs at damaged or missing Type X fire rated gypsum board.

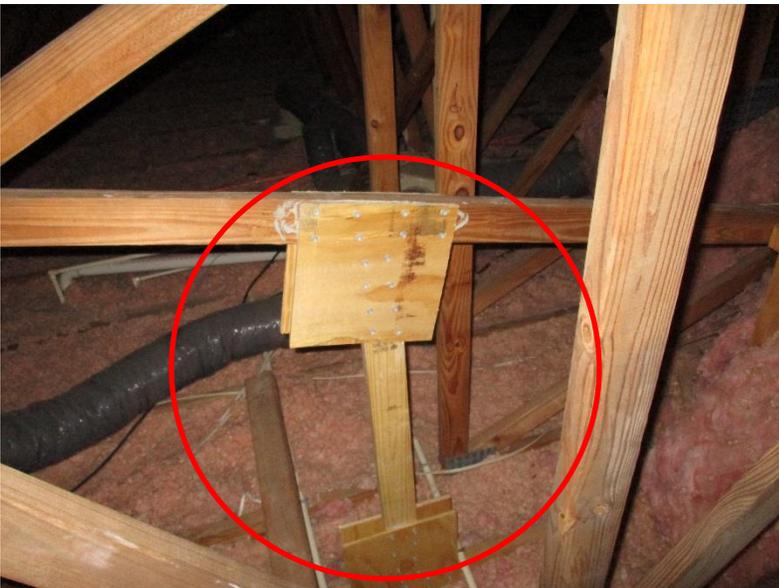
PHOTOGRAPH #4

**BUILDING 25
ATTIC 2526**

Contractor has made repairs at gussets and damaged truss members.

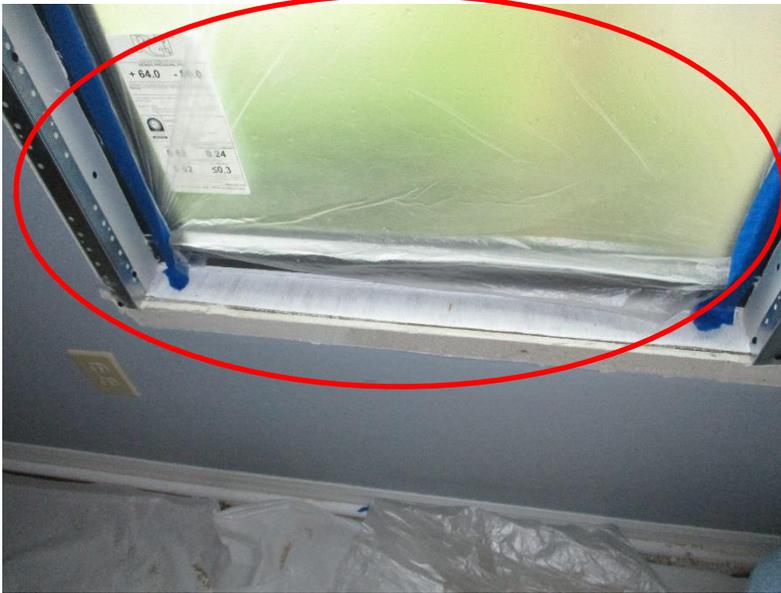
PHOTOGRAPH #5

**BUILDING 25
UNIT #2526**

Contractor is repairing and replacing interior drywall at window returns.

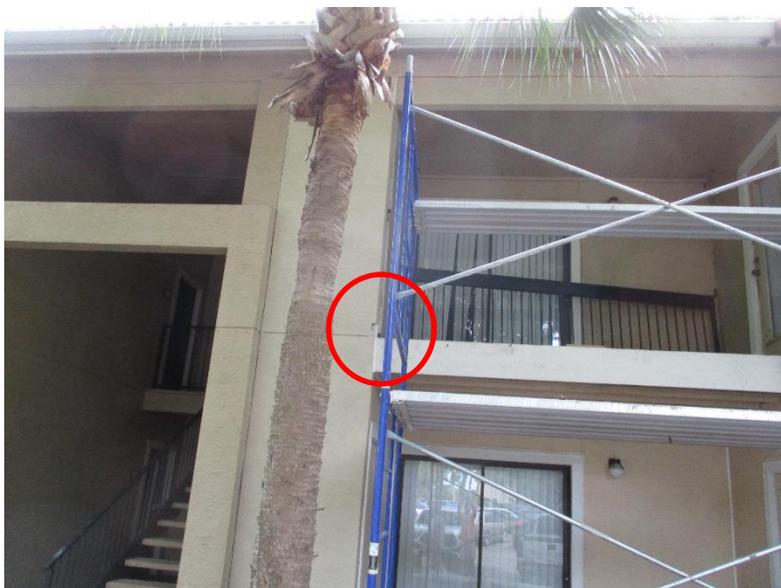
PHOTOGRAPH #6

Unit	Demo	Framing & strapping	Sheathing	Stucco	Sealant	Painting	Punch	Comments
727	X	X	X	/		/		Stucco has been corrected at new upper cedar beam and new stucco has been primed. Stucco does not cover balcony kick out flashing properly and will require repairs (Photograph #6).

**BUILDING 7
UNIT #727 BALCONY**

Stucco has been corrected at new upper cedar beam and new stucco has been primed. Stucco does not cover balcony kick out flashing properly and will require repairs.

1. Stucco does not cover balcony kick out flashing properly and will require repairs (**Photograph #6**).

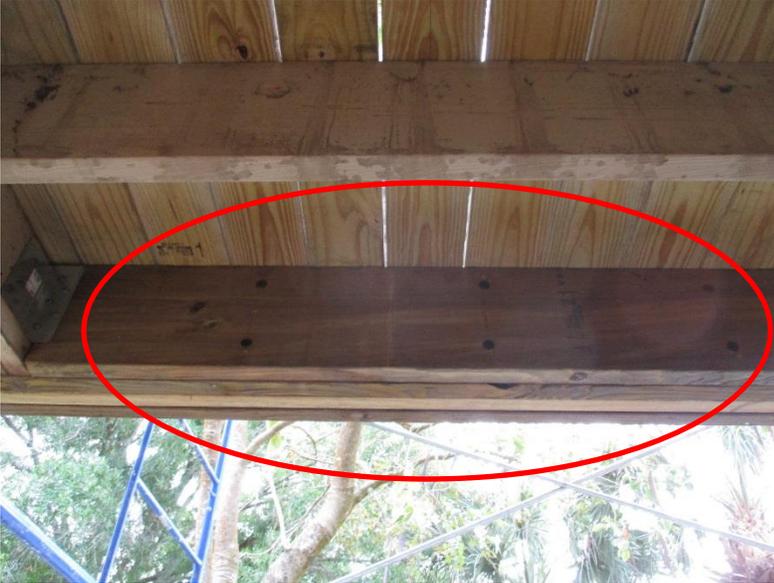
PHOTOGRAPH #7

**BUILDING 13
UNIT #1324 BALCONY**

Contractor has provided Simpson Strong #SDW22458 screws at built up beam.

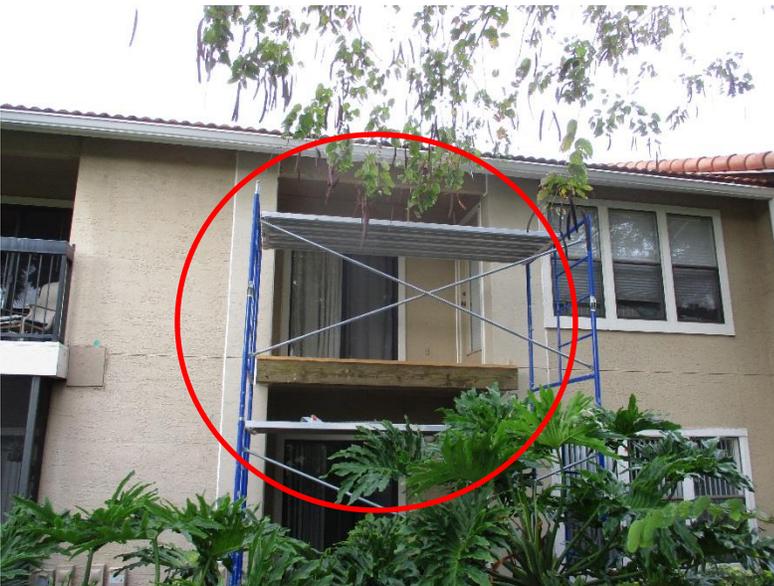
PHOTOGRAPH #8

**BUILDING 13
UNIT #1324 BALCONY**

Contractor has primed new stucco and begun sealant work at joints and transitions.

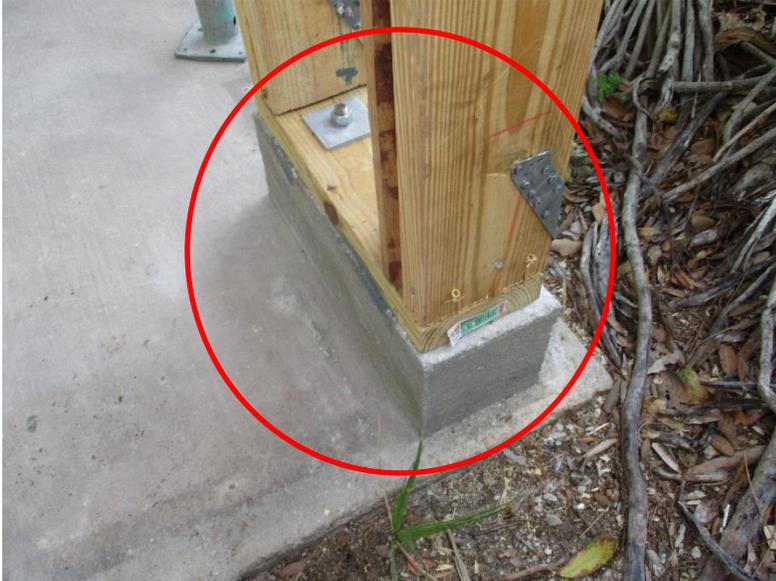
PHOTOGRAPH #9

**BUILDING 18
UNIT #1824 BALCONY**

Contractor has replaced base plates with pressure treated 2x6 PT as required.

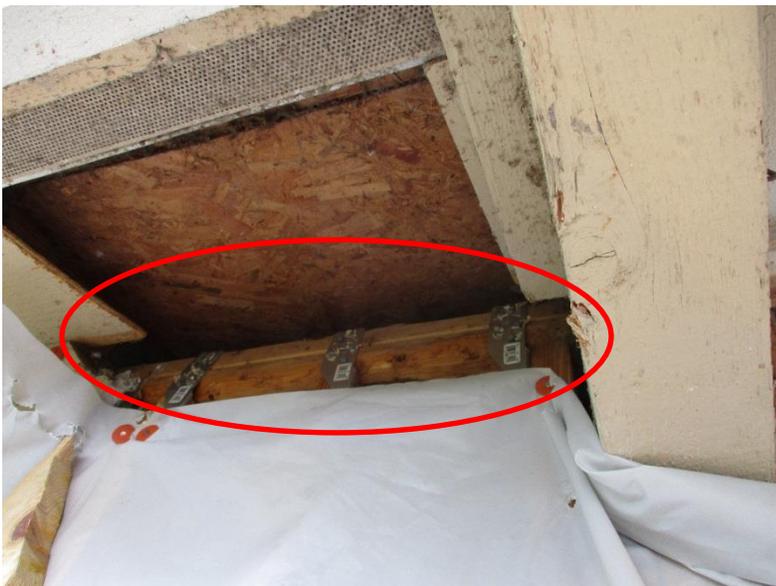
PHOTOGRAPH #10

**BUILDING 18
UNIT #1824 BALCONY**

Contractor has removed previous sheathing and provided Simpson Strong connectors at top plates and truss connections as required.
