## PHOTOGRAPHS

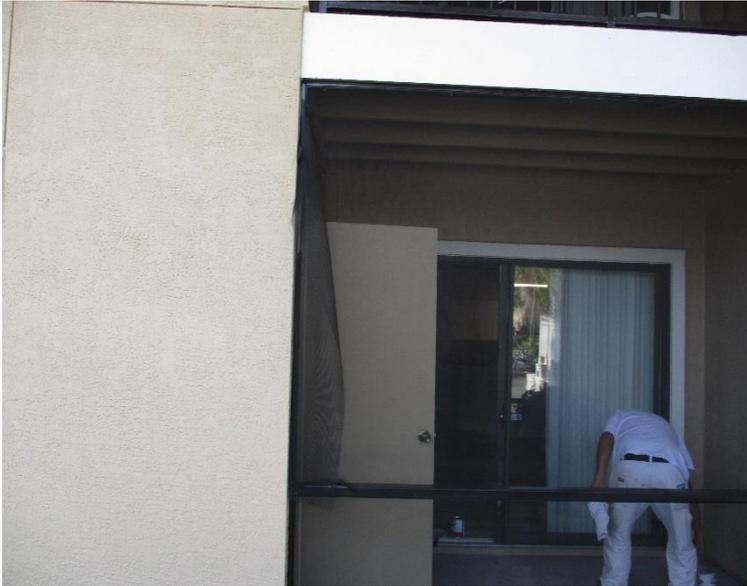
PHOTOGRAPH #1

### **BUILDING 25 SECTION A**

Delta and the property manager walked the site with the contractor to develop the punch list. Screening is not complete at screen enclosures.

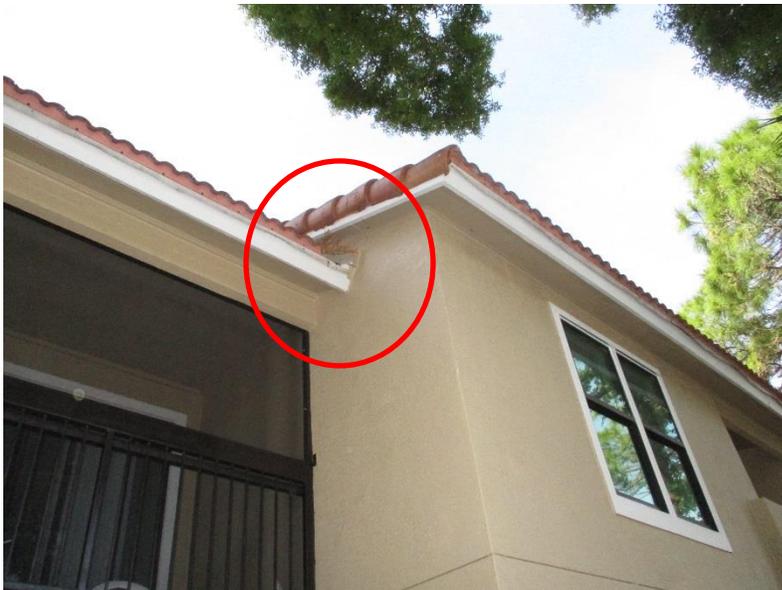
PHOTOGRAPH #2

### **BUILDING 25 SECTION A**

Delta and the property manager walked the site with the contractor to develop the punch list. Roofing tile has not been re-installed at new kick out flashings.

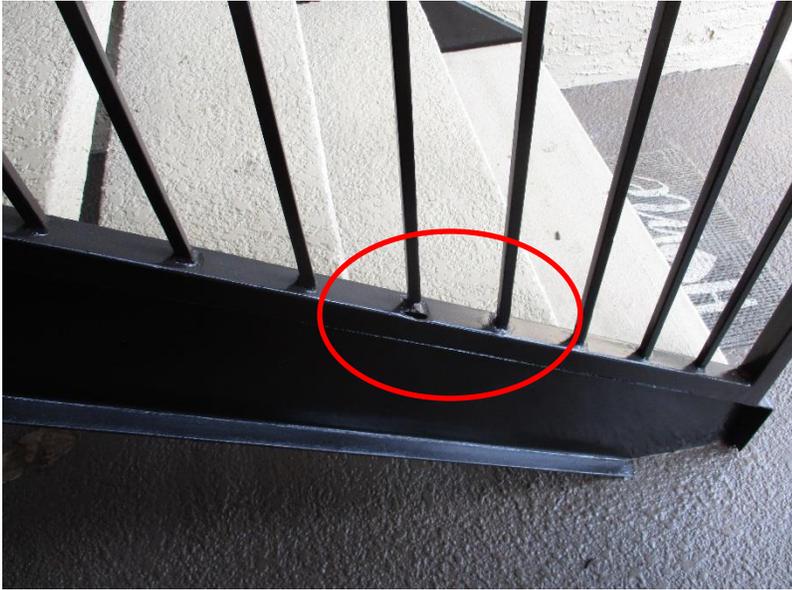
**PHOTOGRAPH #3**

**BUILDING 25  
SECTION B**

Several locations at steel railing have holes. Contractor will have additional welding done at a time and material rate as per contract documents.

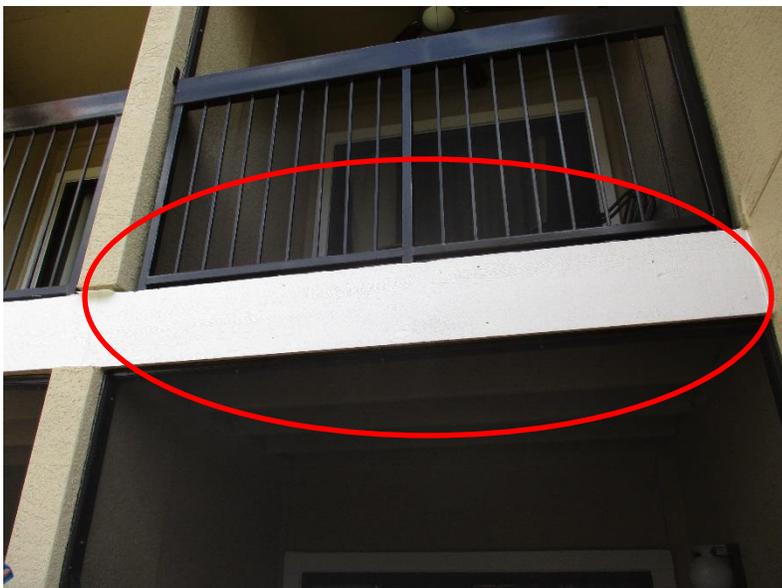
**PHOTOGRAPH #4**

**BUILDING 25  
SECTION F**

Delta and the property manager walked the site with the contractor to develop the punch list. Additional patching and touch ups are required at built up beam's cedar trim.

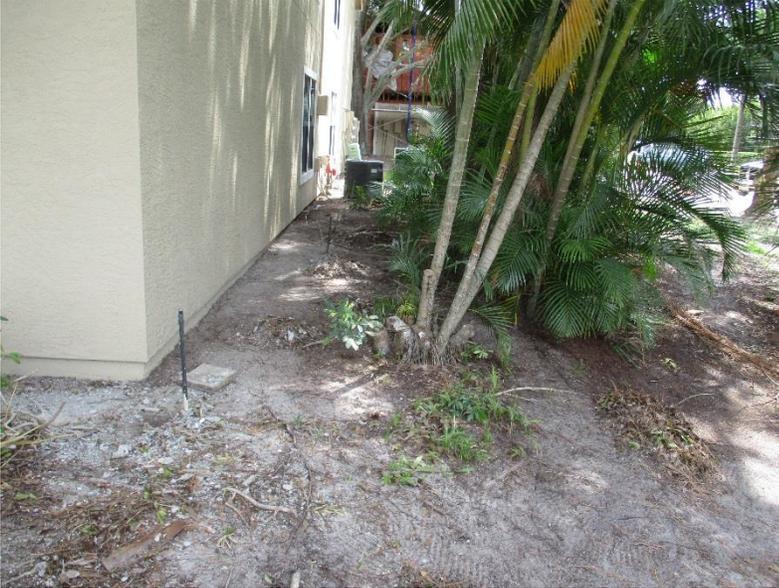
**PHOTOGRAPH #5**

**BUILDING 25  
SECTION D**

Contractor has begun final clean up of grounds.

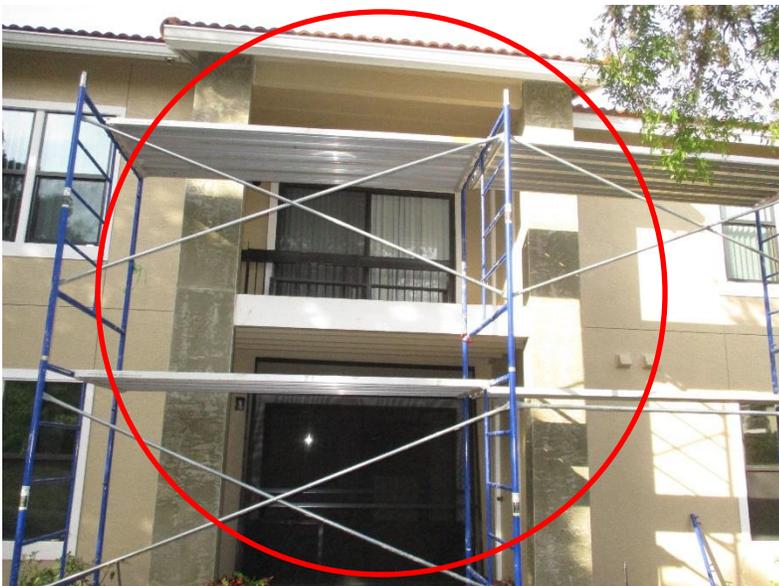
**PHOTOGRAPH #6**

**BUILDING 14  
UNIT #1422 BALCONY**

New stucco system has been provided at repaired columns.

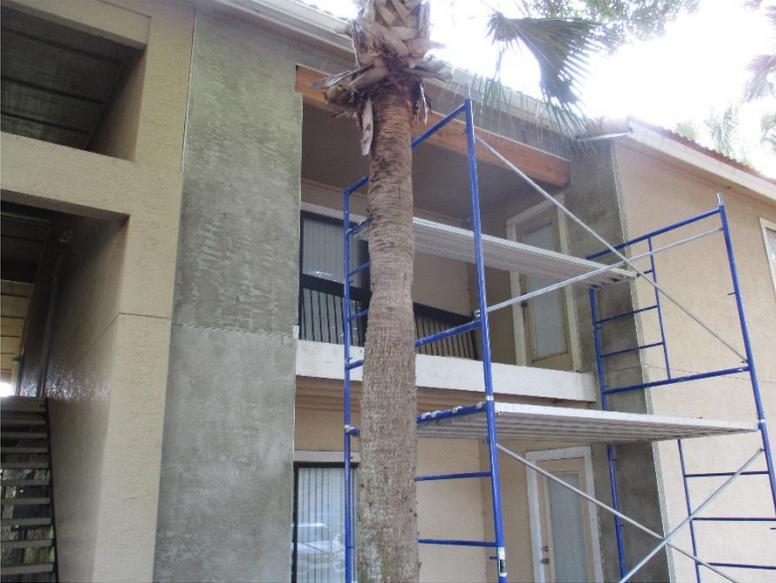
**PHOTOGRAPH #7**

**BUILDING 7  
UNIT #727 BALCONY**

New stucco system has been provided at repairs.

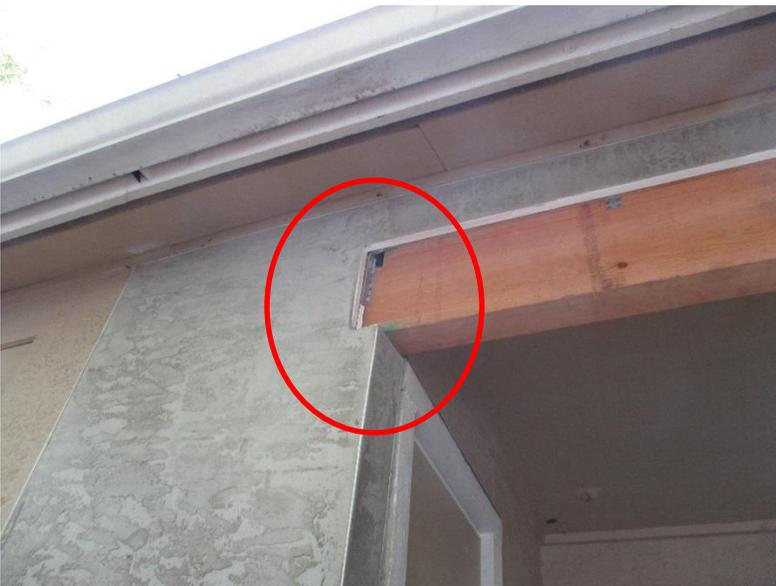
**PHOTOGRAPH #8**

**BUILDING 7  
UNIT #727 BALCONY**

Stucco transition at new beam is not in line with wall and does not cover beam properly.

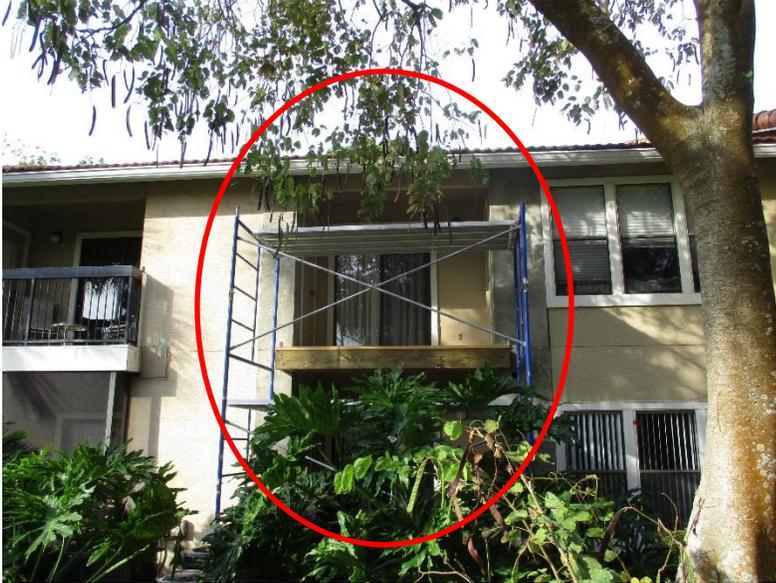
**PHOTOGRAPH #9**

**BUILDING 13  
UNIT #1324 BALCONY**

New stucco system has been provided at repairs.

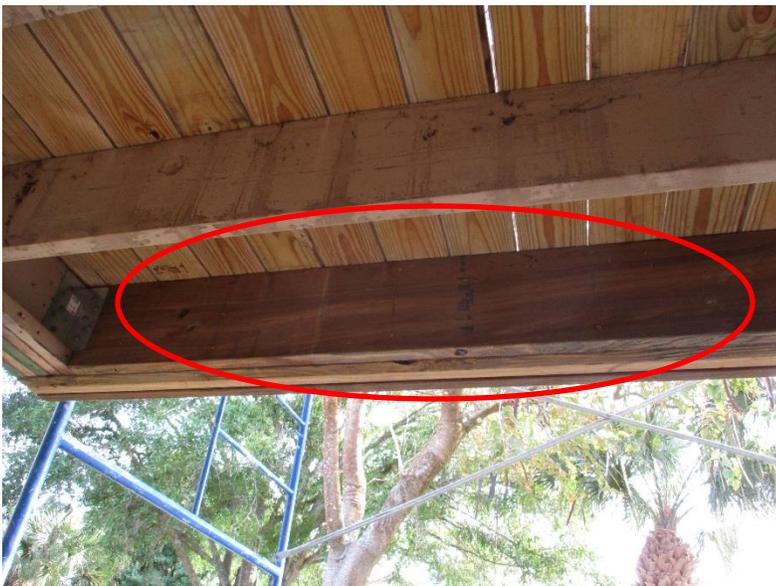
**PHOTOGRAPH #10**

**BUILDING 13  
UNIT #1324 BALCONY**

Contractor has not provided Simpson Strong #SDW22458 screws at built up beam.

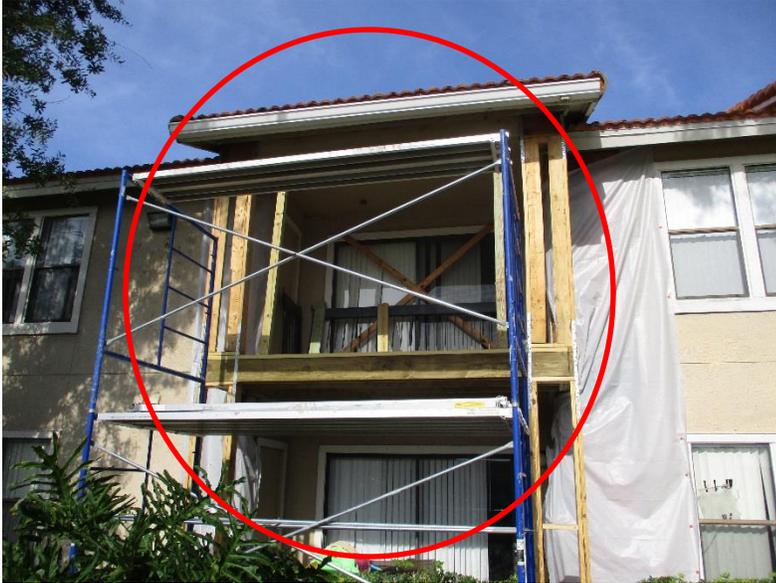
**PHOTOGRAPH #11**

**BUILDING 18  
UNIT #1824 BALCONY**

Contractor has provided built up beam and column repairs.

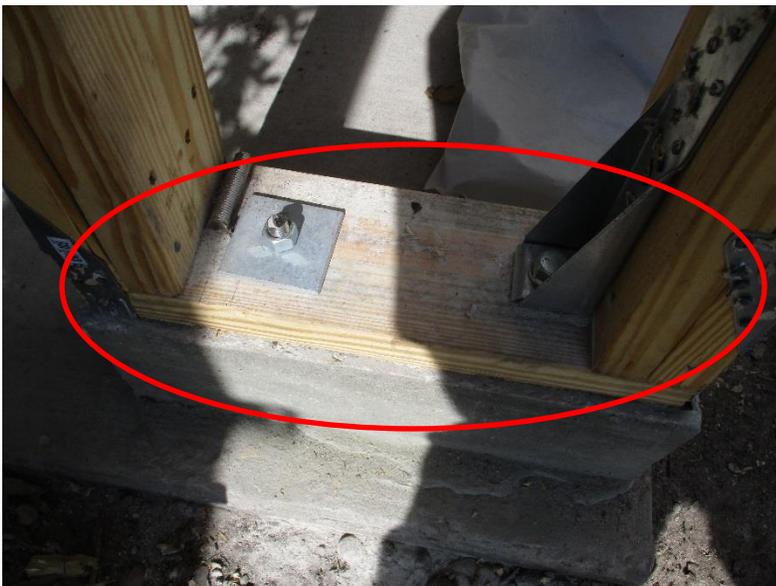
**PHOTOGRAPH #12**

**BUILDING 18  
UNIT #1824 BALCONY**

Contractor did not install pressure treated 2X6 bottom plate as required. Replacement with specified PT material is required.

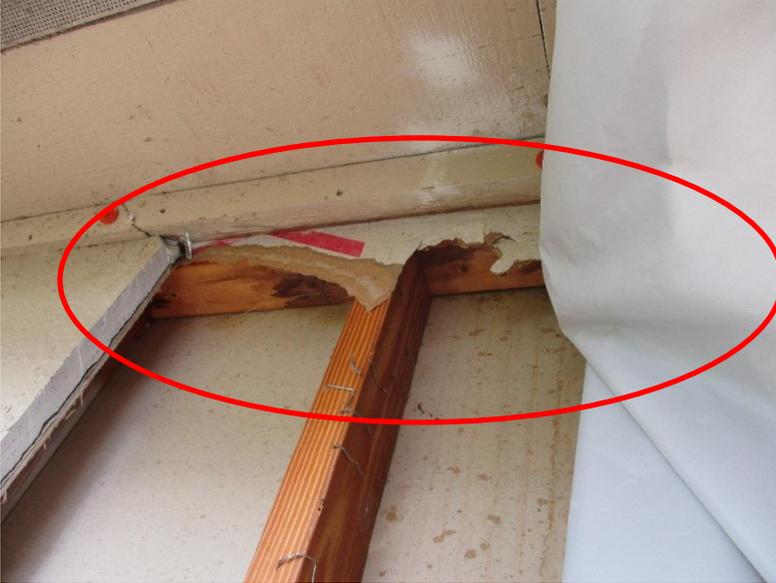
**PHOTOGRAPH #13**

**BUILDING 18  
UNIT #1824 BALCONY**

Contractor has not provided removal of previous sheathing or Simpson Strong connectors at top plates and truss connections.

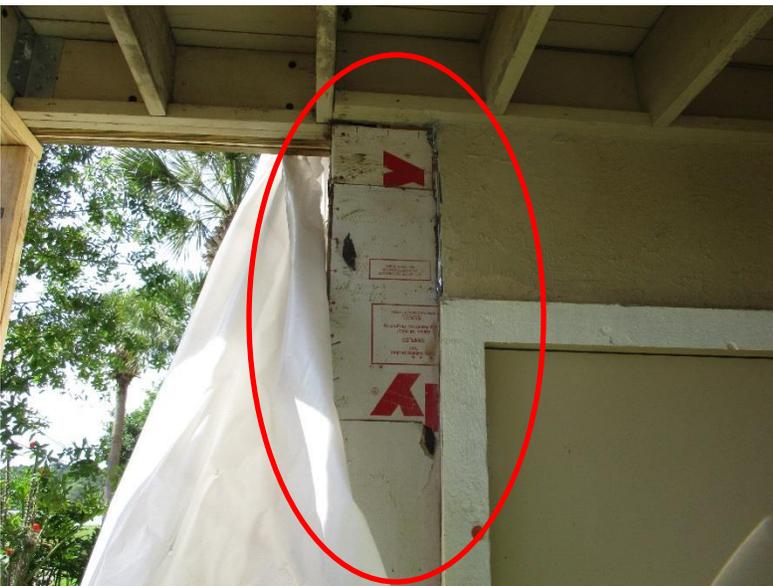
**PHOTOGRAPH #14**

**BUILDING 18  
UNIT #1824 BALCONY**

Contractor has not provided removal of previous sheathing in order to proceed with repairs.
