PHOTOGRAPHS

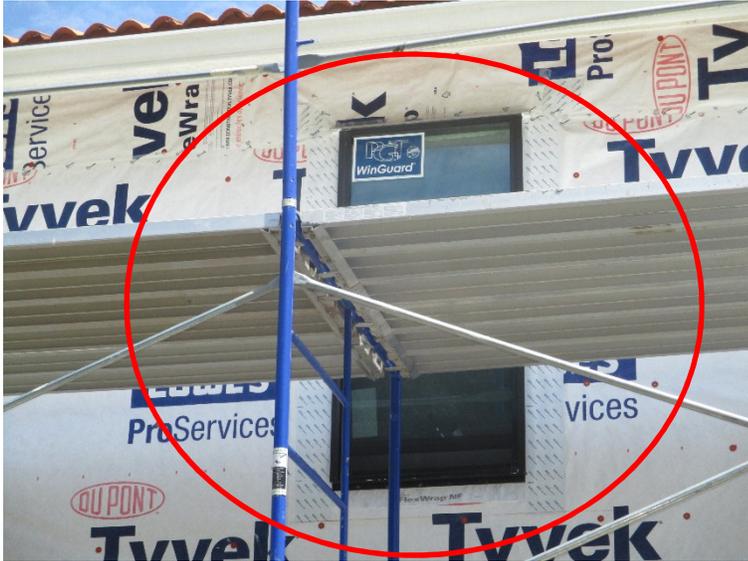
PHOTOGRAPH #1

**BUILDING 24
SECTION G**

Contractor has made corrections to Tyvek HomeWrap by extending Dupont flashing at head of window past jamb flashing and extending jamb flashing past window sill.

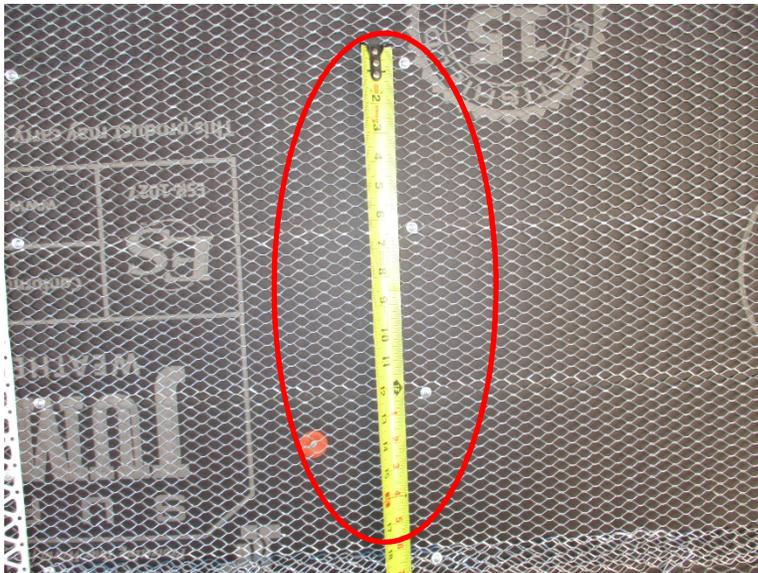
PHOTOGRAPH #2

**BUILDING 24
SECTION D**

Stucco lath attached to wall studs at framing members no more that seven inches.

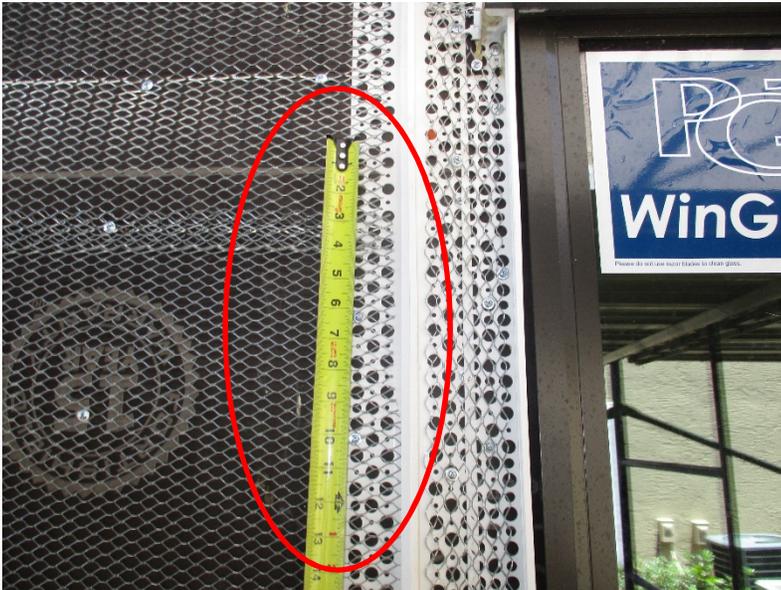
PHOTOGRAPH #3

**BUILDING 24
SECTION D**

Stucco lath overlapped minimum one-inch wire to wire and accessories flanges attached at no more than seven-inch intervals.

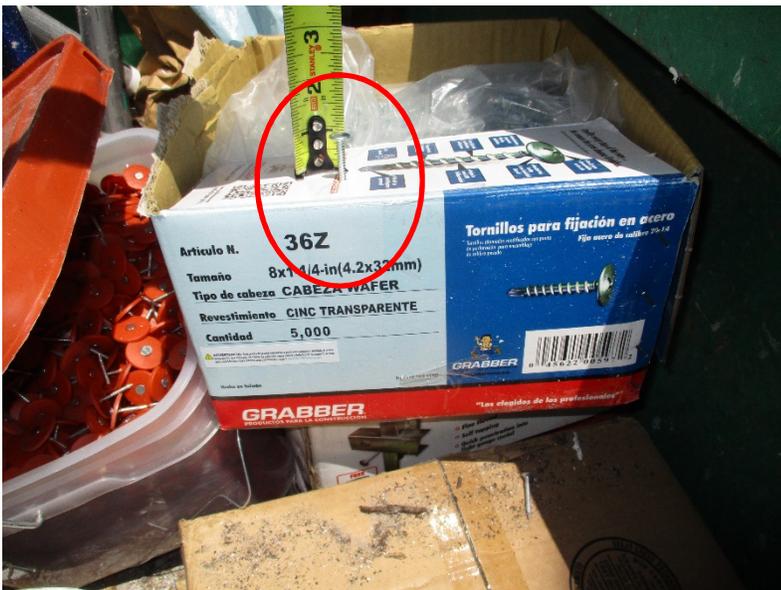
PHOTOGRAPH #4

**BUILDING 24
SECTION D**

Stucco lath and accessories attached with wafer pan head 8 x 1-1/4-inch screws.

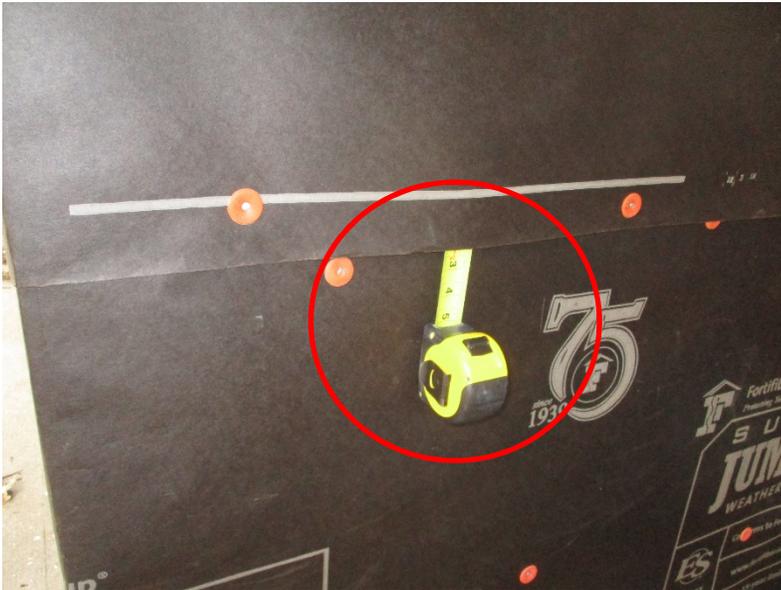
PHOTOGRAPH #5

**BUILDING 24
SECTION B**

JUMBO TEX WRB overlapped minimum of two inches at horizontal overlaps.

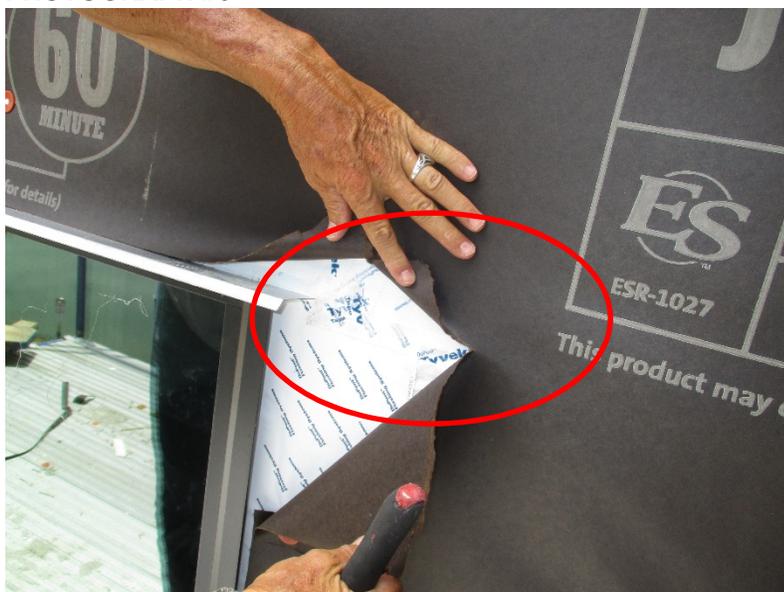
PHOTOGRAPH #6

**BUILDING 24
SECTION H**

Window head flashing and Tyvek HomeWrap has been completed at new windows and ready for JUMBO TEX WRB.

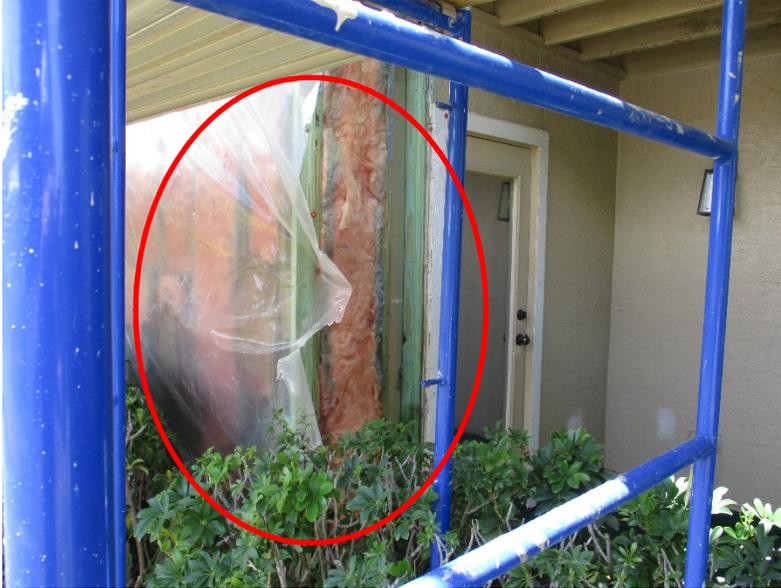
PHOTOGRAPH #7

**BUILDING 24
SECTION E**

Bora - Care terminate treatment has been applied at framing members.

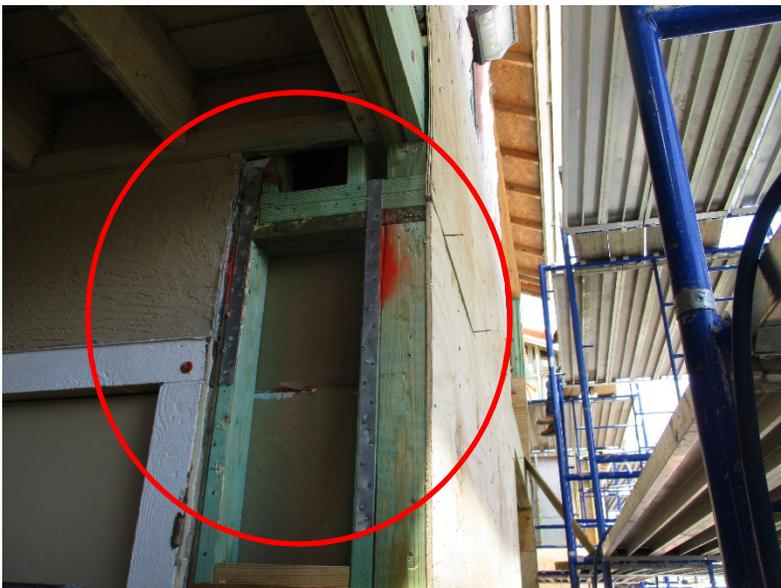
PHOTOGRAPH #8

**BUILDING 24
SECTION F**

Framing straps at balcony wall have been installed and approved for termite treatment and insulation.

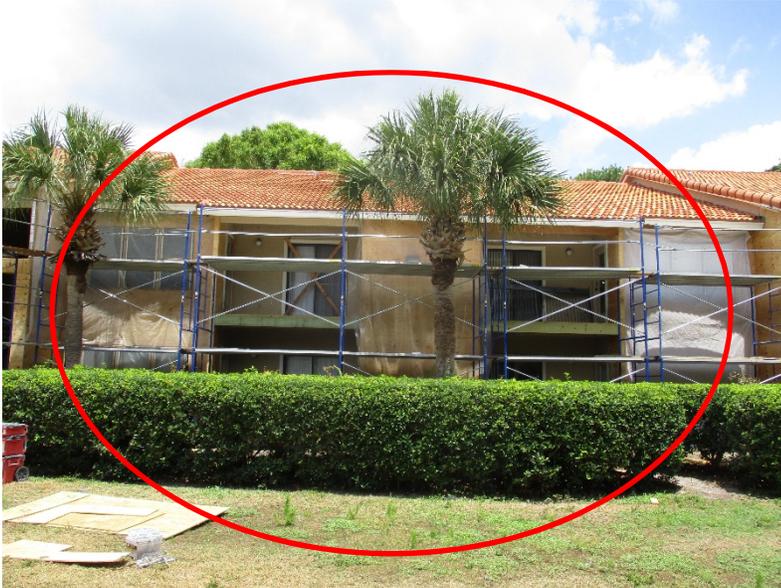
PHOTOGRAPH #9

**BUILDING 24
SECTION F**

Contractor has completed sheathing in preparation for Tyvek WRB and window installation.

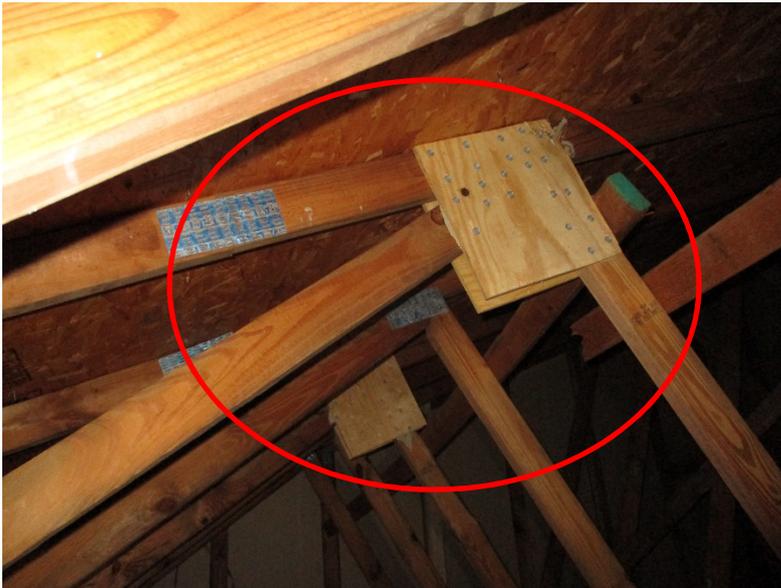
PHOTOGRAPH #10

**BUILDING 24
ATTIC 2425**

Truss scabs, gusset repairs, fire rated board and fire caulking repairs completed by contractor and confirmed by Delta.

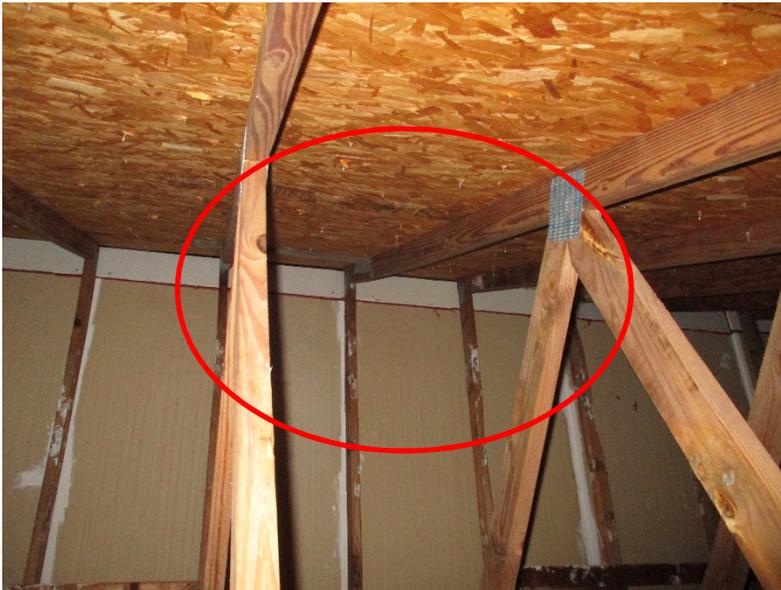
PHOTOGRAPH #11

**BUILDING 24
ATTIC 2423**

Truss scabs, gusset repairs, fire rated board and fire caulking repairs completed by contractor and confirmed by Delta.

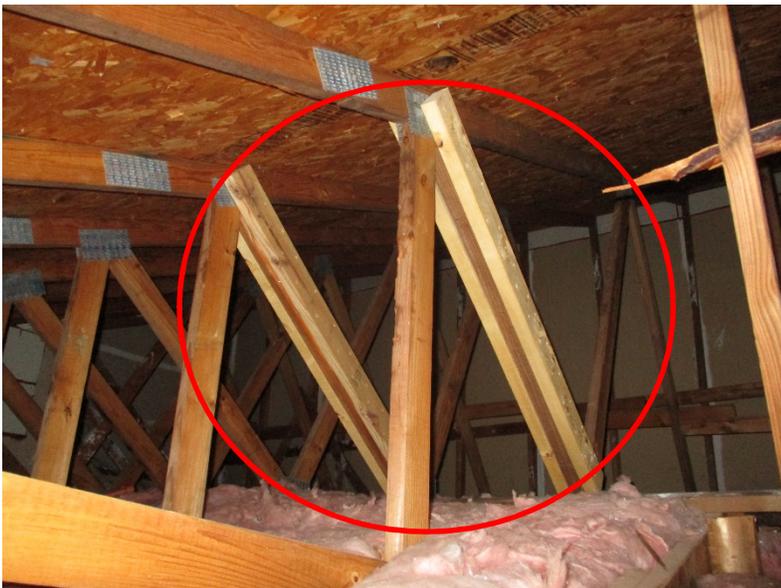
PHOTOGRAPH #12

**BUILDING 24
ATTIC 2426**

Truss scabs, gusset repairs, fire rated board and fire caulking repairs completed by contractor and confirmed by Delta.

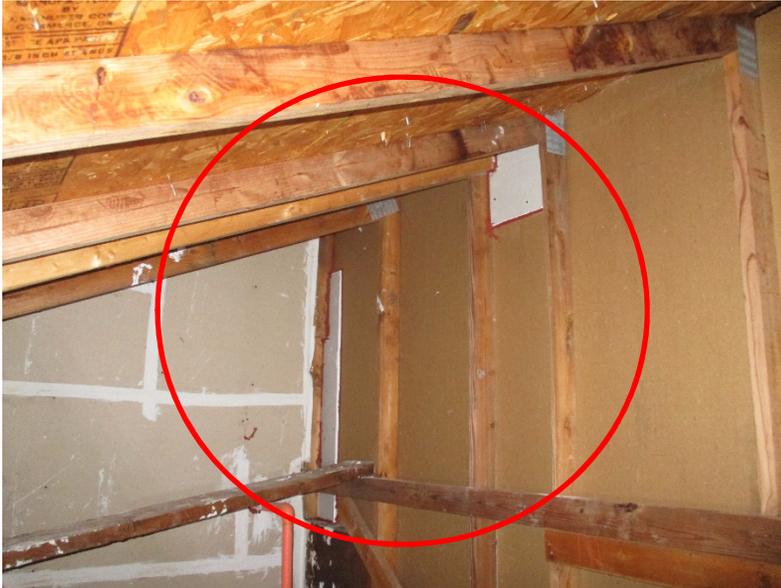
PHOTOGRAPH #13

**BUILDING 24
ATTIC 2424**

Truss scabs, gusset repairs, fire rated board and fire caulking repairs completed by contractor and confirmed by Delta.

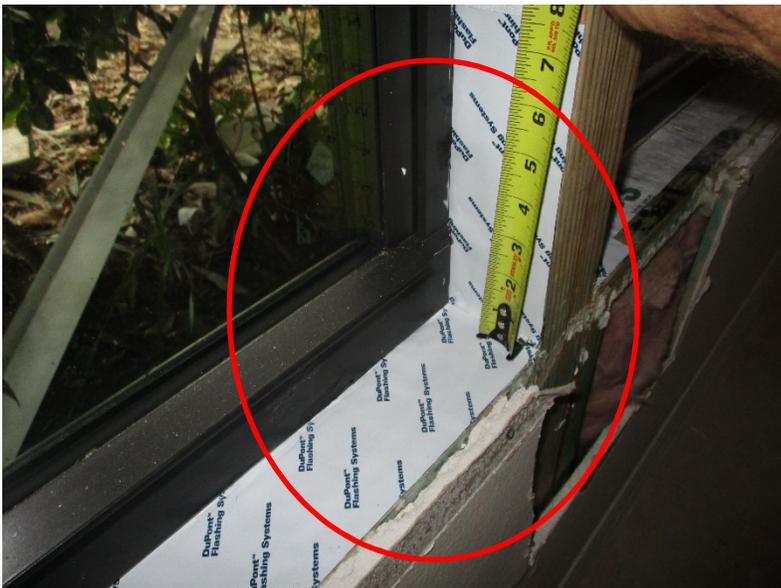
PHOTOGRAPH #14

**BUILDING 24
SECTION B**

Unit #2415 - Contractor has repaired window flashing at interior sill and jambs by adding additional flashing.

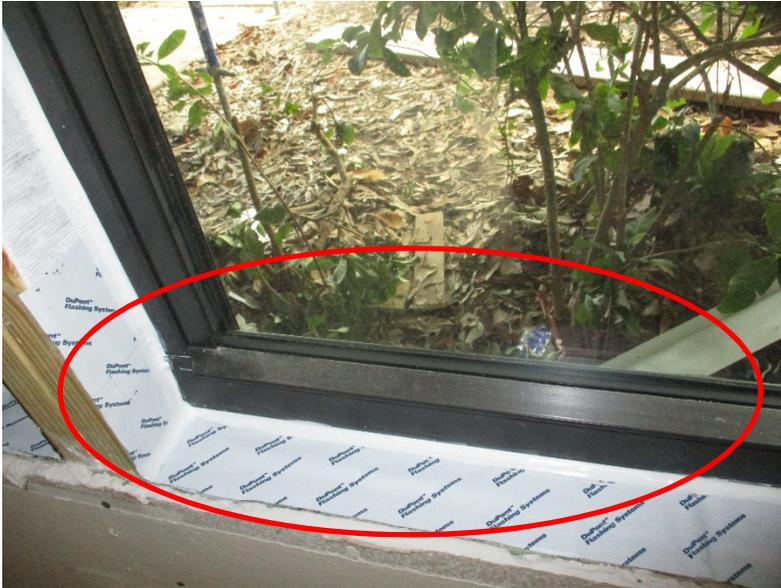
PHOTOGRAPH #15

**BUILDING 24
SECTION B**

Unit #2415 - contractor has repaired window flashing at interior sill and jambs by adding additional flashing and re-installing interior sealant bead.

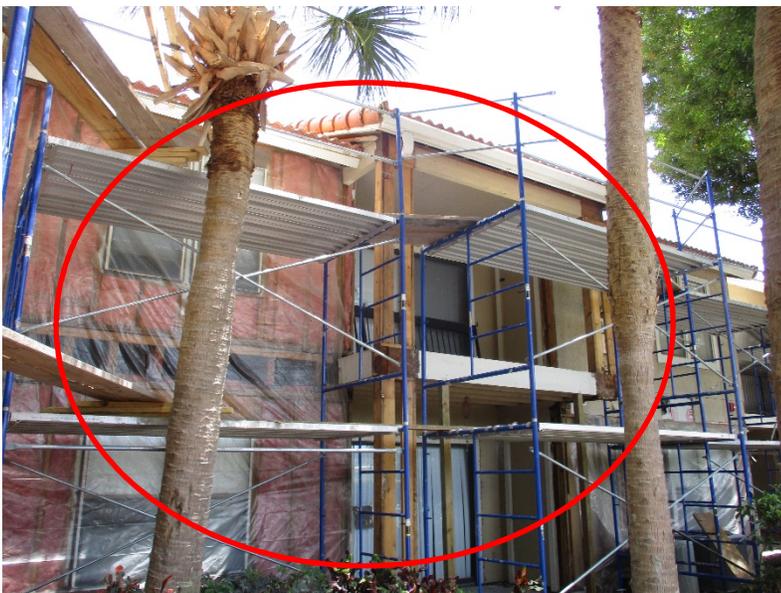
PHOTOGRAPH #16

**BUILDING 26
SECTION B**

Contractor has continued to demo exposing damage at balcony framing and built up beam.

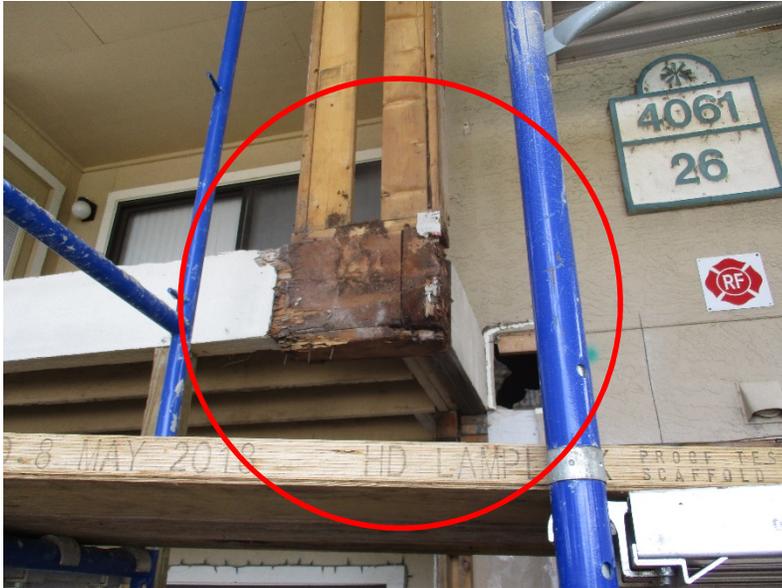
PHOTOGRAPH #17

**BUILDING 26
SECTION B**

Contractor has continued to demo exposing damage at balcony framing and built up beam.

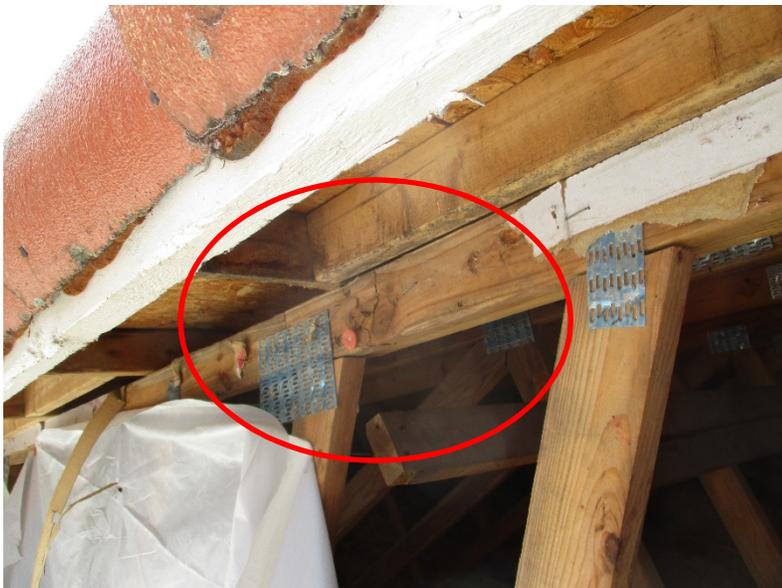
PHOTOGRAPH #18

**BUILDING 26
ATTIC 2622**

Multiple broken trusses and damage noted during repairs.

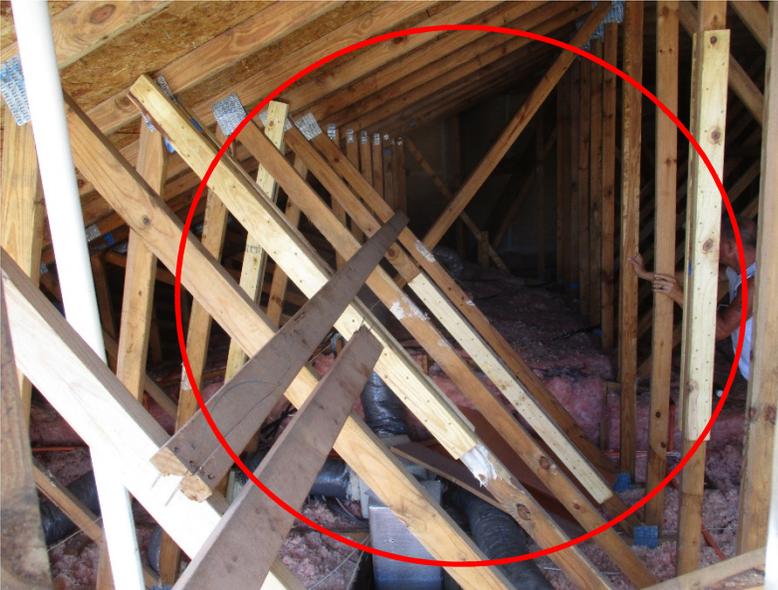
PHOTOGRAPH #19

**BUILDING 26
ATTIC 2622**

Multiple broken trusses and damages being repaired.

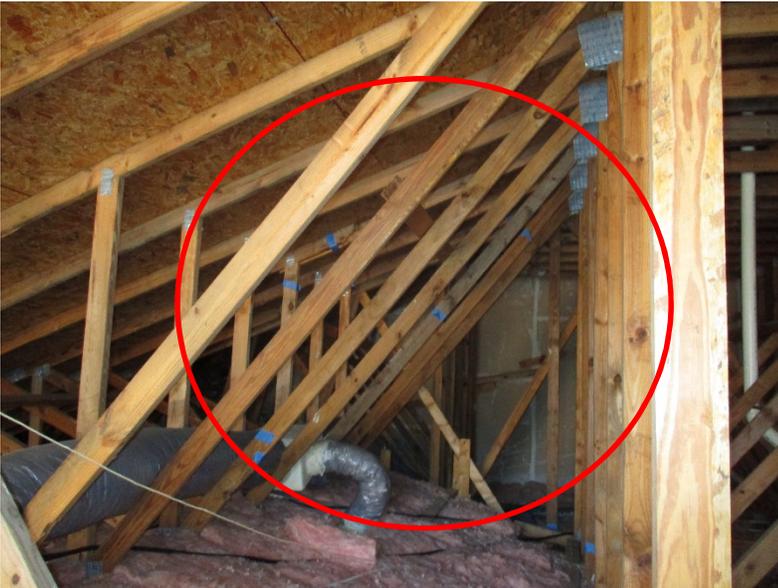
PHOTOGRAPH #20

**BUILDING 24
ATTIC 2426**

Multiple broken trusses and damage noted prior to repairs.
