PHOTOGRAPHS

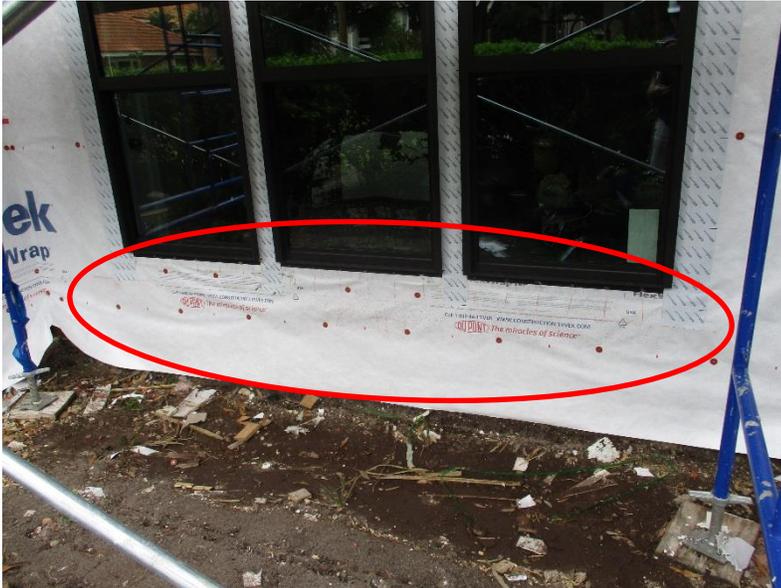
PHOTOGRAPH #1

BUILDING 24 SECTION B

Contractor has made corrections with window flashing by extending bottom edge of flashing below sill flashing.

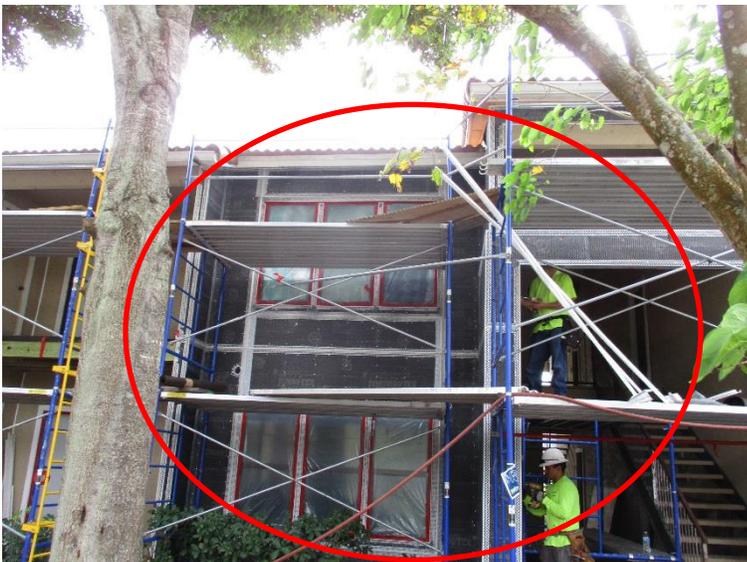
PHOTOGRAPH #2

BUILDING 24 SECTION B

Stucco subcontractor installing stucco accessories and lath in preparation for new stucco applications.

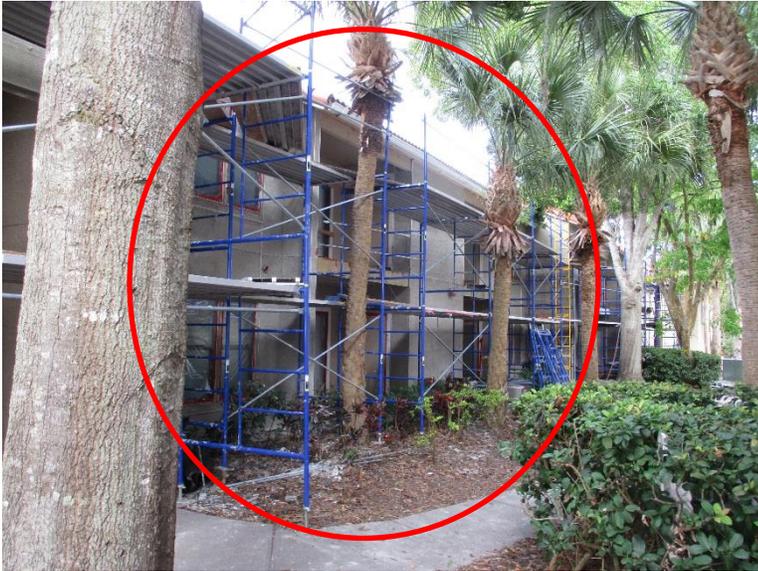
PHOTOGRAPH #3

**BUILDING 24
SECTION B**

Stucco subcontractor has applied scratch coat of stucco.

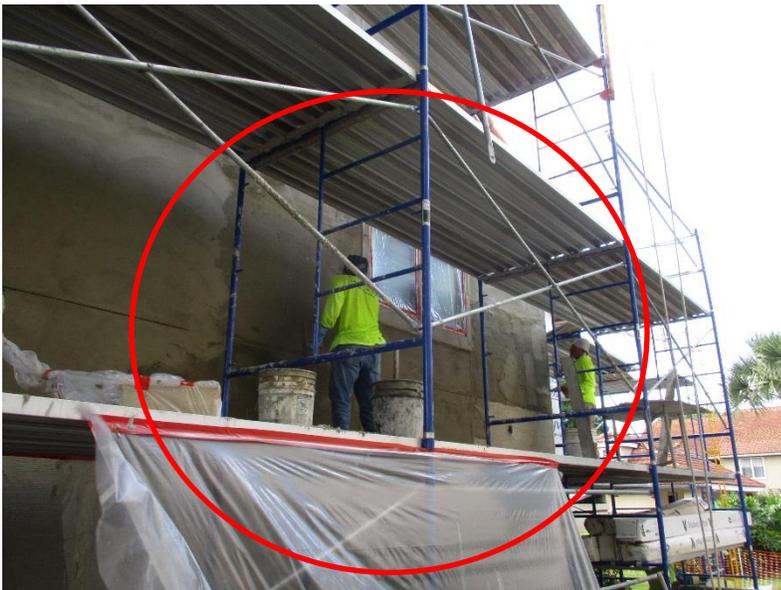
PHOTOGRAPH #4

**BUILDING 24
SECTION D**

Stucco subcontractor has applied scratch coat and began application of brown coat of stucco.

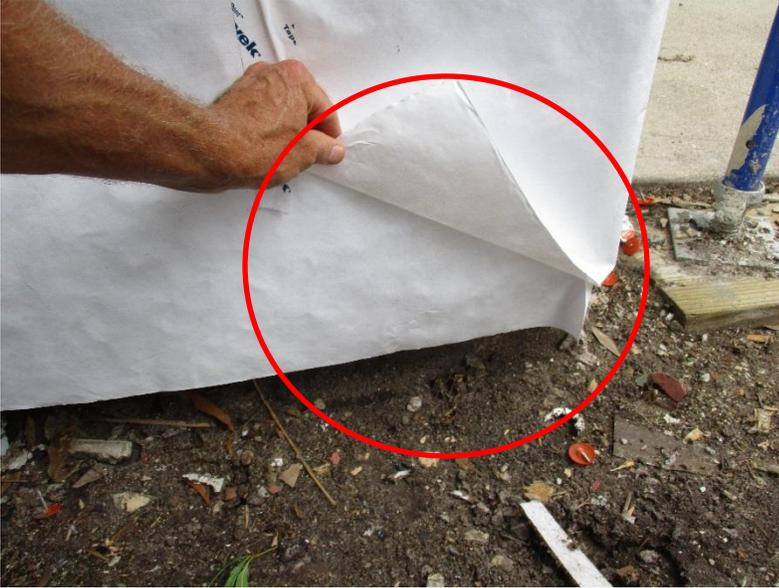
PHOTOGRAPH #5

**BUILDING 24
SECTION F**

Contractor has overlapped Tyvek HomeWrap at outside corners twelve inches minimum as specified.

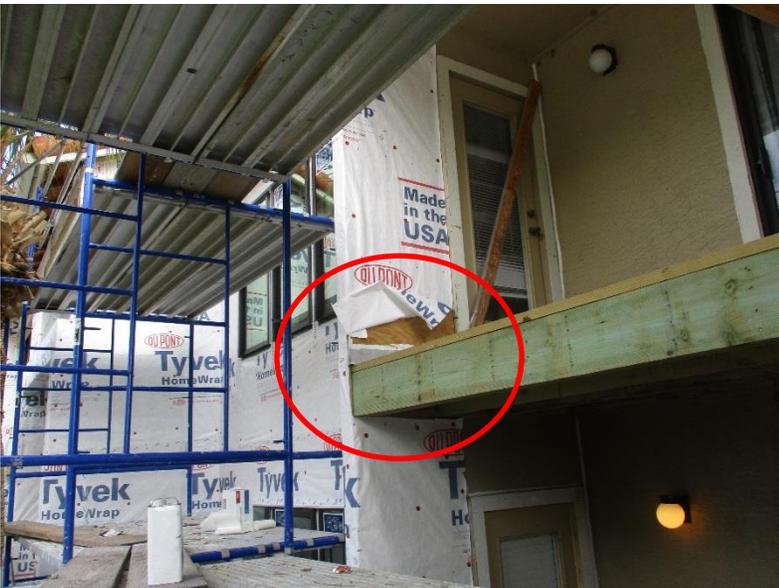
PHOTOGRAPH #6

**BUILDING 24
SECTION F**

Contractor has installed kick out flashing at balcony and set in sealant.

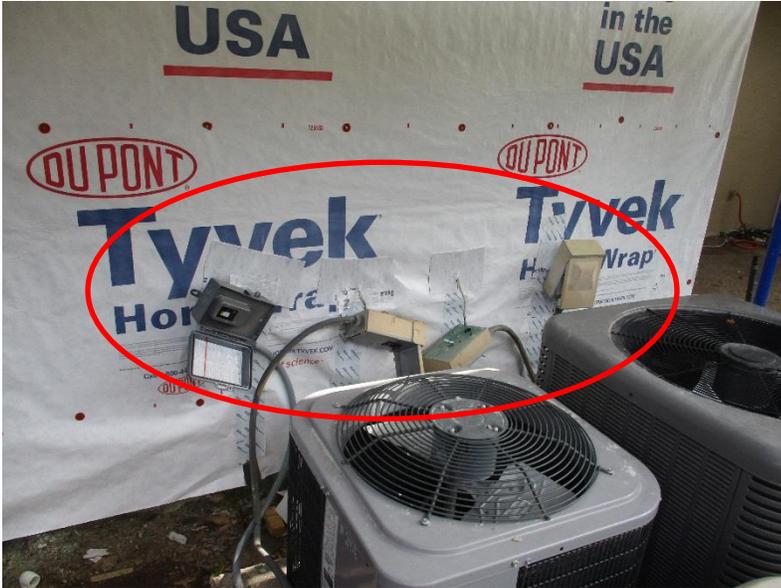
PHOTOGRAPH #7

**BUILDING 24
SECTION F**

Contractor has sealed penetrations at electrical boxes with Dupont Flashing.

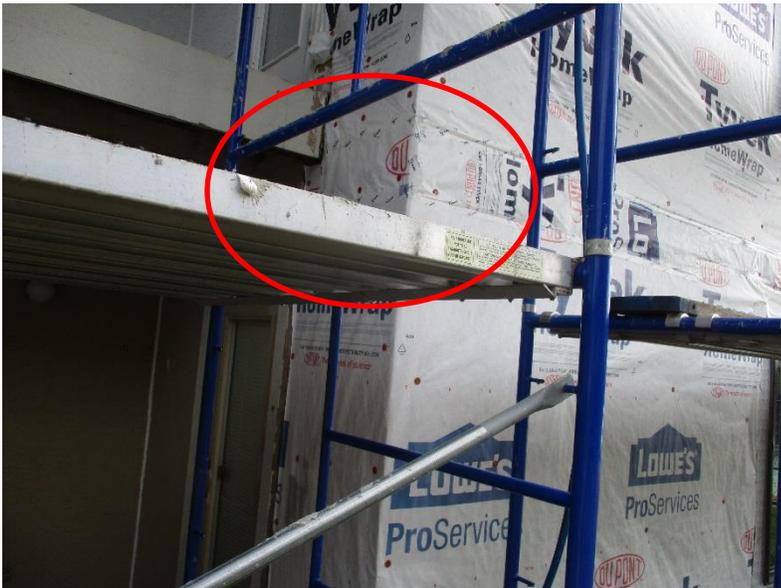
PHOTOGRAPH #8

**BUILDING 24
SECTION G**

Contractor has made corrections at Tyvek HomeWrap by overlapping minimum of six inches at horizontal transition.

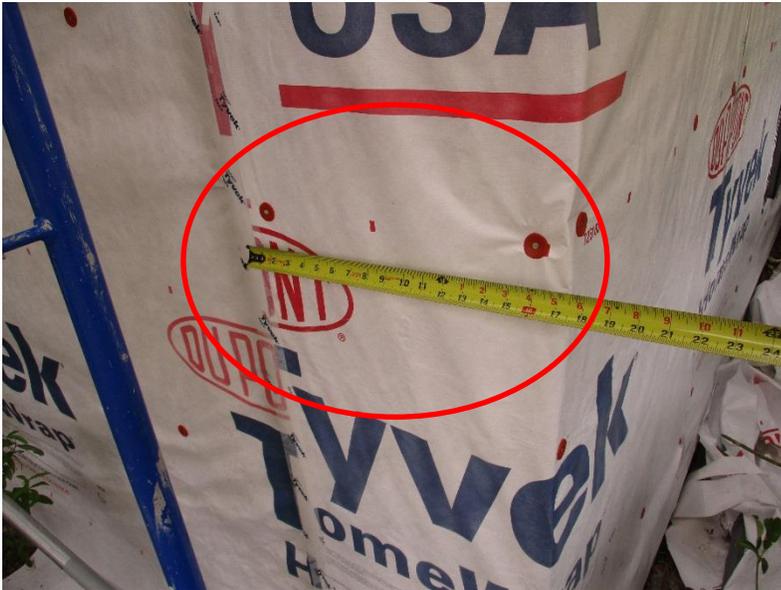
PHOTOGRAPH #9

**BUILDING 24
SECTION G**

Contractor has overlapped Tyvek HomeWrap at outside corners twelve inches minimum as specified.

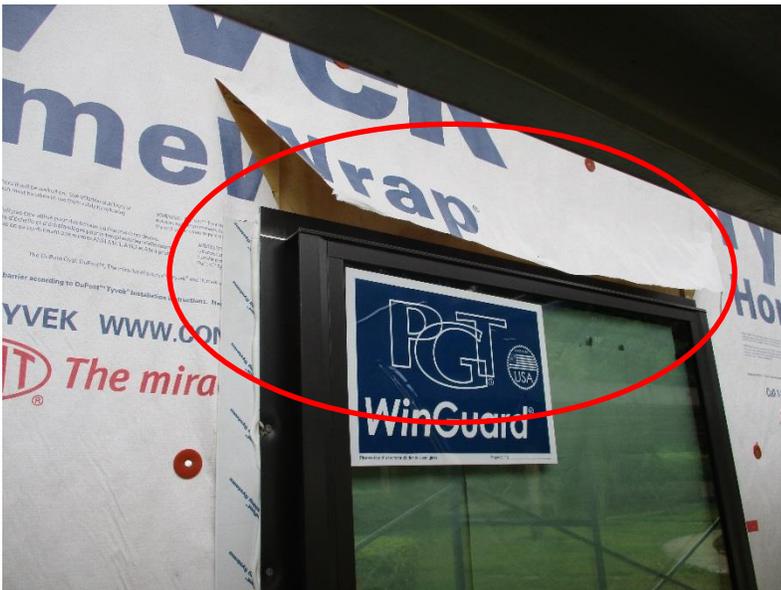
PHOTOGRAPH #10

**BUILDING 24
SECTION E**

Contractor had not fastened top of windows at flange as required.

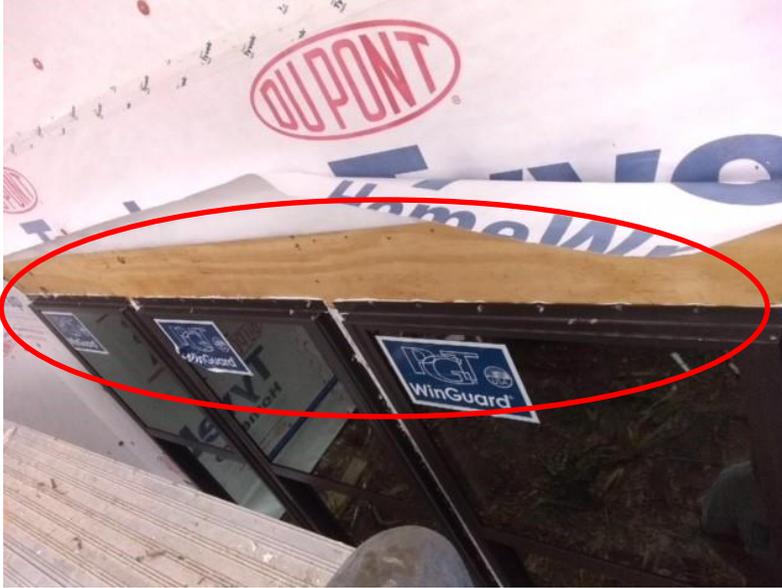
PHOTOGRAPH #11

**BUILDING 24
SECTION E**

Contractor made corrections by fastening top of window flange as required prior to installation of head flashing.

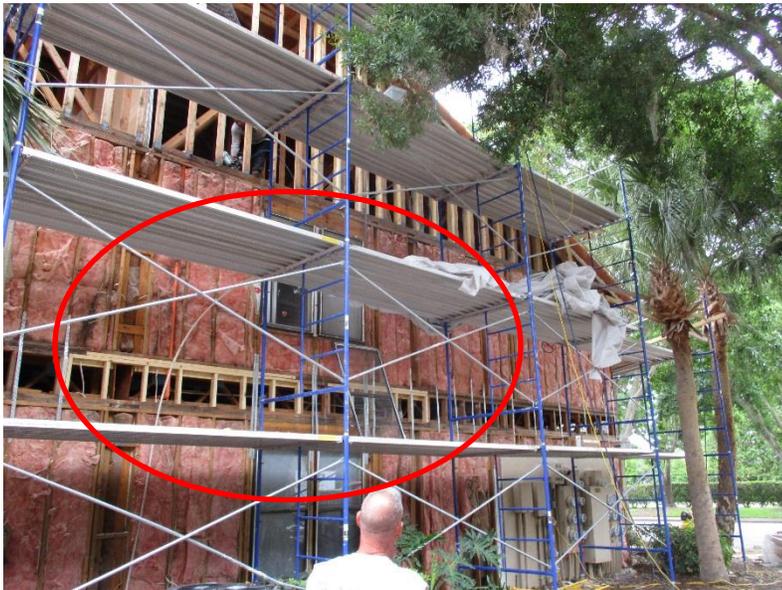
PHOTOGRAPH #12

**BUILDING 26
SECTION H**

Contractor has completed framing repairs. Delta has documented quantities with contractor.

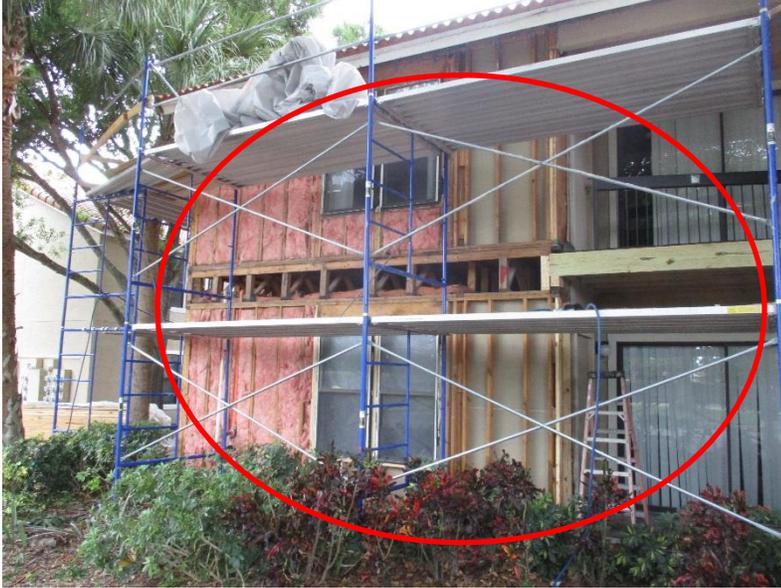
PHOTOGRAPH #13

**BUILDING 26
SECTION A**

Contractor has completed framing repairs. Delta has documented quantities with contractor.

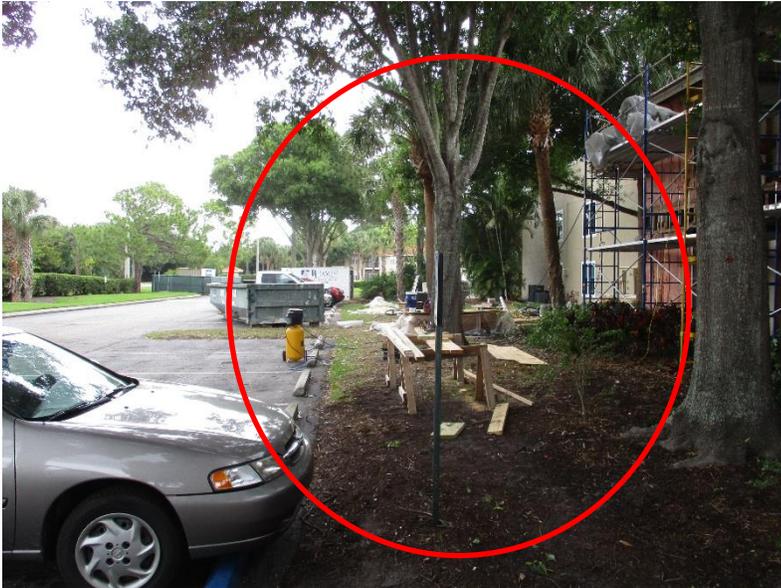
PHOTOGRAPH #14

**BUILDING 26
SECTION A**

Contractors work area around building is required to be fenced off and marked as a hard hat area. This area has not been fenced.

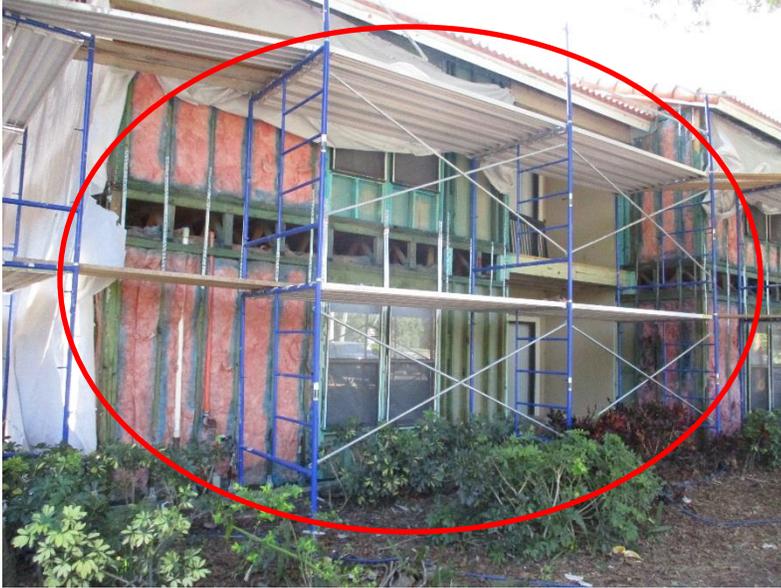
PHOTOGRAPH #15

**BUILDING 26
SECTION A**

Contractor has installed framing connectors and sprayed Bora-Care termite treatment in preparation for insulation and sheathing applications.

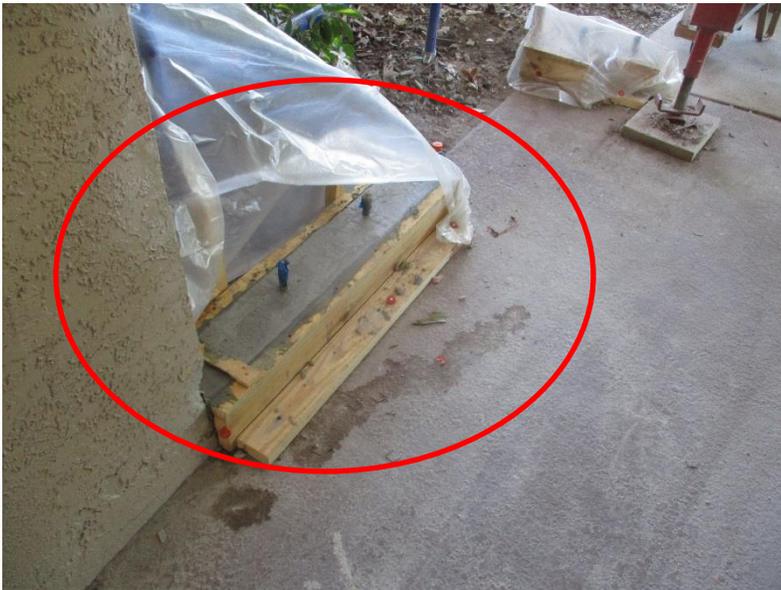
PHOTOGRAPH #16

**BUILDING 26
SECTION A**

Contractor has formed and poured concrete pedestal for breezeway beams and wall support.

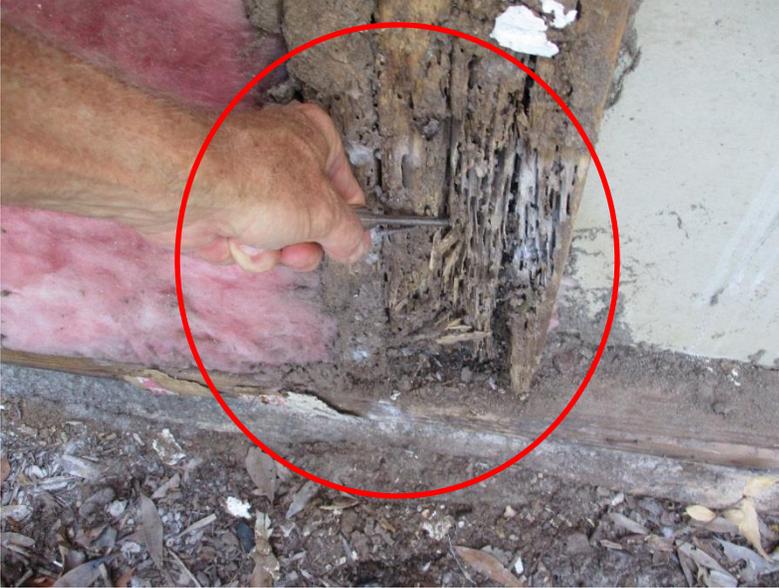
PHOTOGRAPH #17

**BUILDING 26
SECTION B**

Framing damage has been identified and marked by Delta for repairs.

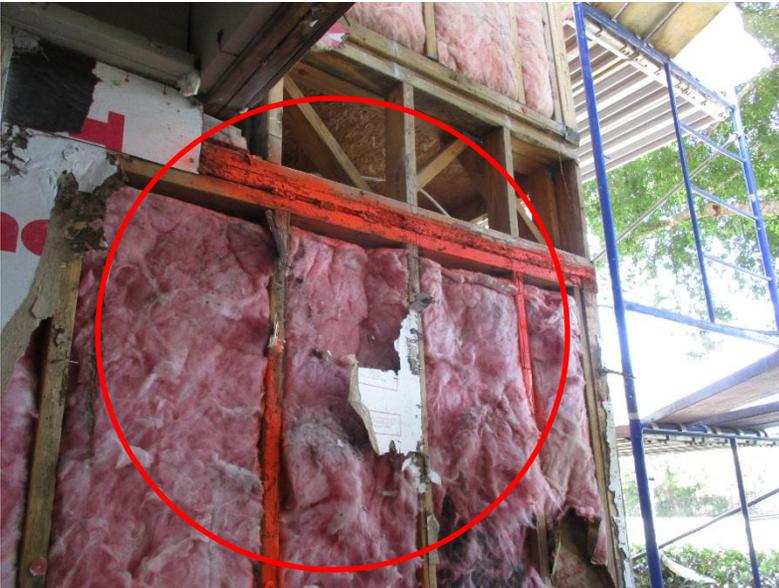
PHOTOGRAPH #18

**BUILDING 26
SECTION B**

Framing damage has been identified and marked by Delta for repairs.

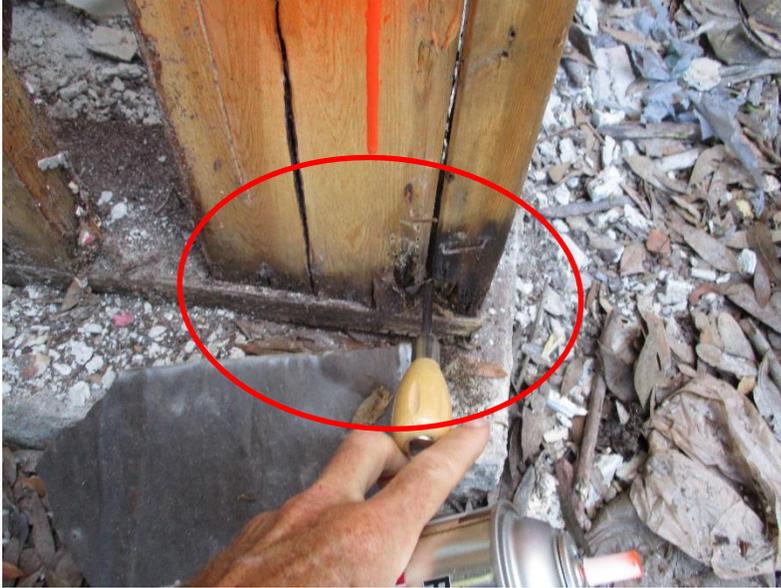
PHOTOGRAPH #19

**BUILDING 26
SECTION B**

Framing damage has been identified and marked by Delta for repairs.

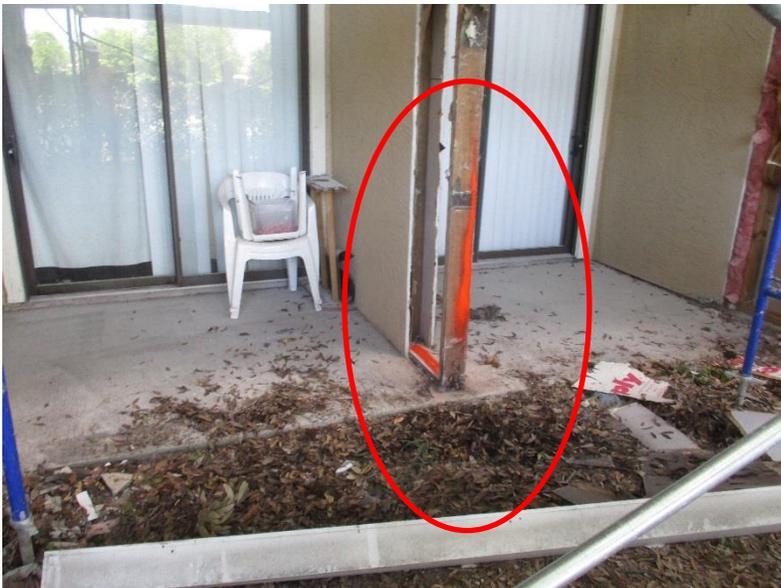
PHOTOGRAPH #20

**BUILDING 26
SECTION B**

Framing damage has been identified and marked by Delta for repairs.

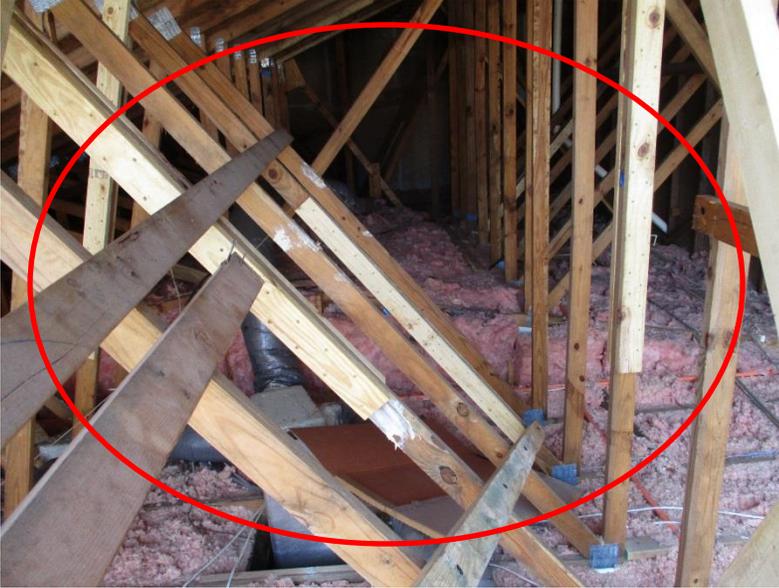
PHOTOGRAPH #21

**BUILDING 26
ATTIC 2622**

Contractor has completed multiple truss repairs, gusset repairs and fire wall repairs.

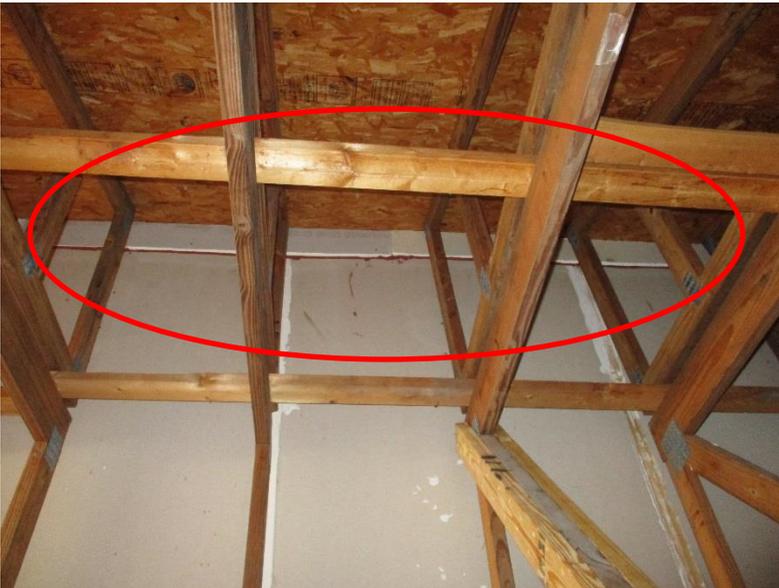
PHOTOGRAPH #22

**BUILDING 26
ATTIC 2622**

Contractor has completed multiple truss repairs, gusset repairs and fire wall repairs.

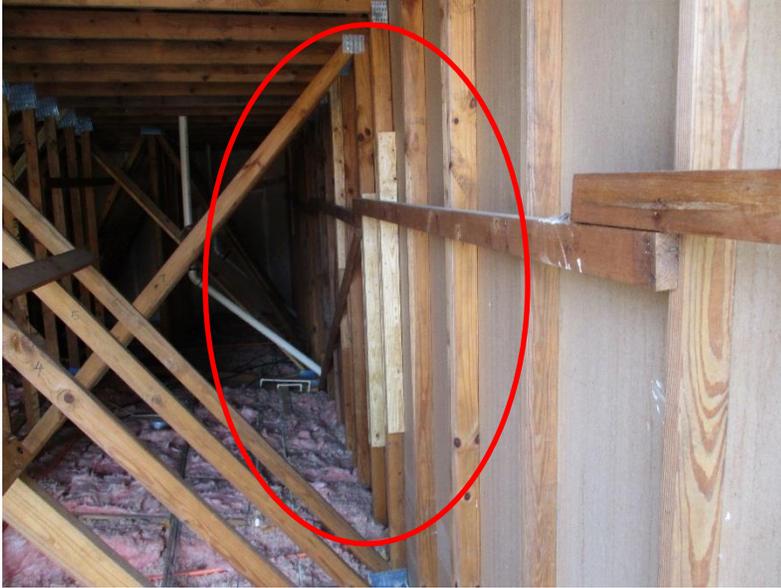
PHOTOGRAPH #23

**BUILDING 26
ATTIC 2621**

Contractor has completed, truss repairs,
gusset repairs and fire wall repairs.
