PHOTOGRAPHS

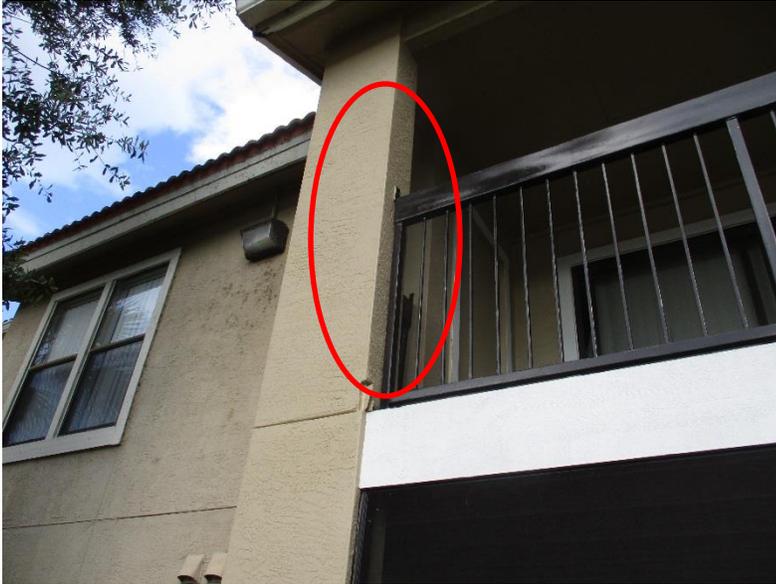
PHOTOGRAPH #1

**BUILDING 18
UNIT #1824 BALCONY**

Top rails have been fastened to stucco walls.

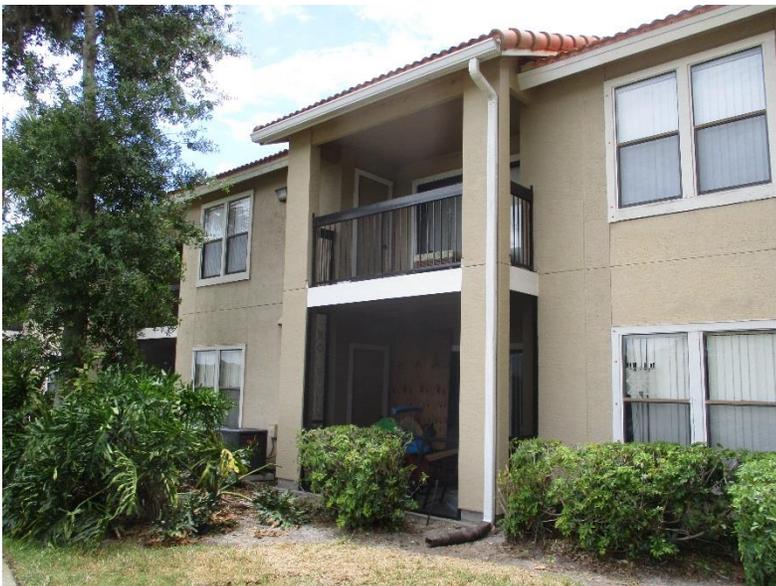
PHOTOGRAPH #2

**BUILDING 18
UNIT #1824 BALCONY**

Re-installation of downspout and cleanup of grounds will have been completed.

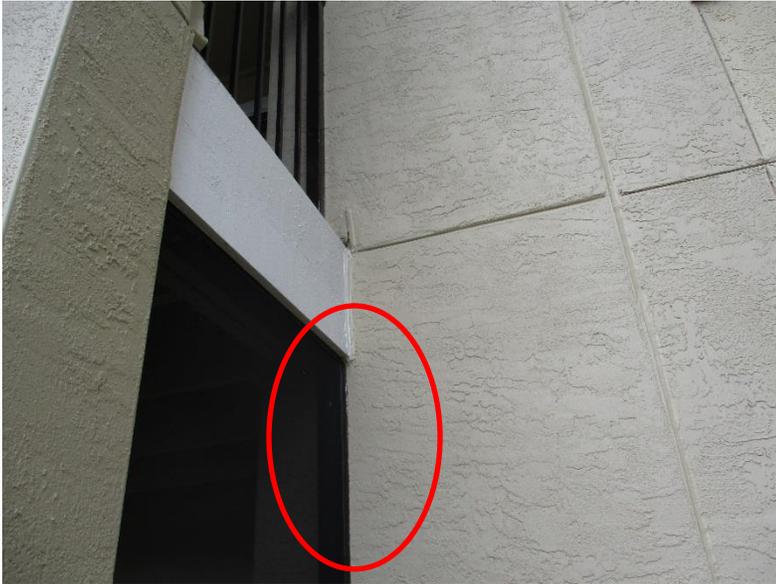
PHOTOGRAPH #3

**BUILDING 18
UNIT #1824 BALCONY**

Bronze caulking has been completed at stucco to screen enclosure.

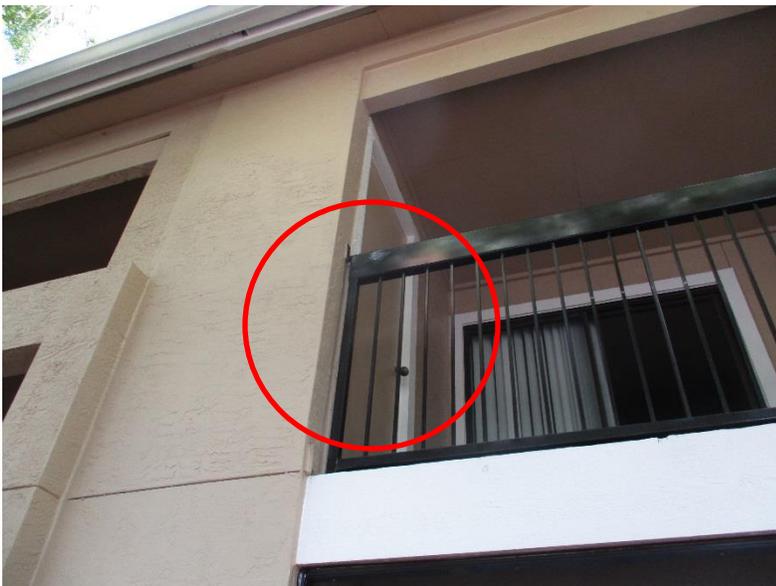
PHOTOGRAPH #4

**BUILDING 7
UNIT #727 BALCONY**

Top rail fastening angle has been moved as required and paint touched up.

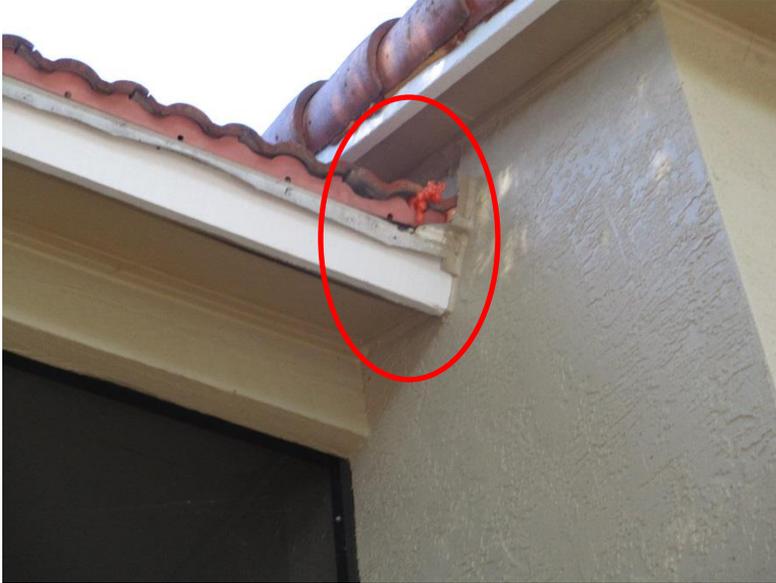
PHOTOGRAPH #5

BUILDING 25

Roof tiles have been re-installed with foam at new kick out flashing.

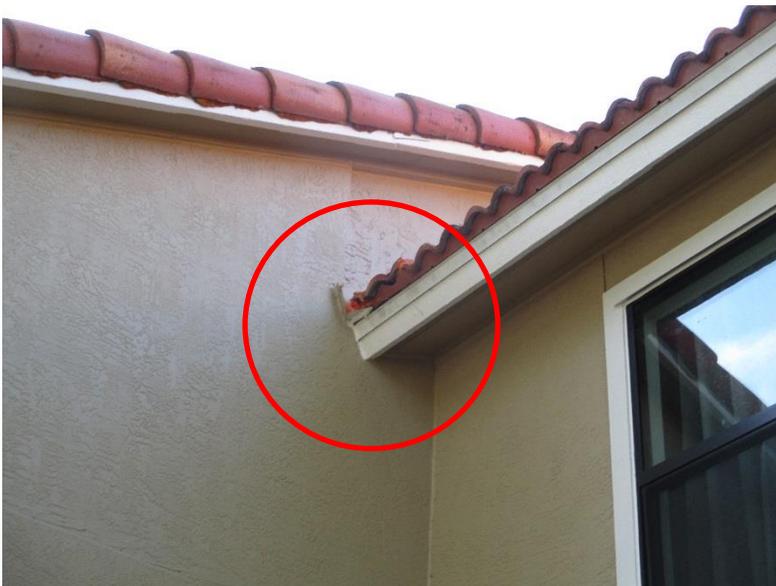
PHOTOGRAPH #6

BUILDING 25

Roof tiles have been re-installed with foam at new kick out flashing.
