PHOTOGRAPHS

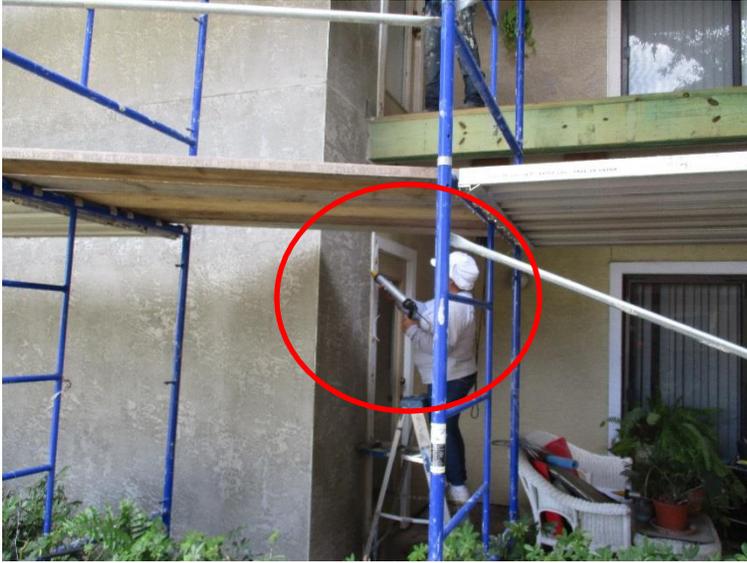
PHOTOGRAPH #1

**BUILDING 24
SECTION A**

Contractor is applying sealants at opening and at transitions in preparation for painting.

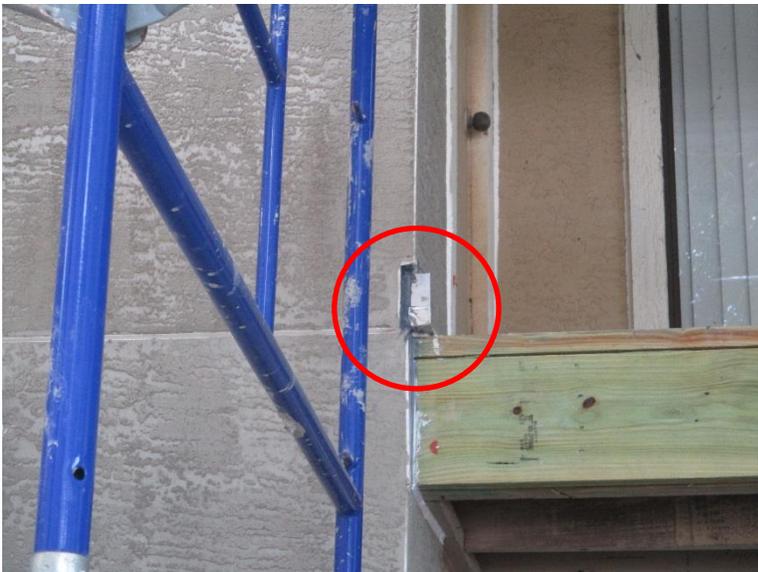
PHOTOGRAPH #2

**BUILDING 24
SECTION B**

Stucco corner bead has been notched out at balcony kick out flashing improperly. Corner bead is to follow straight through and will require repair at several locations.

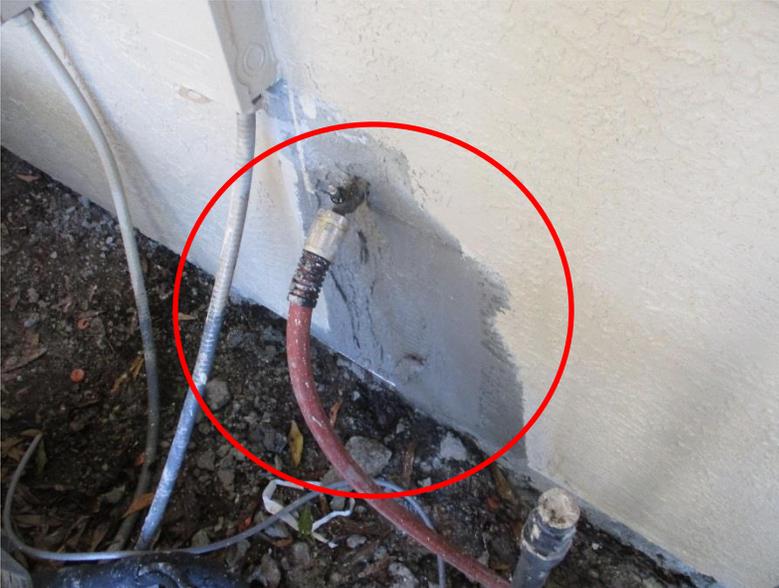
PHOTOGRAPH #3

**BUILDING 24
SECTION B**

Leaking hose has damaged new stucco.

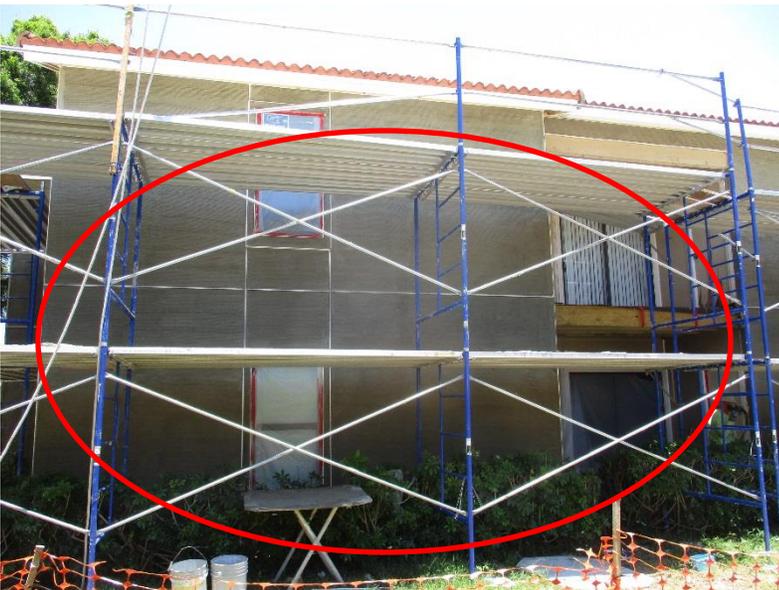
PHOTOGRAPH #4

**BUILDING 24
SECTION E**

Stucco sub-contractor has begun stucco with scratch coat application.

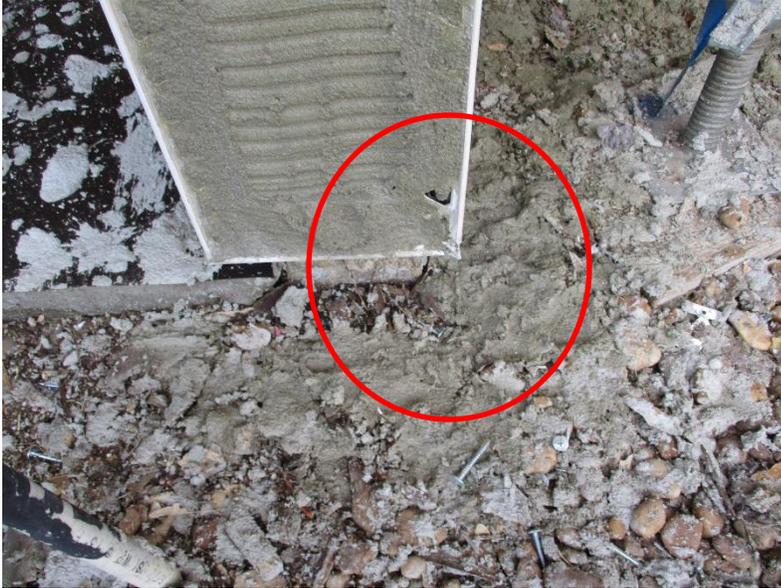
PHOTOGRAPH #5

**BUILDING 24
SECTION F**

Sub-contractor began scratch coat of stucco prior to completing sealants at accessories transition as specified and has not fully embedded scratch coat into corner beading.

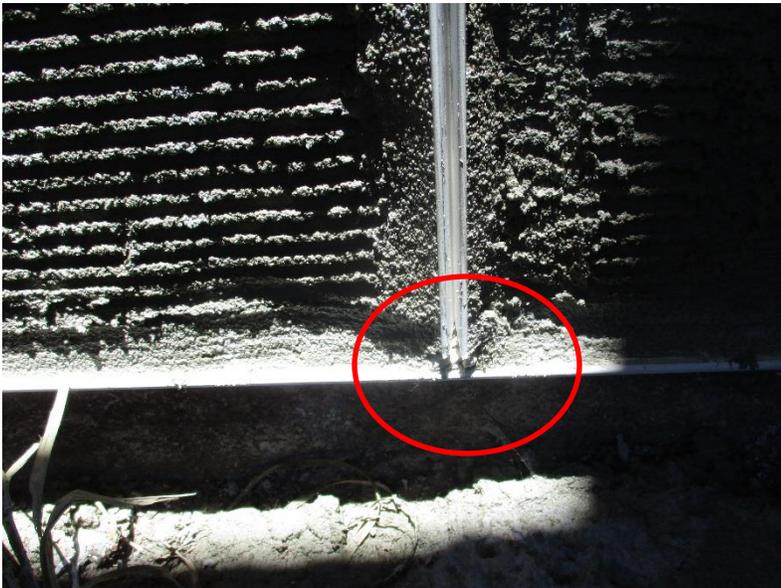
PHOTOGRAPH #6

**BUILDING 24
SECTION F**

Sub-contractor has made corrections at areas not sealed prior to scratch coat of stucco and fully embedded scratch coat into accessories.

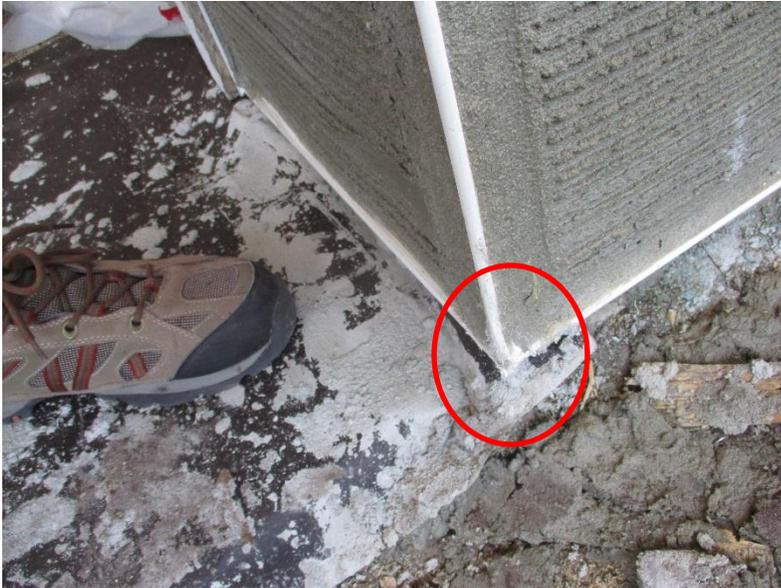
PHOTOGRAPH #7

**BUILDING 24
SECTION F**

Sub-contractor has made corrections at areas not sealed prior to scratch coat of stucco and fully embedded scratch coat into accessories.

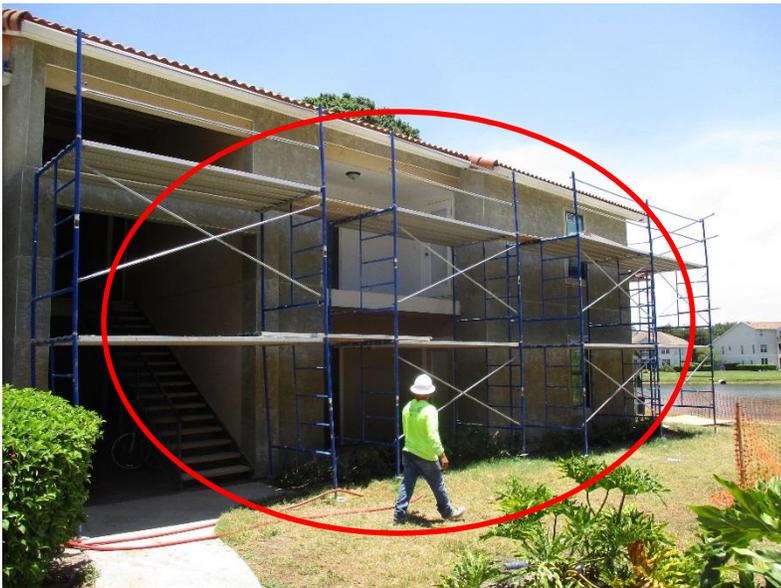
PHOTOGRAPH #8

**BUILDING 24
SECTION G**

Stucco sub-contractor has applied three coat stucco system and in process of moisture curing.

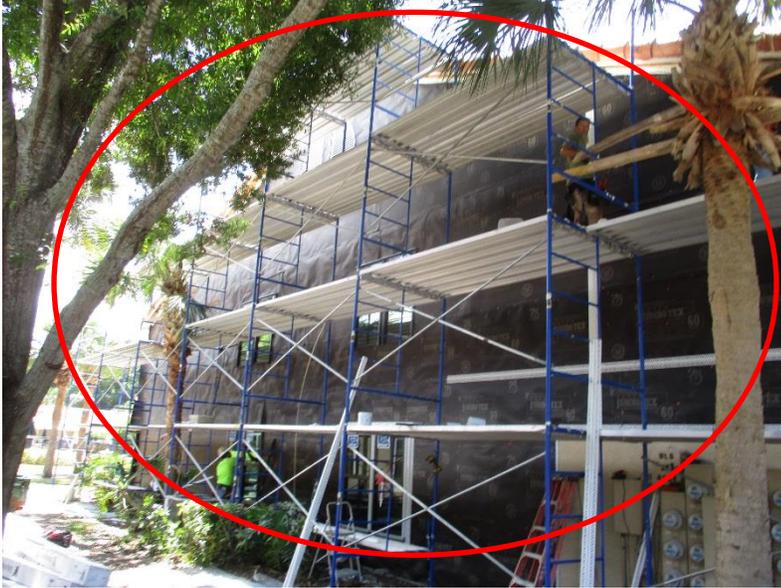
PHOTOGRAPH #9

**BUILDING 26
SECTION H**

Sub-contractor has applied JumboTex weather barrier and begun stucco accessories installation.

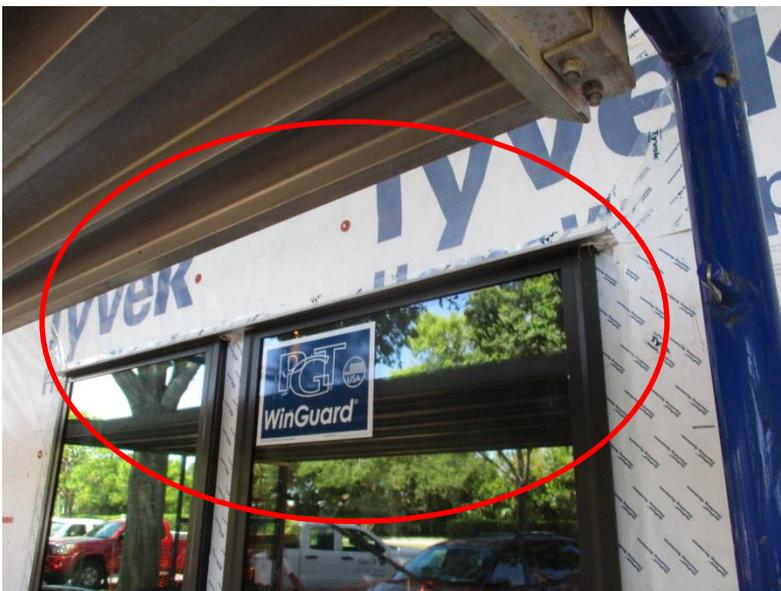
PHOTOGRAPH #10

**BUILDING 26
SECTION A**

Contractor has completed window installation by installing head flashing and Dupont straight flash at head and jambs.

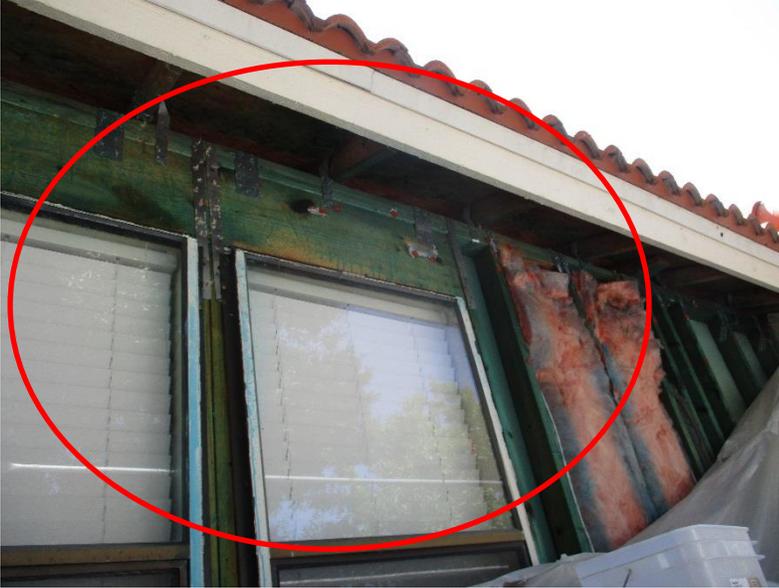
PHOTOGRAPH #11

**BUILDING 26
SECTION B**

Simpson Strong hardware connectors and strapping has been installed and termite treatment has been applied in preparation for new sheathing.

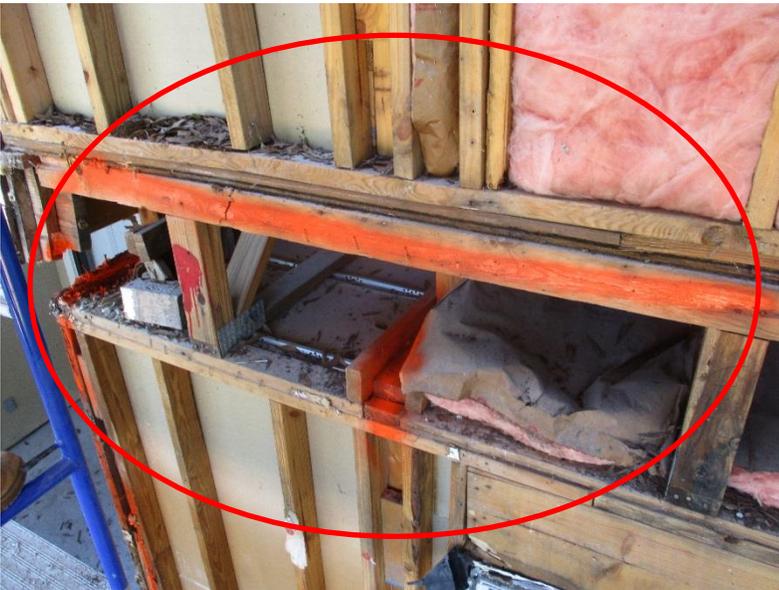
PHOTOGRAPH #12

**BUILDING 26
SECTION C**

Framing damage has been identified and marked for repairs. This subfloor area is damaged and missing framing support.

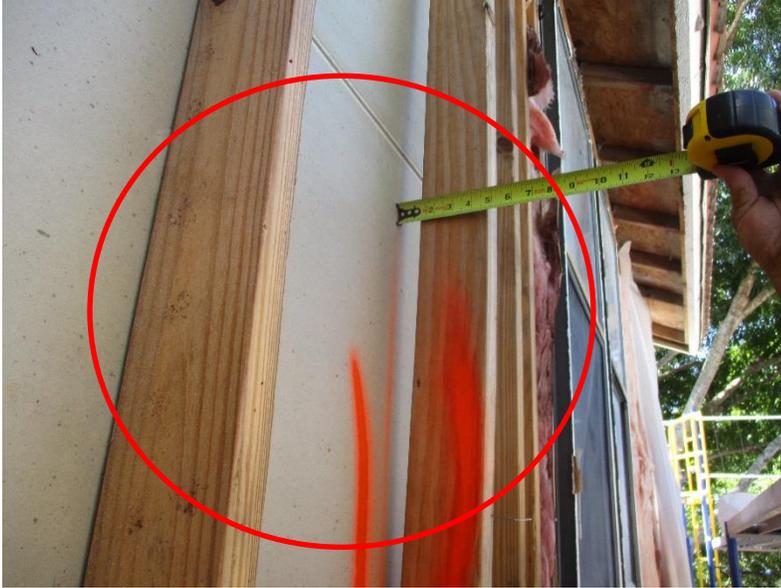
PHOTOGRAPH #13

**BUILDING 26
SECTION C**

Framing damage has been identified and marked for repairs. This framing stud is bowed away from wall and will be replaced.

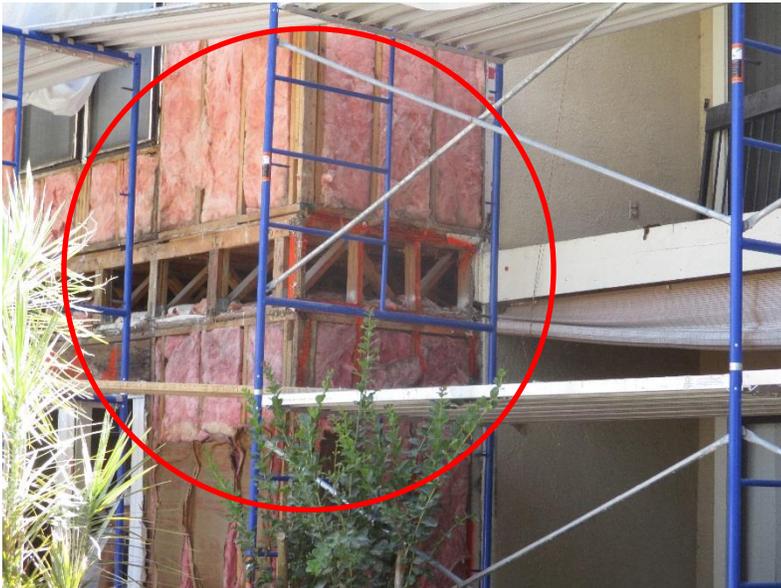
PHOTOGRAPH #14

**BUILDING 26
SECTION C**

Framing damage has been identified and marked for repairs.

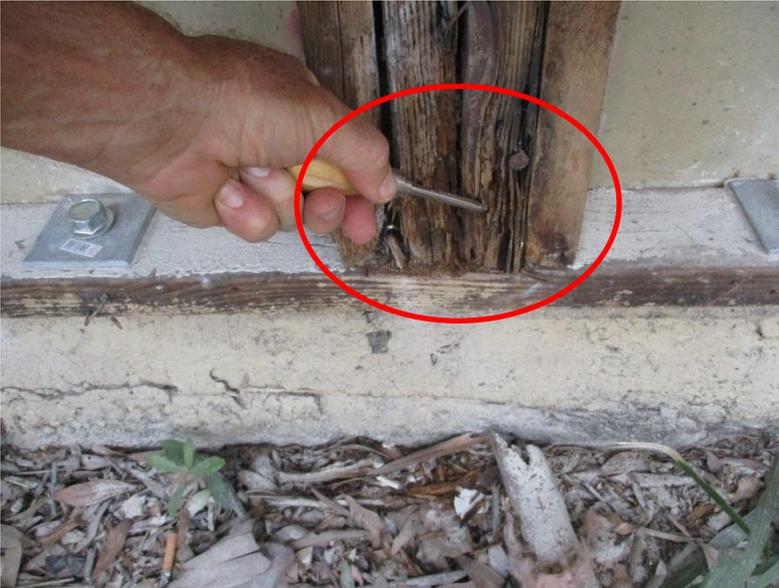
PHOTOGRAPH #15

**BUILDING 26
SECTION D**

Framing damage has been identified and marked for repairs.

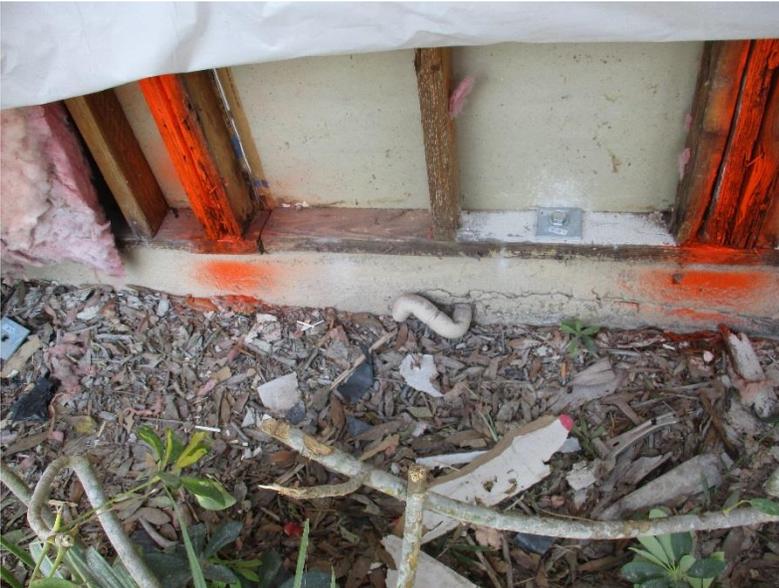
PHOTOGRAPH #16

**BUILDING 26
SECTION D**

Framing damage has been identified and marked for repairs

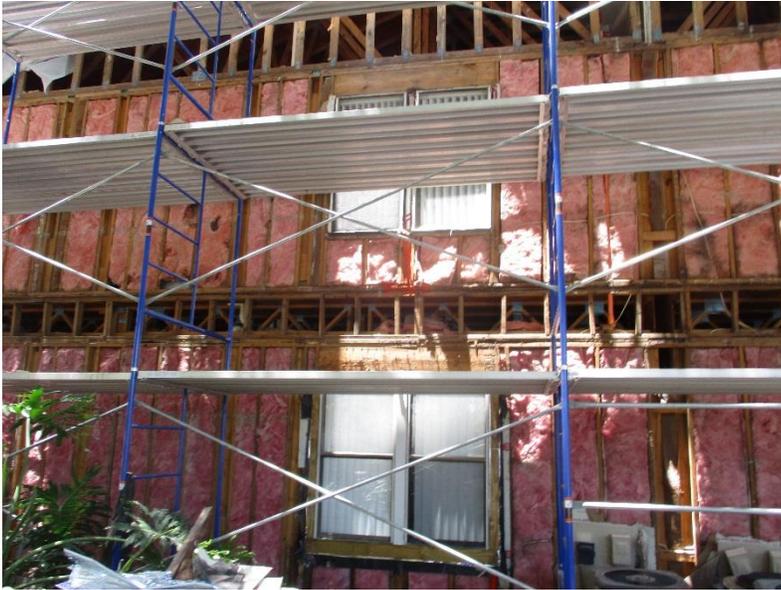
PHOTOGRAPH #17

**BUILDING 26
SECTION D**

Framing damage has been identified and marked for repairs.
