PHOTOGRAPHS

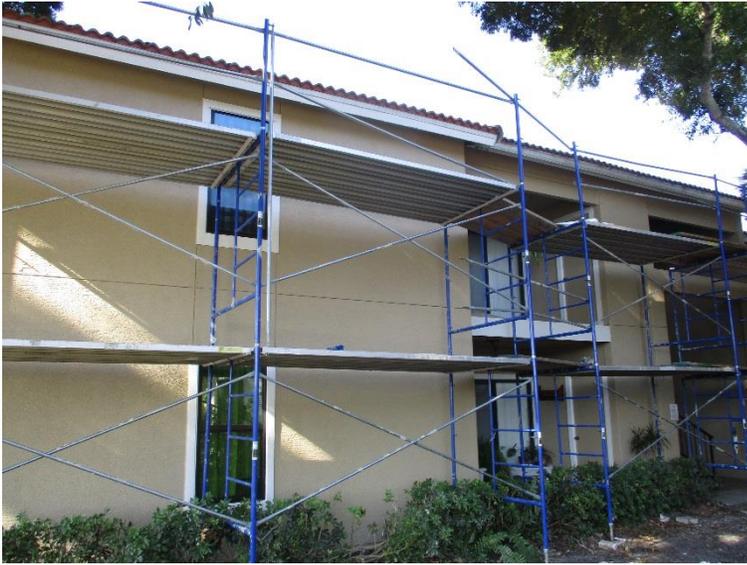
PHOTOGRAPH #1

BUILDING 24 SECTION A

Contractor has primed and finish painted stucco.

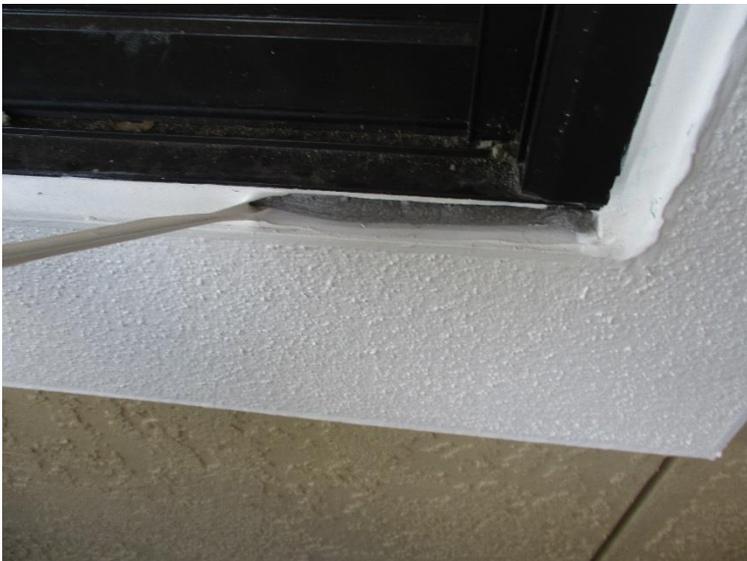
PHOTOGRAPH #2

BUILDING 24 SECTION A

Sealant pull test performed at window perimeter sealant, passed as required by testing protocol in project manual.

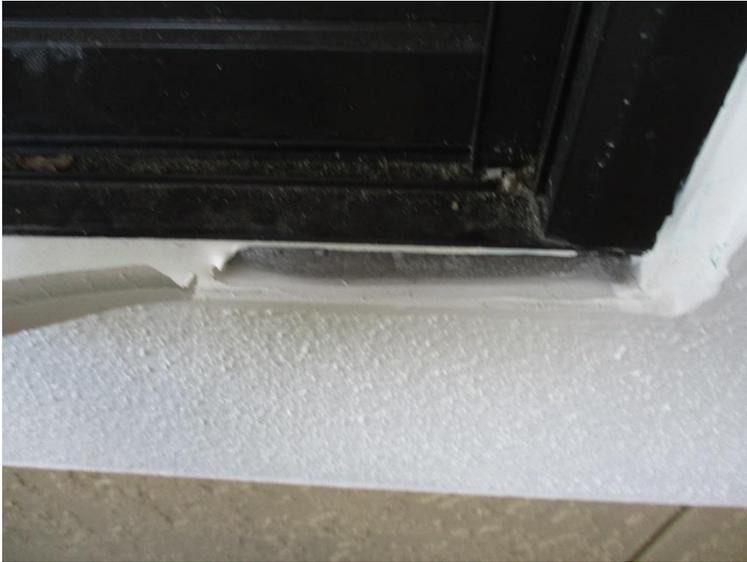
PHOTOGRAPH #3

**BUILDING 24
SECTION A**

Sealant pull test performed at window perimeter sealant, passed as required by testing protocol in project manual.

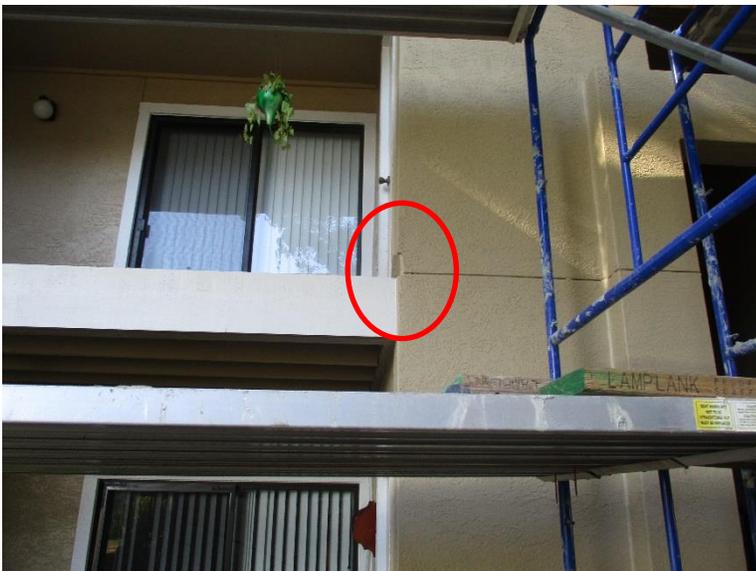
PHOTOGRAPH #4

**BUILDING 24
SECTION B**

Stucco corner bead has been notched out at balcony kick out flashing improperly. Corner bead is to follow straight through and will require repair at several locations.

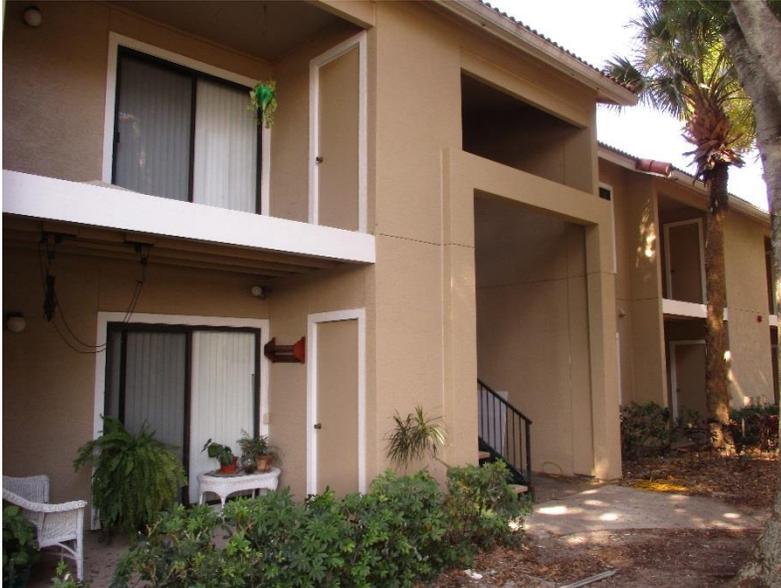
PHOTOGRAPH #5

**BUILDING 24
SECTION B**

Contractor has primed and finish painted stucco. Balcony railings have not yet been painted or re-installed.

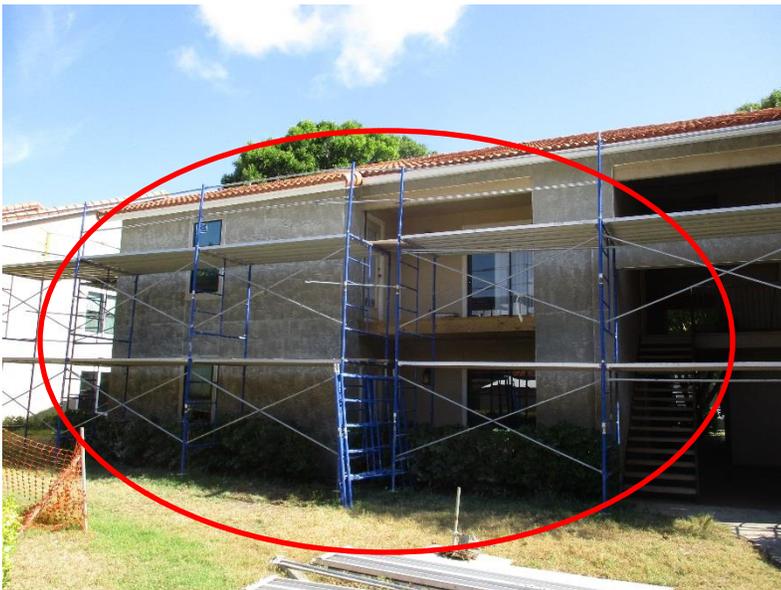
PHOTOGRAPH #6

**BUILDING 24
SECTION E**

Stucco sub-contractor has completed three coat stucco application.

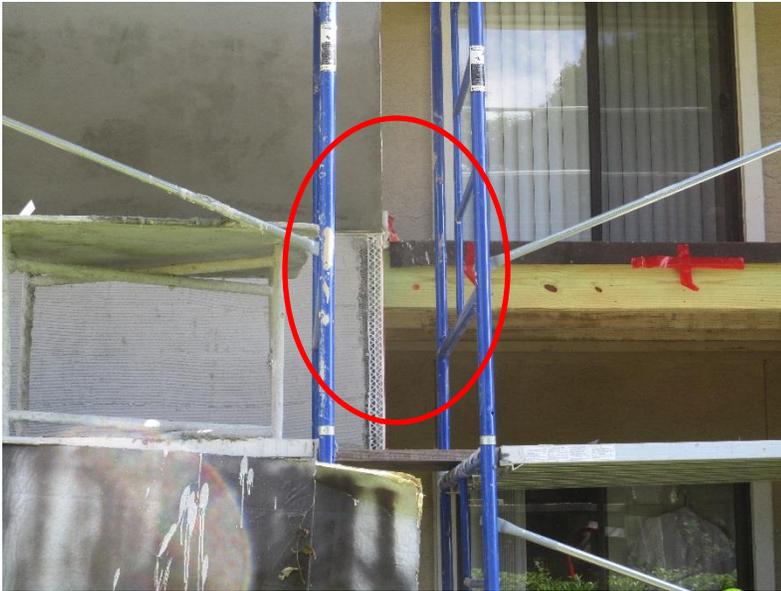
PHOTOGRAPH #7

**BUILDING 24
SECTION F**

Sub-contractor in process of repairing corner bead, improper location at balcony kick out locations.

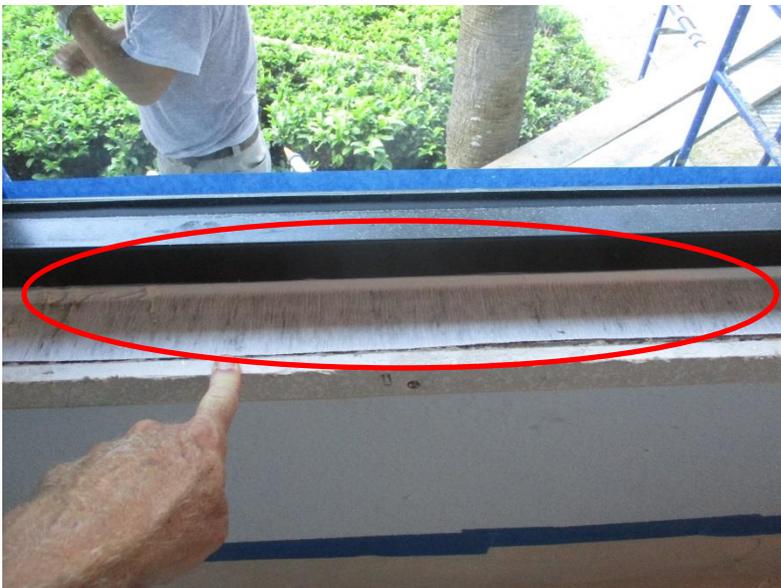
PHOTOGRAPH #8

**BUILDING 24
SECTION F- UNIT 2426**

Contractor has applied interior sealant at window perimeters and in process of drywall repairs.

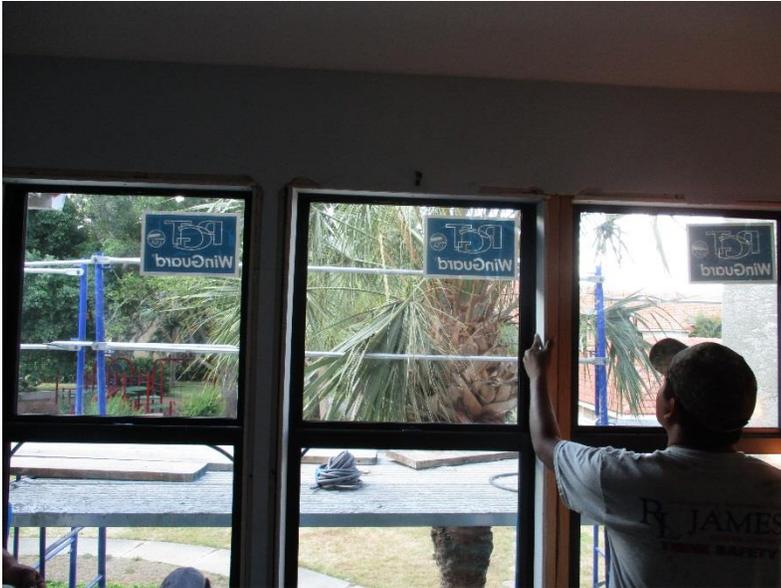
PHOTOGRAPH #9

**BUILDING 24
SECTION F- UNIT 2426**

Contractor has applied interior sealant at window perimeters and in process of drywall repairs.

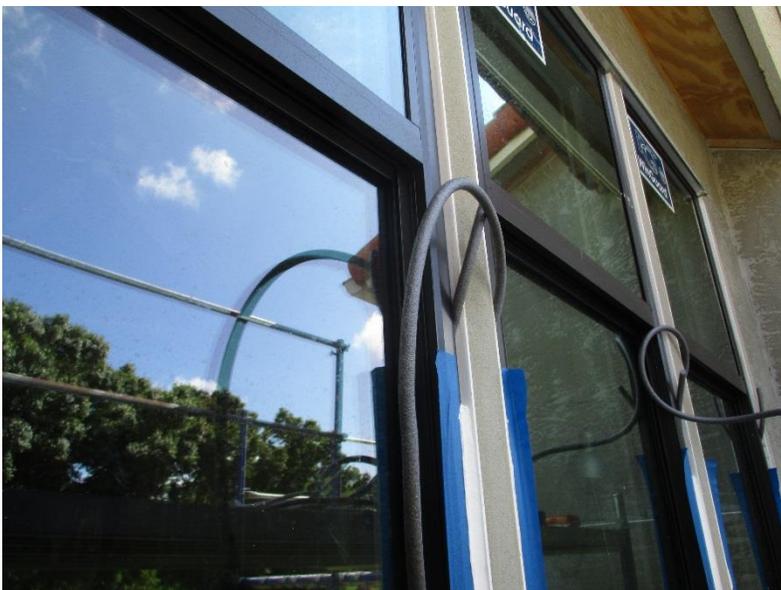
PHOTOGRAPH #10

**BUILDING 24
SECTION F**

Contractor Installing backing rod and applying new perimeter sealants at new windows.

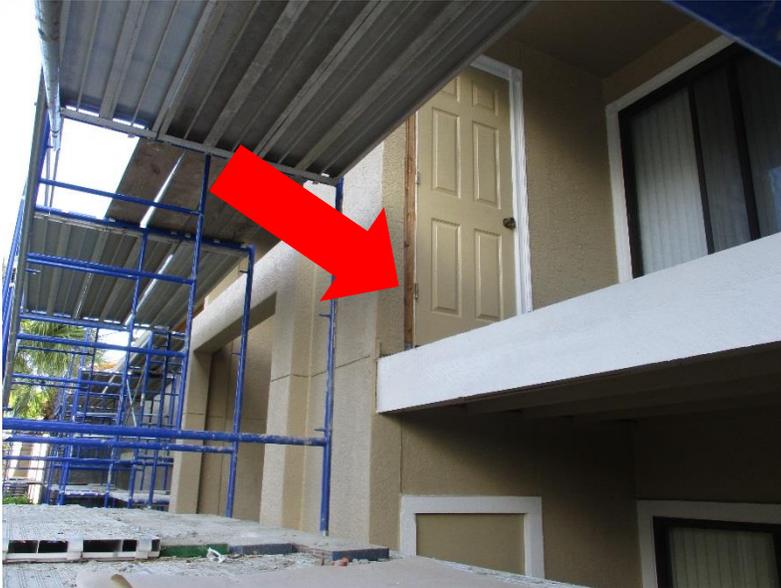
PHOTOGRAPH #11

**BUILDING 24
SECTION G -UNIT #2422**

Door jamb and sill trim has not been replaced.

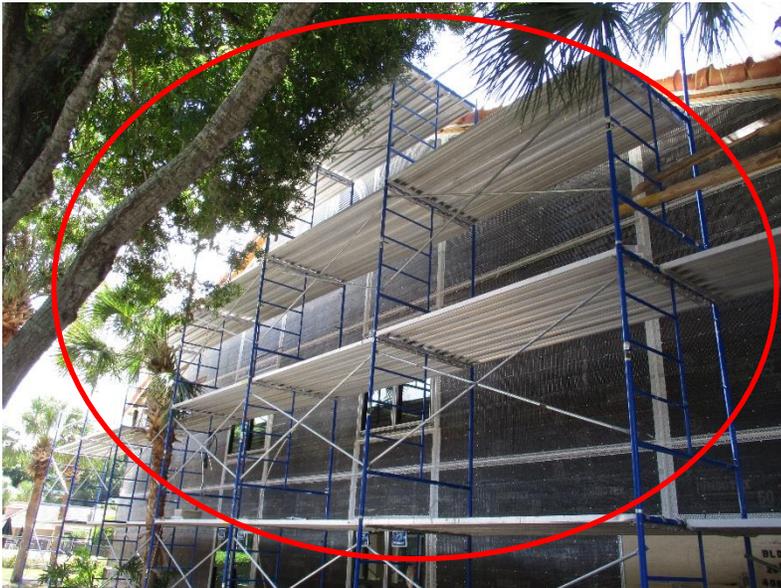
PHOTOGRAPH #12

**BUILDING 26
SECTION H**

Sub-contractor has completed stucco accessories installation in preparation for stucco applications.

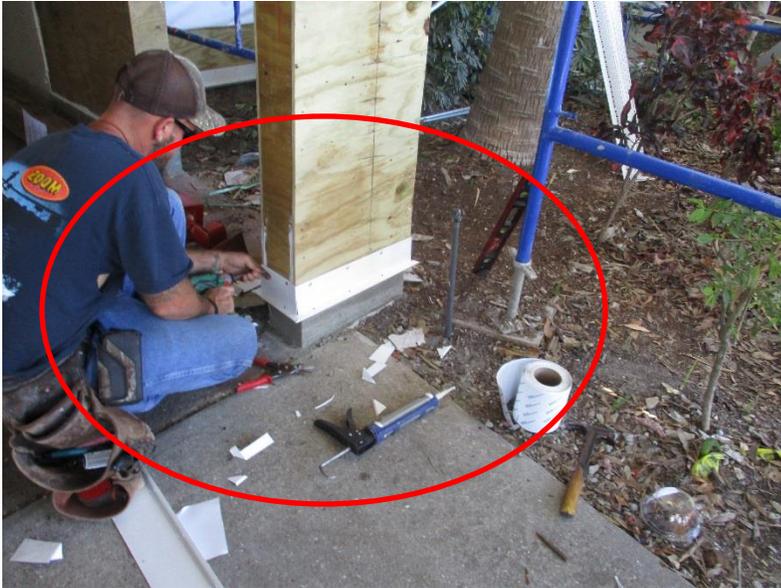
PHOTOGRAPH #13

**BUILDING 26
SECTION A**

Stucco Sub-contractor installing new stucco accessories at base of PT sheathing.

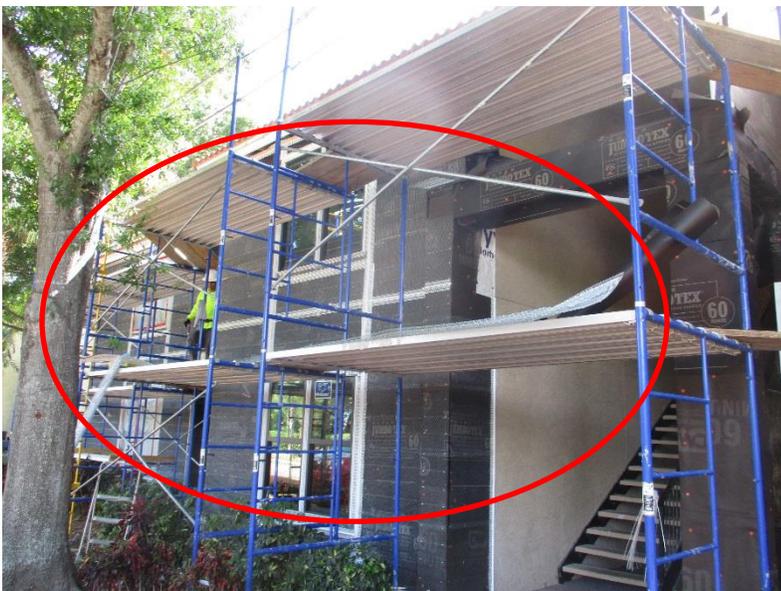
PHOTOGRAPH #14

**BUILDING 26
SECTION A**

Stucco Sub-contractor has applied JumboTex WRB and begun to install stucco accessories.

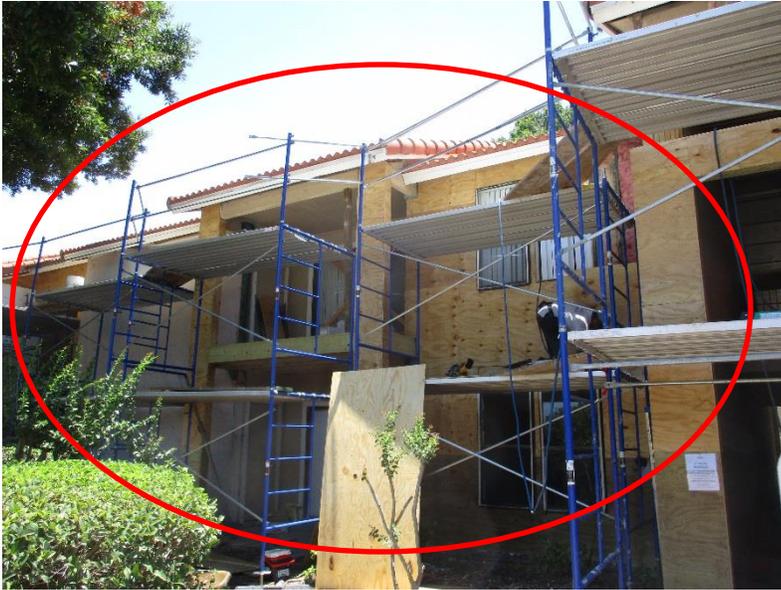
PHOTOGRAPH #15

**BUILDING 26
SECTION B**

Plywood sheathing installed at walls, balconies and breezeways.

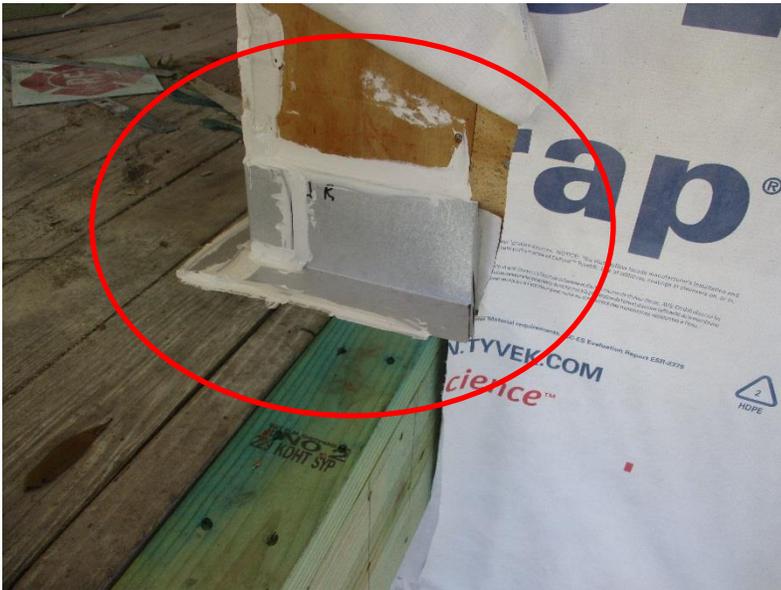
PHOTOGRAPH #16

**BUILDING 26
SECTION B**

New kick out flashing installed at balconies and sealed to sheathing and deck prior to WRB and stucco accessories.

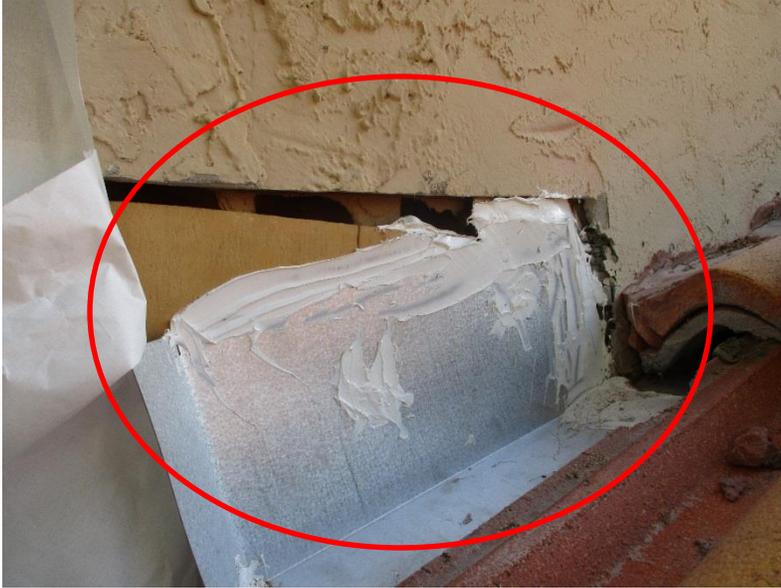
PHOTOGRAPH #17

**BUILDING 26
SECTION B**

Roof kick out flashing installed improperly. Full plywood sheathing and proper tie in to existing remaining stucco detail will be required as per project manual.

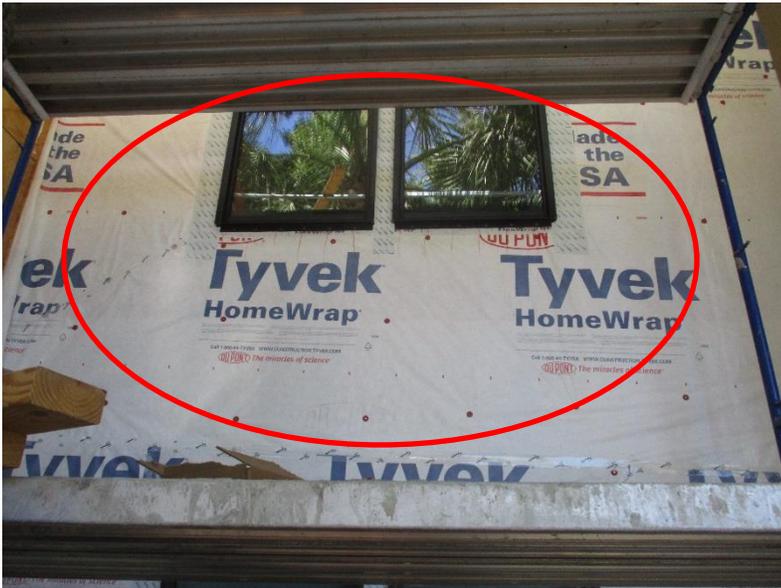
PHOTOGRAPH #18

**BUILDING 26
SECTION B**

Contractor has completed several windows and properly flashed new Dupont window flashings into Tyvek HomeWrap.

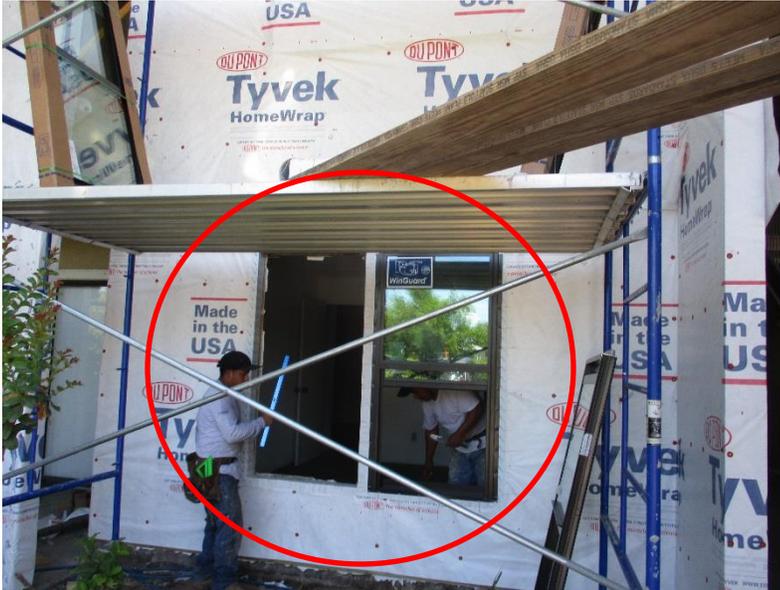
PHOTOGRAPH #19

**BUILDING 26
SECTION B- UNIT #2615**

Contractors is installing new windows, following Dupont / Tyvek installation instructions from project manual.

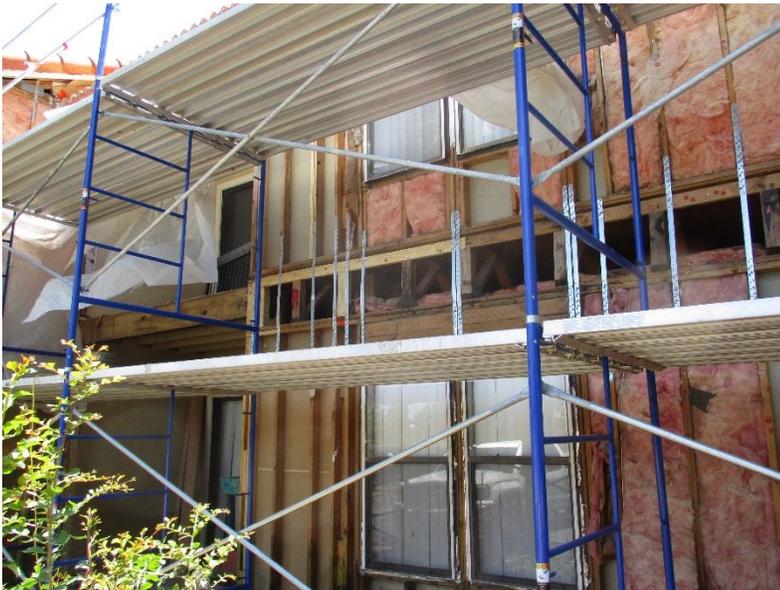
PHOTOGRAPH #20

**BUILDING 26
SECTION C**

Contractor has completed framing repairs, strapping and Simpson Strong connectors in preparation for termite treatment, insulation and new sheathing.

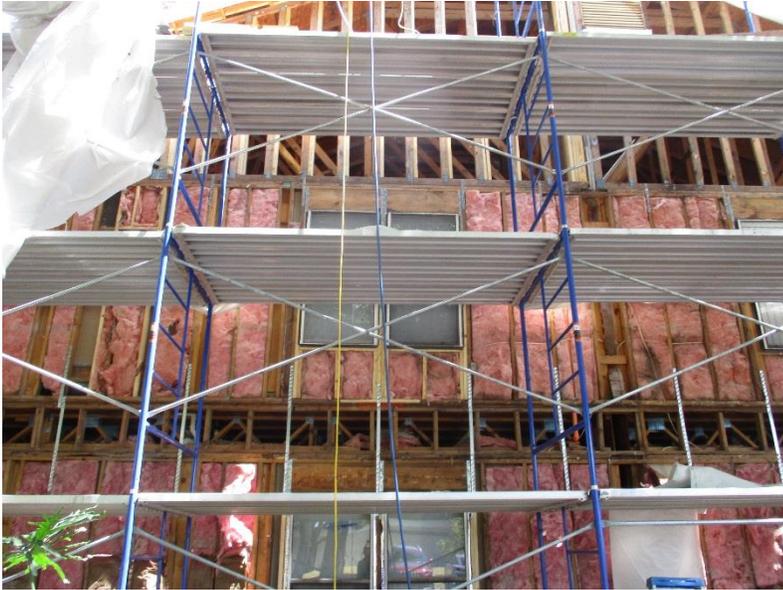
PHOTOGRAPH #21

**BUILDING 26
SECTION D**

Contractor has completed framing repairs at walls and begun strapping and Simpson Strong connectors.

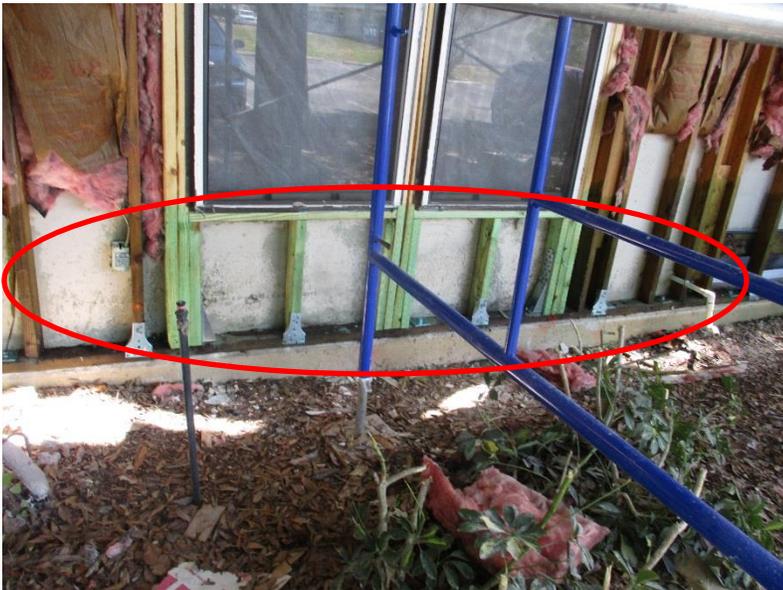
PHOTOGRAPH #22

**BUILDING 26
SECTION D**

Contractor has applied Copper-Green wood preservative at bottom 2 feet of framing.

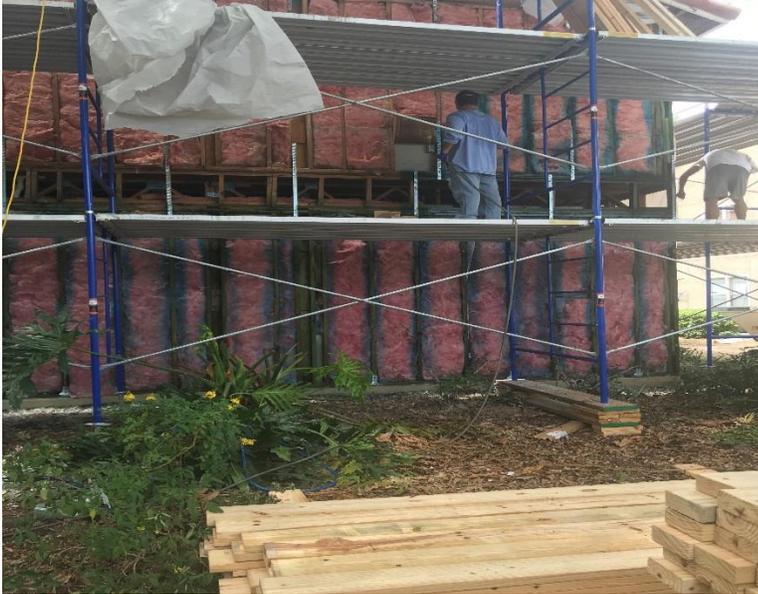
PHOTOGRAPH #23

**BUILDING 26
SECTION D**

Termite sub-contractor is applying Bora-Care termite treatment at all framing members.

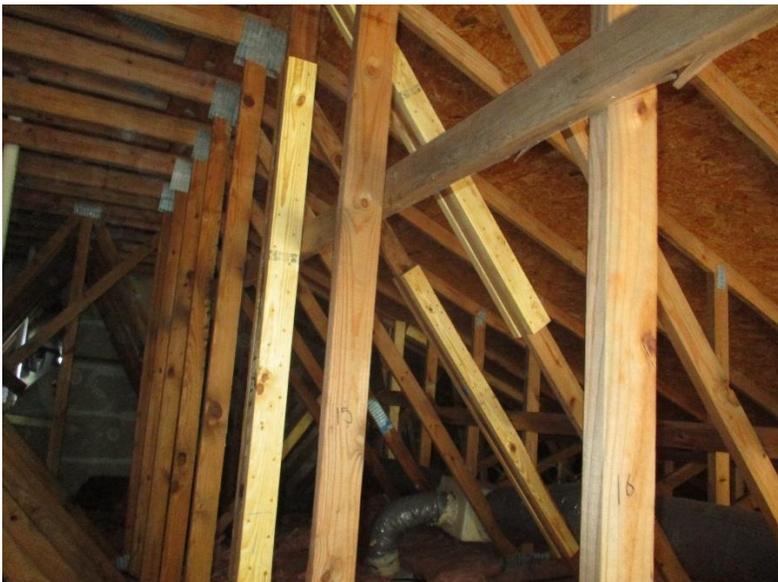
PHOTOGRAPH #24

**BUILDING 26
ATTIC # 2627**

Contractor has completed scab and gusset repairs at damaged truss framing.
