PHOTOGRAPHS

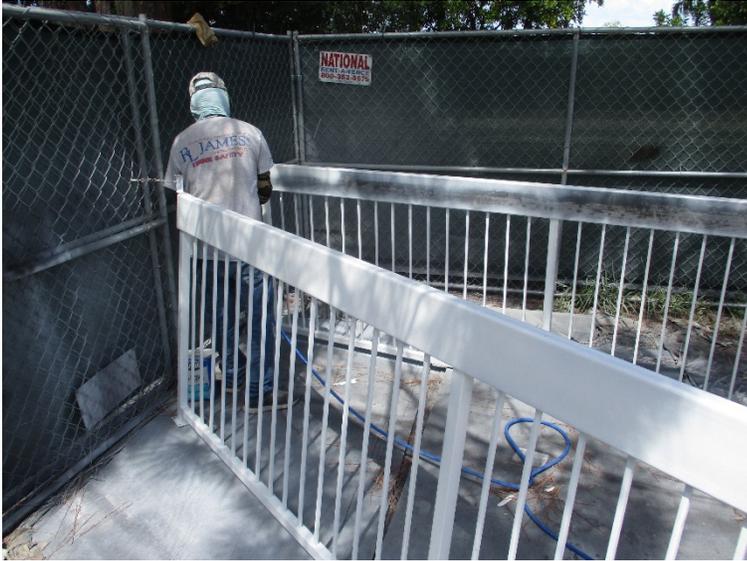
PHOTOGRAPH #1

BUILDING 24 BALCONY RAILING

Contractor is priming railing with #931 Encapsulon Industrial Epoxy Mastic primer.

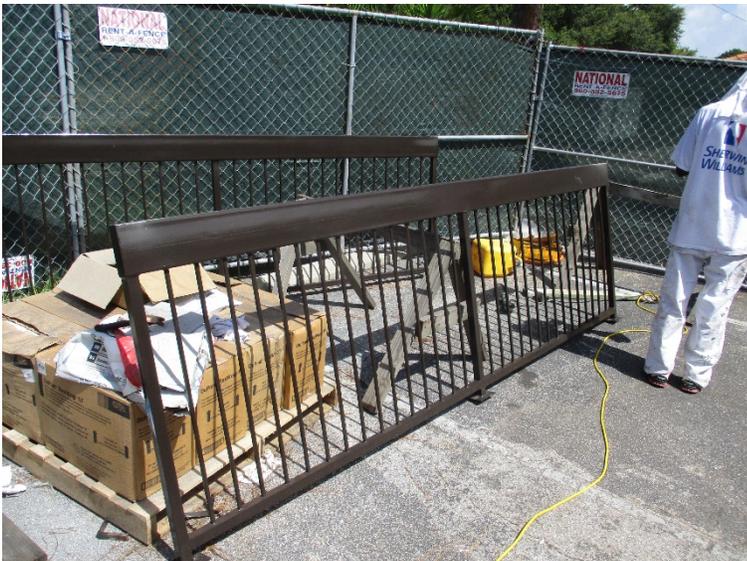
PHOTOGRAPH #2

BUILDING 24 BALCONY RAILING

Contractor has finished balcony railing with Scot-Thane Acrylic gloss enamel.

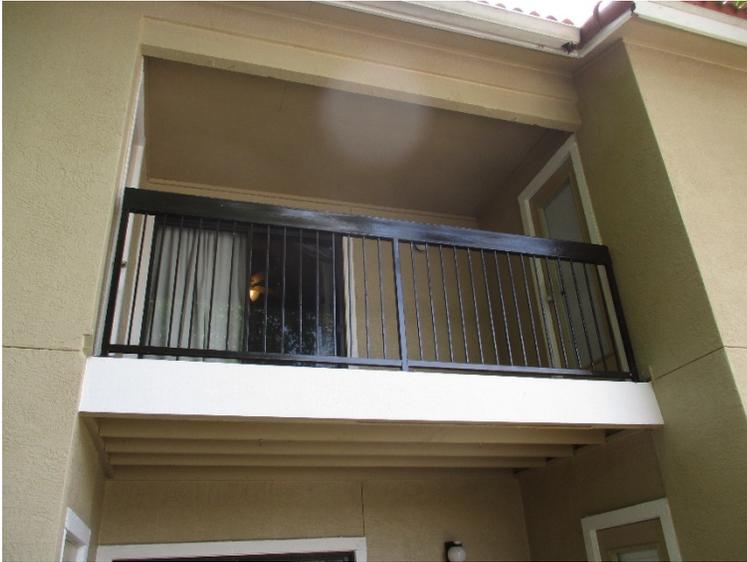
PHOTOGRAPH #3

**BUILDING 24
SECTION C**

Contractor has begun installing painted railings.

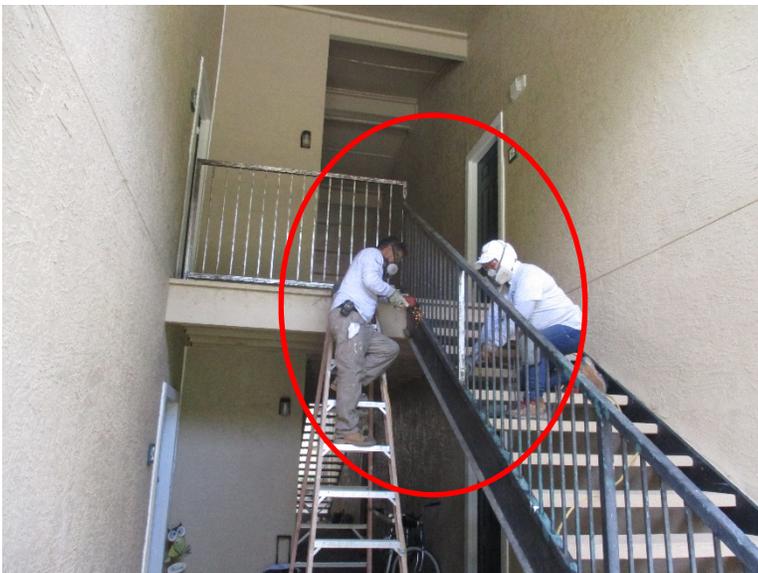
PHOTOGRAPH #4

**BUILDING 24
SECTION E**

Contractor is preparing breezeway railings by removing peeling paint and rust.

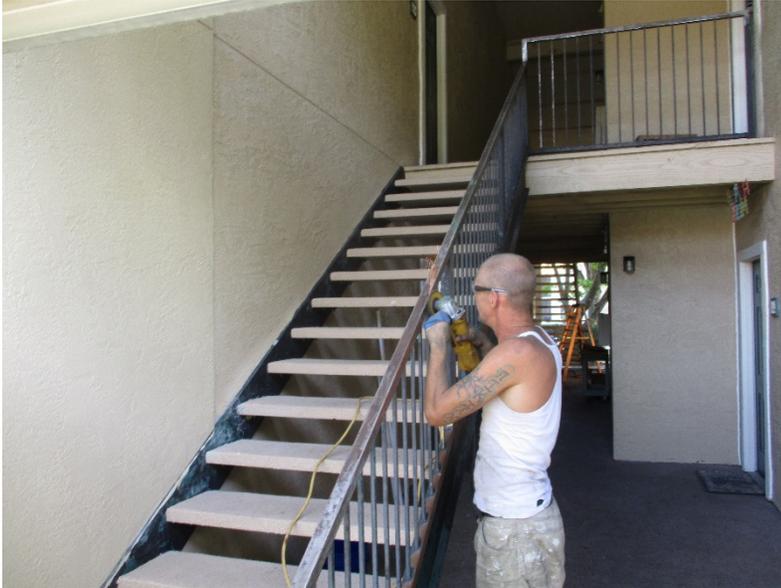
PHOTOGRAPH #5

**BUILDING 24
SECTION G**

Contractor is preparing breezeway railings by removing peeling paint and rust.

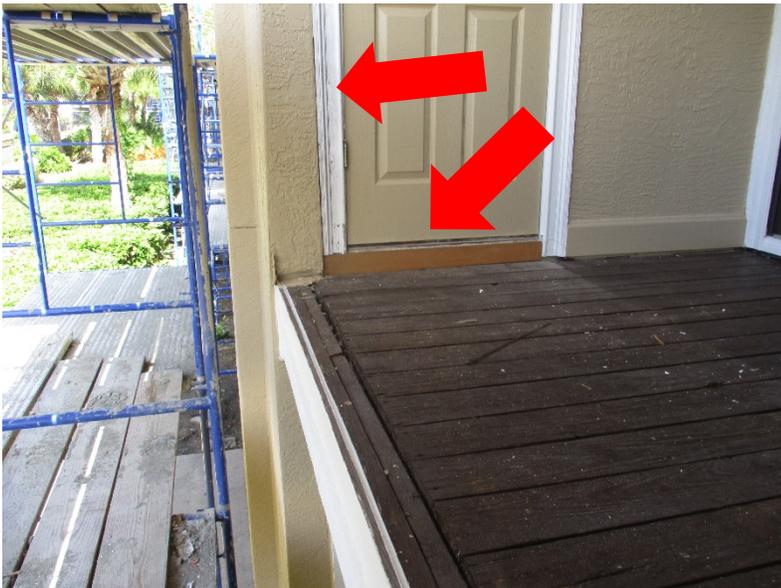
PHOTOGRAPH #6

**BUILDING 24
SECTION G -UNIT #2422**

Door trim and door sill have been replaced.

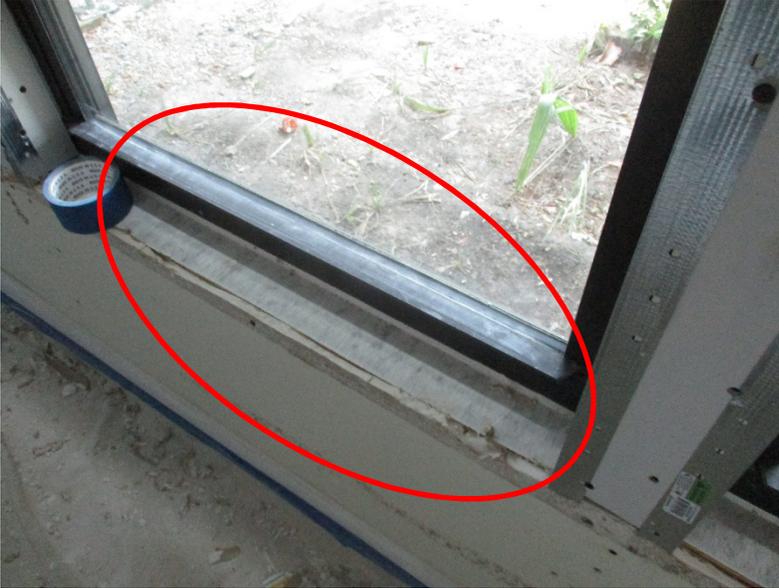
PHOTOGRAPH #7

**BUILDING 24
SECTION F -UNIT #2416**

Interior flashings and sealants installed at window sills as required. Drywall repairs in progress.

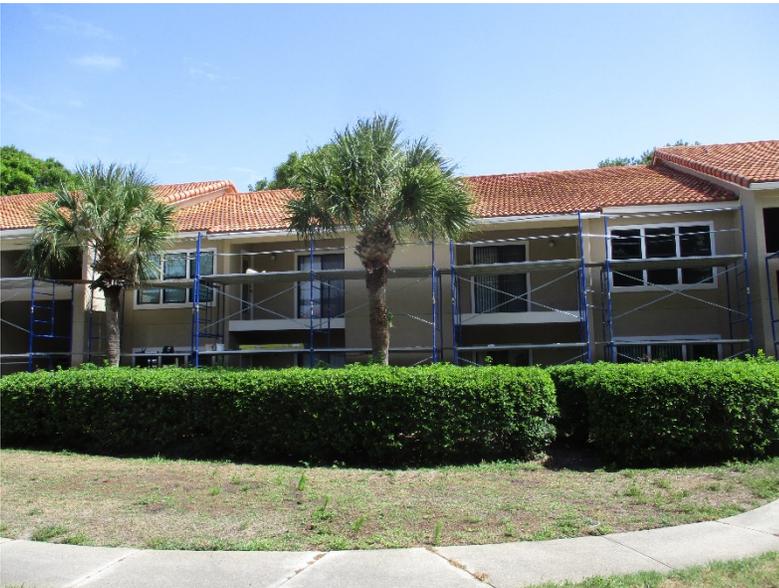
PHOTOGRAPH #8

**BUILDING 24
SECTION F**

Contractor has applied primer and finish paint at stucco walls and balcony wood trim.

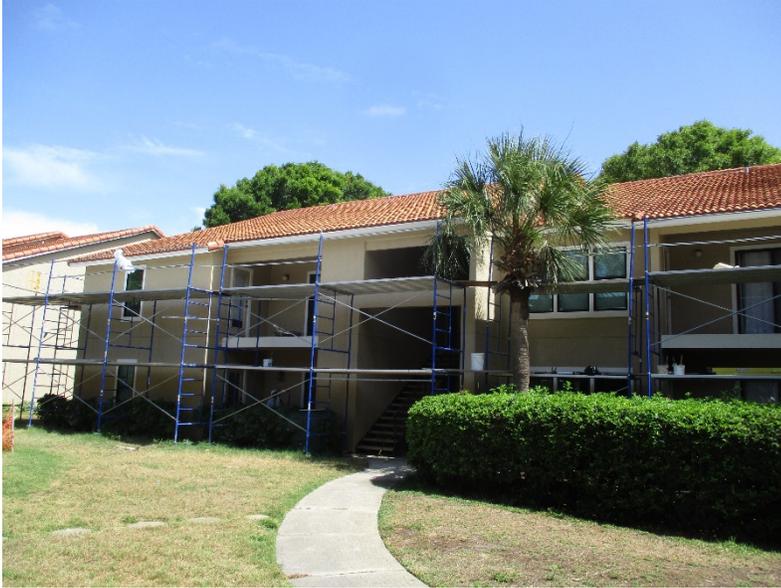
PHOTOGRAPH #9

**BUILDING 24
SECTION E**

Contractor has applied primer and finish paint at stucco walls and balcony wood trim.

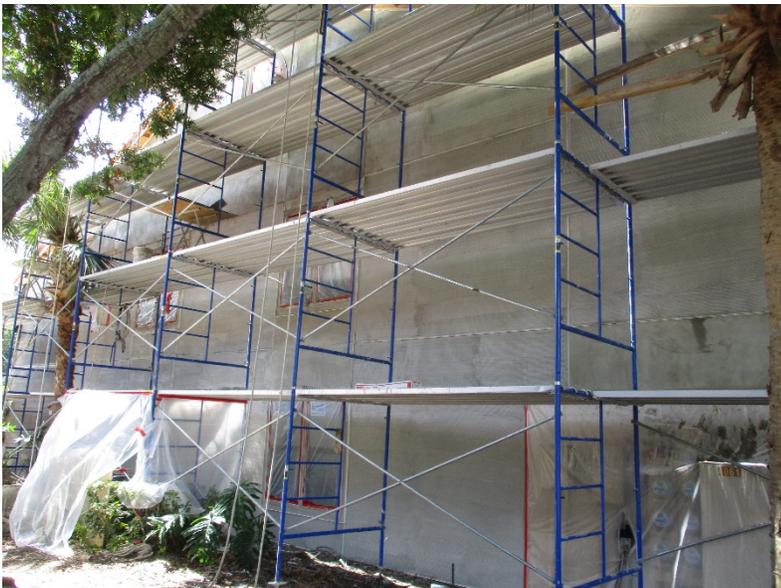
PHOTOGRAPH #10

**BUILDING 26
SECTION H**

Sub-Contractor has applied scratch coat of stucco and begun application of brown coat.

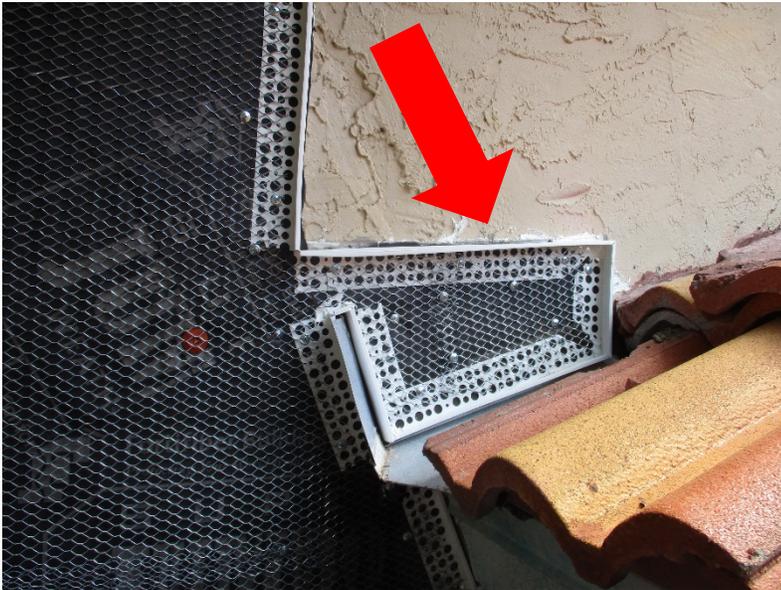
PHOTOGRAPH #11

**BUILDING 26
SECTION B**

Contractor has made corrections at kick out flashing and stucco sub-contractor has applied accessories and lath in preparation for stucco.

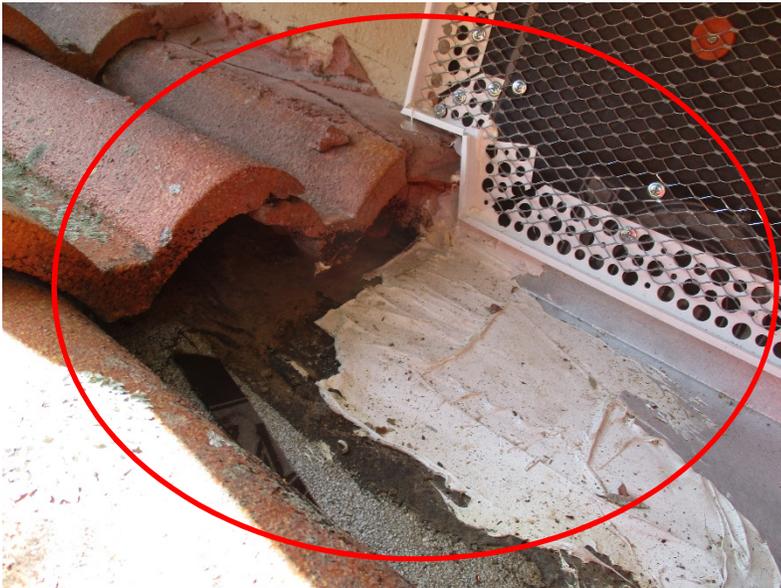
PHOTOGRAPH #12

**BUILDING 26
SECTION C**

Kick out roof flashing has been installed incorrectly over roofing materials.

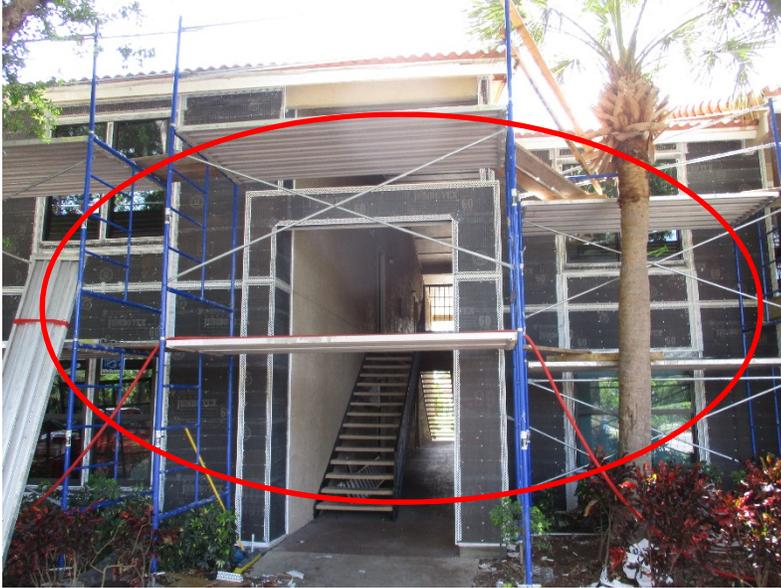
PHOTOGRAPH #13

**BUILDING 26
SECTION B**

Stucco Sub-contractor is installing stucco accessories and lathing in preparation for stucco.

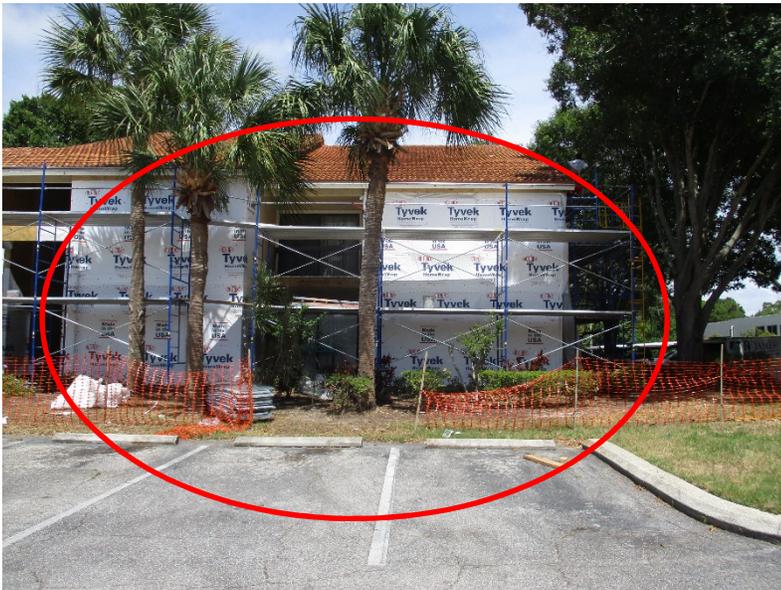
PHOTOGRAPH #14

**BUILDING 26
SECTION C**

Tyvek WRB has been applied over new sheathing in preparation for window installations.

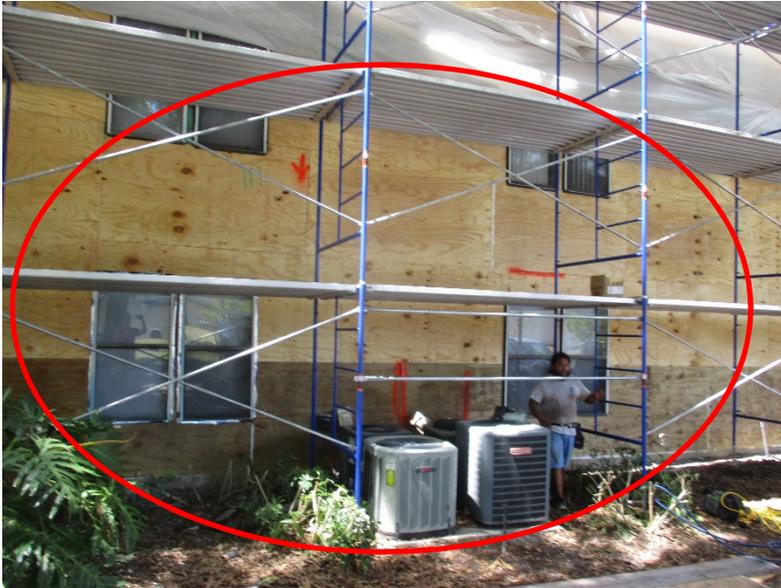
PHOTOGRAPH #15

**BUILDING 26
SECTION D**

Plywood sheathing inspection marked for corrections.

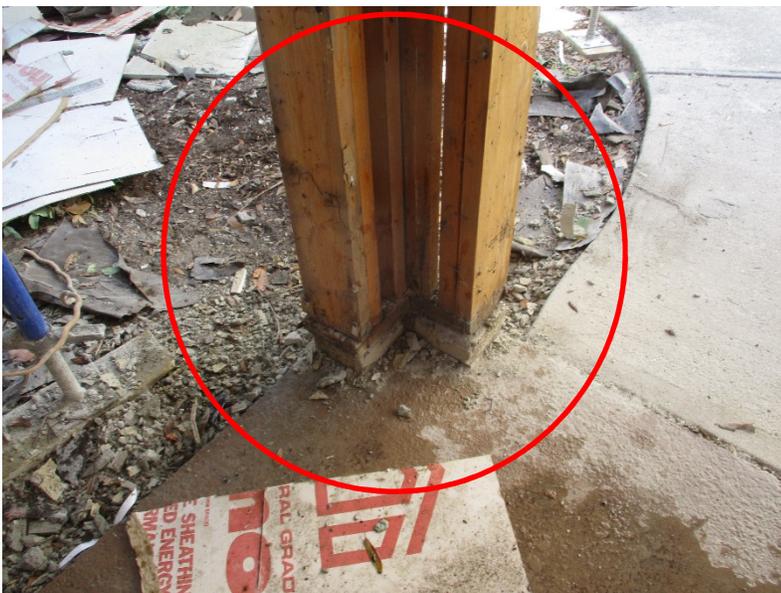
PHOTOGRAPH #16

**BUILDING 26
SECTION E**

Breezeway columns and built up beams do not show damage to framing and will not require framing repairs.

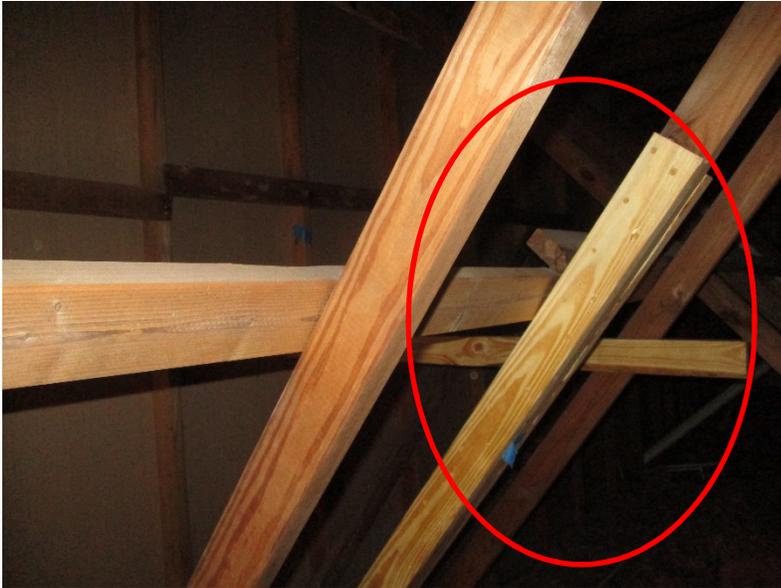
PHOTOGRAPH #17

**BUILDING 26
ATTIC #2628**

Contractor has completed scab and gusset repairs at damaged truss framing.

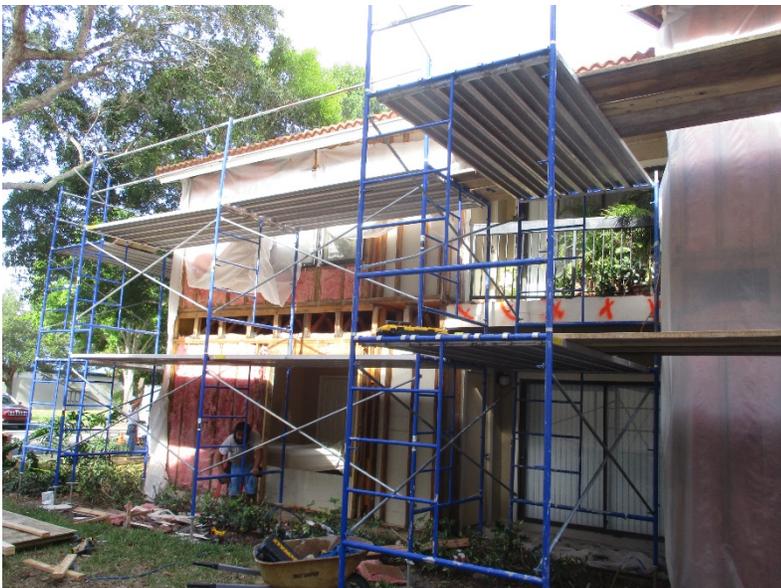
PHOTOGRAPH #18

**BUILDING 26
SECTION E**

Damages have been identified and marked for repairs.

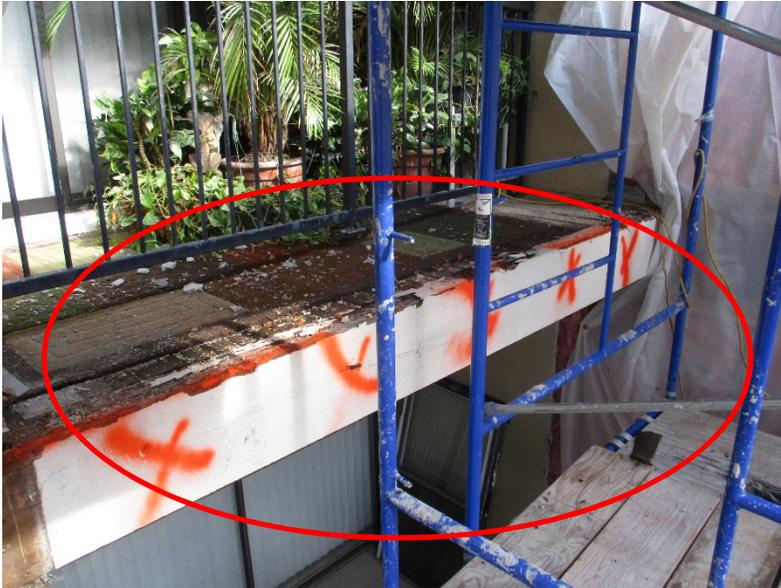
PHOTOGRAPH #19

**BUILDING 26
SECTION E**

Damages have been identified and marked for repairs.

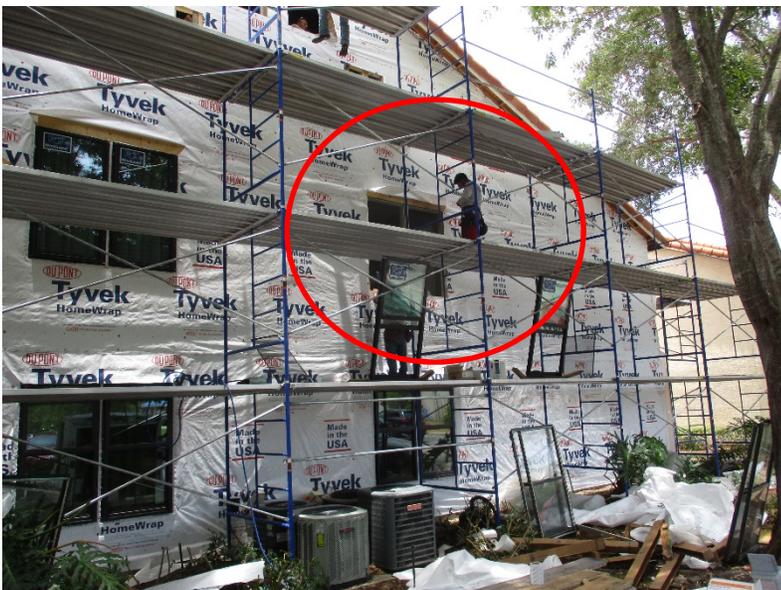
PHOTOGRAPH #20

**BUILDING 26
SECTION D**

Contractor has made sheathing corrections, installed Tyvek HomeWrap WRB and is installing PPG windows.

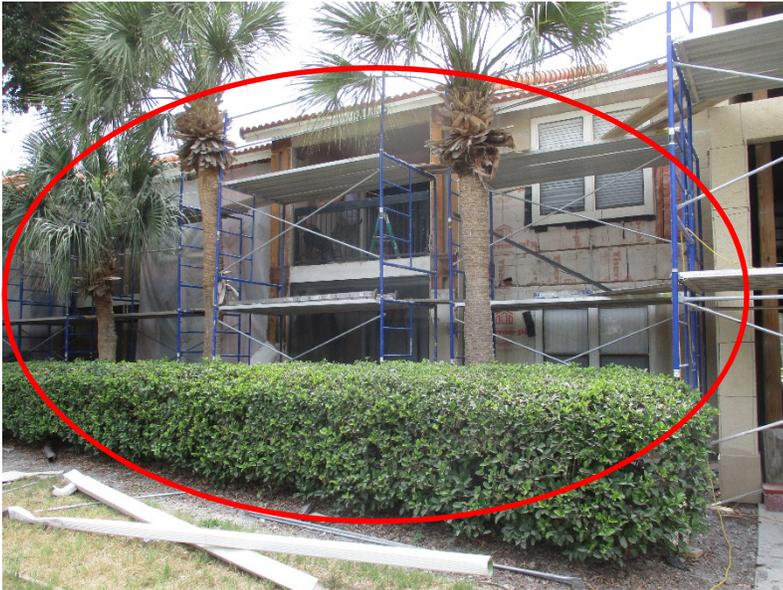
PHOTOGRAPH #21

**BUILDING 26
SECTION F**

Contractor has erected scaffolding and begun demo work at walls and balconies.

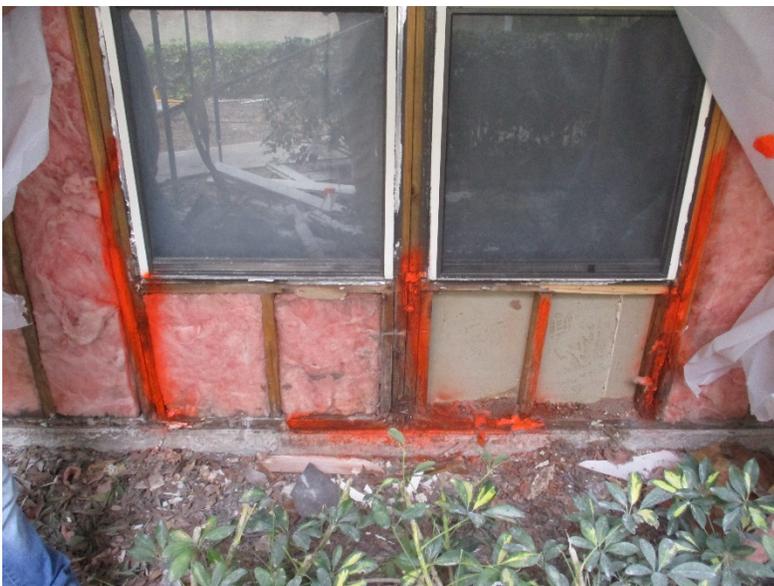
PHOTOGRAPH #22

**BUILDING 26
SECTION F**

Damage to wood framing at window identified and marked for repairs.
