PHOTOGRAPHS

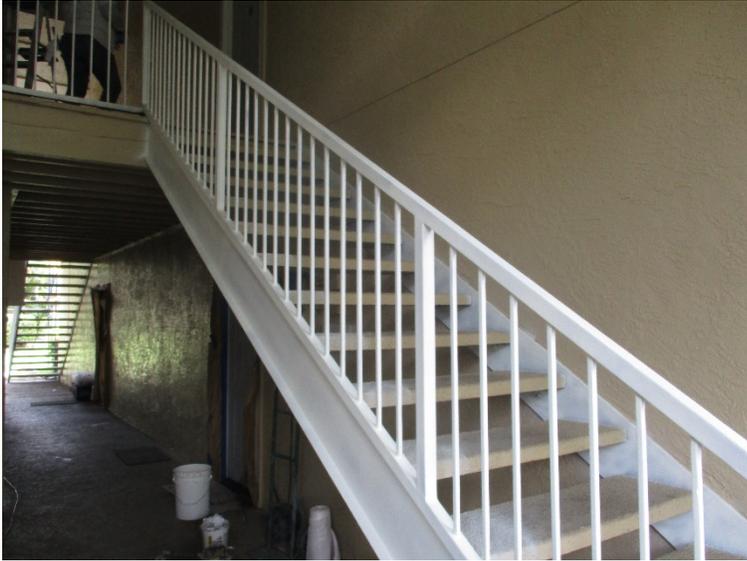
PHOTOGRAPH #1

BUILDING 24 BALCONY RAILING

Contractor is priming railing with #931 Encapsulon Industrial Epoxy Mastic primer.

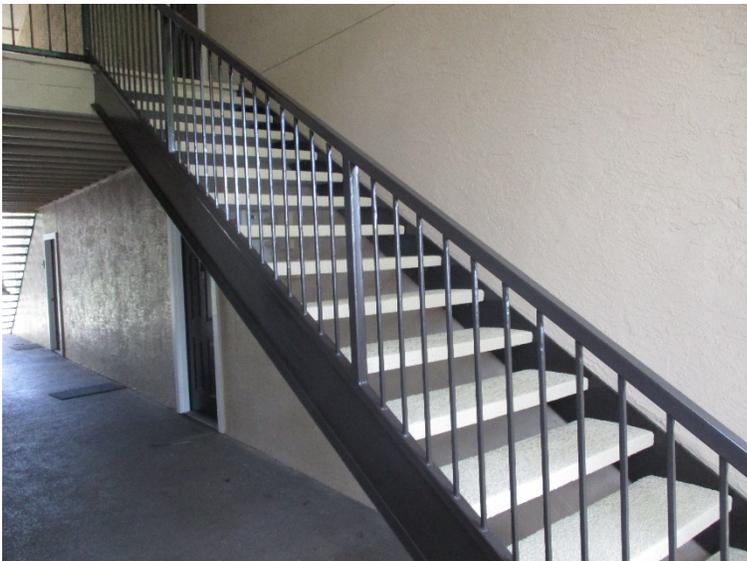
PHOTOGRAPH #2

BUILDING 24 BALCONY RAILING

Contractor has finished balcony railing with Scot-Thane Acrylic gloss enamel.

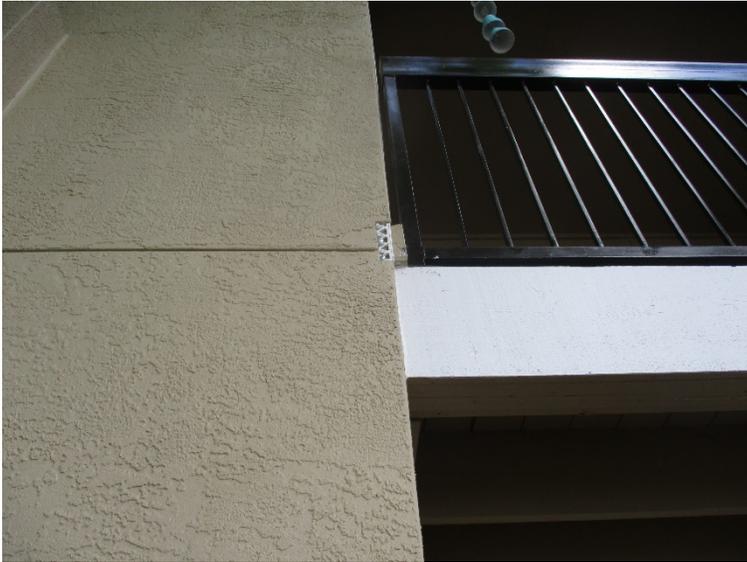
PHOTOGRAPH #3

**BUILDING 24
SECTION B**

Repairs being made at kick out flashings where stucco was notched out incorrectly.

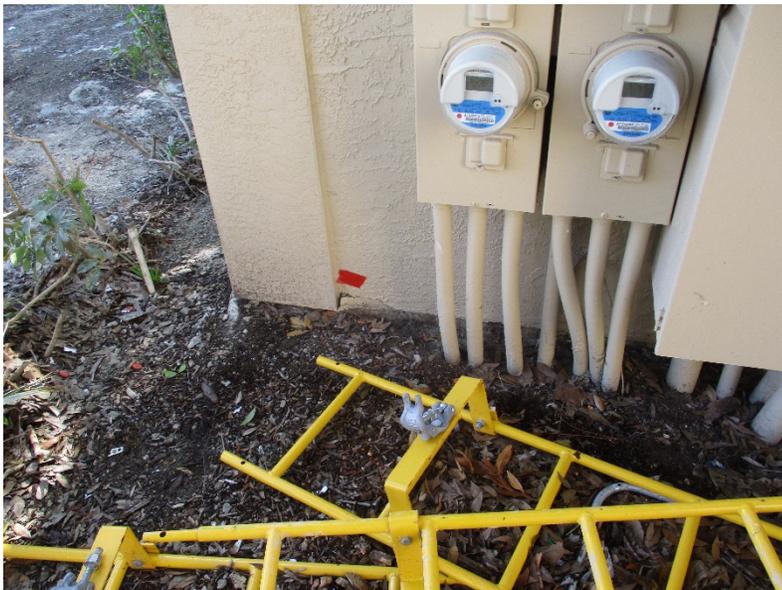
PHOTOGRAPH #4

**BUILDING 24
SECTION D**

Pre-punch by Delta identified stucco repair to be made.

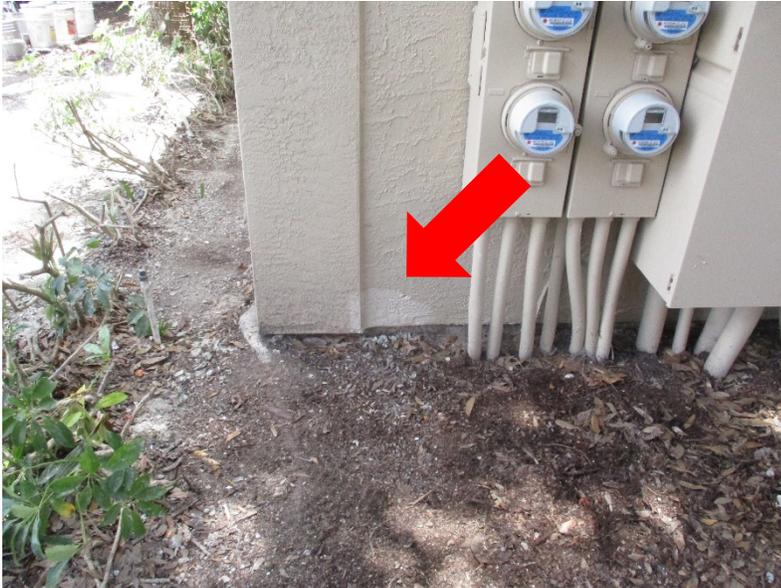
PHOTOGRAPH #5

**BUILDING 24
SECTION D**

Stucco repaired, previously identified and marked by Delta pre-punch.

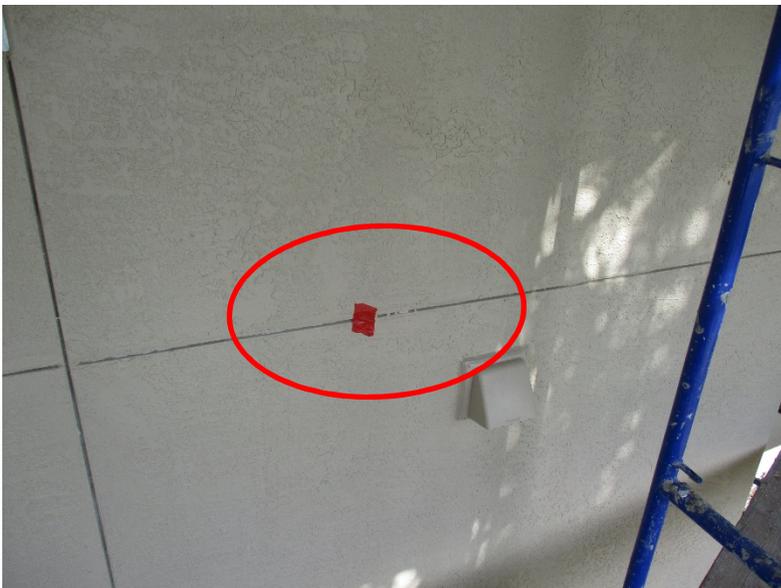
PHOTOGRAPH #6

**BUILDING 24
SECTION H**

Other details marked by Delta pre-punch. Stucco or paint has bridged control joint and will be removed and touched up.

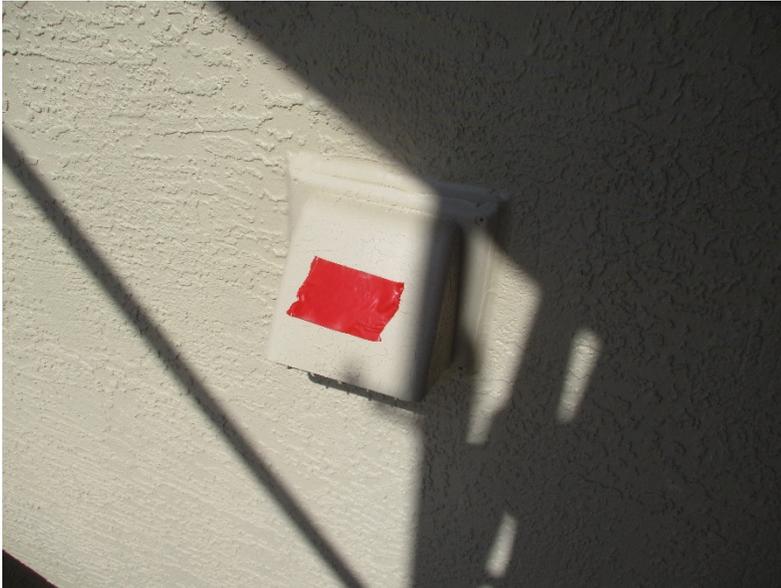
PHOTOGRAPH #7

**BUILDING 24
SECTION H**

Paint on dryer vent covers is distorted and will require re-painting.

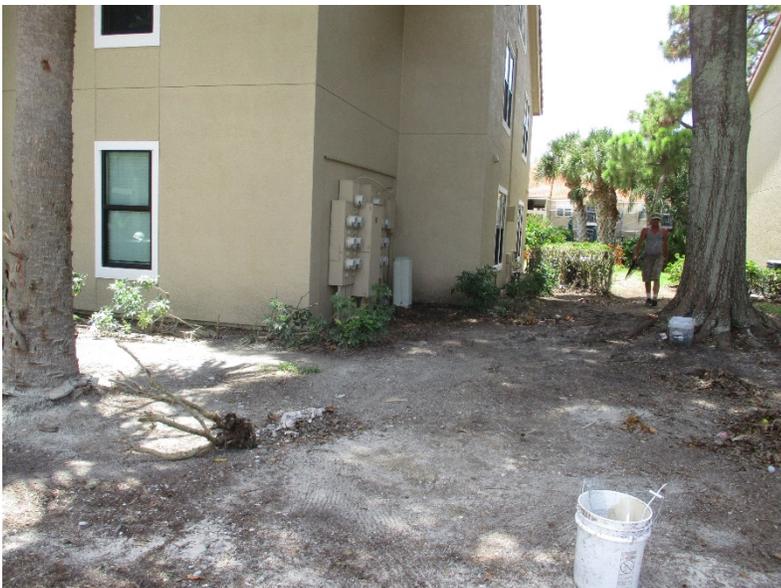
PHOTOGRAPH #8

**BUILDING 24
SECTION C**

Contactor has removed scaffold and materials and has begun site cleanup of grounds around building.

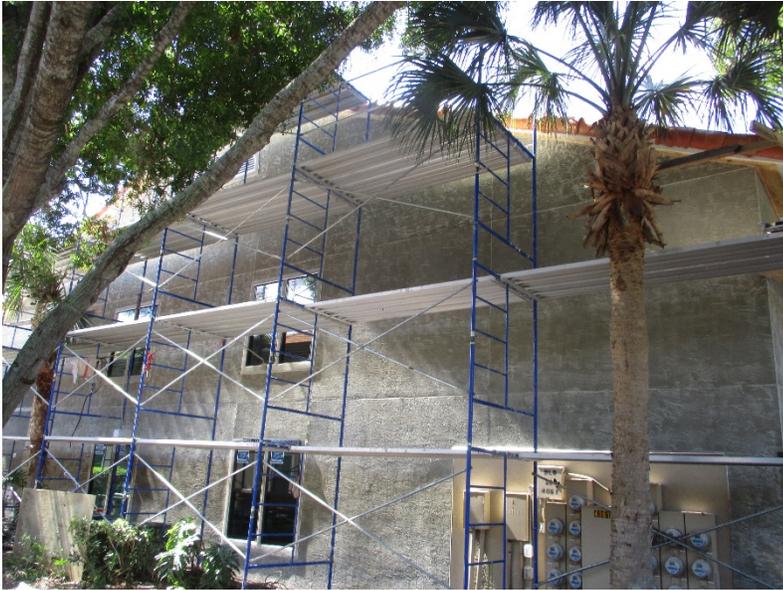
PHOTOGRAPH #9

**BUILDING 26
SECTION H**

Sub-Contractor has applied finish coat of stucco and in process of moisture curing.

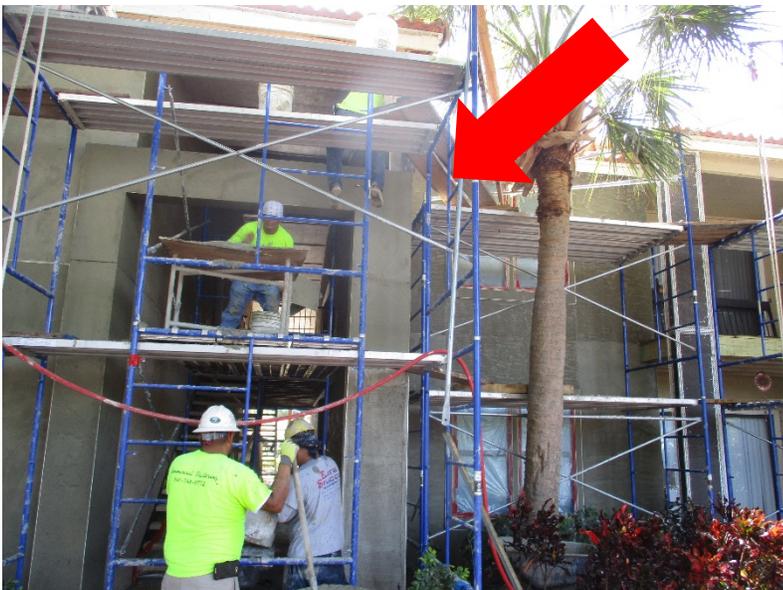
PHOTOGRAPH #10

**BUILDING 26
SECTION A**

Stucco sub-contractor is applying brown coat over scratch coat at breezeway area.

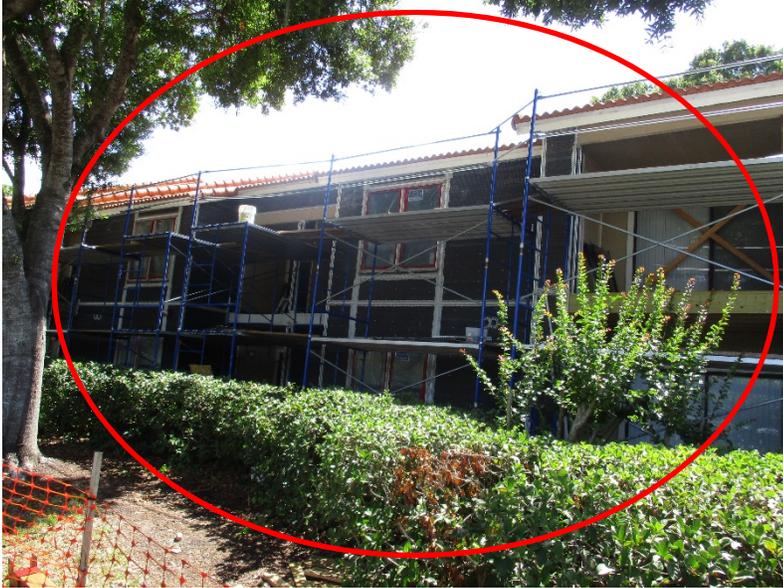
PHOTOGRAPH #11

**BUILDING 26
SECTION B**

JumboTex WRB, stucco accessories and lath have been applied in preparation for stucco.

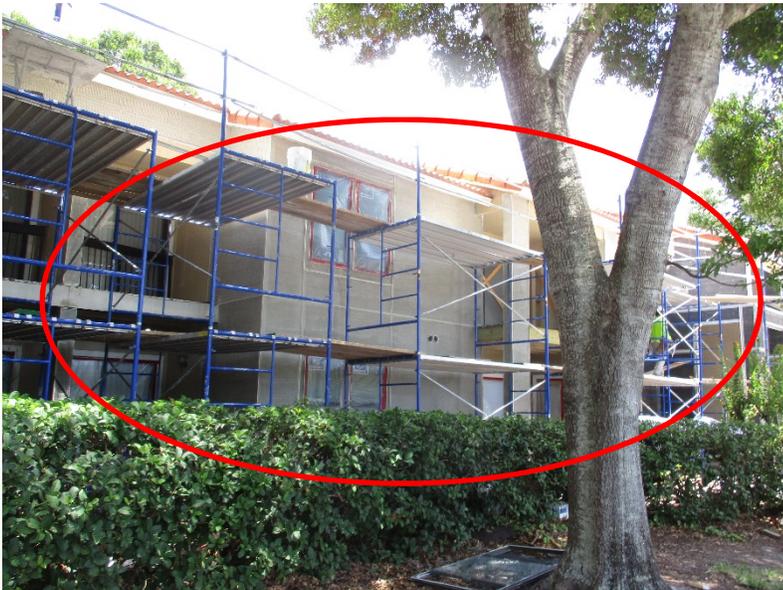
PHOTOGRAPH #12

**BUILDING 26
SECTION B**

Stucco Sub-contractor is applying new stucco in three coat system.

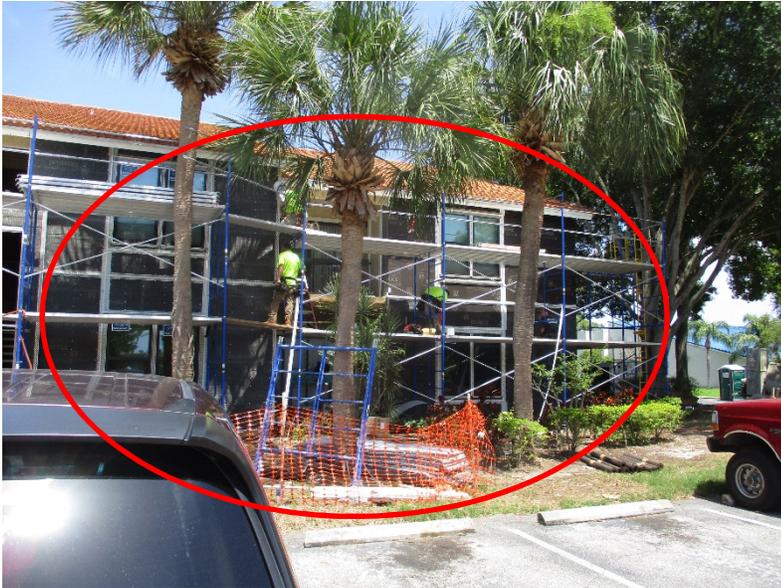
PHOTOGRAPH #13

**BUILDING 26
SECTION C**

JumboTex WRB, stucco accessories and lath are being applied in preparation for stucco.

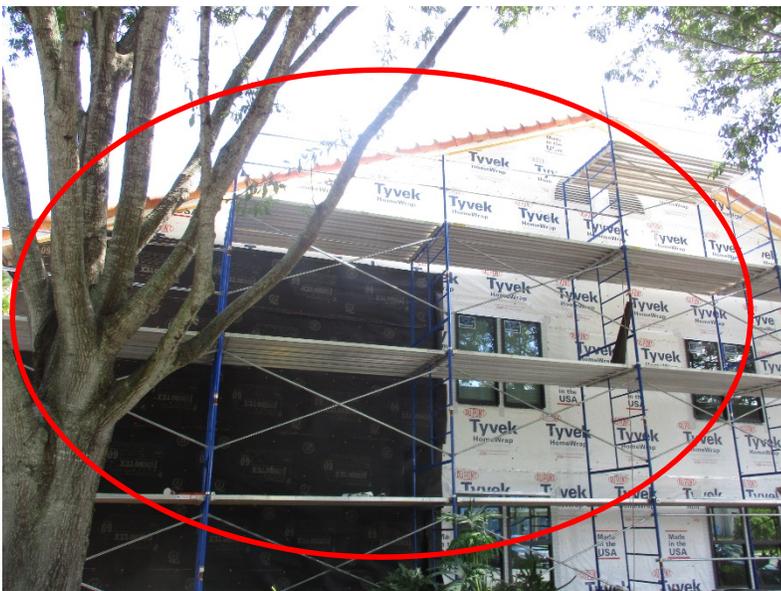
PHOTOGRAPH #14

**BUILDING 26
SECTION D**

Stucco sub-contractor has begun to install JumboTex WBR.

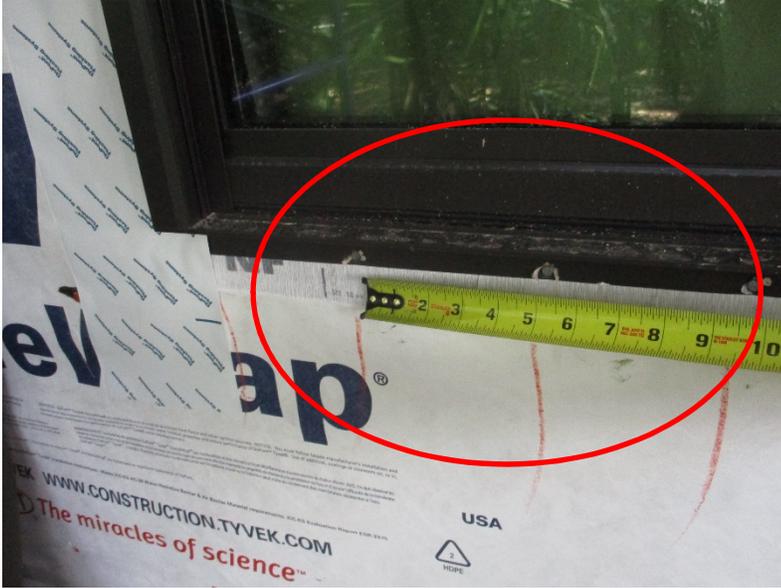
PHOTOGRAPH #15

**BUILDING 26
SECTION D**

Window flanges have been fastened in accordance with manufactures NOAs.

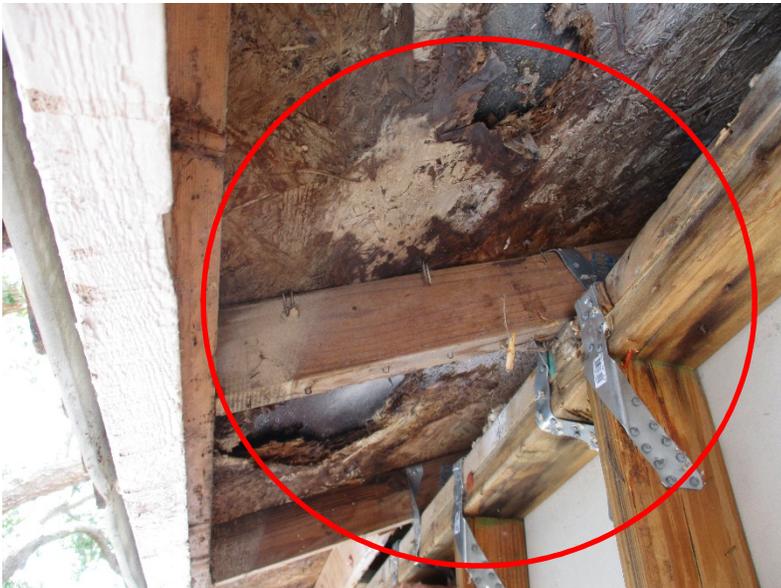
PHOTOGRAPH #16

**BUILDING 26
SECTION E**

Roof sheathing damaged. Repairs are to be done by roofing contractors for owners.

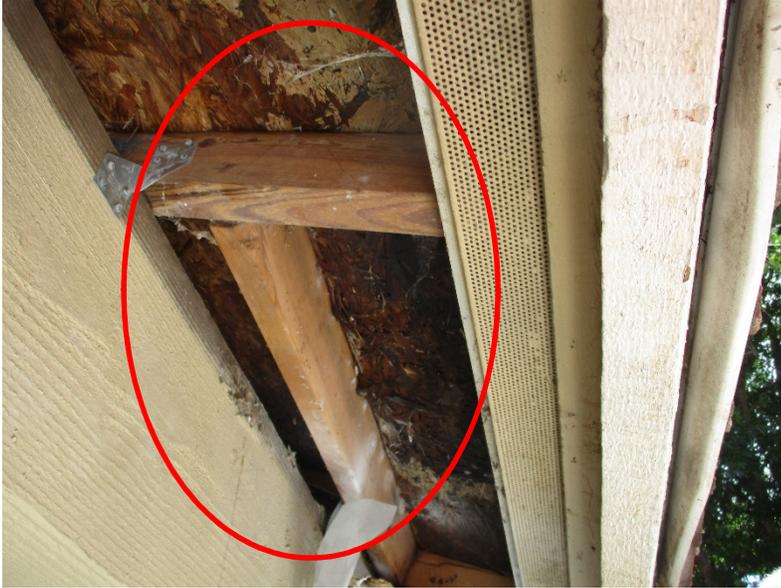
PHOTOGRAPH #17

**BUILDING 26
SECTION F**

Roof sheathing damaged. Repairs are to be done by roofing contractors for owners.

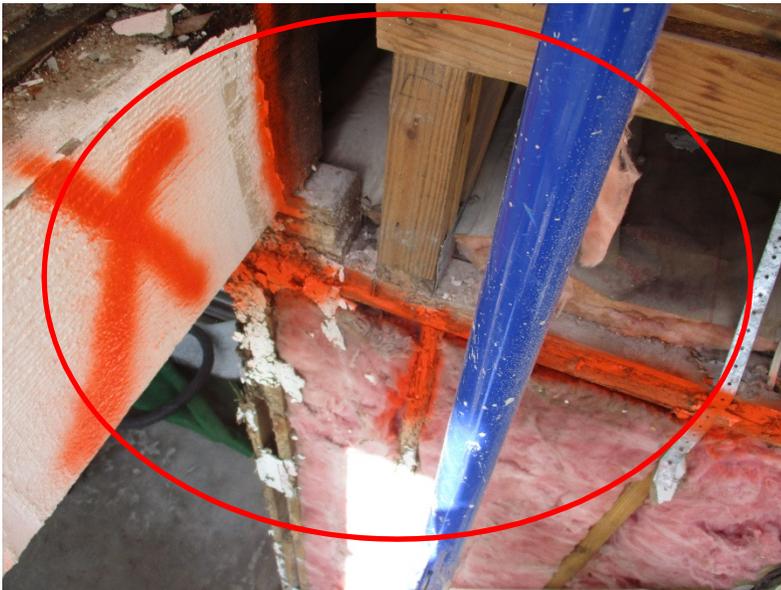
PHOTOGRAPH #18

**BUILDING 26
SECTION F**

Damages at balcony built up beams, columns and wall framing have been identified and marked for repairs.

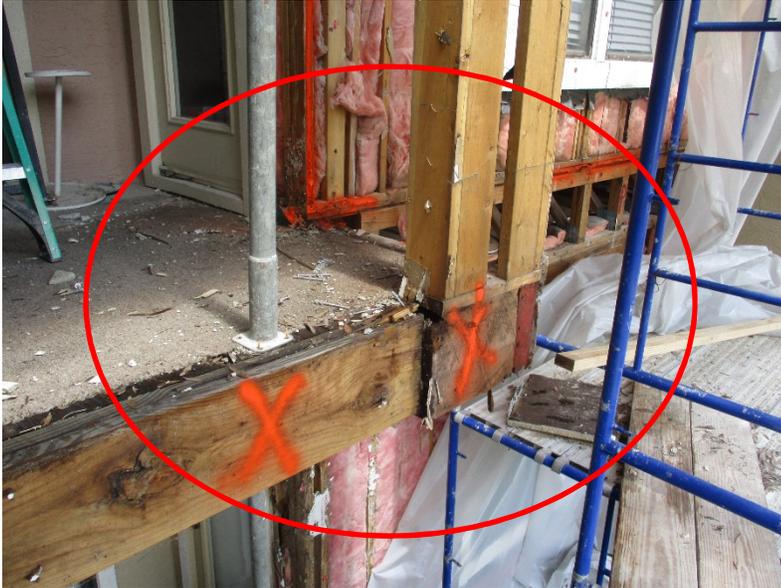
PHOTOGRAPH #19

**BUILDING 26
SECTION F**

Damages at balcony built up beams, columns and wall framing have been identified and marked for repairs.

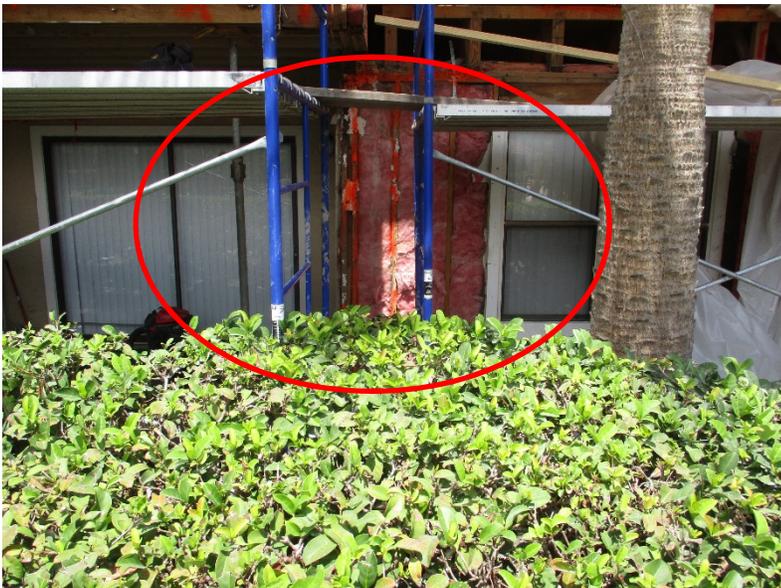
PHOTOGRAPH #20

**BUILDING 26
SECTION F**

Damages at balcony built up beams, columns and wall framing have been identified and marked for repairs.

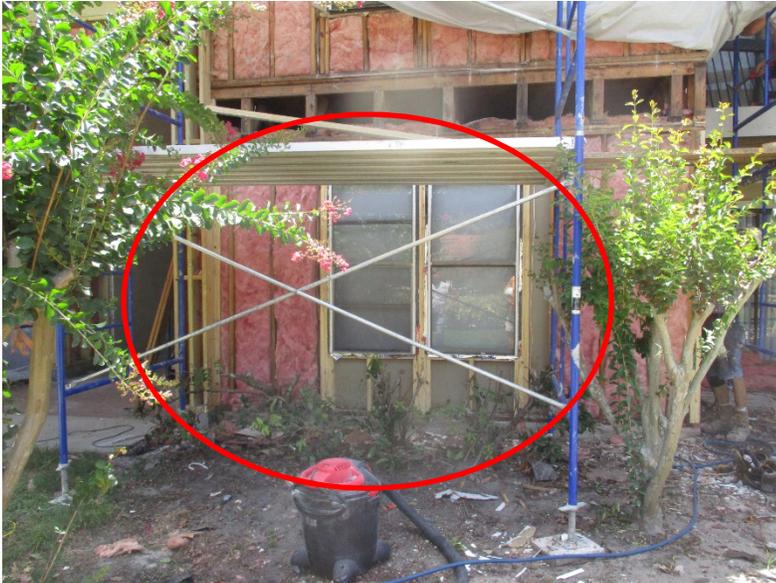
PHOTOGRAPH #21

**BUILDING 26
SECTION F**

Contractor in process of making repairs at damaged framing.

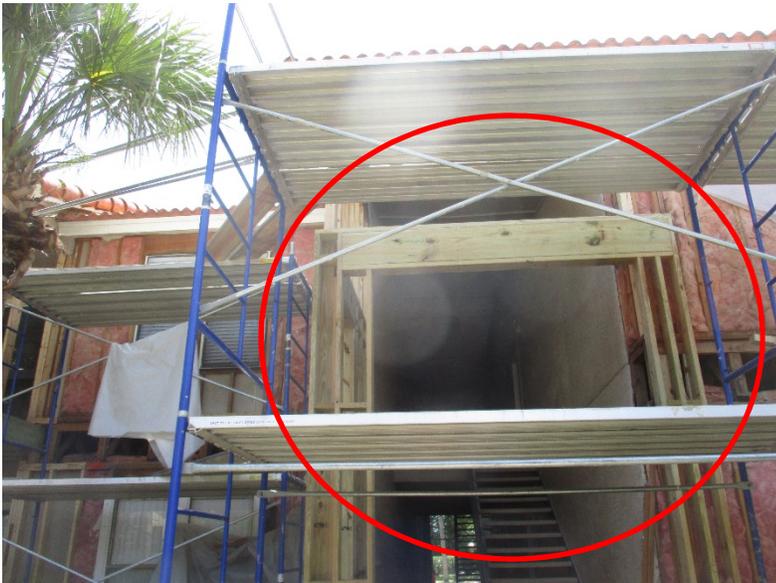
PHOTOGRAPH #22

**BUILDING 26
SECTION G**

Contractor in process of making repairs at damaged breezeway built up beams and columns.
