PHOTOGRAPHS

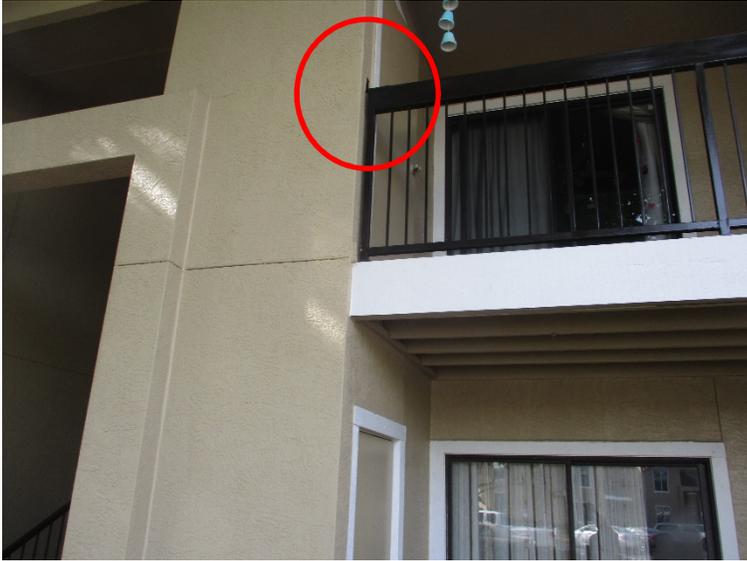
PHOTOGRAPH #1

BUILDING 24 BALCONY RAILINGS

Top railing angles have been placed, fastened to wall and paint touched up.

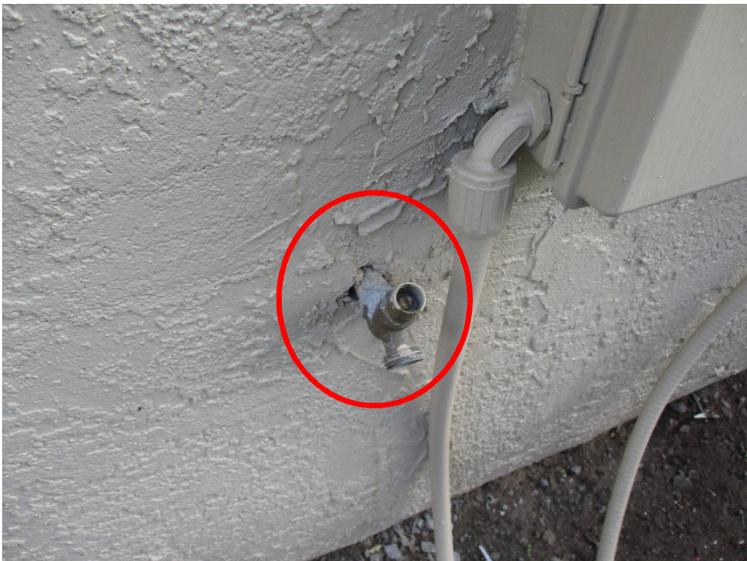
PHOTOGRAPH #2

BUILDING 24 SECTION F

Water hose bib will require sealant at penetration through stucco.

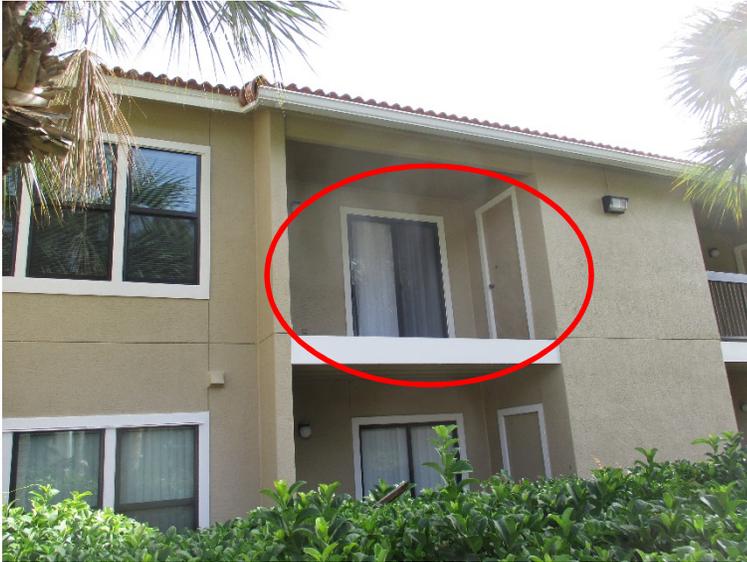
PHOTOGRAPH #3

**BUILDING 24
SECTION F- UNIT #2426**

New railing for balcony has not been delivered for installation.

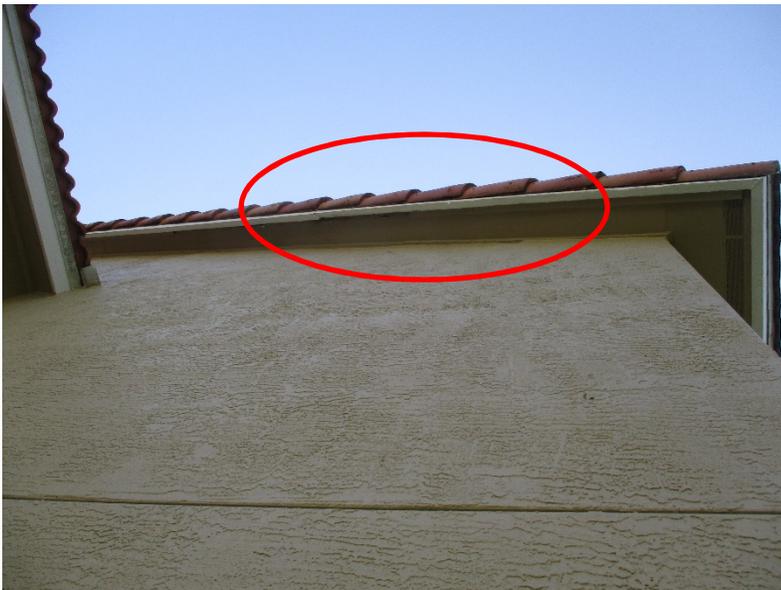
PHOTOGRAPH #4

**BUILDING 24
SECTION D**

Pre-punch by Delta identified repair to be made at soffit where voids exist.

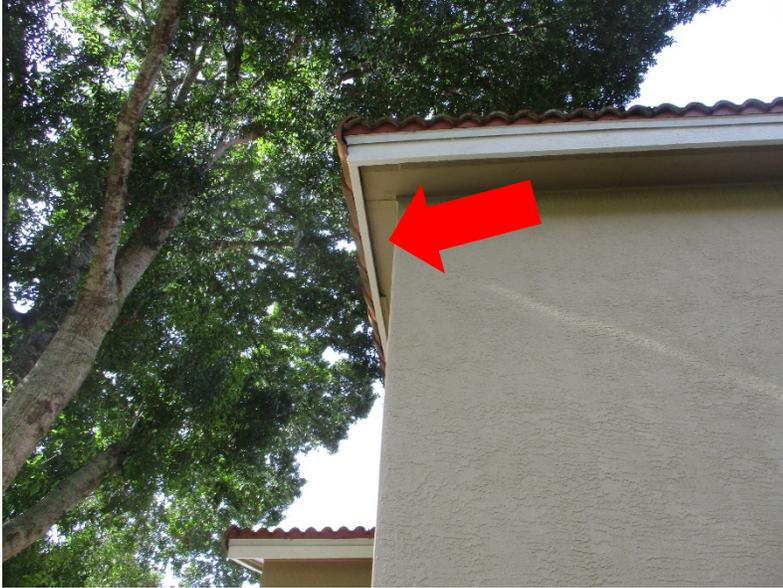
PHOTOGRAPH #5

**BUILDING 24
SECTION A**

Pre-punch by Delta identified repair to be made at soffit where voids exist.

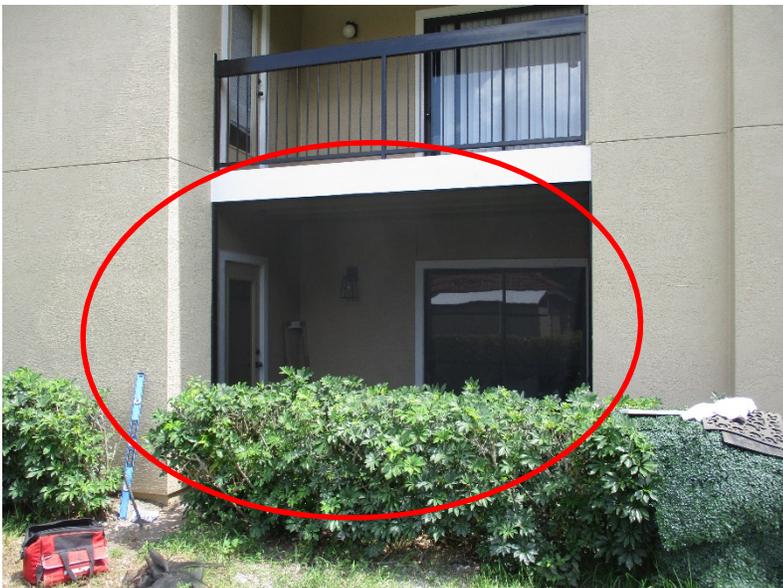
PHOTOGRAPH #6

**BUILDING 24
SECTION E**

Screen enclosures are being installed at previously screened areas.

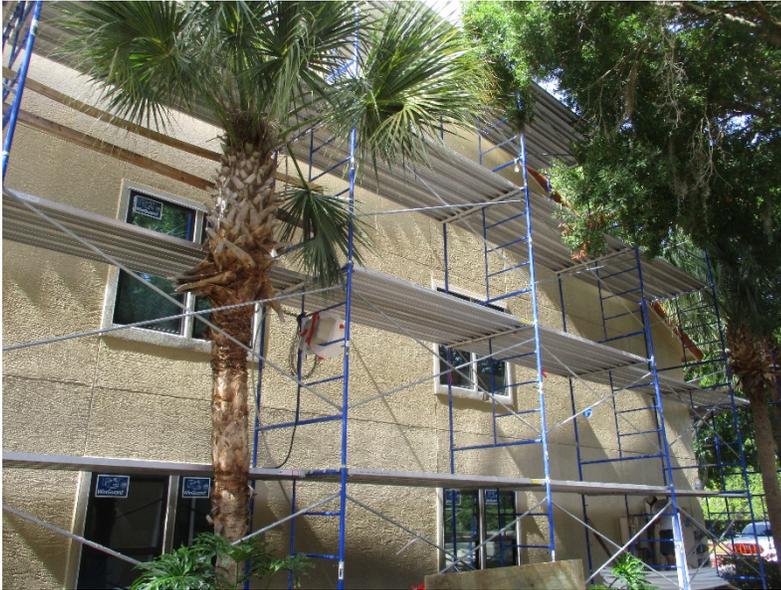
PHOTOGRAPH #7

**BUILDING 26
SECTION H**

Contractor has primed and painted stucco.

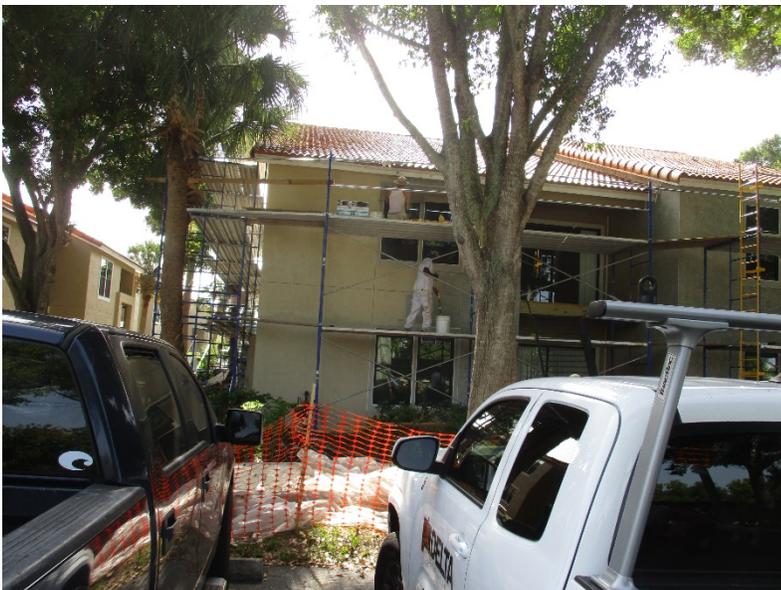
PHOTOGRAPH #8

**BUILDING 26
SECTION A**

Contractor has begun to prime new stucco.

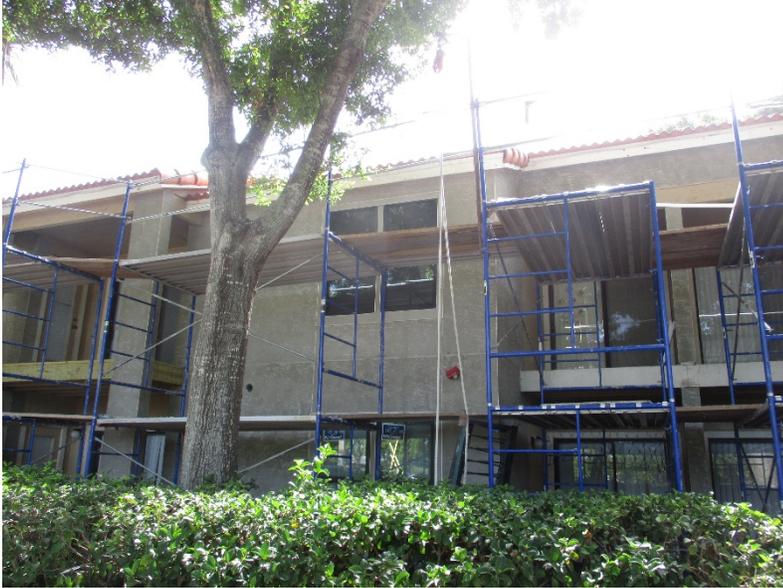
PHOTOGRAPH #9

**BUILDING 26
SECTION B**

Sub-Contractor has applied a three coats stucco system and in process of moisture curing.

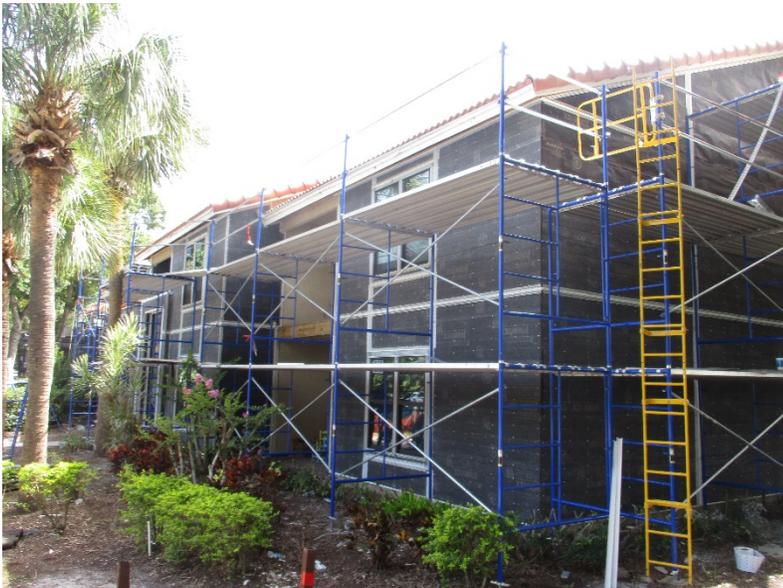
PHOTOGRAPH #10

**BUILDING 26
SECTION C**

Stucco sub-contractor has installed JumboTex WRB, stucco accessories and lath in preparation for stucco application.

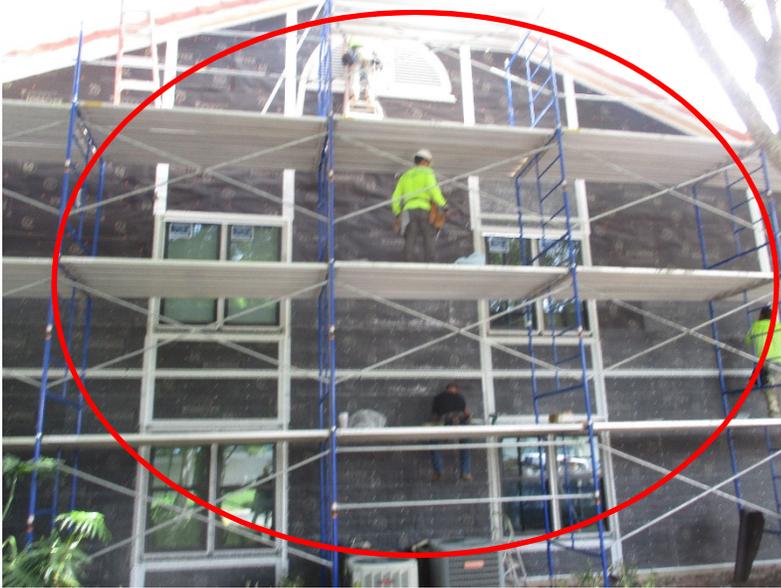
PHOTOGRAPH #11

**BUILDING 26
SECTION D**

Stucco sub-contractor installing accessories and lath in preparation for stucco.

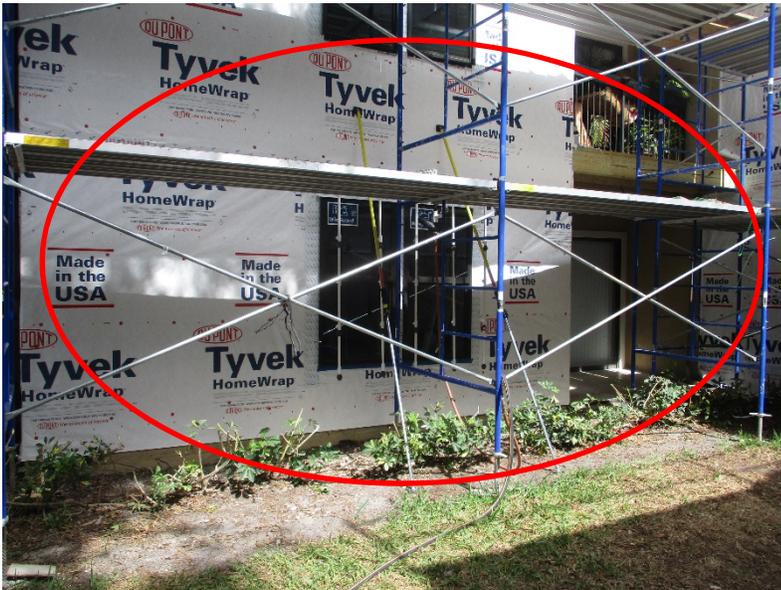
PHOTOGRAPH #12

**BUILDING 26
SECTION E**

Tyvek, flashings and windows have been installed.

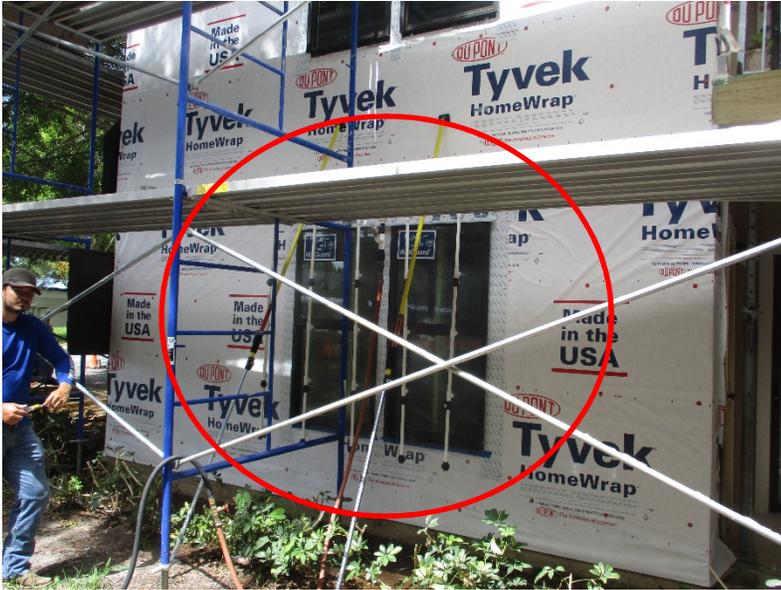
PHOTOGRAPH #13

**BUILDING 26
UNIT 2418- WATER TESTING**

Independent Testing Agency setting up for ASTM E 1105 field testing.

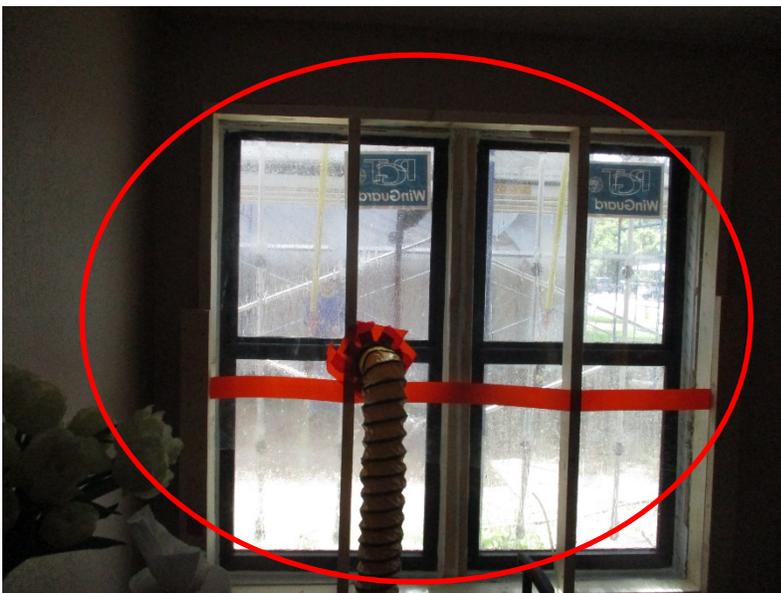
PHOTOGRAPH #14

**BUILDING 26
UNIT 2418- WATER TESTING**

ASTM E 1105 testing performed at bedroom double window section E passed with no leaks.

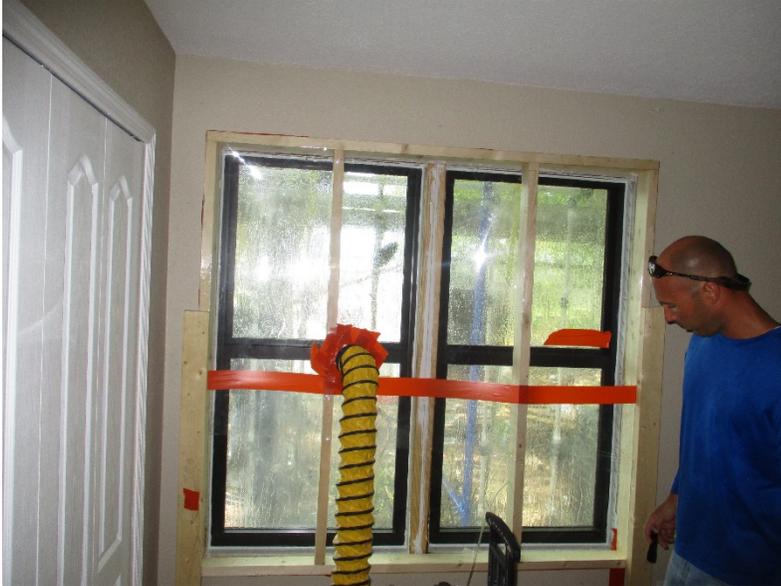
PHOTOGRAPH #15

**BUILDING 26
UNIT 2418- WATER TESTING**

ASTM E 1105 testing performed at bedroom double window section D passed with no leaks.

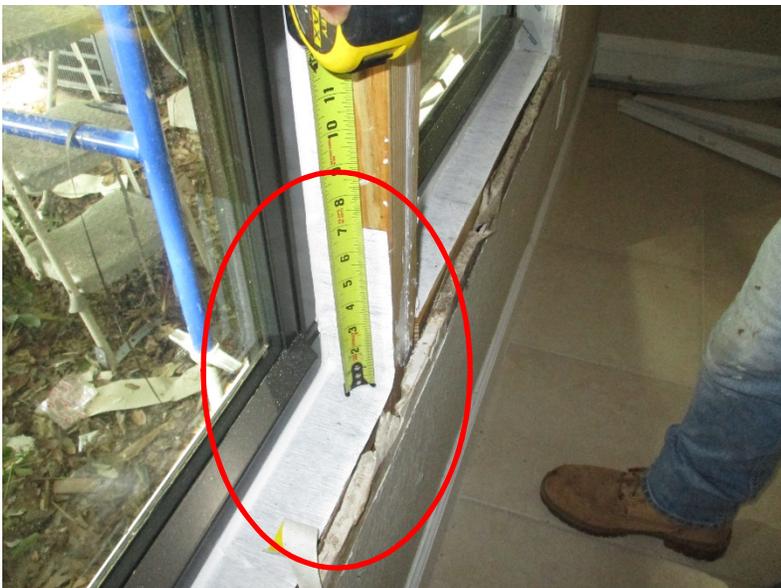
PHOTOGRAPH #16

**BUILDING 26
UNIT 2418 – SECTION D**

Dupont flashings installed as per manufacturer's instructions.

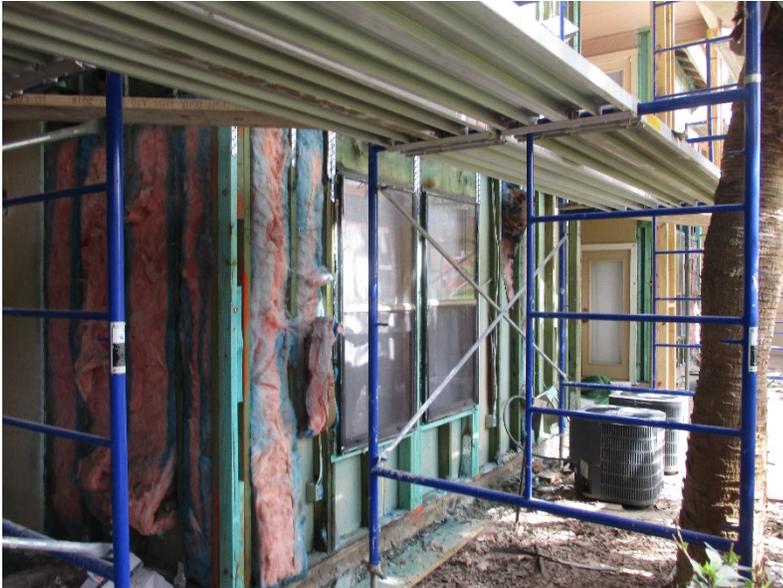
PHOTOGRAPH #17

**BUILDING 26
SECTION F**

Bora-Care termite treatment has been applied in preparation for sheathing.

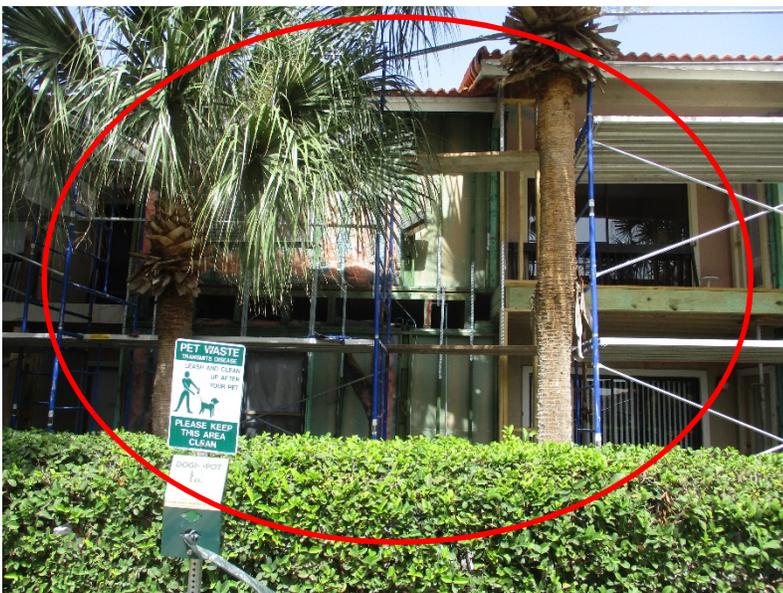
PHOTOGRAPH #18

**BUILDING 26
SECTION F**

Balconies and framed walls have been repaired and Simpson Strong connectors are in place.

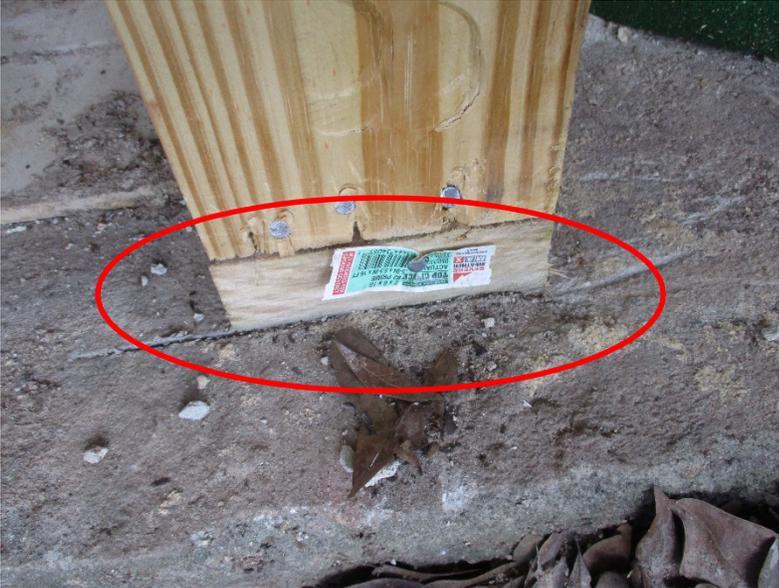
PHOTOGRAPH #19

**BUILDING 26
SECTION F**

Pressure treated lumber used at base plate applications.

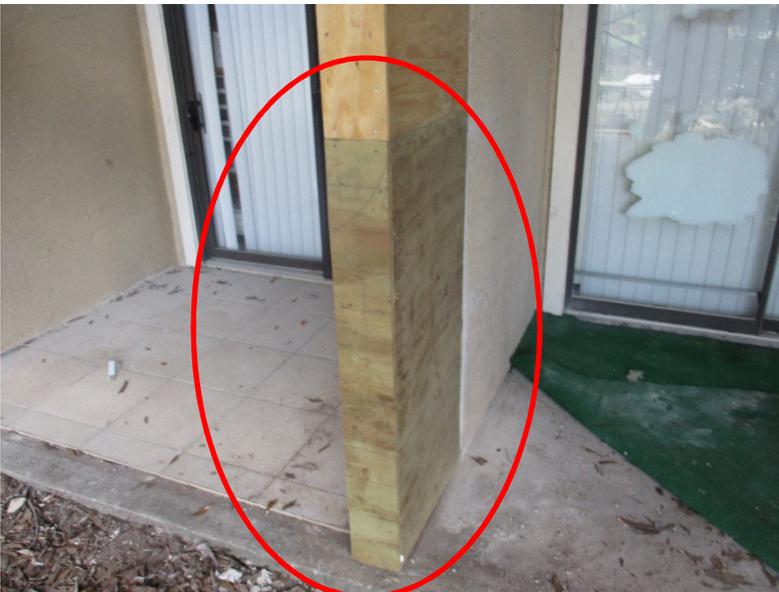
PHOTOGRAPH #20

**BUILDING 26
SECTION F**

Pressure treated plywood used at lower section of sheathing.

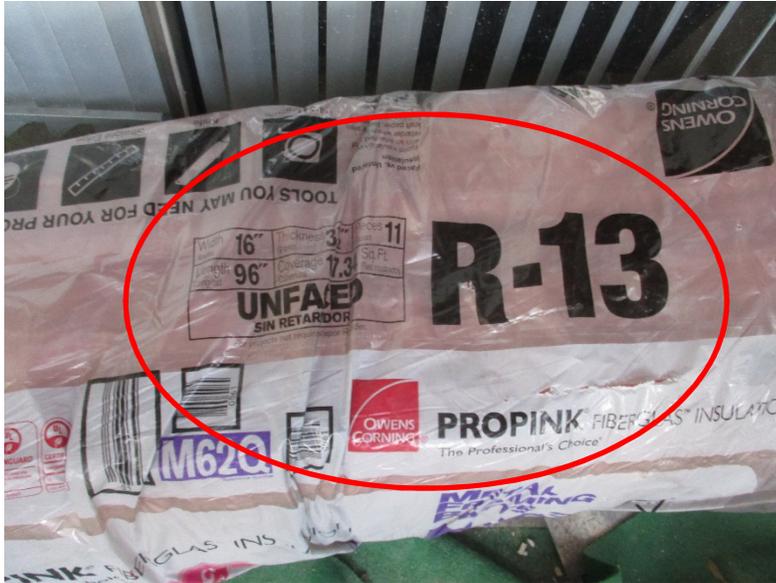
PHOTOGRAPH #21

**BUILDING 26
SECTION F**

Owens Corning R-13 insulation being installed where missing or damaged prior to sheathing application.
