PHOTOGRAPHS

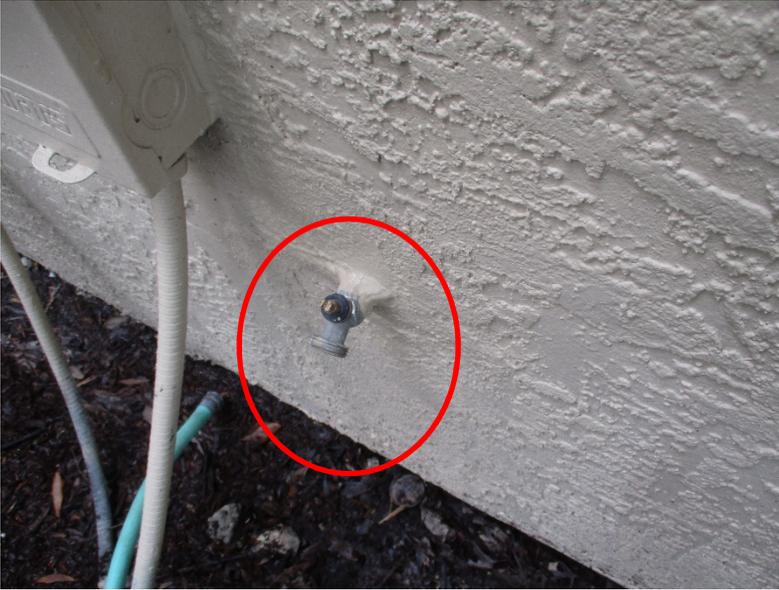
PHOTOGRAPH #1

**BUILDING 24
SECTION B**

Hose bib has been sealed at stucco.

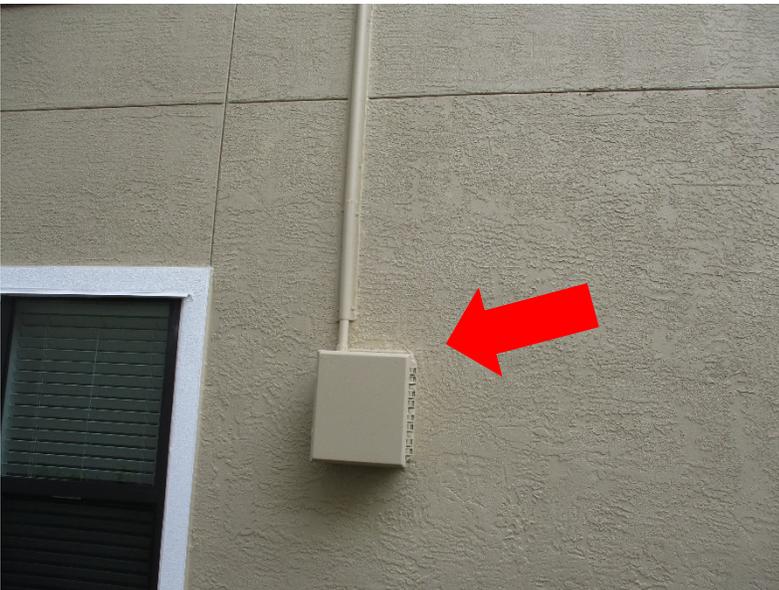
PHOTOGRAPH #2

**BUILDING 24
SECTION D**

Utility boxes have been touched up with matching paint.

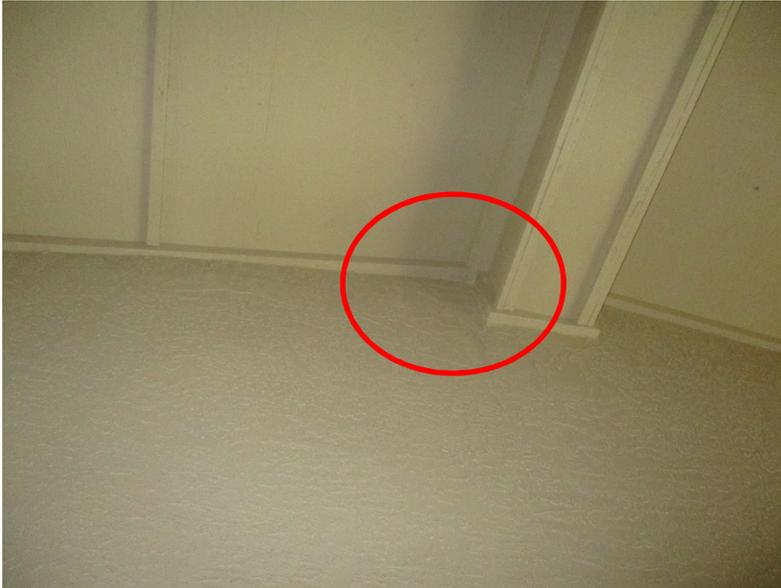
PHOTOGRAPH #3

**BUILDING 24
SECTION A- BREEZWAY**

Void in stucco has been repaired and re-painted.

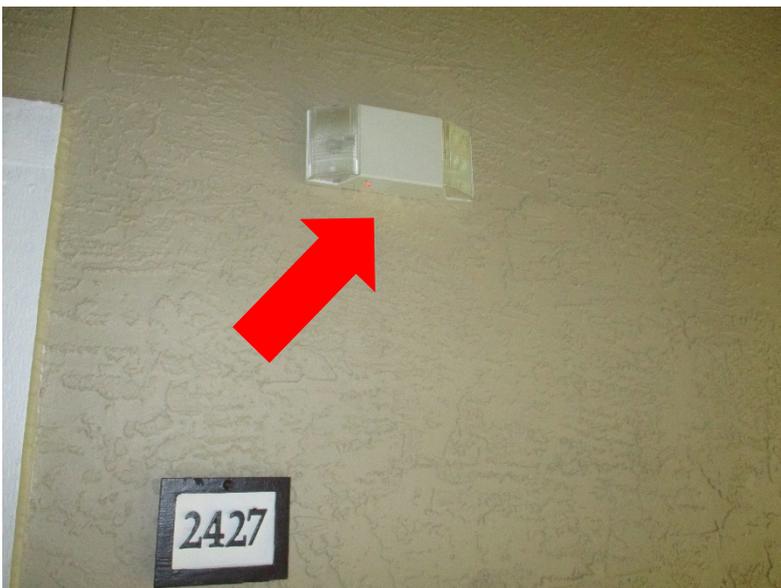
PHOTOGRAPH #4

**BUILDING 24
BREEZWAY AT UNIT #2427**

Hole under light fixture has been filled and re-painted.

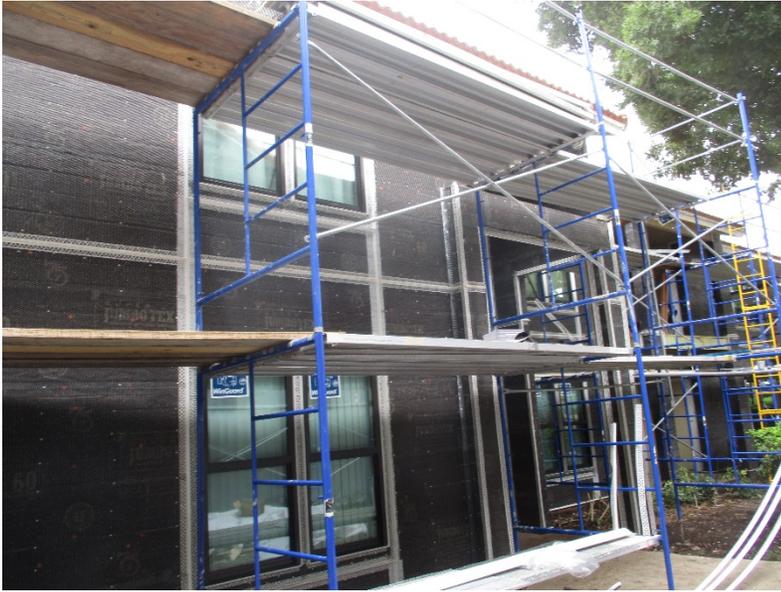
PHOTOGRAPH #5

**BUILDING 26
SECTION E**

Stucco sub-contractor has installed JumboTex WRB, stucco accessories and lath in preparation for stucco application.

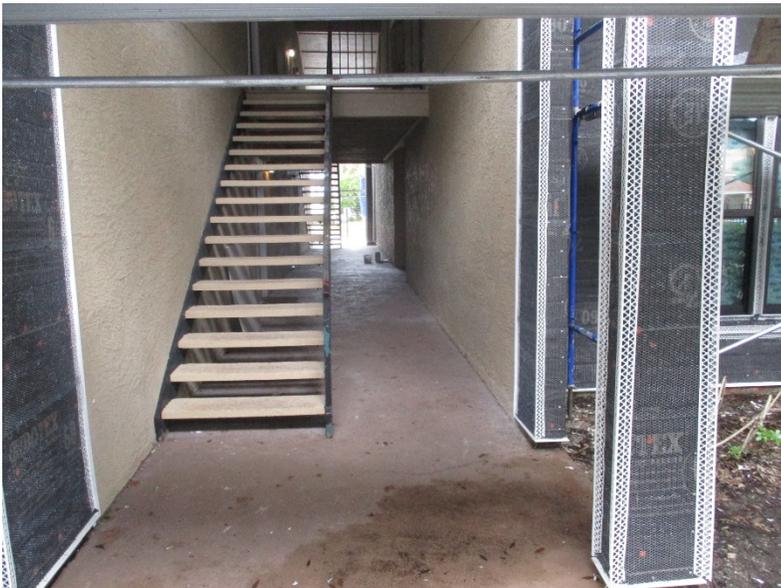
PHOTOGRAPH #6

**BUILDING 26
SECTION E BREEZWAY**

Stucco sub-contractor has installed JumboTex WRB, stucco accessories and lath in preparation for stucco application.

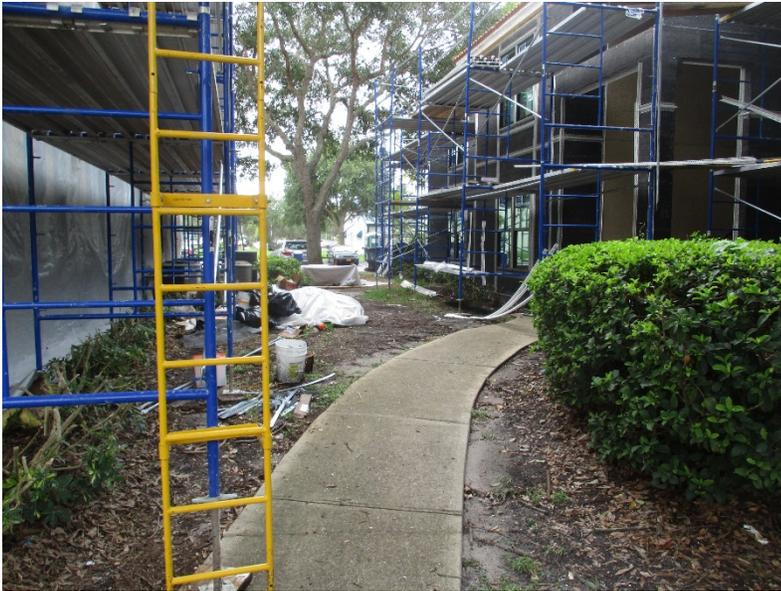
PHOTOGRAPH #7

**BUILDING 26
SECTION E AND F**

Grounds below and around scaffolding is not fenced off as planned. Clean up of site is not acceptable or in accordance with contract document requirements.

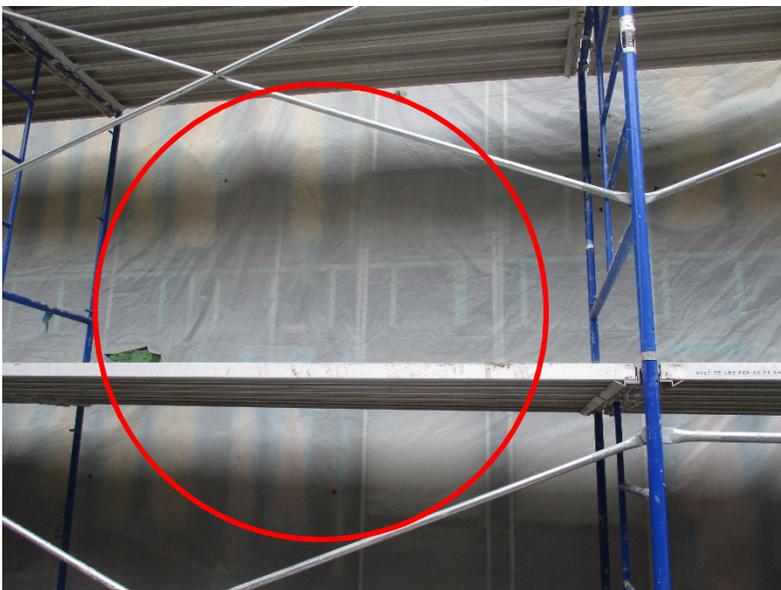
PHOTOGRAPH #8

**BUILDING 27
SECTION H**

Gable end wall framing has been sprayed with Bora-Care termite treatment in preparation for installation of sheathing.

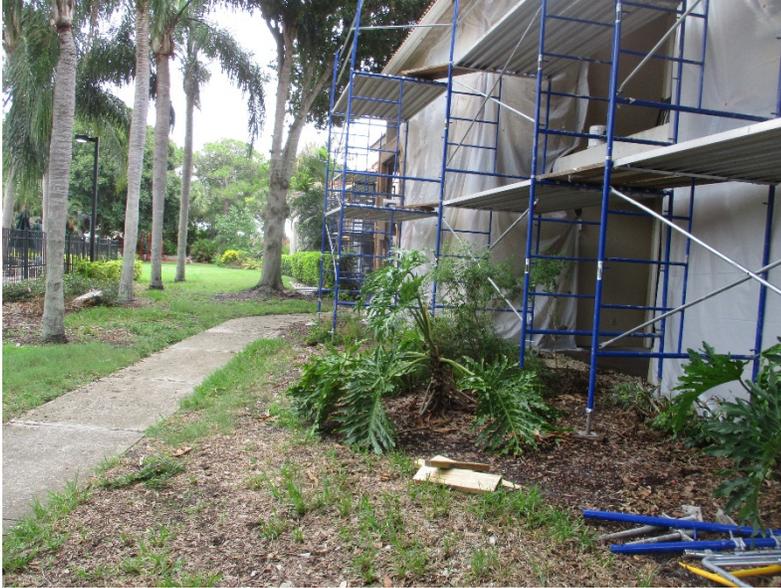
PHOTOGRAPH #9

**BUILDING 27
SECTION G**

Grounds below and around scaffolding is not fenced off as planned.

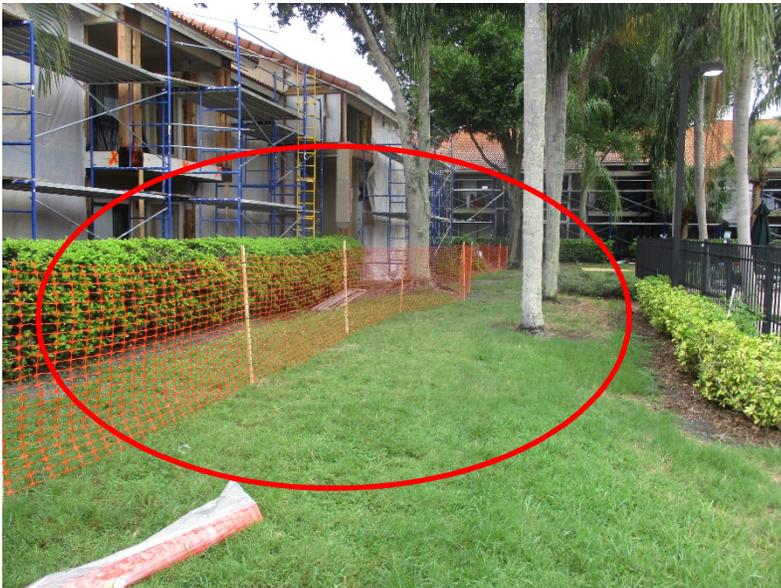
PHOTOGRAPH #10

**BUILDING 27
SECTION G**

Contractor has installed construction fencing below scaffolding work areas.

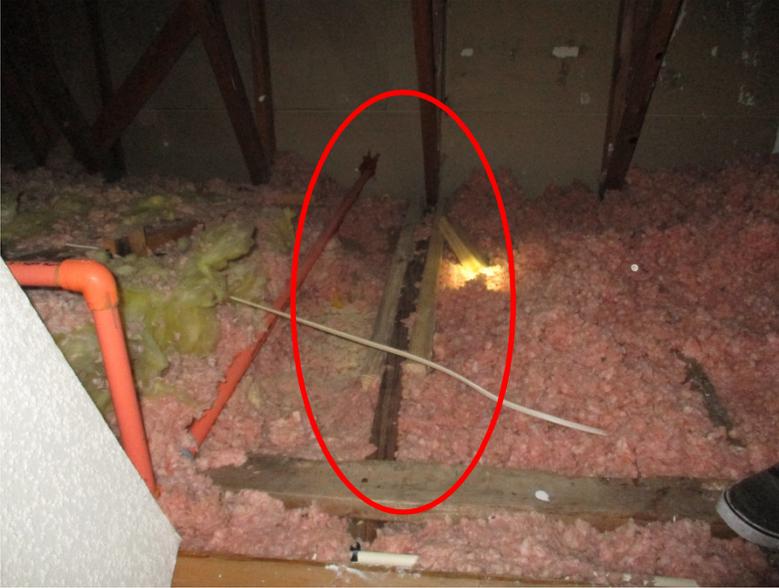
PHOTOGRAPH #11

**BUILDING 27
ATTIC #2724**

Contractor has made gusset repairs, scab repairs and fire wall repairs.

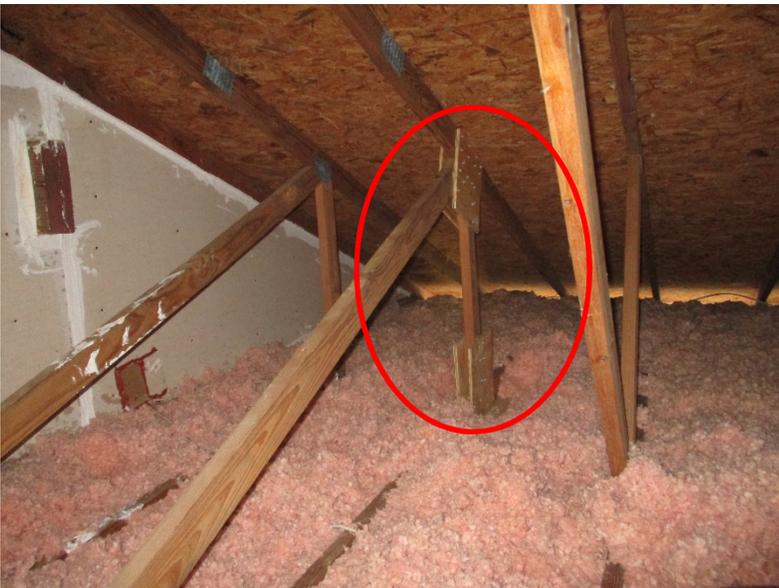
PHOTOGRAPH #12

**BUILDING 27
ATTIC #2724**

Contractor has made gusset repairs, scab repairs and fire wall repairs.

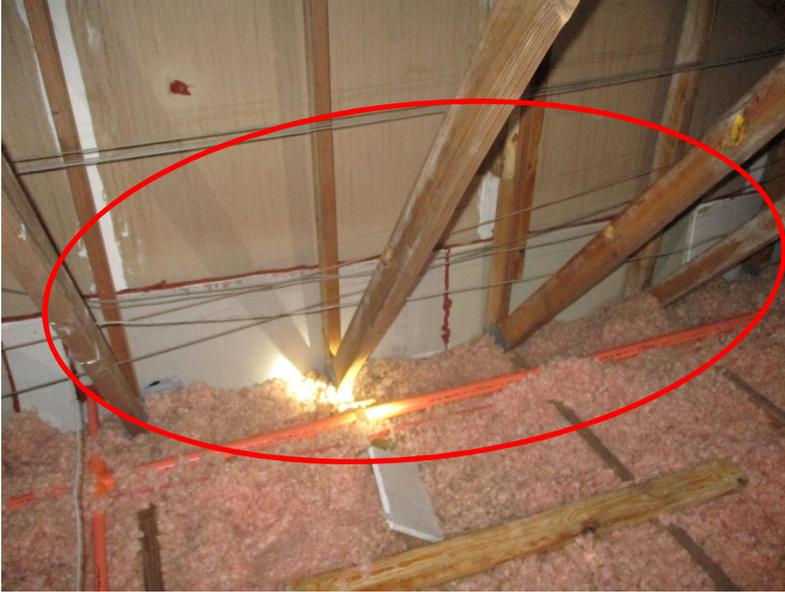
PHOTOGRAPH #13

**BUILDING 27
ATTIC # 2723**

Contractor has made gusset repairs, scab repairs and fire wall repairs.

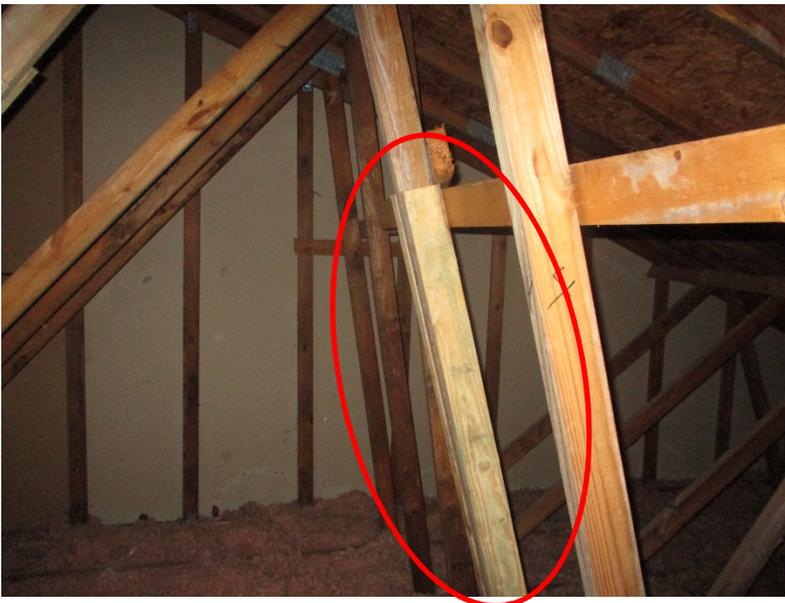
PHOTOGRAPH #14

**BUILDING 27
ATTIC # 2723**

Contractor has made gusset repairs, scab repairs and fire wall repairs.

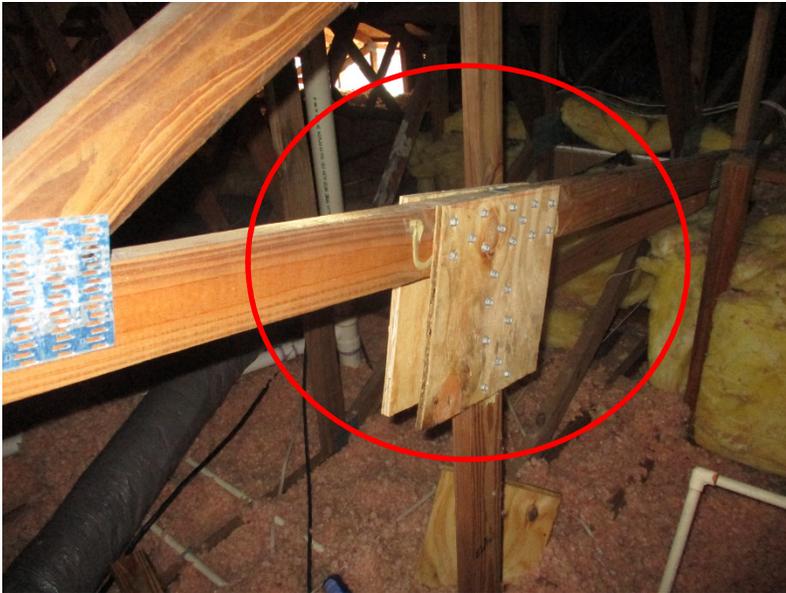
PHOTOGRAPH #15

**BUILDING 27
ATTIC # 2726**

Contractor has made gusset repairs, scab repairs and fire wall repairs.
