FIELD OBSERVATION REPORT - Bldgs. #26

Permit No. 19-10770200 BR
Owner: Village Grand Condo Assn. Inc.
Project Address: 4017 Crockers Lake Blvd., Sarasota, FL
Contractor: RL James Inc
Inspector (e): Mike Jones
Type of Assessment: Progress

FIELD OBSERVATION REPORT - Bldgs. #2

PROJECT NAME:
 WOOD FRAME REPAIRS & RELATED WORK
 VINTAGE GRANDE CONDOMINIUM
 ASSOCIATION, INC.
 4012 CROCKERS LAKE BLVD.,
 SARASOTA, FL 34238

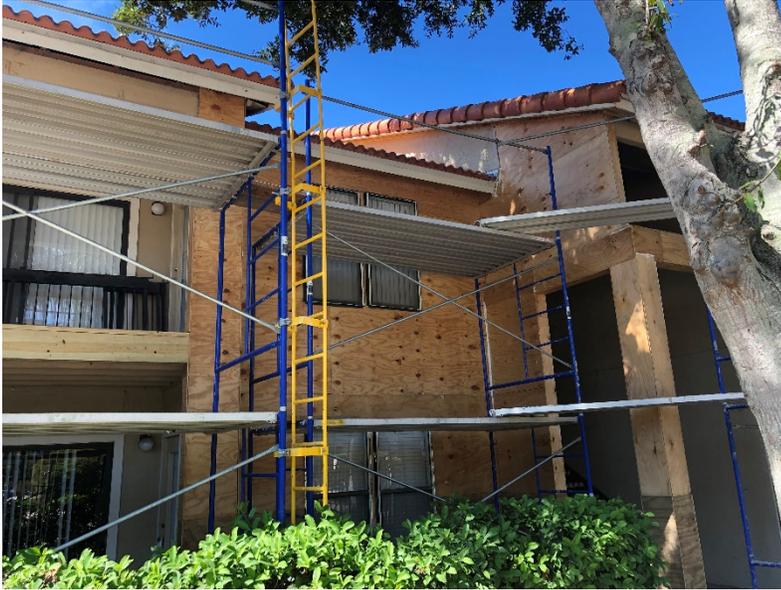
PHOTOGRAPH #1

BUILDING 27 SECTION F

Plywood sheathing installed and inspected for compliance.

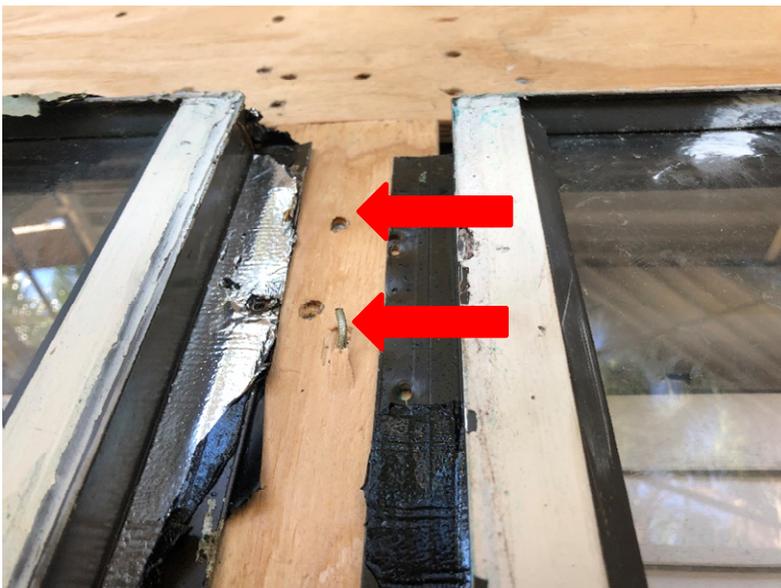
PHOTOGRAPH #2

BUILDING 27 SECTION F

- Contractor advised not to store more than one week of work around the buildings. The laydown yard is for the bulk of the construction material.
- Construction material stored around the building must inside approved safety fence per construction documents (Photograph #13).
- Contractor to remove damaged fasteners and plywood sheathing with overhead nails the plywood to be removed and replaced (Photographs #2 and #3).

Contractor to remove damaged fasteners and plywood sheathing with overdriven nails the plywood to be removed and replaced.

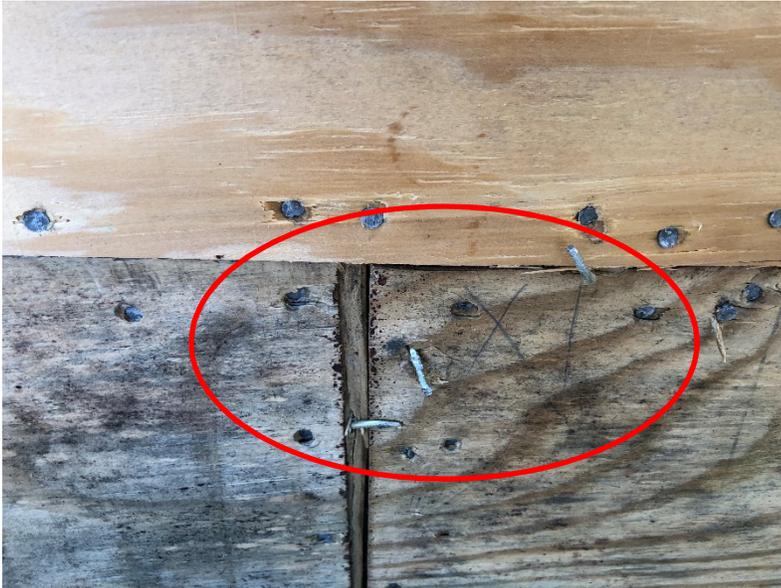
PHOTOGRAPH #3

**BUILDING 27
SECTION F**

Contractor to remove damaged fasteners and plywood sheathing with overdriven nails the plywood to be removed and replaced.

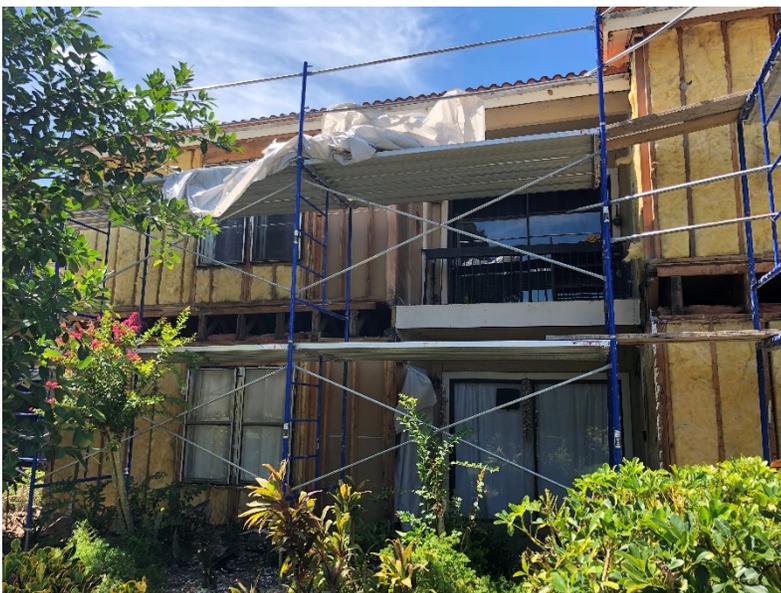
PHOTOGRAPH #4

**BUILDING 27
SECTION E**

Contractor has removed existing stucco and Delta to document deteriorated framing and mark for removal and replacement.

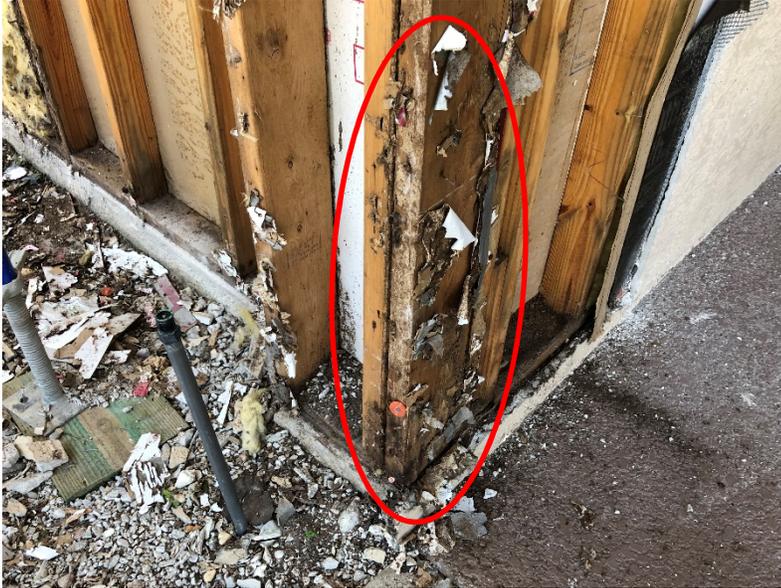
PHOTOGRAPH #5

**BUILDING 27
SECTION E**

Deteriorated of studs at the 1st floor patio documented and marked for demolition.

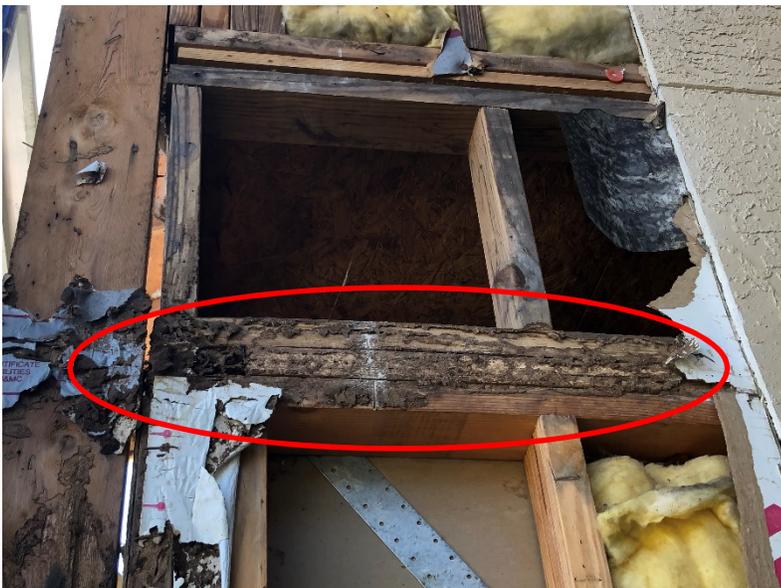
PHOTOGRAPH #6

**BUILDING 27
SECTION E**

Deteriorated top plate at the 1st floor documented and marked for demolition.

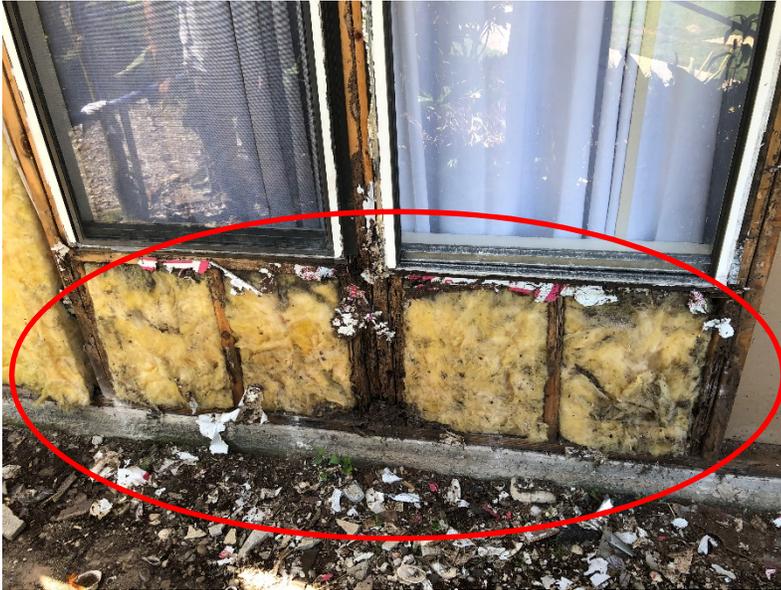
PHOTOGRAPH #7

**BUILDING 27
SECTION E**

Deteriorated window framing studs and bottom plate at 1st floor windows documented and marked for demolition.

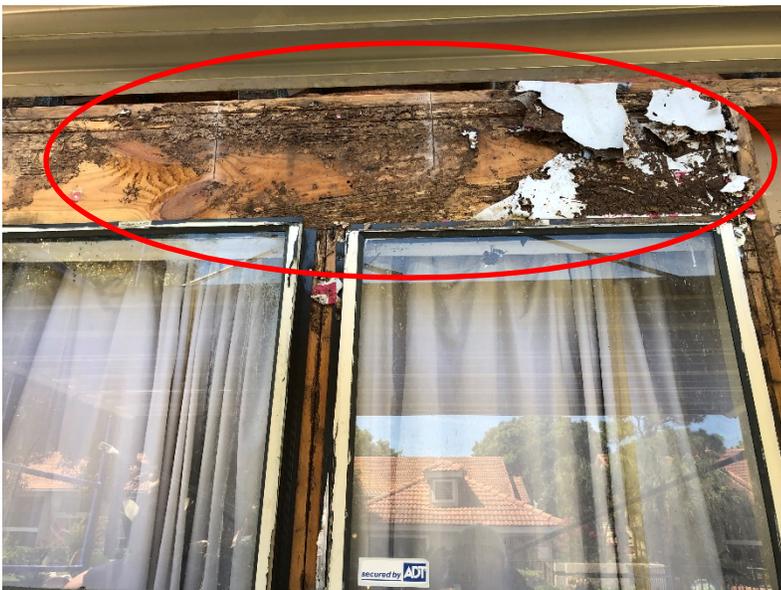
PHOTOGRAPH #8

**BUILDING 27
SECTION E**

Deteriorated header at the 2nd floor windows documented and marked for demolition.

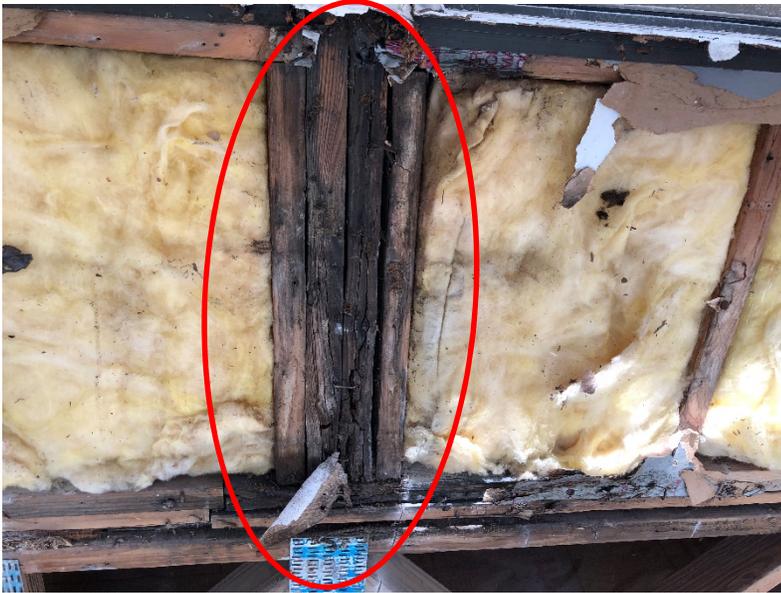
PHOTOGRAPH #9

**BUILDING 27
SECTION E**

Deteriorated studs and bottom plate at 2nd floor windows documented and marked for demolition.

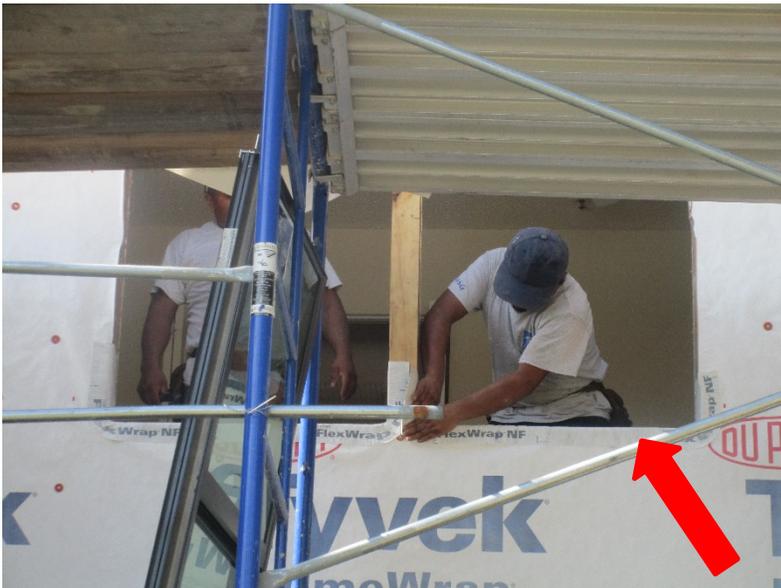
PHOTOGRAPH #10

**BUILDING 27
SECTION F**

Installation of Tyvek flex wrap being at windowsill in progress.

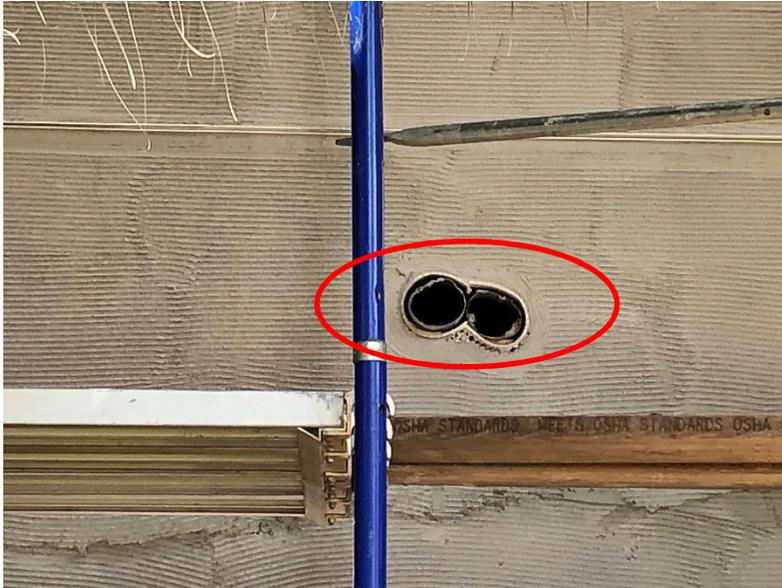
PHOTOGRAPH #11

**BUILDING 26
SECTION F**

Installation of dryer vents not per construction documents. Contractor to rework stucco and sheathing and install per construction documents.

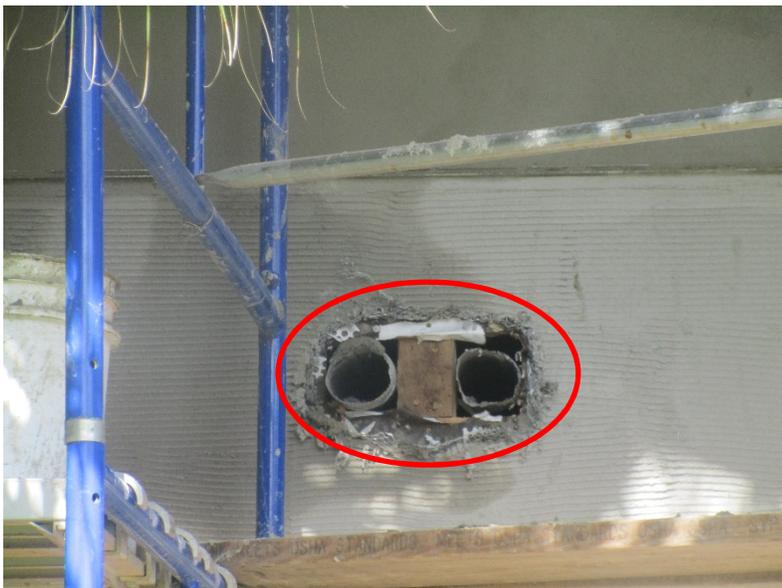
PHOTOGRAPH #12

**BUILDING 26
SECTION F**

Installation of dryer vents per construction documents in progress.

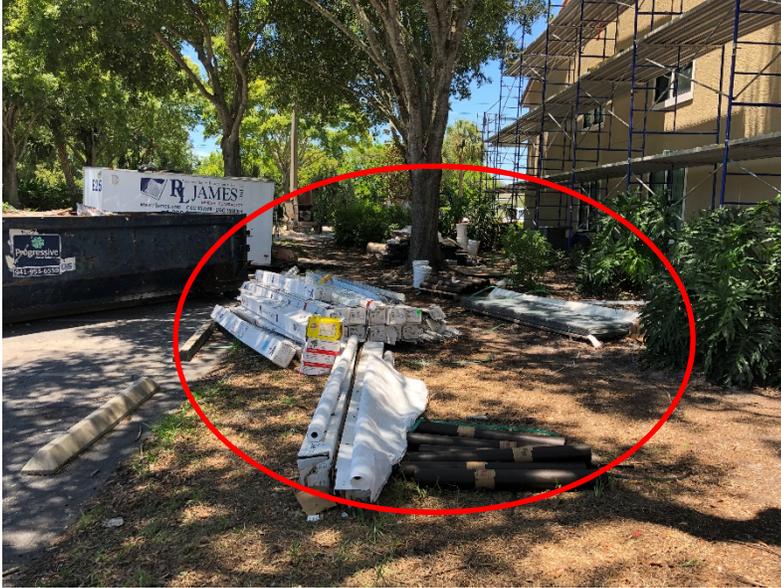
PHOTOGRAPH #13

**BUILDING 26/27
COMMON AREA**

Contractor advised not to store more than one week of work around the buildings. The laydown yard is for the bulk of the construction material. Construction material stored around the building must inside approved safety fence per construction documents.

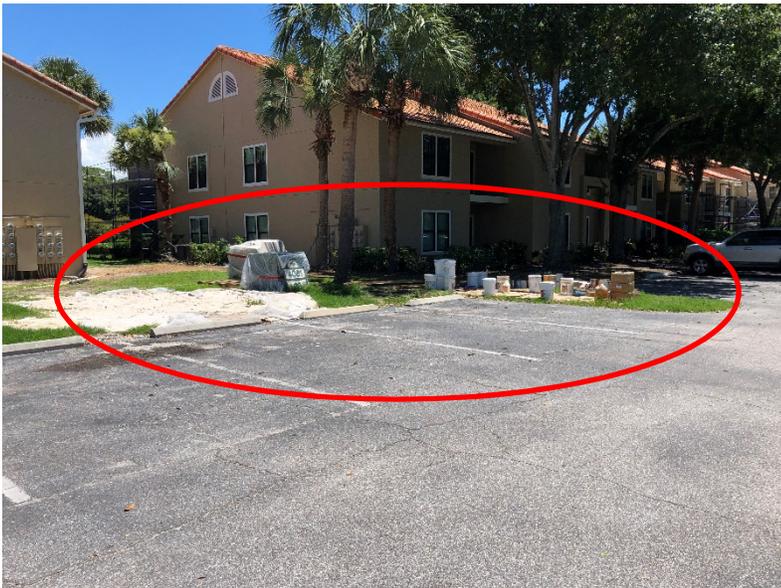
PHOTOGRAPH #14

**BUILDINGS 25/26
COMMON AREA**

- Contractor advised not to store more than one week of work around the buildings. The laydown yard is for the bulk of the construction material. Construction material stored around the building must include approved safety fence per construction documents. (Photograph #14).

Contractor advised not to store more than one week of work around the buildings. The laydown yard is for the bulk of the construction material. Construction material stored around the building must inside approved safety fence per construction documents.
