**FIELD OBSERVATION REPORT - Bldgs. #26**

Permit No. 19-10770200 BR  
 Owner: Vintage Grand Condo Assn, Inc.  
 Project Address: 4017 Crockers Lake Blvd., Sarasota, FL  
 Contractor: RL James Inc  
 Inspector (s): Mark Boss PM  
 Type of Assessment: Progress

**FIELD OBSERVATION REPORT - Bldgs. #27**

PROJECT NAME:  
 WOOD FRAME REPAIRS & RELATED WORK (PHASE II)  
 VINTAGE GRANDE CONDOMINIUM ASSOCIATION, INC.  
 4012 CROCKERS LAKE BLVD., SARASOTA, FL 34238

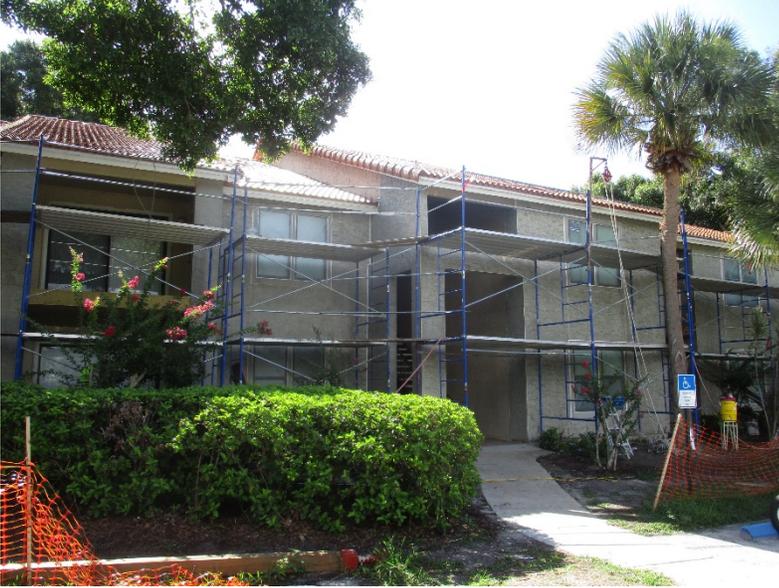
**PHOTOGRAPH #1**

### **BUILDING 26 SECTION C**

Stucco sub-contractor has applied finish coat of stucco.

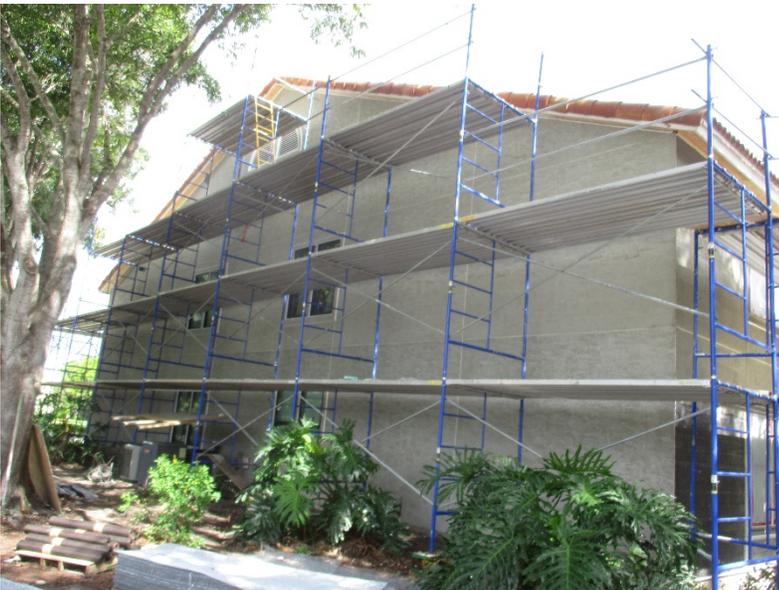
**PHOTOGRAPH #2**

### **BUILDING 26 SECTION D**

Stucco sub-contractor has applied finish coat of stucco.

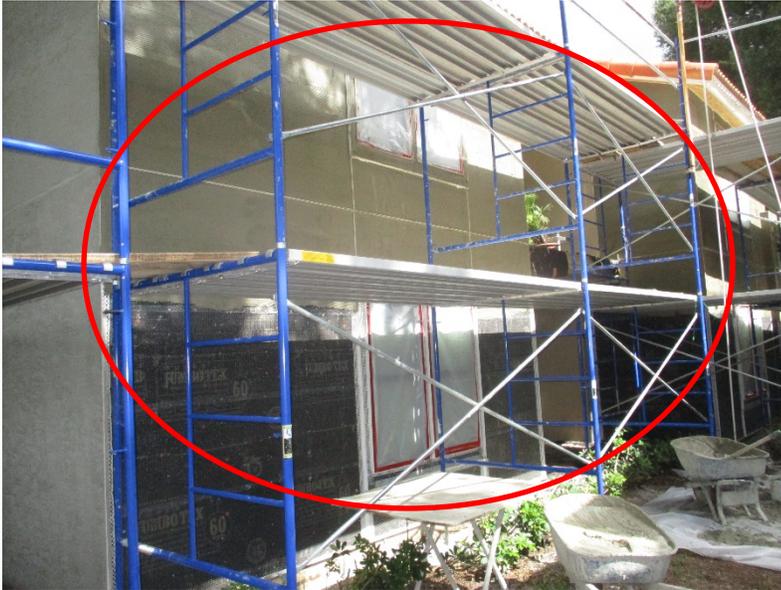
**PHOTOGRAPH #3**

**BUILDING 26  
SECTION E**

Stucco sub-contractor has begun scratch coat of stucco.

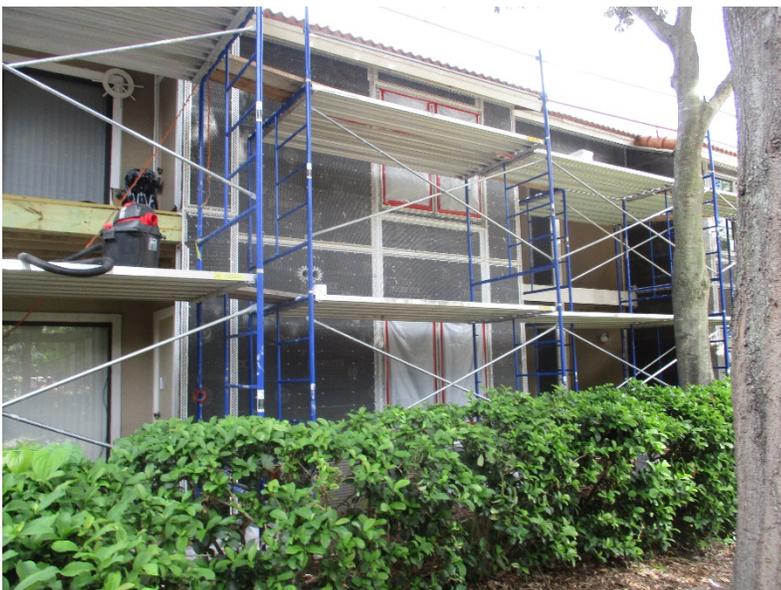
**PHOTOGRAPH #4**

**BUILDING 26  
SECTION F**

Stucco sub-contractor has applied JumboTex WRB, stucco accessories and metal lath in preparation for new stucco.

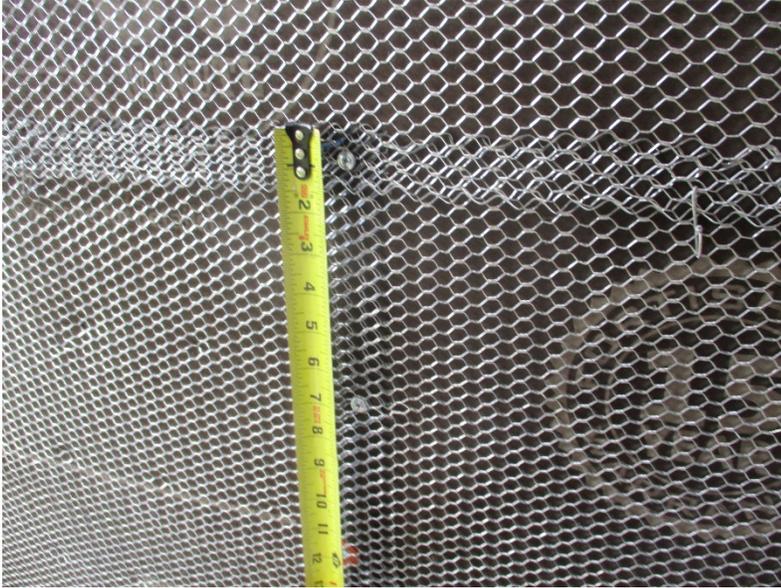
**PHOTOGRAPH #5**

**BUILDING 26  
SECTION F**

Fastening patterns and overlapping of metal lath inspected for compliance.

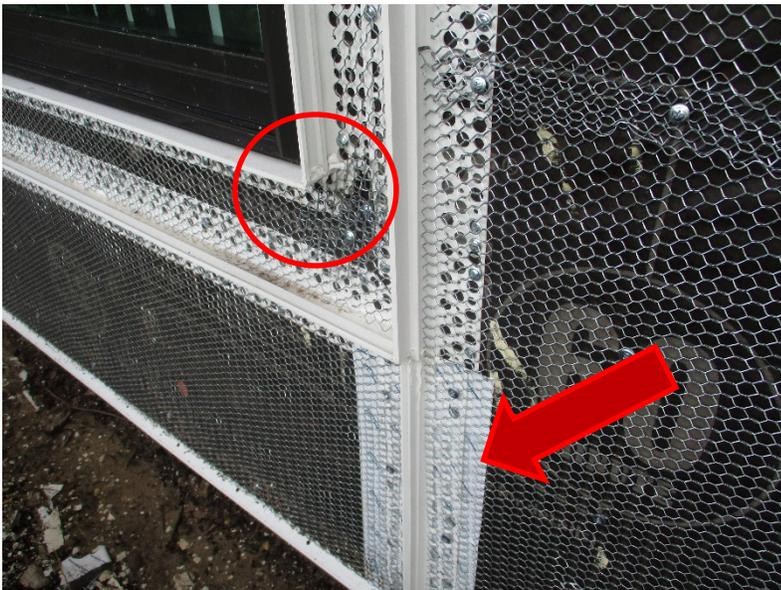
**PHOTOGRAPH #6**

**BUILDING 26  
SECTION F**

Flashing behind vertical control joints and sealant at intersections and corners of accessories inspected for compliance.

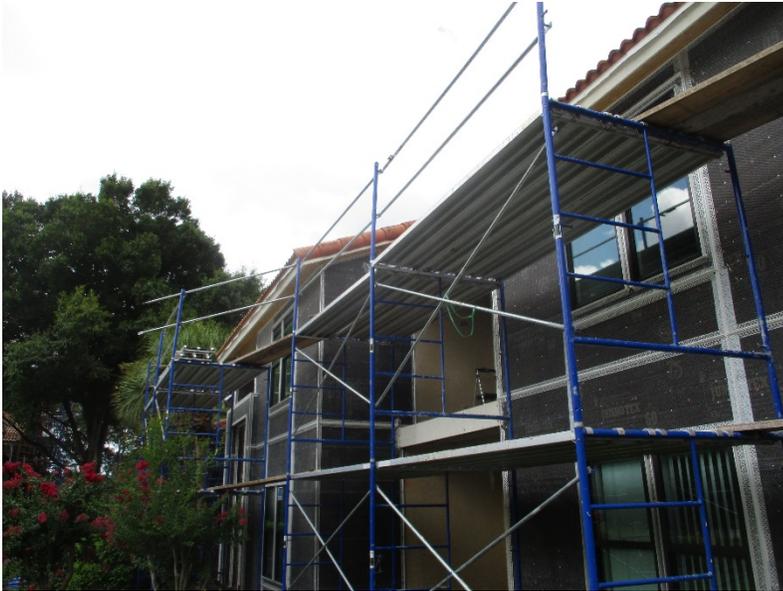
**PHOTOGRAPH #7**

G	X	NA	NA	X	X	/	X	X	X			NA			Stucco sub-contractor has applied JumboTex WRB, stucco accessories and lathing in preparation for new stucco (Photograph #7).
H	X	X	X	X	X	X	X	X	X	X	X	X	X

**BUILDING 26  
SECTION G**

Stucco sub-contractor has applied JumboTex WRB, stucco accessories and lathing in preparation for new stucco.

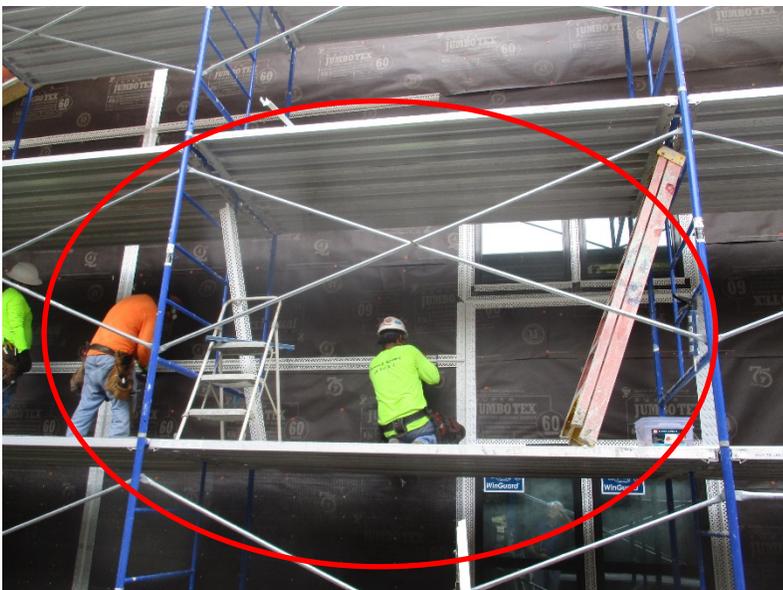
**PHOTOGRAPH #8**

**BUILDING 27  
SECTION H**

Stucco sub-contractor has applied JumboTex WRB and begun to apply stucco accessories.

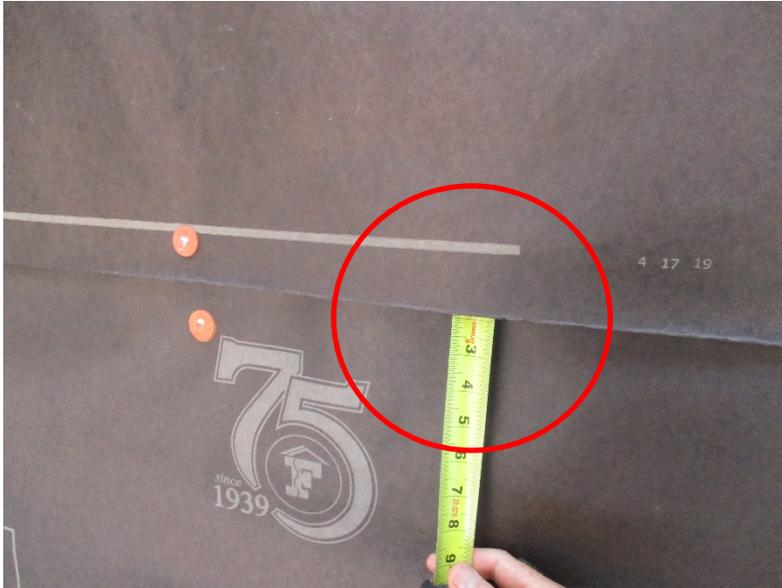
**PHOTOGRAPH #9**

**BUILDING 27  
SECTION H**

JumboTex WRB inspected for overlapping requirements.

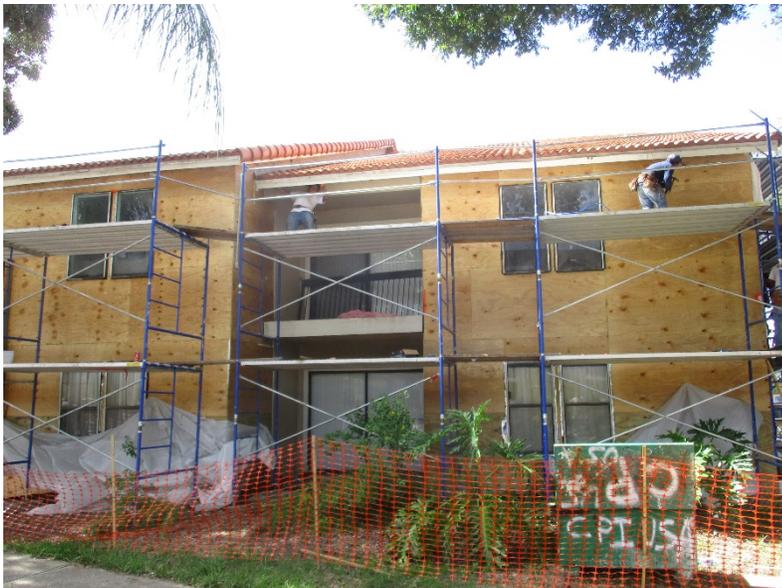
**PHOTOGRAPH #10**

**BUILDING 27  
SECTION G**

Plywood sheathing in place and ready for inspection.

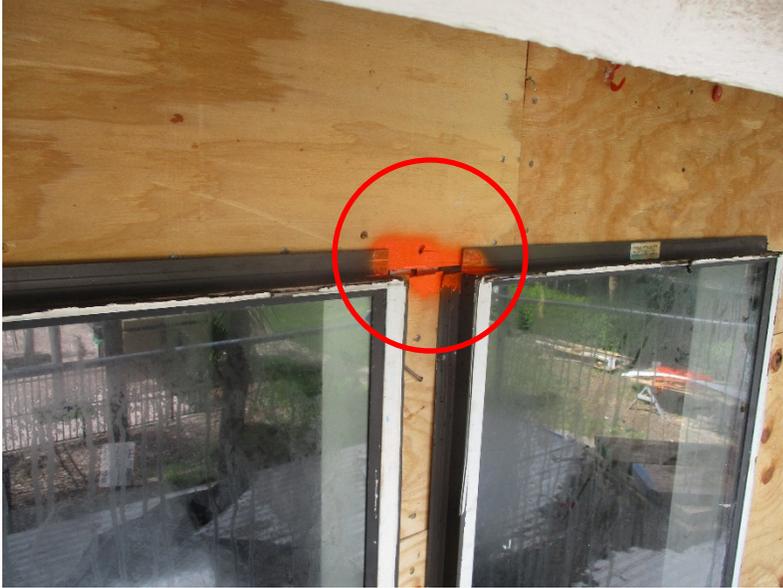
**PHOTOGRAPH #11**

**BUILDING 27  
SECTION G**

Gap at plywood seam marked for correction during inspection.

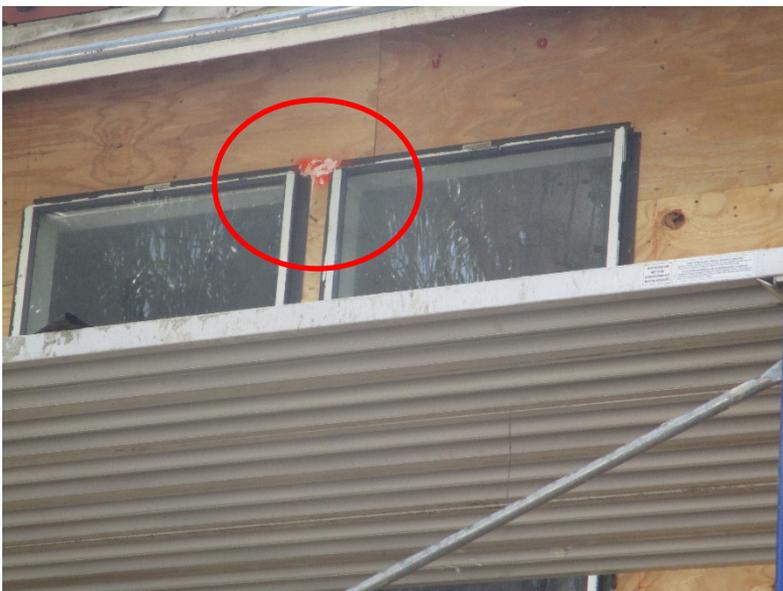
**PHOTOGRAPH #12**

**BUILDING 27  
SECTION G**

Gap at plywood seam filled.

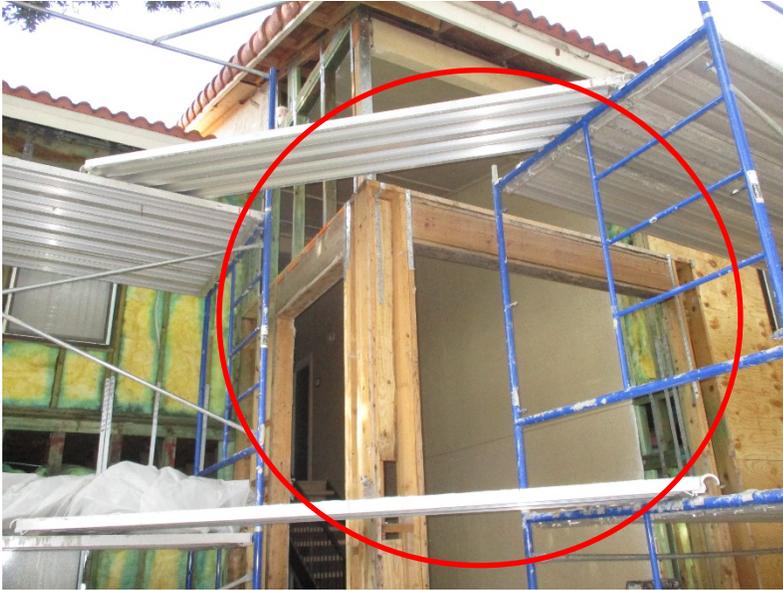
**PHOTOGRAPH #13**

**BUILDING 27  
SECTION G**

Framing repairs and Simpson Strong-Tie strapping in place at Breezeway area.

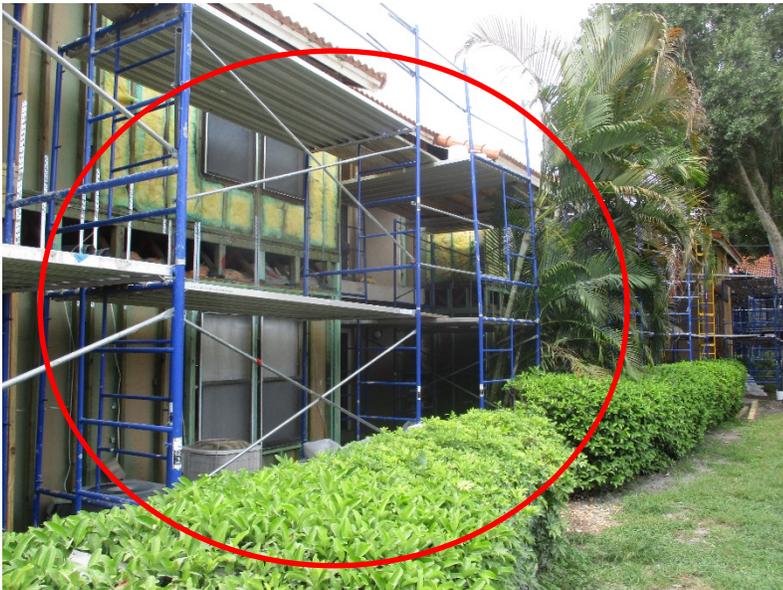
**PHOTOGRAPH #14**

**BUILDING 27  
SECTION F**

Framing repairs, Simpson Strong-Tie strapping and connectors inspected for compliance.

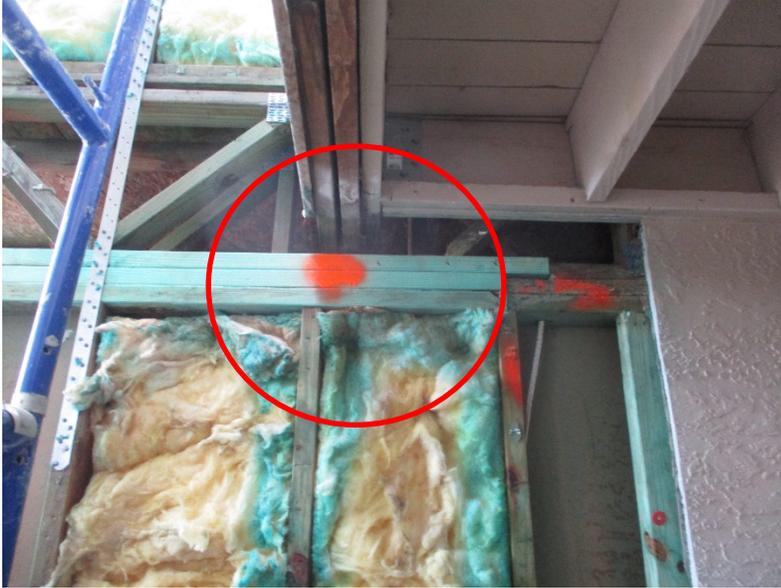
**PHOTOGRAPH #15**

**BUILDING 27  
SECTION F**

Blocking at top plate framing to build up beam has not been installed.

1. Blocking at top plate framing to build up beam to be installed (Photograph #15).
2. Titan HD anchor missing at this base plate location to be installed (Photograph #16).

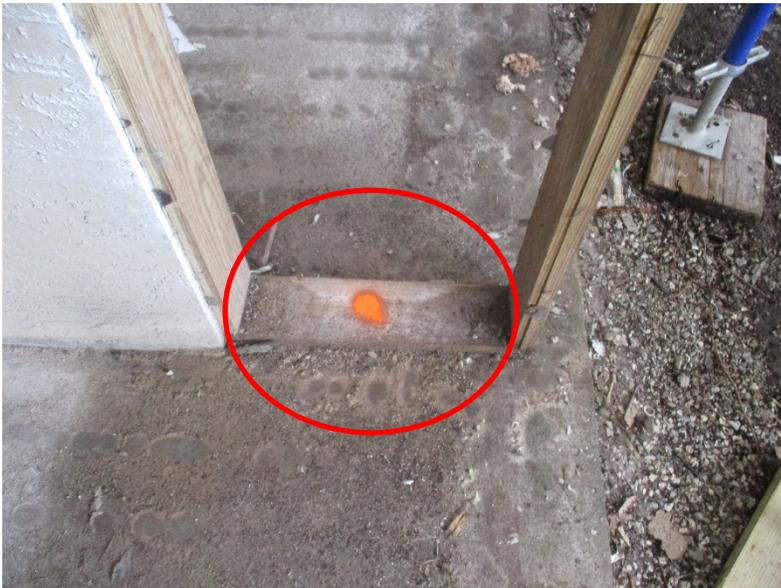
**PHOTOGRAPH #16**

**BUILDING 27  
SECTION F**

Titan HD anchor is missing at this base plate location.

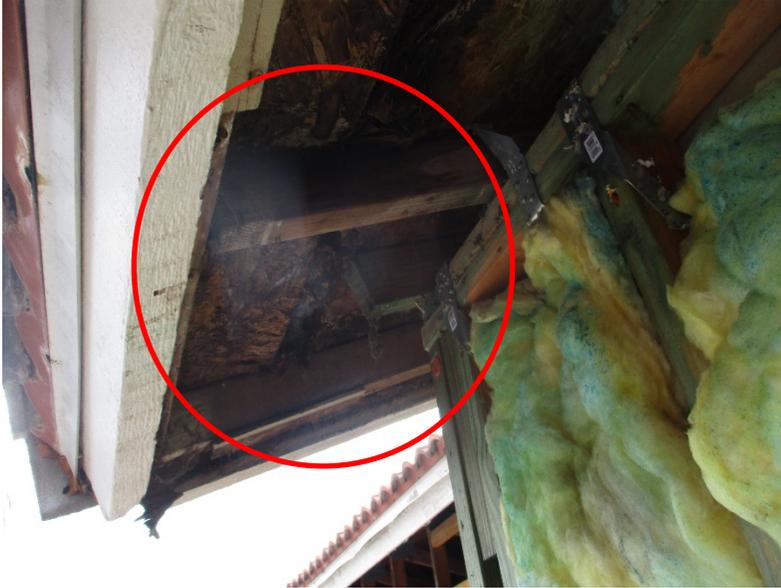
**PHOTOGRAPH #17**

**BUILDING 27  
SECTION F**

Damaged roof sheathing at several areas.  
This repair is not in project scope of  
repairs.

1. Roofing sheathing damage to be repaired by owners roofing contractor (Photographs #17, #18 and #19).

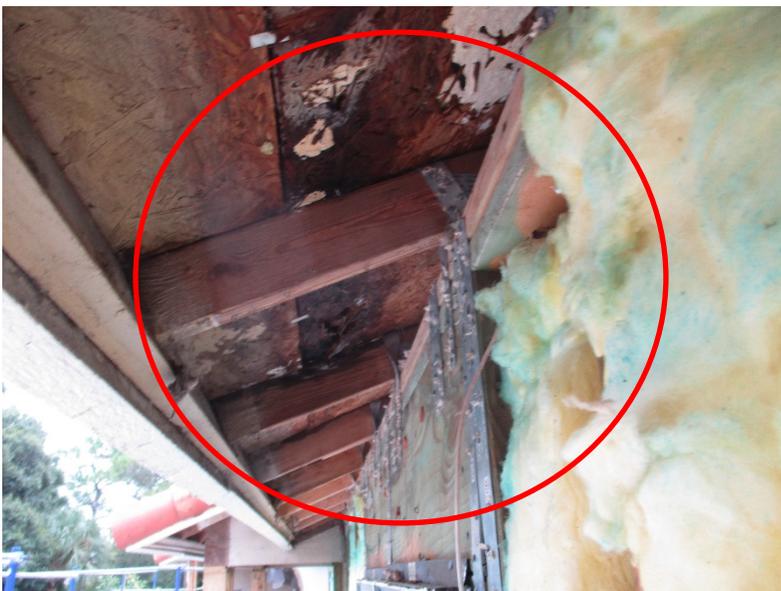
**PHOTOGRAPH #18**

**BUILDING 27  
SECTION F**

Damaged roof sheathing at several areas.  
This repair is not in project scope of  
repairs.

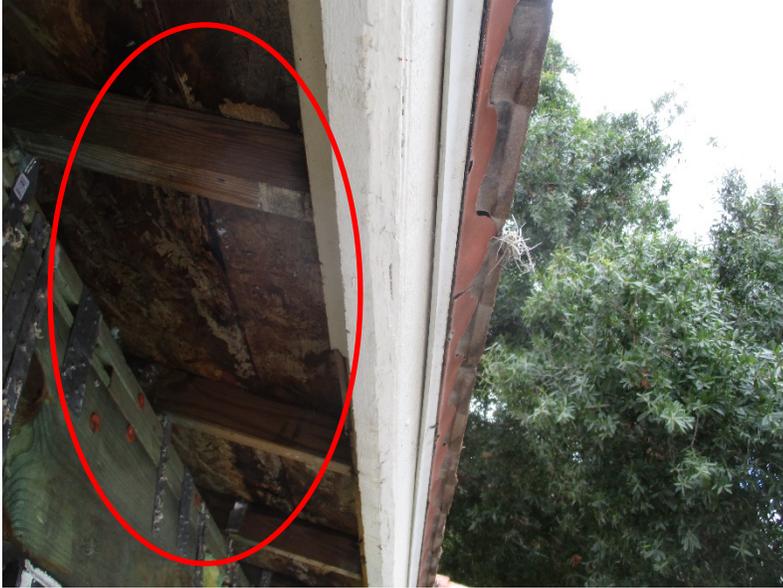
**PHOTOGRAPH #19**

**BUILDING 27  
SECTION F**

Damaged roof sheathing at several areas.  
This repair is not in project scope of  
repairs.

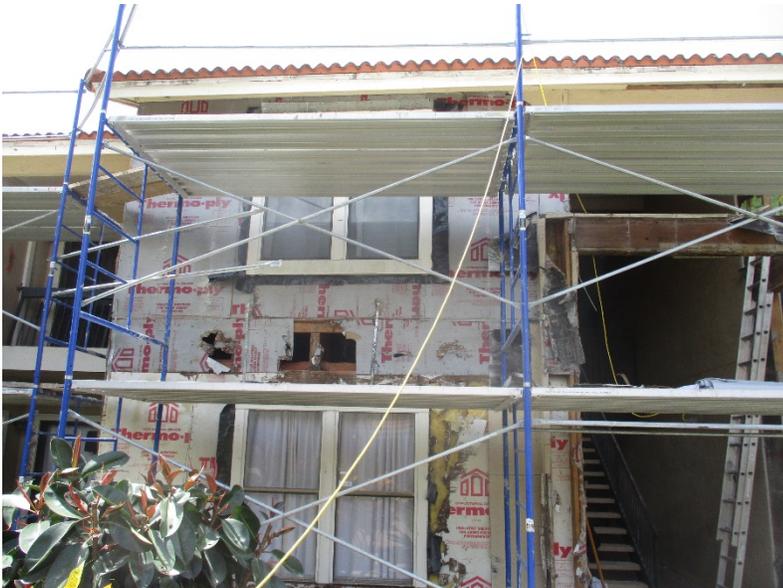
**PHOTOGRAPH #20**

**BUILDING 27  
SECTION E**

Removal of stucco and Thermo-ply has  
begun.

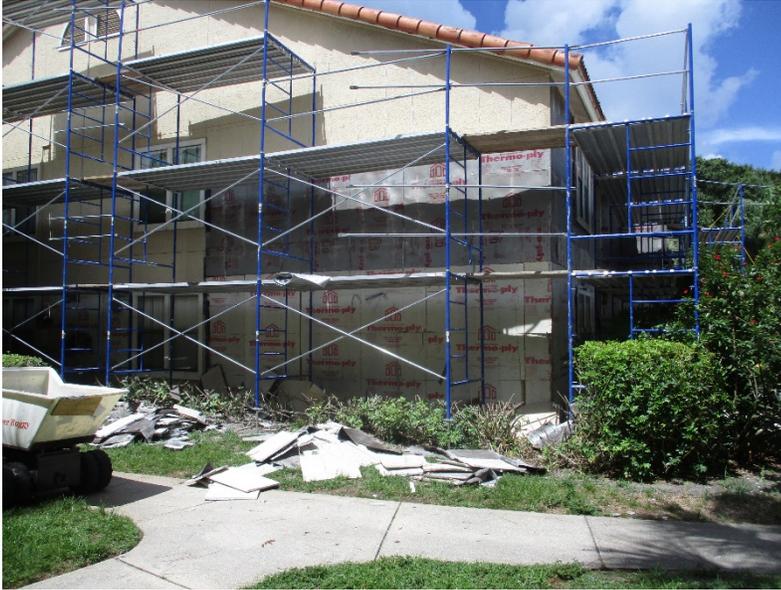
**PHOTOGRAPH #21**

**BUILDING 27  
SECTION D**

Removal of stucco and Thermo-ply has begun.
