**PHOTOGRAPHS**

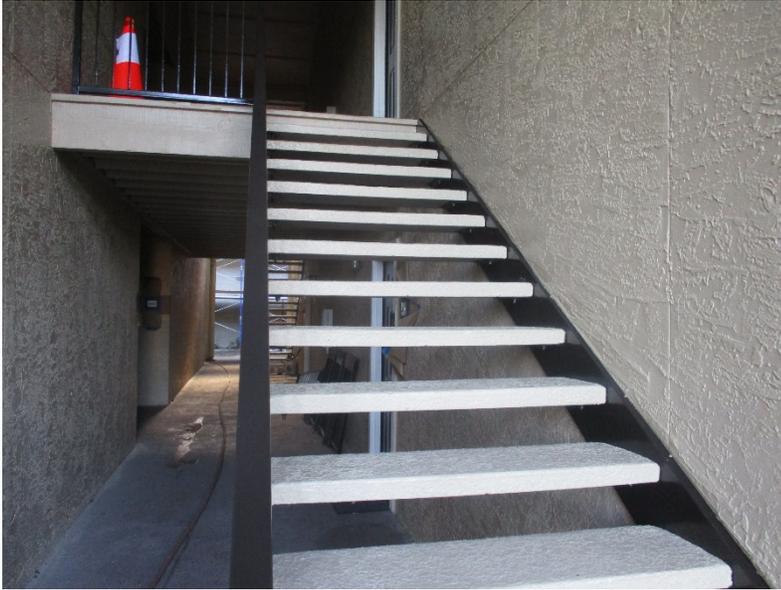
**PHOTOGRAPH #1**

**BUILDING 26  
SECTION A**

Breezeway steps and railing finish paint has been applied.

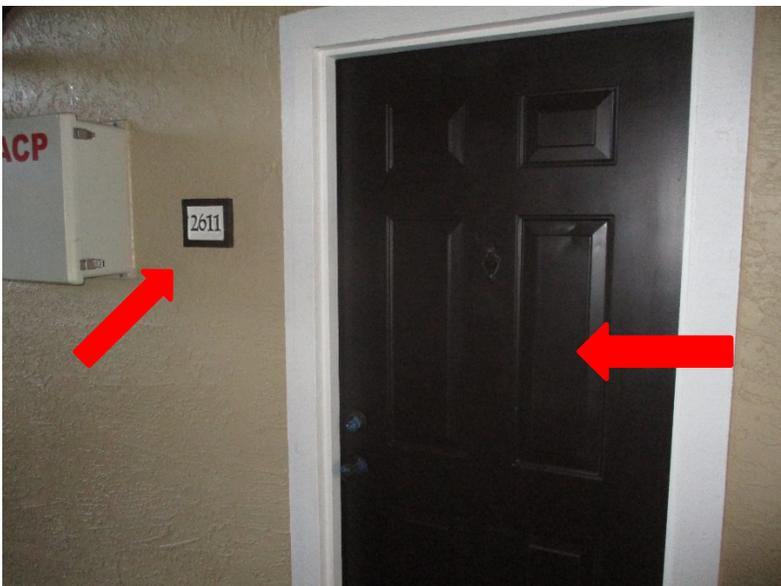
**PHOTOGRAPH #2**

**BUILDING 26  
SECTION A**

Entrance doors and sign finish paint has been applied.

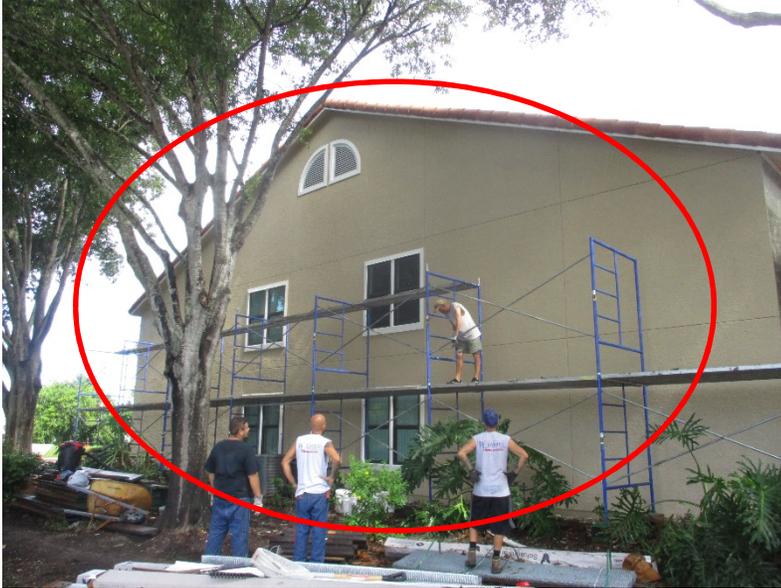
**PHOTOGRAPH #3**

**BUILDING 26  
SECTION D**

Contractor has applied finish paint and is removing scaffolding.

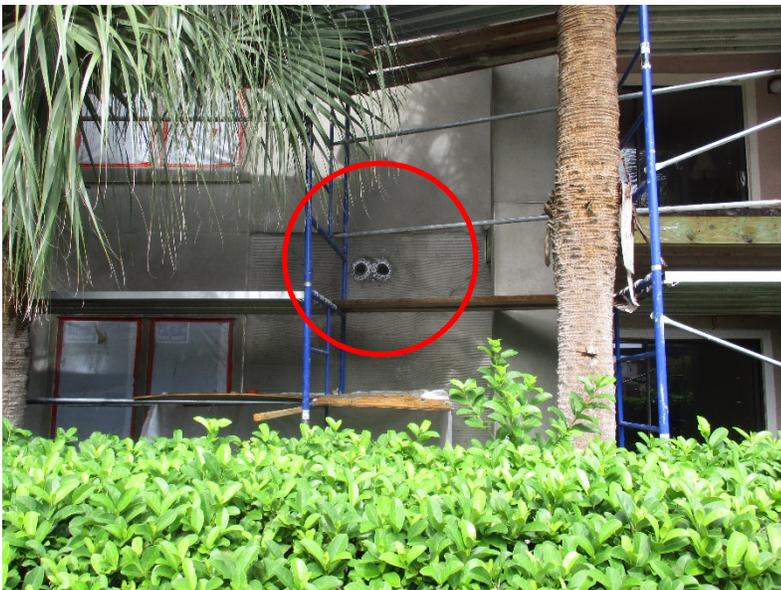
**PHOTOGRAPH #4**

**BUILDING 26  
SECTION F**

Contractor has removed and repositioned dryer vents as directed.

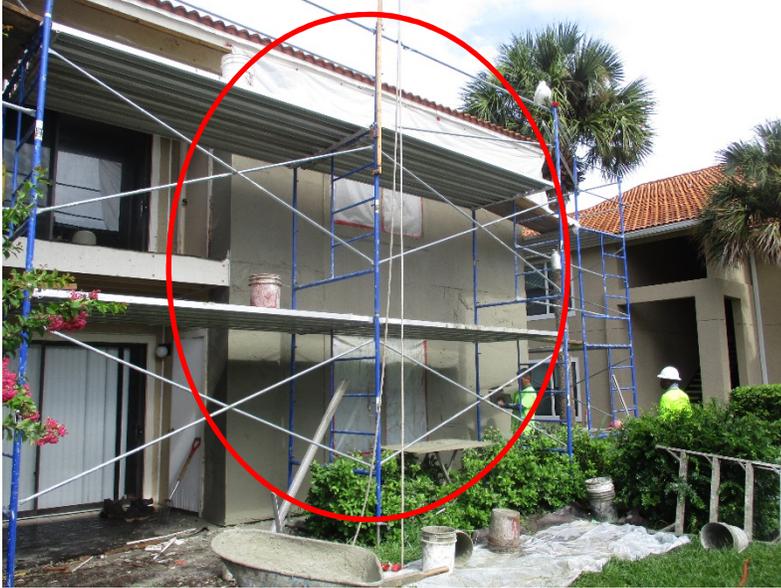
**PHOTOGRAPH #5**

**BUILDING 26  
SECTION G**

Stucco sub-contractor applying brown coat of stucco.

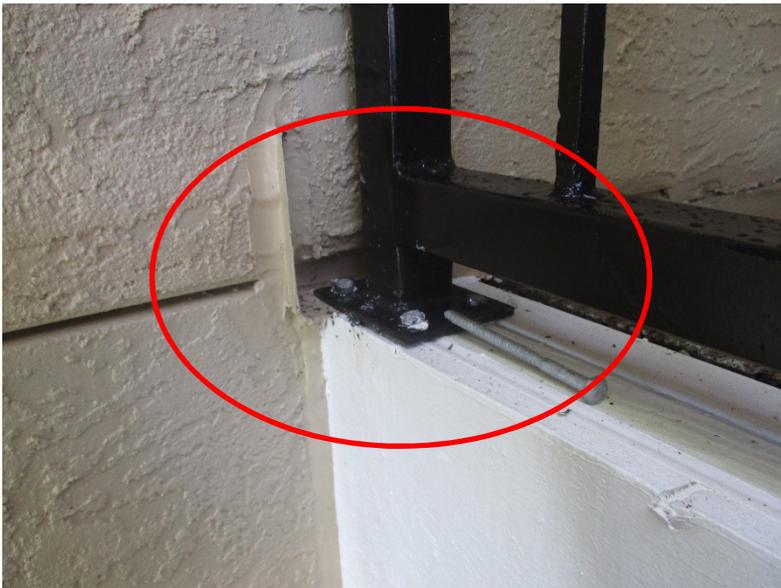
**PHOTOGRAPH #6**

**BUILDING 26  
SECTION B**

Contractor installing repainted railings with 4" lag bolts set in sealant.

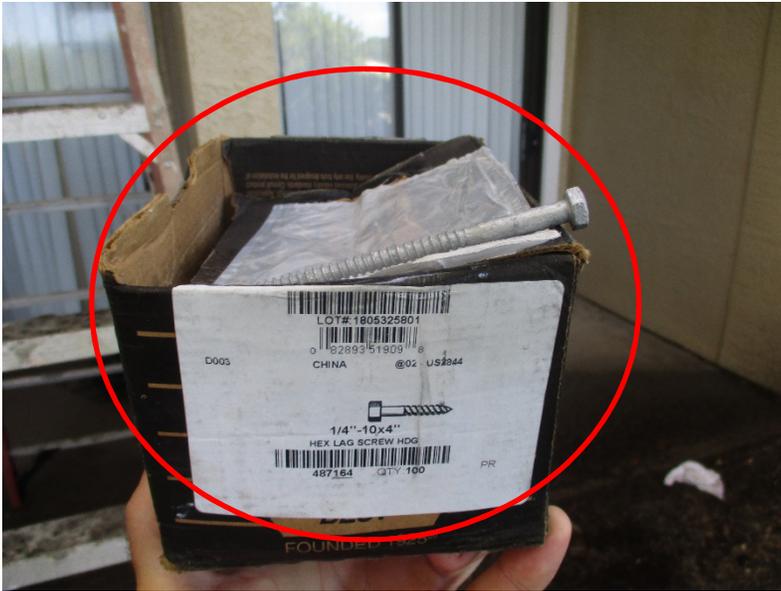
**PHOTOGRAPH #7**

**BUILDING 26  
SECTION B**

Contractor installing repainted railings with 4" lag bolts set in sealant.

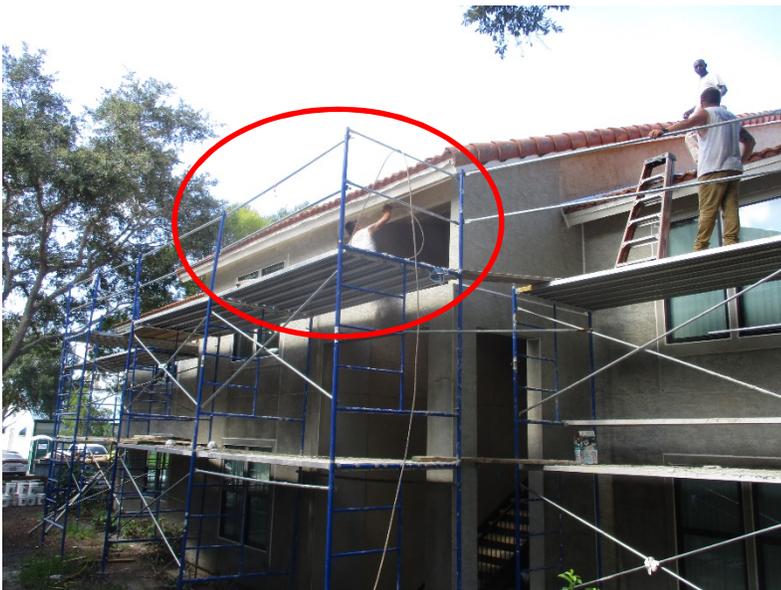
**PHOTOGRAPH #8**

**BUILDING 26  
SECTION E**

Contractor spray painting new soffit with Sherwin Williams Legacy Ultra Prime.

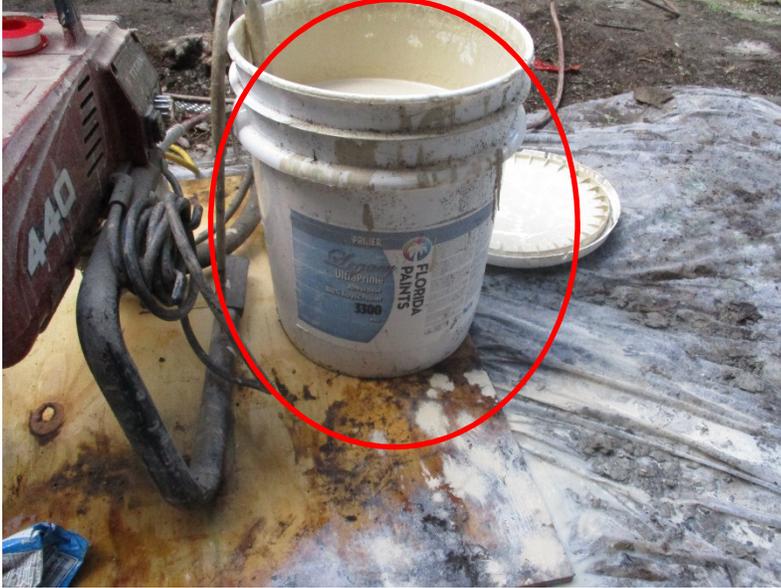
**PHOTOGRAPH #9**

**BUILDING 26  
SECTION E**

Contractor spray painting new soffit with Florida Paints Legacy Ultra Prime

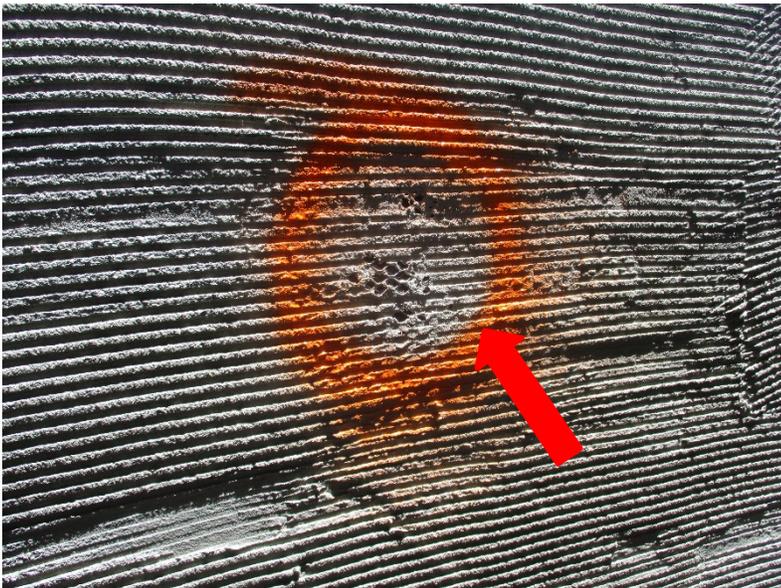
**PHOTOGRAPH #10**

**BUILDING 27  
SECTION H**

Several areas of stucco scratch coat not properly embedded into metal lath have been marked for correction.

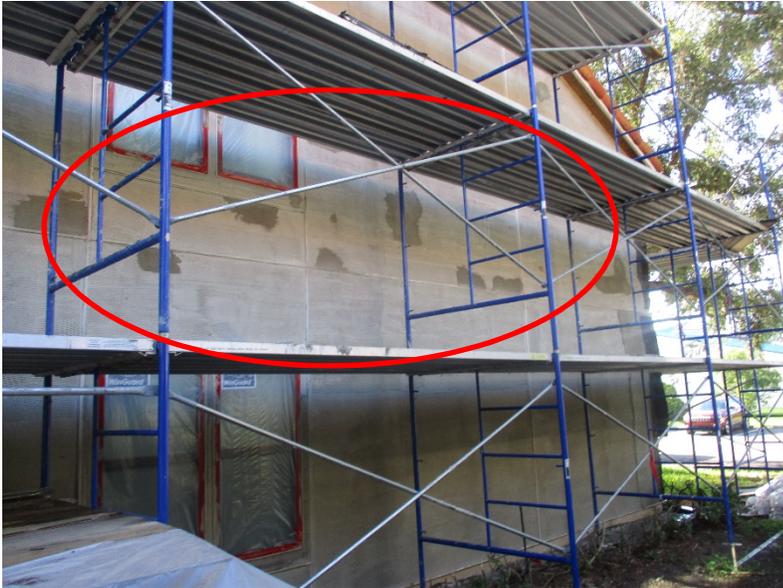
**PHOTOGRAPH #11**

**BUILDING 27  
SECTION H**

Stucco sub – contractor has made corrections at marked areas where scratch coat was deficient.

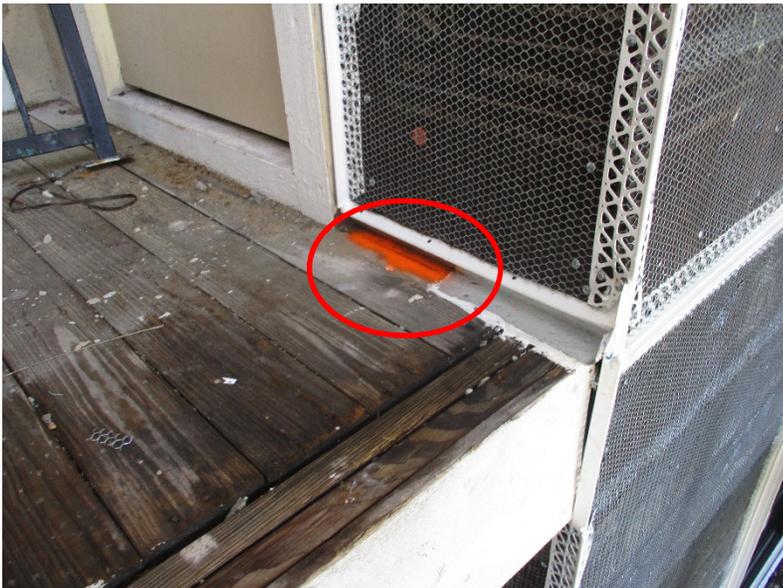
**PHOTOGRAPH #12**

**BUILDING 27  
SECTION G**

Flashing at unit # 2722 does not extend to the end of the new wall repairs and marked for corrections.

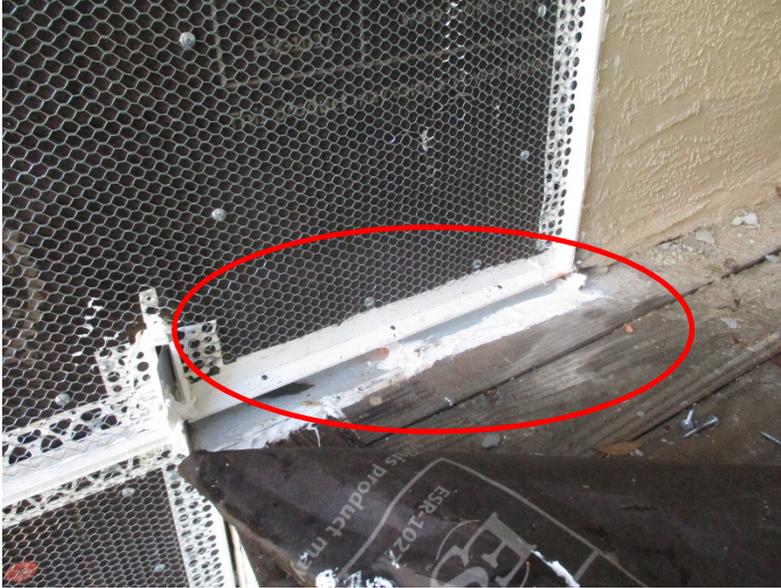
**PHOTOGRAPH #13**

**BUILDING 27  
SECTION G**

Contractor has made corrections at unit #2722 flashing deficiencies.

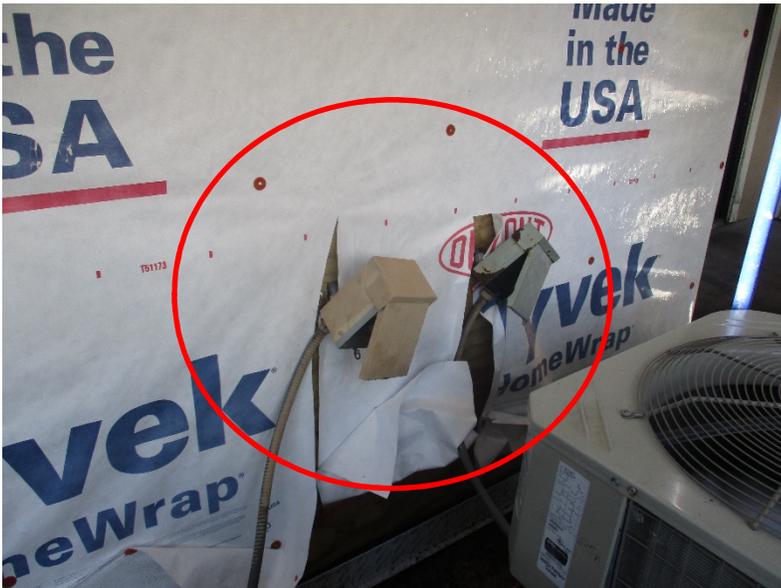
**PHOTOGRAPH #14**

**BUILDINGS 27  
SECTION F**

Contractor will be required to seal Tyvek WRB around AC electrical boxes before secondary WRB is applied by Stucco sub - contractor.

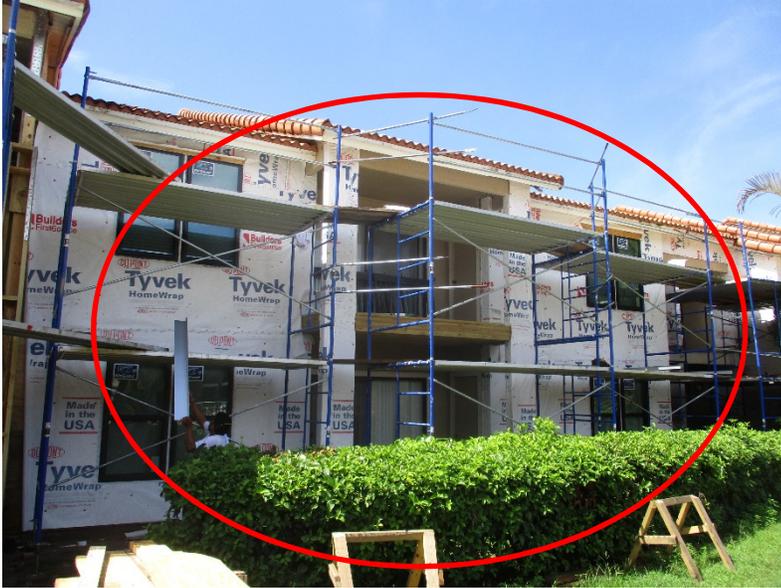
**PHOTOGRAPH #15**

**BUILDINGS 27  
SECTION F**

Contractor has completed Tyvek WRB, Dupont flashings and window installations.

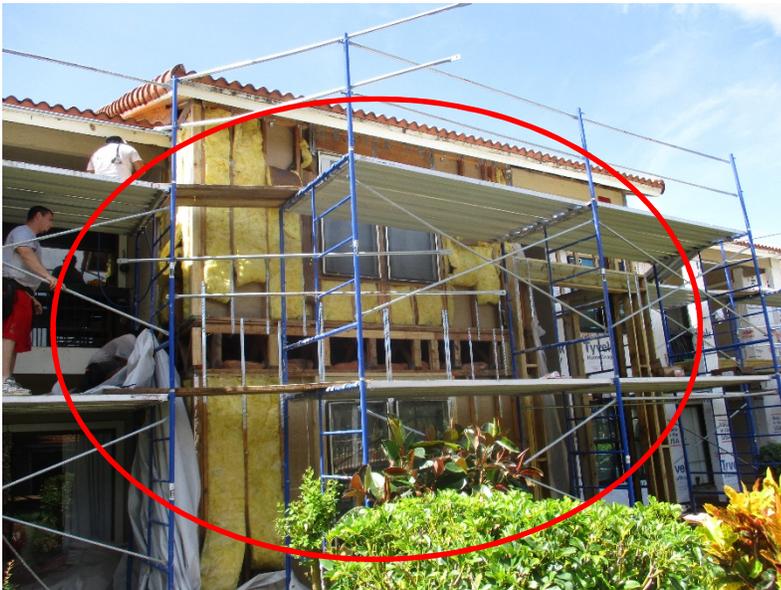
**PHOTOGRAPH #16**

**BUILDINGS 27  
SECTION E**

Framing, strapping and Simpson Strong Tie connectors inspected for compliance.

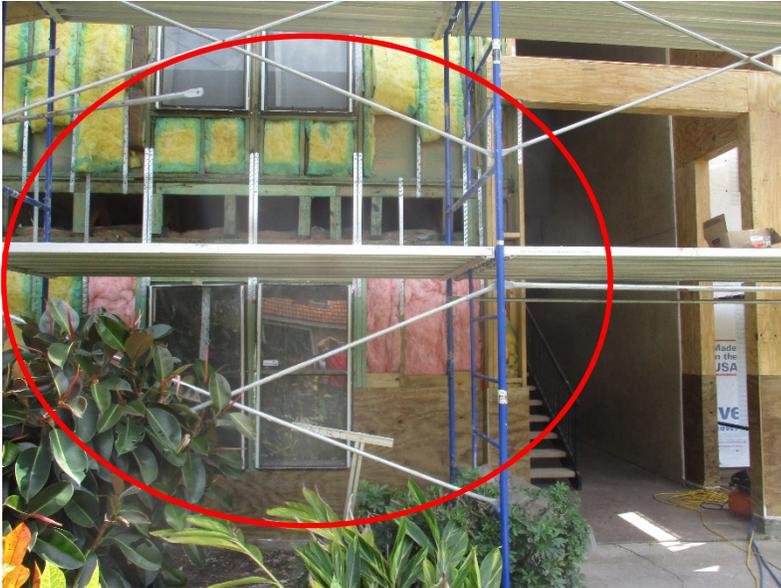
**PHOTOGRAPH #17**

**BUILDINGS 27  
SECTION E**

Bora-Care termite treatment has been applied, insulation placed and ply-wood sheathing has begun.

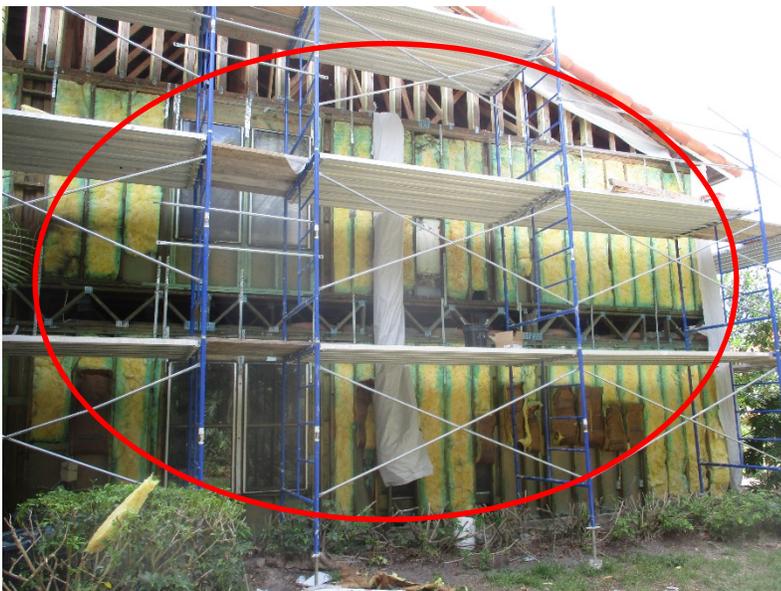
**PHOTOGRAPH #18**

**BUILDINGS 27  
SECTION D**

Gable end framing repairs, strapping, Simpson Strong Tie connectors and termite treatment applied.

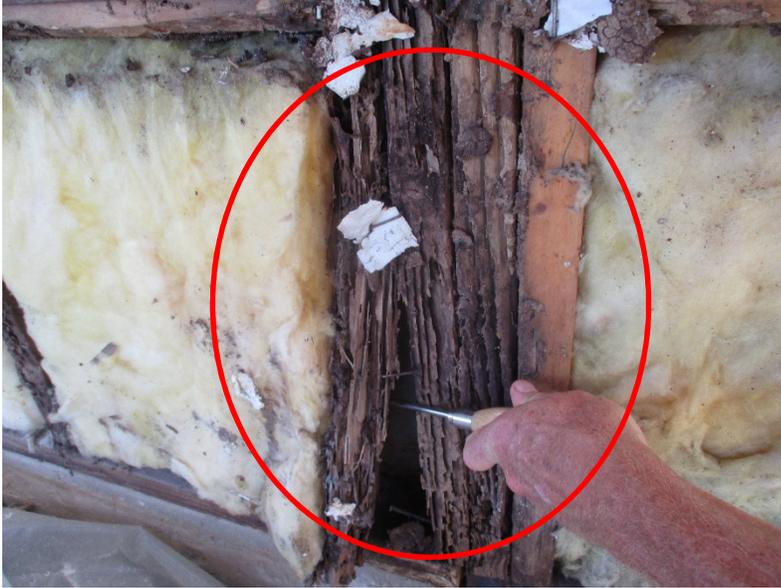
**PHOTOGRAPH #19**

**BUILDINGS 27  
SECTION C**

Framing damage inspected and marked for repairs.

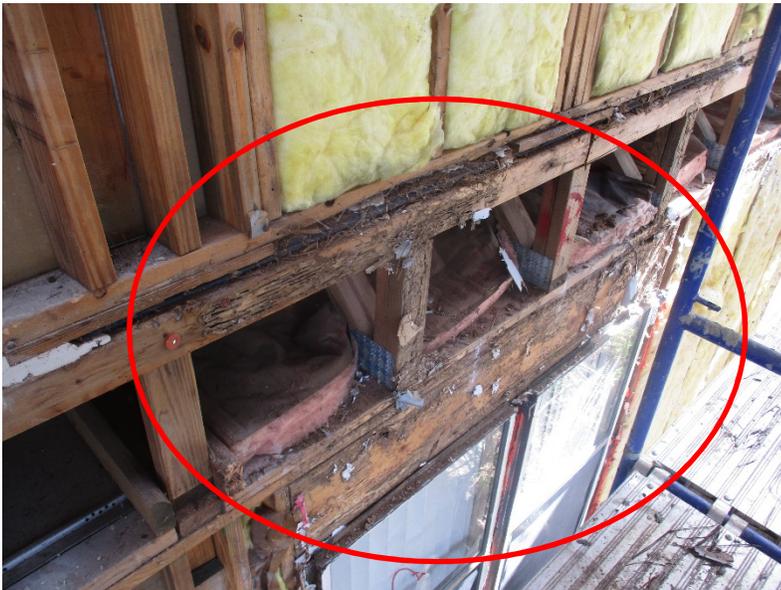
**PHOTOGRAPH #20**

**BUILDINGS 27  
SECTION C**

Framing damage inspected and marked for repairs.

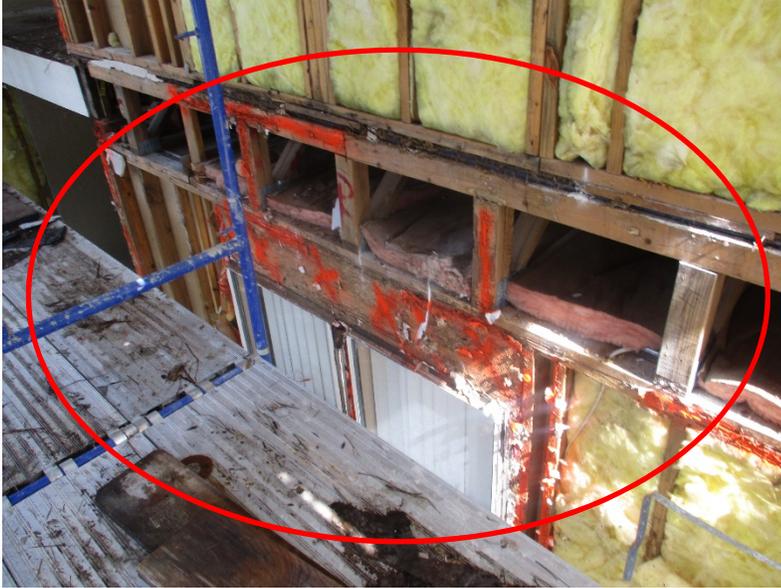
**PHOTOGRAPH #21**

**BUILDINGS 27  
SECTION C**

Framing damage inspected and marked for repairs.

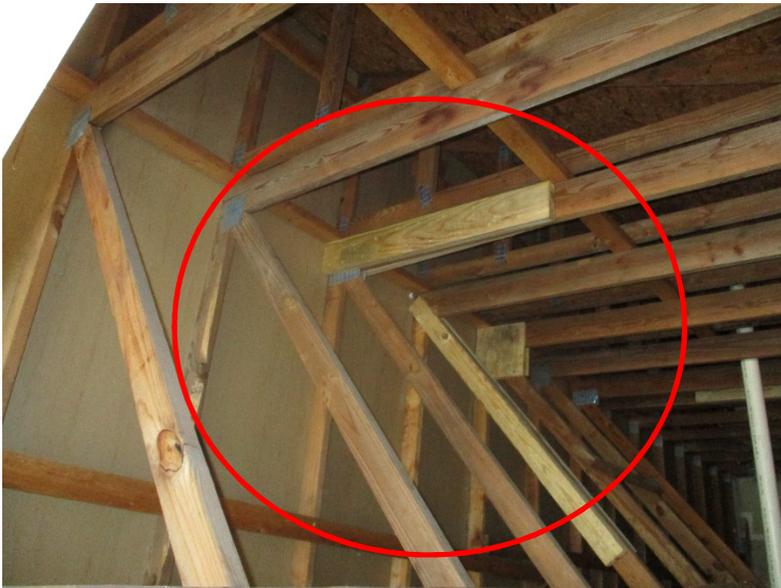
**PHOTOGRAPH #22**

**BUILDINGS 27  
ATTIC #2728**

Repairs made to gussets, trusses and fire walls.

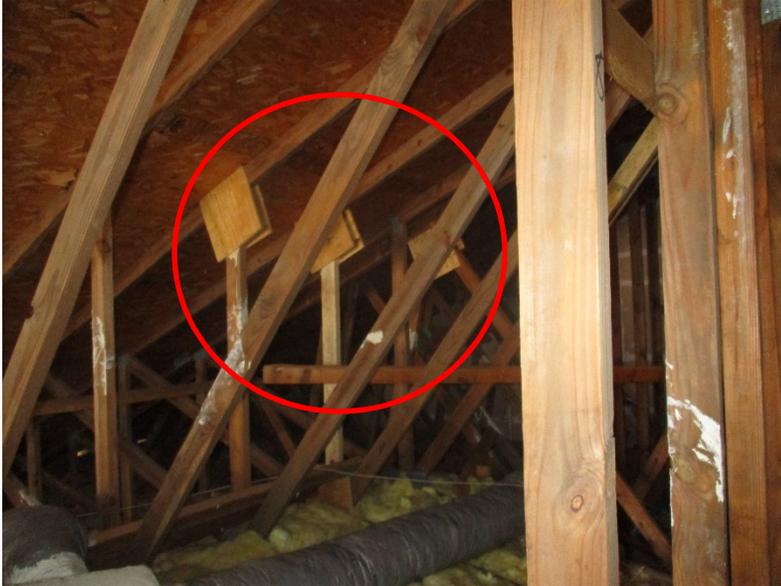
**PHOTOGRAPH #23**

**BUILDINGS 27  
ATTIC #2727**

Repairs made to gussets, trusses and fire walls.

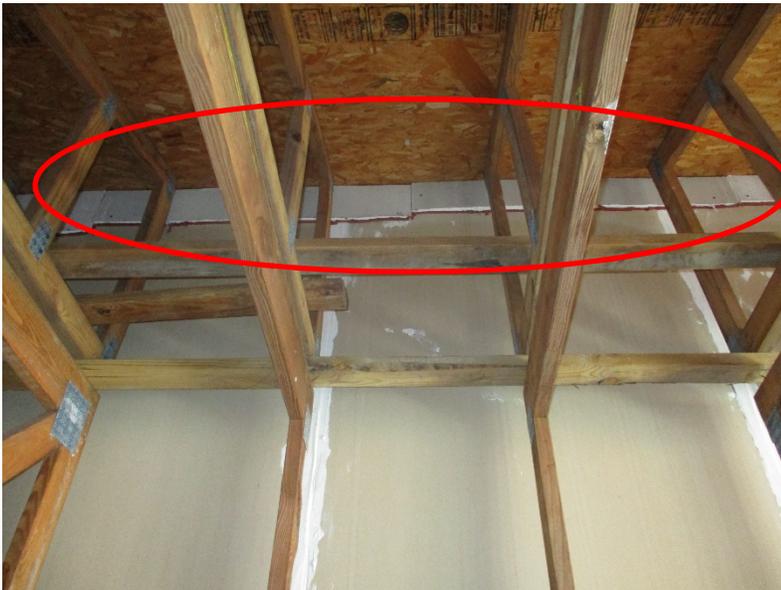
**PHOTOGRAPH #24**

**BUILDINGS 27  
ATTIC #2727**

Repairs made to gussets, trusses and fire walls.
