PHOTOGRAPHS

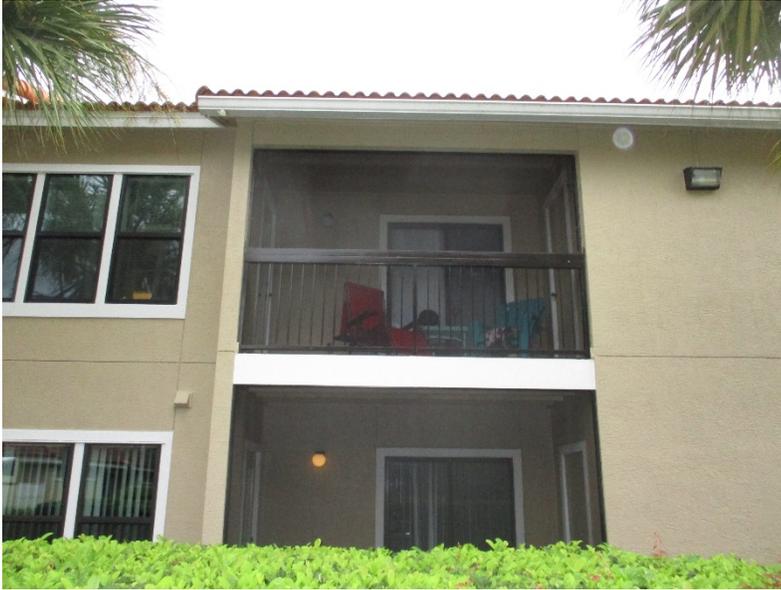
PHOTOGRAPH #1

**BUILDING 24
UNIT #2726**

New railing and screen enclosure are complete at balcony.

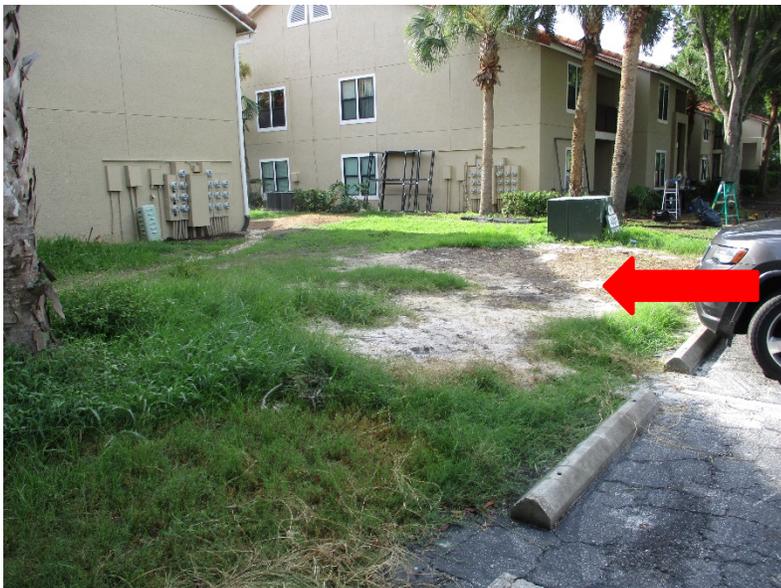
PHOTOGRAPH #2

**BUILDING 26
SECTION A**

Materials at stucco staging area have been removed.

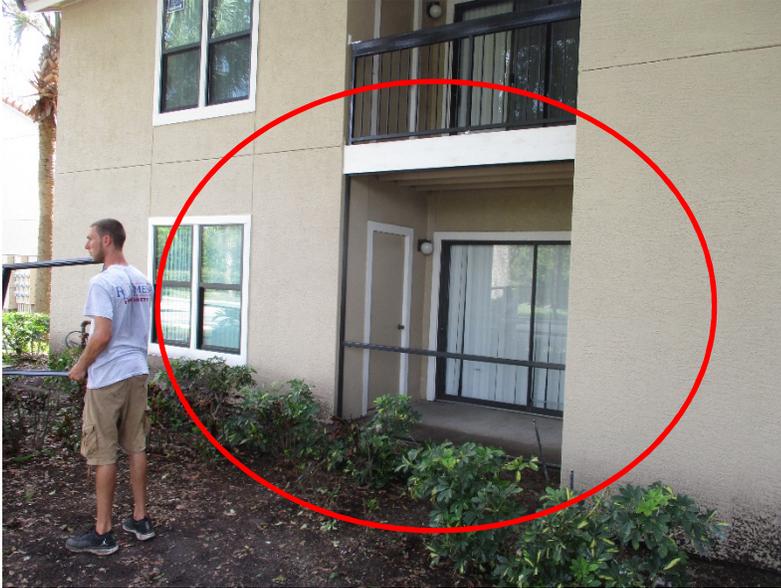
PHOTOGRAPH #3

**BUILDING 26
SECTION B**

Contractor has begun to install new screen enclosures at ground level units.

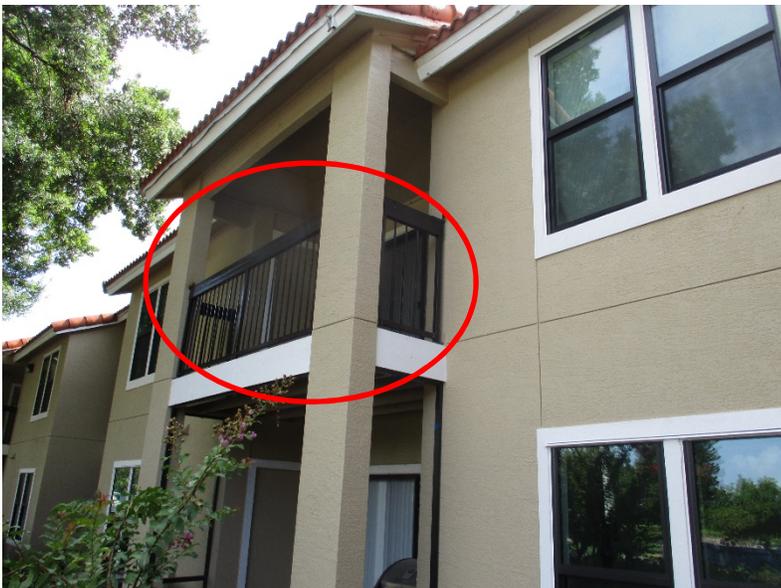
PHOTOGRAPH #4

**BUILDING 26
SECTION C**

Contractor has installed several balcony railings and attached to walls with angles welded to railing top rail.

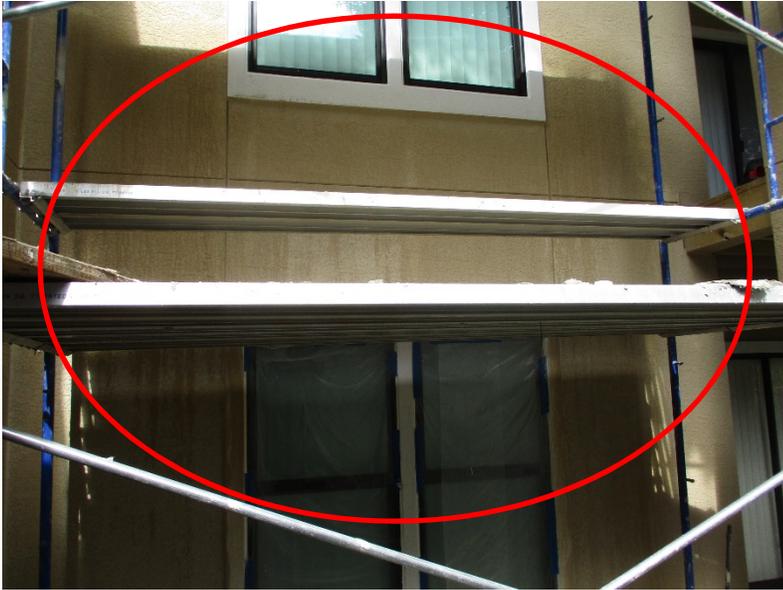
PHOTOGRAPH #5

**BUILDING 26
SECTION F**

Finish coat of paint on stucco has washed off from rain and will require reapplication.

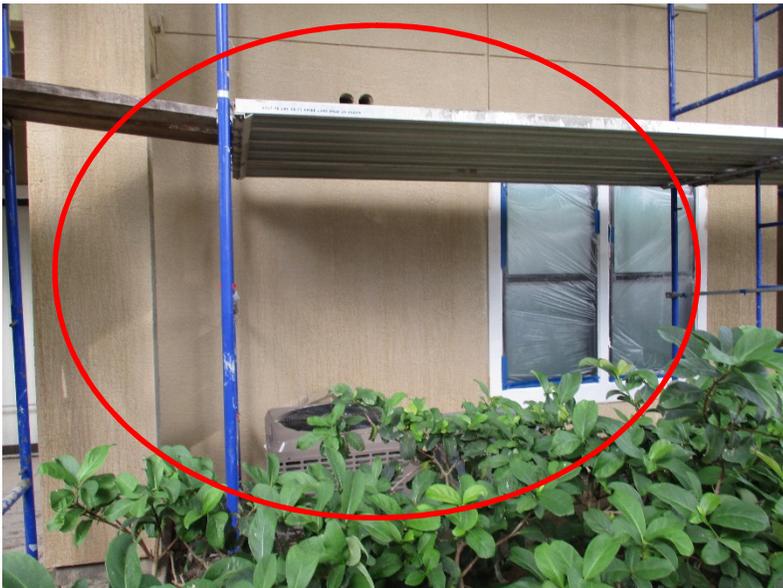
PHOTOGRAPH #6

**BUILDING 26
SECTION F**

Finish coat of paint on stucco has washed off from rain and will require reapplication.

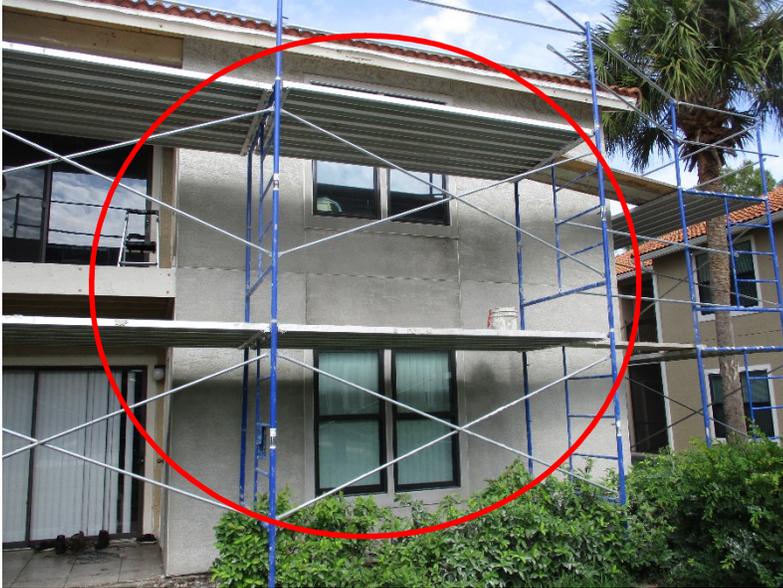
PHOTOGRAPH #7

**BUILDING 26
SECTION G**

Sub-contractor has completed finish coat of stucco.

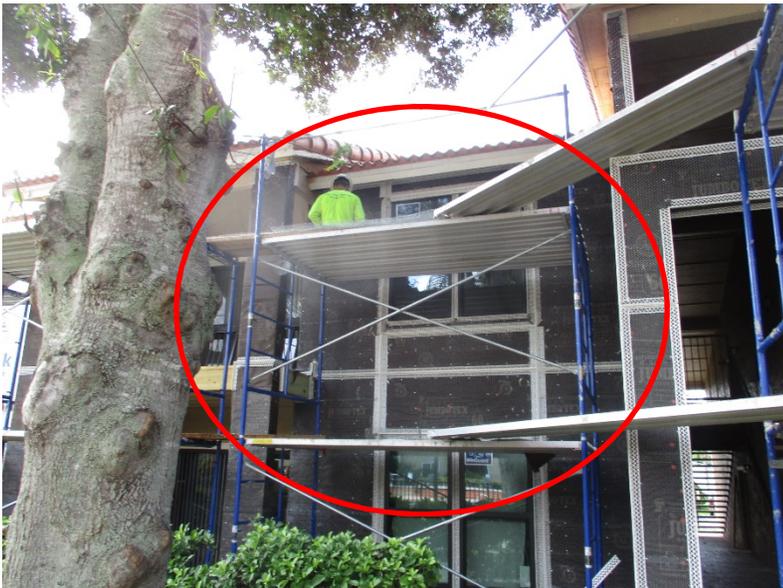
PHOTOGRAPH #8

**BUILDING 2
SECTION G**

Stucco sub-contractor applying stucco accessories and metal lath.

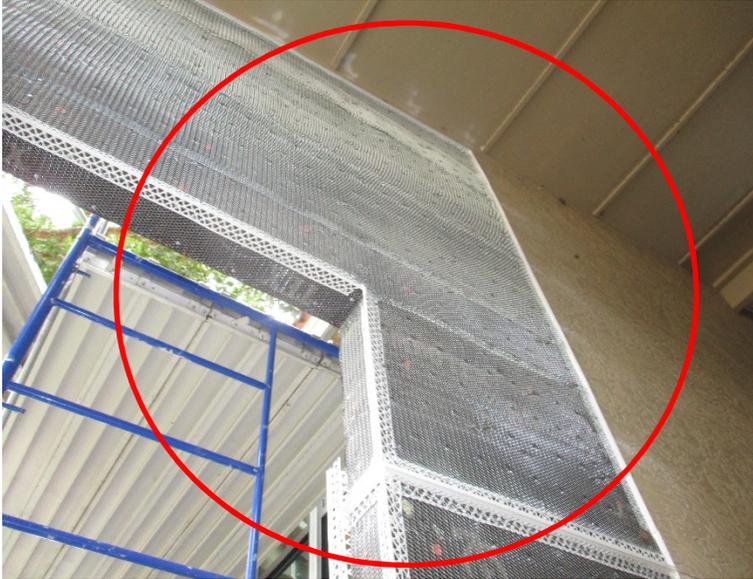
PHOTOGRAPH #9

**BUILDING 26
SECTION G**

Stucco sub-contractor has installed alternate metal lath in this area that has not been submitted or approved for application.

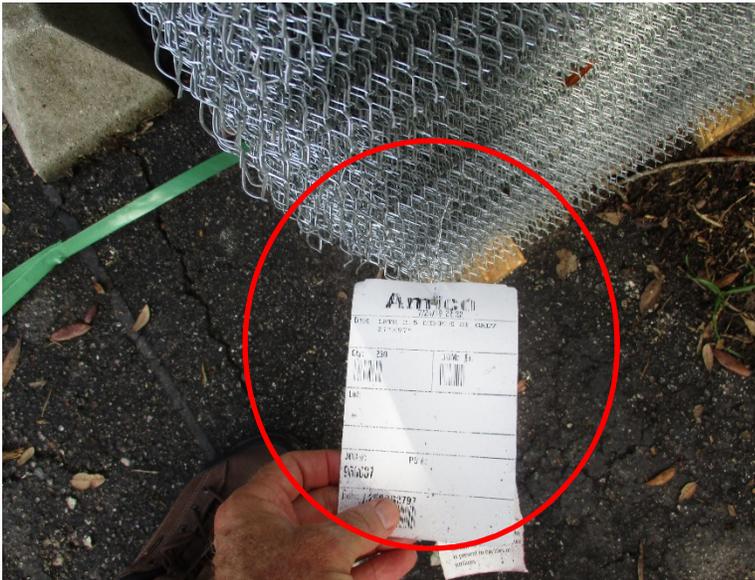
PHOTOGRAPH #10

**BUILDING 27
SECTION H**

Stucco sub-contractor has installed alternate metal lath in this area that has not been submitted or approved for application.

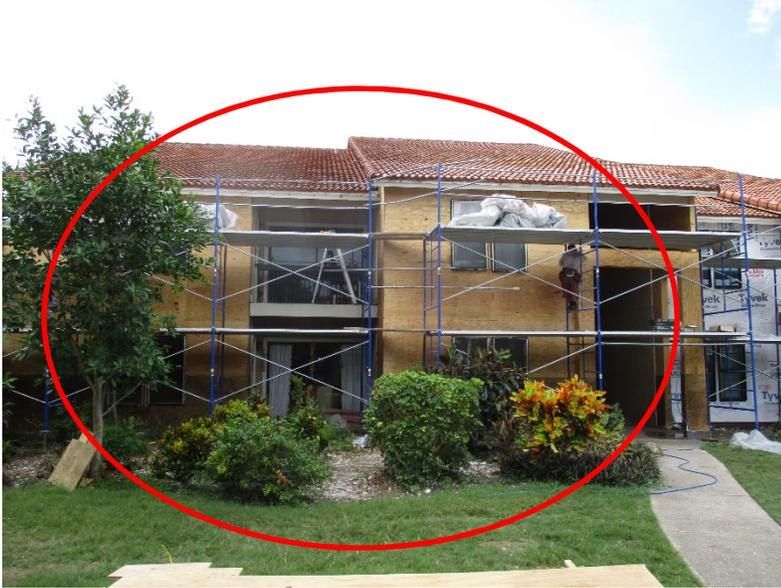
PHOTOGRAPH #11

**BUILDING 27
SECTION E**

Plywood sheathing installed and inspected, is ready for Tyvek WRB and window installations.

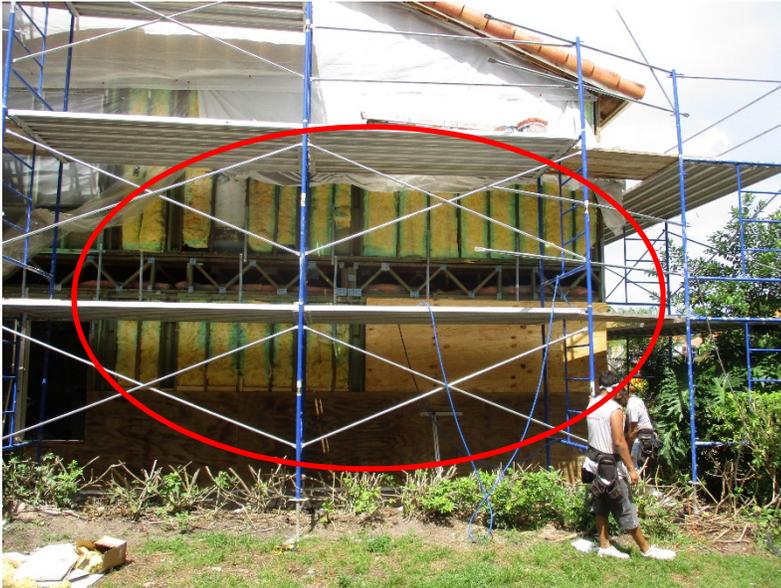
PHOTOGRAPH #12

**BUILDING 27
SECTION D**

Contractor has begun to install plywood sheathing.

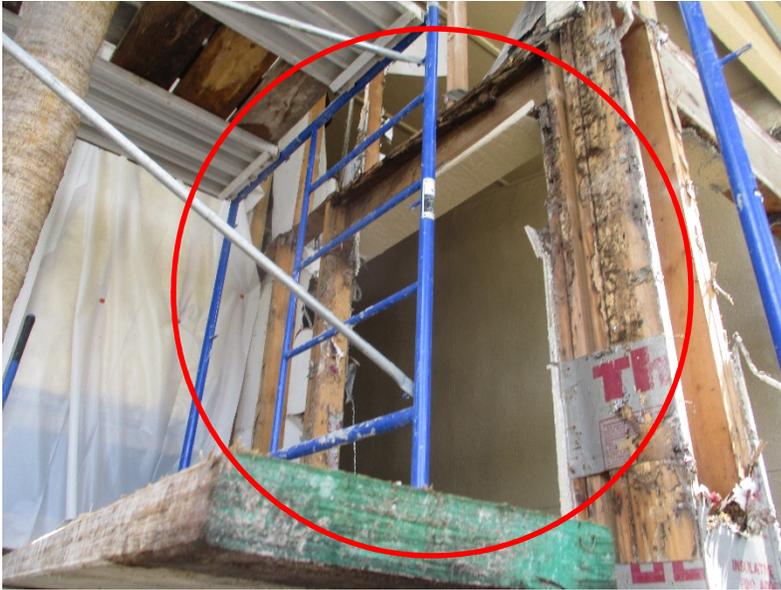
PHOTOGRAPH #13

**BUILDING 27
SECTION C**

Breezeway built up beams and framing damage, documented and marked for replacement.

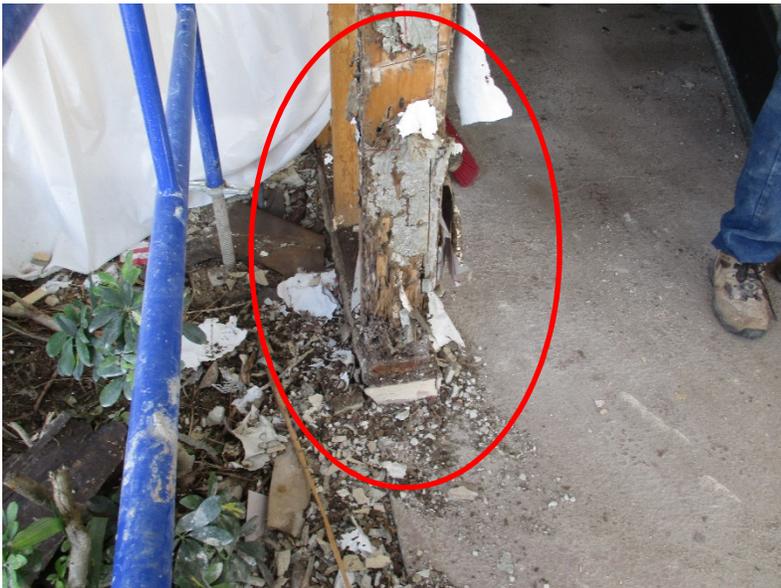
PHOTOGRAPH #14

**BUILDING 27
SECTION C**

Breezeway built up beams and framing damage, documented and marked for replacement.

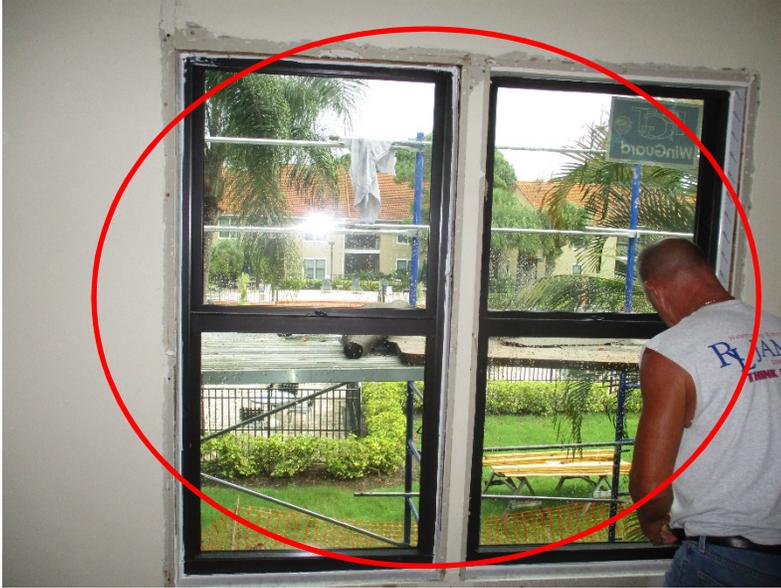
PHOTOGRAPH #15

**BUILDINGS 27
UNIT #2724**

Windows installations have been inspected for compliance.

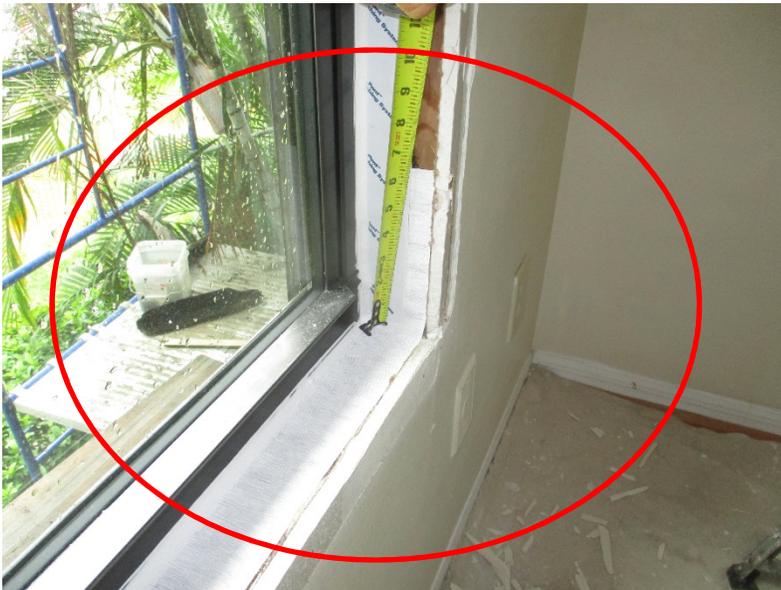
PHOTOGRAPH #16

**BUILDINGS 27
UNIT #2724**

Windows installations have been inspected for compliance.

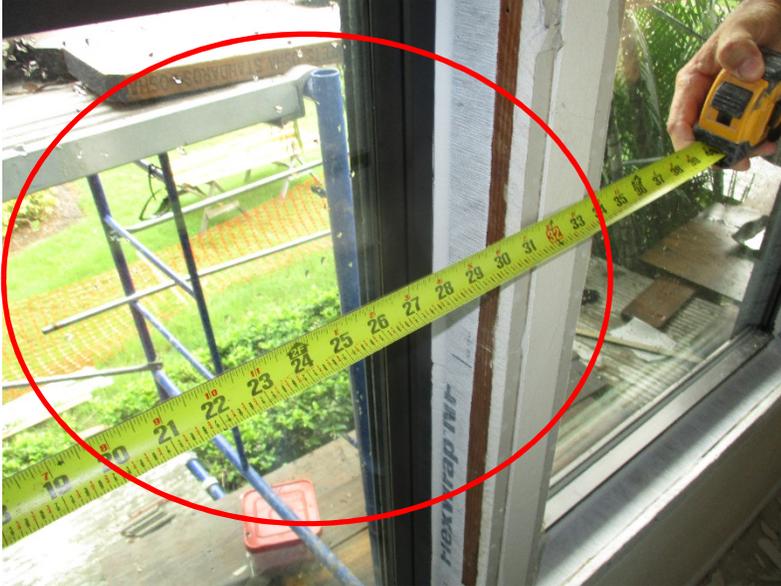
PHOTOGRAPH #17

**BUILDINGS 27
UNIT #2724**

Windows installations have been inspected for compliance.

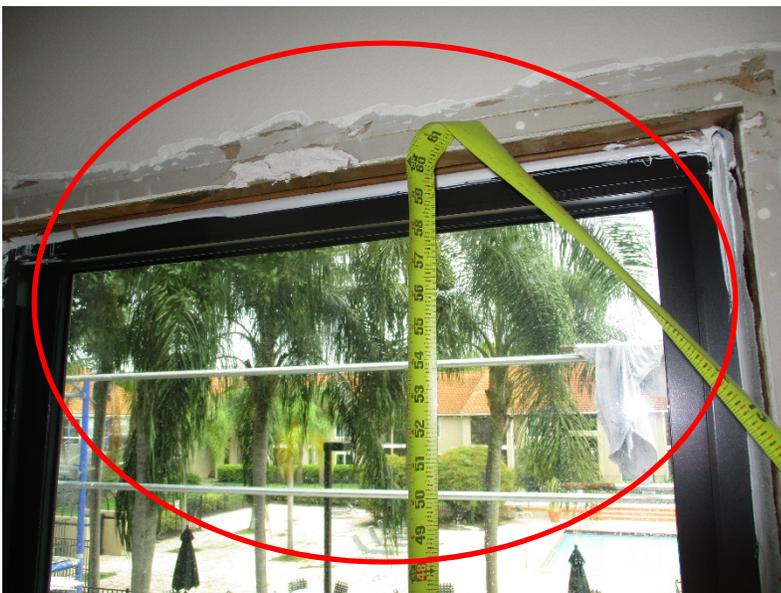
PHOTOGRAPH #18

**BUILDINGS 27
UNIT #2724**

Windows installations have been inspected for compliance.

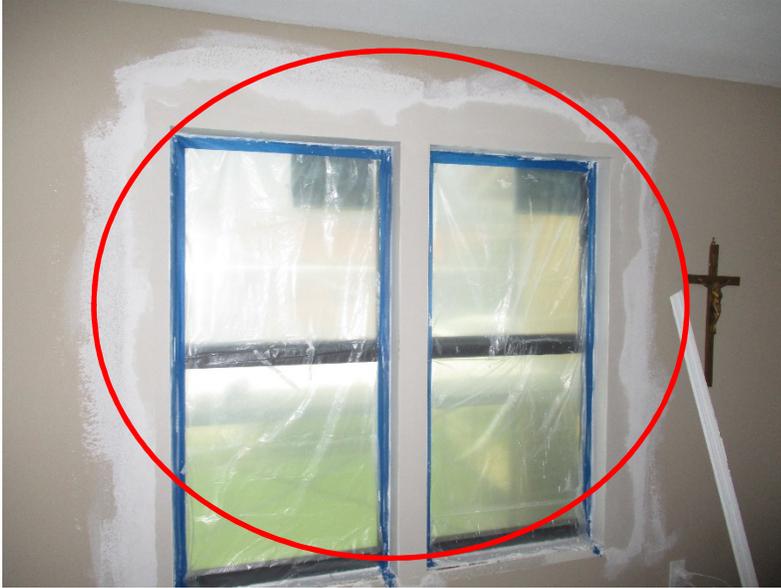
PHOTOGRAPH #19

**BUILDINGS 27
UNIT #2726**

Contractor has made drywall repairs at newly installed windows.

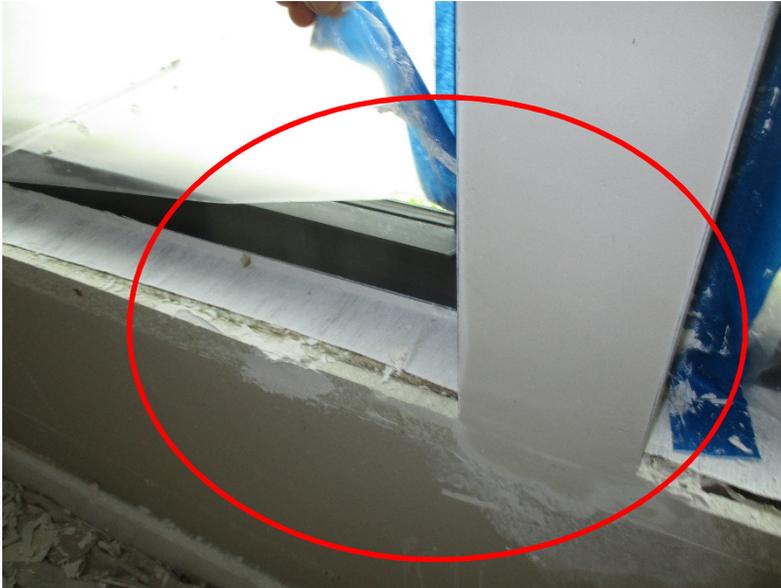
PHOTOGRAPH #20

**BUILDINGS 27
UNIT #2726**

Contractor has made drywall repairs at newly installed windows.
