PHOTOGRAPHS

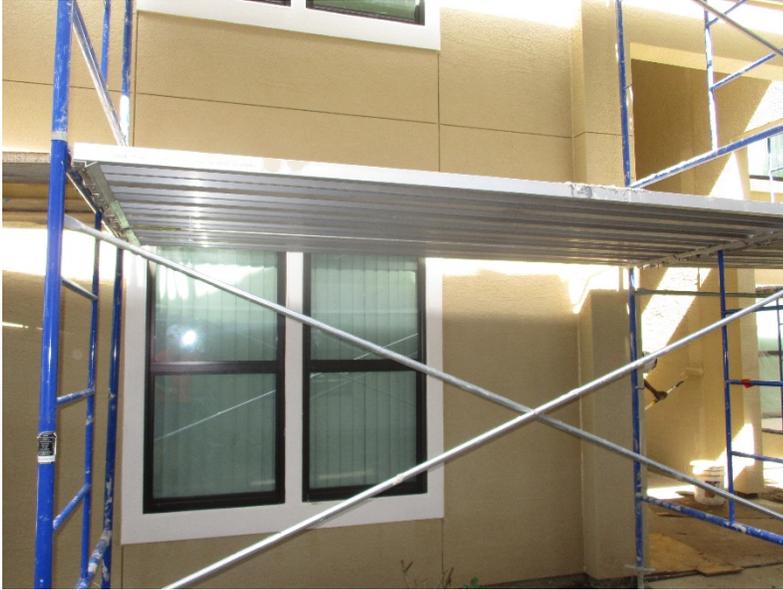
PHOTOGRAPH #1

BUILDING 26 SECTION E

Finish coat of paint has been re-applied at locations previously washed off.

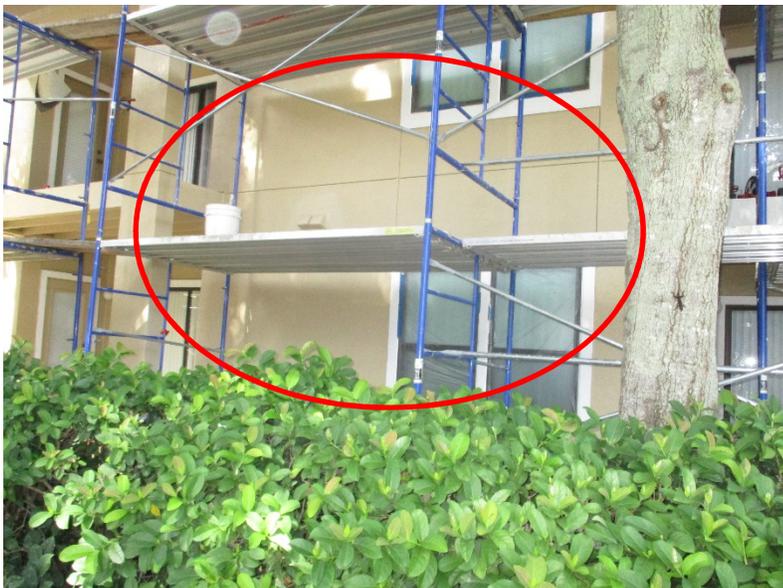
PHOTOGRAPH #2

BUILDING 26 SECTION F

Finish coat of paint has been re-applied at locations previously washed off.

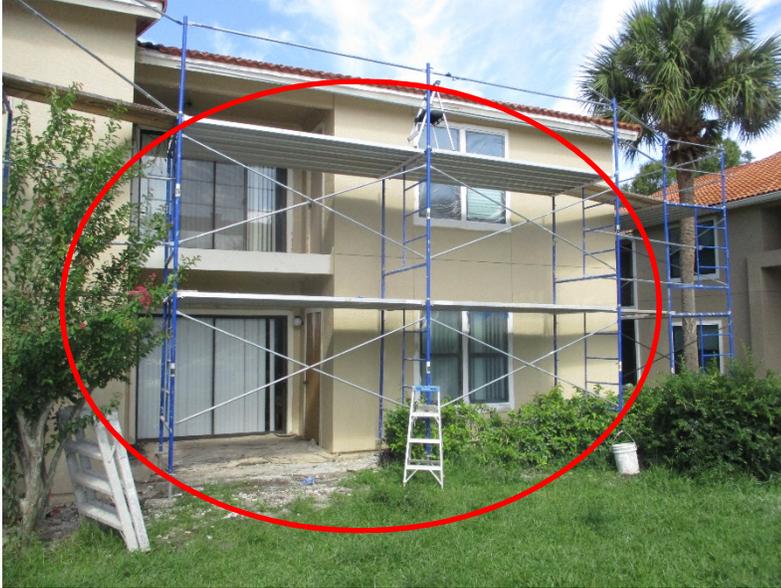
PHOTOGRAPH #3

**BUILDING 26
SECTION G**

Contractor has applied finish coating to stucco surfaces.

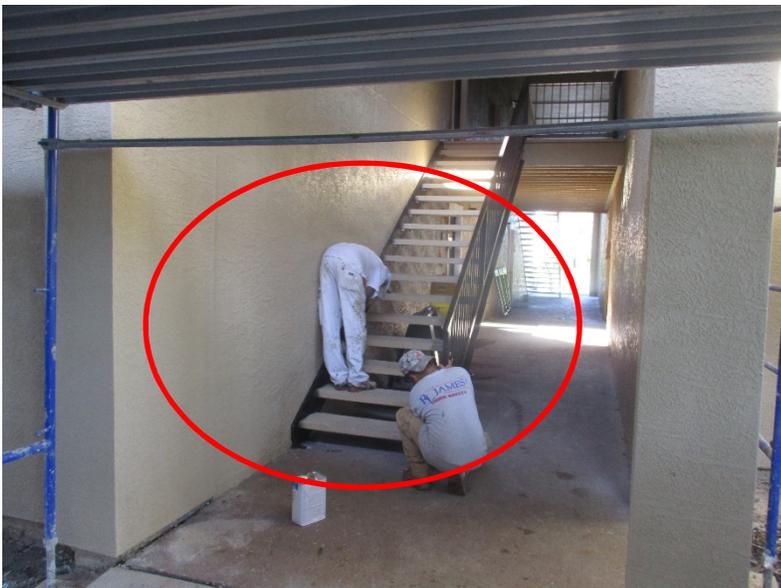
PHOTOGRAPH #4

**BUILDING 26
SECTION E**

Contractor is painting stair pads and stair railings.

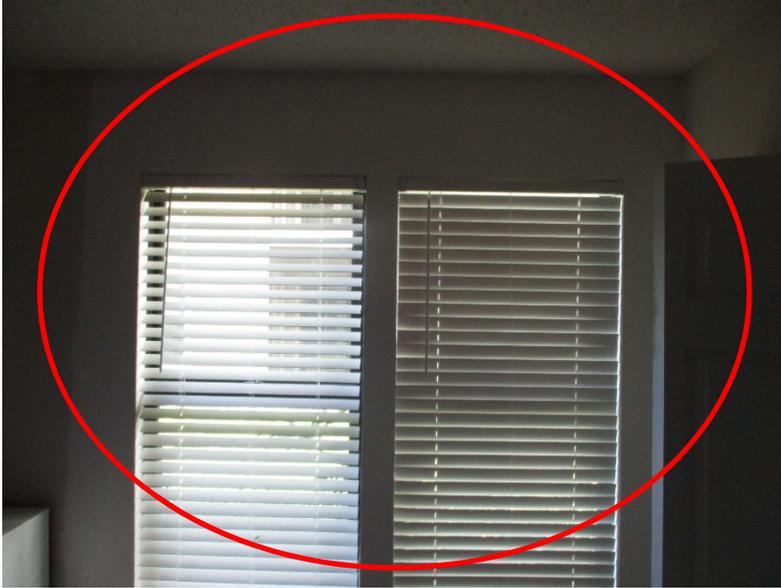
PHOTOGRAPH #5

**BUILDING 26
UNIT # 2612**

Delta walked through all accessible units for inspection of interior window repair work with contractor and representative from Vintage Grand.

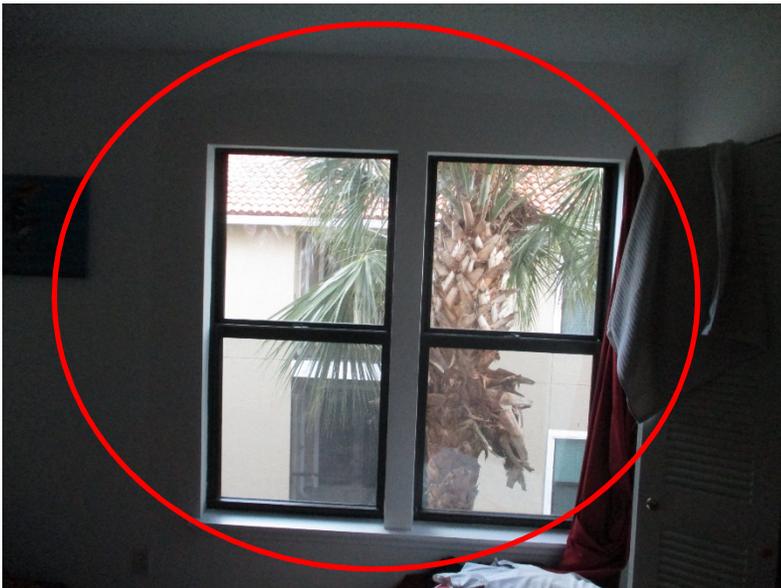
PHOTOGRAPH #6

**BUILDING 26
UNIT #2622**

Delta walked through all accessible units for inspection of interior window repair work with contractor and representative from Vintage Grand.

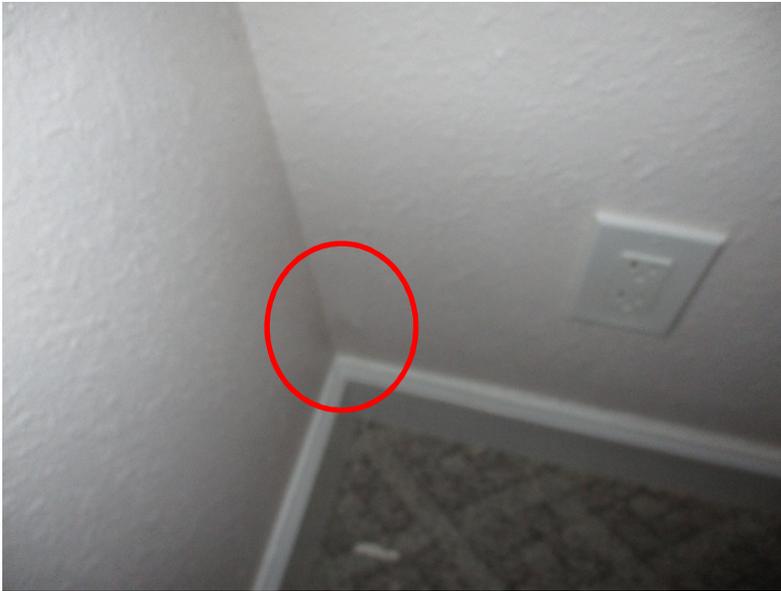
PHOTOGRAPH #7

**BUILDING 26
UNIT #2616**

Drywall has been damaged at interior side and contractor has scheduled repairs with owners.

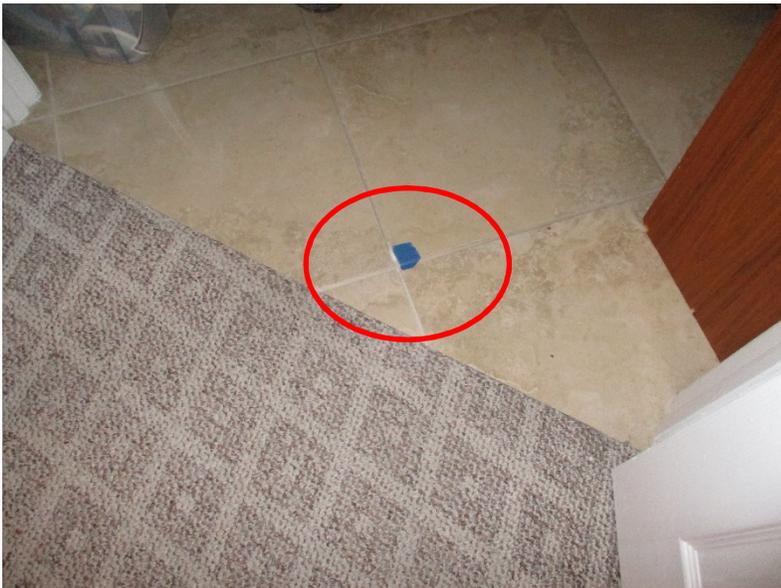
PHOTOGRAPH #8

**BUILDING 26
UNIT #2616**

Contractor has spilled paint at tile area and has scheduled clean up with owners.

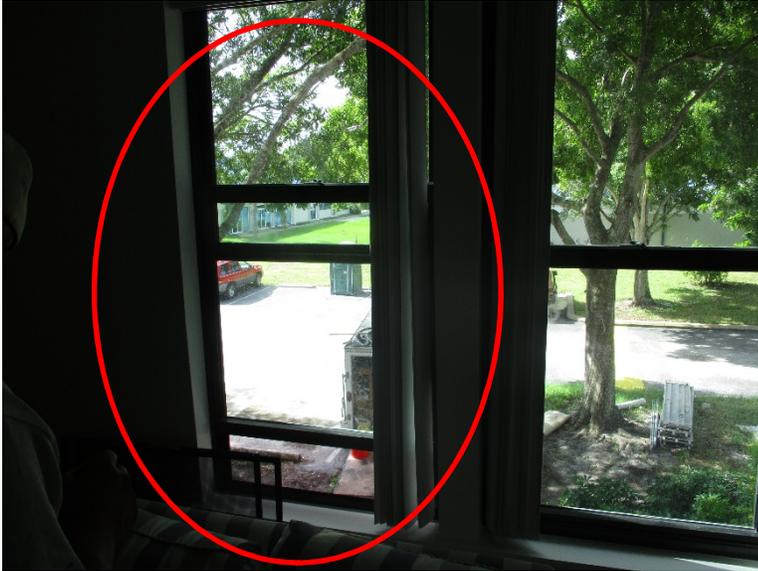
PHOTOGRAPH #9

**BUILDING 26
UNIT #2627**

Window does not open or close properly
and will be repaired by contractor.

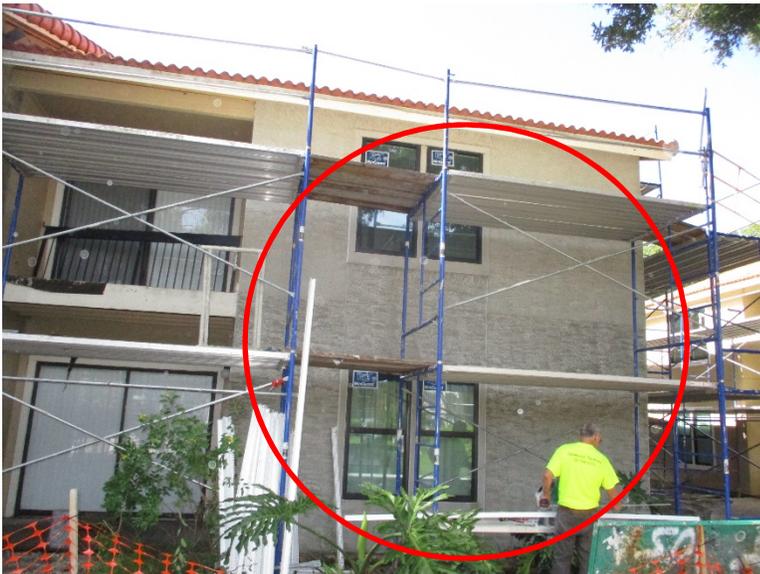
PHOTOGRAPH #10

**BUILDING 27
SECTION G**

Stucco sub-contractor has applied finish
stucco.

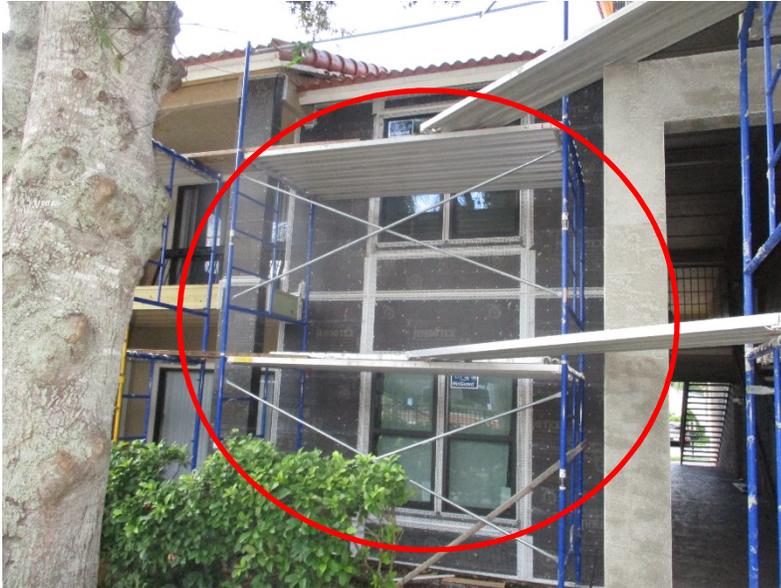
PHOTOGRAPH #11

**BUILDING 27
SECTION F**

Stucco sub-contractor has installed alternate metal lath in this area that was not submitted or approved for application.

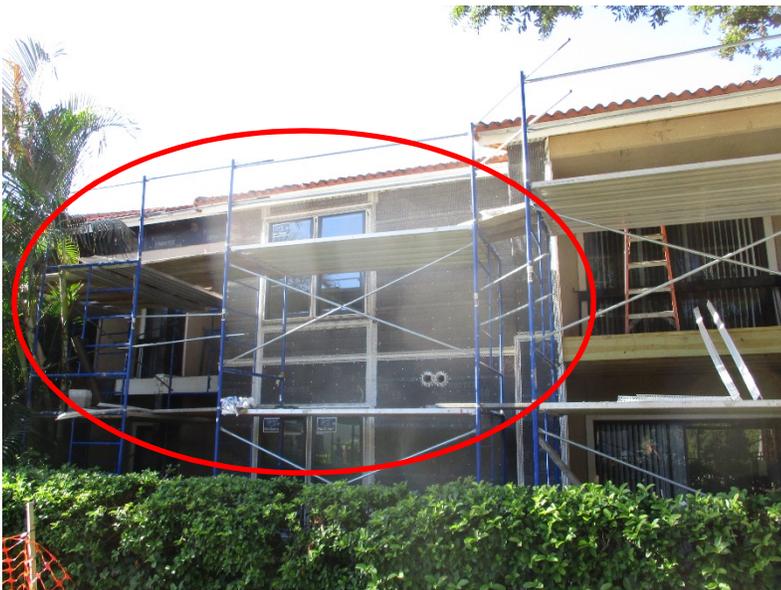
PHOTOGRAPH #12

**BUILDING 27
SECTION F**

Contractor has installed originally submitted and approved metal lath.

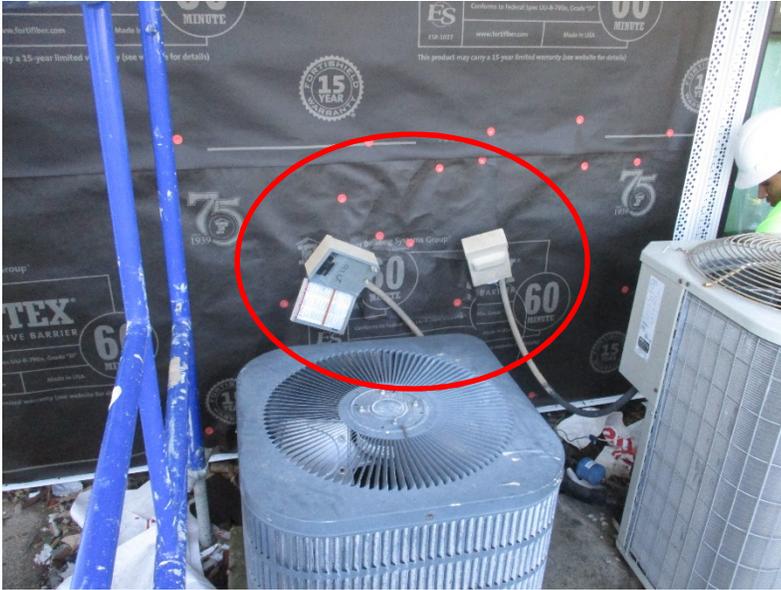
PHOTOGRAPH #13

**BUILDING 27
SECTION F**

Contractor has sealed Tyvek WRB around electrical boxes prior to application of secondary WRB applied by stucco sub-contractor.

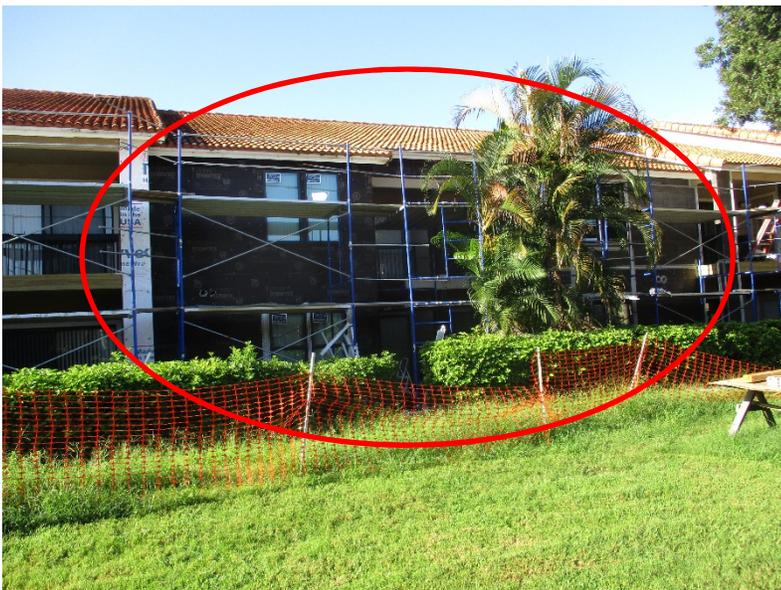
PHOTOGRAPH #14

**BUILDING 27
SECTION F**

JobTex WRB has been applied by stucco sub-contractor.

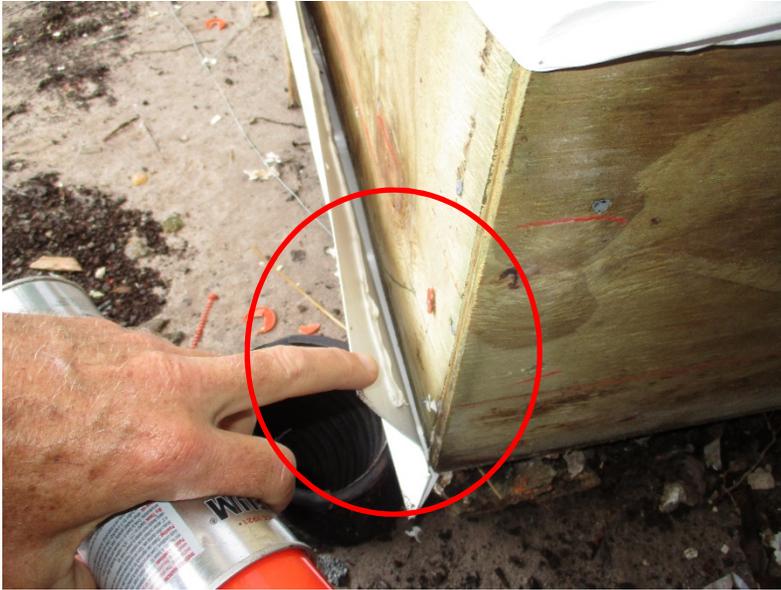
PHOTOGRAPH #15

**BUILDING 27
SECTION E**

Weep screed stucco accessory being installed at base of new pressure treated plywood sheathing with sealant as required.

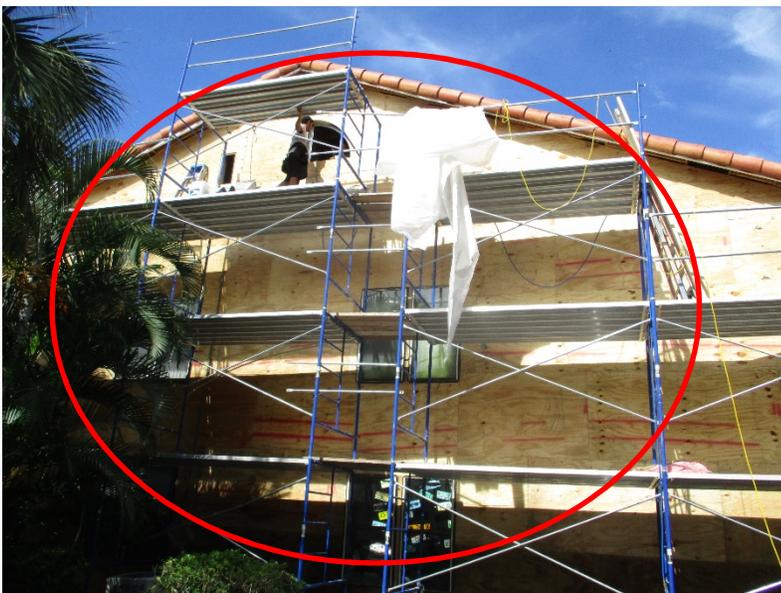
PHOTOGRAPH #16

**BUILDING 27
SECTION D**

Plywood sheathing installed and inspected for compliance.

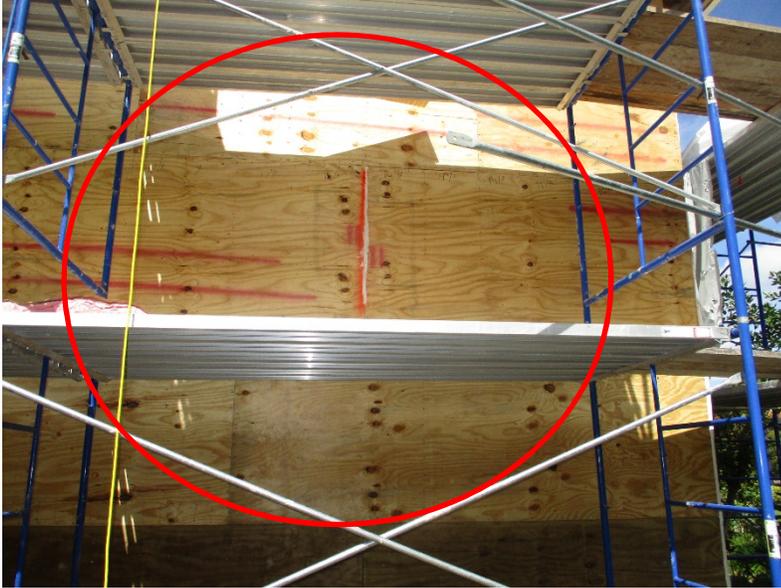
PHOTOGRAPH #17

**BUILDING 27
SECTION D**

Contractor has made corrections at plywood installation marked by Delta.

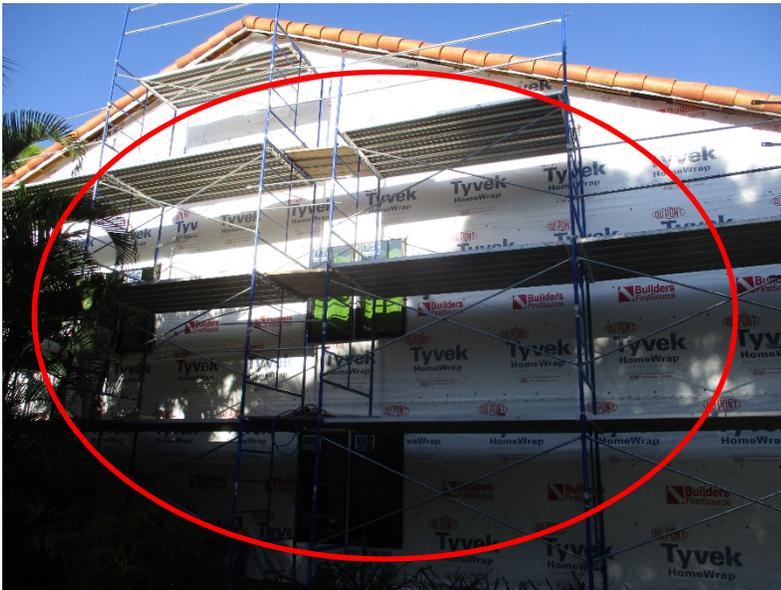
PHOTOGRAPH #18

**BUILDING 27
SECTION D**

Tyvek WRB has been applied and new windows set into openings with Dupont flashings.

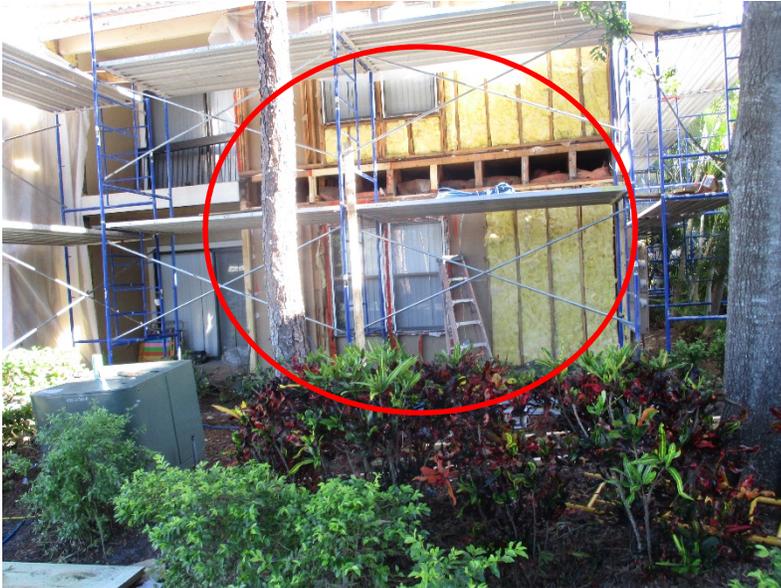
PHOTOGRAPH #19

**BUILDING 27
SECTION C**

Contractor has begun framing repairs at walls and subfloor areas.

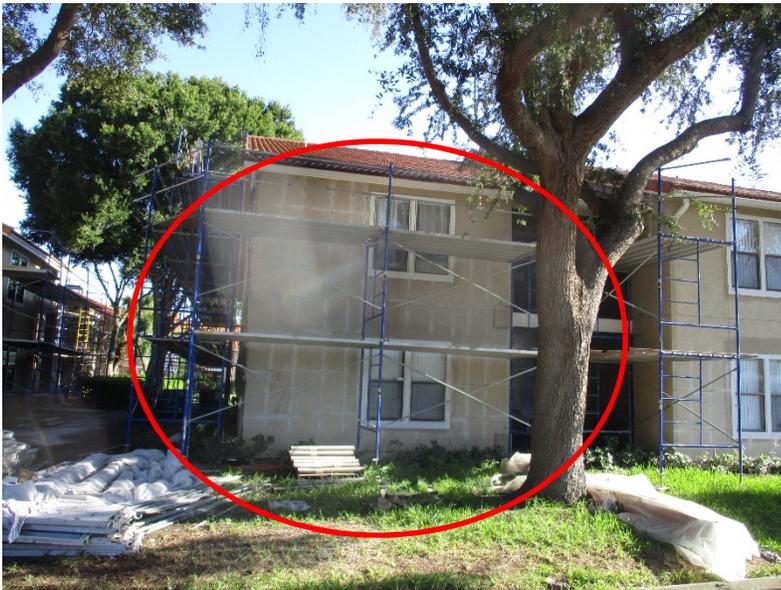
PHOTOGRAPH #20

**BUILDINGS 27
SECTION A**

Contractor has erected access scaffolding and begun demolition.
