### PHOTOGRAPHS

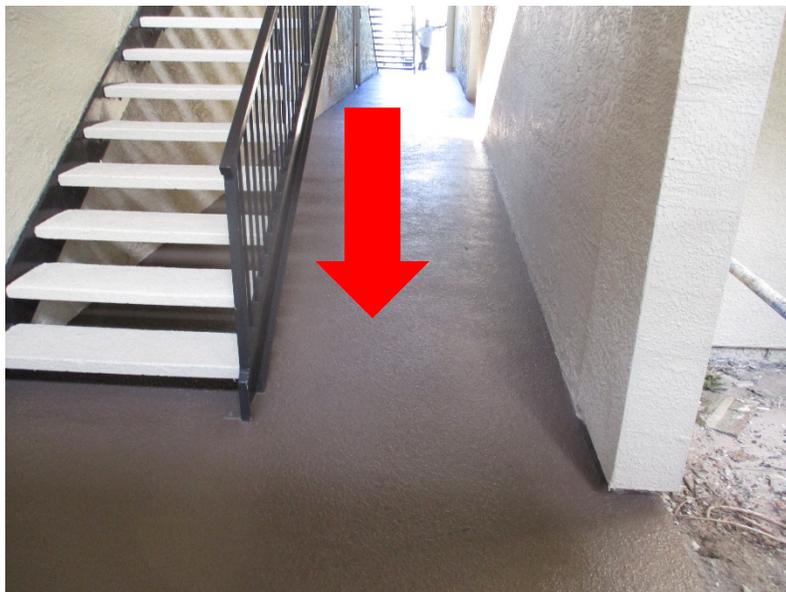
PHOTOGRAPH #1

#### BUILDING 26 SECTION E

Florida Paints TropiCrete concrete sealer has been applied to ground level walkways.

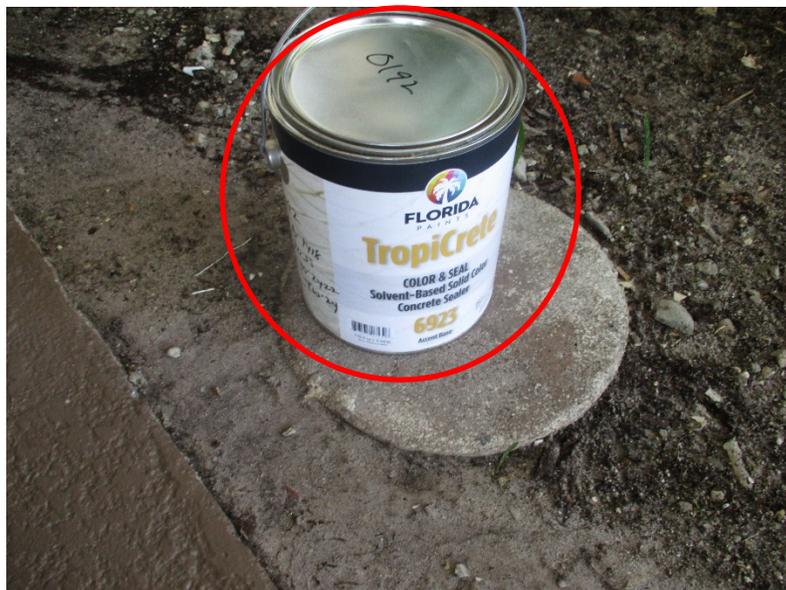
PHOTOGRAPH #2

#### BUILDING 26 SECTION E

Florida Paints TropiCrete concrete sealer has been applied to ground level walkways.

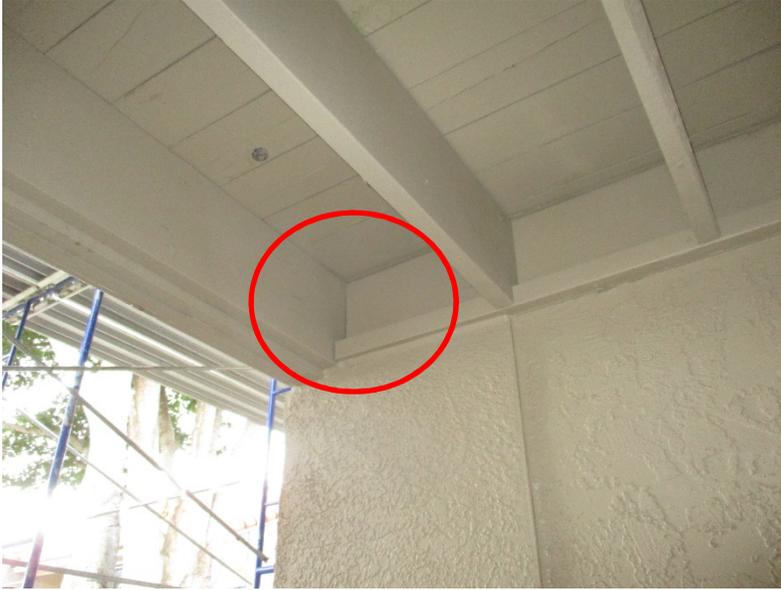
**PHOTOGRAPH #3**

**BUILDING 26  
SECTION F**

Simpson #HSLQ37-SDS2.5 shear clip required at this C2 Balcony has not yet been installed.

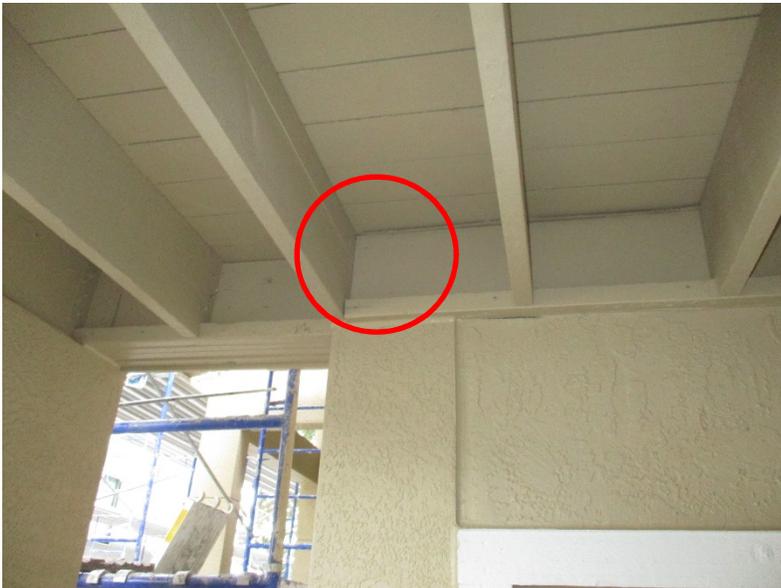
**PHOTOGRAPH #4**

**BUILDING 26  
SECTION F**

Simpson HGA10KT shear clip required at this C1A Balcony has not yet been installed.

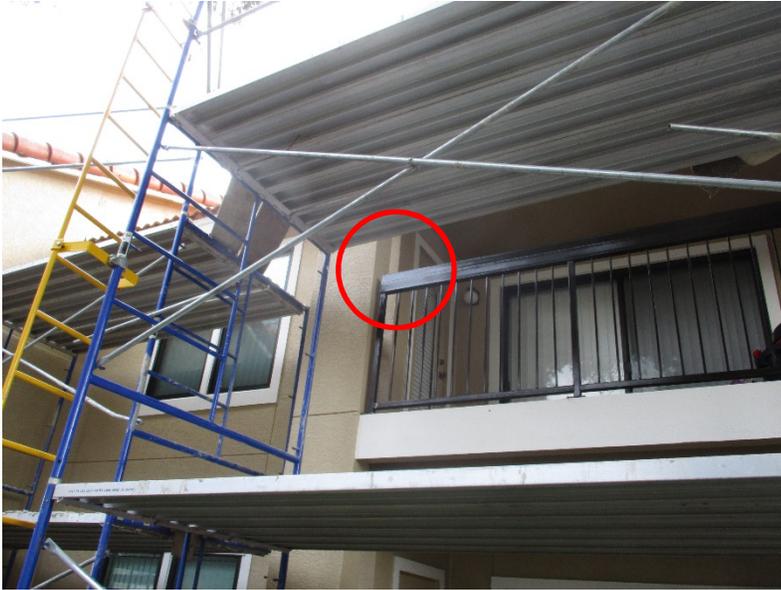
**PHOTOGRAPH #5**

**BUILDING 26  
SECTION F**

Balcony railings have been installed but top railing anchors have not yet been attached to columns.

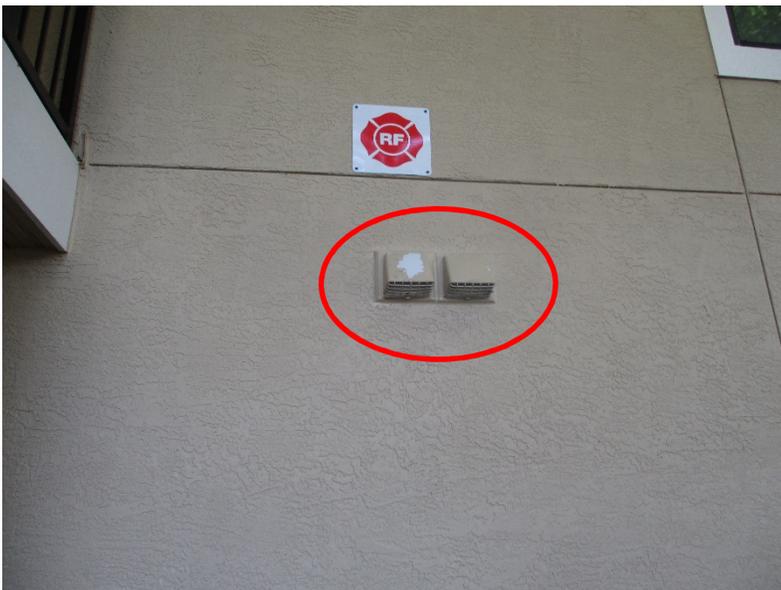
**PHOTOGRAPH #6**

**BUILDING 26  
SECTION B**

Finish paint is peeling off new dryer vents.

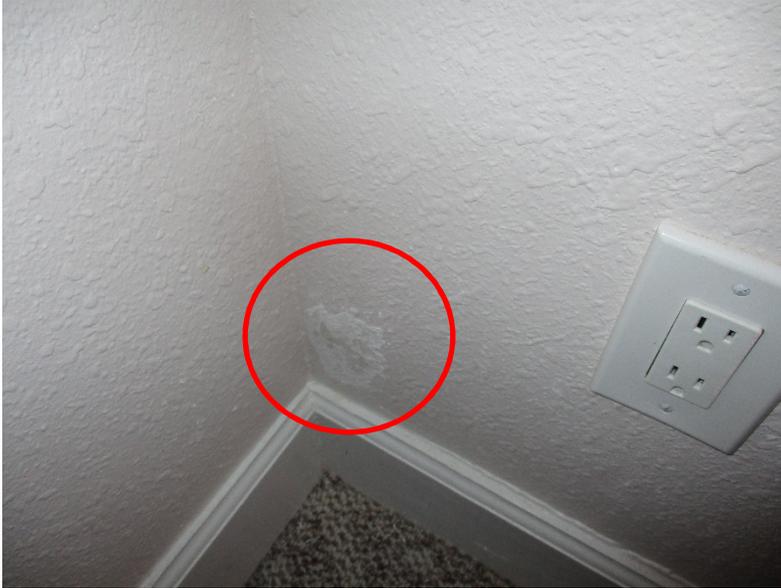
**PHOTOGRAPH #7**

**BUILDING 26  
UNIT #2616**

Drywall has been repaired at interior side where damaged.

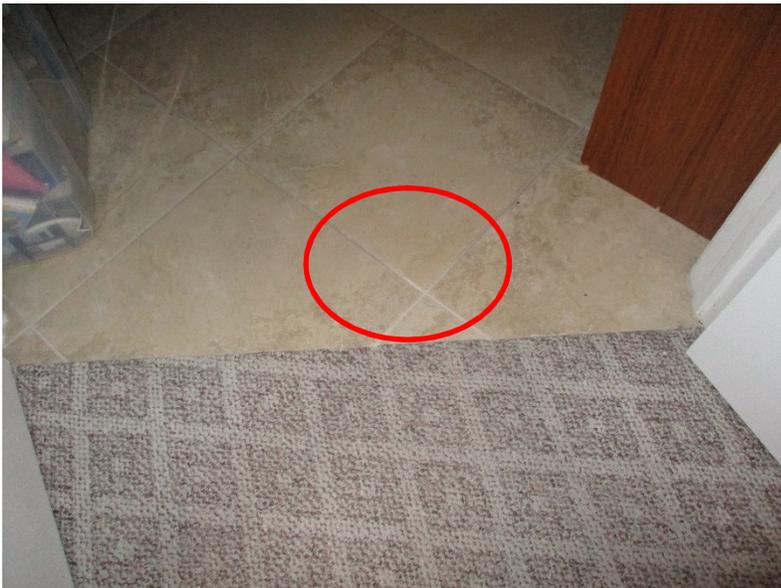
**PHOTOGRAPH #8**

**BUILDING 26  
UNIT #2616**

Contractor has cleaned area of spilled paint at owners' tiles.

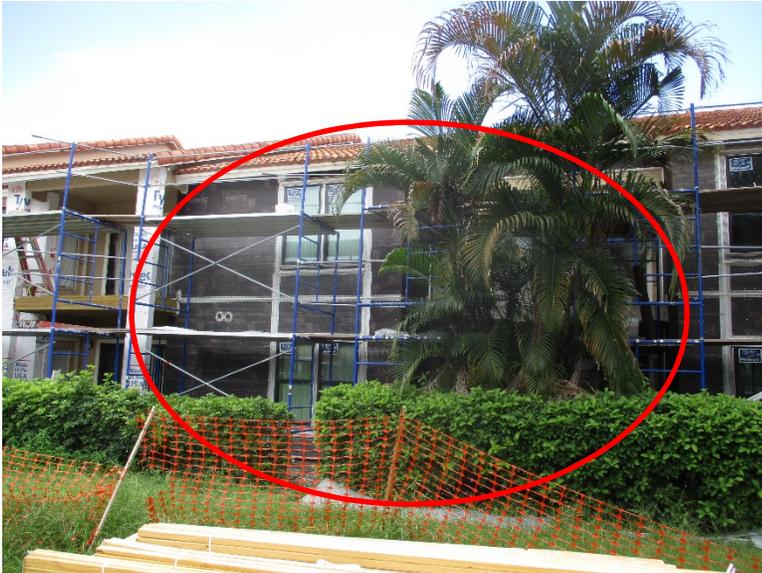
**PHOTOGRAPH #9**

**BUILDING 27  
SECTION F**

Stucco sub-contractor continuing to apply new lathing and stucco accessories.

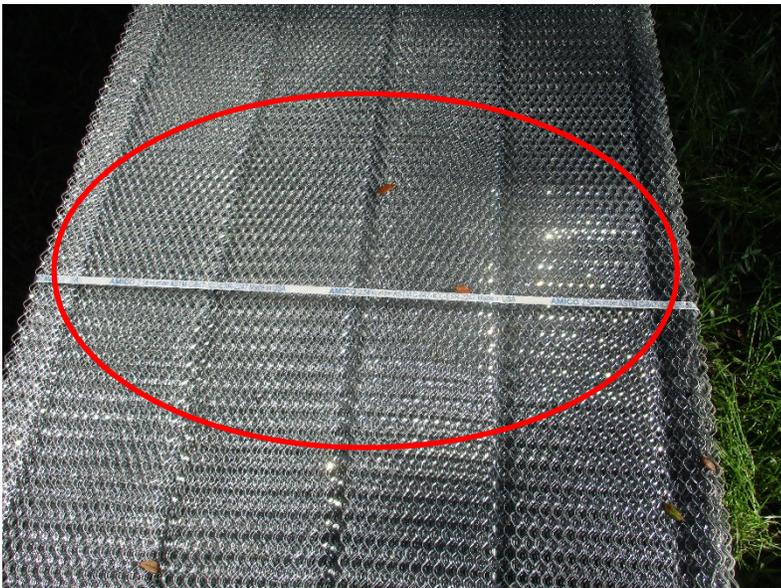
**PHOTOGRAPH #10**

**BUILDING 27  
SECTION F**

Metal lathing now being applied is the originally submitted and approved product.

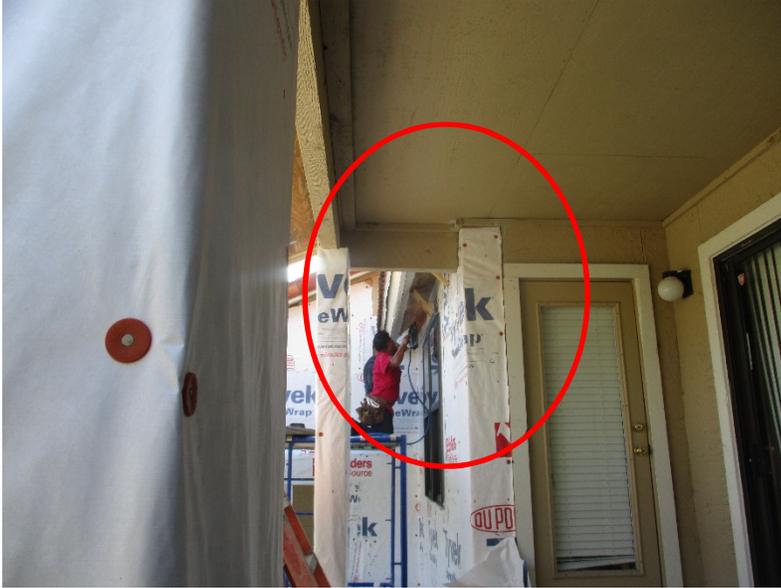
**PHOTOGRAPH #11**

**BUILDING 27  
SECTION F**

Contractor is installing new soffit wood with vented soffit screen.

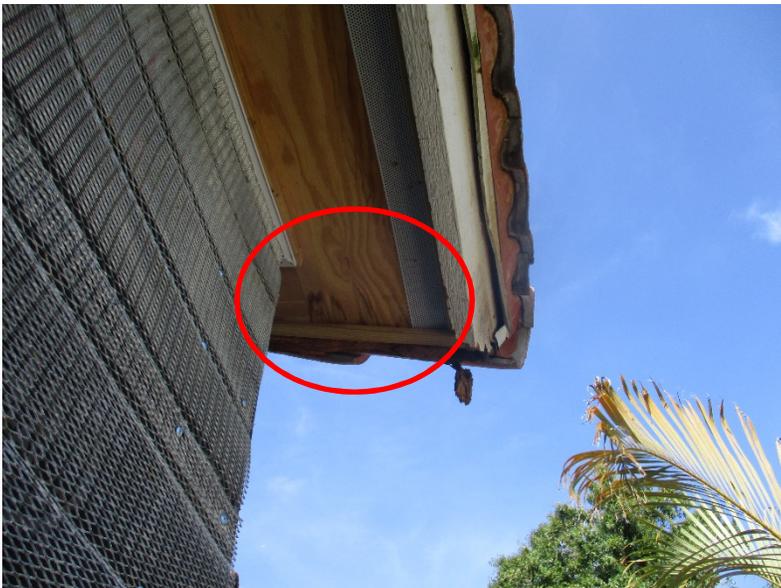
**PHOTOGRAPH #12**

**BUILDING 27  
SECTION F**

Newly installed soffit wood appears to be stained from roof leaks.

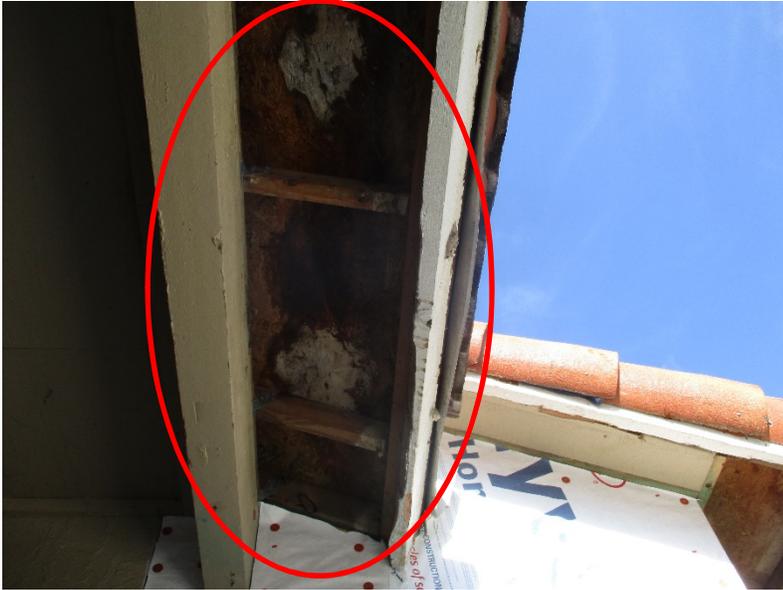
**PHOTOGRAPH #13**

**BUILDING 27  
SECTION E**

Pre-existing roof leaking and damaged roof sheathing is to be repaired by owners roofing contractors.

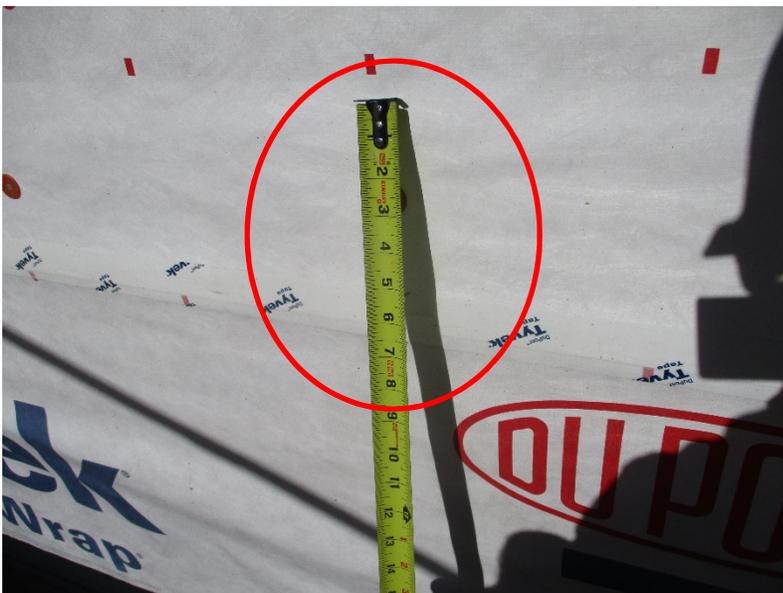
**PHOTOGRAPH #14**

**BUILDING 27  
SECTION D**

Tyvek WRB checked for overlapping and taping of seams.

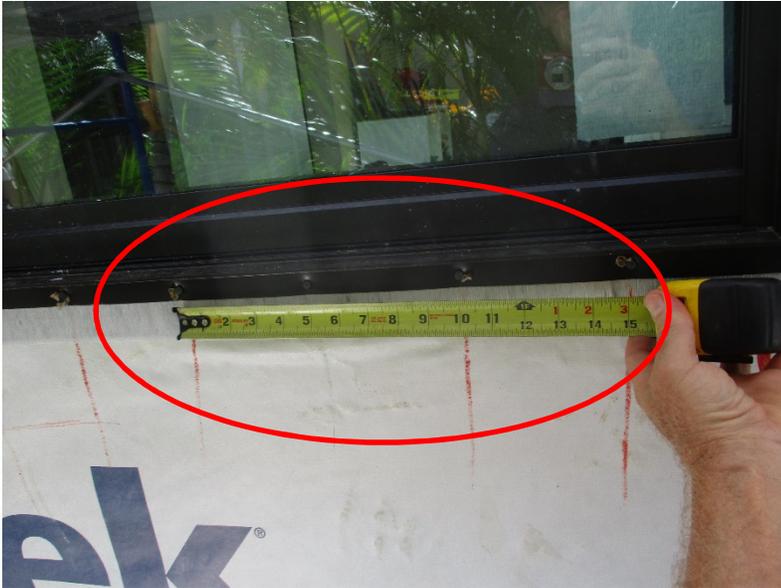
**PHOTOGRAPH #15**

**BUILDING 27  
SECTION D**

Window fin nailing and Dupont flashings checked at newly installed PGT windows.

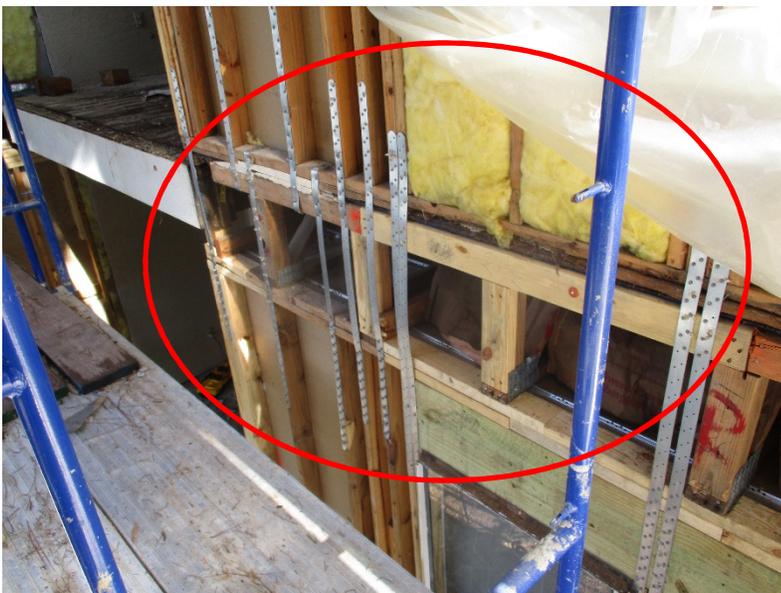
**PHOTOGRAPH #16**

**BUILDING 27  
SECTION C**

Contractor has performed framing repairs and strapping.

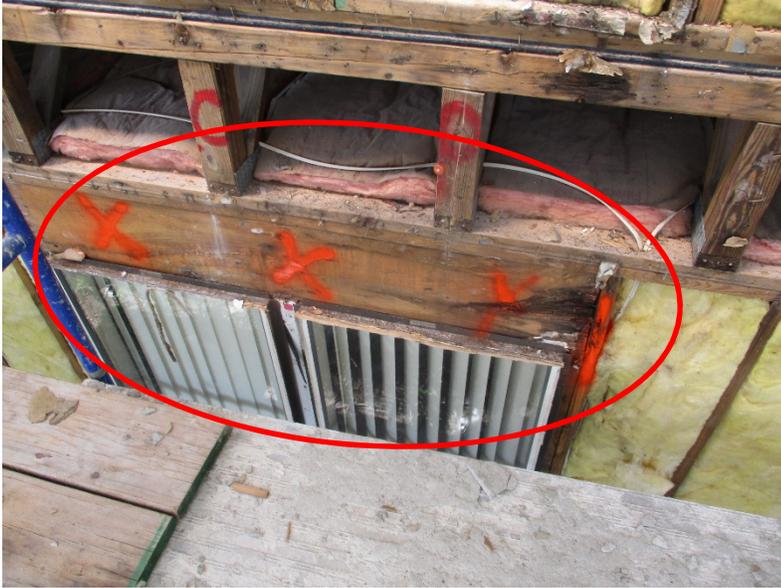
**PHOTOGRAPH #17**

**BUILDING 27  
SECTION B**

Damaged framing being marked for repairs.

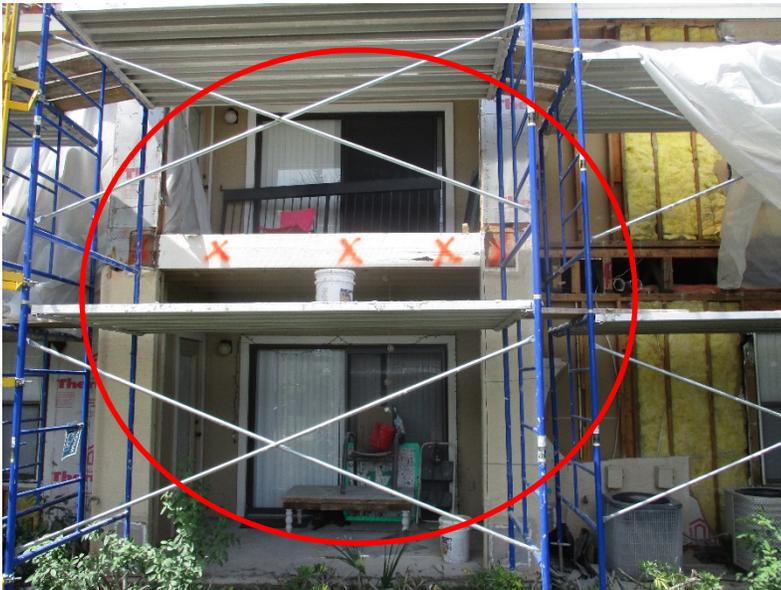
**PHOTOGRAPH #18**

**BUILDING 27  
SECTION B**

Damaged framing being marked for repairs.

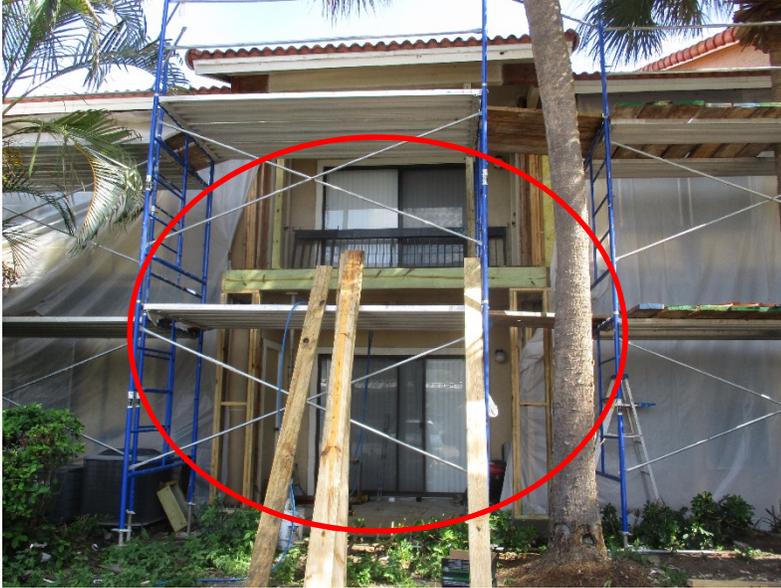
**PHOTOGRAPH #19**

**BUILDINGS 27  
SECTION B**

Contractor has performed repairs at damaged C1A type balcony.

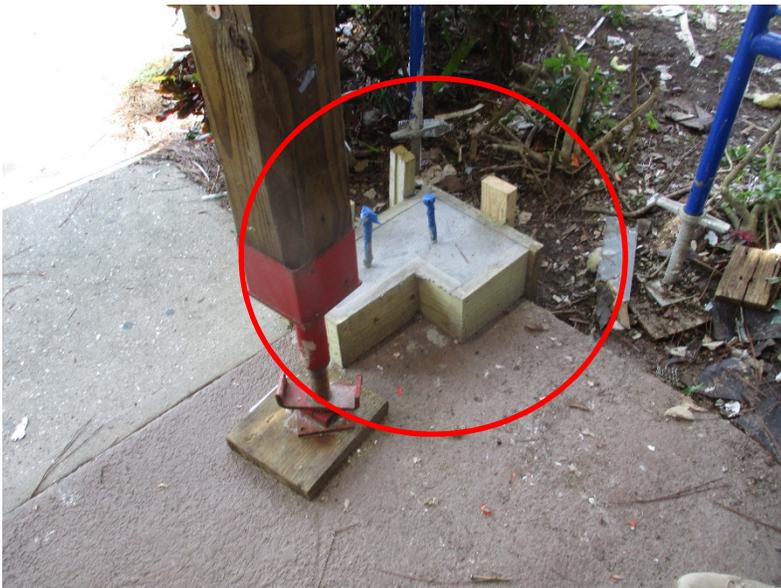
**PHOTOGRAPH #20**

**BUILDINGS 27  
SECTION B**

Contractor has poured new concrete pedestal for breezeway column.

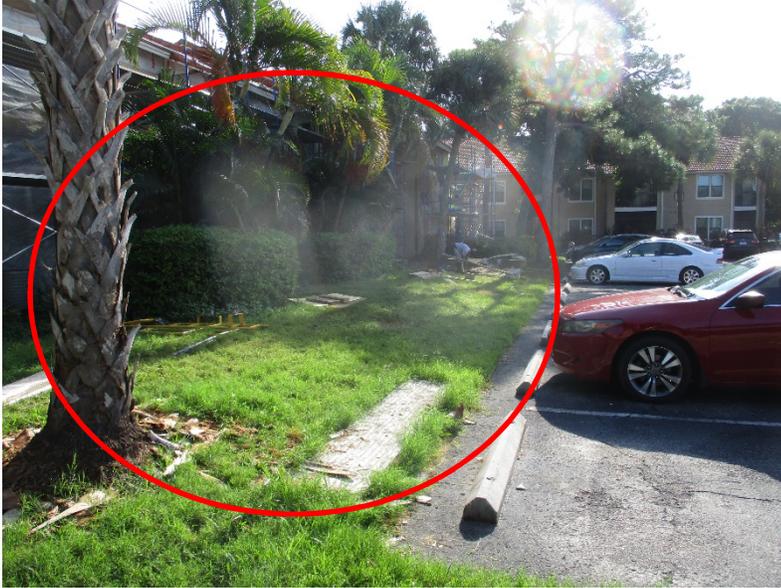
**PHOTOGRAPH #21**

**BUILDINGS 27  
SECTION A**

Construction fencing has not been provided.
