**PHOTOGRAPHS**

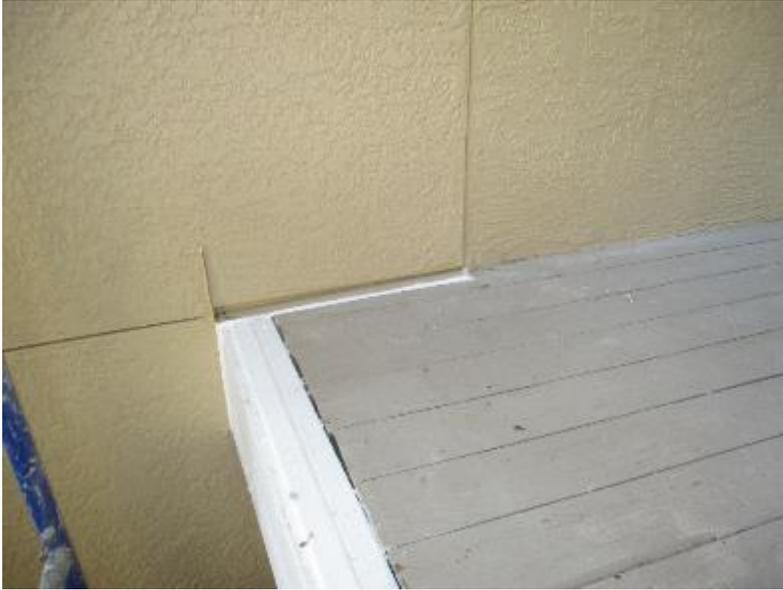
**PHOTOGRAPH #1**

**BUILDING 27  
SECTION F**

Contractor has installed sealants at balcony deck kick out flashing transitions.

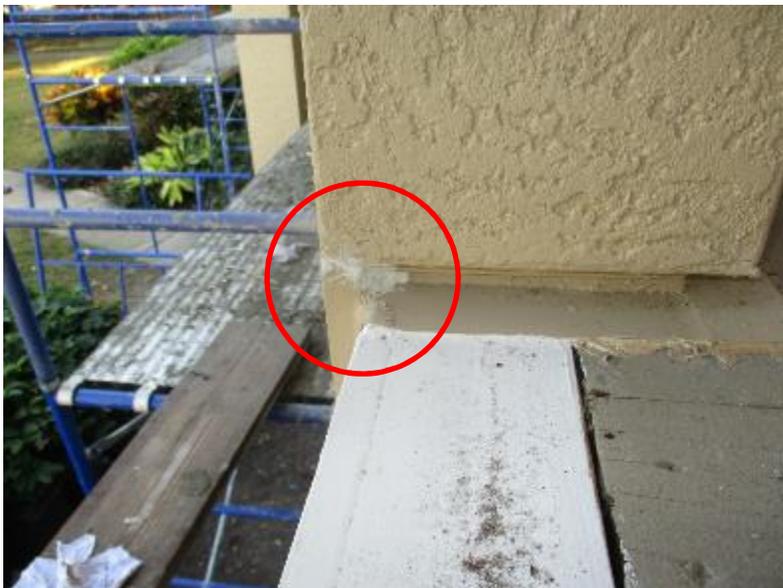
**PHOTOGRAPH #2**

**BUILDING 27  
SECTION F**

Contractor has installed sealants at balcony deck kick out flashing transitions.

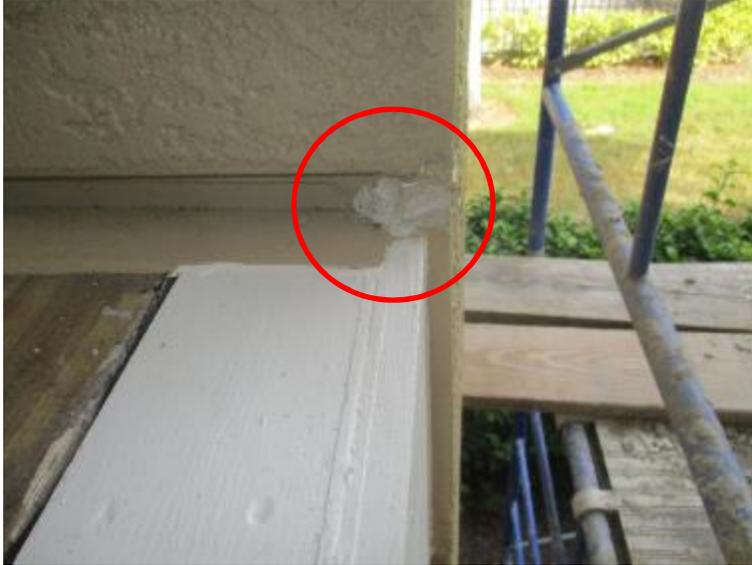
**PHOTOGRAPH #3**

**BUILDING 27  
SECTION F**

Contractor has installed sealants at balcony deck kick out flashing transitions.

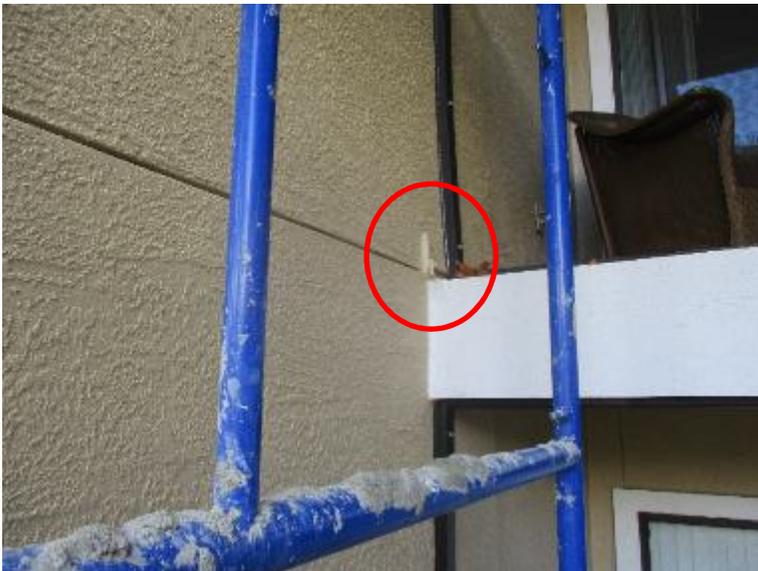
**PHOTOGRAPH #4**

**BUILDING 27  
SECTION G**

Contractor has installed sealants at balcony deck kick out flashing transitions.

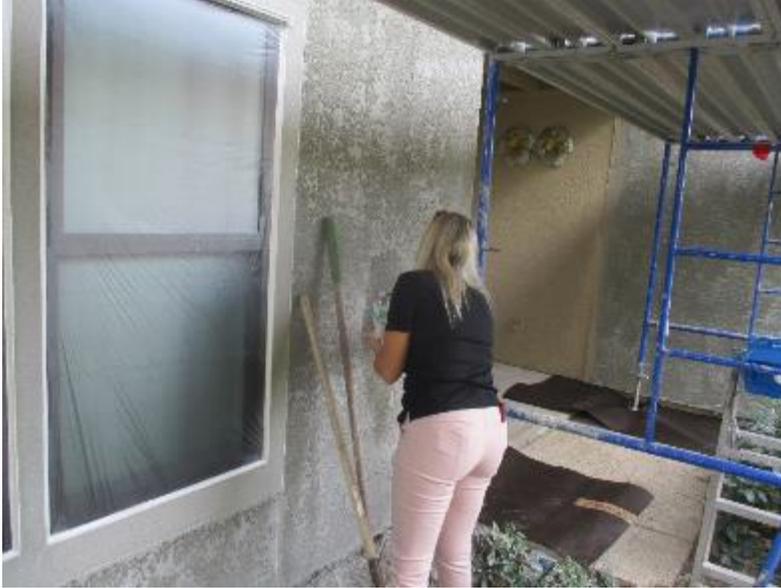
**PHOTOGRAPH #5**

**BUILDING 27  
SECTION E**

Florida Paint representative performed PH tests at new stucco for approval to proceed with paint application.

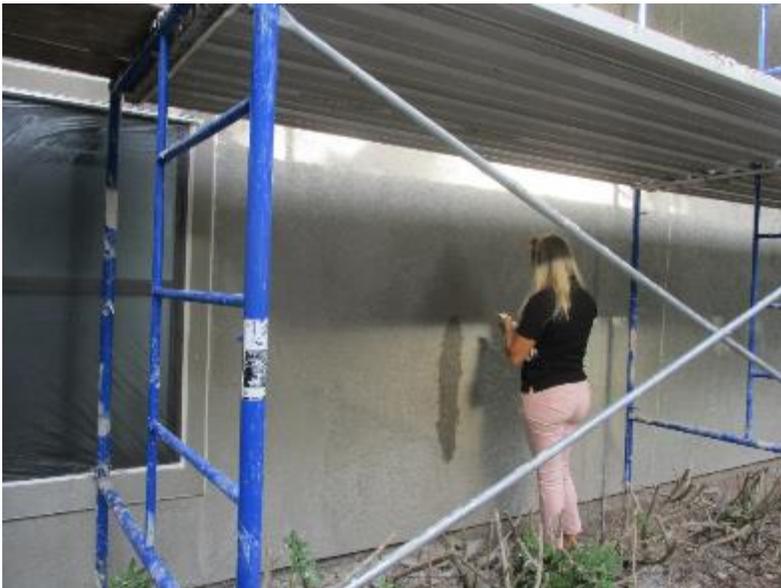
**PHOTOGRAPH #6**

**BUILDING 27  
SECTION D**

Florida Paint representative performed PH tests at new stucco for approval to proceed with paint application.

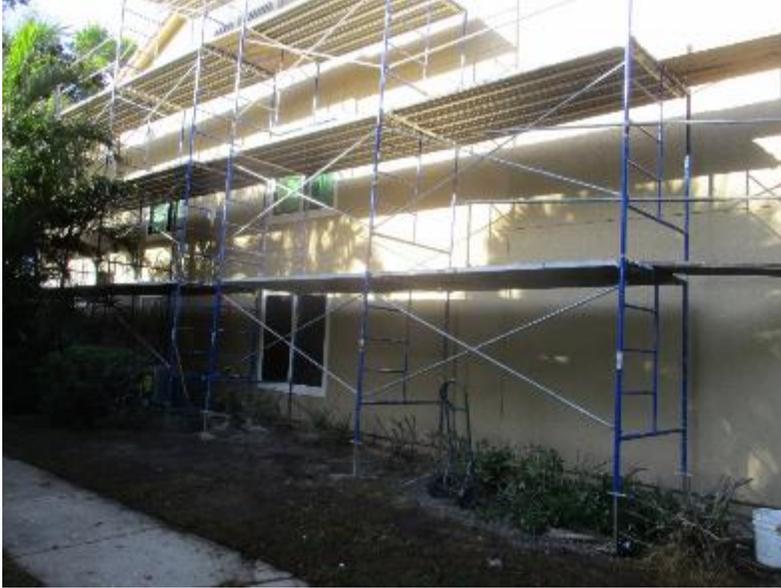
**PHOTOGRAPH #7**

**BUILDING 27  
SECTION D**

Contractor has primed and painted new stucco.

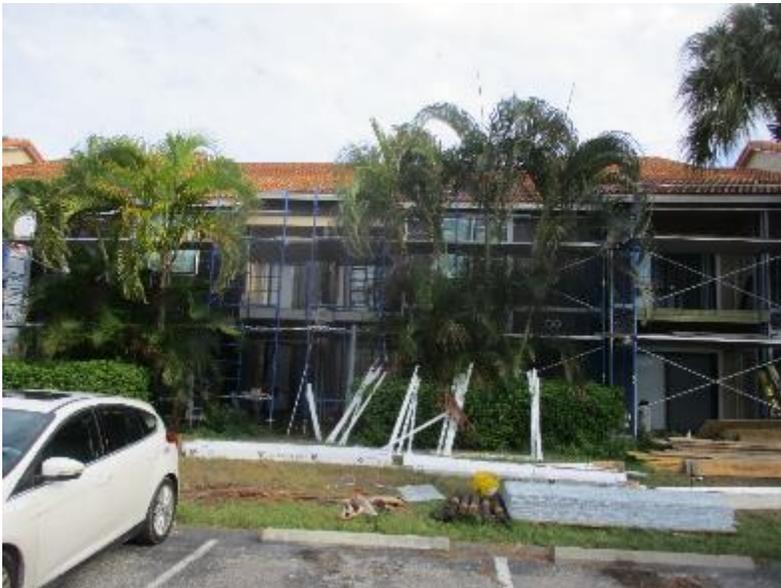
**PHOTOGRAPH #8**

**BUILDING 27  
SECTION B**

Sub-contractor in process of applying stucco lath and stucco accessories.

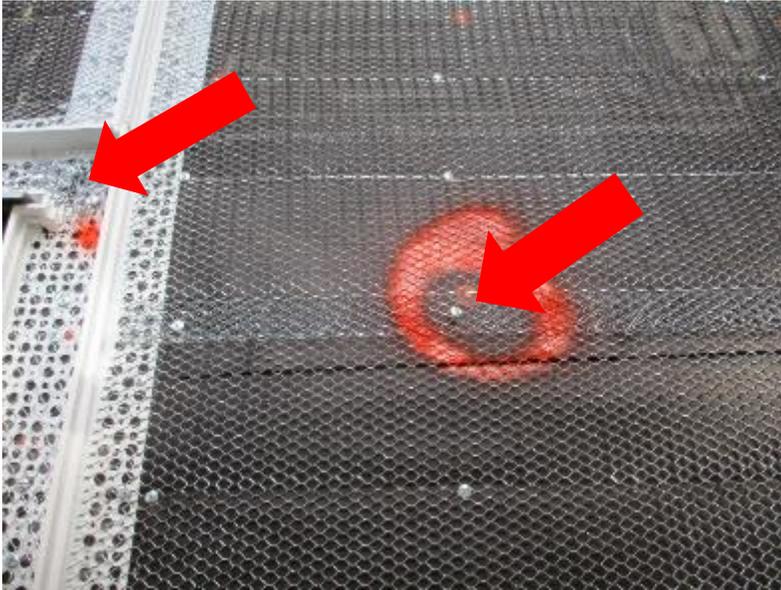
**PHOTOGRAPH #9**

**BUILDING 27  
SECTION B**

Fasteners not fully embedded at lath,  
marked for correction.

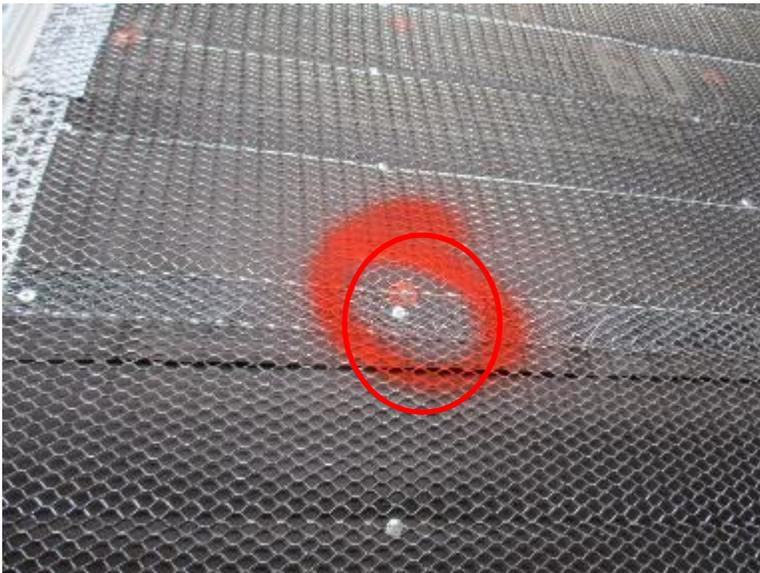
**PHOTOGRAPH #10**

**BUILDING 27  
SECTION B**

Sub-contractor made corrections to  
fasteners not fully embedded at lath.

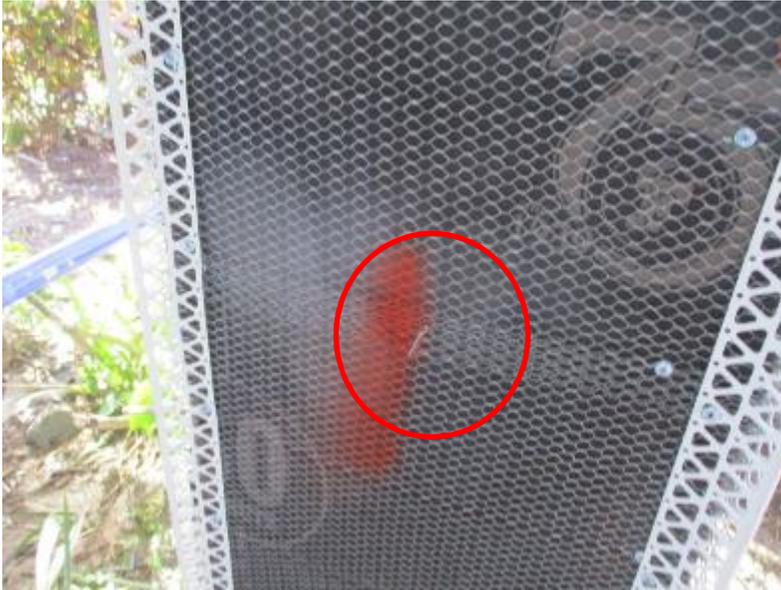
**PHOTOGRAPH #11**

**BUILDING 27  
SECTION B**

Sub -contractor made corrections at lath overlapping where it was not connected with tie wire.

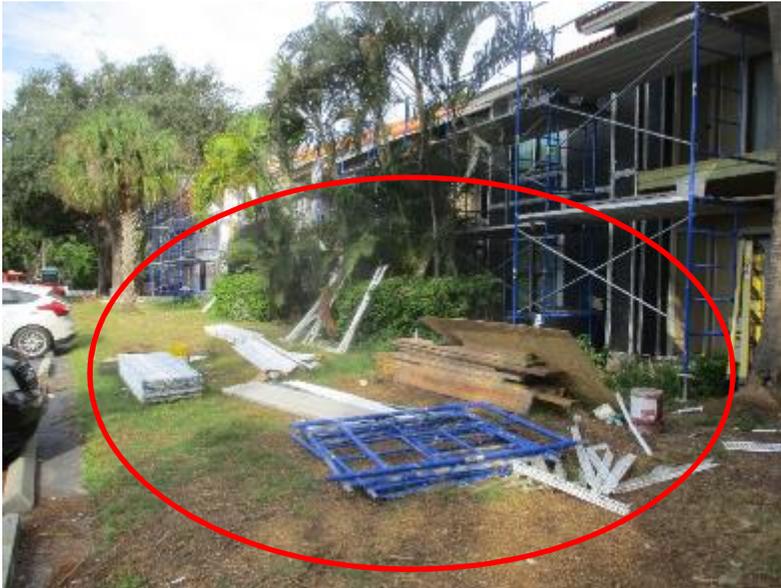
**PHOTOGRAPH #12**

**BUILDING 27  
SECTION B**

Contractor fencing not in place.

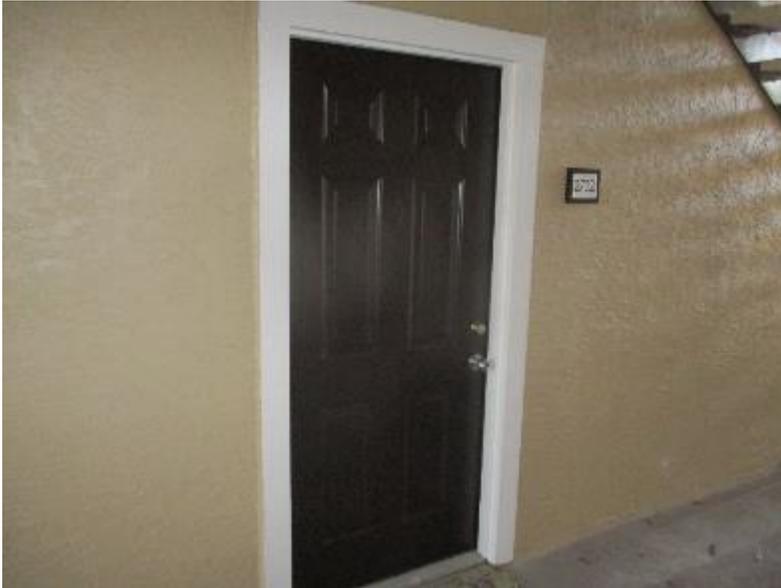
**PHOTOGRAPH #13**

**BUILDING 27  
SECTION A-BREEZWAY**

Contractor has finish painted front doors.

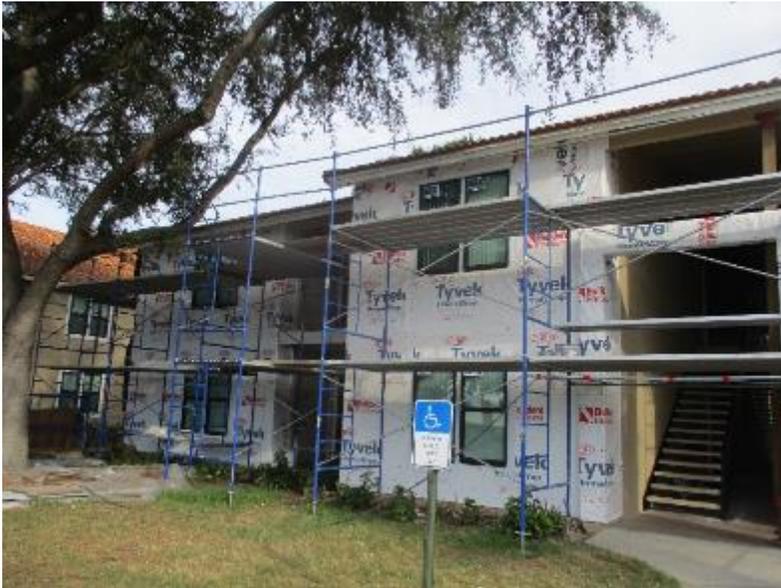
**PHOTOGRAPH #14**

**BUILDING 27  
SECTION A**

Contractor has installed Tyvek HomeWrap, DuPont flashings and new PGT windows.

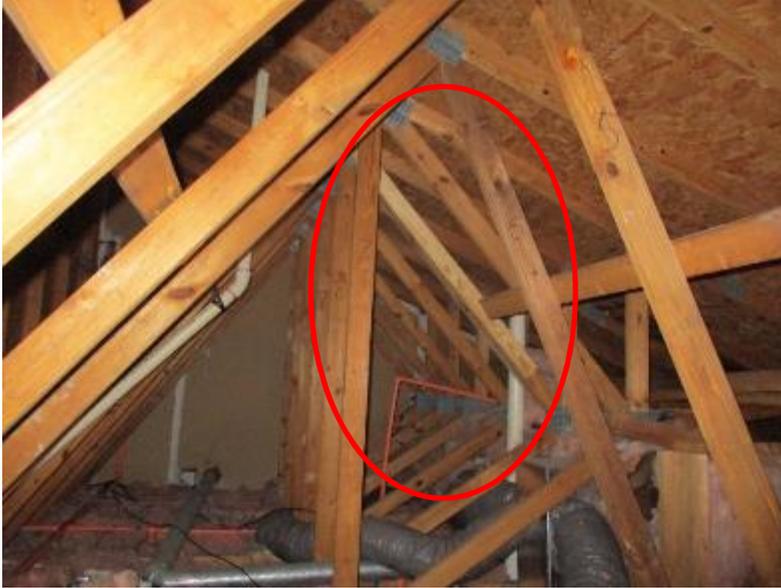
**PHOTOGRAPH #15**

**BUILDING 10  
SECTION F – UNIT #1024**

Attic framing and firewall repairs reviewed and quantified with Contractor.

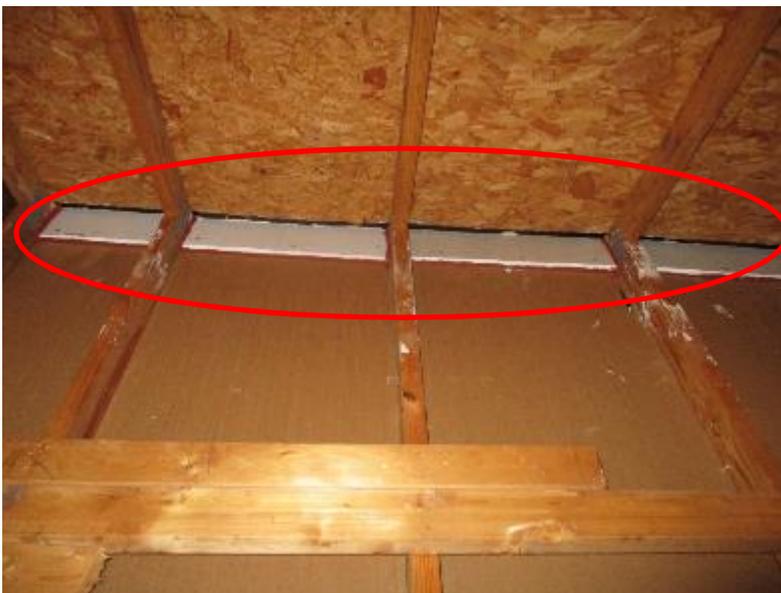
**PHOTOGRAPH #16**

**BUILDING 10  
SECTION F – UNIT #1024**

Attic framing and firewall repairs reviewed and quantified with Contractor.

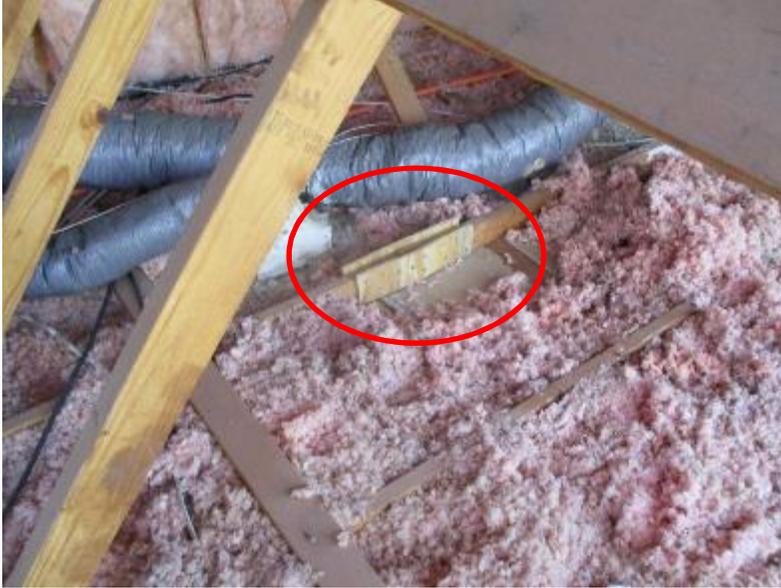
**PHOTOGRAPH #17**

**BUILDING 10  
SECTION D – UNIT #1028**

Attic framing and firewall repairs reviewed and quantified with Contractor.

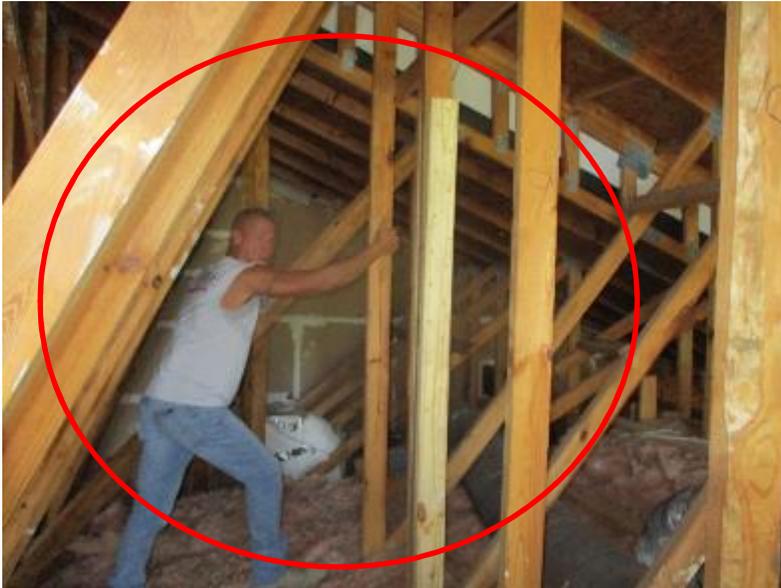
**PHOTOGRAPH #18**

**BUILDING 10  
SECTION D – UNIT #1028**

Attic framing and firewall repairs reviewed and quantified with Contractor.

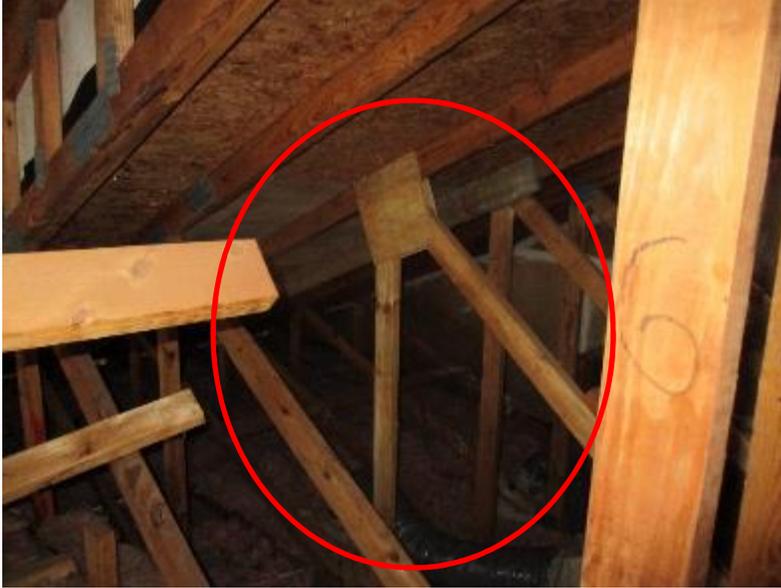
**PHOTOGRAPH #19**

**BUILDING 10  
SECTION D – UNIT #1027**

Attic framing and firewall repairs reviewed and quantified with Contractor.

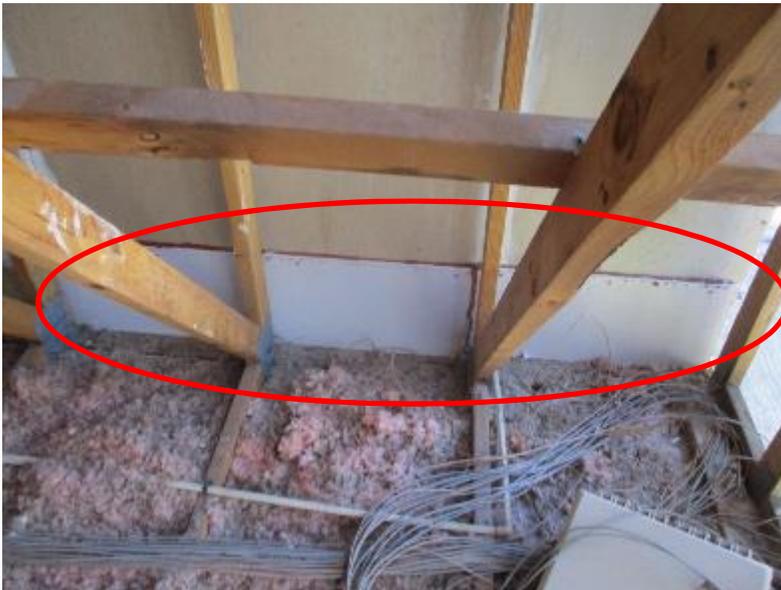
**PHOTOGRAPH #20**

**BUILDING 10  
SECTION D – UNIT #1027**

Attic framing and firewall repairs reviewed and quantified with Contractor.

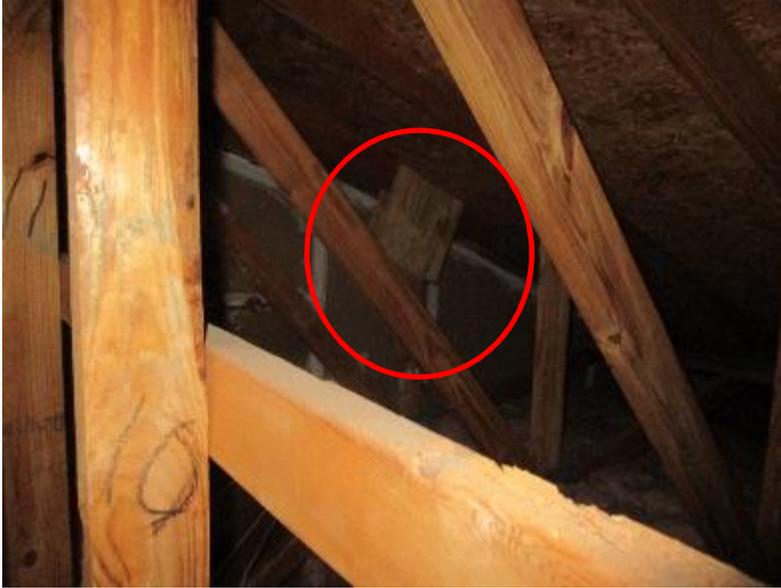
**PHOTOGRAPH #21**

**BUILDING 10  
SECTION B – UNIT #1025**

Attic framing and firewall repairs reviewed and quantified with Contractor.

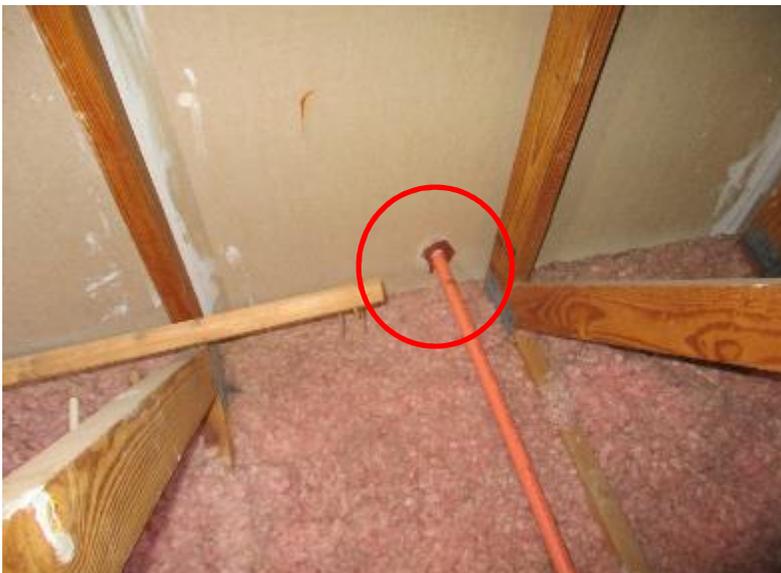
**PHOTOGRAPH #22**

**BUILDING 10  
SECTION B – UNIT #1025**

Attic framing and firewall repairs reviewed and quantified with Contractor.

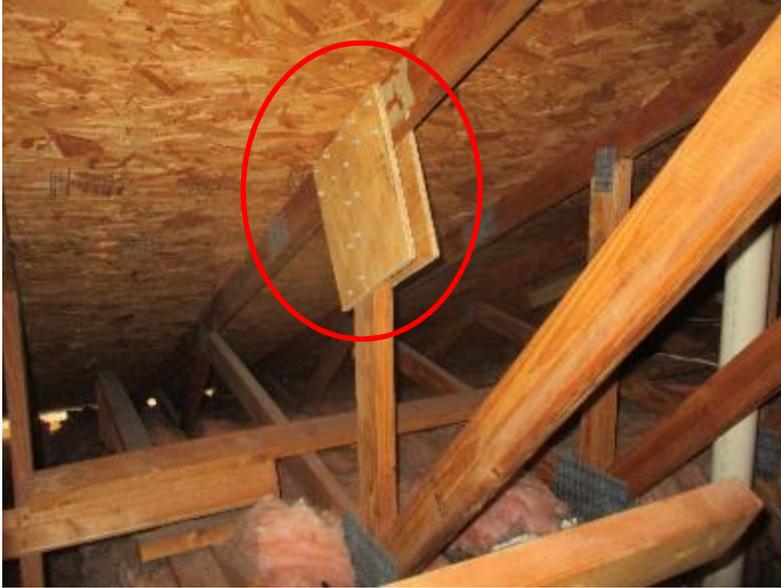
**PHOTOGRAPH #23**

**BUILDING 10  
SECTION B – UNIT #1026**

Attic framing and firewall repairs reviewed and quantified with Contractor.

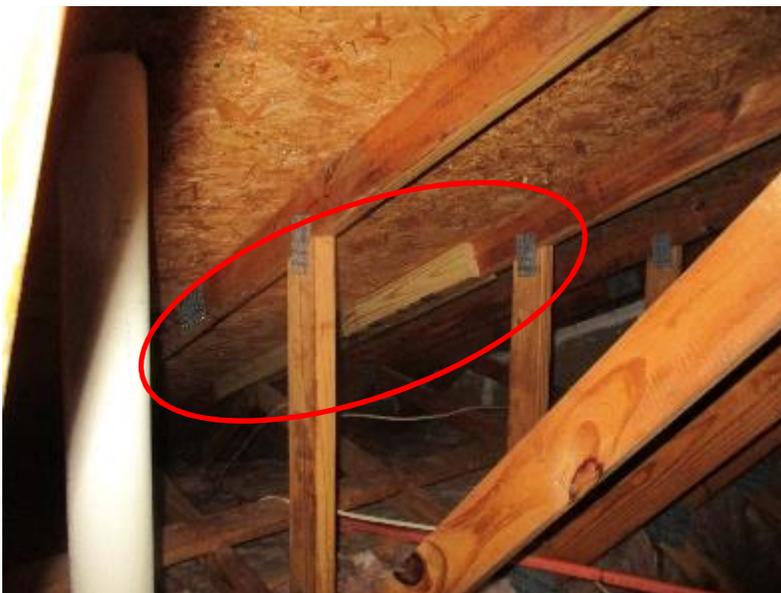
**PHOTOGRAPH #24**

**BUILDING 10  
SECTION B – UNIT #1026**

Attic framing and firewall repairs reviewed and quantified with Contractor.

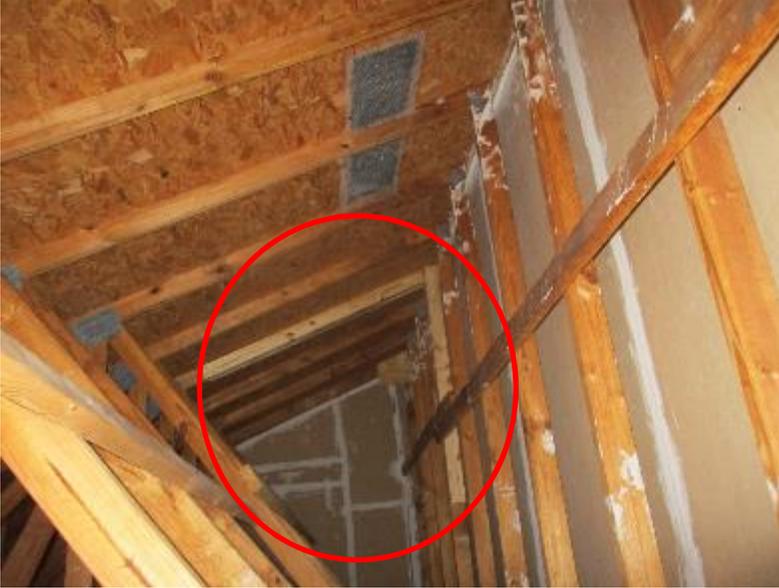
**PHOTOGRAPH #25**

**BUILDING 10  
SECTION F – UNIT #1023**

Attic framing and firewall repairs reviewed and quantified with Contractor.

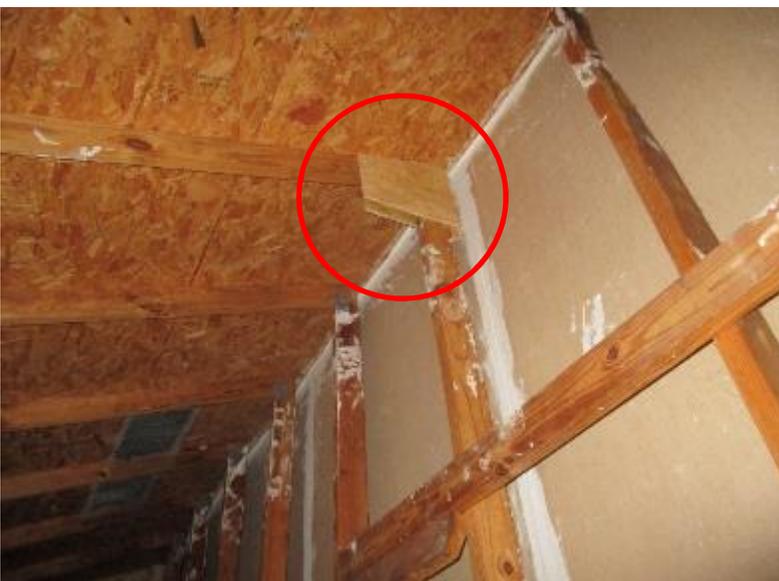
**PHOTOGRAPH #26**

**BUILDING 10  
SECTION F – UNIT #1023**

Attic framing and firewall repairs reviewed and quantified with Contractor.

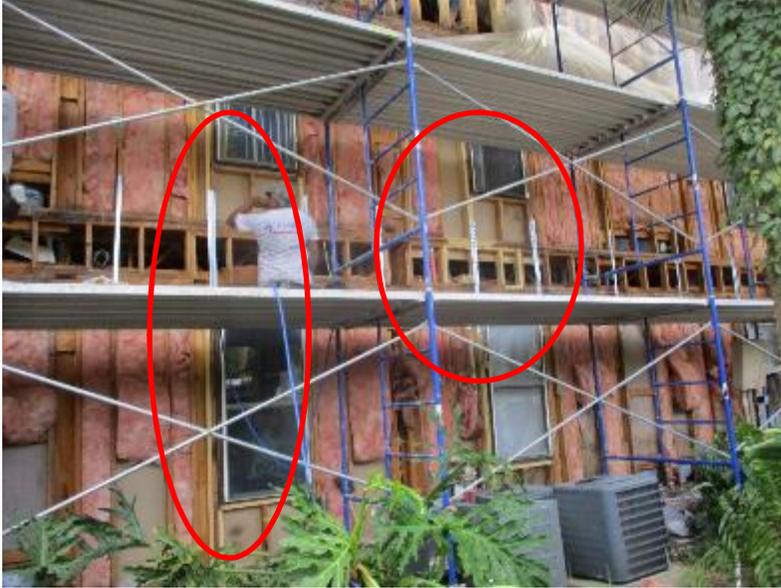
**PHOTOGRAPH #27**

**BUILDING 10  
SECTION D**

Contractor has performed repairs at framing studs, top plates, sub floor and window headers.

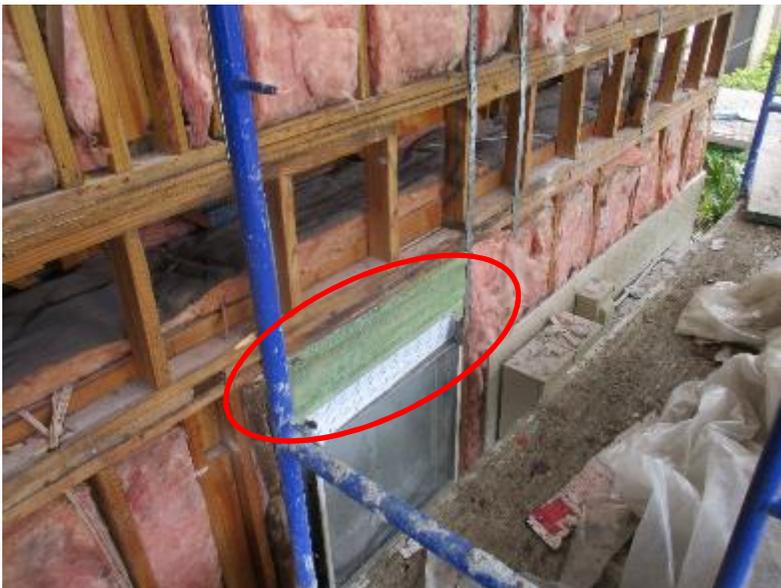
**PHOTOGRAPH #28**

**BUILDING 10  
SECTION D**

Contractor has performed repairs at framing studs, top plates, sub floor and window headers

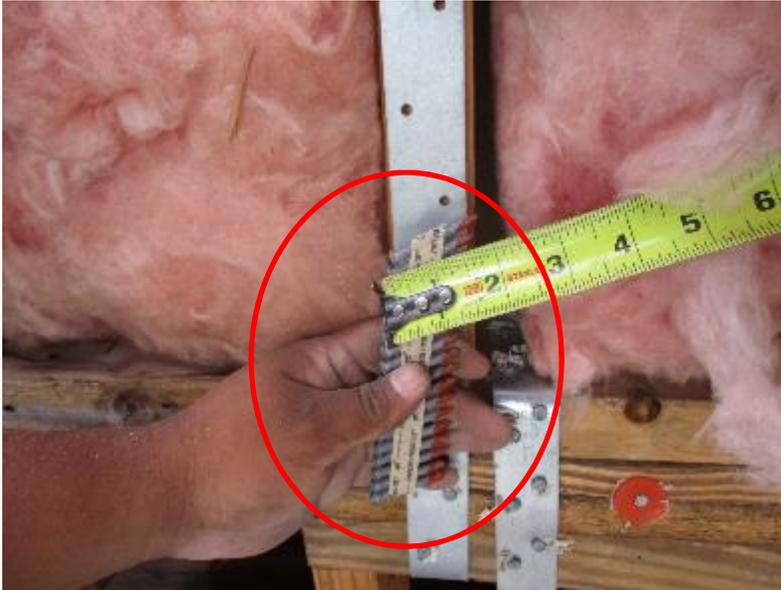
**PHOTOGRAPH #29**

**BUILDING 10  
SECTION D**

Simpson Strong – Tie, 10d 1 ½ " nails used for fastening connector straps.

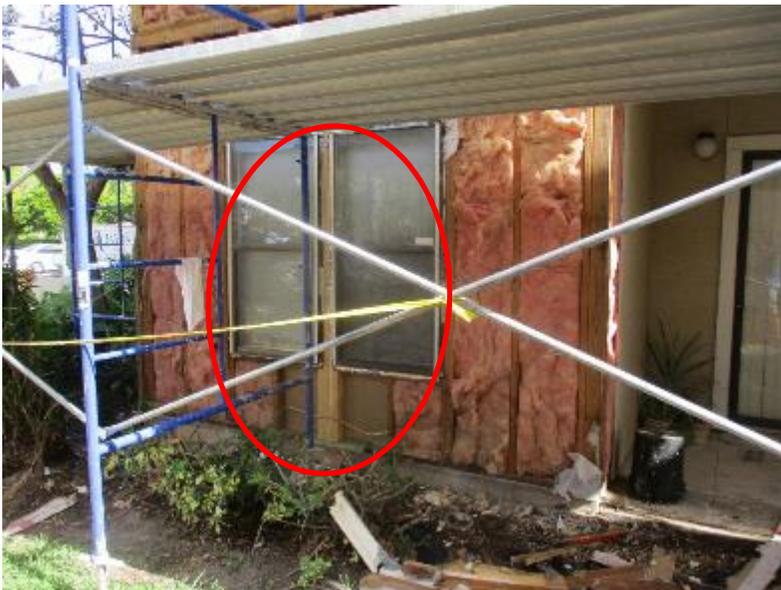
**PHOTOGRAPH #30**

**BUILDING 10  
SECTION E**

Contractor has performed repairs at framing studs, and bottom plate.
