PHOTOGRAPHS

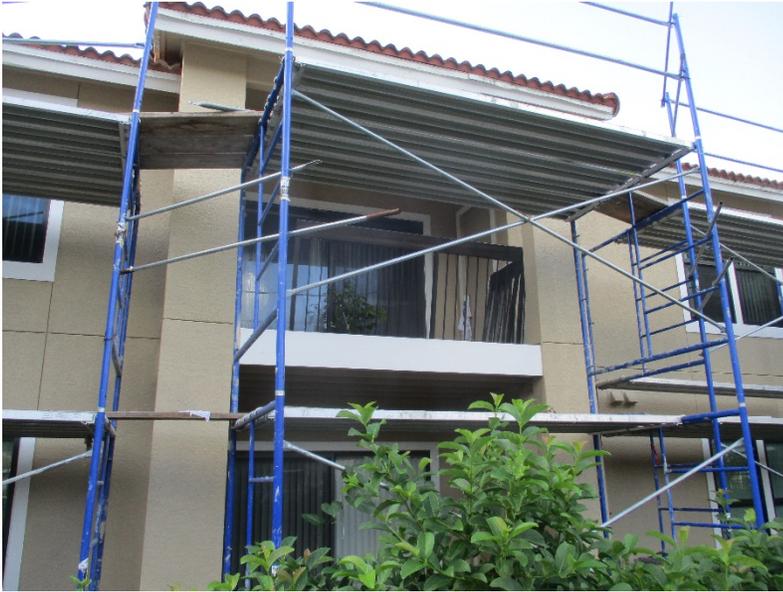
PHOTOGRAPH #1

BUILDING 27 SECTION F

Contractor has loaded re-painted rails onto decks for installation.

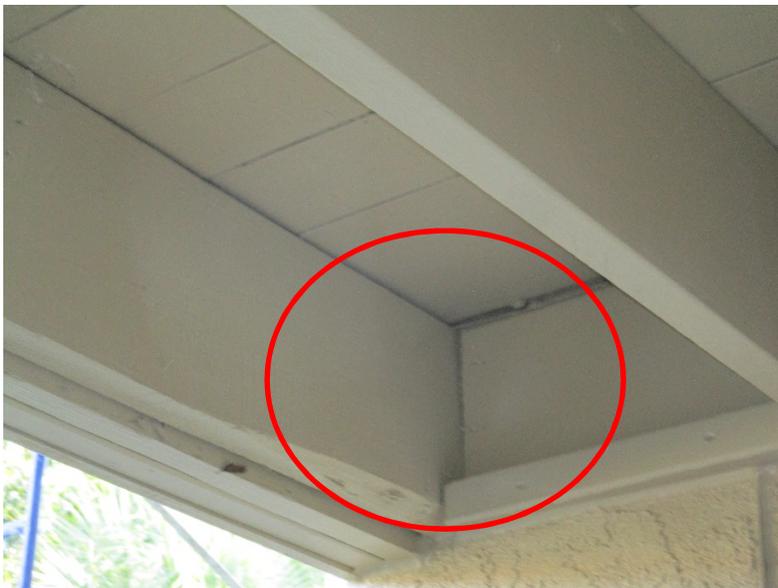
PHOTOGRAPH #2

BUILDING 27 SECTION F

Unit #2718- Simpson Strong -Tie shear clip and screws have not been installed at built up rail beam.

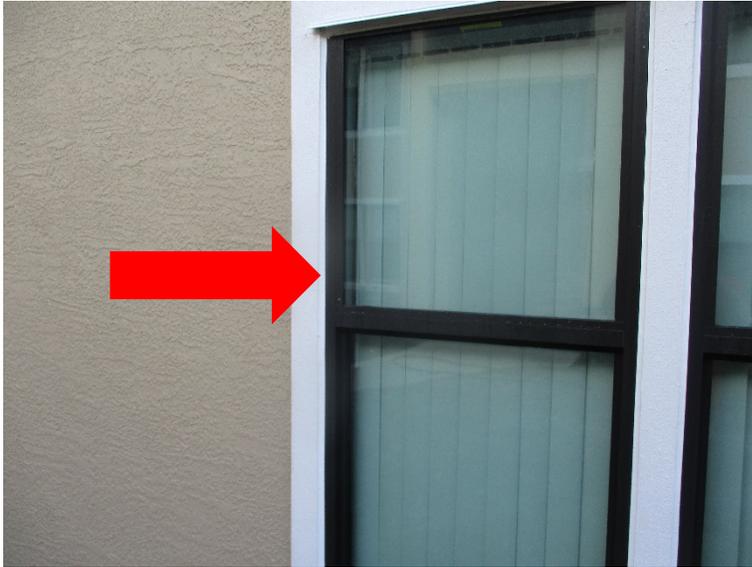
PHOTOGRAPH #3

**BUILDING 27
SECTION F**

Contractor has removed and replaced several window perimeter sealants were adhesion concerns are present.

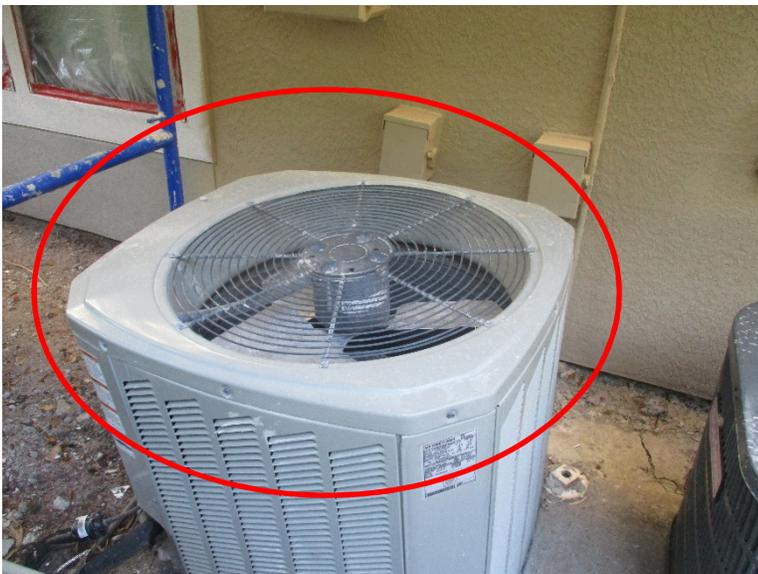
PHOTOGRAPH #4

**BUILDING 27
SECTION D**

Stucco and construction debris on A/C equipment.

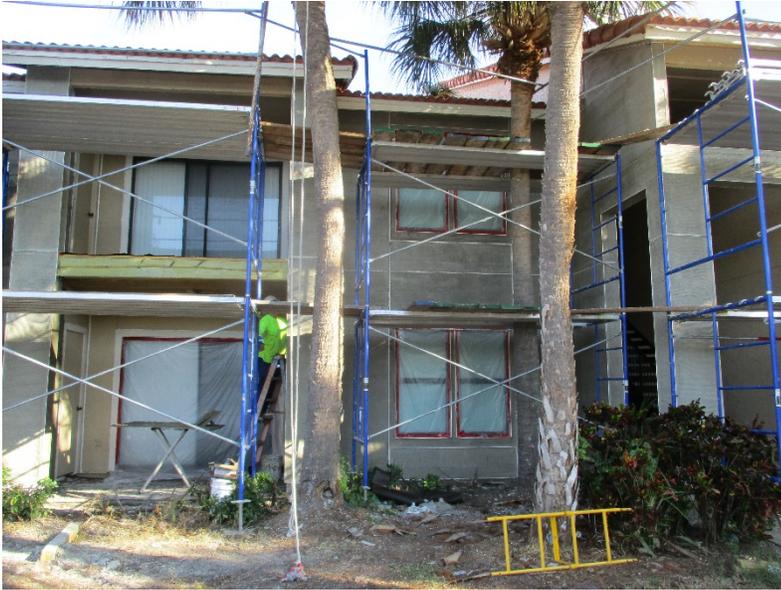
PHOTOGRAPH #5

**BUILDING 27
SECTION B**

Stucco sub-contractor applying scratch and brown coats.

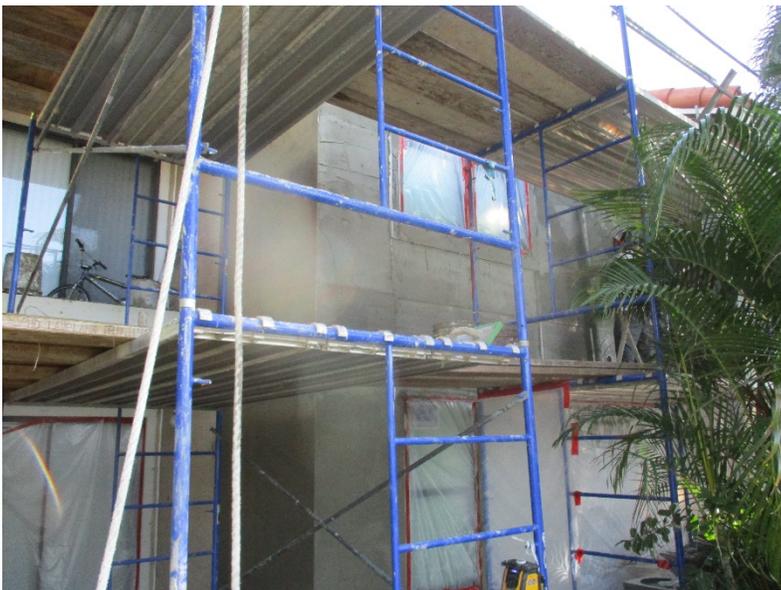
PHOTOGRAPH #6

**BUILDING 27
SECTION B**

Stucco sub-contractor applying scratch and brown coats.

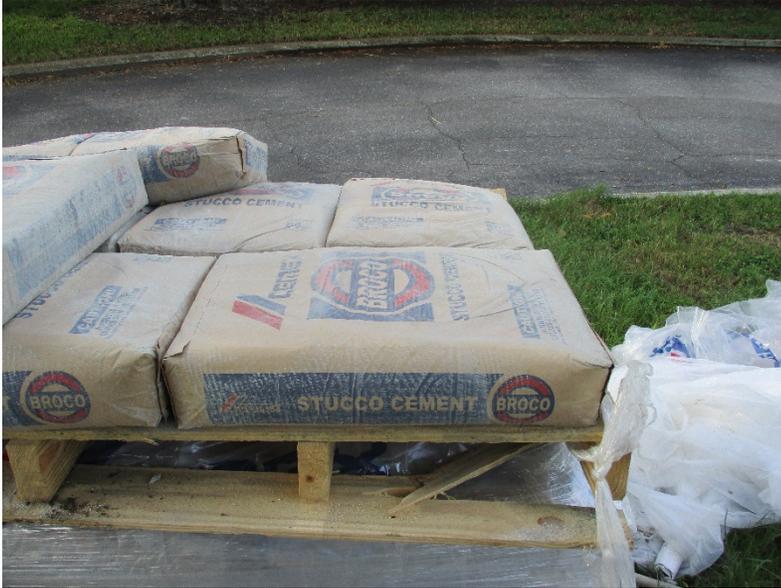
PHOTOGRAPH #7

**BUILDING 27
SECTION B**

Sub-contractor applying Broco stucco cement.

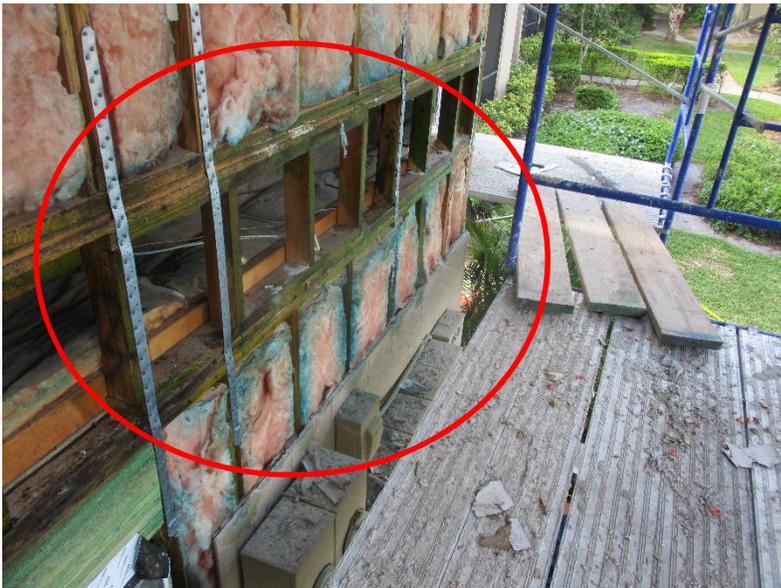
PHOTOGRAPH #8

**BUILDING 10
SECTION D**

Termite control company has applied Bora-Care termite treatment.

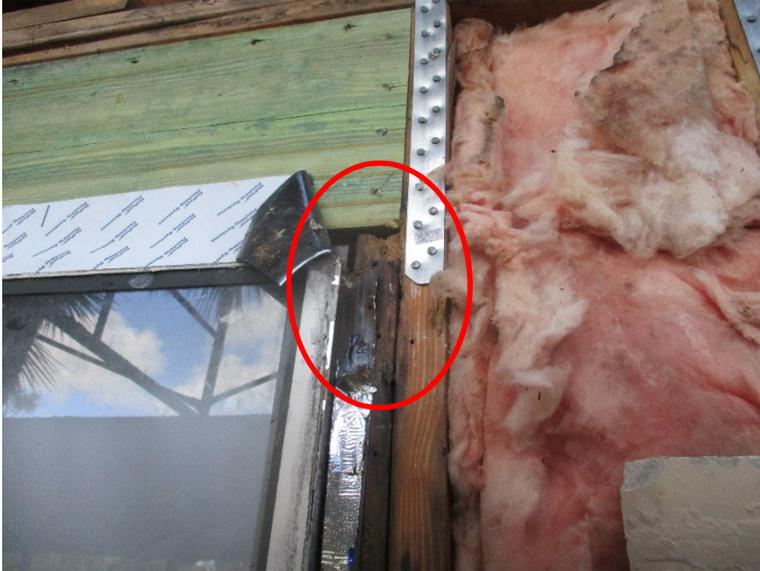
PHOTOGRAPH #9

**BUILDING 10
SECTION D**

Contractor has not removed and replaced damaged framing at windows edge.

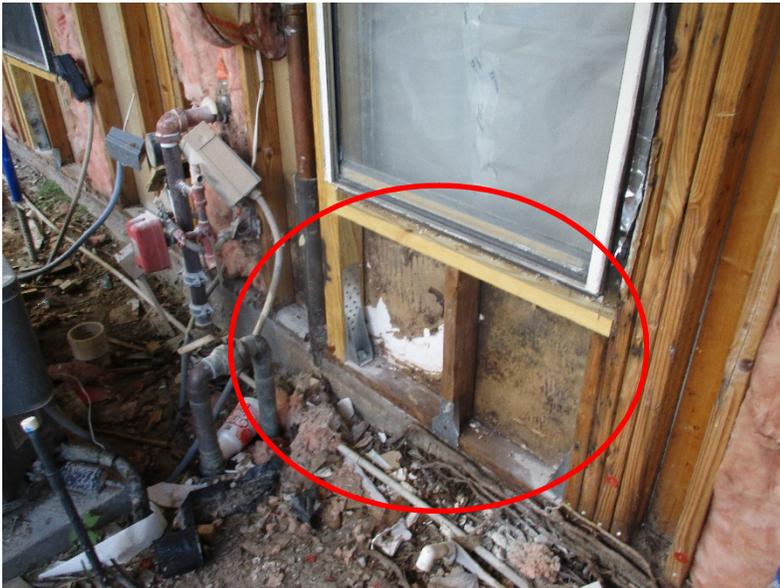
PHOTOGRAPH #10

**BUILDING 10
SECTION D**

Unit #1018- drywall damage exposed when sheathing and insulation removed. Vintage Grand management notified of required repairs not included in current scope of contractor's repairs.

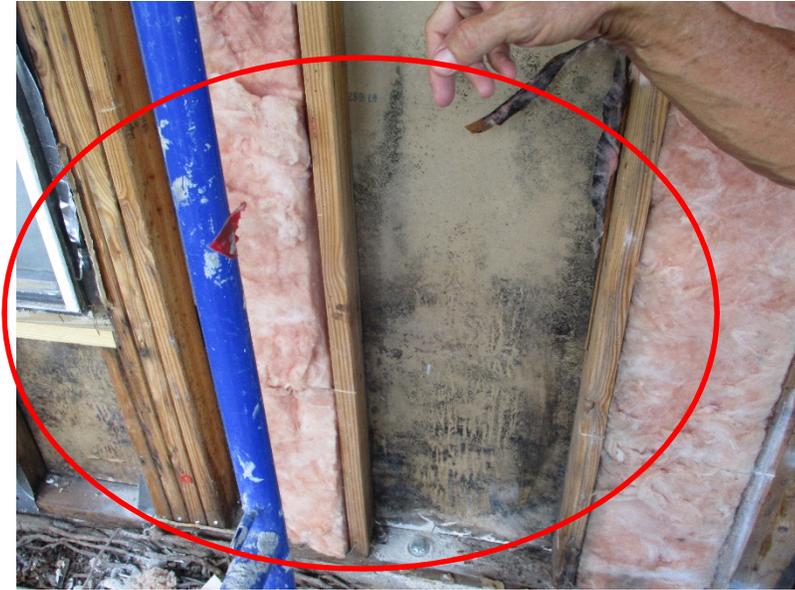
PHOTOGRAPH #11

**BUILDING 10
SECTION D**

Unit #1018- drywall damage exposed when sheathing and insulation removed. Vintage Grand management notified of required repairs not included in current scope of contractor's repairs.

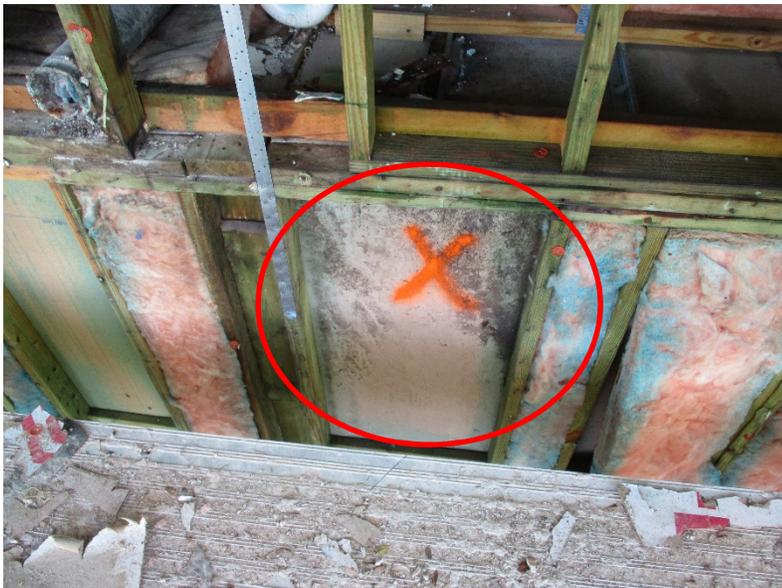
PHOTOGRAPH #12

**BUILDING 10
SECTION D**

Unit #1018- drywall damage exposed when sheathing and insulation removed. Vintage Grand management notified of required repairs not included in current scope of contractor's repairs.

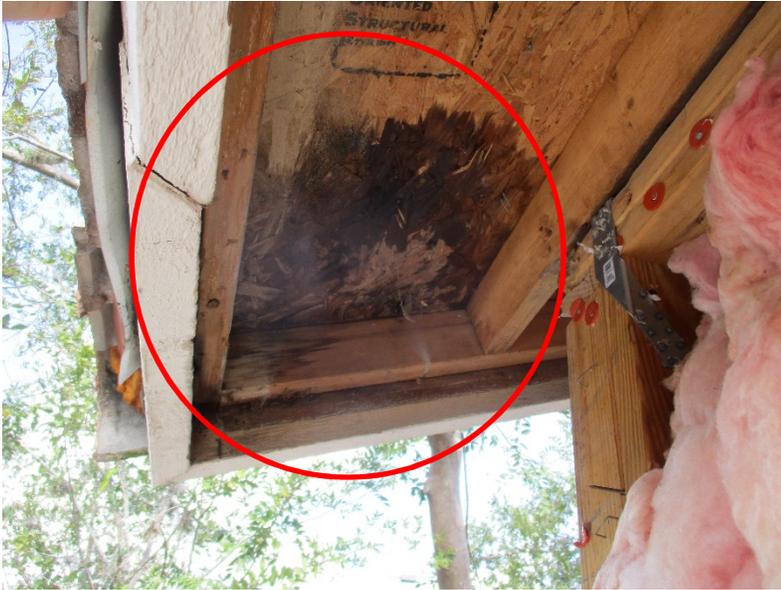
PHOTOGRAPH #13

**BUILDING 10
SECTION E**

Roof sheathing leak damage not covered in scope of repairs.

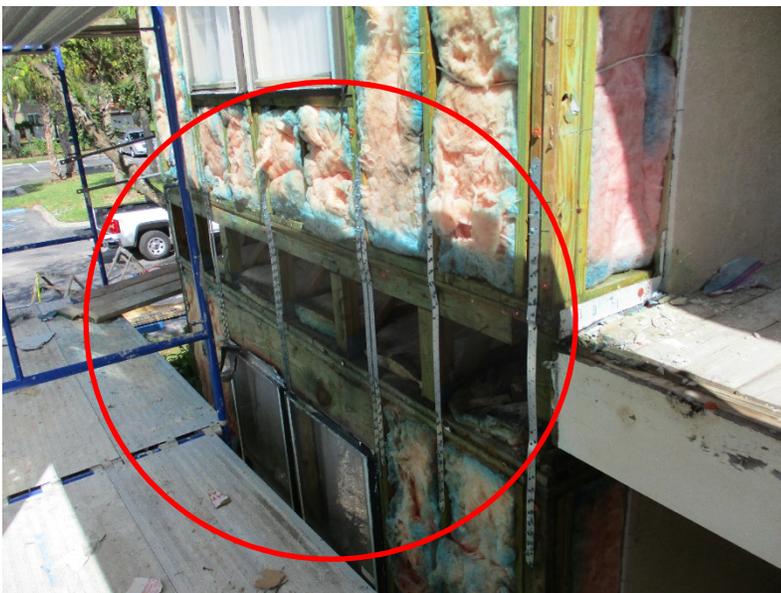
PHOTOGRAPH #14

**BUILDING 10
SECTION E**

Contractor has installed Simpson Strong-Tie strap connectors at framing.

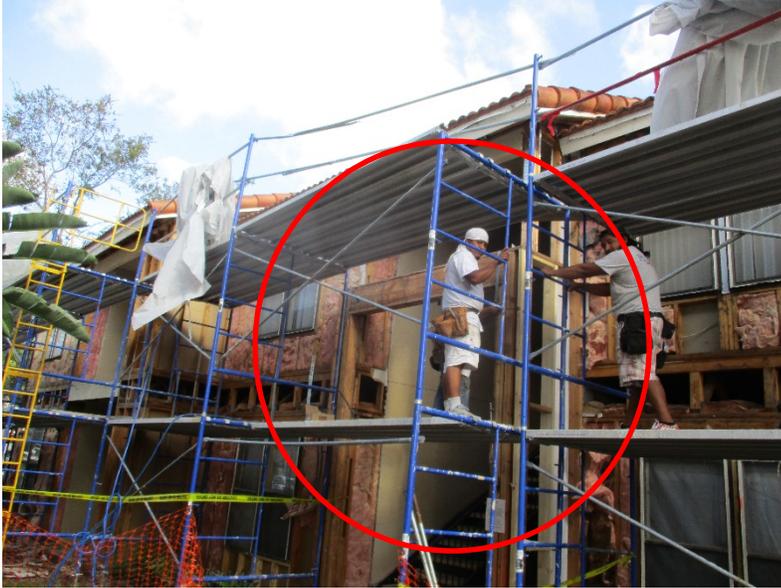
PHOTOGRAPH #15

**BUILDING 10
SECTION E**

Framing repairs and new Simpson Strong-Tie connectors being installed at breezeway area.

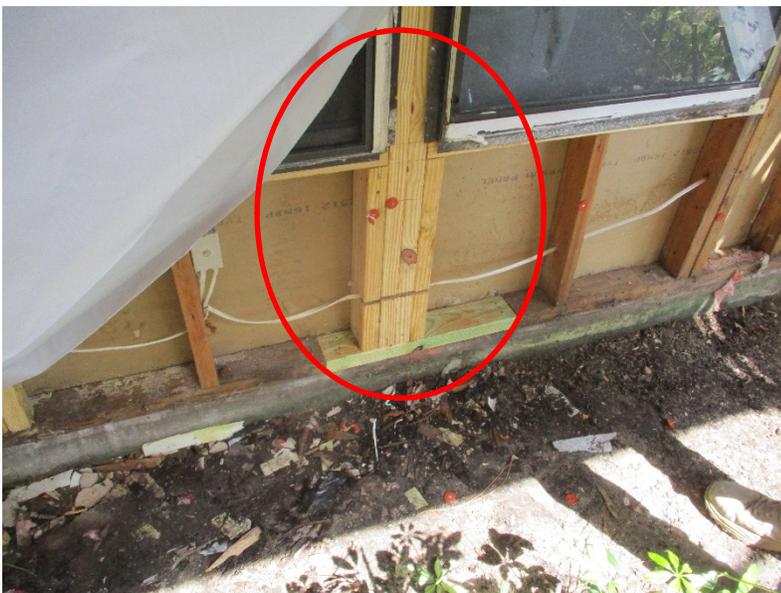
PHOTOGRAPH #16

**BUILDING 10
SECTION F**

Framing repairs reviewed and quantified with contractor.

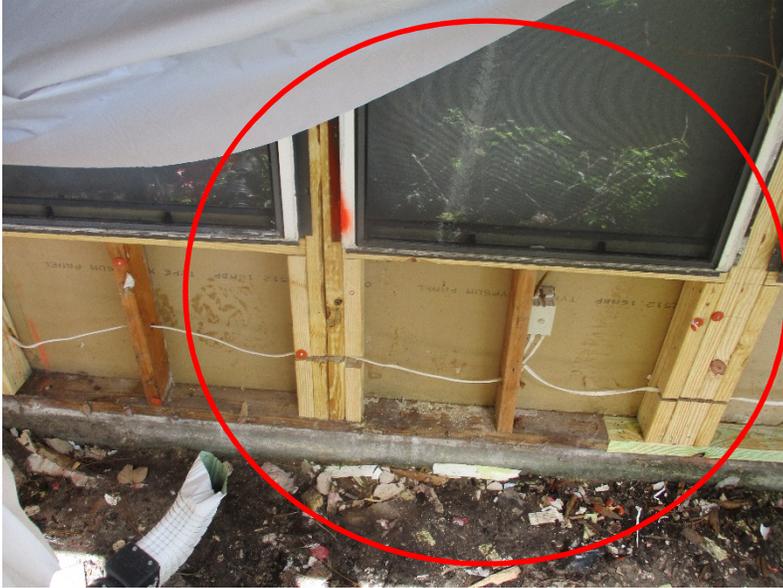
PHOTOGRAPH #17

**BUILDING 10
SECTION F**

Framing repairs reviewed and quantified with contractor.

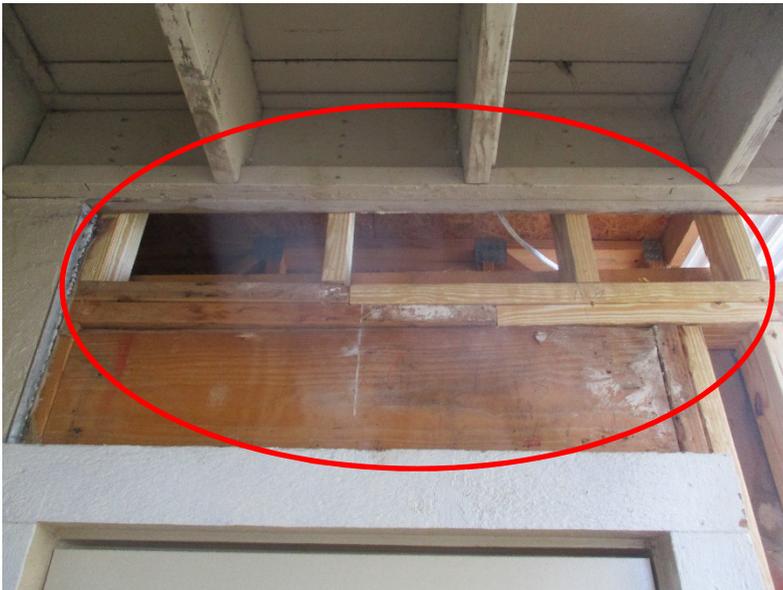
PHOTOGRAPH #18

**BUILDING 10
SECTION F**

Unit #1024 -framing repairs in progress as directed by ESI #1.

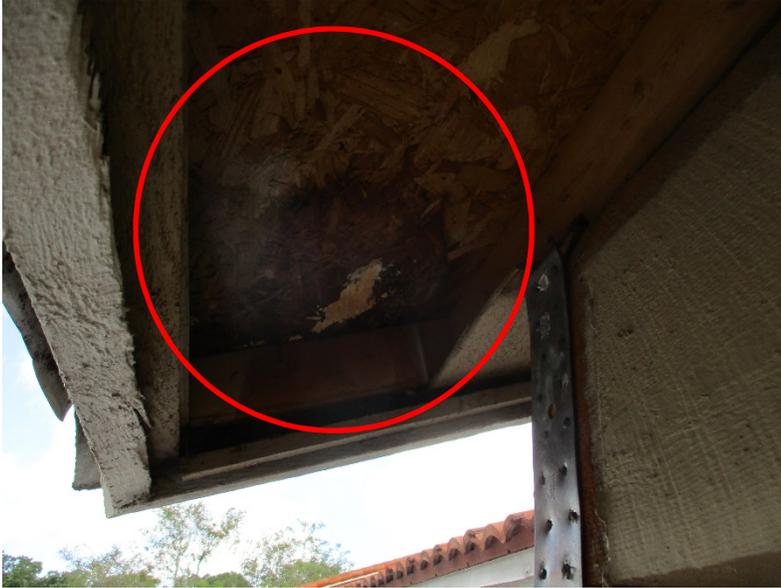
PHOTOGRAPH #19

**BUILDING 10
SECTION G**

Roof sheathing leak damage not covered
in scope of repairs.

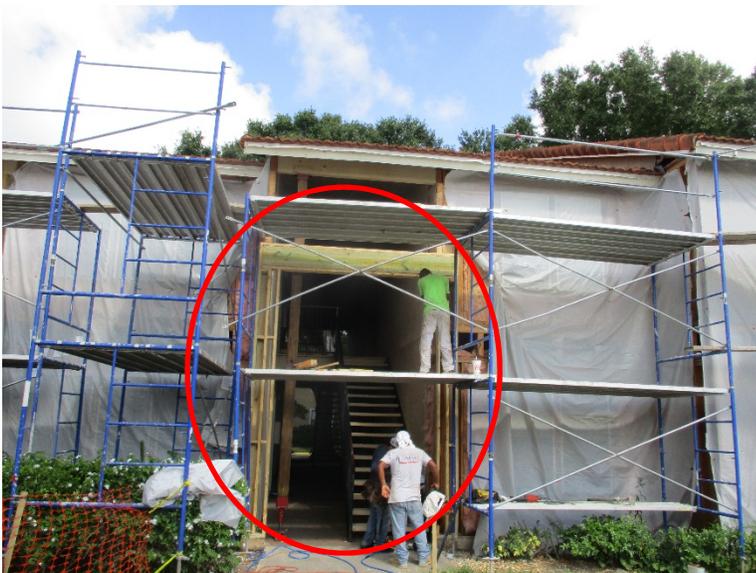
PHOTOGRAPH #20

**BUILDING 10
SECTION G – BREEZWAY**

Contractor rebuilding damaged
breezeway framing.

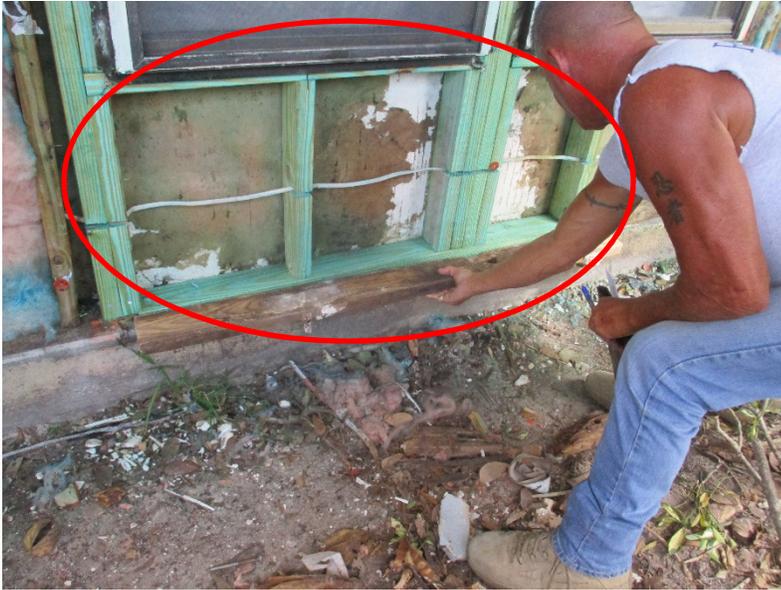
PHOTOGRAPH #21

**BUILDING 10
SECTION G**

Framing repairs reviewed and quantified with contractor.
