PHOTOGRAPHS

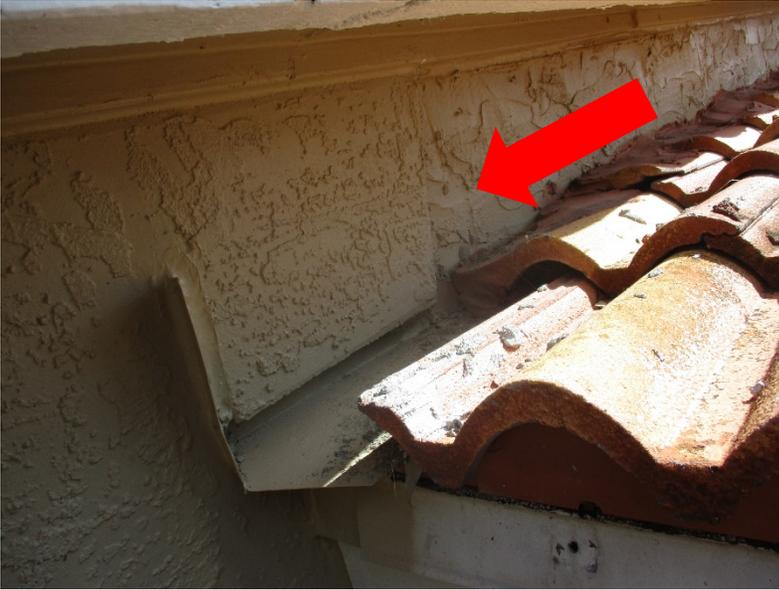
PHOTOGRAPH #1

BUILDING 26 SECTION C

Kick out flashing detail complete. Roof tiles have not been re-installed.

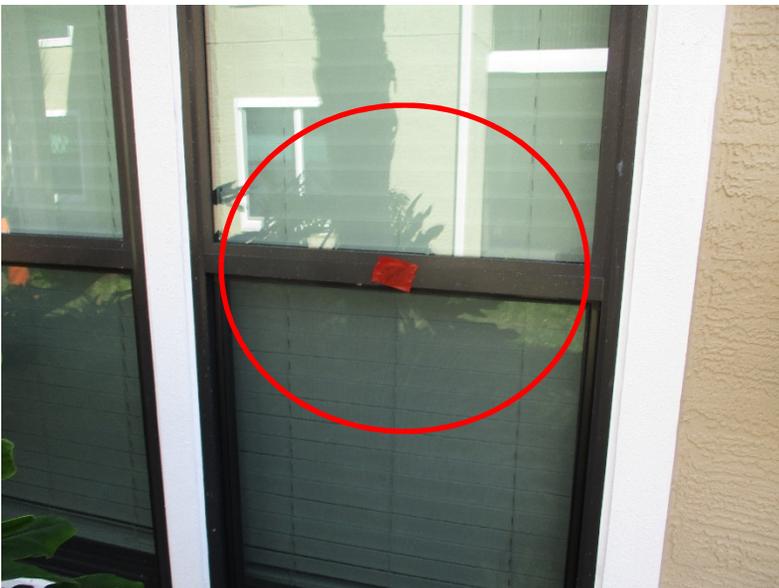
PHOTOGRAPH #2

BUILDING 26 SECTION G

Owner's representative walked building with Contractor and Delta. Several punch items were marked and noted. The punch list will be provided by Delta.

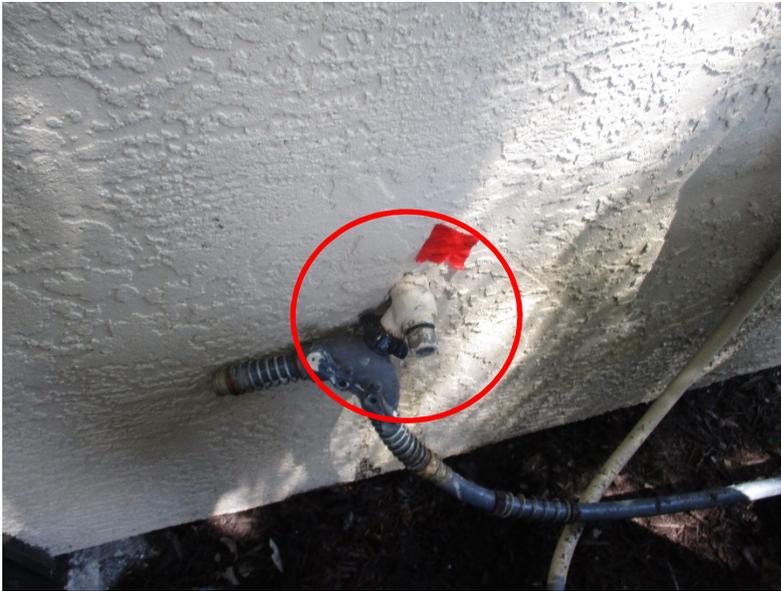
PHOTOGRAPH #3

**BUILDING 26
SECTION B**

Owner's representative walked building with Contractor and Delta. Several punch items were marked and noted. The punch list will be provided by Delta.

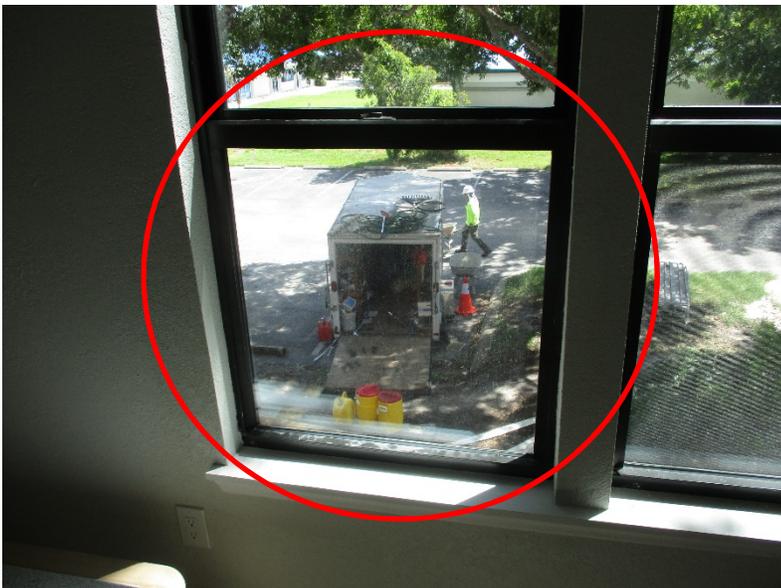
PHOTOGRAPH #4

**BUILDING 26
SECTION D- UNIT #2627**

Window identified as inoperable during interior punch walkthrough has been repaired.

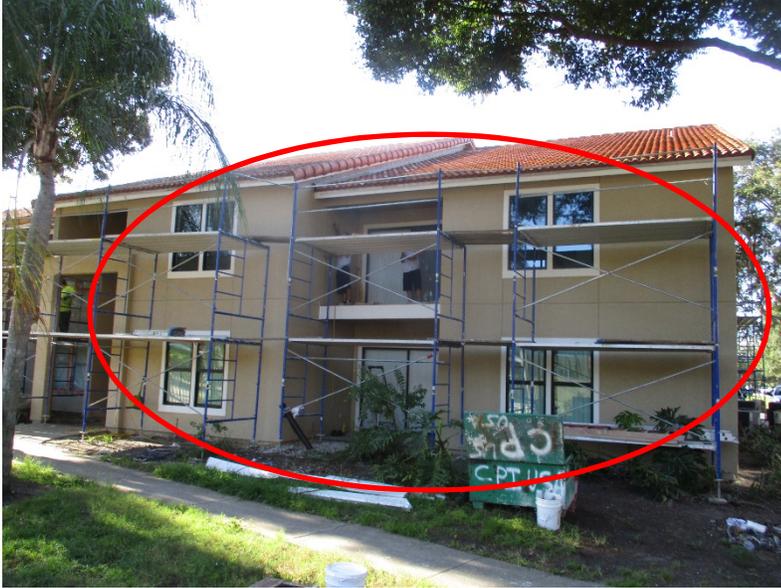
PHOTOGRAPH #5

**BUILDING 27
SECTION G**

Contractor has primed and painted new stucco.

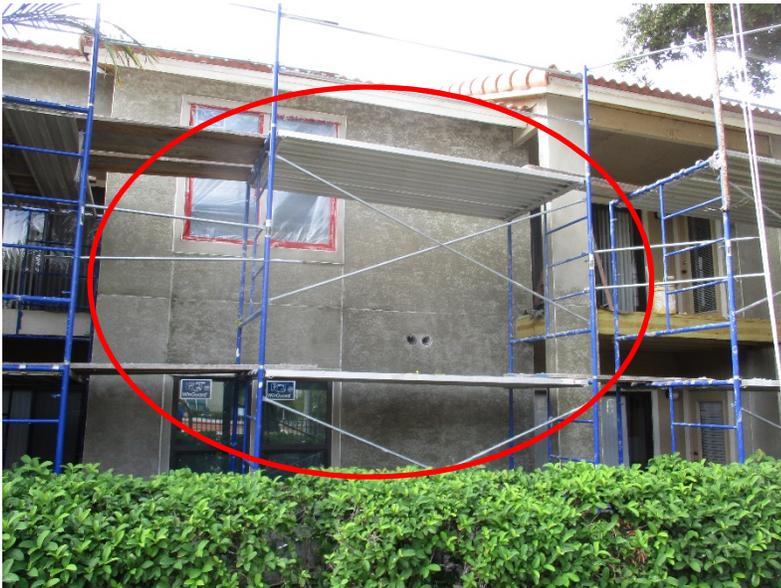
PHOTOGRAPH #6

**BUILDING 27
SECTION F**

Stucco sub – contractor has applied sand and finish texture coats at portions of the section.

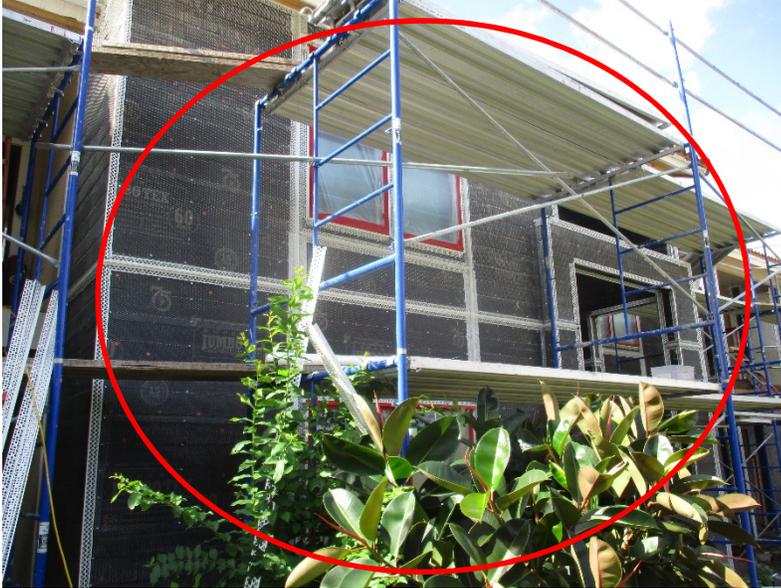
PHOTOGRAPH #7

**BUILDING 27
SECTION F**

Stucco accessories and lath have been completed and inspected for compliance.

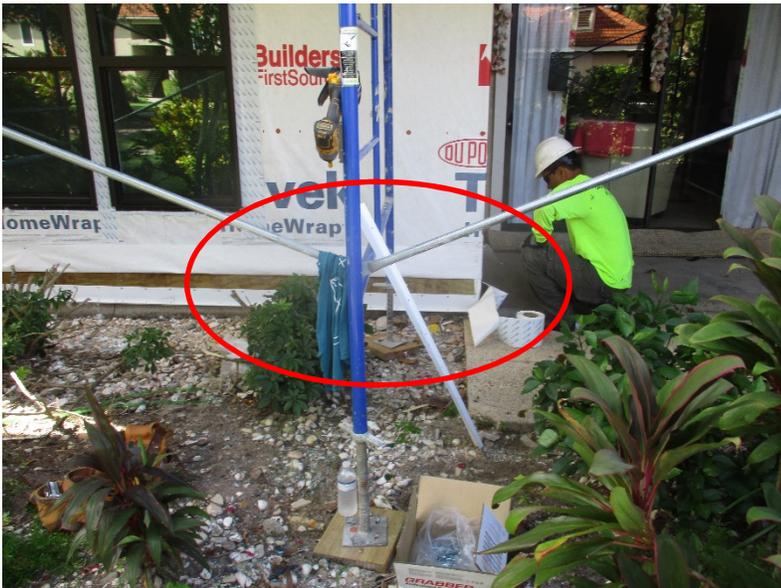
PHOTOGRAPH #8

**BUILDING 27
SECTION E**

Stucco weep accessory being installed at base of wall.

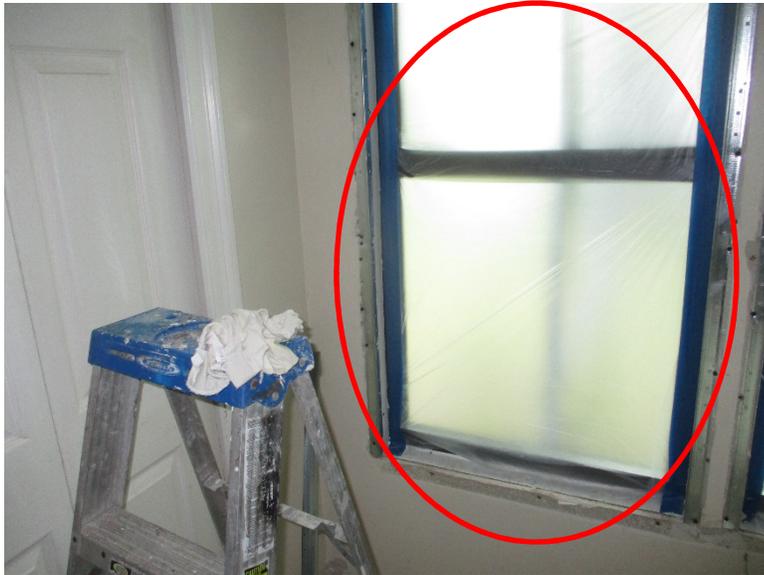
PHOTOGRAPH #9

**BUILDING 27
SECTION E**

Unit #2718- Contractor has applied interior sealant bead to window and in process of repairing drywall.

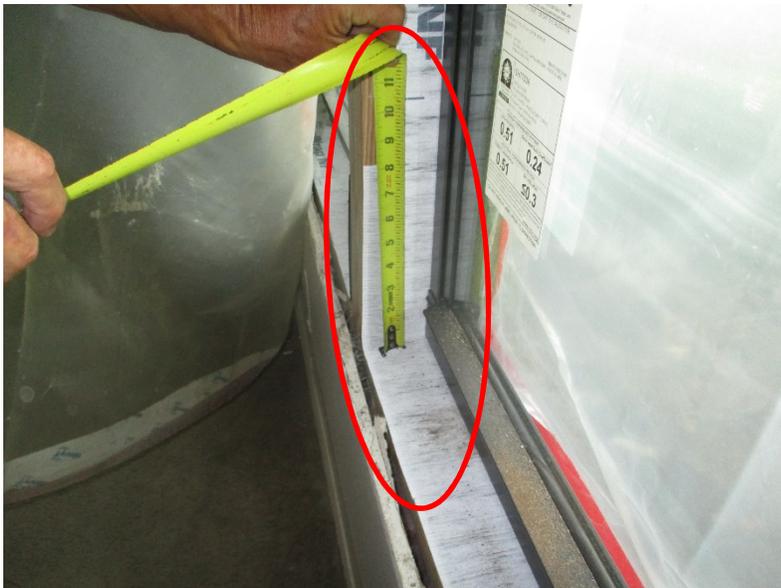
PHOTOGRAPH #10

**BUILDING 27
SECTION E**

Unit #2718- DuPont flashing inspected for proper installation and overlapping.

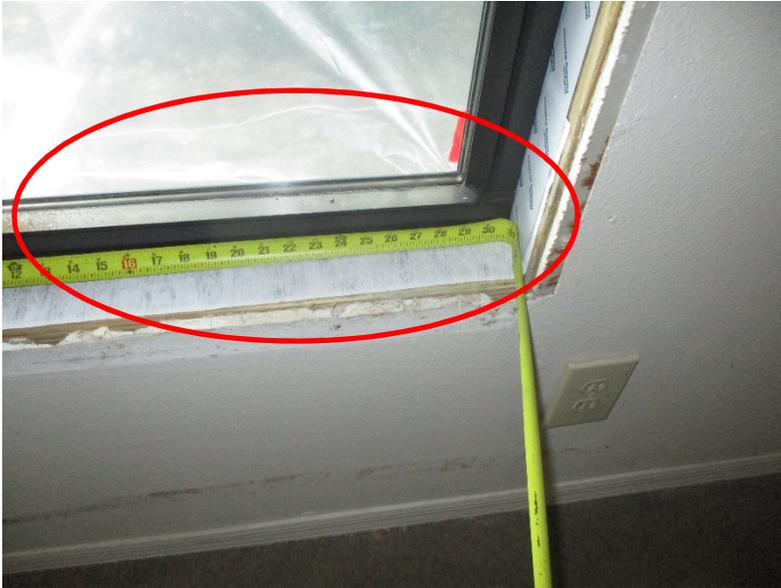
PHOTOGRAPH #11

**BUILDING 27
SECTION E**

Unit #2718- Window installation checked for proper fit and dimensions.

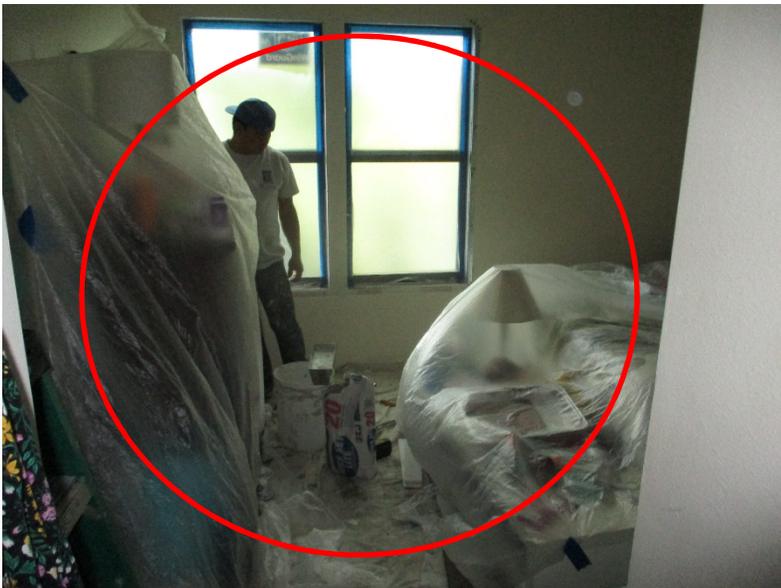
PHOTOGRAPH #12

**BUILDING 27
SECTION E**

Unit #2718- Contractor is covering owner's property to avoid damage while repairs are in progress.

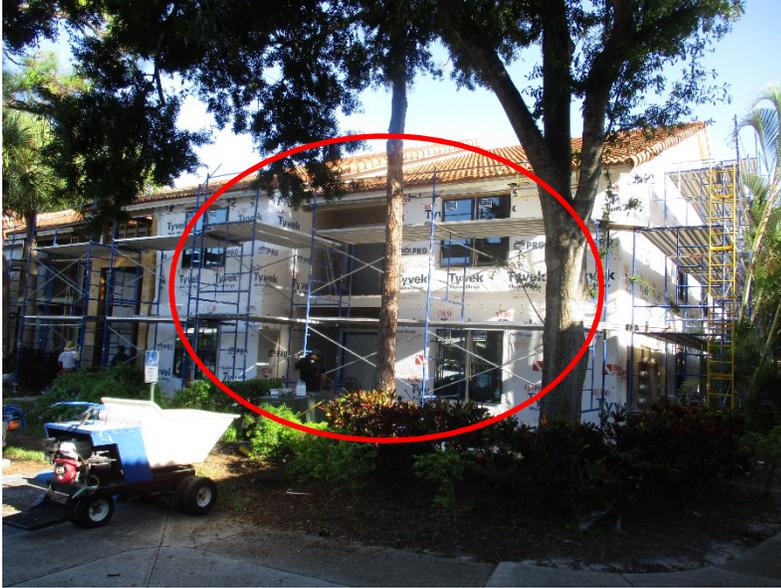
PHOTOGRAPH #13

**BUILDING 27
SECTION C**

Tyvek WRB and new windows have been installed and inspected for compliance.

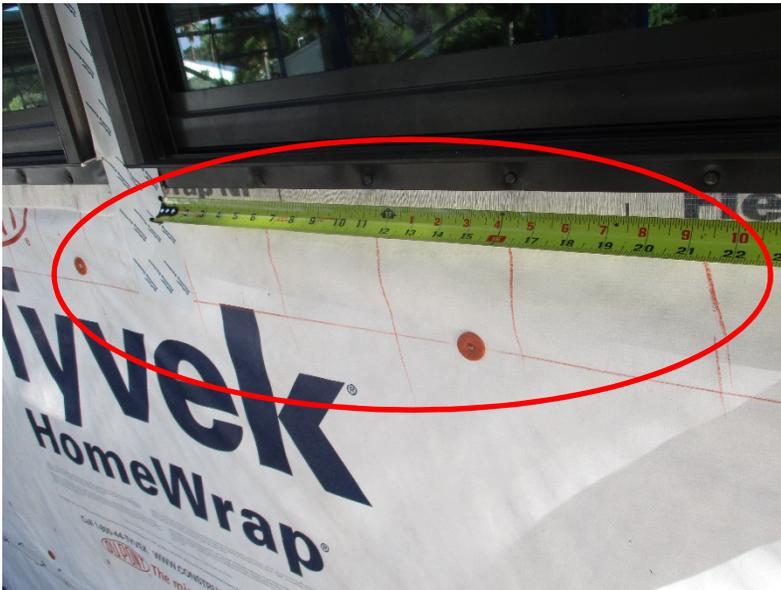
PHOTOGRAPH #14

**BUILDING 27
SECTION C**

Tyvek WRB and new windows have been installed and inspected for compliance.

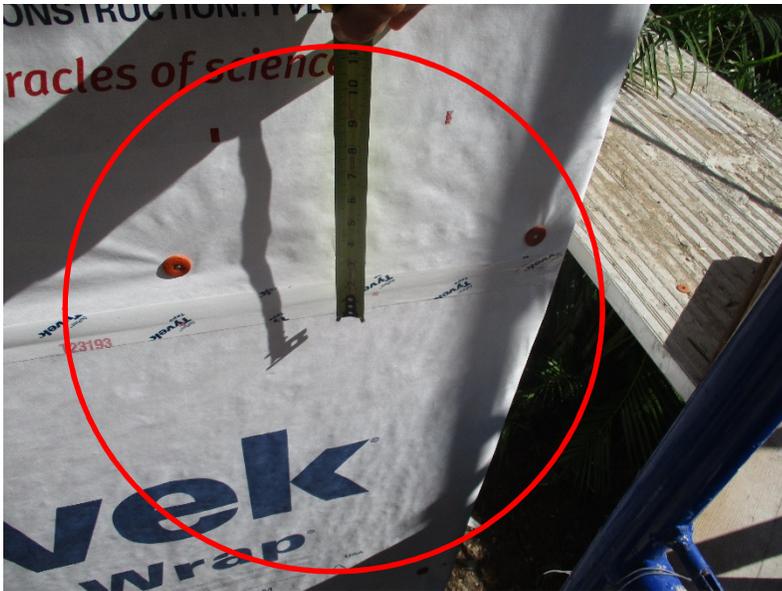
PHOTOGRAPH #15

**BUILDING 27
SECTION C**

Tyvek WRB and new windows have been installed and inspected for compliance.

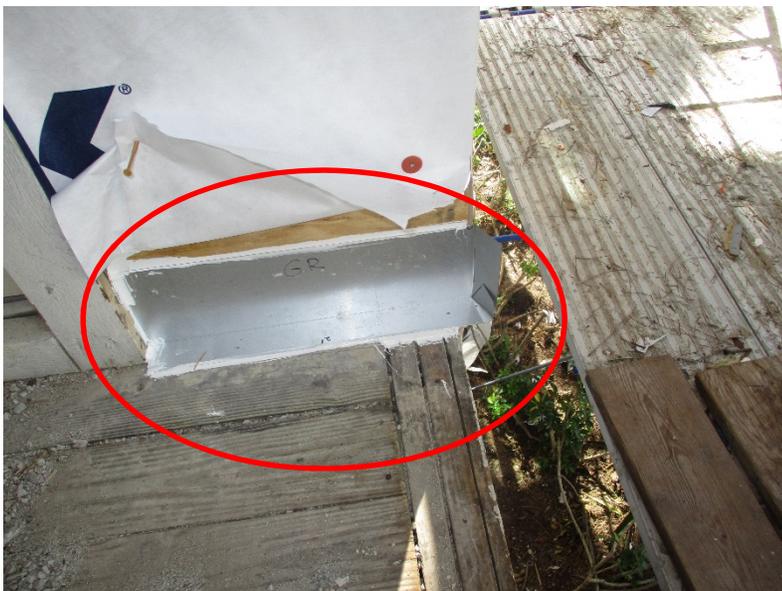
PHOTOGRAPH #16

**BUILDING 27
SECTION C**

Contractor has installed kick out flashing at new sheathing to deck transitions.

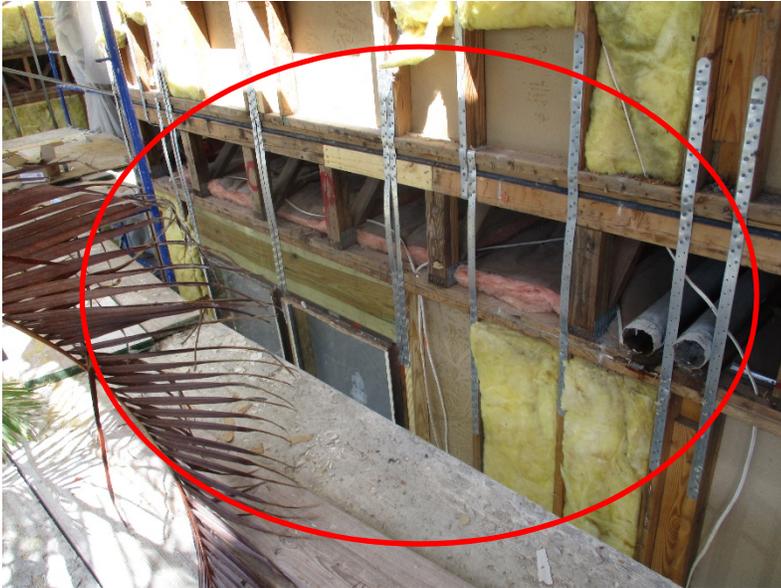
PHOTOGRAPH #17

**BUILDING 27
SECTION B**

Contractor has repaired damaged framing and installed Simpson Strong-Tie connectors.

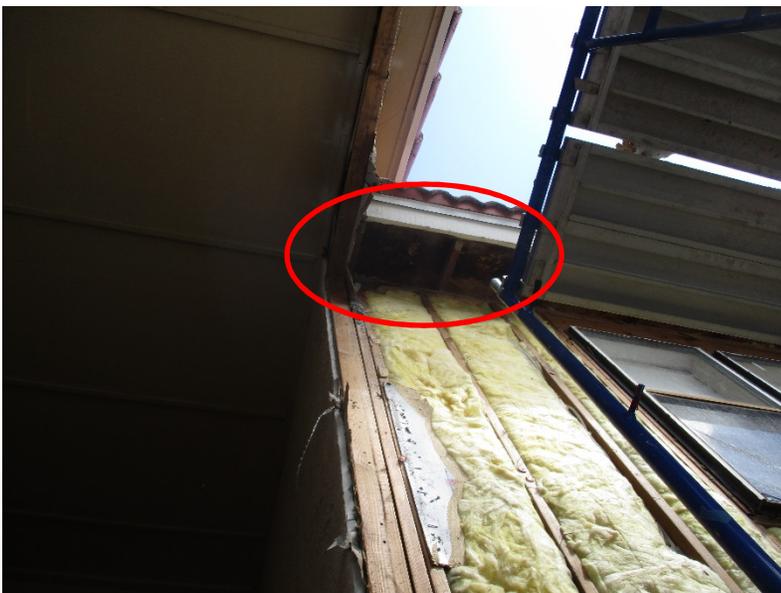
PHOTOGRAPH #18

**BUILDING 27
SECTION B**

Roof sheathing is damaged by previous roofing leaks and is to be repaired by owner's contractor.

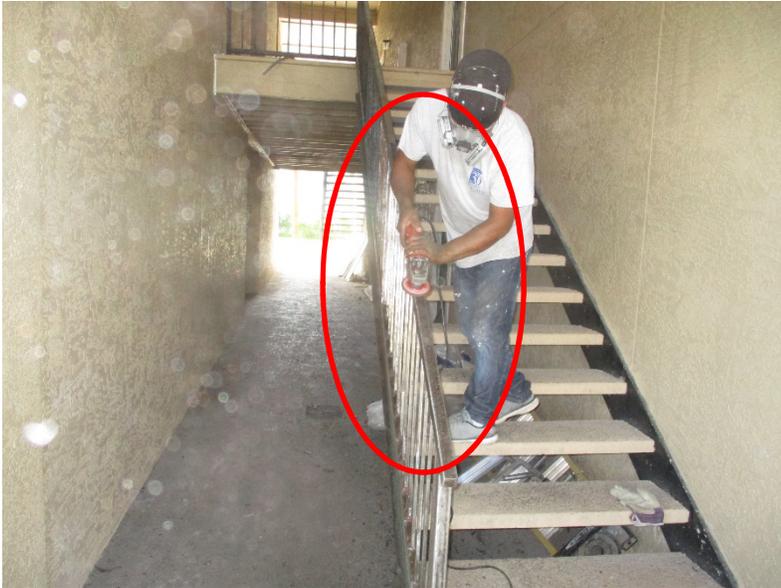
PHOTOGRAPH #19

**BUILDING 27
SECTION A**

Contractor has begun to prepare metal railings for primer at stairways.
