PHOTOGRAPHS

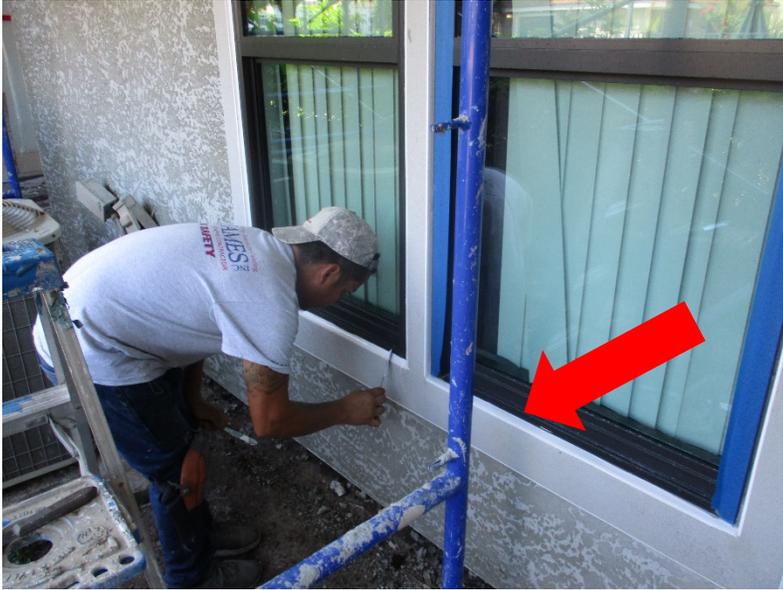
PHOTOGRAPH #1

**BUILDING 27
SECTION F**

Contractor is installing window perimeter sealants.

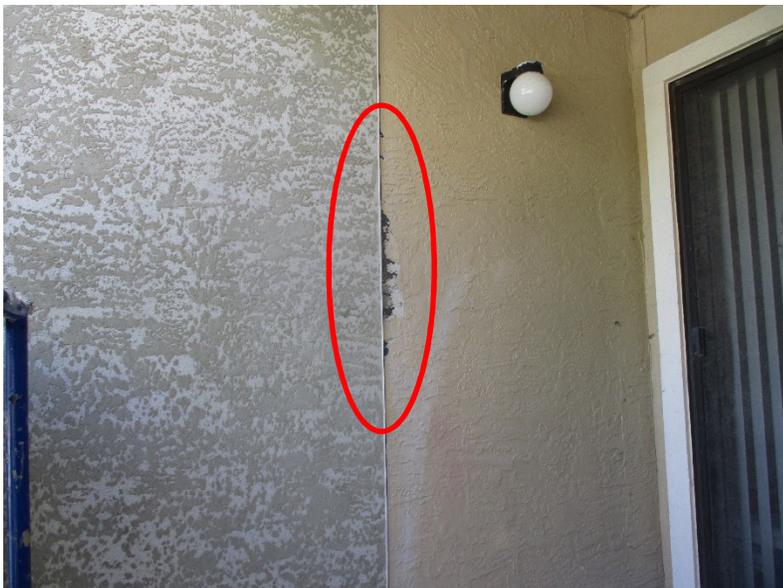
PHOTOGRAPH #2

**BUILDING 27
SECTION F**

Stucco has been damaged beyond stucco stop vinyl accessory.

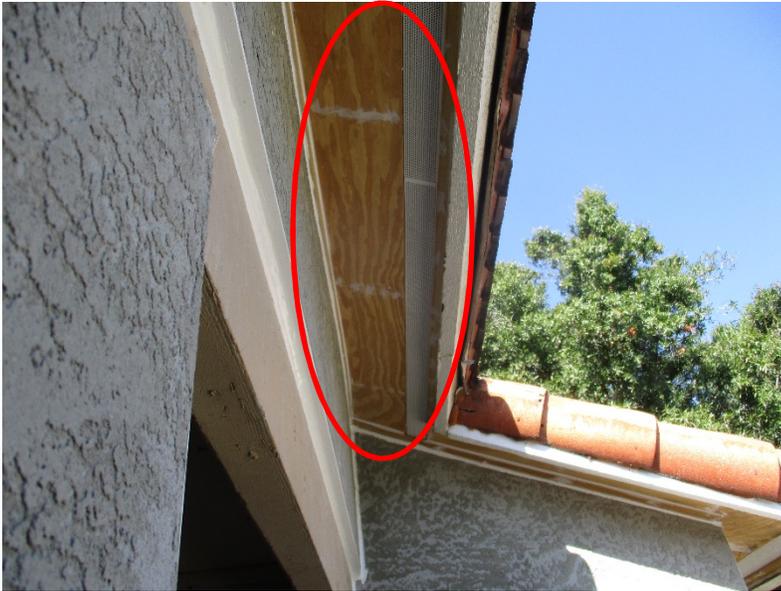
PHOTOGRAPH #3

**BUILDING 27
SECTION F**

New wood soffit and soffit vent has been installed and prepared for paint primer.

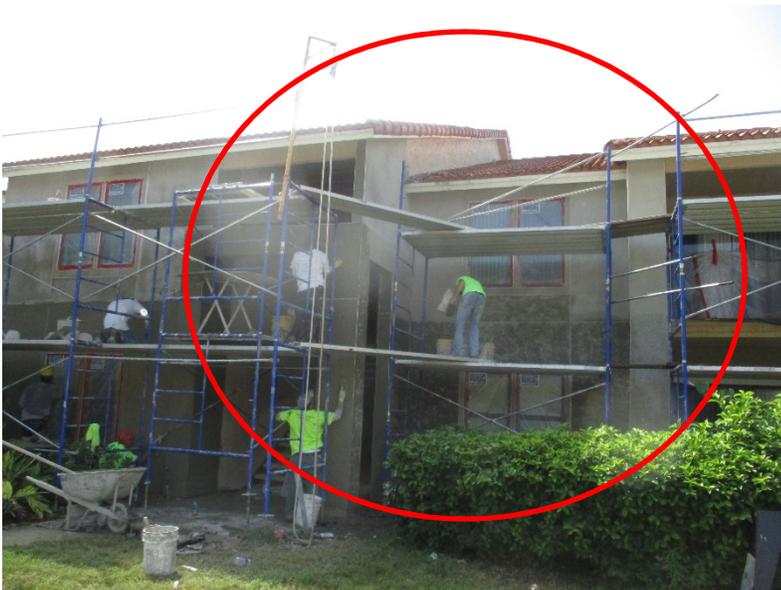
PHOTOGRAPH #4

**BUILDING 27
SECTION F**

Stucco Sub-contractor is applying sand coats and finish coats.

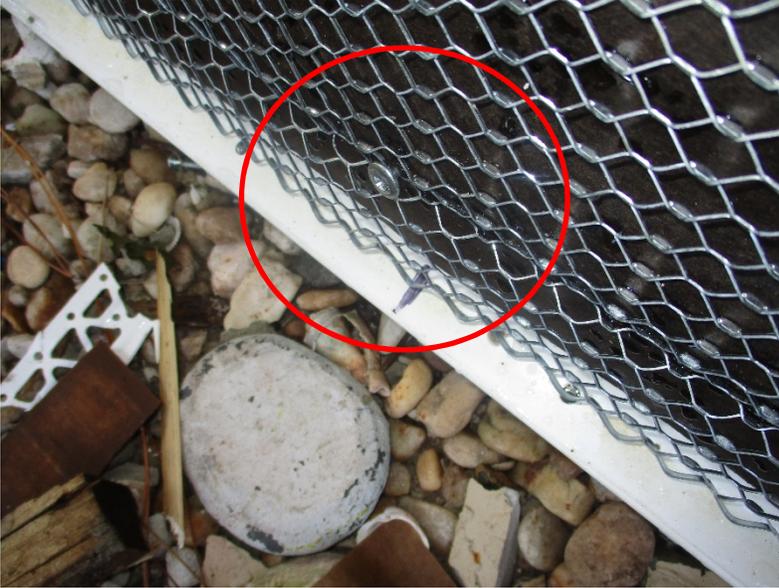
PHOTOGRAPH #5

**BUILDING 27
SECTION E**

Metal lath fasteners were not properly installed.

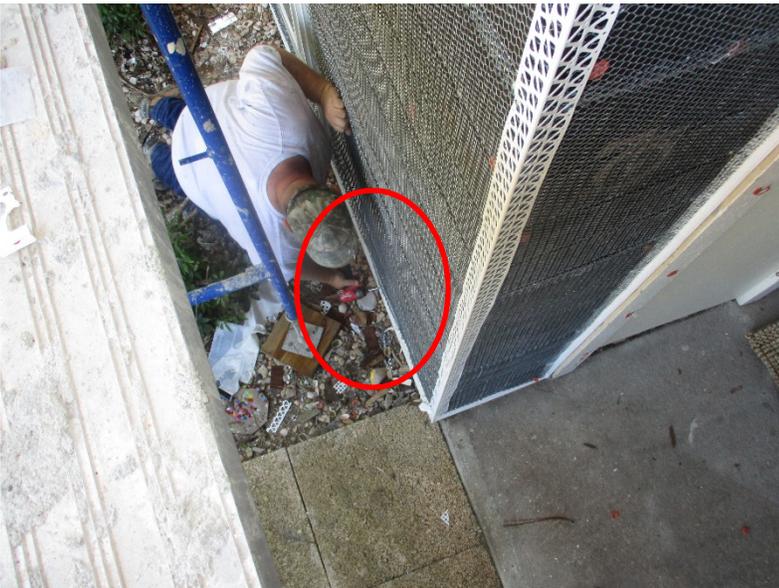
PHOTOGRAPH #6

**BUILDING 27
SECTION E**

Stucco subcontractor corrected metal lath fasteners as directed.

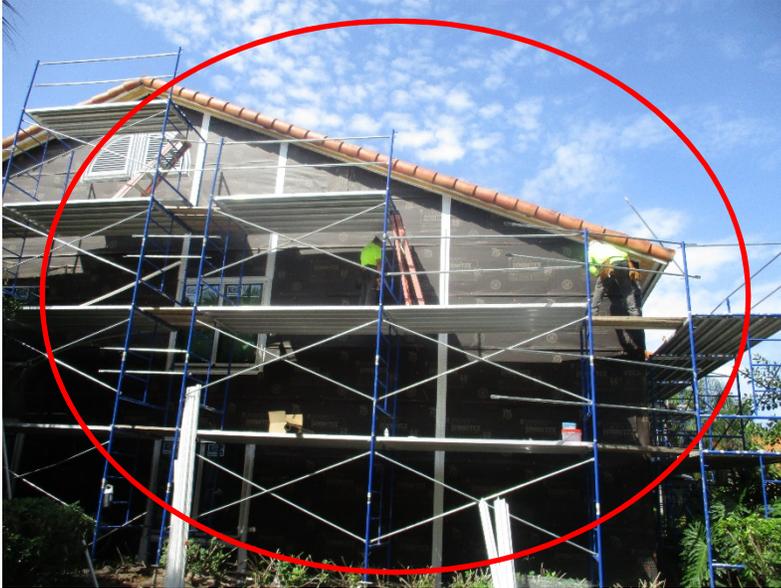
PHOTOGRAPH #7

**BUILDING 27
SECTION D**

JumboTex WRB and stucco accessories are being installed.

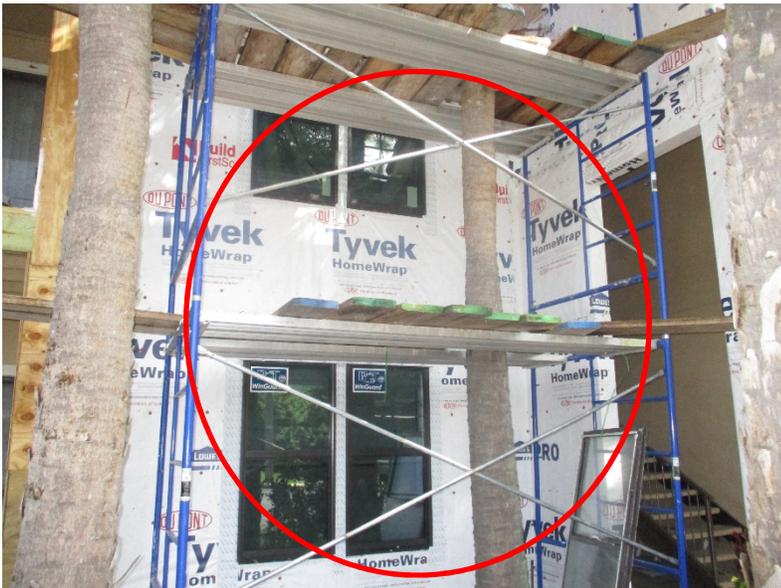
PHOTOGRAPH #8

**BUILDING 27
SECTION C**

Tyvek WRB and Dupont flashing details applied and PGT windows installed.

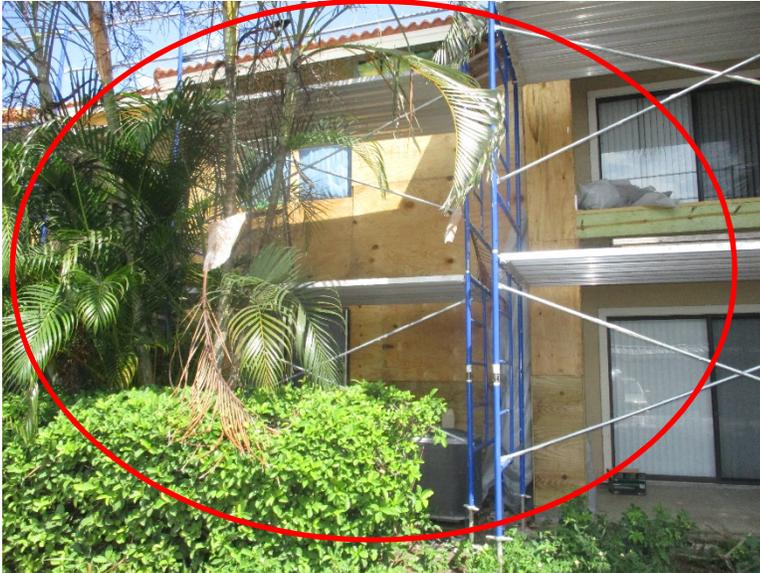
PHOTOGRAPH #9

**BUILDING 27
SECTION B**

Contractor has applied plywood sheathing.

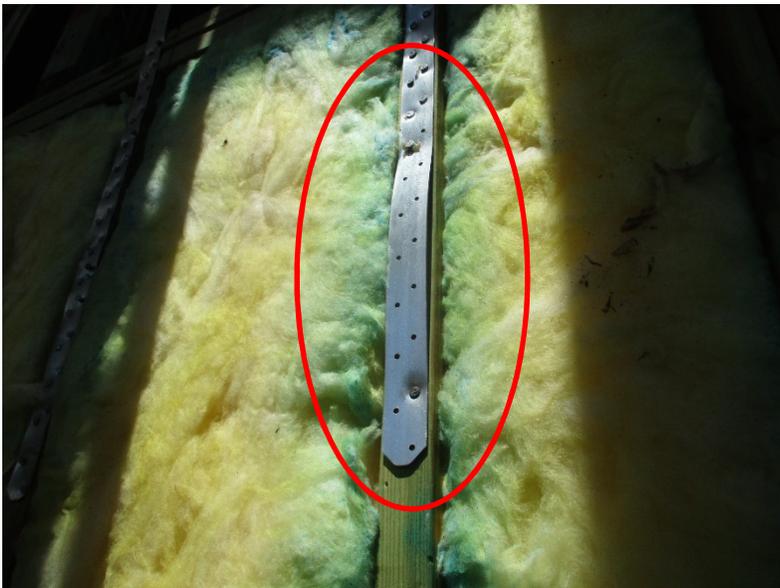
PHOTOGRAPH #10

**BUILDING 27
SECTION B**

Simpson Strong-Tie connector strap has not been fully nailed. Contractor made corrections when discovered.

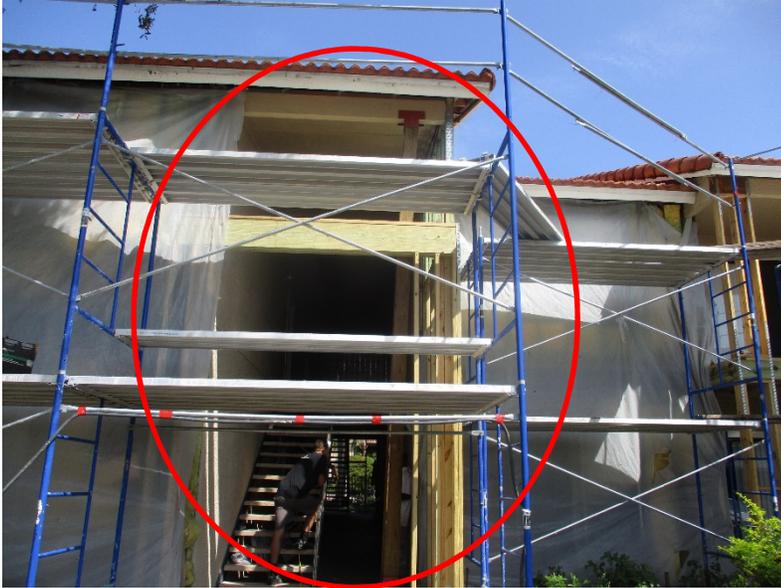
PHOTOGRAPH #11

**BUILDING 27
SECTION A**

Contractor has made full repairs at breezeway columns and built up beam.

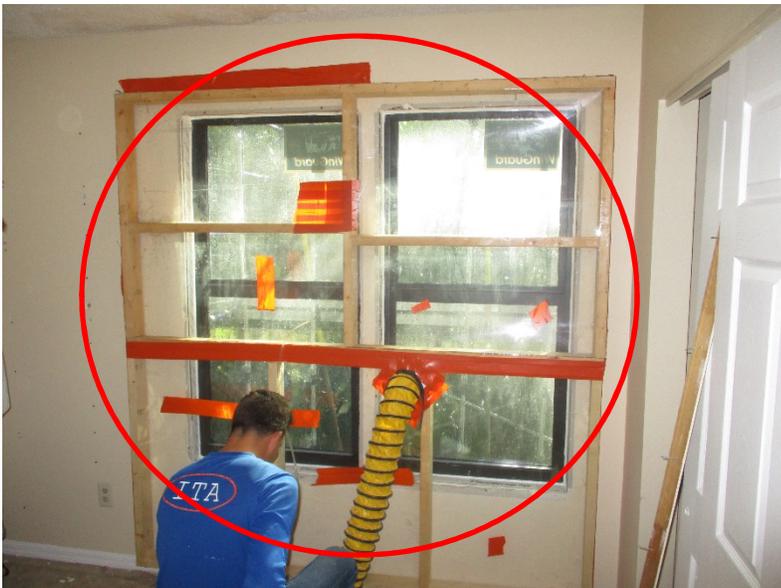
PHOTOGRAPH #12

**BUILDING 27
SECTION D**

Unit #2727- ITA testing company water tested bedroom double windows following ASTM test methods and AAMA 502 testing guidelines outlined in project manual. Test failed with water intrusion at lower sill.

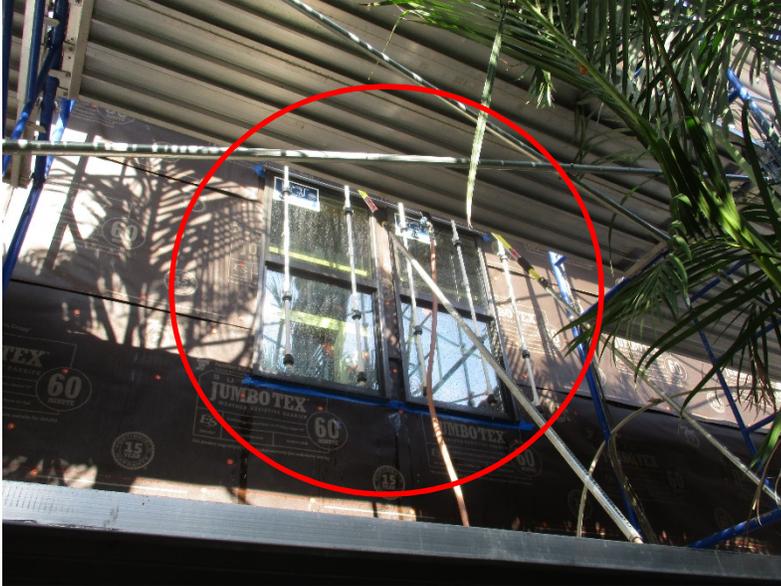
PHOTOGRAPH #13

**BUILDING 27
SECTION D**

Unit #2727- ITA testing company water tested bedroom double windows following ASTM test methods and AAMA 502 testing guidelines outlined in project manual. Test failed with water intrusion at lower sill.

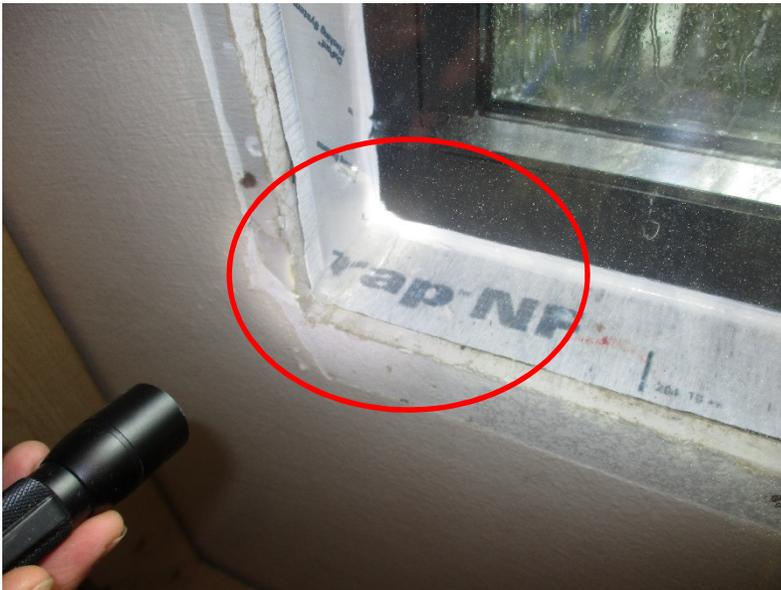
PHOTOGRAPH #14

**BUILDING 27
SECTION D**

Unit #2727- ITA testing company water tested bedroom double windows following ASTM test methods and AAMA 502 testing guidelines outlined in project manual. Test failed with water intrusion at lower sill.

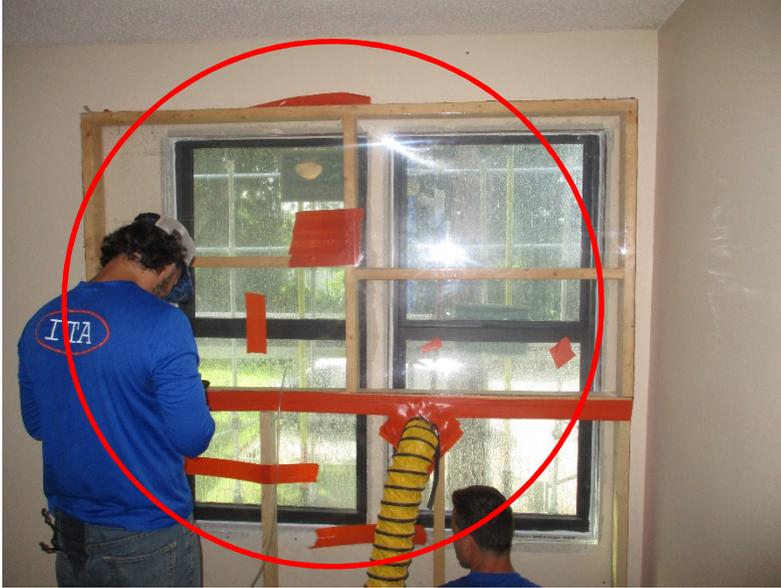
PHOTOGRAPH #15

**BUILDING 27
SECTION E**

Unit #2727- ITA testing company water tested 2nd bedroom double windows following ASTM test methods and AAMA 502 testing guidelines outlined in project manual. Test failed with water intrusion at lower sill.

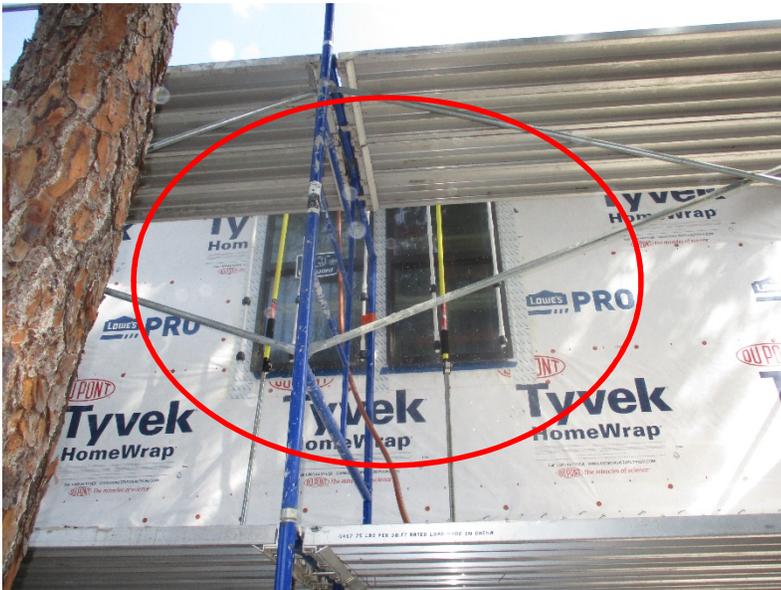
PHOTOGRAPH #16

**BUILDING 27
SECTION D**

Unit #2727- ITA testing company water tested 2nd bedroom double windows following ASTM test methods and AAMA 502 testing guidelines outlined in project manual. Test failed with water intrusion at lower sill.

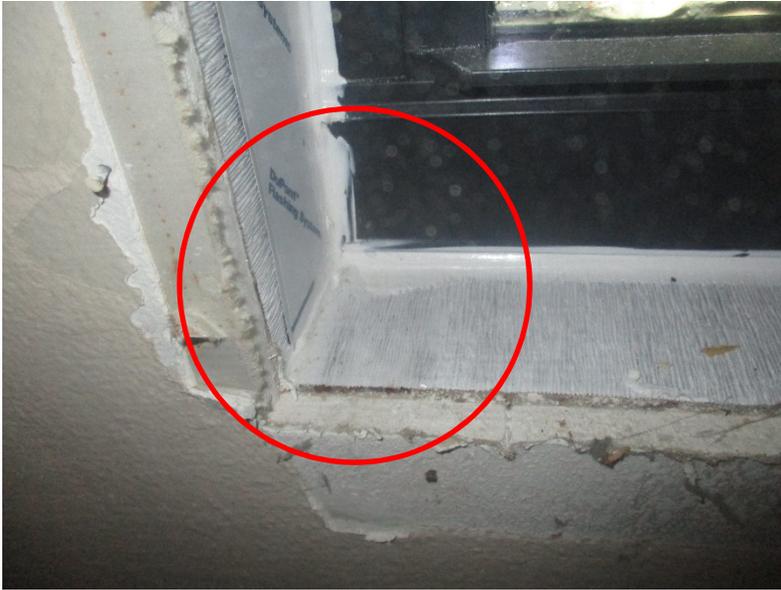
PHOTOGRAPH #17

**BUILDING 27
SECTION D**

Unit #2727- ITA testing company water tested 2nd bedroom double windows following ASTM test methods and AAMA 502 testing guidelines outlined in project manual. Test failed with water intrusion at lower sill.

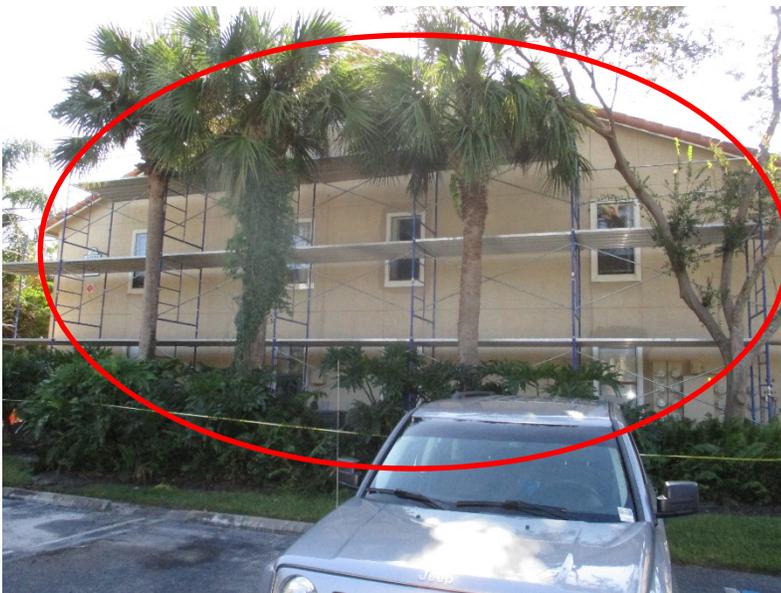
PHOTOGRAPH #18

**BUILDING 10
SECTION D**

Contractor has erected access framing scaffolding.

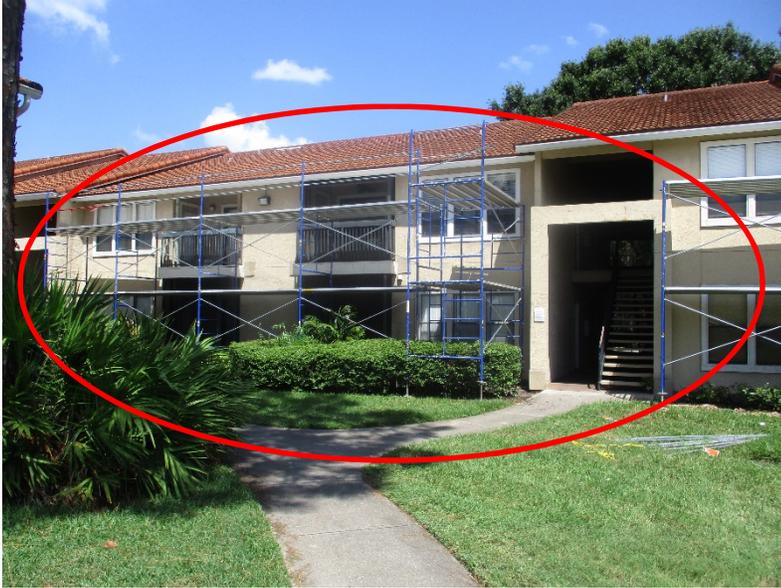
PHOTOGRAPH #19

**BUILDING 10
SECTION F**

Contractor has erected access framing scaffolding.
