## PHOTOGRAPHS

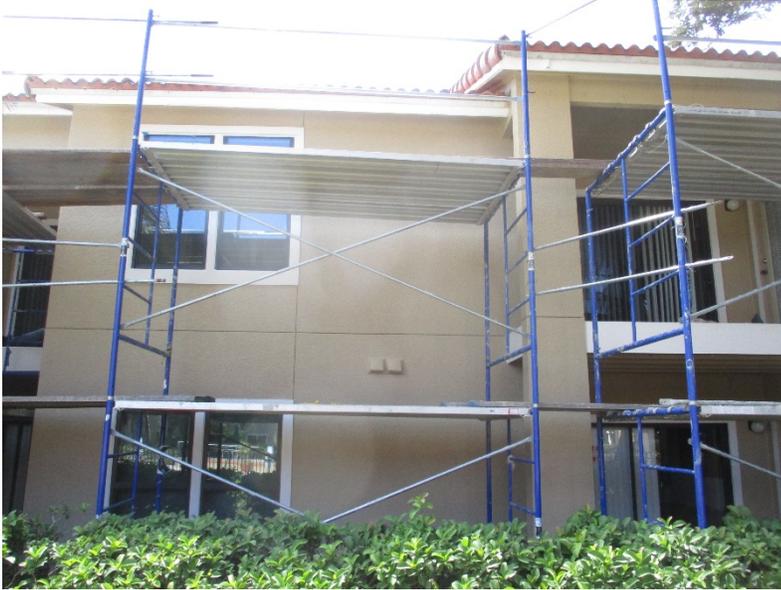
**PHOTOGRAPH #1**

### **BUILDING 27 SECTION F**

Contractor has applied finish paint at stucco and wood trim.

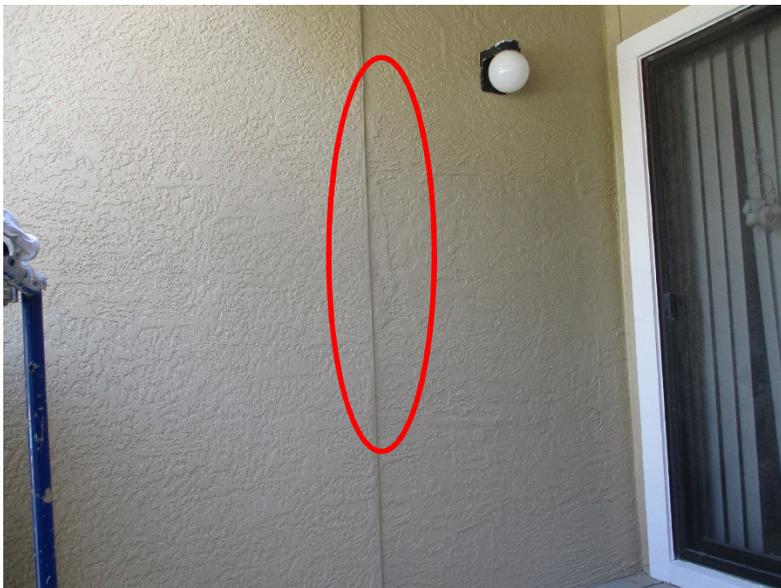
**PHOTOGRAPH #2**

### **BUILDING 27 SECTION F**

Stucco has been repaired where damaged beyond stucco stop vinyl accessory.

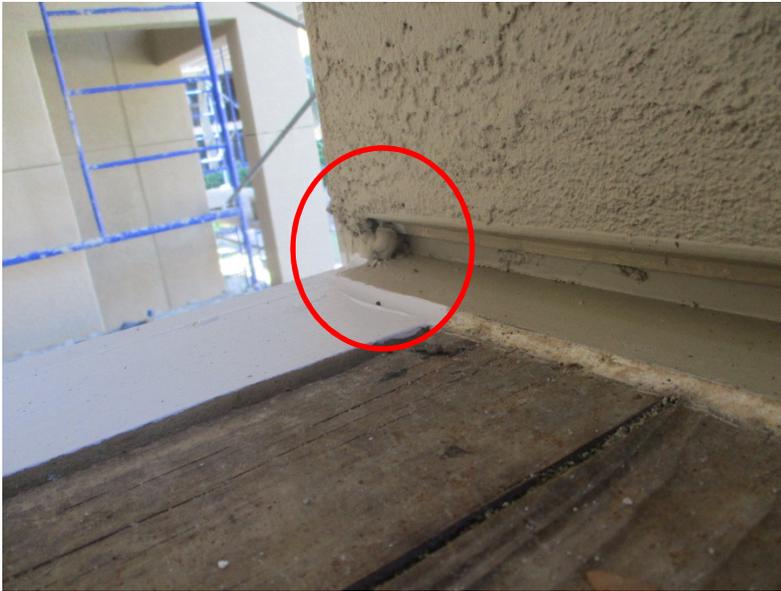
**PHOTOGRAPH #3**

**BUILDING 27  
SECTION F**

At several balconies flashing has not been properly sealed at transition to stucco accessories.

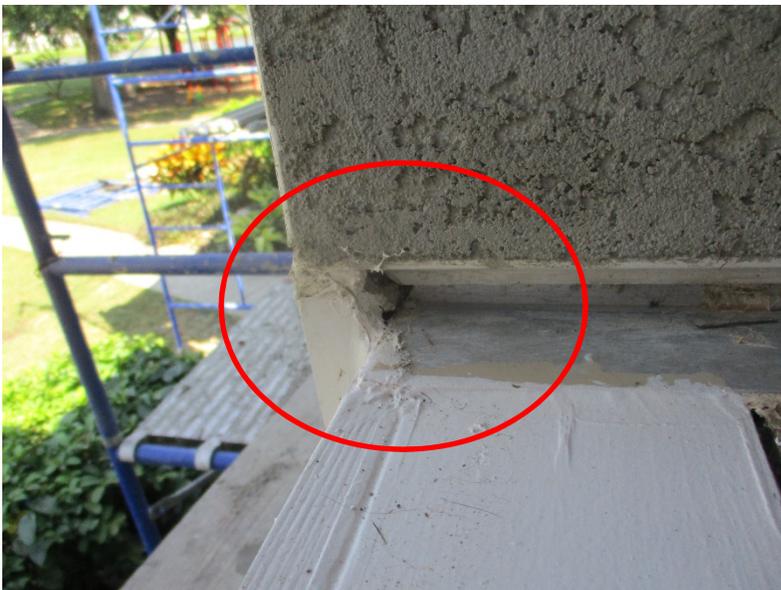
**PHOTOGRAPH #4**

**BUILDING 27  
SECTION F**

At several balconies flashing has not been properly sealed at transition to stucco accessories.

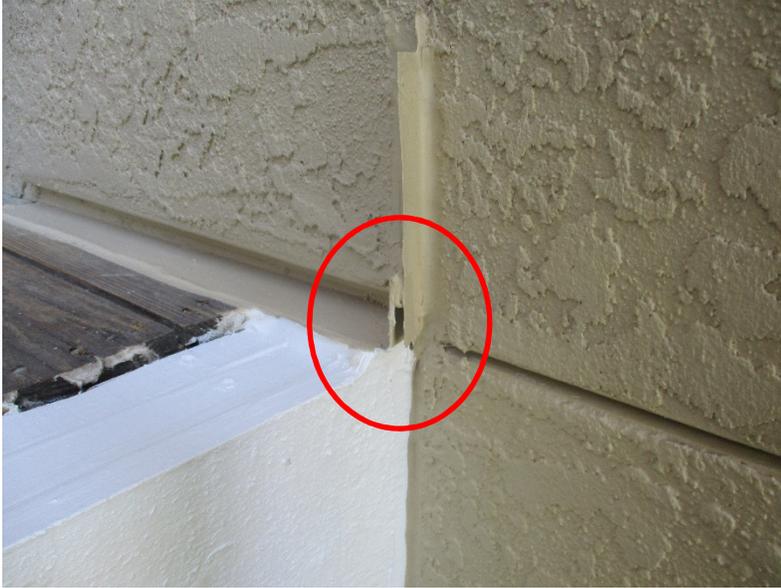
**PHOTOGRAPH #5**

**BUILDING 27  
SECTION F**

Kick out flashing is not lapped or sealed properly.

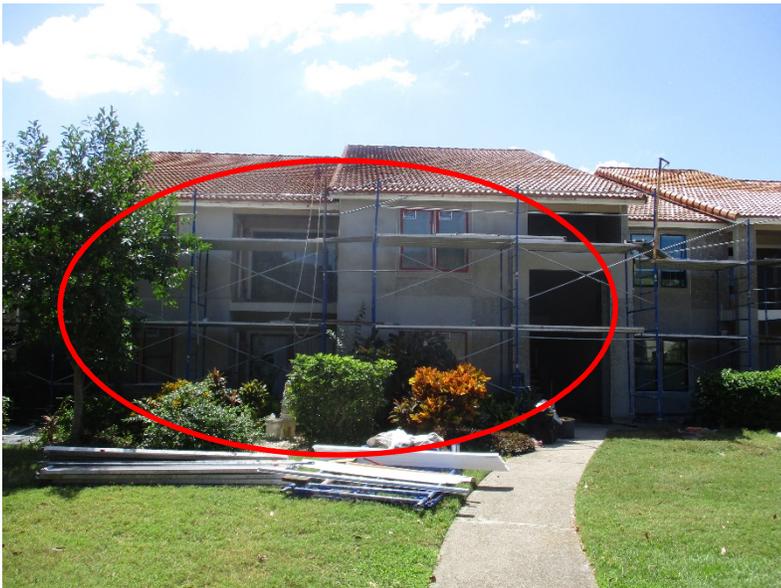
**PHOTOGRAPH #6**

**BUILDING 27  
SECTION E**

Stucco subcontractor is applying sand and finish coats of stucco.

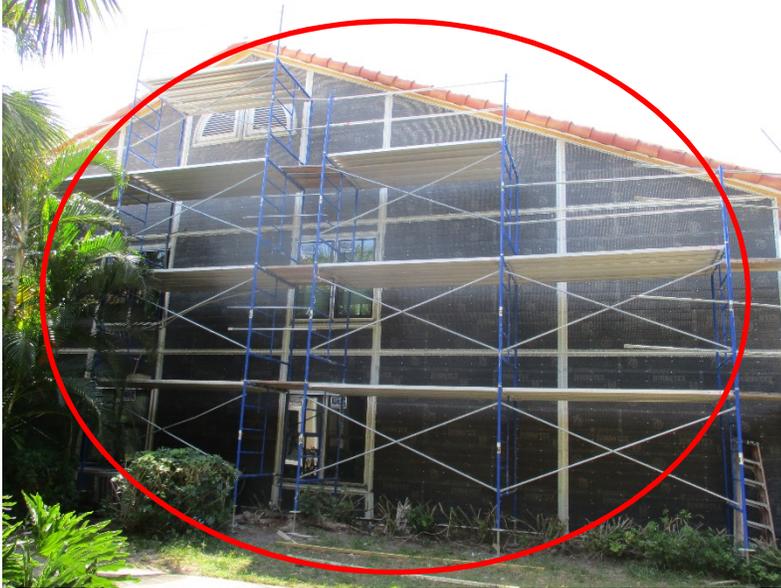
**PHOTOGRAPH #7**

**BUILDING 27  
SECTION D**

JumboTex WRB and stucco accessories are being installed.

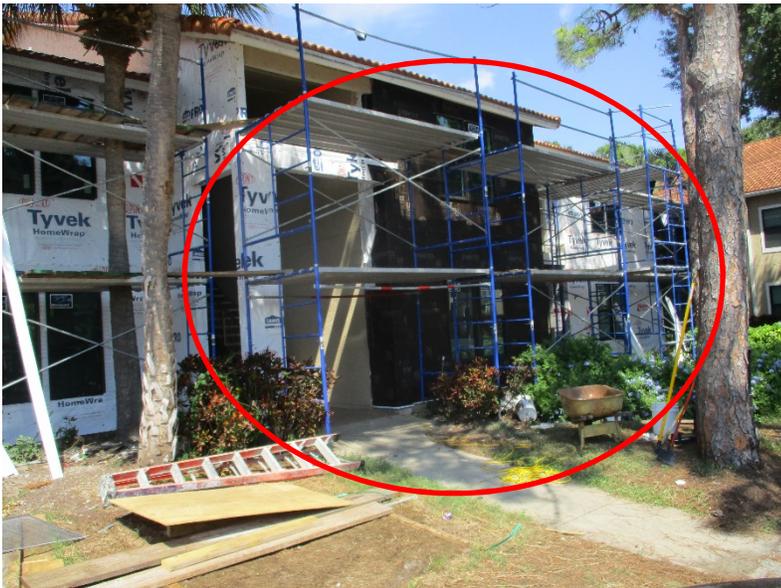
**PHOTOGRAPH #8**

**BUILDING 27  
SECTION C**

JumboTex WRB is being installed.

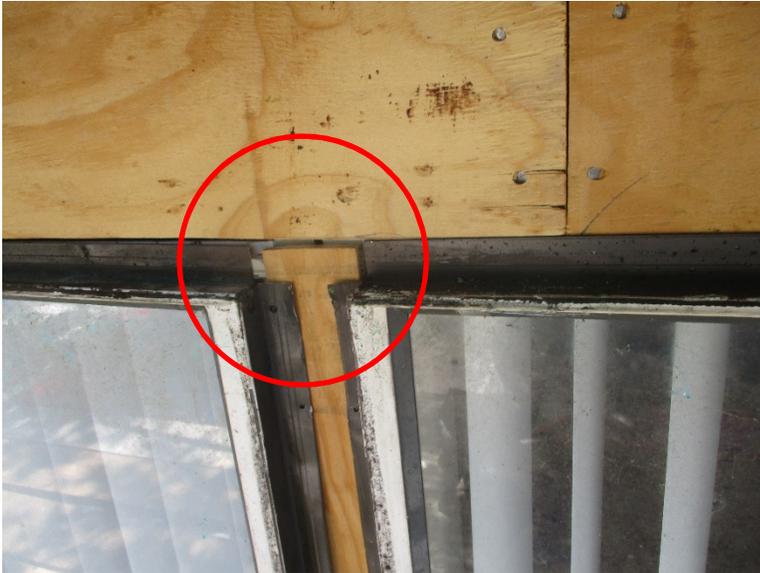
**PHOTOGRAPH #9**

**BUILDING 27  
SECTION A**

Gaps between sheets of plywood sheathing at several window head locations are not 1/8".

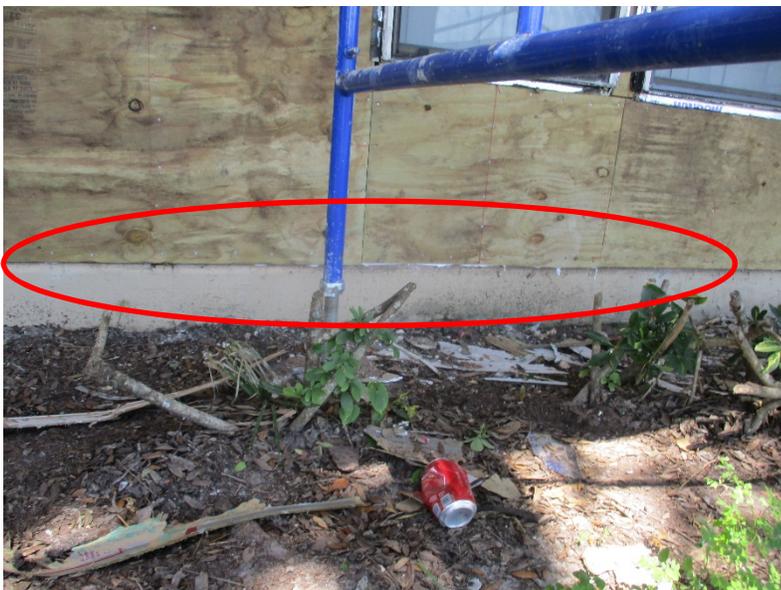
**PHOTOGRAPH #10**

**BUILDING 27  
SECTION A**

PT plywood has been sealed to concrete slab per C.O. # 2.

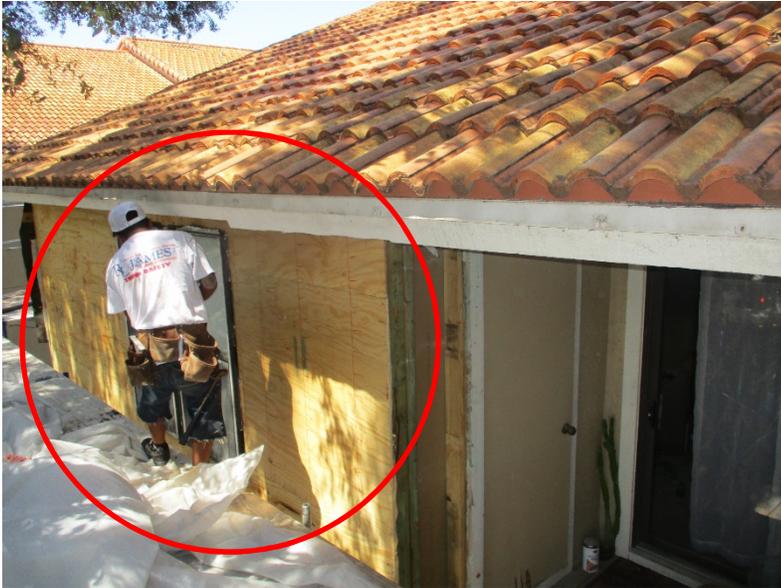
**PHOTOGRAPH #11**

**BUILDING 27  
SECTION A**

Contractor installing plywood sheathing.

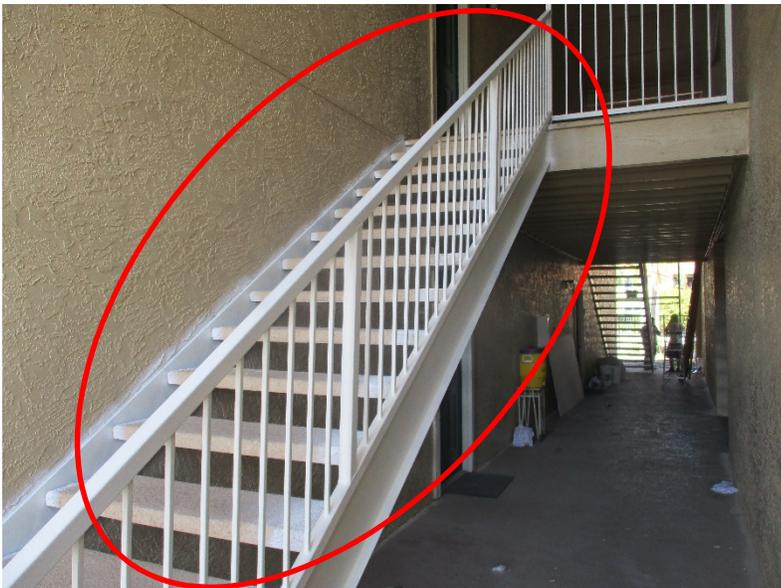
**PHOTOGRAPH #12**

**BUILDING 27  
SECTION A- BREEWAY**

Contractor has primed steel at stairs and railings with Florida Paints Epoxy Mastic Primer.

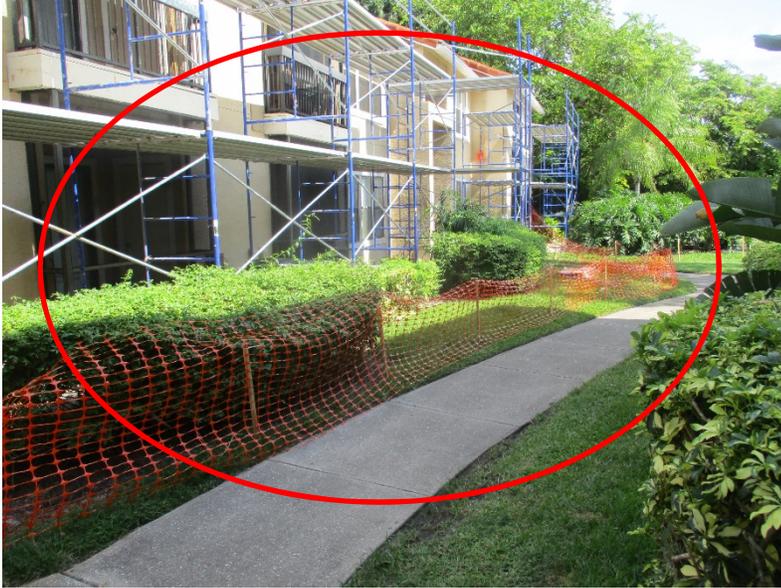
**PHOTOGRAPH #13**

**BUILDING 10  
SECTION E AND F**

Contractor has erected frame scaffold and provided construction fencing.
