PHOTOGRAPHS

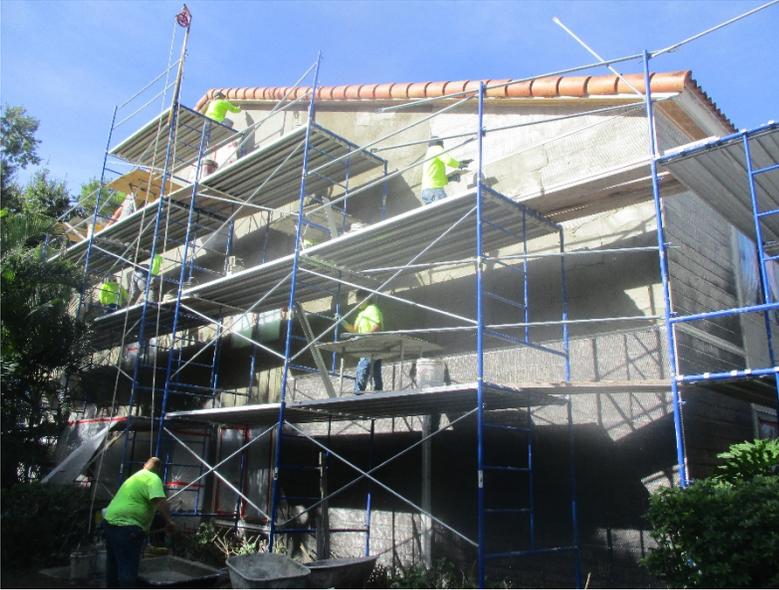
PHOTOGRAPH #1

BUILDING 27 SECTION D

Stucco sub-contractor applying scratch coat of stucco.

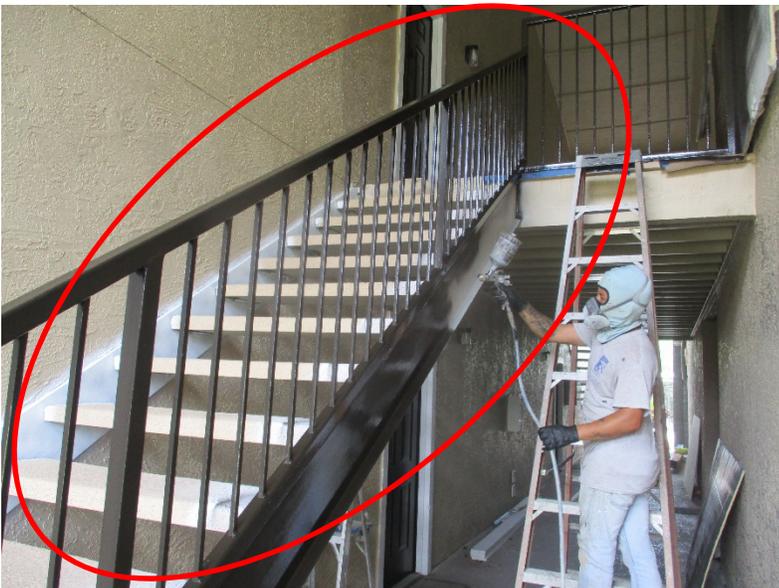
PHOTOGRAPH #2

BUILDING 27 SECTION C

Florida Paints Two Part Aliphatic Urethane Enamel finish being applied to railings.

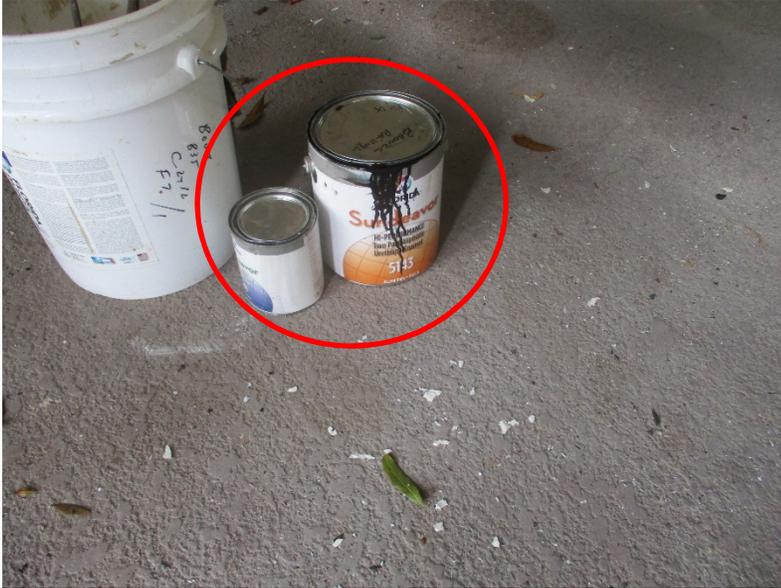
PHOTOGRAPH #3

**BUILDING 27
SECTION C**

Florida Paints Two Part Aliphatic Urethane Enamel finish being applied to railings.

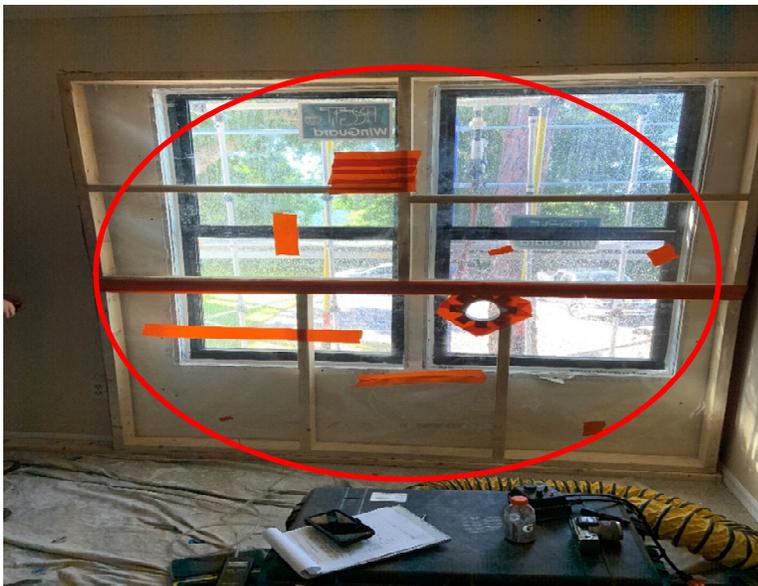
PHOTOGRAPH #4

**BUILDING 27
SECTION C – UNIT #2727**

Both double windows passed re-testing by Independent Testing Agency that previously failed and were repaired by PGT.

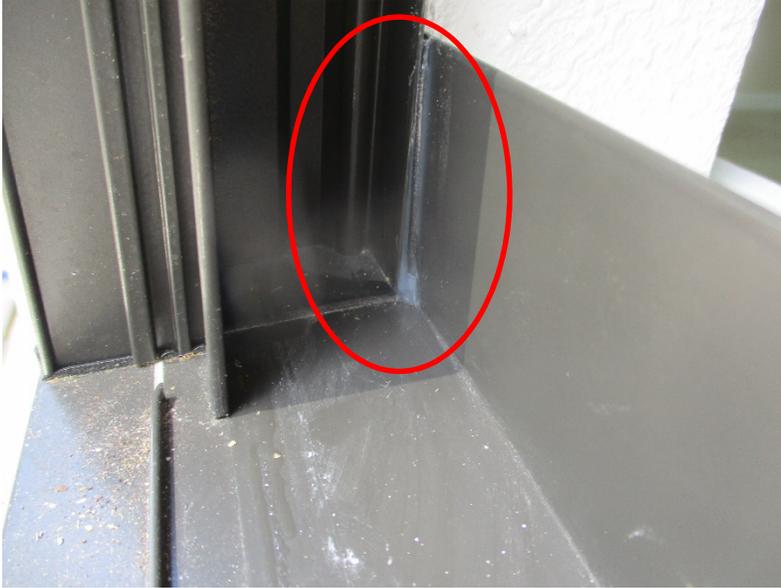
PHOTOGRAPH #5

**BUILDING 27
SECTION C – UNIT #2727**

PGT has made repairs at metal to metal sill to jamb transitions with silicone sealants.

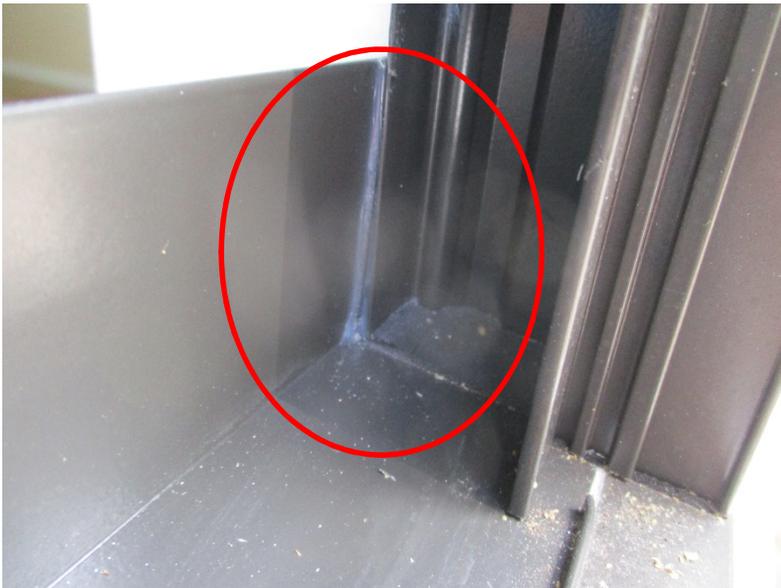
PHOTOGRAPH #6

**BUILDING 27
SECTION C – UNIT #2727**

PGT has made repairs at metal to metal sill to jamb transitions with silicone sealants.

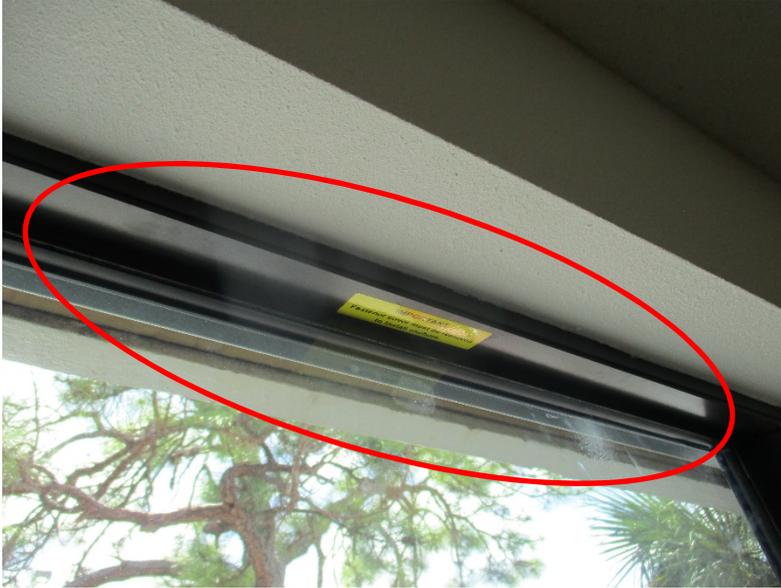
PHOTOGRAPH #7

**BUILDING 27
SECTION C – UNIT #2727**

AAMA sticker required is missing from several windows.

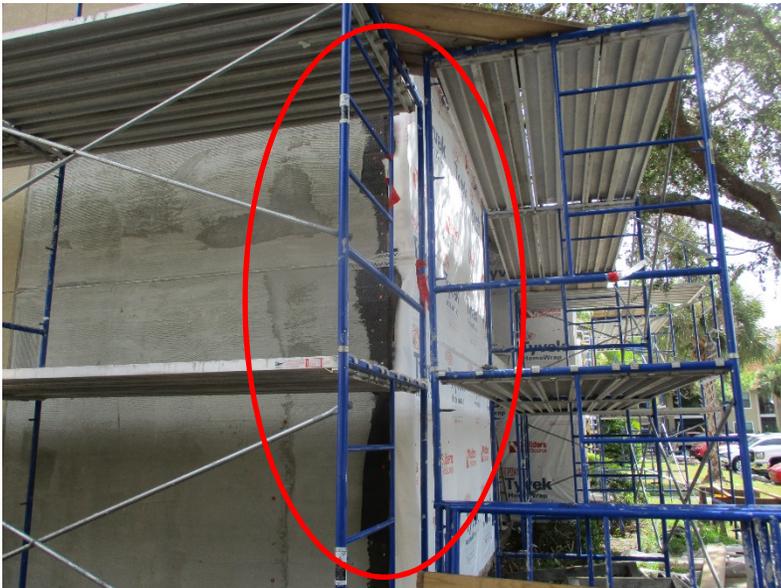
PHOTOGRAPH #8

**BUILDING 27
SECTION A**

Overlap of both Super Jumbo Tex 60 and Tyvek HomeWrap WRB at outside corner are not 12 inches as specified.

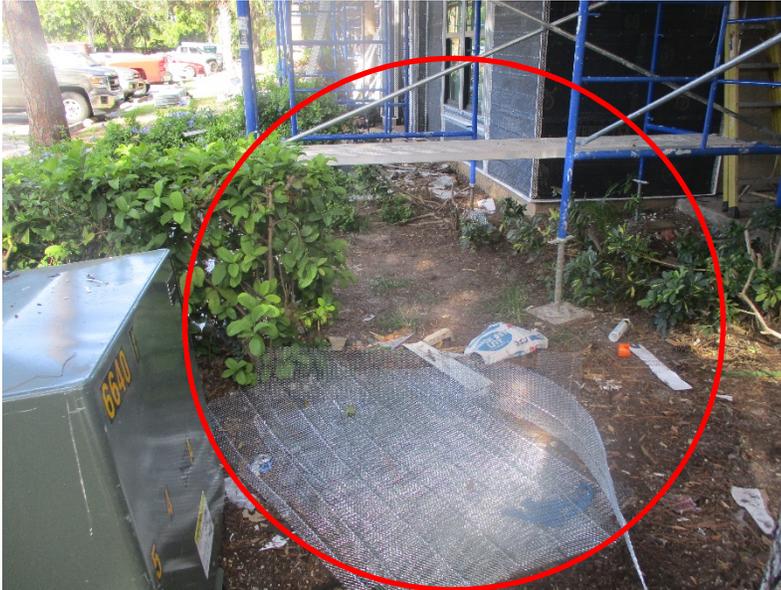
PHOTOGRAPH #9

**BUILDING 27
SECTION B**

Debris and materials left remaining around building site not within a fenced construction area.

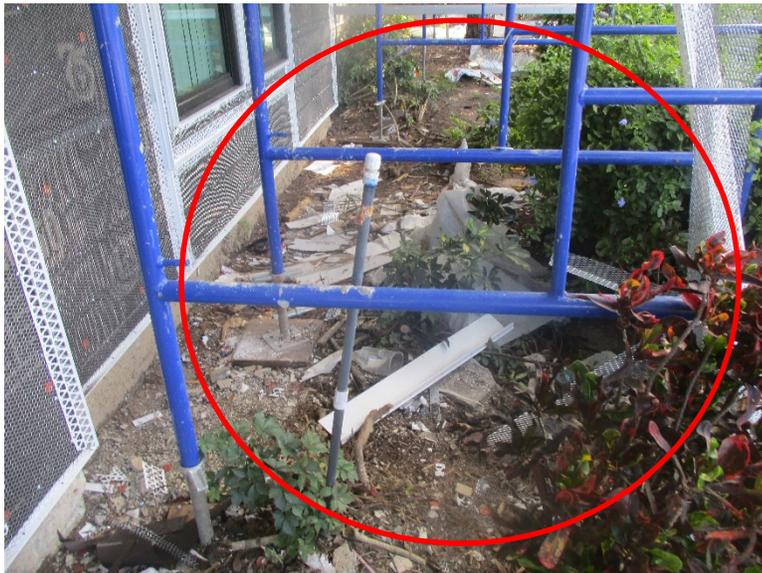
PHOTOGRAPH #10

**BUILDING 27
SECTION B**

Debris and materials left remaining around building site not within a fenced construction area.

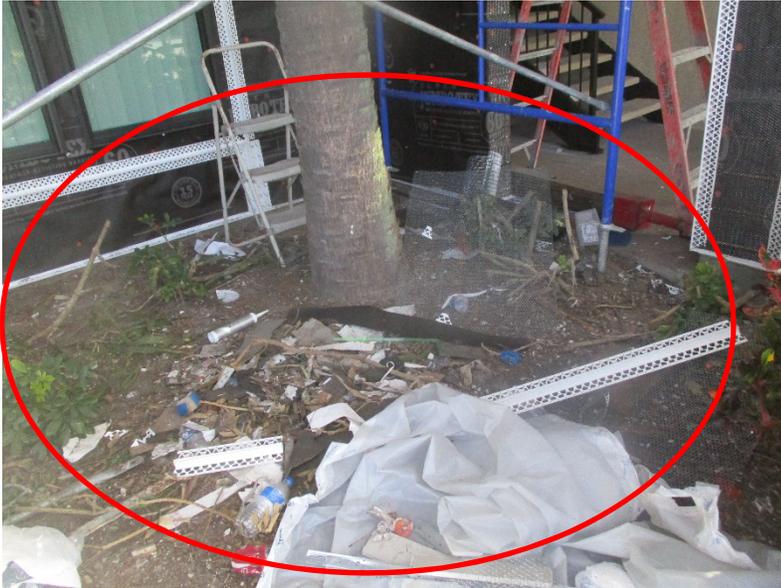
PHOTOGRAPH #11

**BUILDING 27
SECTION B**

Debris and materials left remaining around building site not within a fenced construction area.

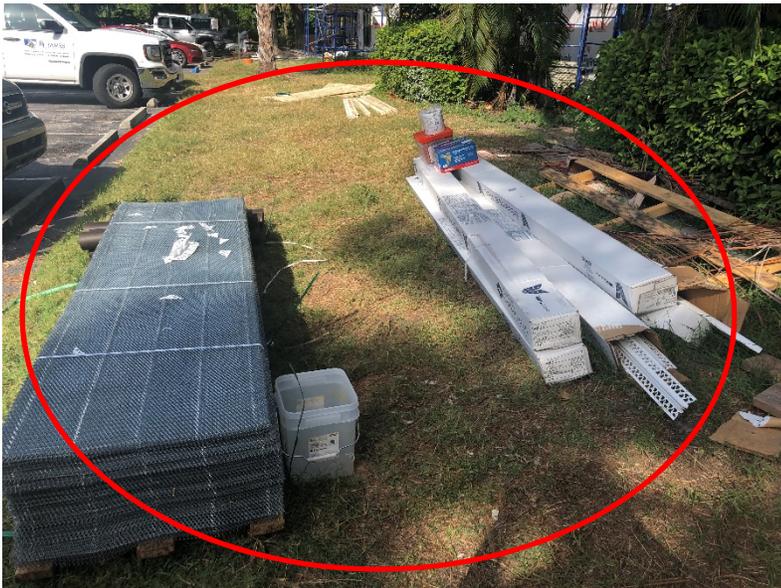
PHOTOGRAPH #12

**BUILDING 27
SECTION B**

Debris and materials left remaining around building site not within a fenced construction area.

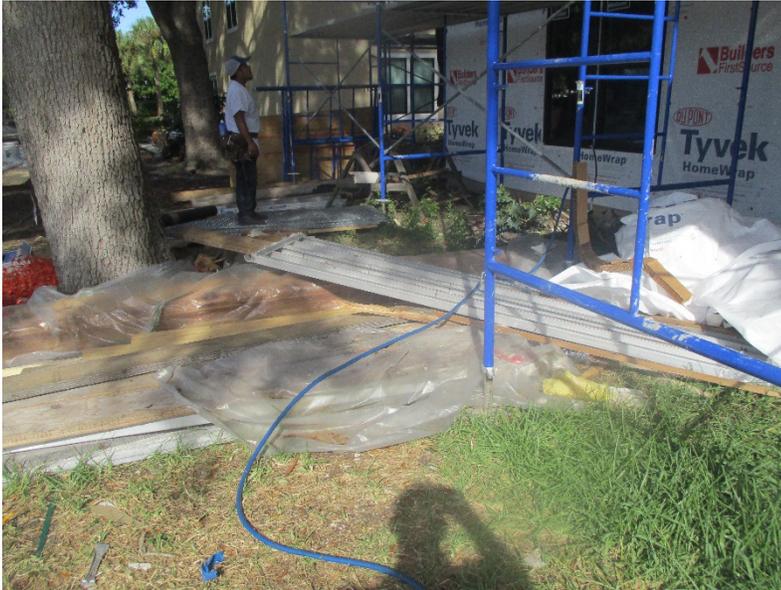
PHOTOGRAPH #13

**BUILDING 27
SECTION A**

Debris and materials left remaining around building site not within a fenced construction area.

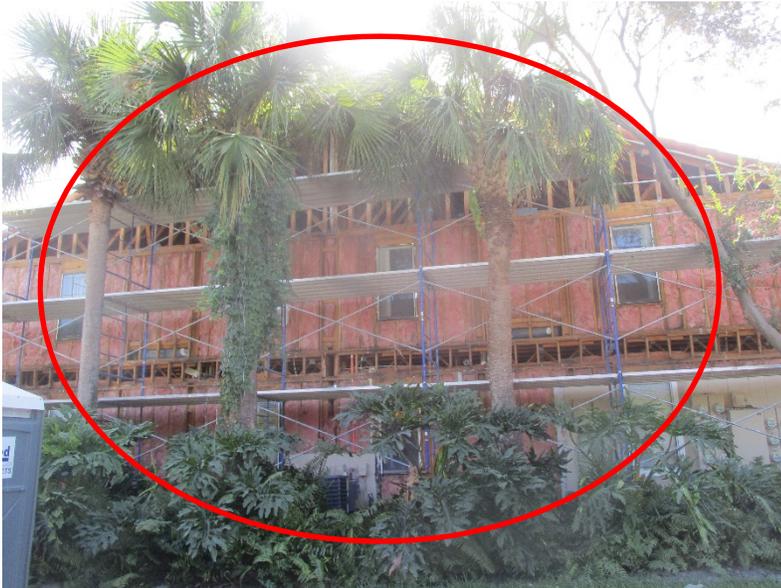
PHOTOGRAPH #14

**BUILDING 10
SECTION D**

Damages identified and marked for repairs.

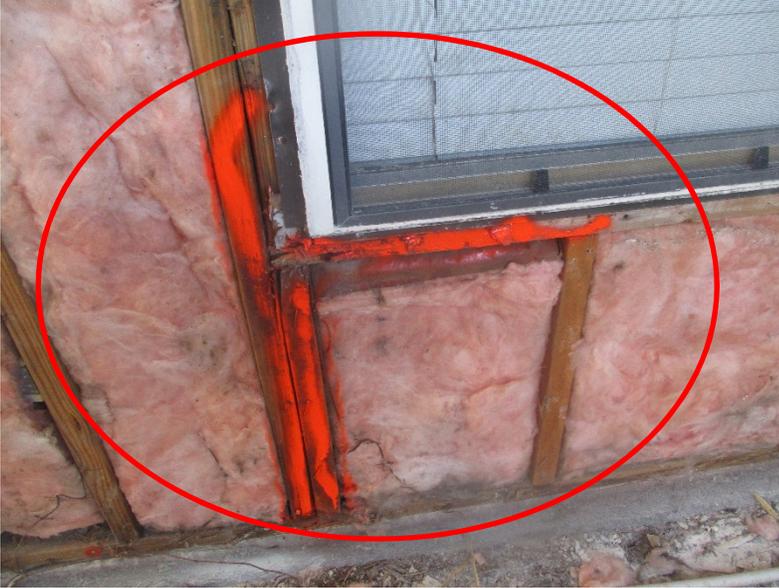
PHOTOGRAPH #15

**BUILDING 10
SECTION D**

Damages identified and marked for repairs.

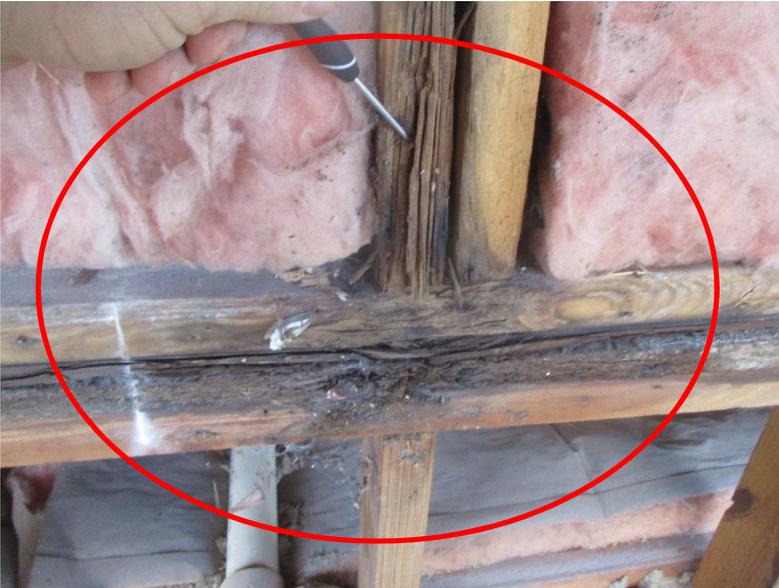
PHOTOGRAPH #16

**BUILDING 10
SECTION D**

Damages identified and marked for repairs.

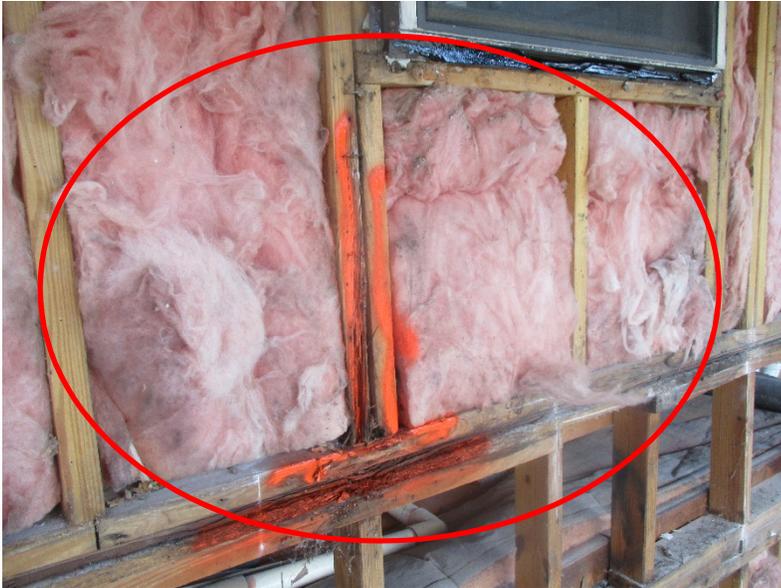
PHOTOGRAPH #17

**BUILDING 10
SECTION D**

Damages identified and marked for repairs.

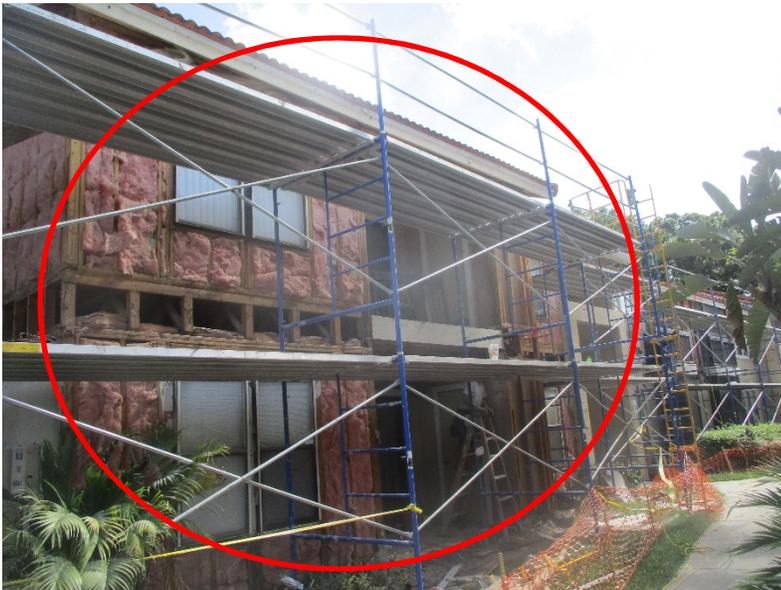
PHOTOGRAPH #18

**BUILDING 10
SECTION E**

Damages identified and marked for repairs.

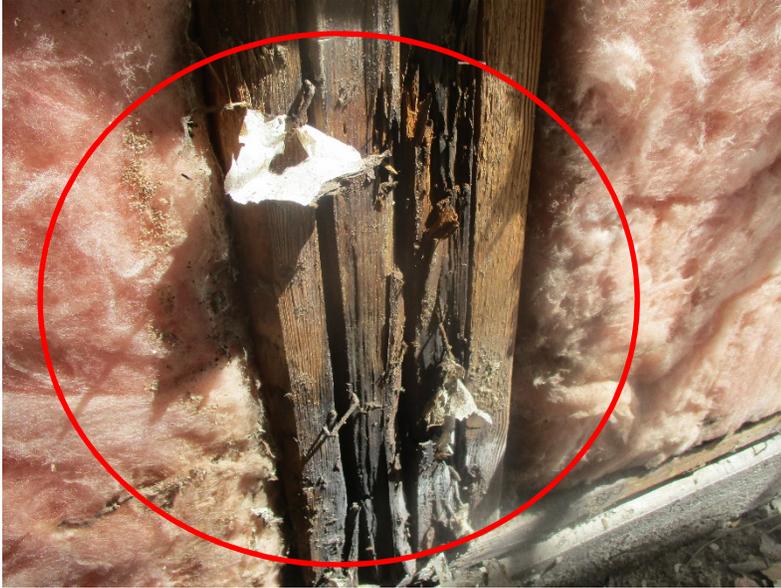
PHOTOGRAPH #19

**BUILDING 10
SECTION E**

Damages identified and marked for repairs.

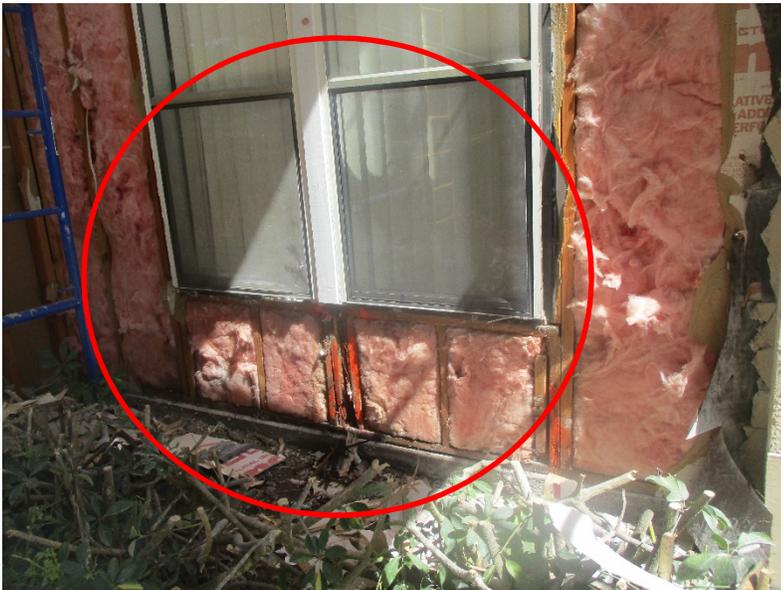
PHOTOGRAPH #20

**BUILDING 10
SECTION E**

Damages identified and marked for repairs.
