PHOTOGRAPHS

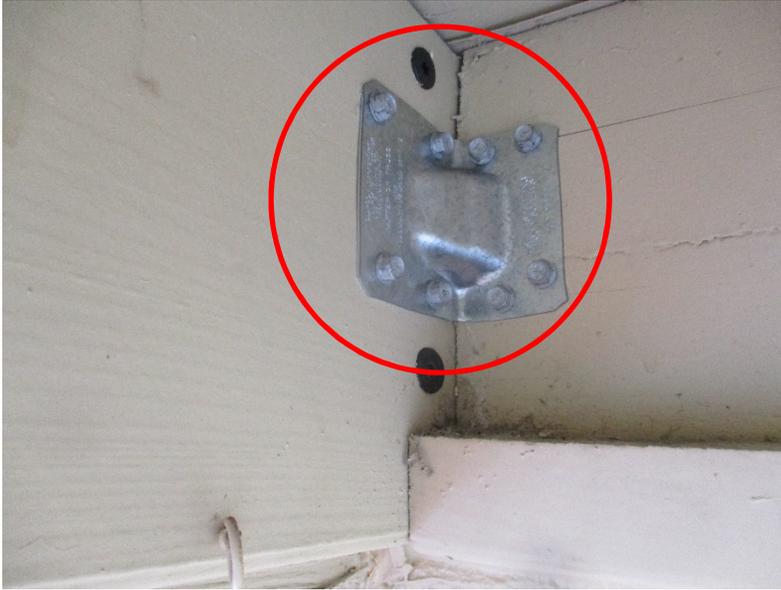
PHOTOGRAPH #1

**BUILDING 27
UNIT #2718-SECTION G**

Contractor has installed Simpson HGA10KT shear clip instead of specified HSLQ37 shear clips. Delta informed contractor to replace.

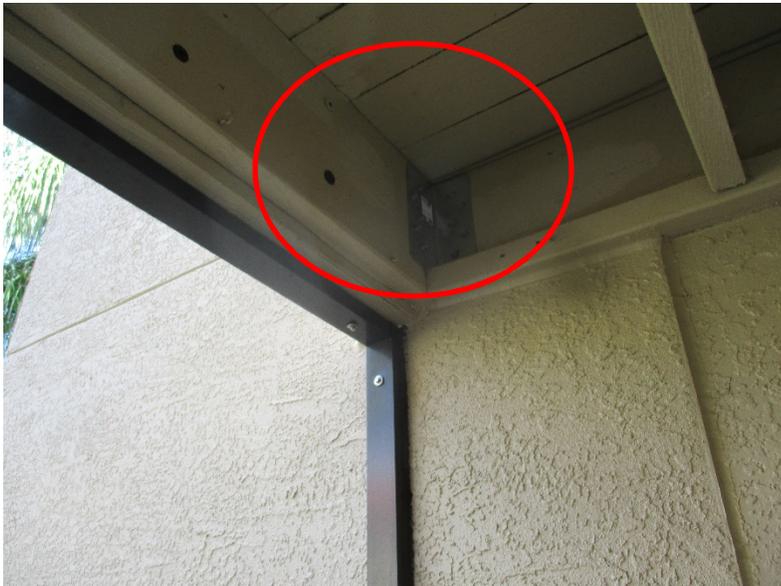
PHOTOGRAPH #2

**BUILDING 27
UNIT #2718-SECTION G**

Contractor has installed Simpson HSLQ37 shear clips, as well as #SDW22458 screws at built-up rail beam.

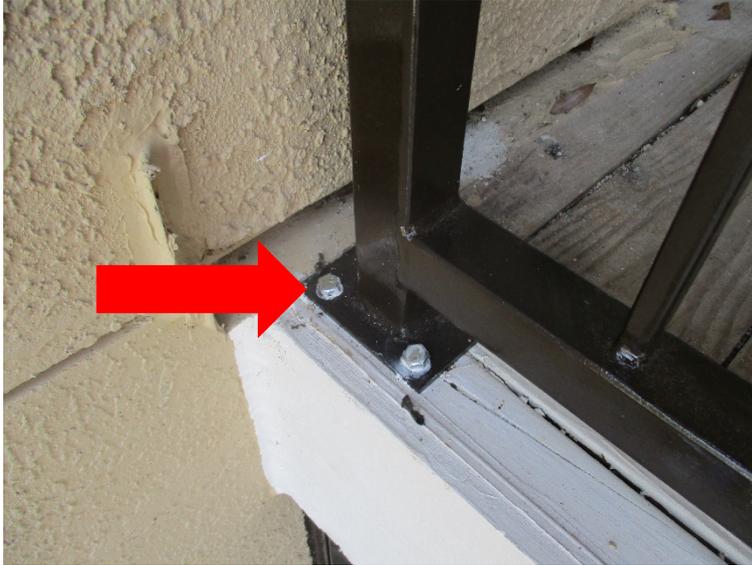
PHOTOGRAPH #3

**BUILDING 27
SECTION G**

Contractor has installed 4" steel lag screws at steel rail post. Delta informed contractor galvanized lag screws are required.

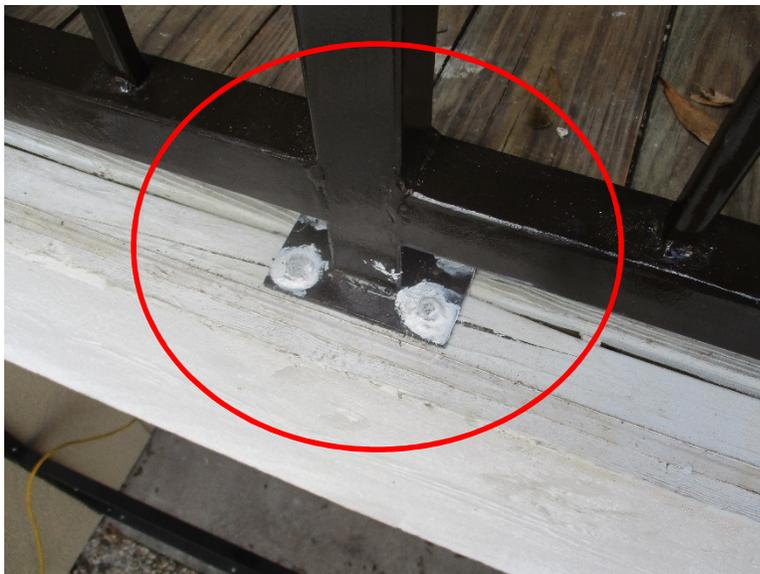
PHOTOGRAPH #4

**BUILDING 27
SECTION G**

Contractor has replaced steel lag screws with 4" galvanized lag screws.

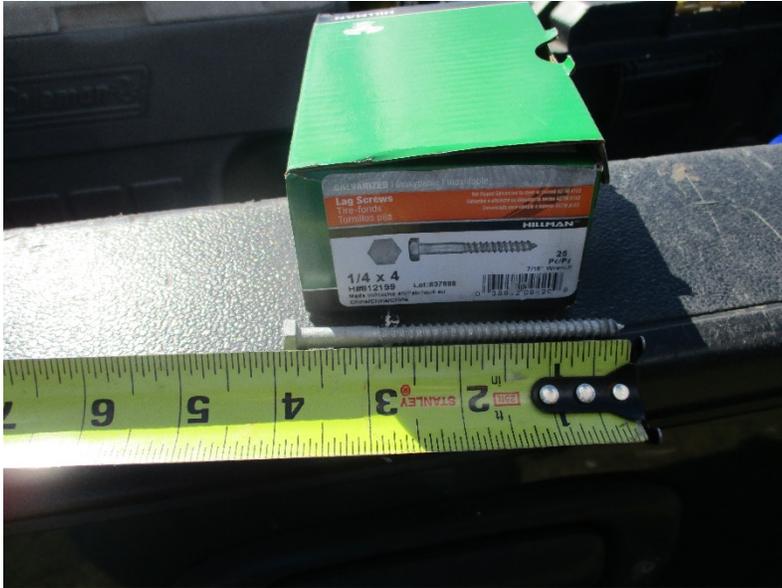
PHOTOGRAPH #5

**BUILDING 27
SECTION G**

Contractor has replaced steel lag screws with 4" galvanized lag screws.

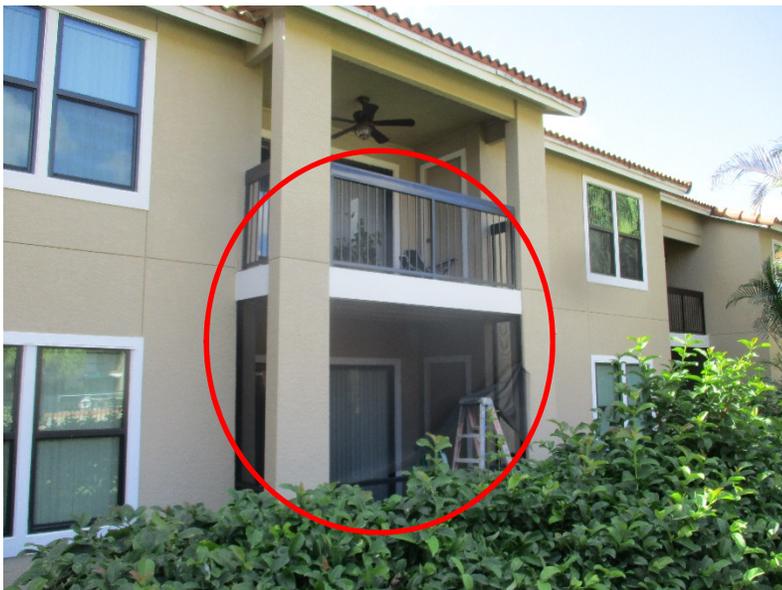
PHOTOGRAPH #6

**BUILDING 27
SECTION F**

Contractor is installing railings and screen enclosures at upper and lower lanais.

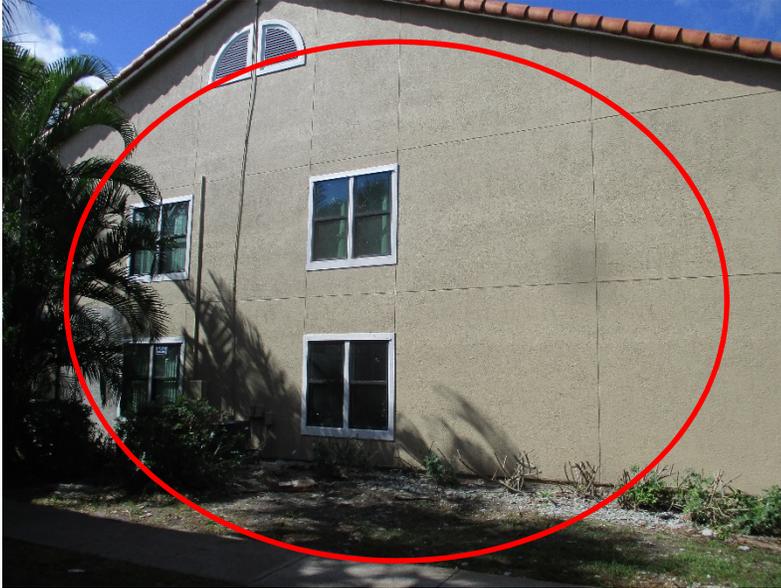
PHOTOGRAPH #7

**BUILDING 27
SECTION D**

Contractor has removed scaffolding.

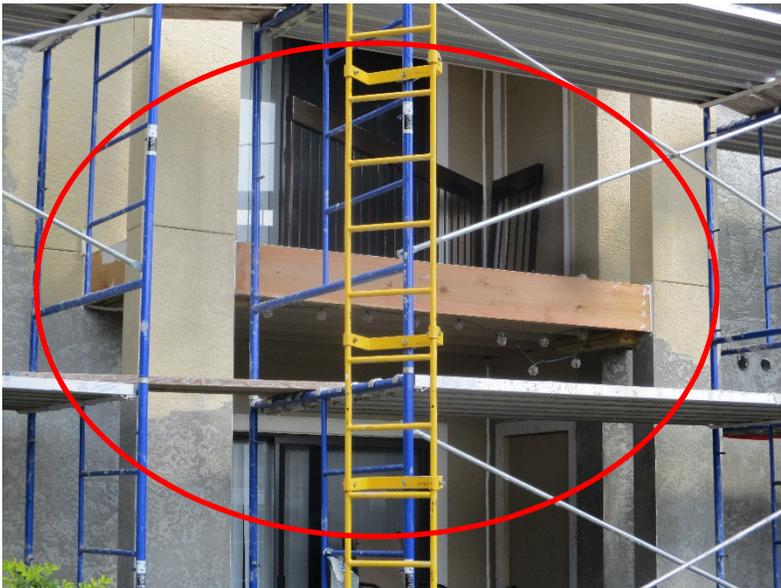
PHOTOGRAPH #8

**BUILDING 27
SECTION B**

Contractor has completed rail beam detail by adding cedar trim boards.

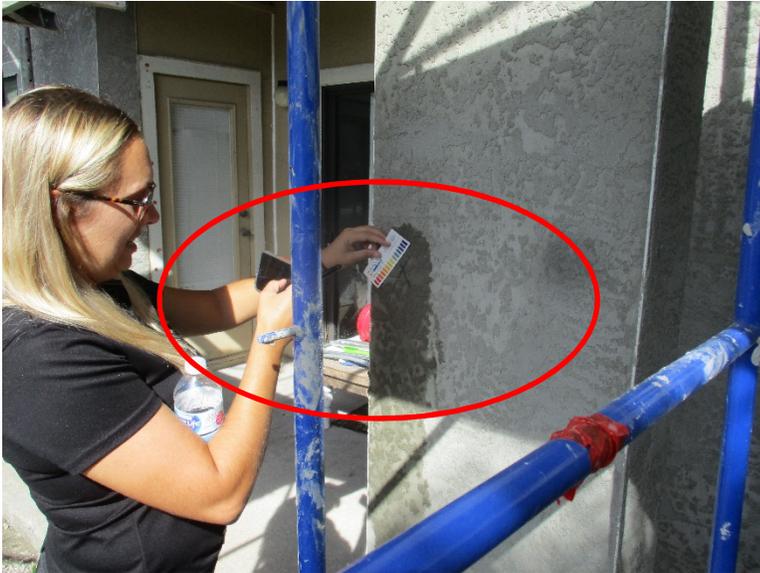
PHOTOGRAPH #9

**BUILDING 27
SECTION B**

Florida Paint representative performed PH test of new stucco for approval of paint applications.

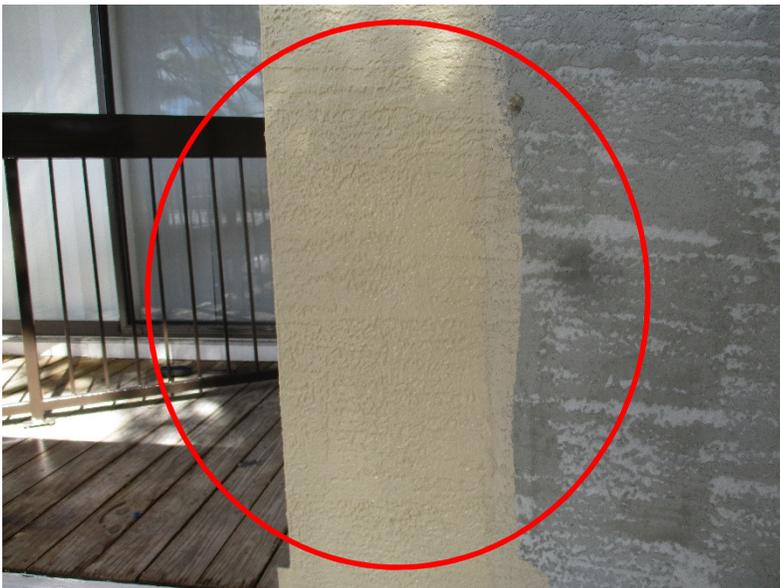
PHOTOGRAPH #10

**BUILDING 27
SECTION B**

Contractor has begun to apply primer and finish coats of paint at new stucco.

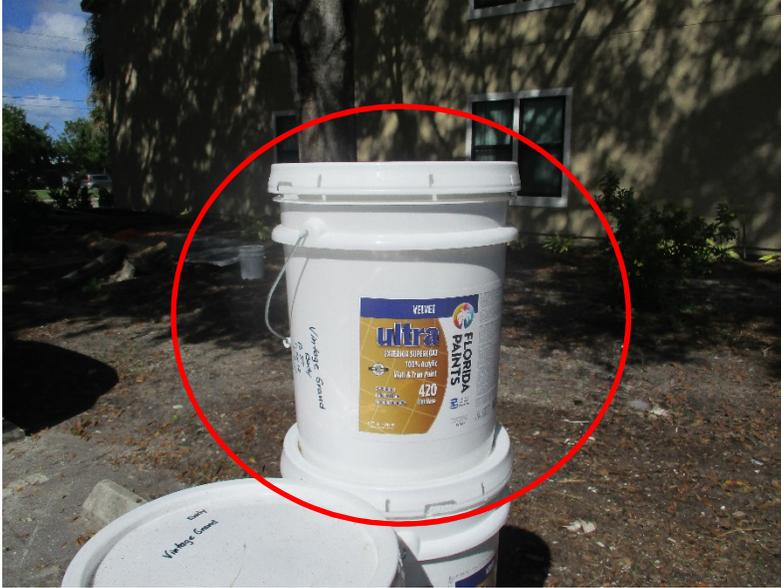
PHOTOGRAPH #11

**BUILDING 27
SECTION B**

Contractor has begun to apply primer and finish coats of paint at new stucco.

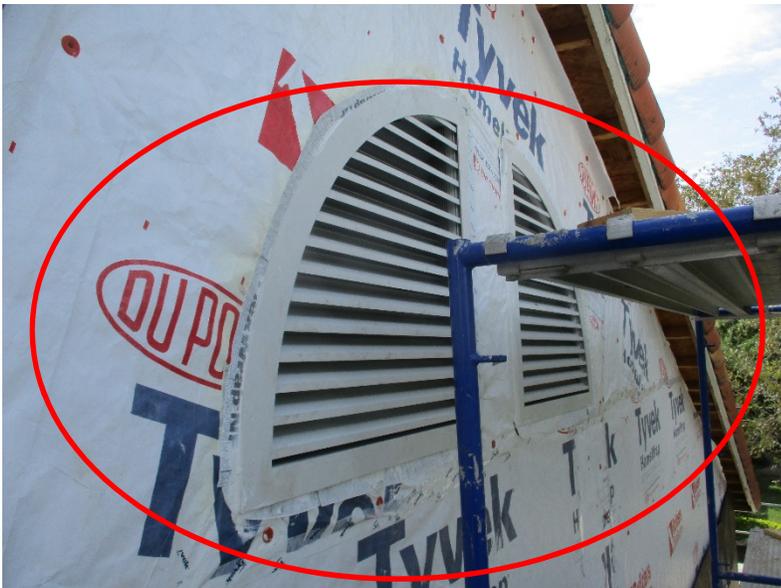
PHOTOGRAPH #12

**BUILDING 10
SECTION D**

Contractor has installed new GreenHeck louvers.

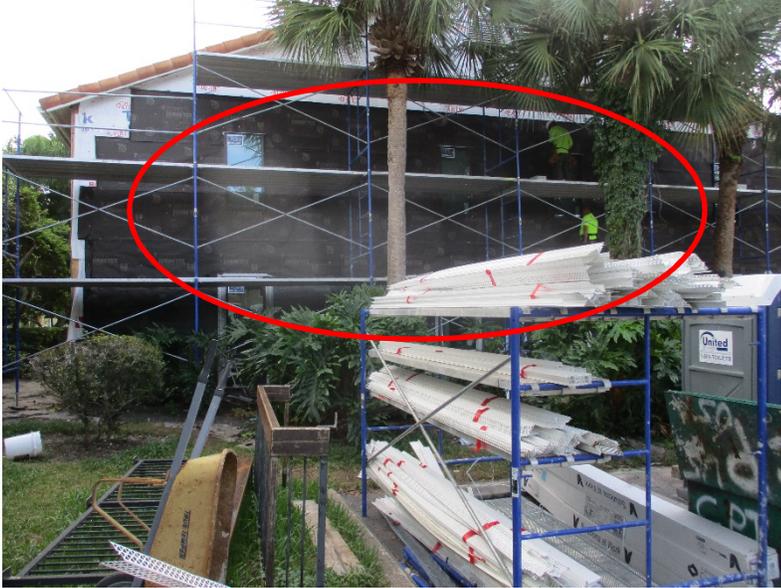
PHOTOGRAPH #13

**BUILDING 10
SECTION D**

Sub-contractor is installing JumboTex WRB over Tyvek HomeWrap.

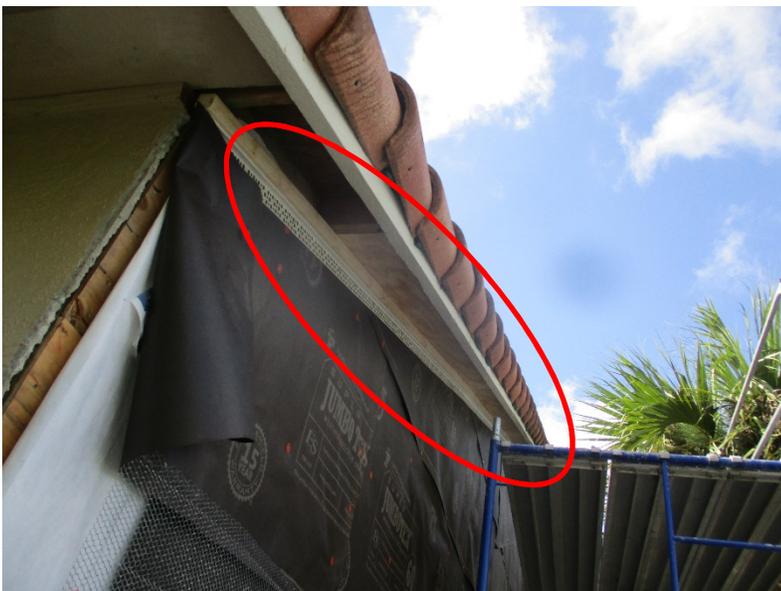
PHOTOGRAPH #14

**BUILDING 10
SECTION D**

New soffit has been installed and stucco accessories are being installed.

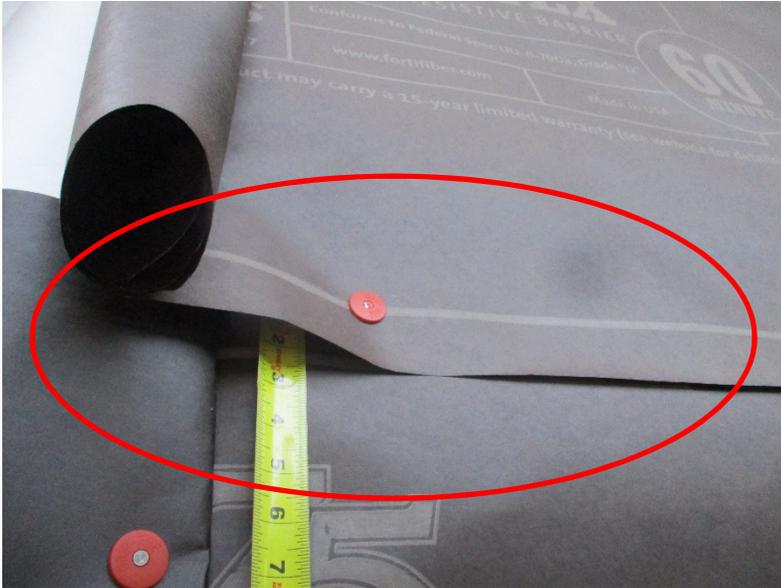
PHOTOGRAPH #15

**BUILDING 10
SECTION D**

JumboTex 60 WRB overlapped horizontally 2 inches minimum.

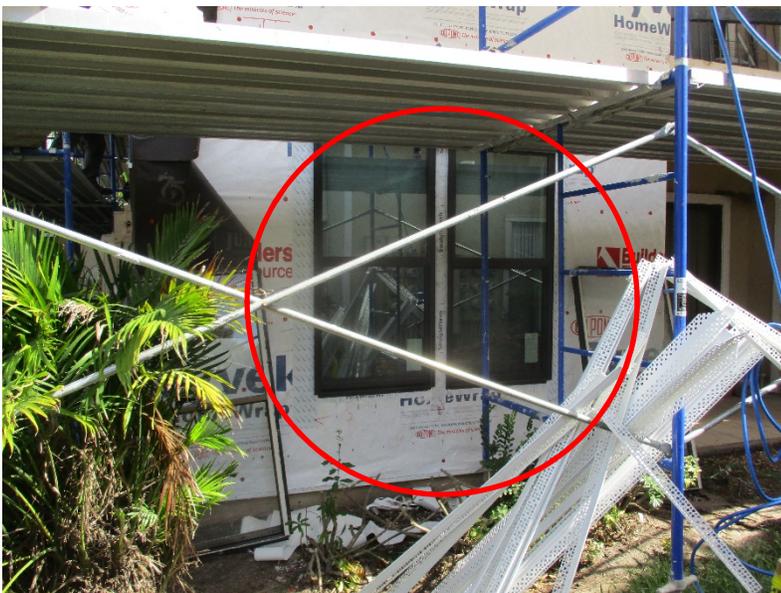
PHOTOGRAPH #16

**BUILDING 10
SECTION E**

DuPont flashings and PGT windows installed.

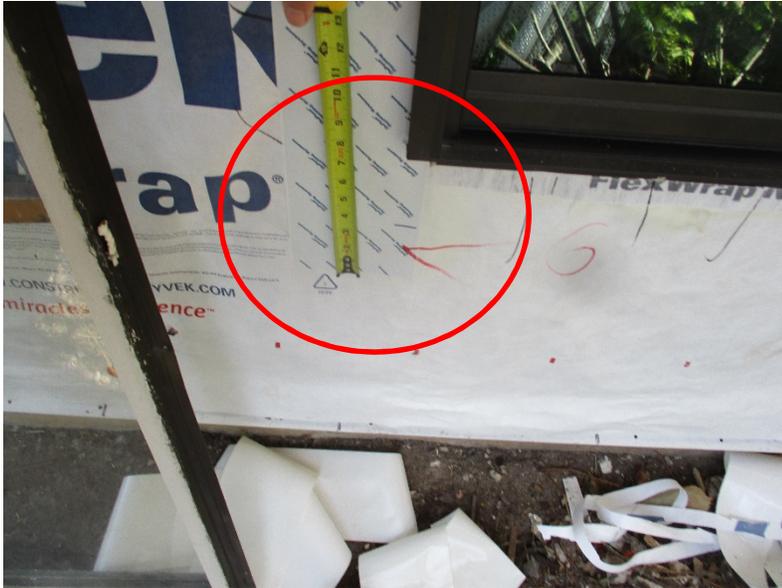
PHOTOGRAPH #17

**BUILDING 10
SECTION E**

DuPont StraightFlash has been installed over window fin and extended down 6 inches.

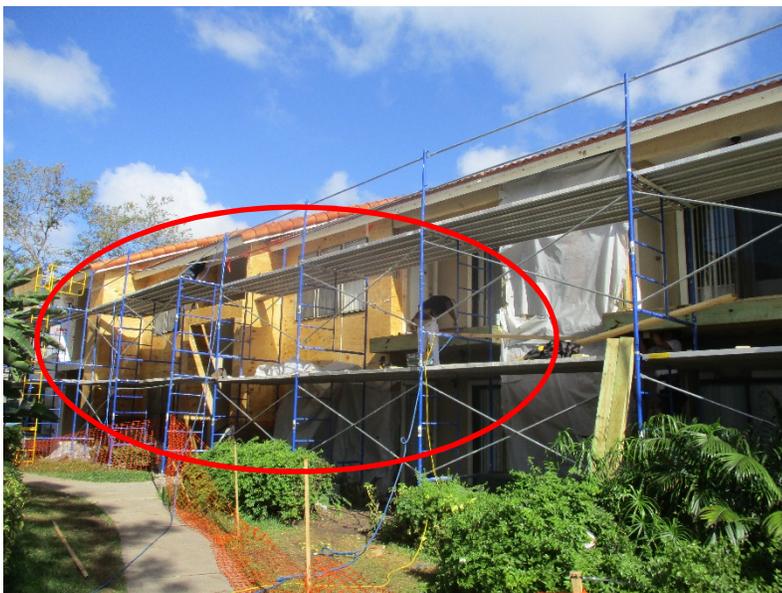
PHOTOGRAPH #18

**BUILDING 10
SECTION F**

Contractor is installing 15/32" plywood sheathing.

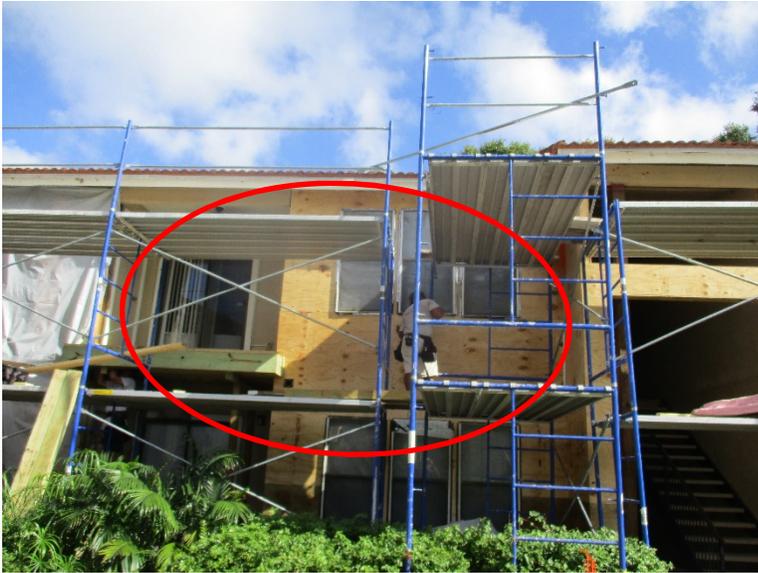
PHOTOGRAPH #19

**BUILDING 10
SECTION D**

Contractor is installing 15/32" plywood sheathing.

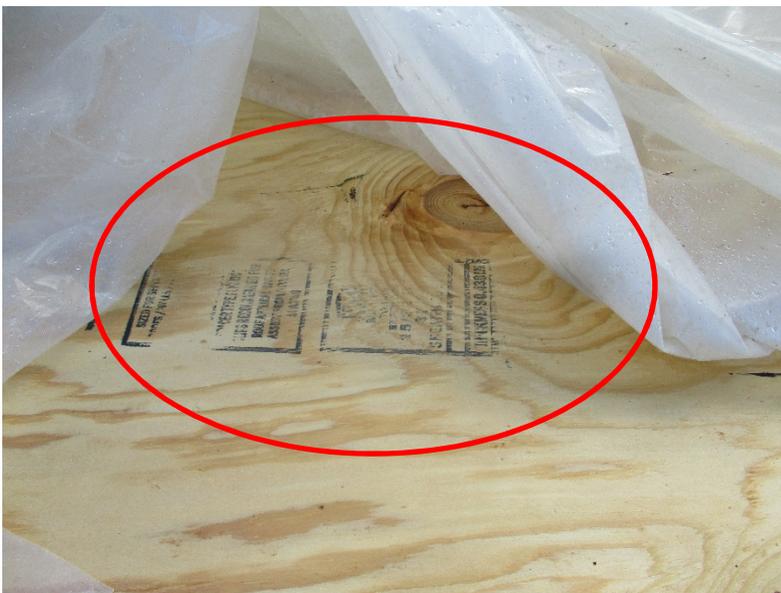
PHOTOGRAPH #20

**BUILDING 10
SECTION F**

Contractor is installing 15/32" plywood sheathing

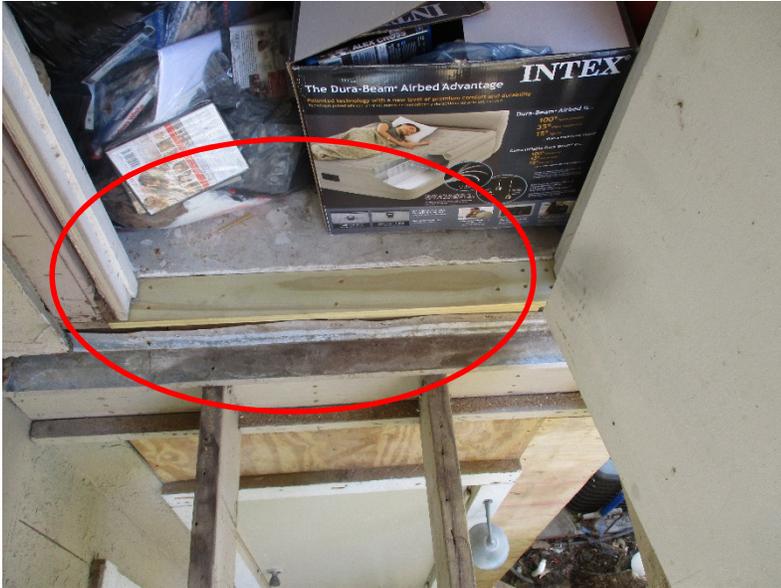
PHOTOGRAPH #21

**BUILDING 10
SECTION F**

Contractor has repaired additional damaged framing at balcony door sills.

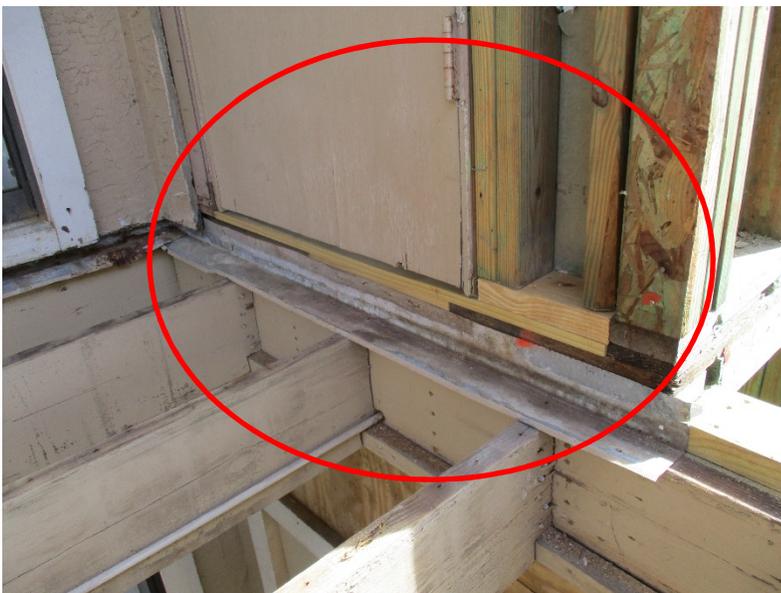
PHOTOGRAPH #22

**BUILDING 10
SECTION F**

Contractor has repaired additional damaged framing at balcony door sills.

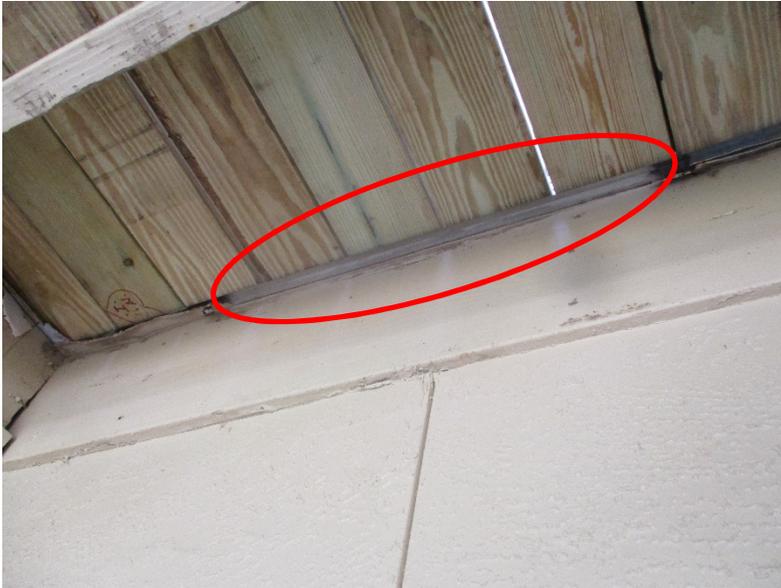
PHOTOGRAPH #23

**BUILDING 10
SECTION F**

Contractor has installed new flashing,
prior to installing new deck boards.

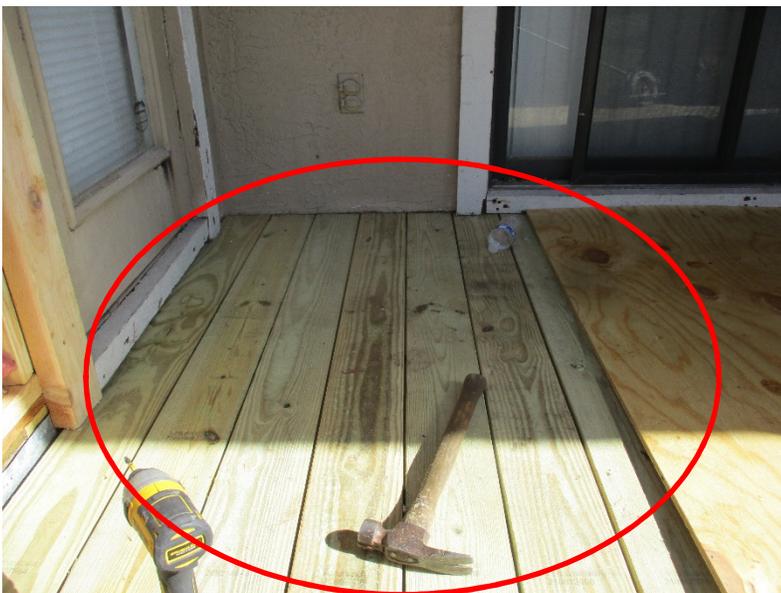
PHOTOGRAPH #24

**BUILDING 10
SECTION F**

New PT 2"x6" decking has been installed
at Type A1 balconies.

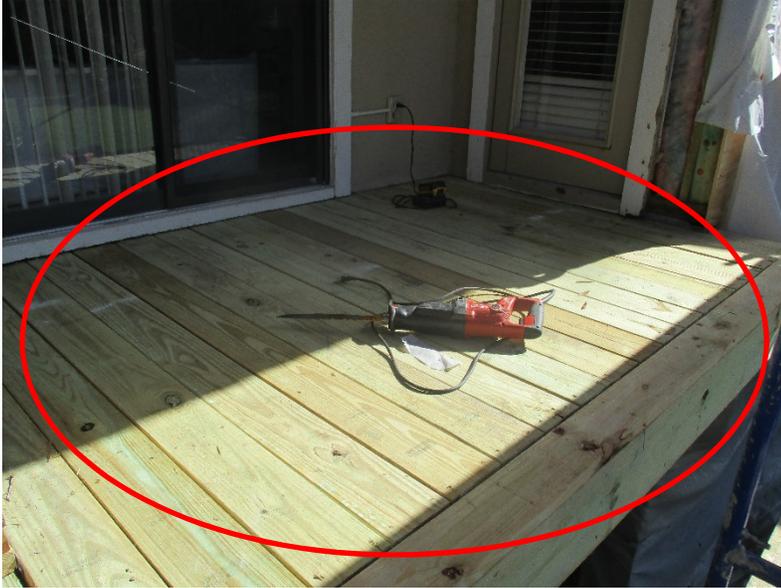
PHOTOGRAPH #25

**BUILDING 10
SECTION F**

New PT 2"x6" decking has been installed at Type A1 balconies.

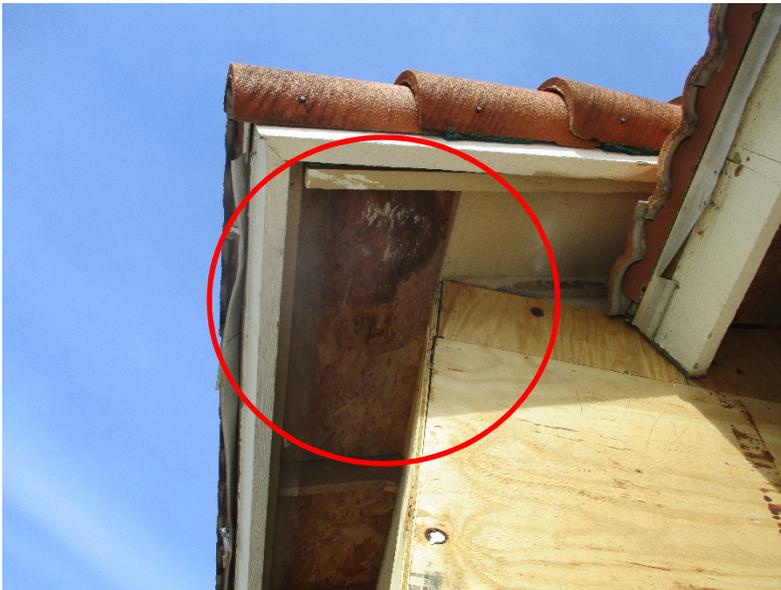
PHOTOGRAPH #26

**BUILDING 10
SECTION F**

Roof sheathing water damage. Owners responsible for repairs.

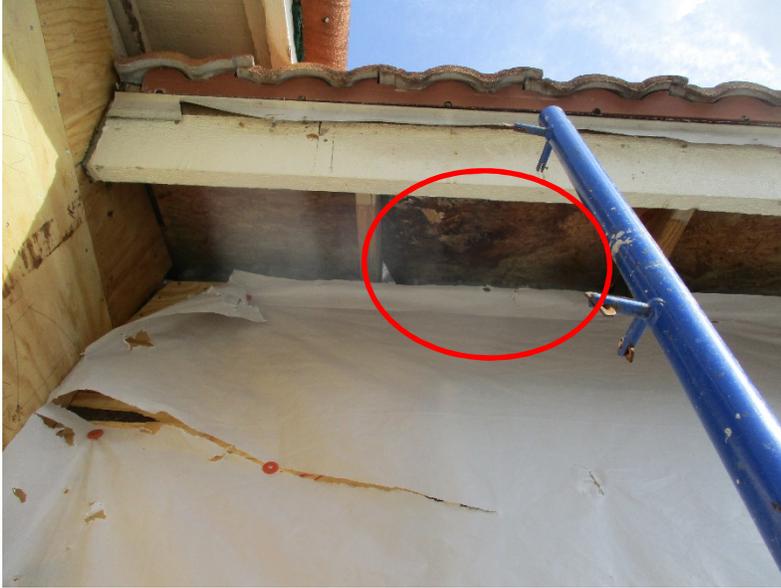
PHOTOGRAPH #27

**BUILDING 10
SECTION F**

Roof sheathing water damage. Owners responsible for repairs.
