PHOTOGRAPHS

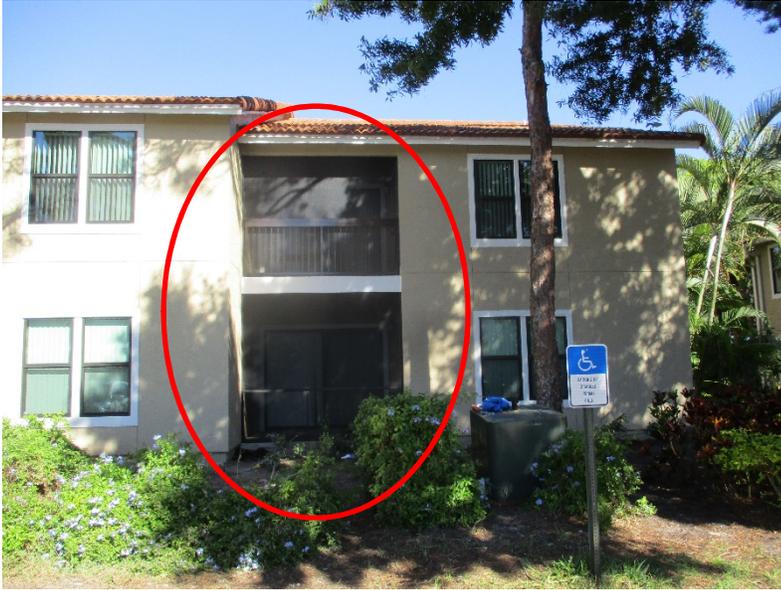
PHOTOGRAPH #1

BUILDING 27 SECTION C

Contractor has installed screen enclosures.

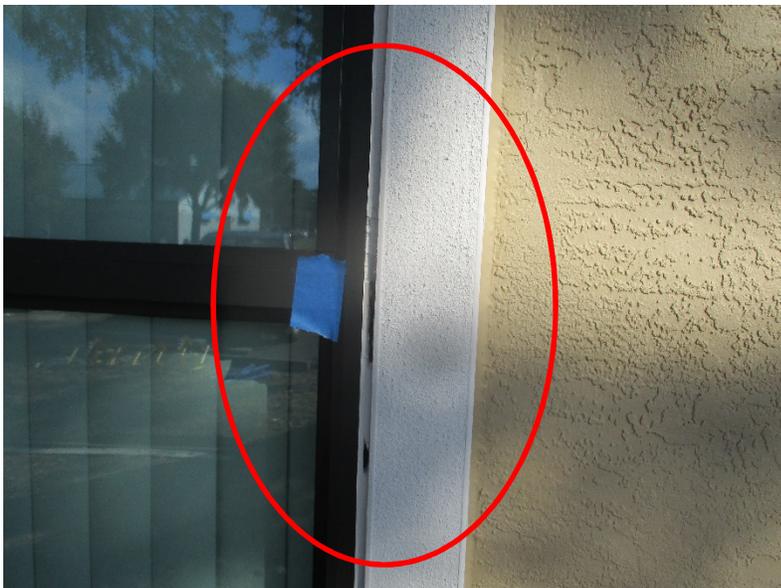
PHOTOGRAPH #2

BUILDING 27 SECTION A

BASF representative has done sealant pull tests.

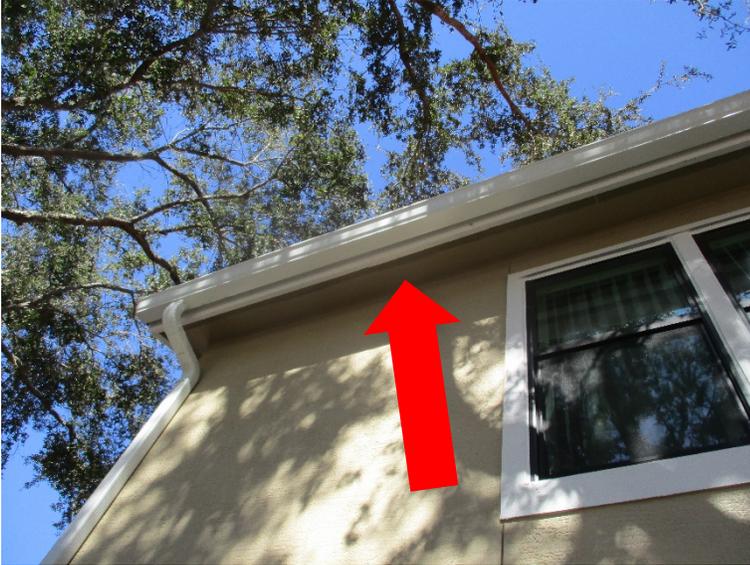
PHOTOGRAPH #3

**BUILDING 27
SECTION A – PUNCH ITEM**

Split seam at small section of soffit wood to soffit screen.

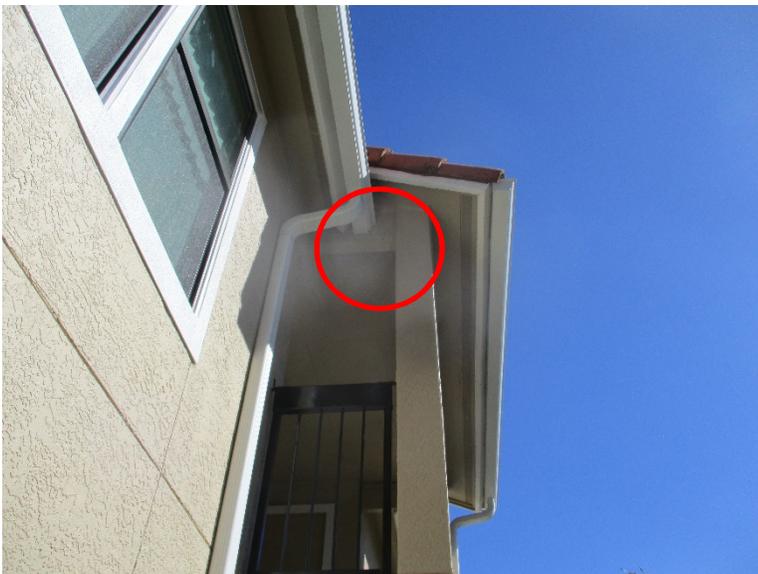
PHOTOGRAPH #4

**BUILDING 27
SECTION B- PUNCH ITEM**

Paint missed at balcony beam.

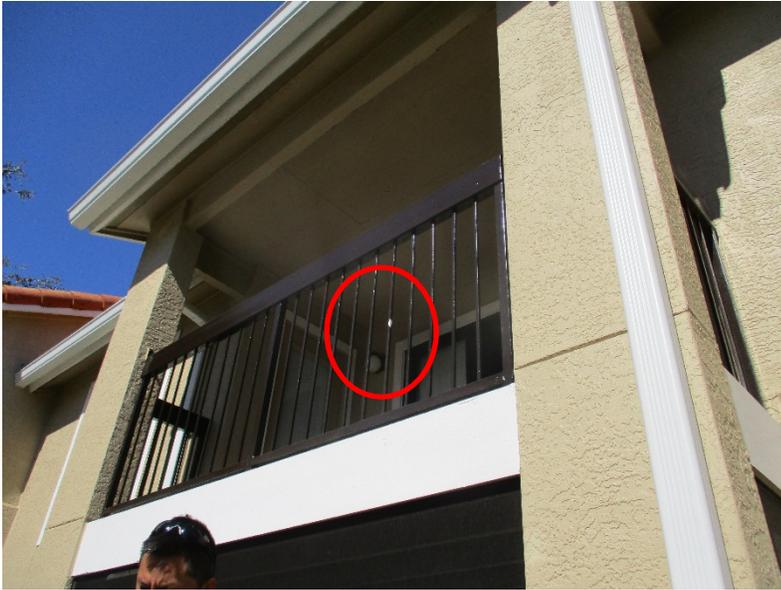
PHOTOGRAPH #5

**BUILDING 27
SECTION B – PUNCH ITEM**

White paint on bronze railing.

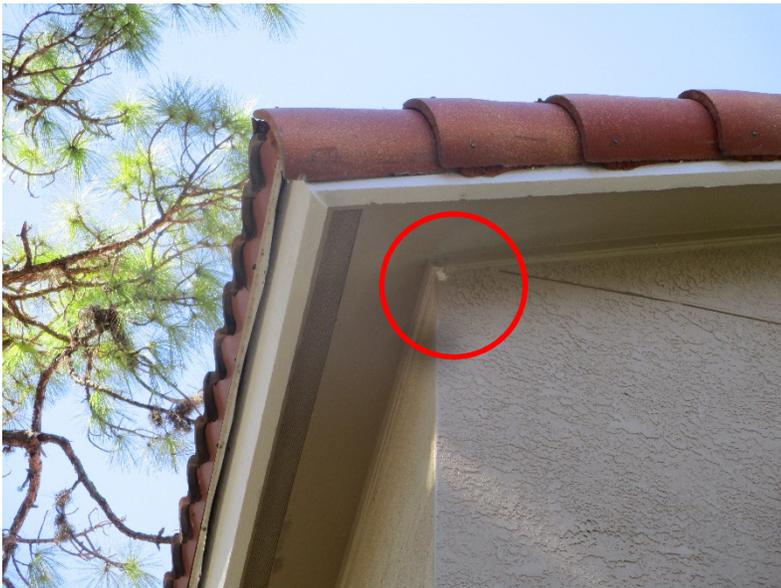
PHOTOGRAPH #6

**BUILDING 27
SECTION D- PUNCH ITEM**

Missed paint at upper corner of stucco.

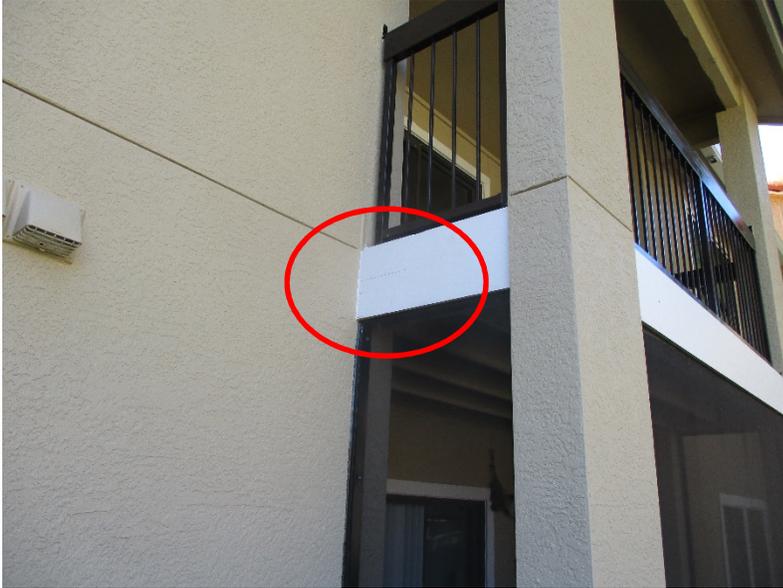
PHOTOGRAPH #7

**BUILDING 27
SECTION F- PUNCH ITEM**

Cedar trim at balcony cracked.

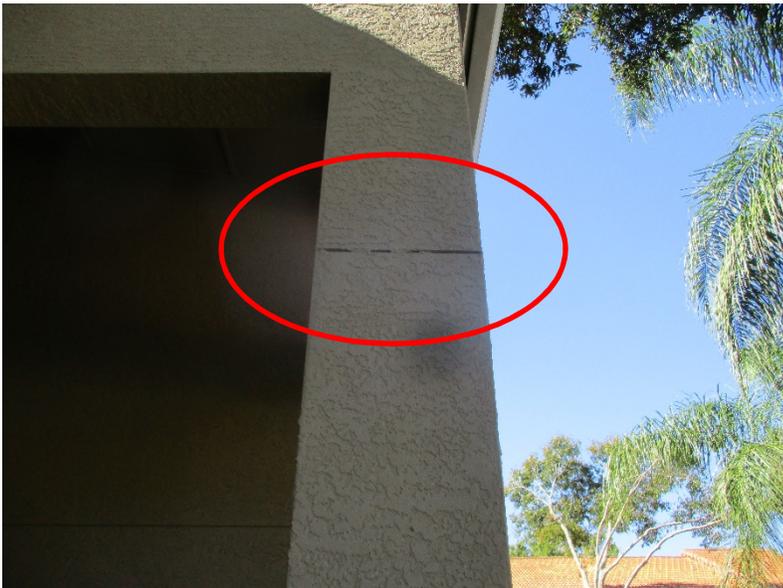
PHOTOGRAPH #8

**BUILDING 27
SECTION B- PUNCH ITEM**

Excessive Stucco in control joint.

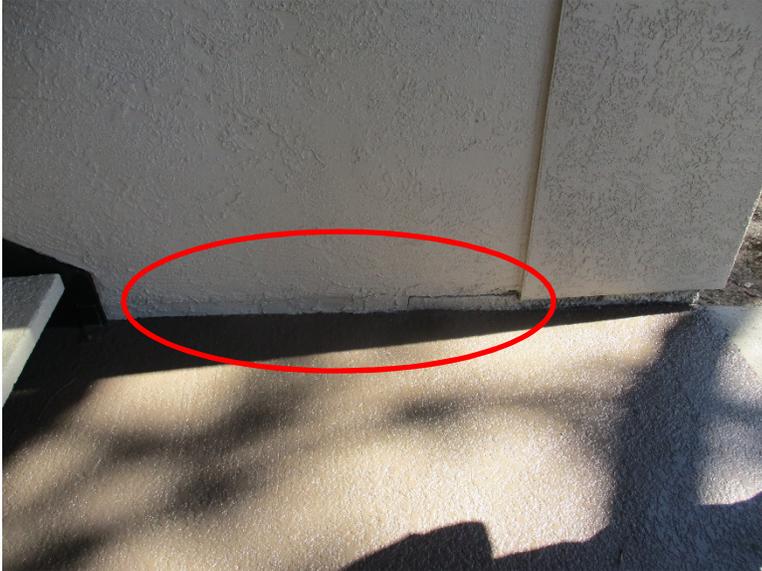
PHOTOGRAPH #9

**BUILDING 27
SECTION B- PUNCH ITEM**

Existing stucco cracked at bottom of breezeway wall.

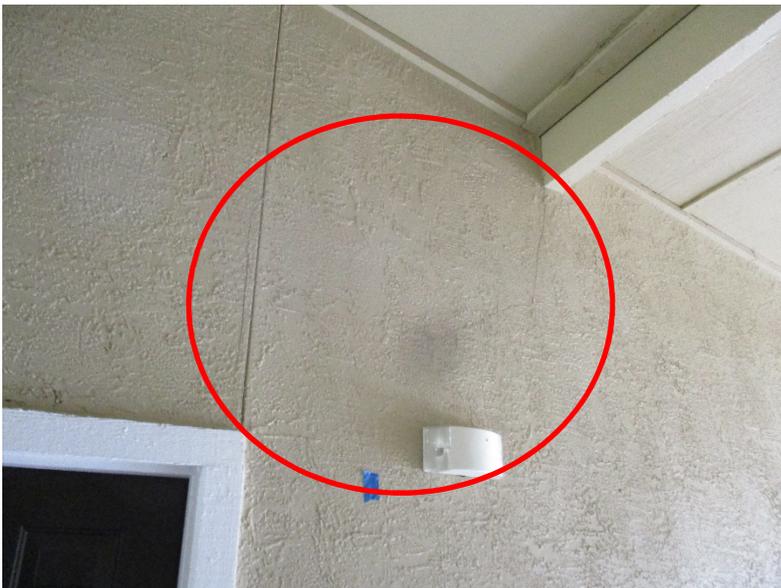
PHOTOGRAPH #10

**BUILDING 27
SECTION B- PUNCH ITEM**

Existing stucco cracked at upper breezeway wall.

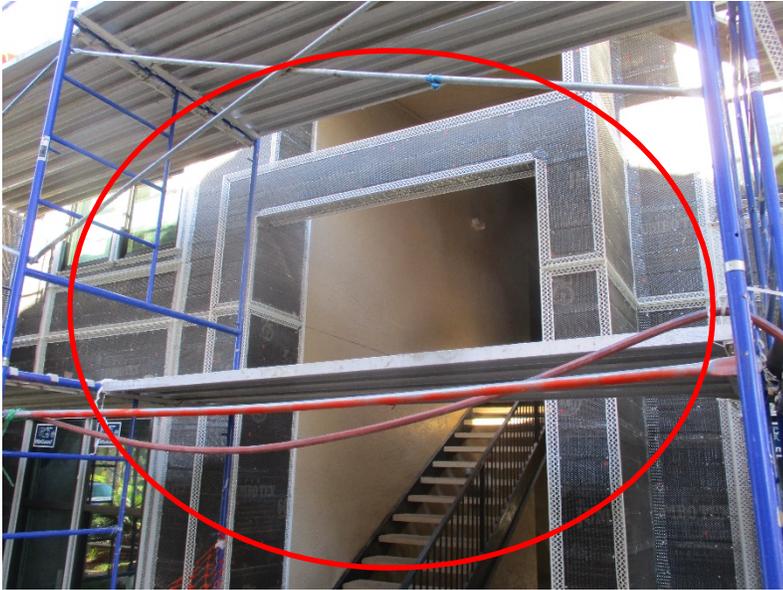
PHOTOGRAPH #11

**BUILDING 10
SECTION E**

Stucco sub-applied stucco accessories and metal lath.

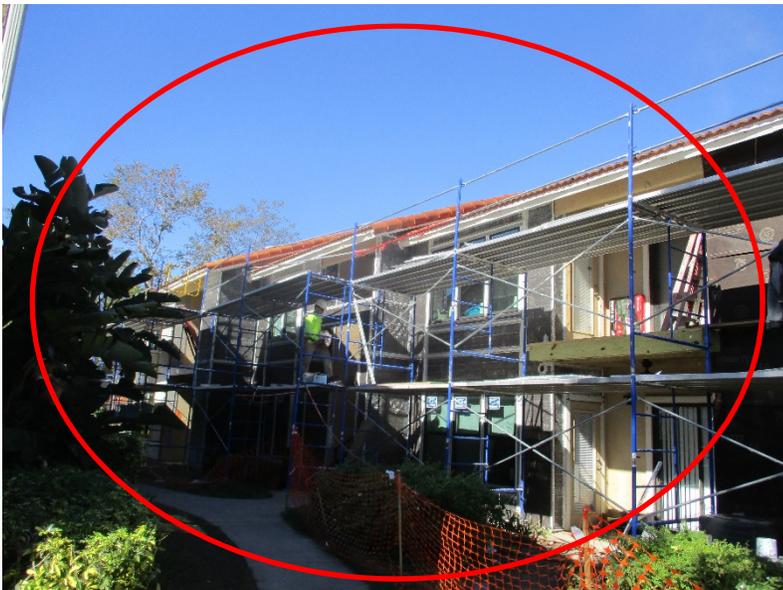
PHOTOGRAPH #12

**BUILDING 10
SECTION F**

Stucco sub-contractor in process of applying JumboTex 60 and stucco accessories.

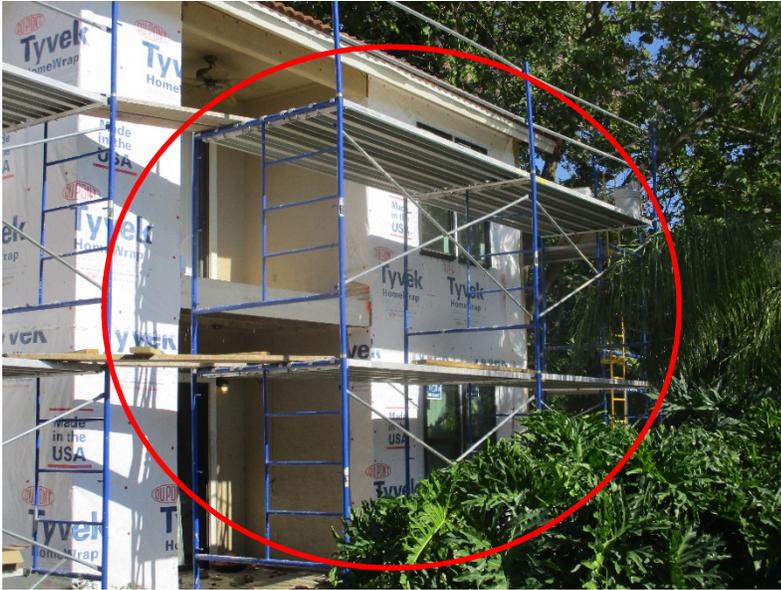
PHOTOGRAPH #13

**BUILDING 10
SECTION G**

Contractor has installed new PGT windows.

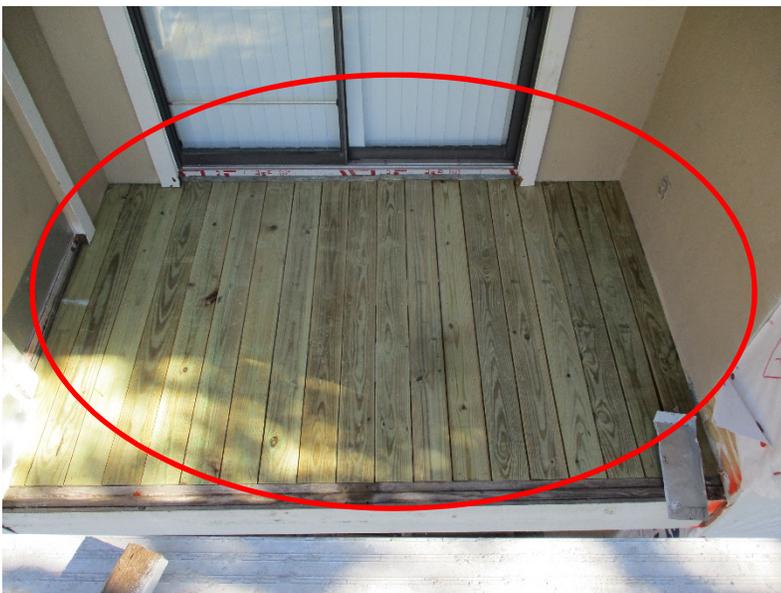
PHOTOGRAPH #14

**BUILDING 10
SECTION G**

Unit #1022- New PT deck boards at balcony.

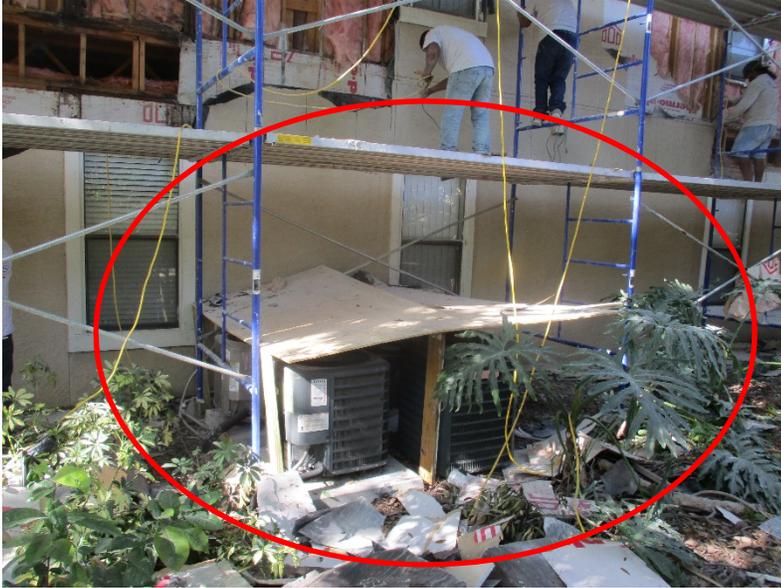
PHOTOGRAPH #15

**BUILDING 10
SECTION H**

Contractor has protected A/C equipment from falling objects during demolition work.

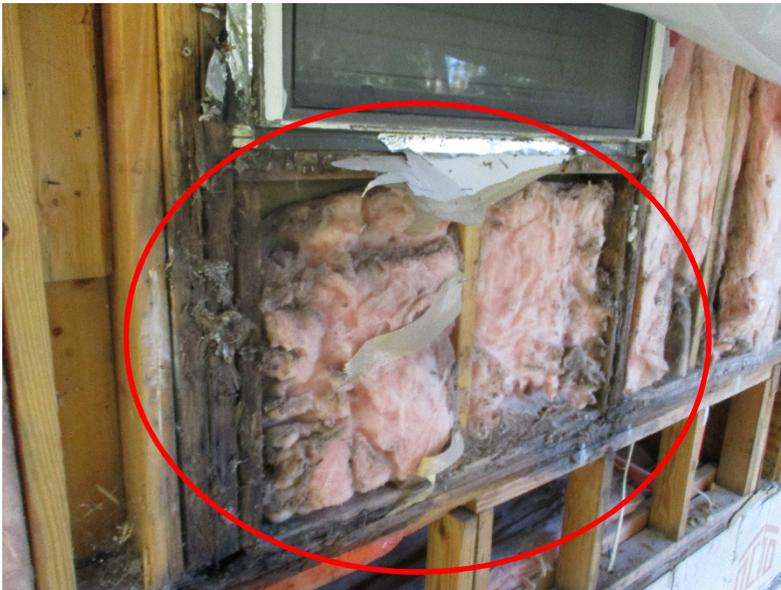
PHOTOGRAPH #16

**BUILDING 10
SECTION H**

Framing damage identified and marked for repairs.

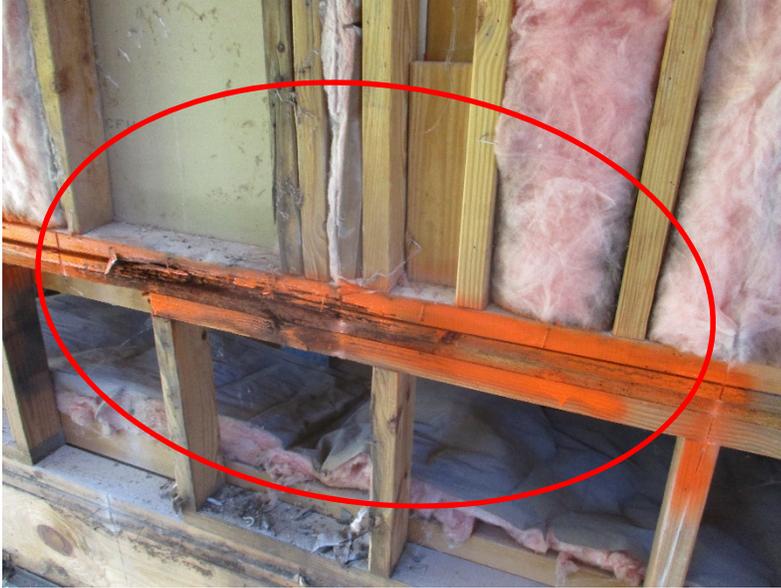
PHOTOGRAPH #17

**BUILDING 10
SECTION H**

Framing damage identified and marked for repairs.

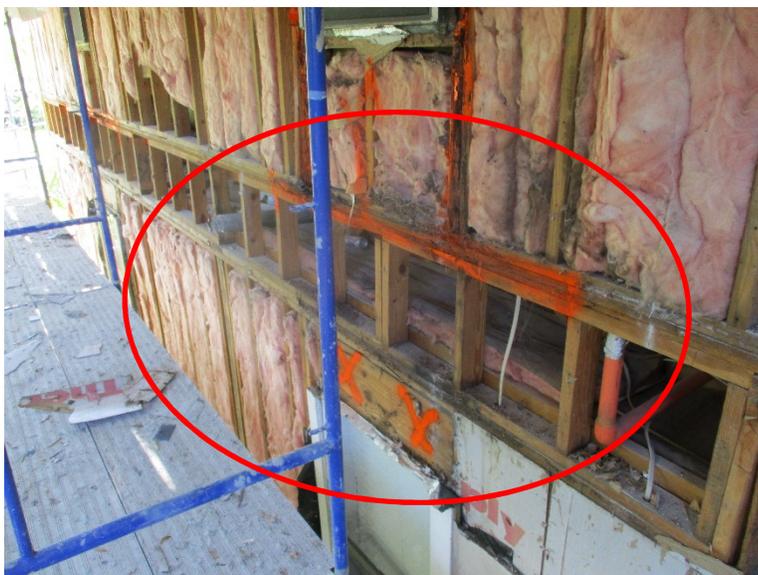
PHOTOGRAPH #18

**BUILDING 10
SECTION H**

Framing damage identified and marked for repairs.

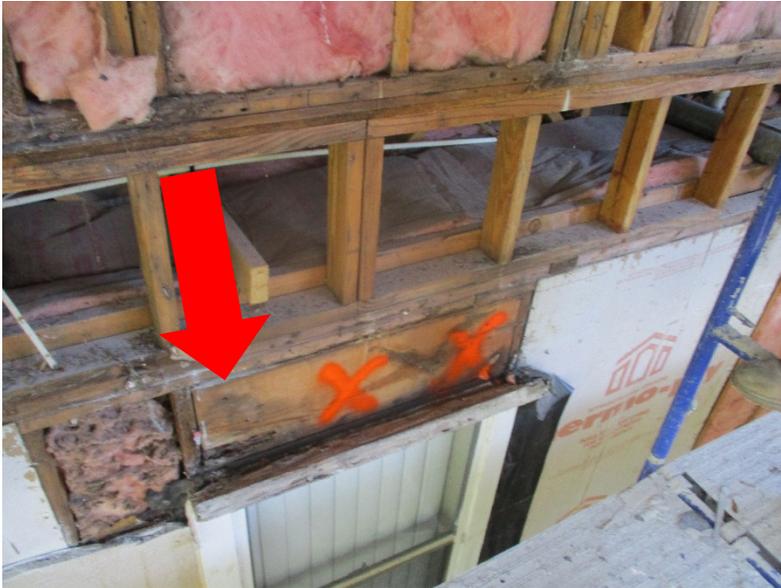
PHOTOGRAPH #19

**BUILDING 10
SECTION H**

Framing damage identified and marked for repairs.

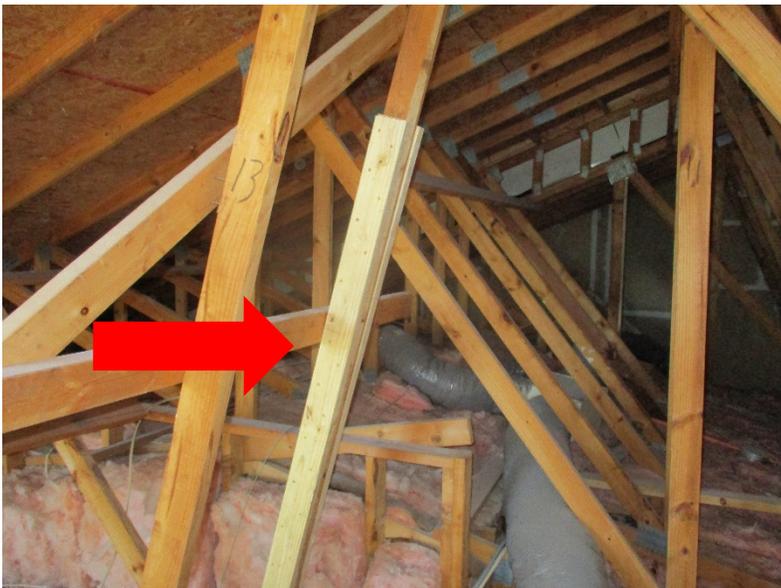
PHOTOGRAPH #20

**BUILDING 10
SECTION H -UNIT #1022**

Contractor has performed framing scab and firewall repairs.

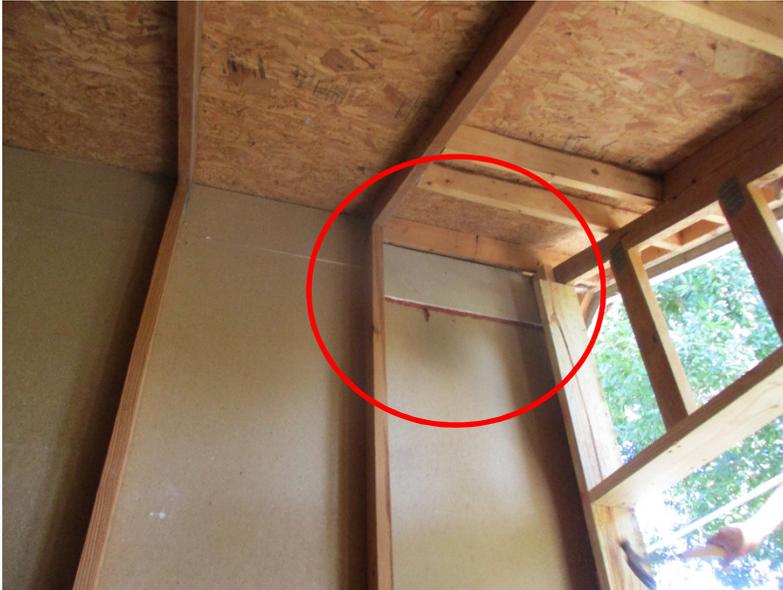
PHOTOGRAPH #21

**BUILDING 10
SECTION H -UNIT #1022**

Contractor has performed framing scab and firewall repairs.

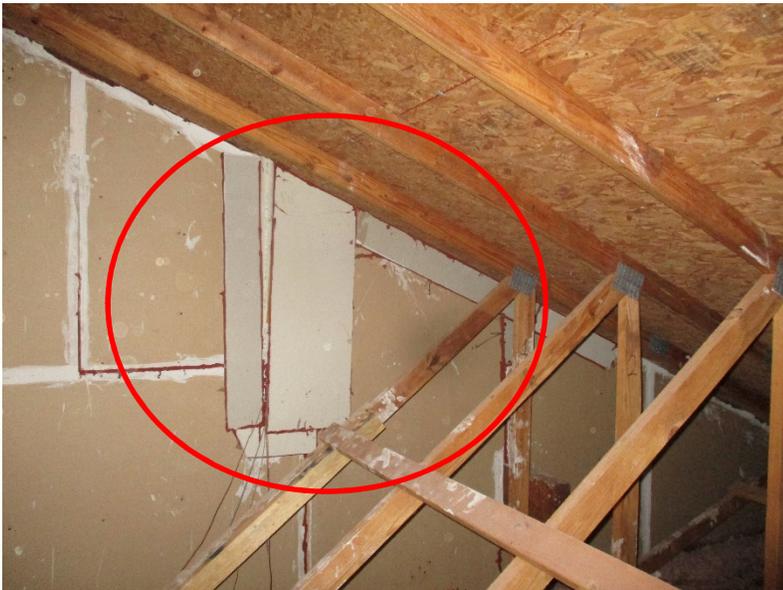
PHOTOGRAPH #22

**BUILDING 10
SECTION H -UNIT #1021**

Contractor has performed framing scab and firewall repairs.

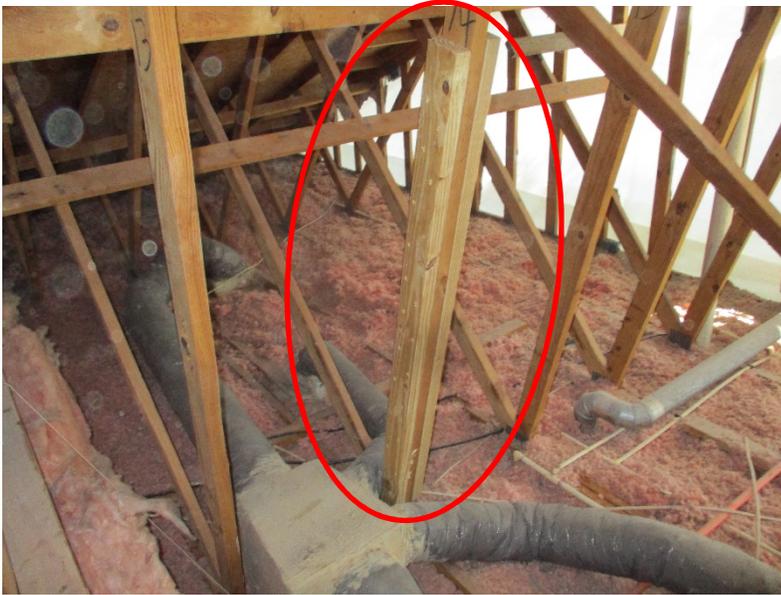
PHOTOGRAPH #23

**BUILDING 10
SECTION H -UNIT #1021**

Contractor has performed framing scab and firewall repairs.

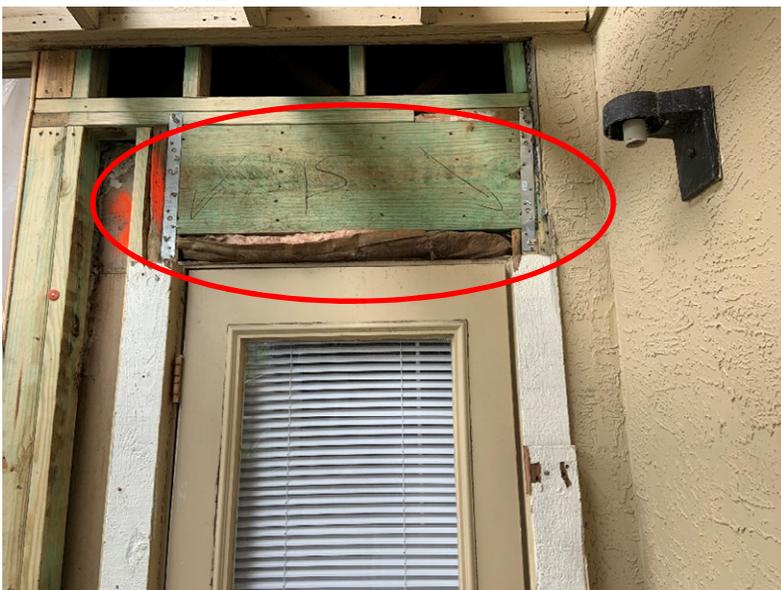
PHOTOGRAPH #24

**BUILDING 10
SECTION F**

Contractor has installed Simpson Strong-Tie Connector straps at door header as per ESI#1.
