**PHOTOGRAPHS**

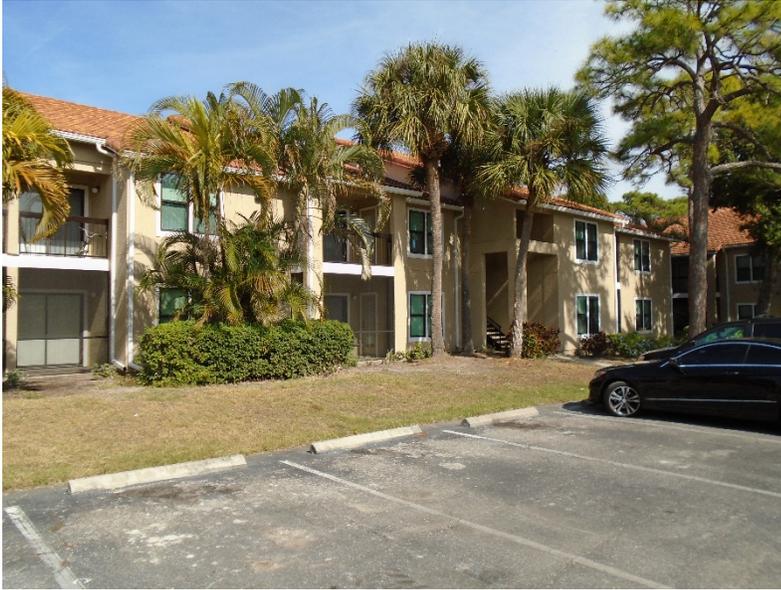
**PHOTOGRAPH #1**

**BUILDING 27  
SECTION B**

Contractor has completed punch list and cleaned site.

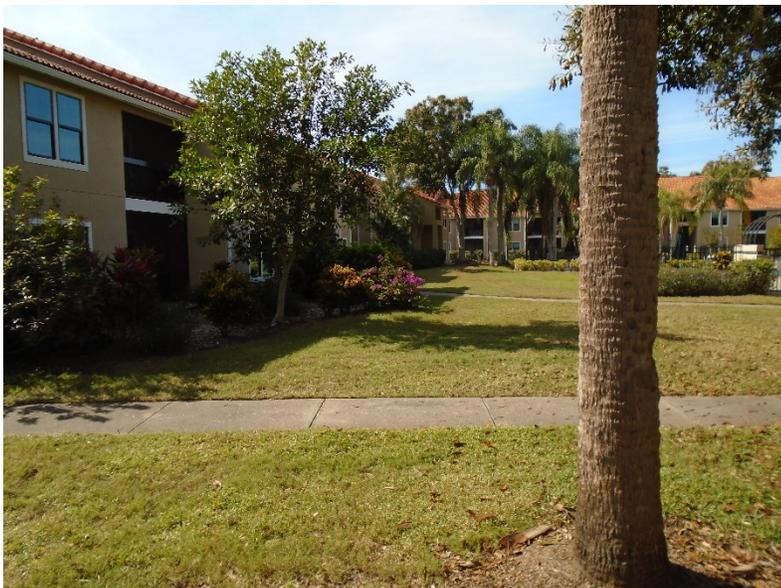
**PHOTOGRAPH #2**

**BUILDING 27  
SECTION F**

Contractor has completed punch list and cleaned site.

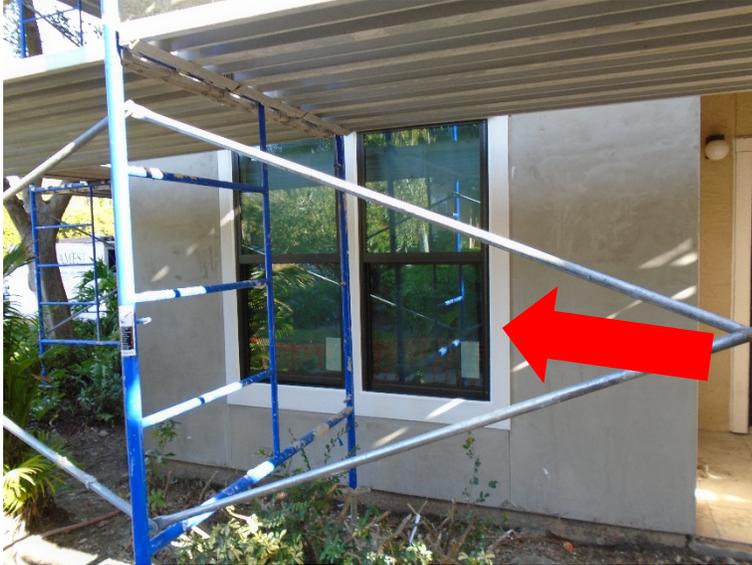
**PHOTOGRAPH #3**

**BUILDING 10  
SECTION D**

New sealant has been installed at window perimeter and stucco band has been primed.

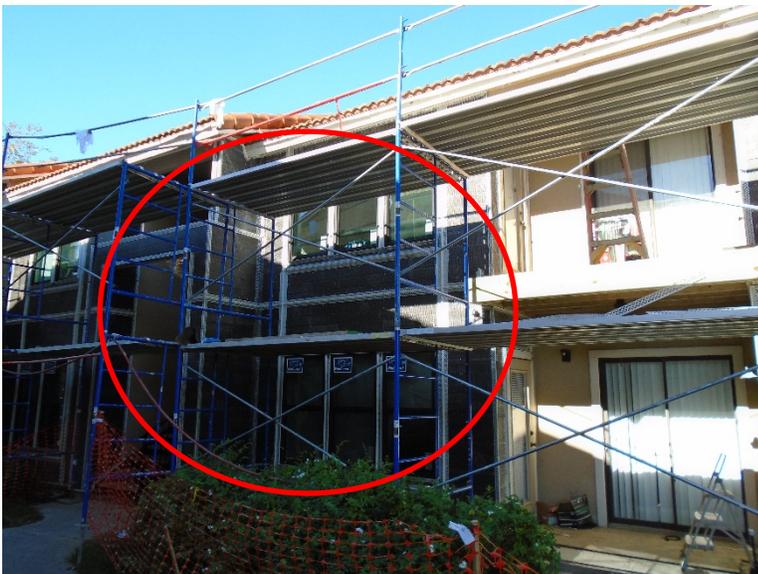
**PHOTOGRAPH #4**

**BUILDING 10  
SECTION F**

Stucco sub-contractor has applied JumboTex 60, stucco accessories and lath.

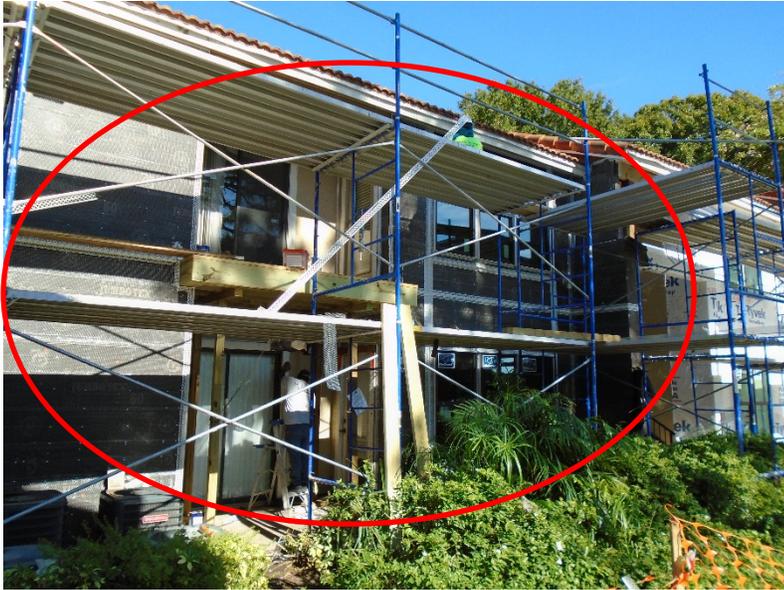
**PHOTOGRAPH #5**

**BUILDING 10  
SECTION F**

Stucco sub-contractor has applied JumboTex 60 WRB, stucco accessories and lath.

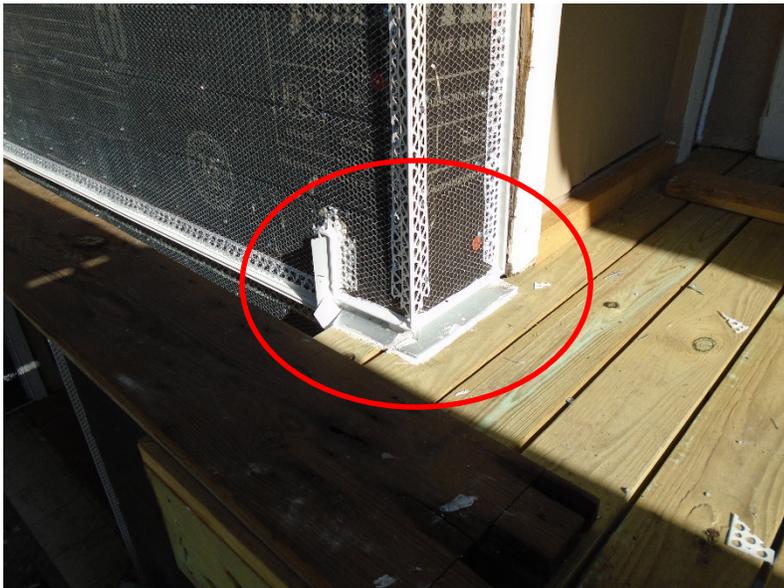
**PHOTOGRAPH #6**

**BUILDING 10  
SECTION F**

Contractor has installed balcony deck kick out flashing.

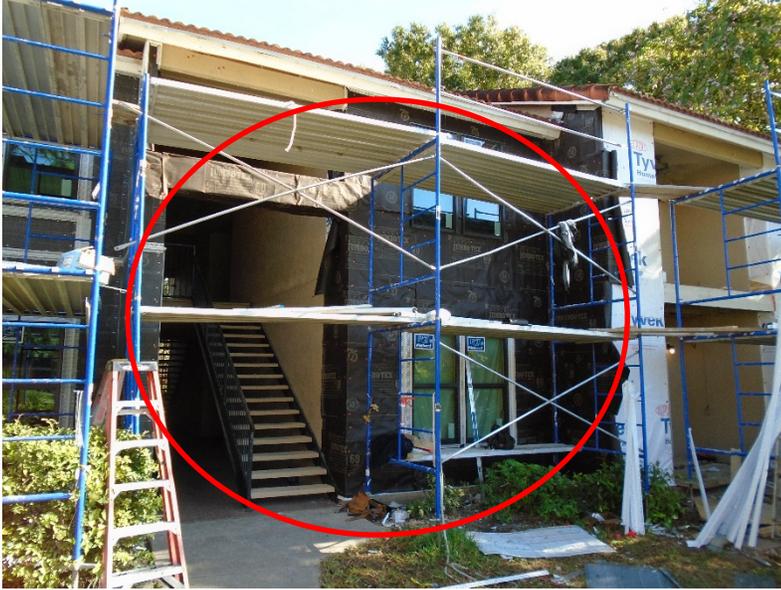
**PHOTOGRAPH #7**

**BUILDING 10  
SECTION G**

Stucco sub-contractor installing  
JumboTex WRB over Tyvek HomeWrap.

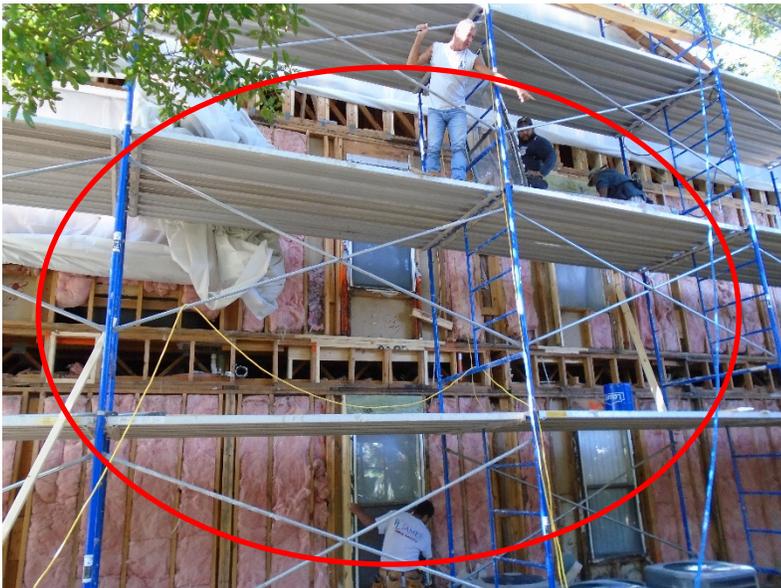
**PHOTOGRAPH #8**

**BUILDING 10  
SECTION H**

Contractor performing framing repairs at  
subflooring, studs and headers.

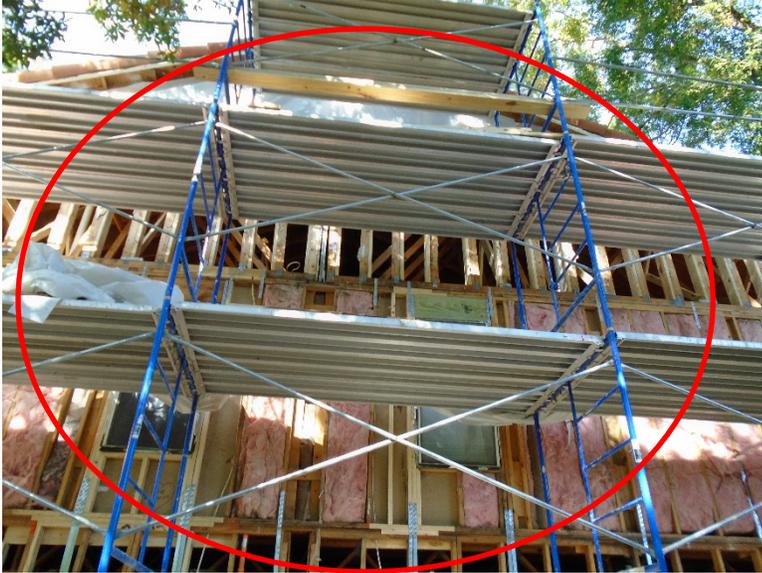
**PHOTOGRAPH #9**

**BUILDING 10  
SECTION H**

Contractor installing Simpson Strong-Tie connectors and straps.

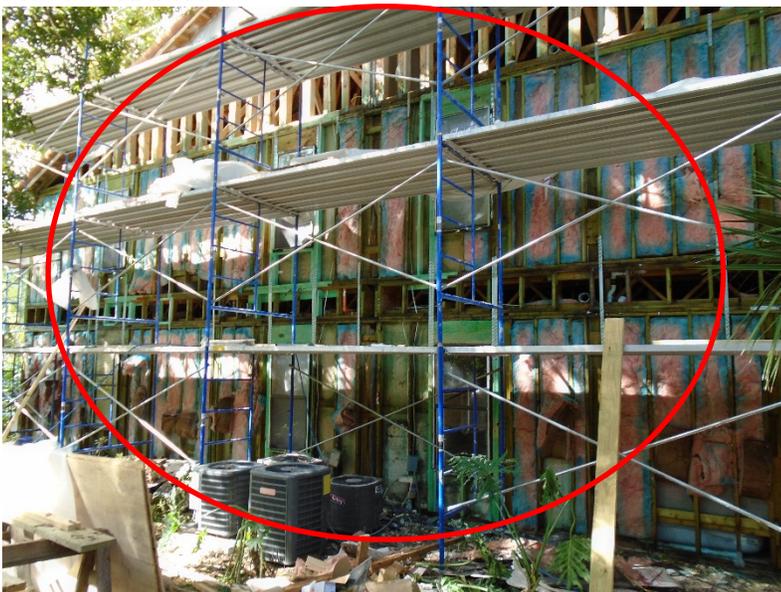
**PHOTOGRAPH #10**

**BUILDING 10  
SECTION H**

Termite contractor has applied Bora Care termite treatment at framing.

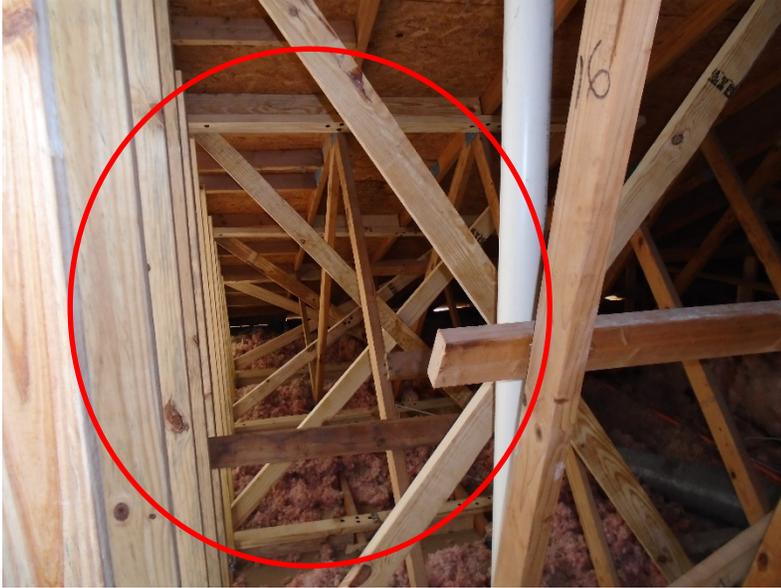
**PHOTOGRAPH #11**

**BUILDING 10  
SECTION H**

Contractor has performed gable end wall bracing and reinforcing.

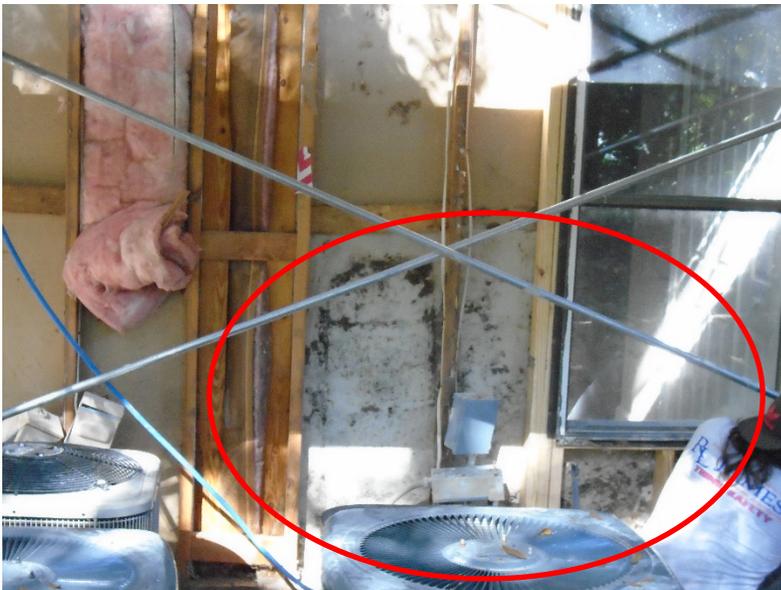
**PHOTOGRAPH #12**

**BUILDING 10  
SECTION H- UNIT 1011**

Damaged drywall to be removed and repaired from inside unit.

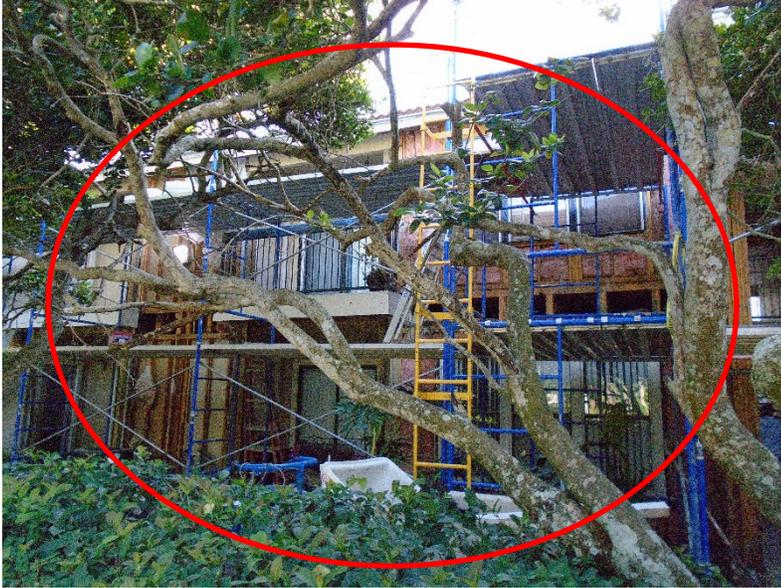
**PHOTOGRAPH #13**

**BUILDING 10  
SECTION B**

Contractor in process of removal of stucco and sheathing.
